Case Study: Metallurgical and Mechanical Analysis of *Castellated Via* Rigid-Flex Connection

Rebecca Wheeling, Ph.D.
Sandia National Laboratories
NM, USA
rwheeli@sandia.gov

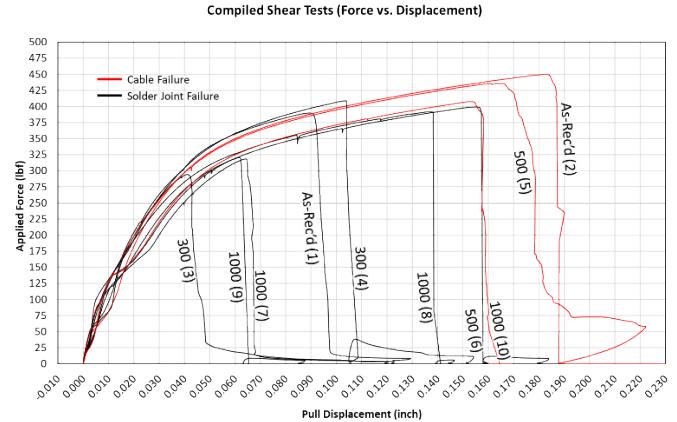
Figure 8. Force vs. displacement plots for all shear tests. Each curve is labeled with its aging condition in number of cycles and its sample ID in parenthesis. Black curves indicate solder joint failures and red curves indicate flex cable failures.

3 out of the top 4 peak load values are due to failures at the flex cable, rather than at the solder joints.

Peak failure loads varied between 294 and 450 lbf with no obvious trend between number of thermal cycles and peak failure load is observed. The highest peak loads are exhibited by the units where the cable failed rather than the solder interconnections. The 3 cable failures indicate that the solder joints are not necessarily the limiting factor in mechanical strength. Aging appears to have had little impact on the cable performance either, as these failures included an as-received assembly and an assembly cycled 1000 times.

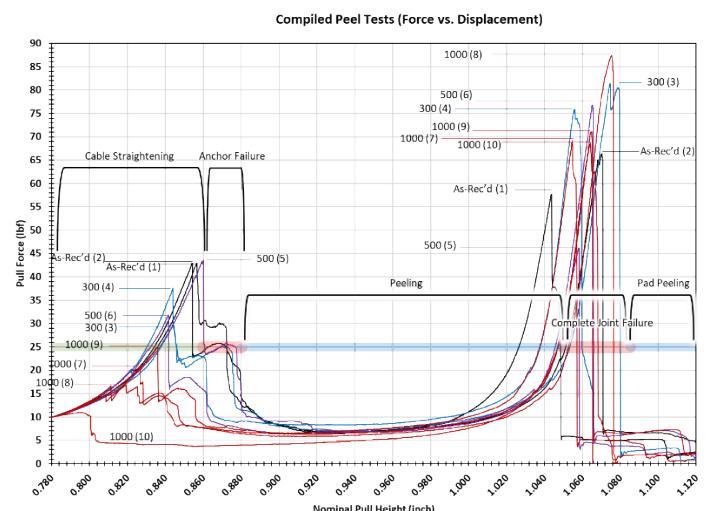
Figure 7. Force vs. displacement plots for all peel tests. Each curve is labeled with its aging condition in number of cycles and its sample ID in parenthesis. Black, blue, purple, and red curves denote as-received, 300 cycle, 500 cycle, and 1000 cycle conditions, respectively. The curves are broken into 5 regions, denoting observed behavior during testing.

The force-displacement curves highlight several distinct loading conditions imposed and associated observations of the flex-cable assembly and solder joints. A bimodal distribution of failures is evident. 2 distinct failures were observed in every test: 1) failure of the 2 larger anchor joints; and 2) failure of the remaining 25 castellations between the anchors.

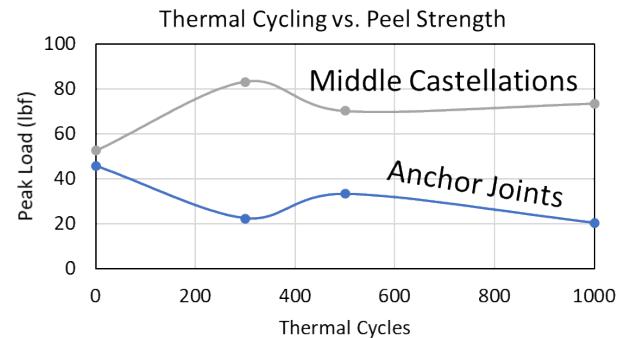
Anchor joints failed at much lower loads, relatively, and should thus be considered the limiting factor for interconnection failure. Figure 19 highlights the average failure loads of the anchor joints compared to the inner castellations as a function of aging condition.

Figure 19. Plot that compares average failure loads of middle castellations (gray) and anchor joints (blue).

The main difference between the side castellations and inner castellations is size and orientation to loading direction; the lower failure loads makes sense, as the solder volume shared between these 2 joints is much less than that between the 25 other joints. If the anchor joints are meant to provide the bulk of the mechanical performance for the cable, larger and or more anchor joints may be desirable. The anchor joints do appear to successfully isolate early mechanical failure though, while presumably still permitting the inner joints to provide the electrical connectivity and performance for cable functionality.
