**Contamination Source Review for Building E6891,
Edgewood Area, Aberdeen Proving Ground, Maryland**

S.D. Zellmer, A.K. Draugelis, J. Rueda, and R.E. Zimmerman

September 1995

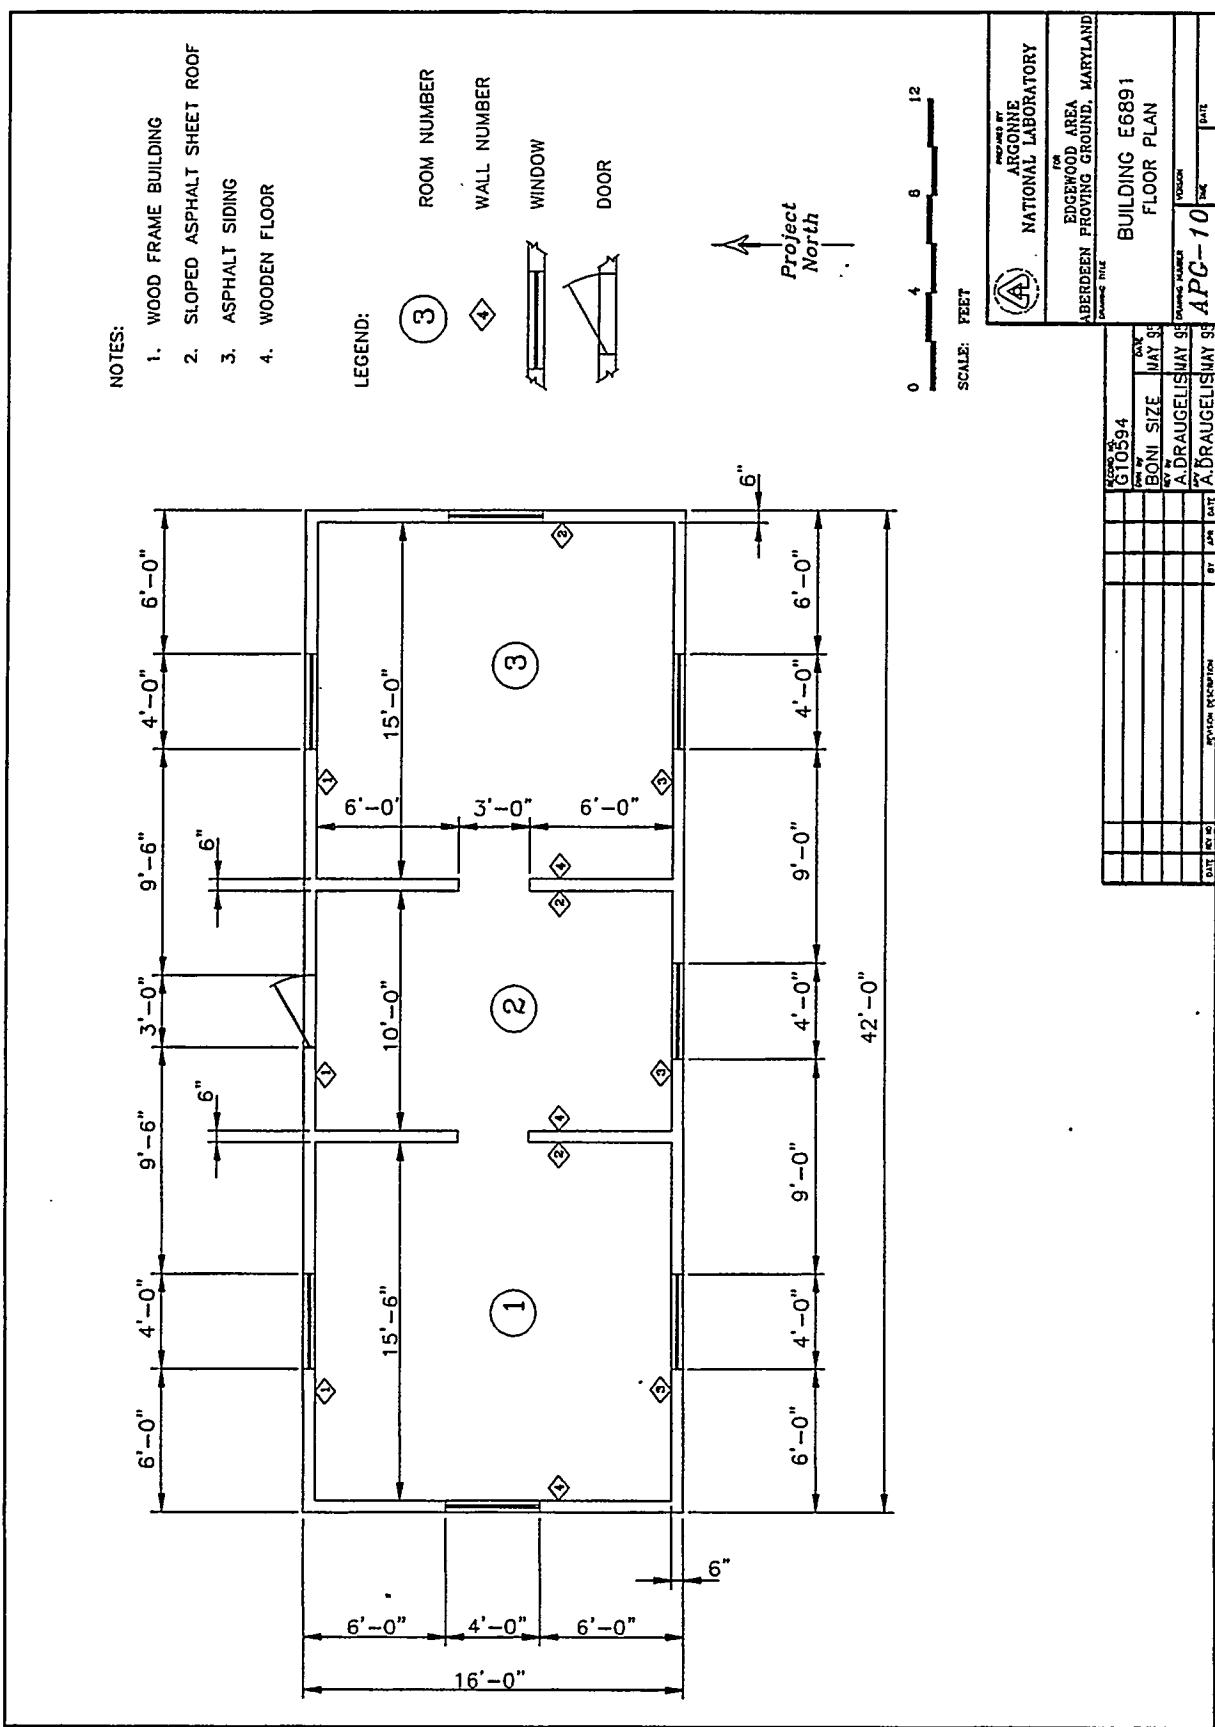
FIGURE 3 Floor Plan of Building E6891

Building E6891 originally contained three rooms, but the interior walls had collapsed. Original room dimensions were: room 1, 15 ft 6 in. by 15 ft; room 2, 10 ft by 15 ft; and room 3, 15 ft by 15 ft. Interior walls with doorways separated the center room (room 2) and the two outer rooms (rooms 1 and 3). Figure 3 shows the floor plan of the building, developed during the ANL survey and from historical documentation (EAI Corporation 1989).

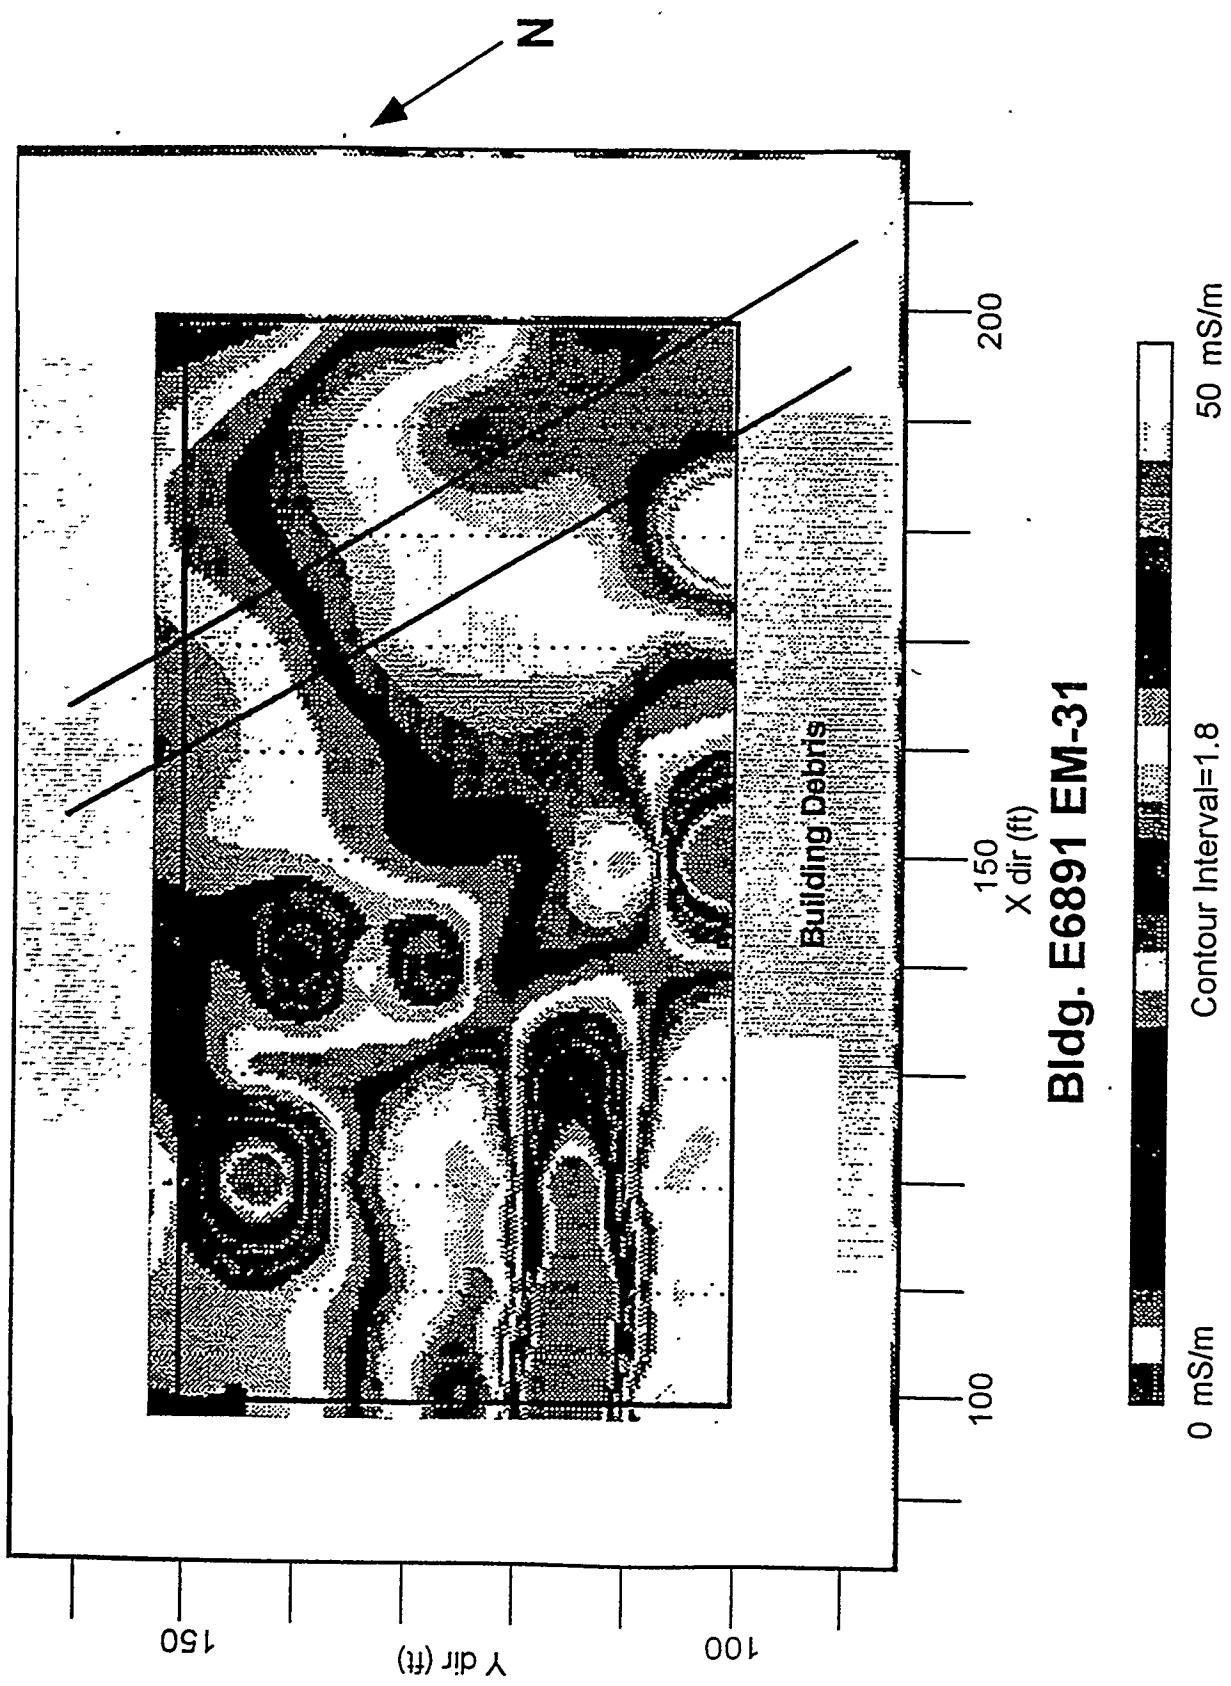
FIGURE 6 Map of the N-S Conductivity Anomalies at Building E6891 Site (measured by using a Geonics EM-31 instrument)

- Large-diameter magnetic electromagnetic field (EMF), conductivity, and ground penetrating radar (GPR) anomalies are centered about 10 ft east and 45 ft north of the northwest corner of the building debris. EMF and magnetic point anomalies were also observed about 15 ft east and 25 ft north of the northwest corner of the building debris. A probable source for these anomalies is buried metals.

- A linear conductivity low was observed starting about 15 ft north of the northwest corner of the building debris and extending about 30 ft to the east. Point magnetic and EMF anomalies are also observed within this conductivity low. These anomalies were complex and discrete point metal sources resulting in different signatures for different instruments.

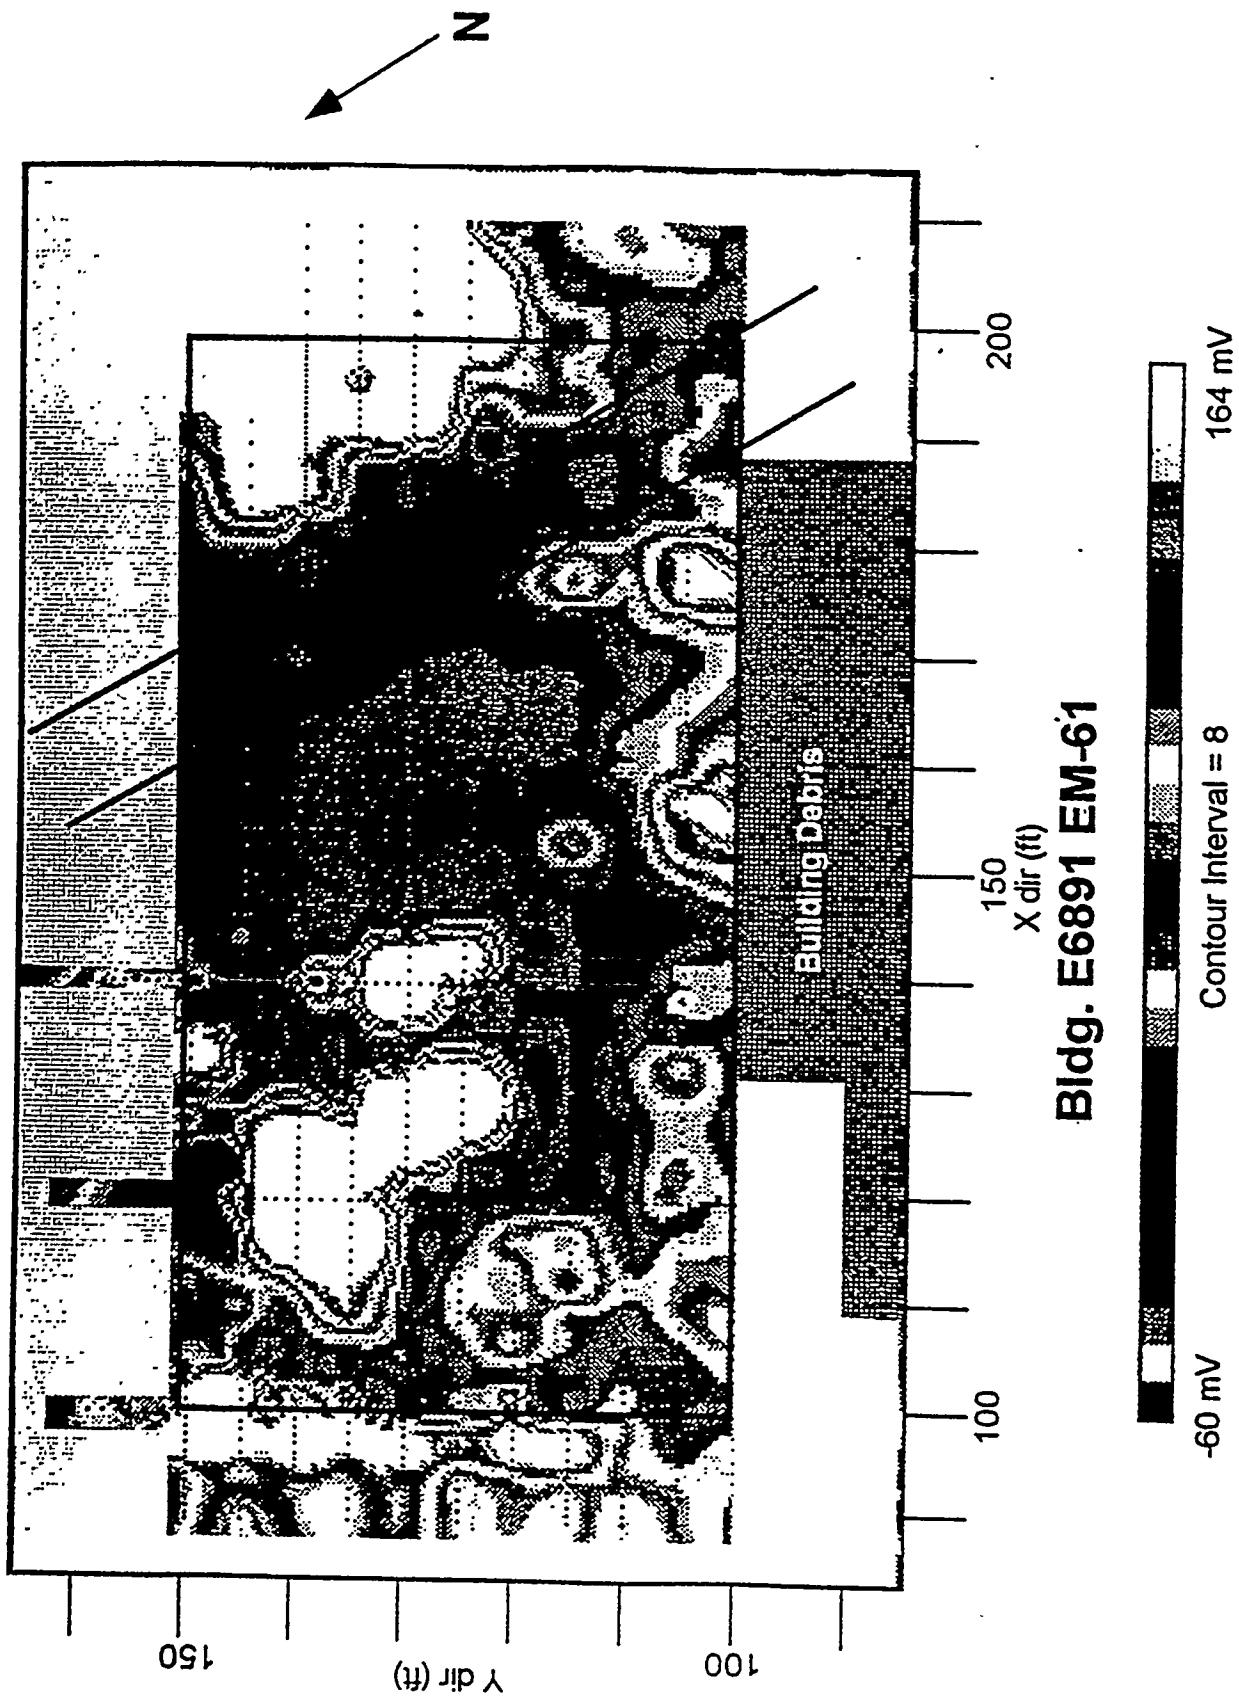
FIGURE 9 Map of the EMF Anomalies at Building E6891 Site (measured by using a Geonics EM-61 instrument)

- Magnetic, EMF, and GPR anomalies were observed in the area northeast of the gravel road. This area is about 10 ft east and 35 north of the northeast corner of the building debris. ANL personnel noted uneven terrain in this area, suggesting that these anomalies are caused by waste metals.

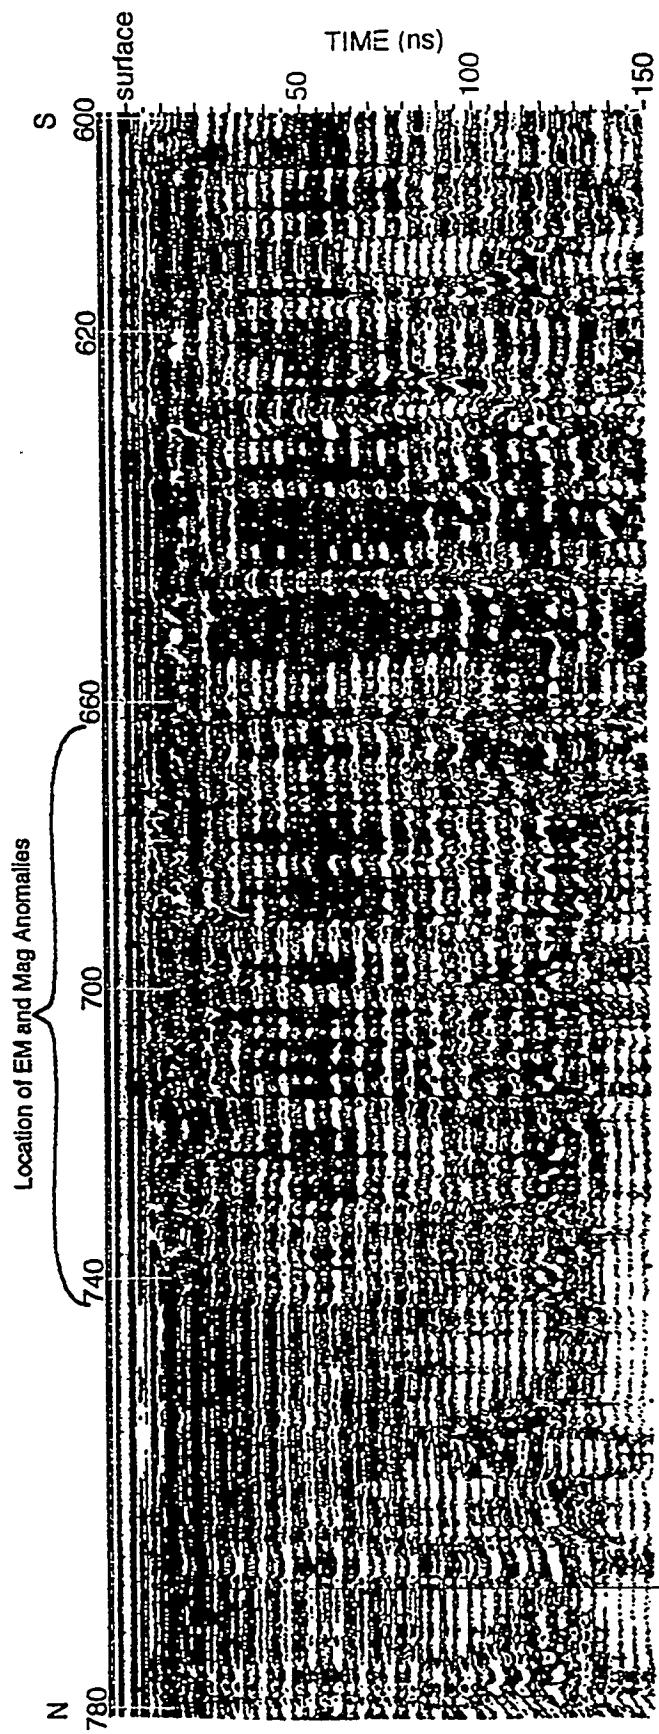
FIGURE 17 Ground Radar Image Along the Long Axis of the Anomaly Located in the Northern Section of the Southeast Dump Site Survey Grid (The maximum penetration depth is estimated at 3 feet.)

GPR data did not correspond well with magnetic or resistivity data at the two principal anomalies discussed above. GPR transects perpendicular to the anomalies showed very subtle or no changes in electrical properties, however, transects parallel to the long axes of the anomalies displayed chaotic reflection zones characteristic of disturbed soils (Figures 17 and 18). Hyperbolas were not evident in the radar data suggesting that the buried objects responsible for the EM and magnetic anomalies are probably an accumulation of small metallic objects such as shell casings. The reason for the inconsistencies between radar transects at different orientations across the EM/magnetic anomalies is unknown.
