**Contamination Source Review for Building E3236,
Edgewood Area, Aberdeen Proving Ground, Maryland**

ANL/ESD/TM-104

S.D. Zellmer, M.P. Smits, A.K. Draugelis, M.A. Glennon, J. Rueda, and R.E. Zimmerman

September 1995

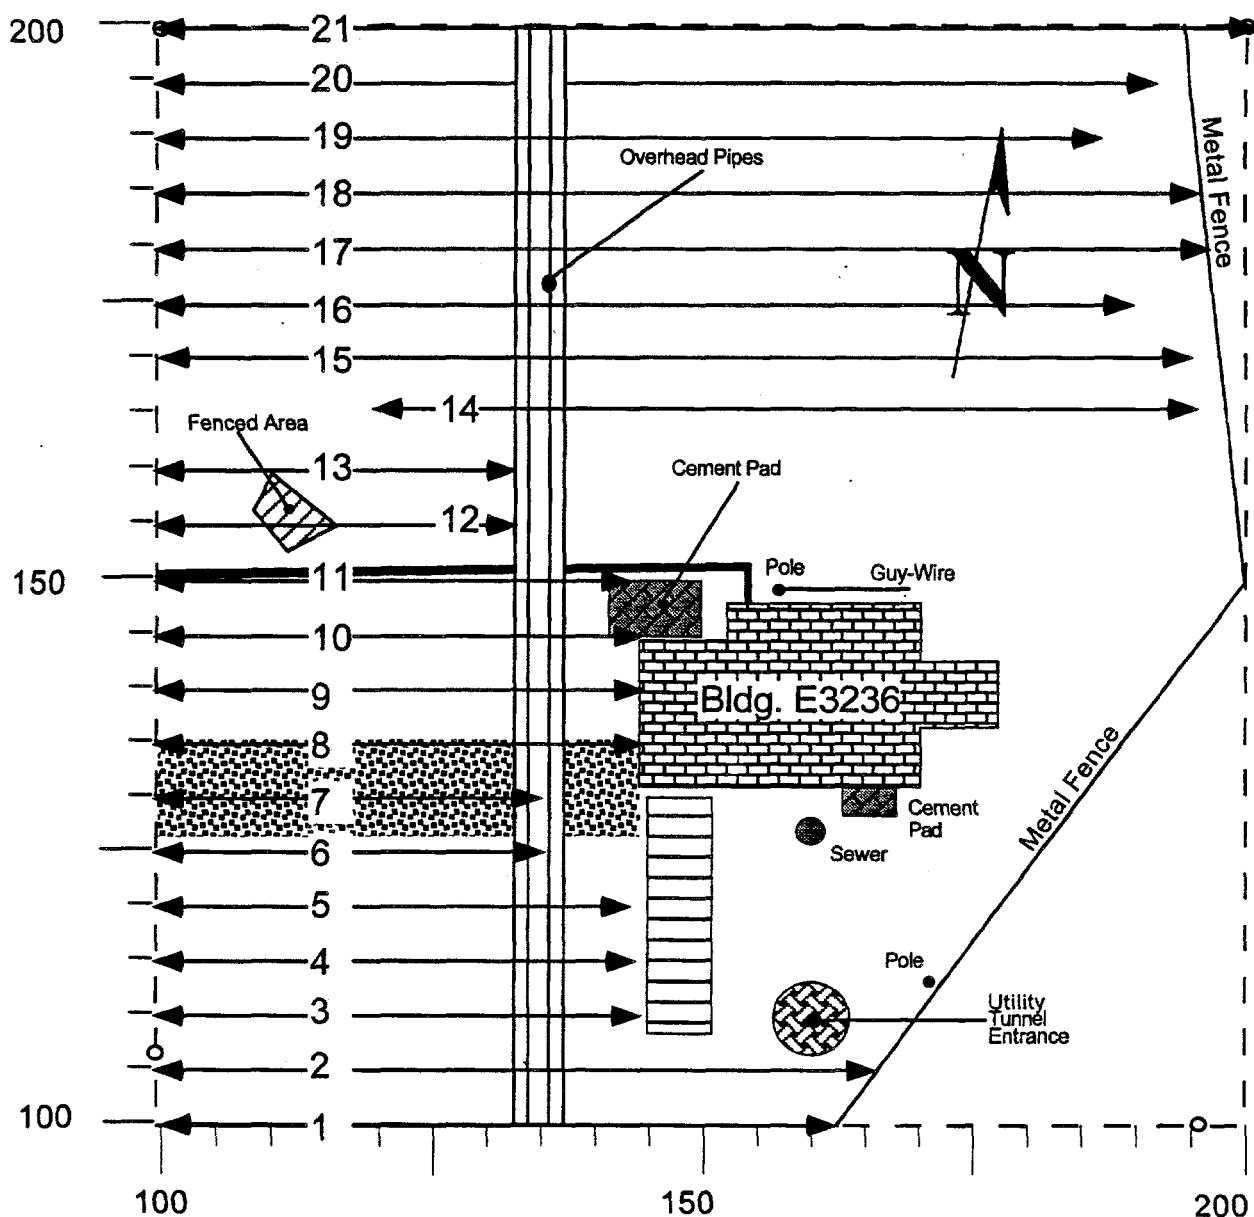
FIGURE 3 Map of GPR Transects Conducted Near Building E3236

1. Continuously recording, total-field magnetometer (EG&G Geometrics G822L), with Y transects spaced 5 ft apart and X tie lines spaced 5 ft apart.
2. Time-Domain Geonics EM-61, designed for detection of metals, with Y transects spaced 5 ft apart and X tie lines spaced 5 ft apart.
3. Ground-Penetrating radar GSSI, SIR 3, with Y transects spaced 5 ft apart. The locations of GPR profiles and their assigned reference numbers are shown in Figure 3.
