**Contamination Source Review for Building E5485,
Edgewood Area, Aberdeen Proving Ground, Maryland**

Energy Systems Division
Argonne National Laboratory

September 1995

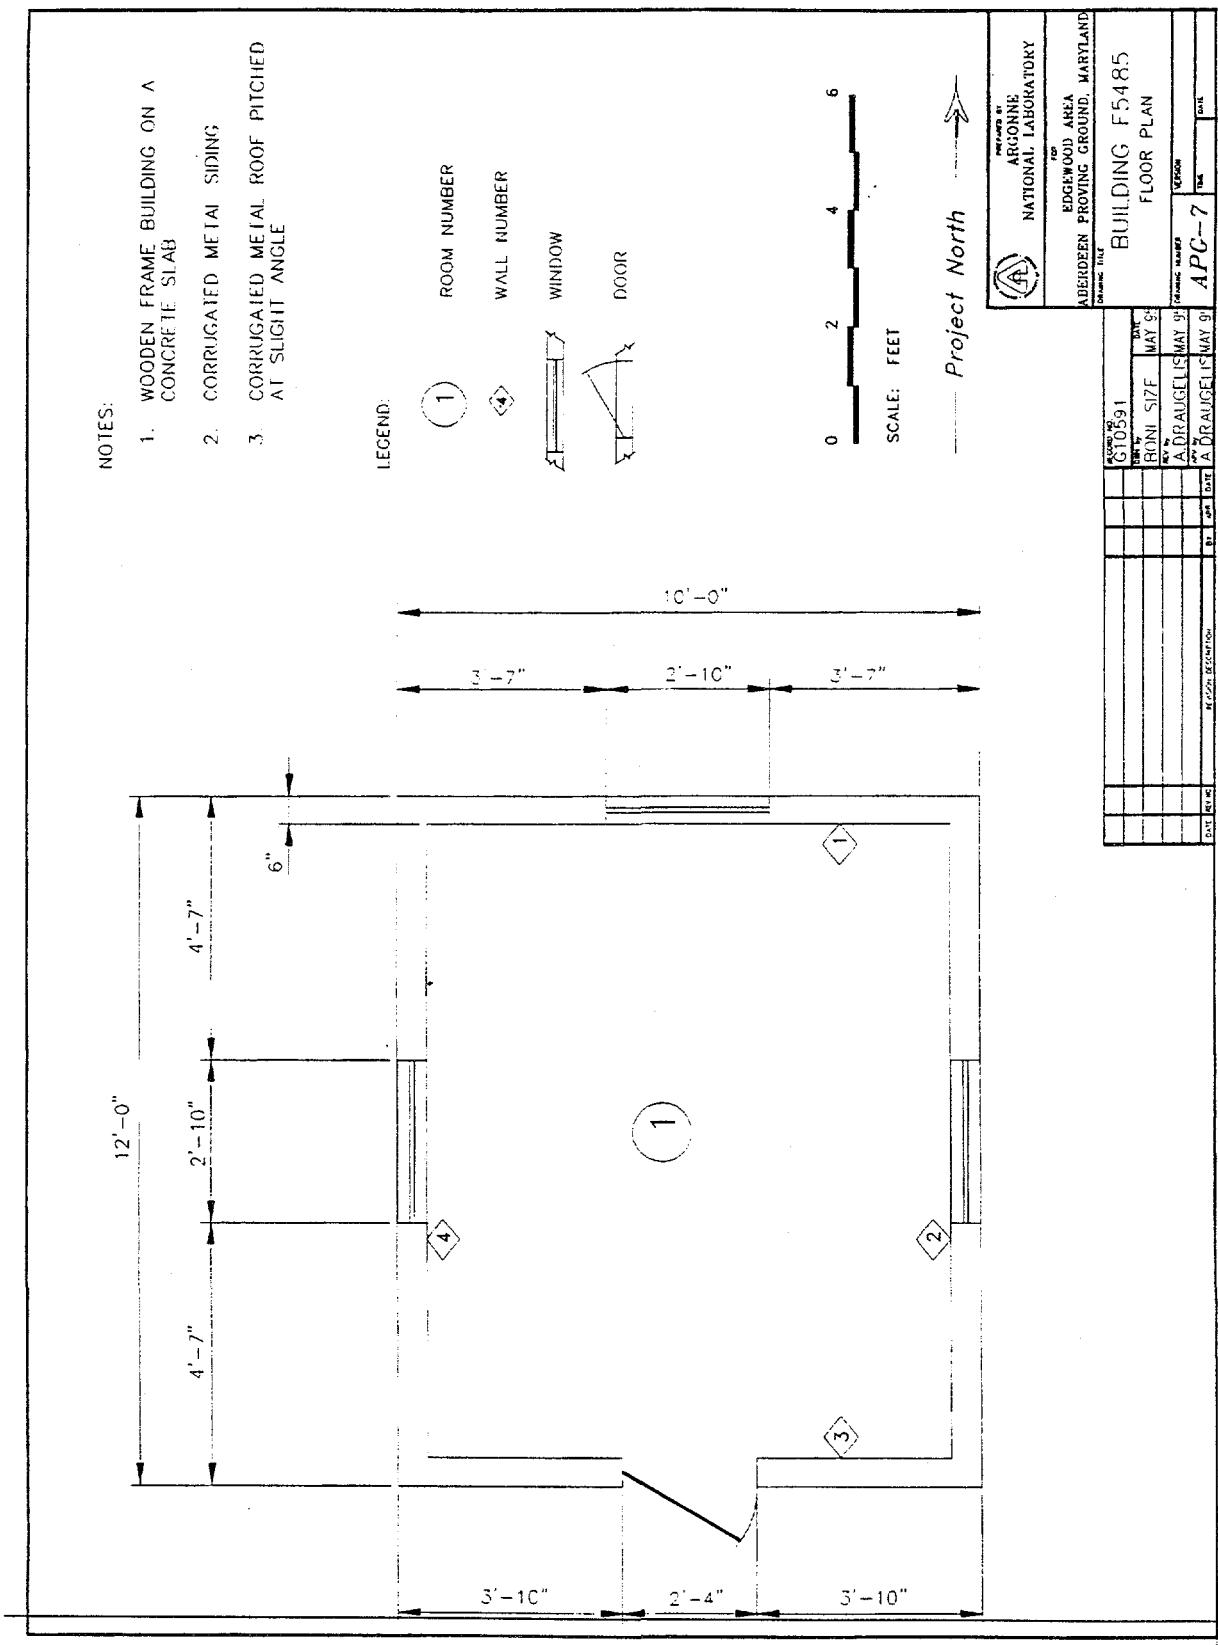
FIGURE 3 Building E5485 Floor Plan

The exterior dimensions of Building E5485 are 10 ft by 12 ft (Figure 3).

Building E5485 consists of one room measuring 9 ft 6 in. by 11 ft 6 in. (Figures 3 and 5).
