**Contamination Source Review for Building E3162,  
Edgewood Area, Aberdeen Proving Ground, Maryland**

G.A. Miller, A.K. Draugelis, J. Rueda, and R.E. Zimmerman

September 1995

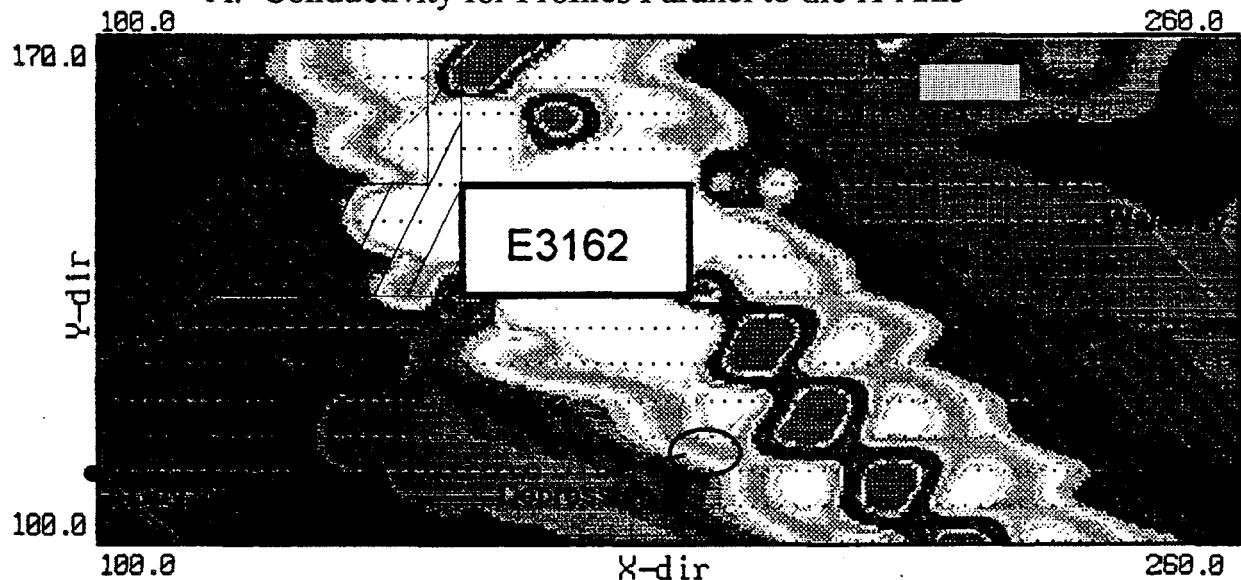
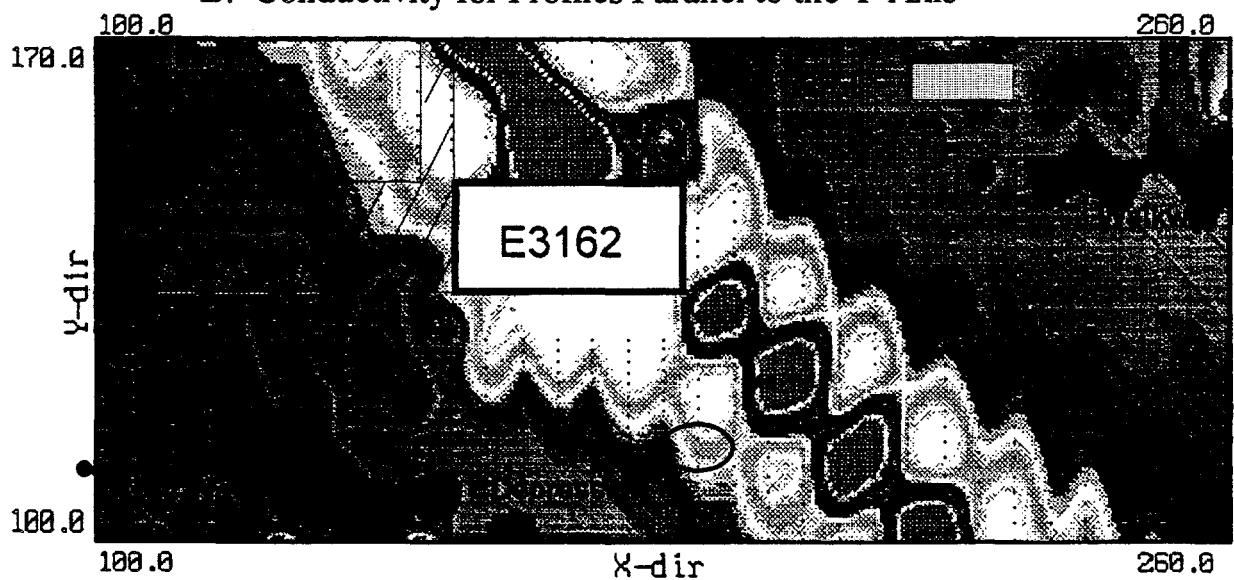
A: Conductivity for Profiles Parallel to the X-Axis

Two broad positive EMF anomalies are located at the northeast and northwest corners of the survey area. The anomaly in the northwest corner is probably caused by the overhead steam line. The anomaly in the northeast corner is probably caused by Building E3165, which is located immediately north of the survey area.

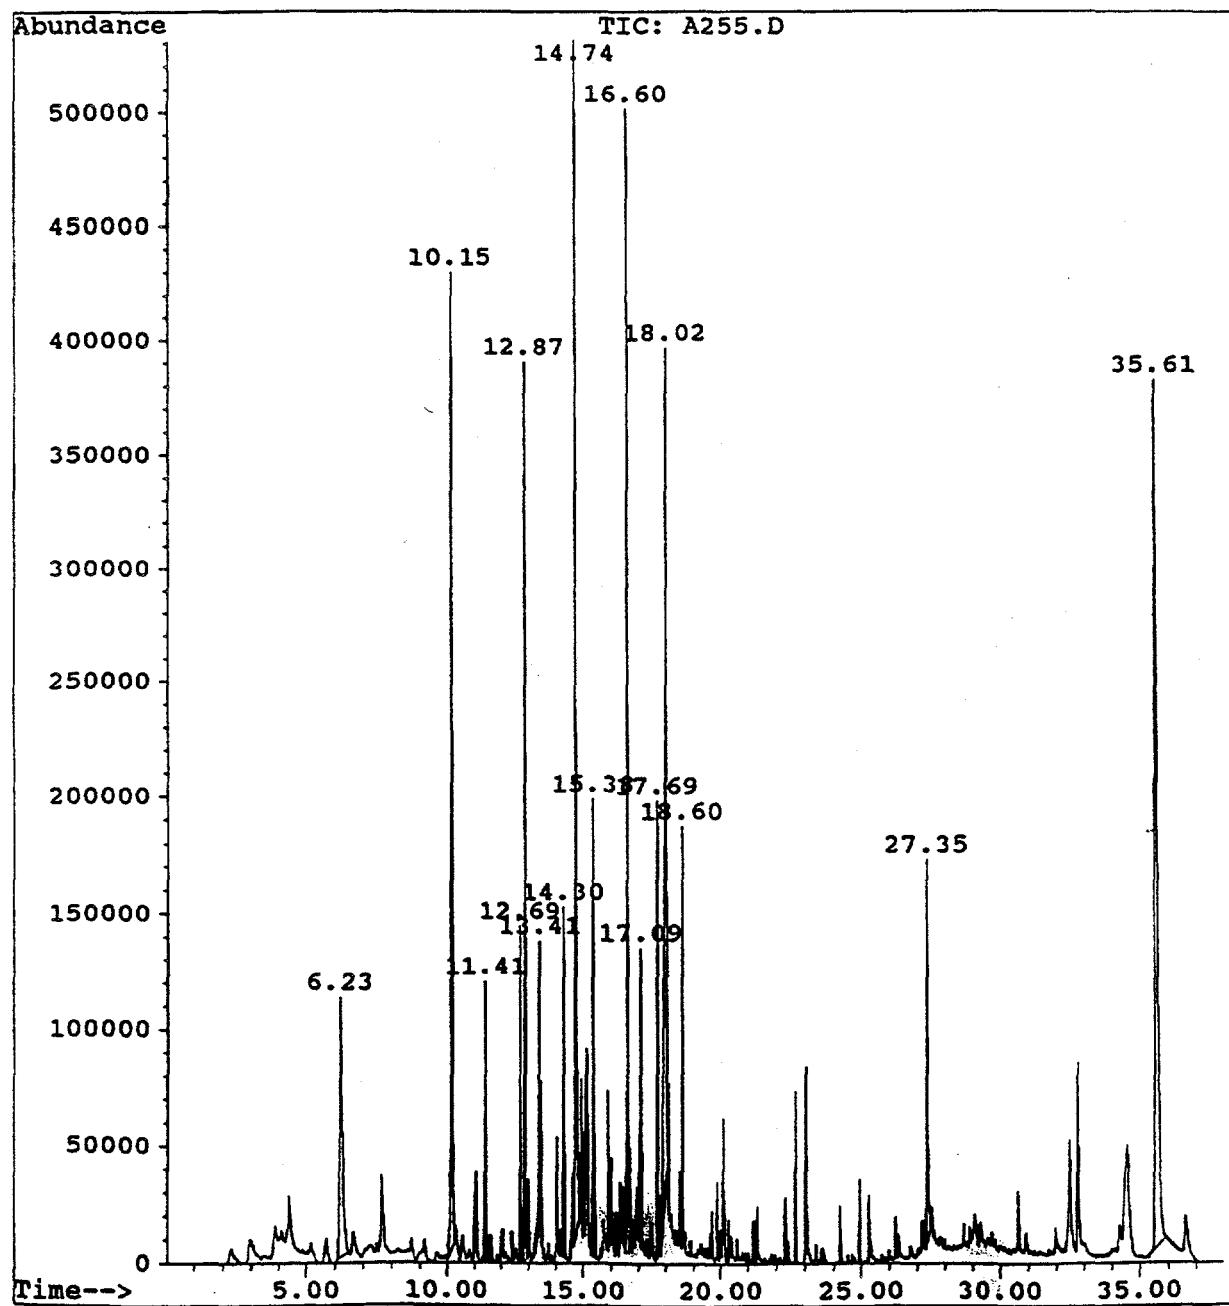
Figure 1 is a total ion chromatogram (TIC) of the air sample taken in E3162. Figures 2 and 3 are TICs of the outside air samples. Table 1 is the air sampling data sheet.

File : A:\A255.D  
Operator : lar  
Acquired : 18 Nov 94 5:50 pm using AcqMethod PILOT  
Instrument : 5972 - In  
Sample Name: 255(52) E3162 inside 10:15-12:15 200mL/min  
Misc Info : start, 200mL/min end NE corner facing NE  
Vial Number: 1

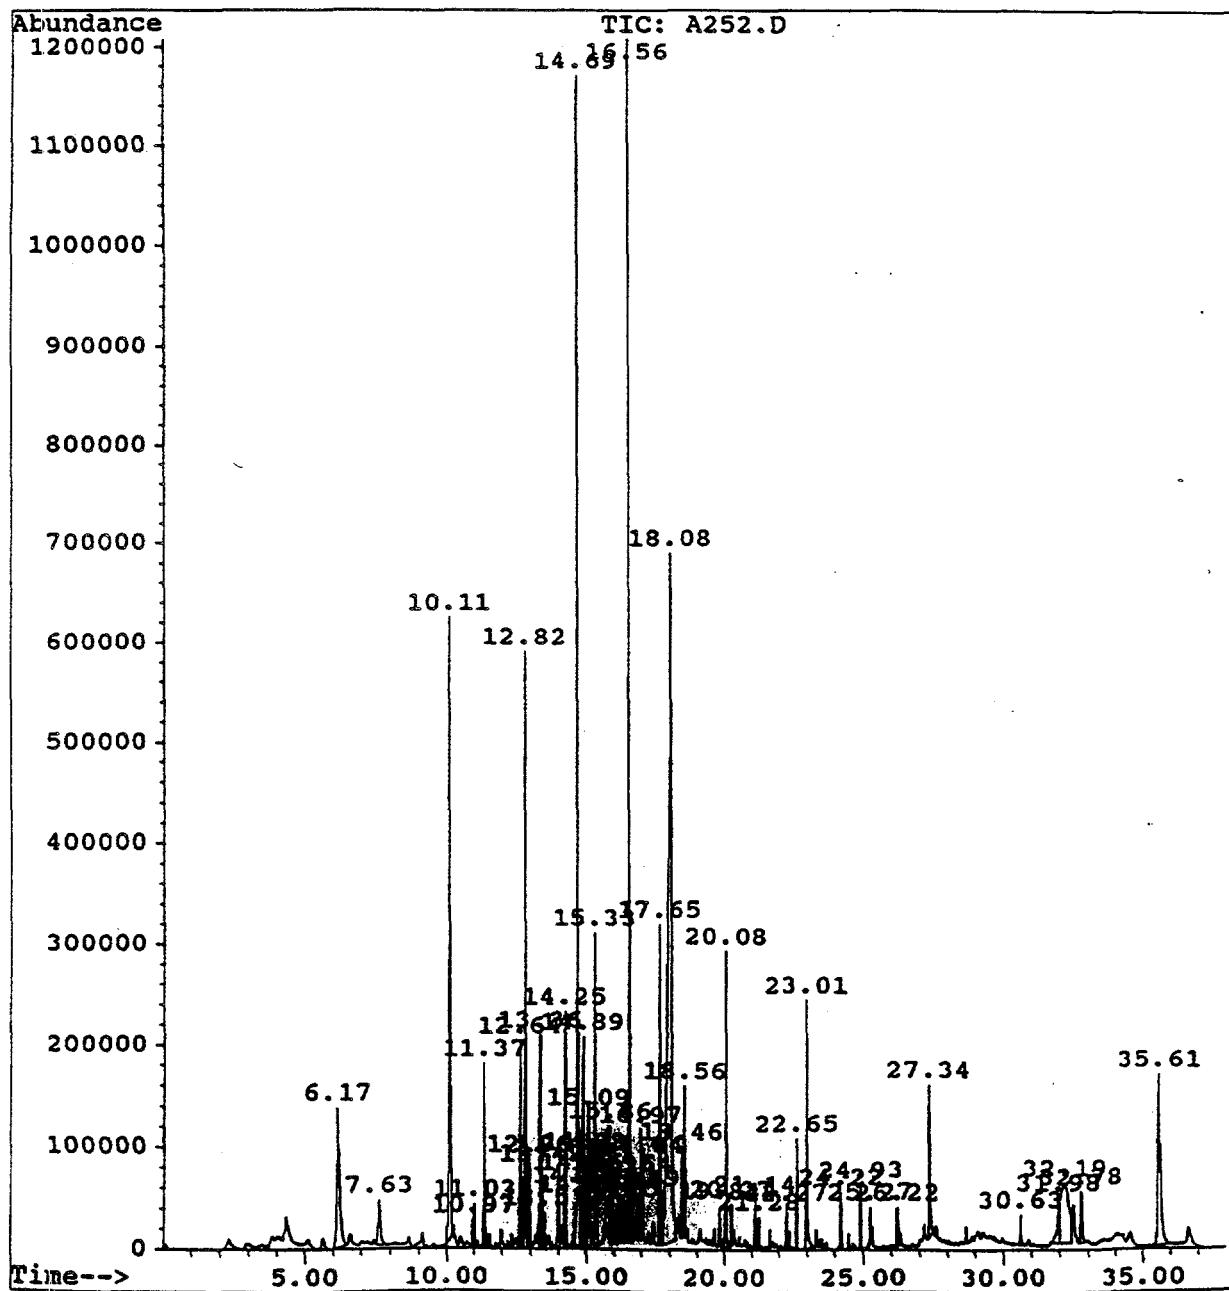
File : A:\A252.D  
Operator : lar  
Acquired : 18 Nov 94 3:19 pm using AcqMethod PILOT  
Instrument : 5972 - In  
Sample Name: 252(48) E3162 outside 10:02-12:02 200mL/min  
Misc Info : start, 300mL/min end SW corner facing SW  
Vial Number: 1

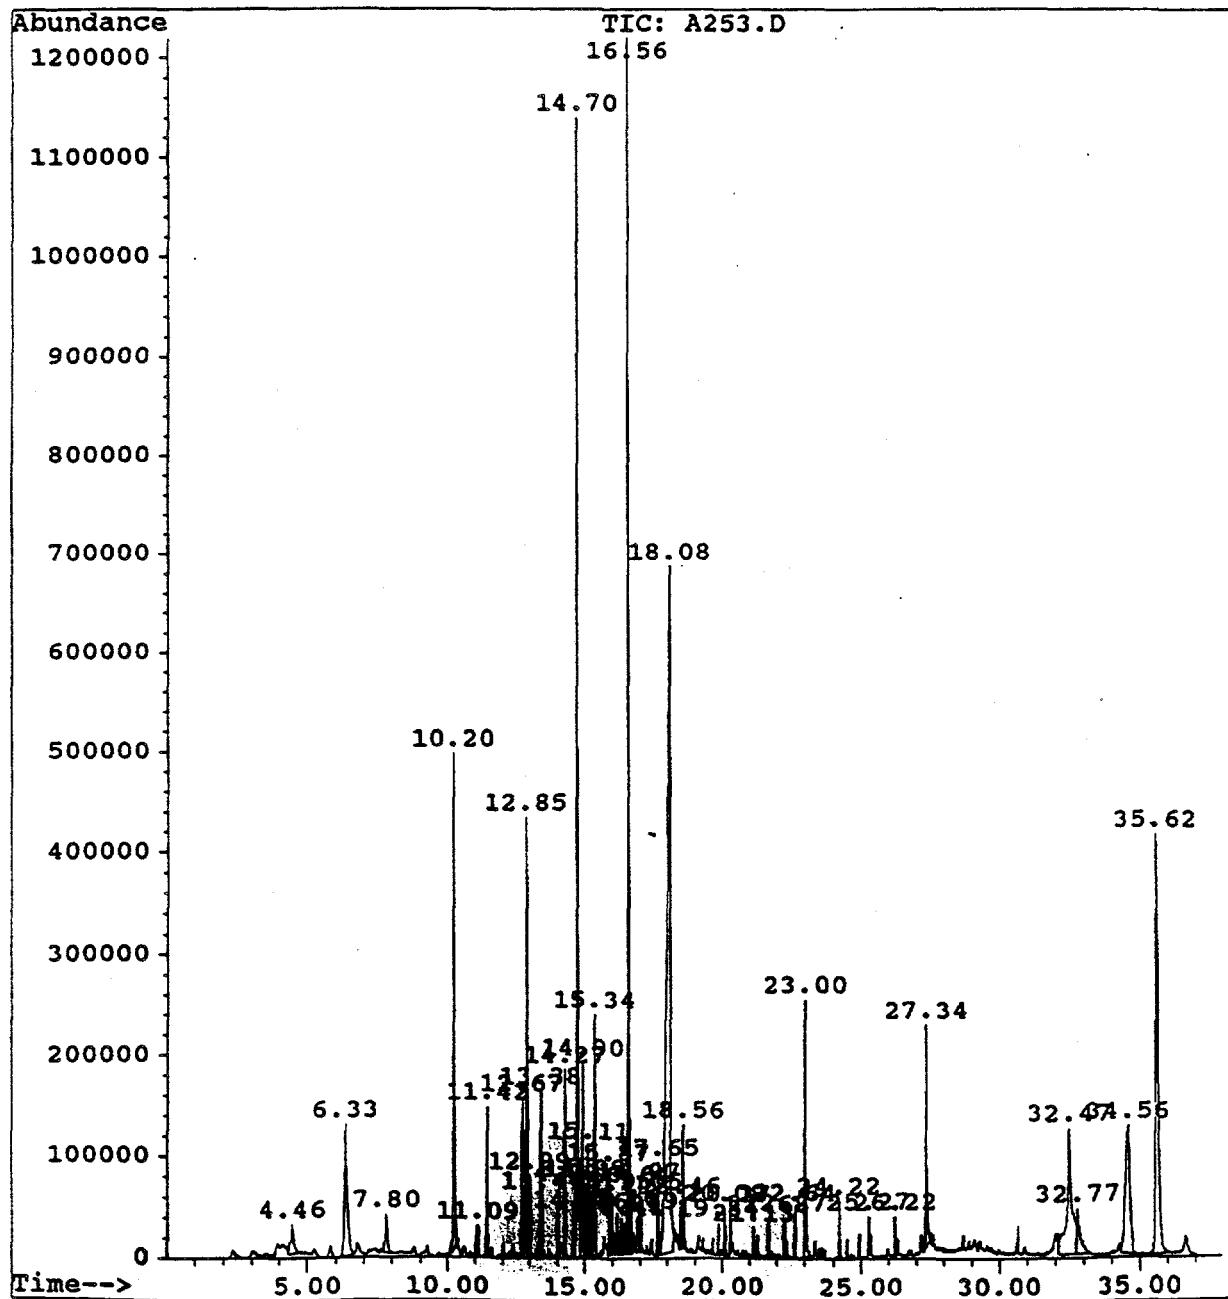
File : A:\A253.D  
Operator : lar  
Acquired : 18 Nov 94 4:08 pm using AcqMethod PILOT  
Instrument : 5972 - In  
Sample Name: 253(47) E3162 outside 10:02-12:02 200mL/min  
Misc Info : start, 300mL/min end NE corner facing NE  
Vial Number: 1
