## **Tidd Hot Gas Clean Up Program**

### **Final Report**

October 1995

The Tidd Hot Gas Clean Up (HGPU) system was installed in the Tidd Pressurized Fluidized Bed Combustion (PFBC) Demonstration Plant, which is the first utility-scale PFBC plant in the United States. The plant is owned and operated by Ohio Power Company and is located on the banks of the Ohio River, approximately 75 miles downstream of Pittsburgh, Pennsylvania.

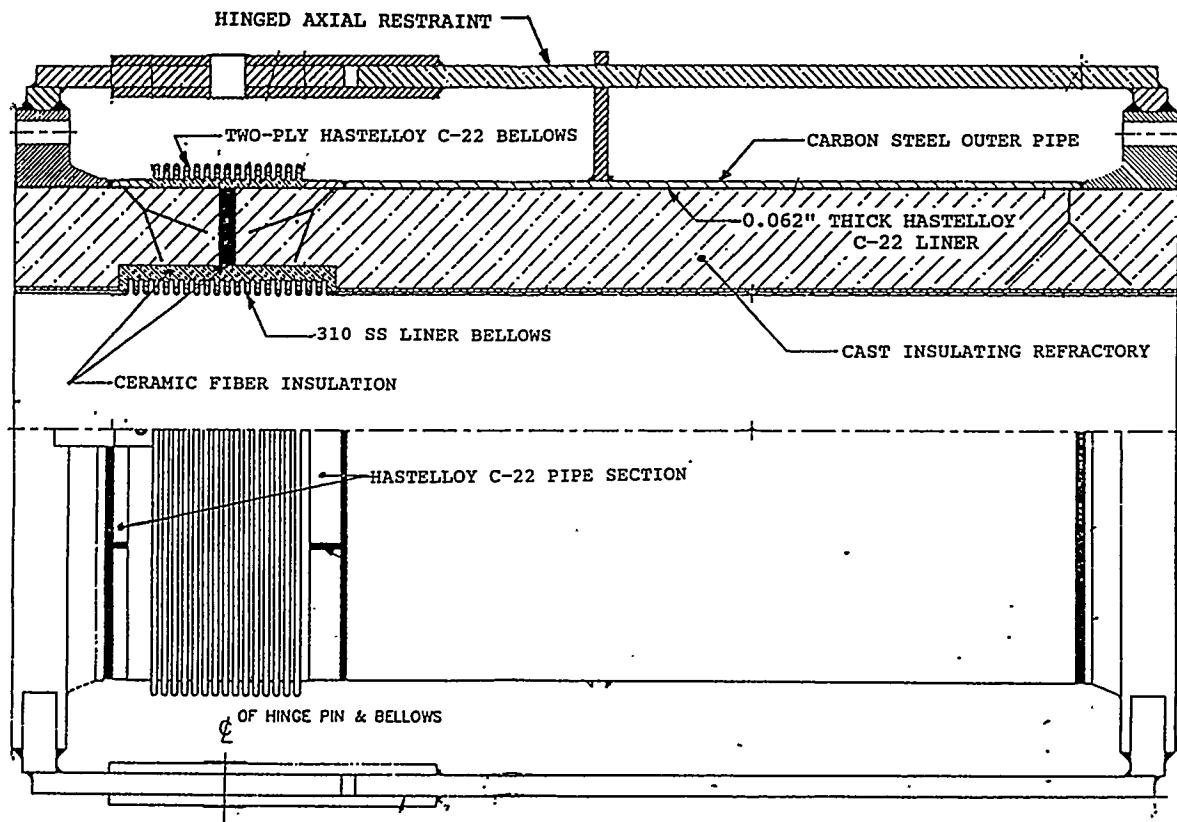
Figure 4.2.2 - Typical Expansion Joint After Modifications

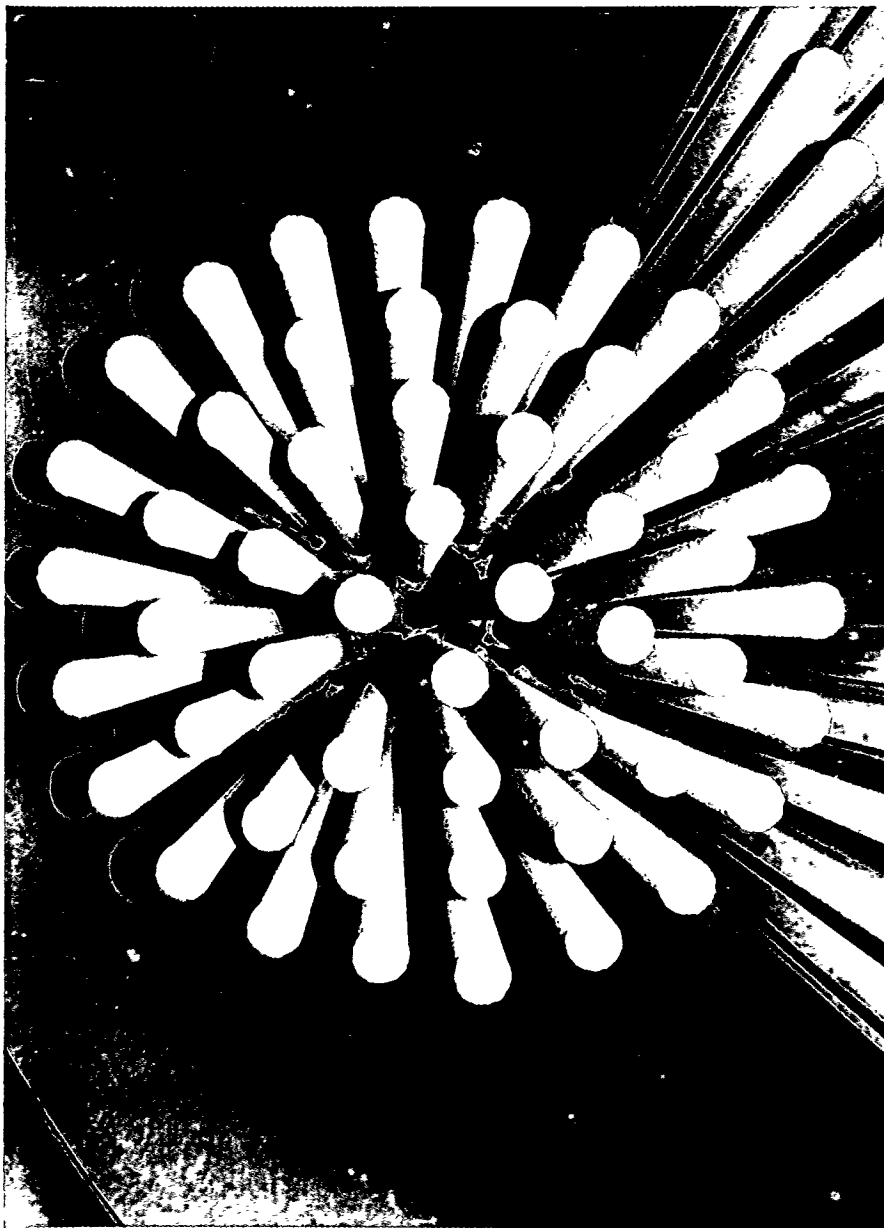
**Figure 4.3.1 - Photograph of Bottom Filter Candles Following Test Run 1**

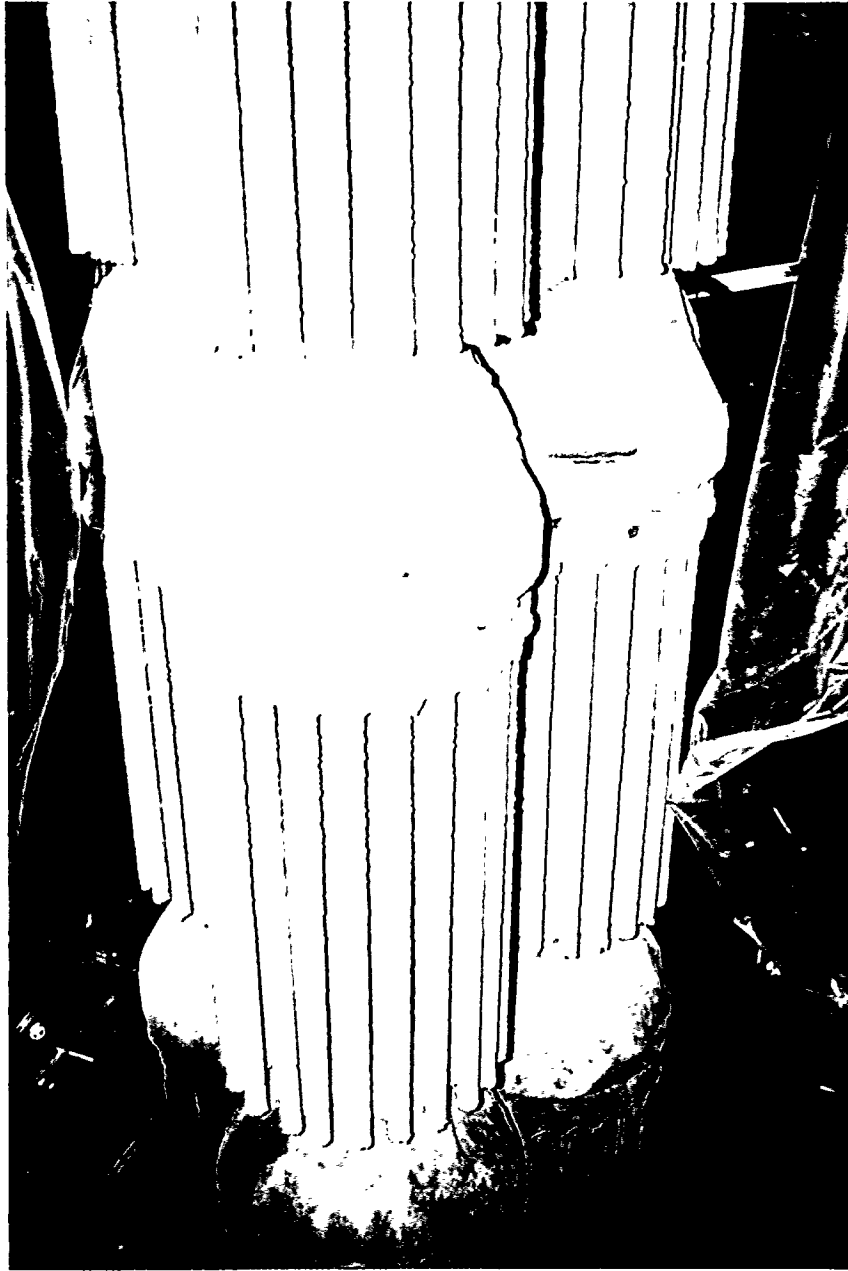
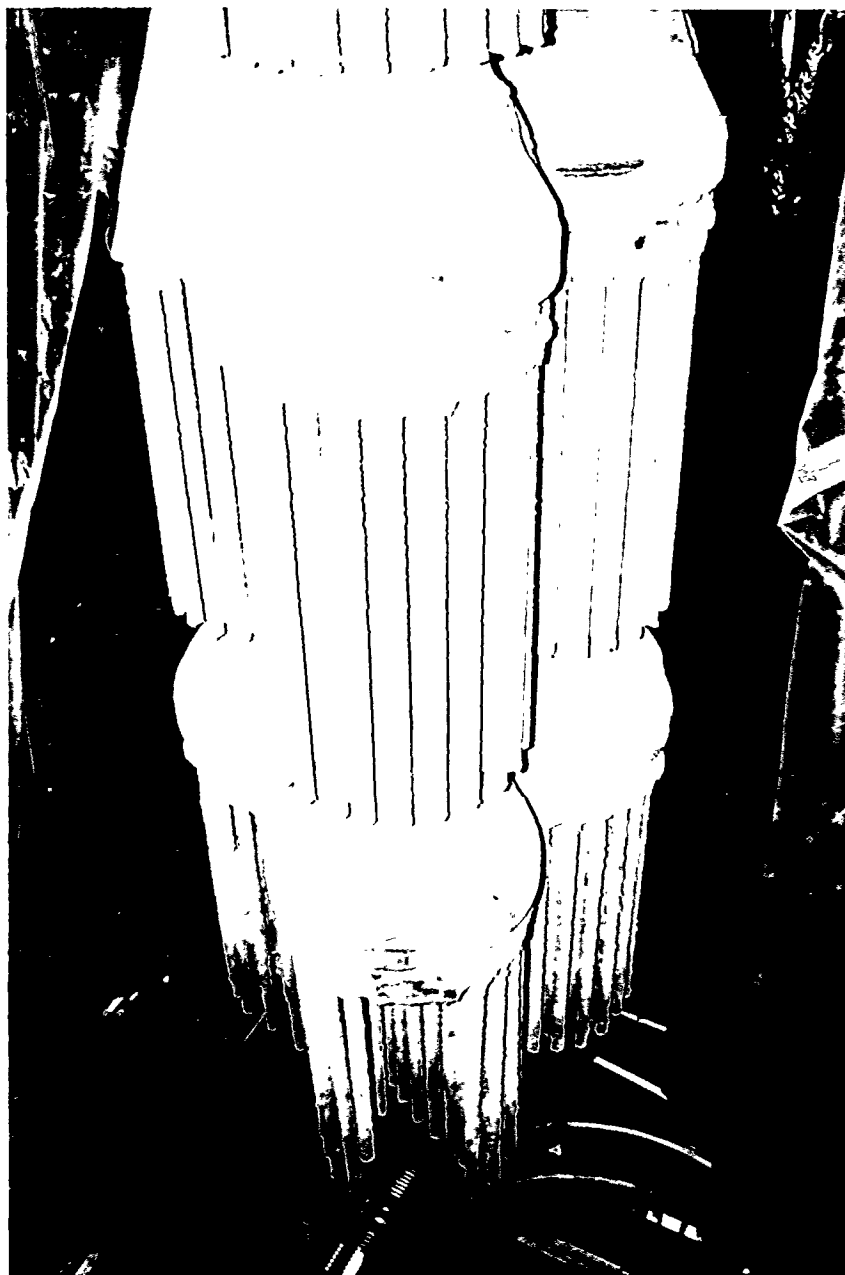
| RUN NO. | COAL FIRE | | UNIT TRIP | | COAL FIRE HOURS | NOTES |
|---|---|---|---|---|---|---|
| 4 | 11/25/92 | 12:11 | 12/07/92 | 09:56 | 285.8 | Warm startup. Unit trip due to XJ7 failure. 21 candles found broken during outage. |

**Figure 4.3.2 - Photograph of Filter Internals Following Test Run 4**

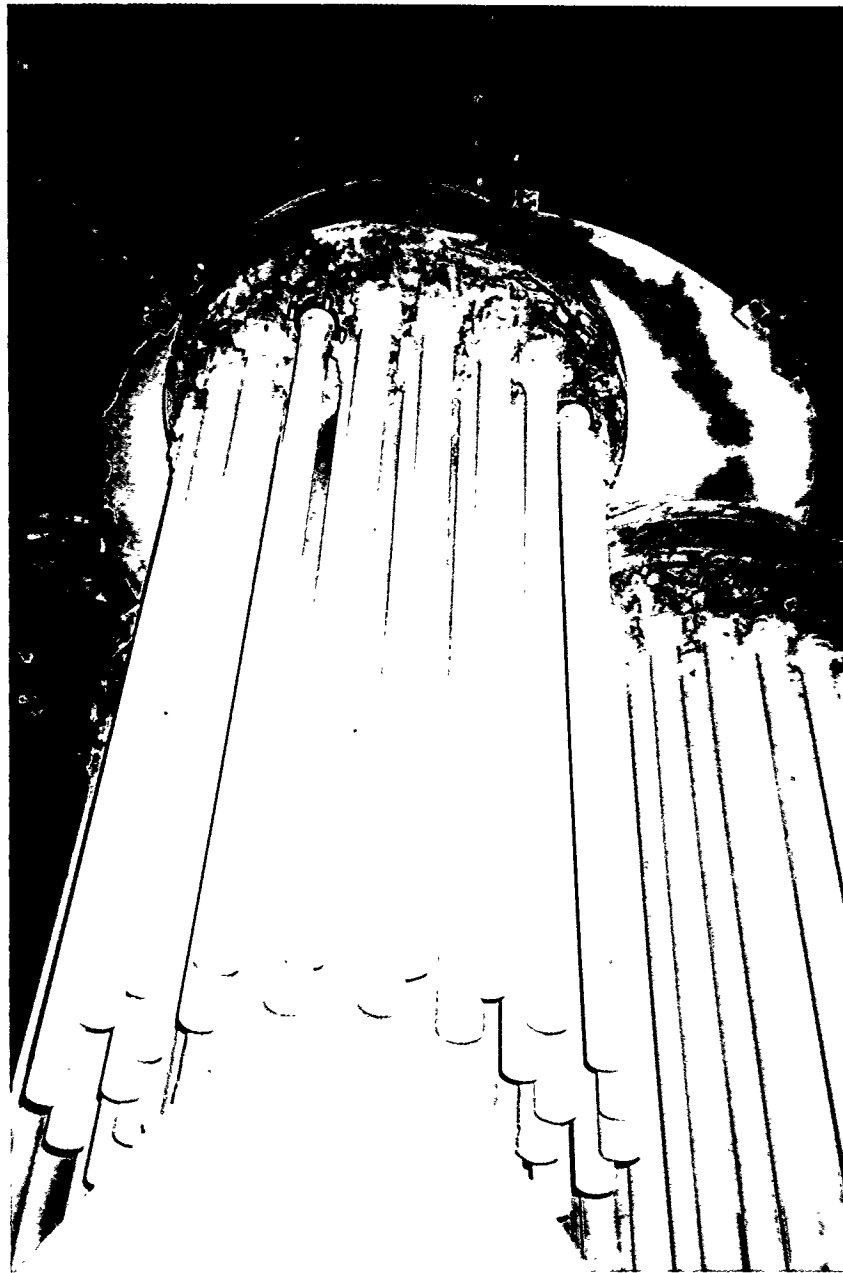
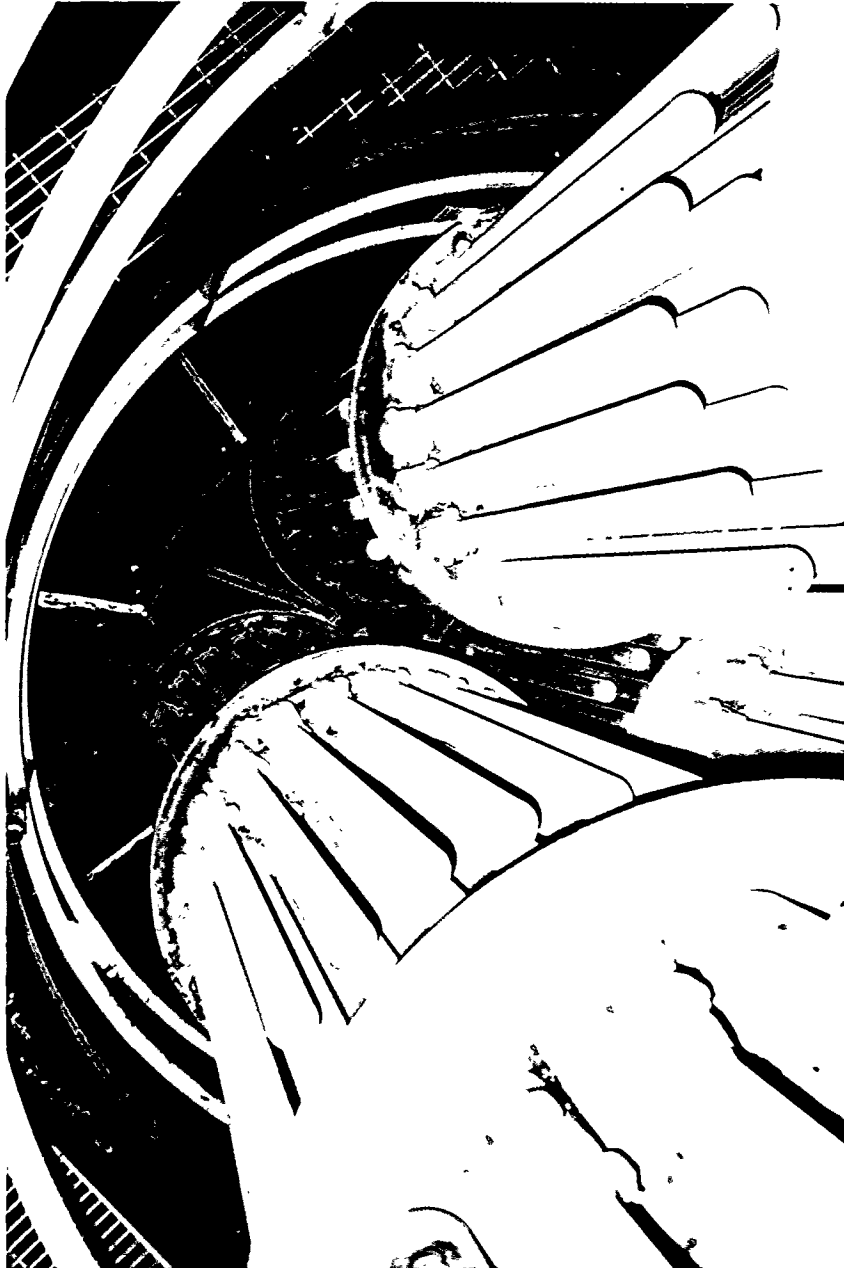
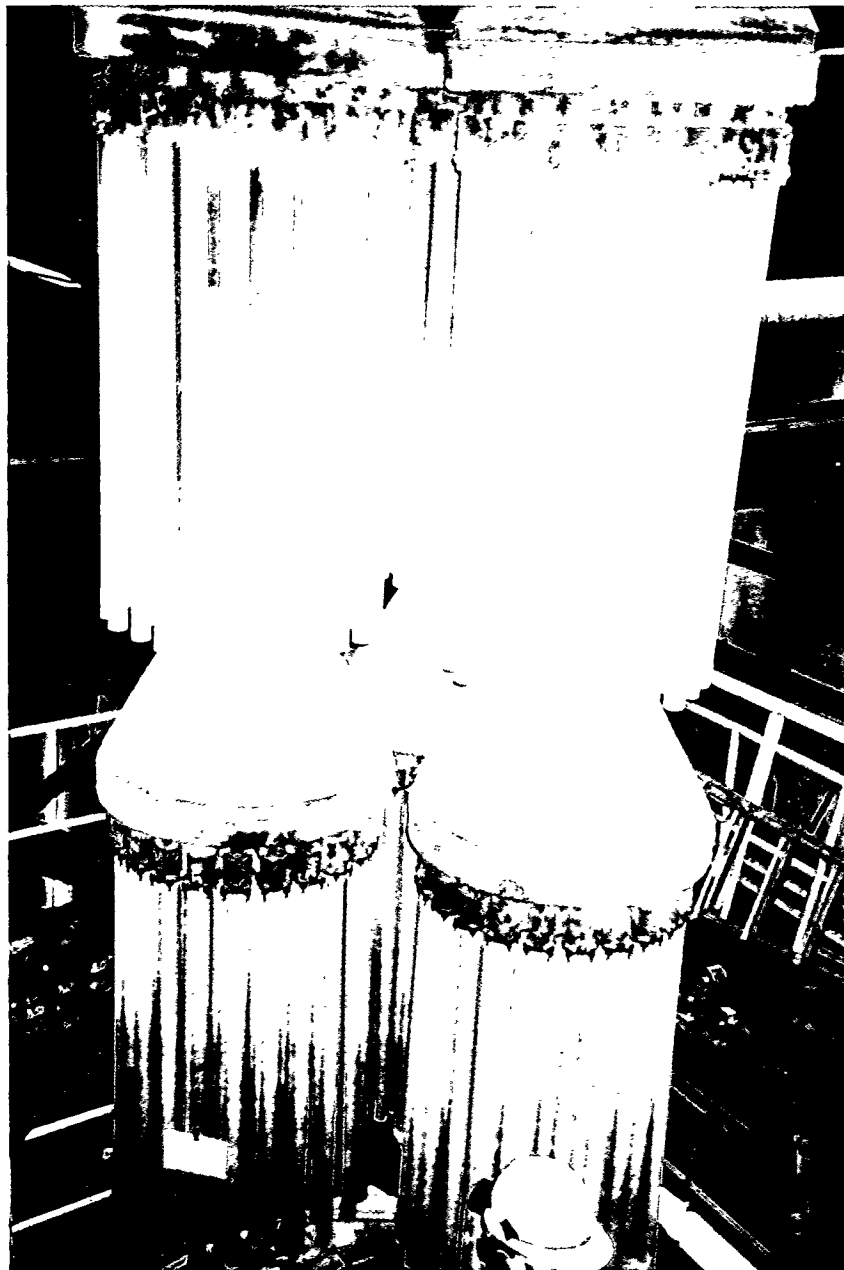
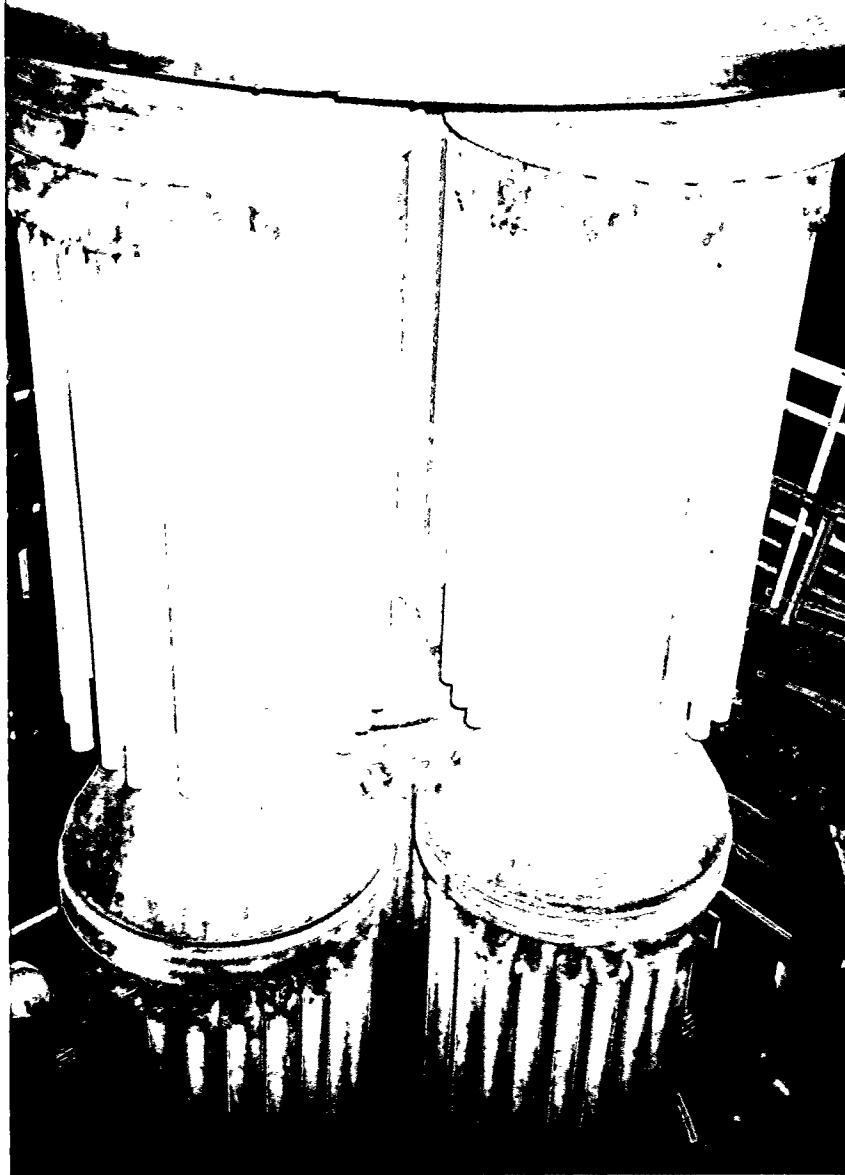
**Figure 4.3.12 - Photograph of Filter Internals Before Test Period II**

Prior to the resumption of testing, all of the filter candles in the bottom plenums were replaced and all of the ash accumulation on the filter candles and metal surfaces in the upper and middle plenums was removed, as shown in Figures 4.3.12 through 4.3.15.

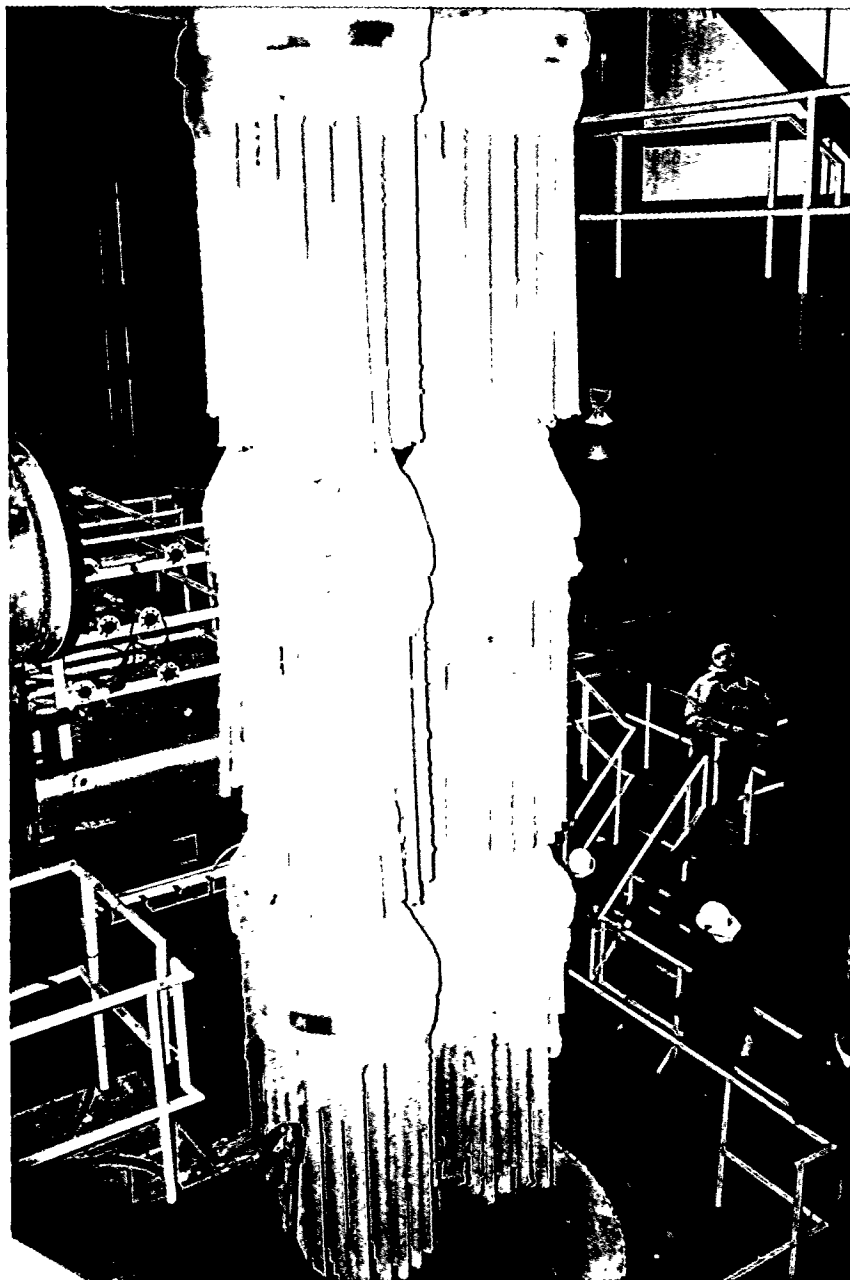
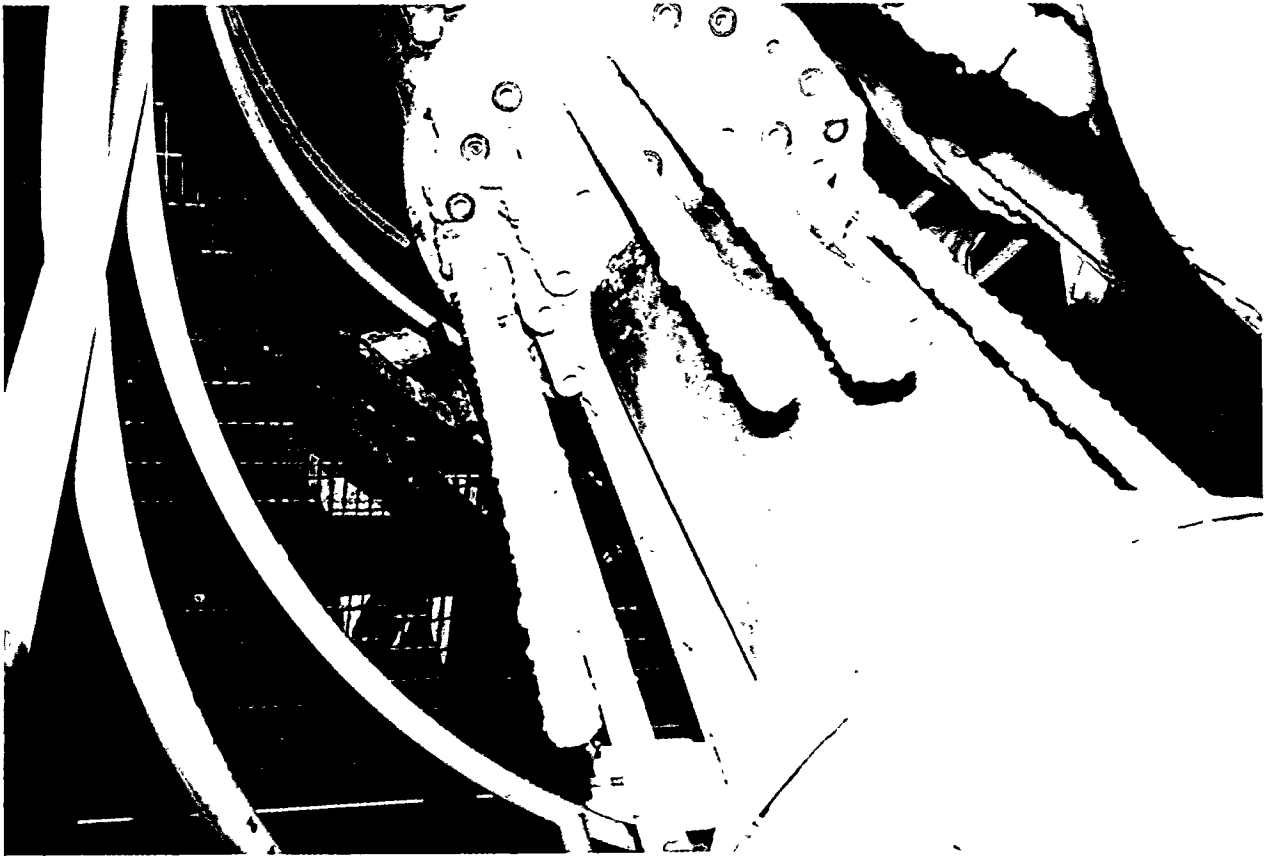
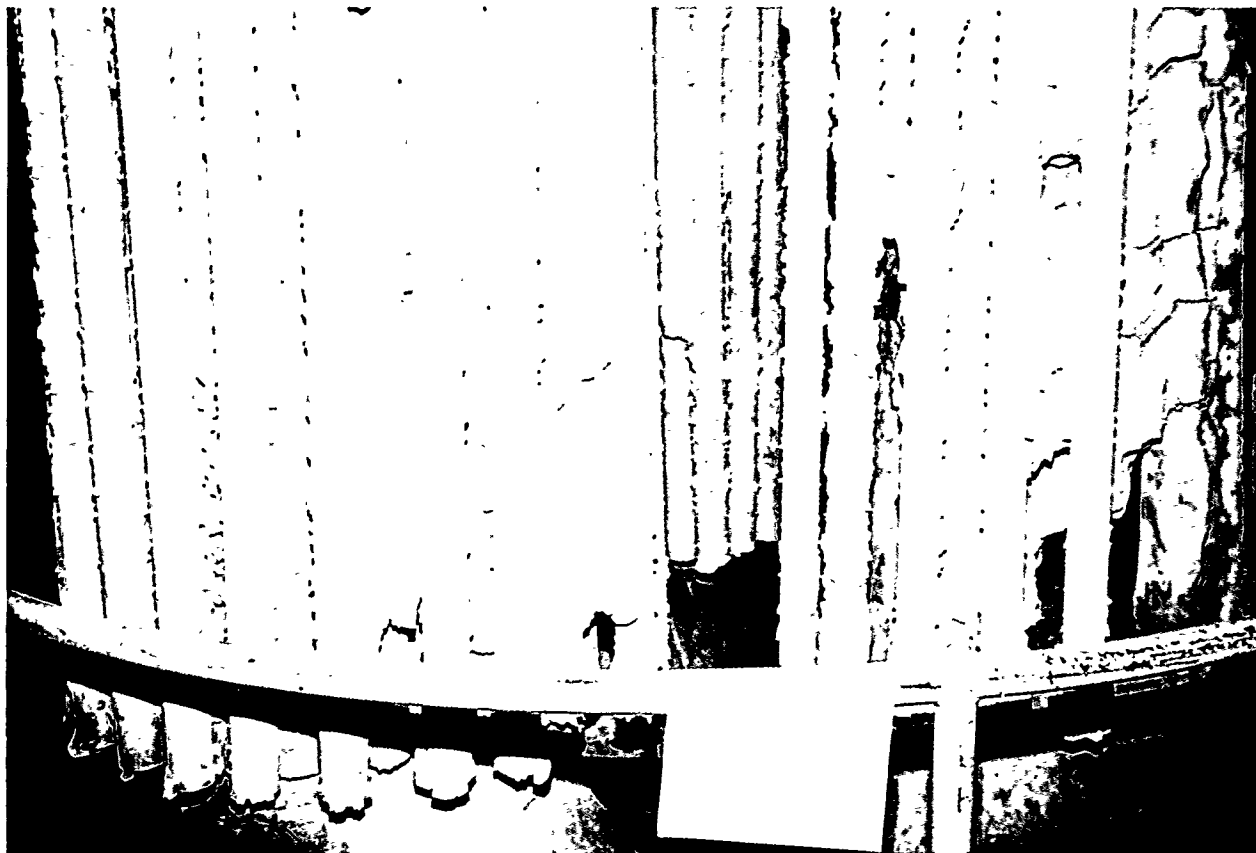
| RUN NO. | COAL FIRE | | UNIT TRIP | | COAL FIRE HOURS | NOTES |
|---|---|---|---|---|---|---|
| 11 | 08/29/93 | 23:31 | 09/23/93 | 20:12 | 596.7 | Combustor trip due to leak in sorbent transport pipe. 62 candles found broken during outage. |

**Figure 4.4.6 - Photograph of Filter Internals Following Test Run 11**

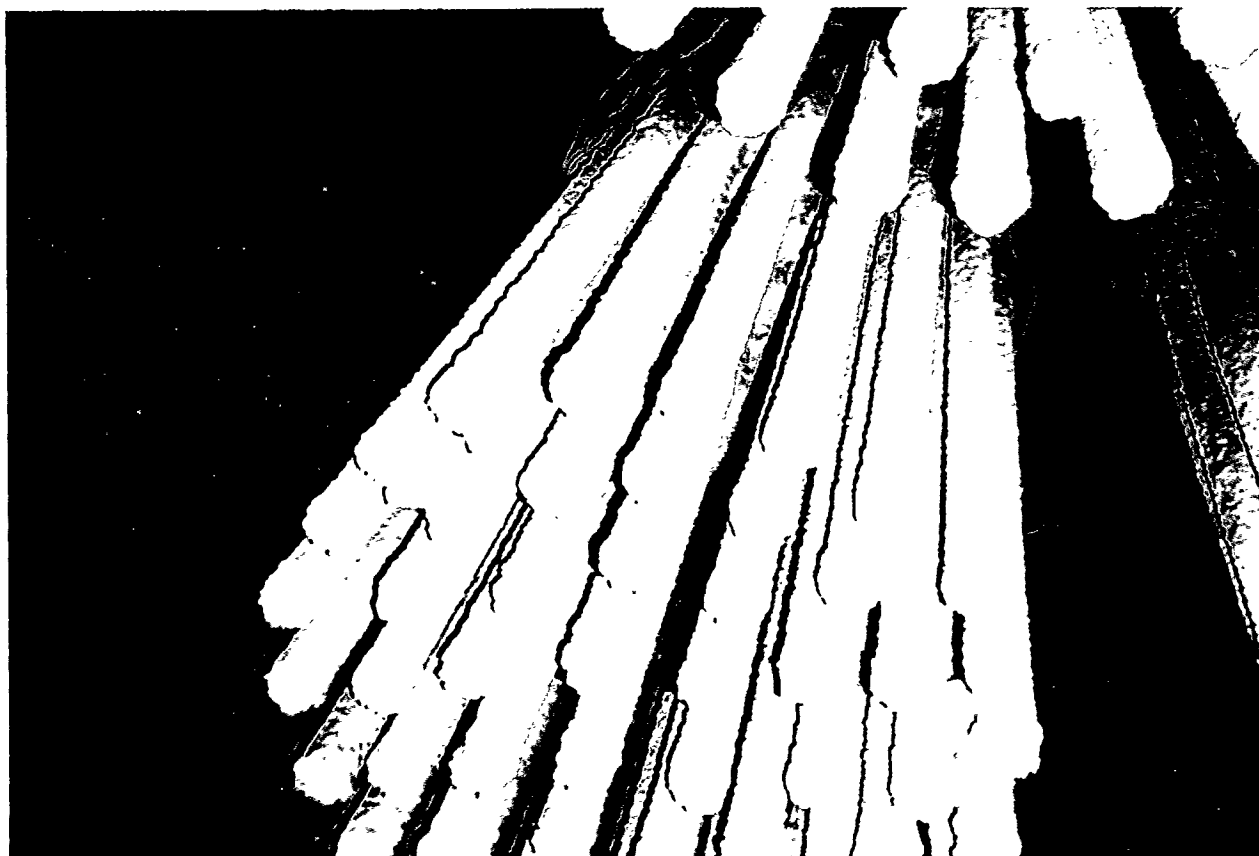
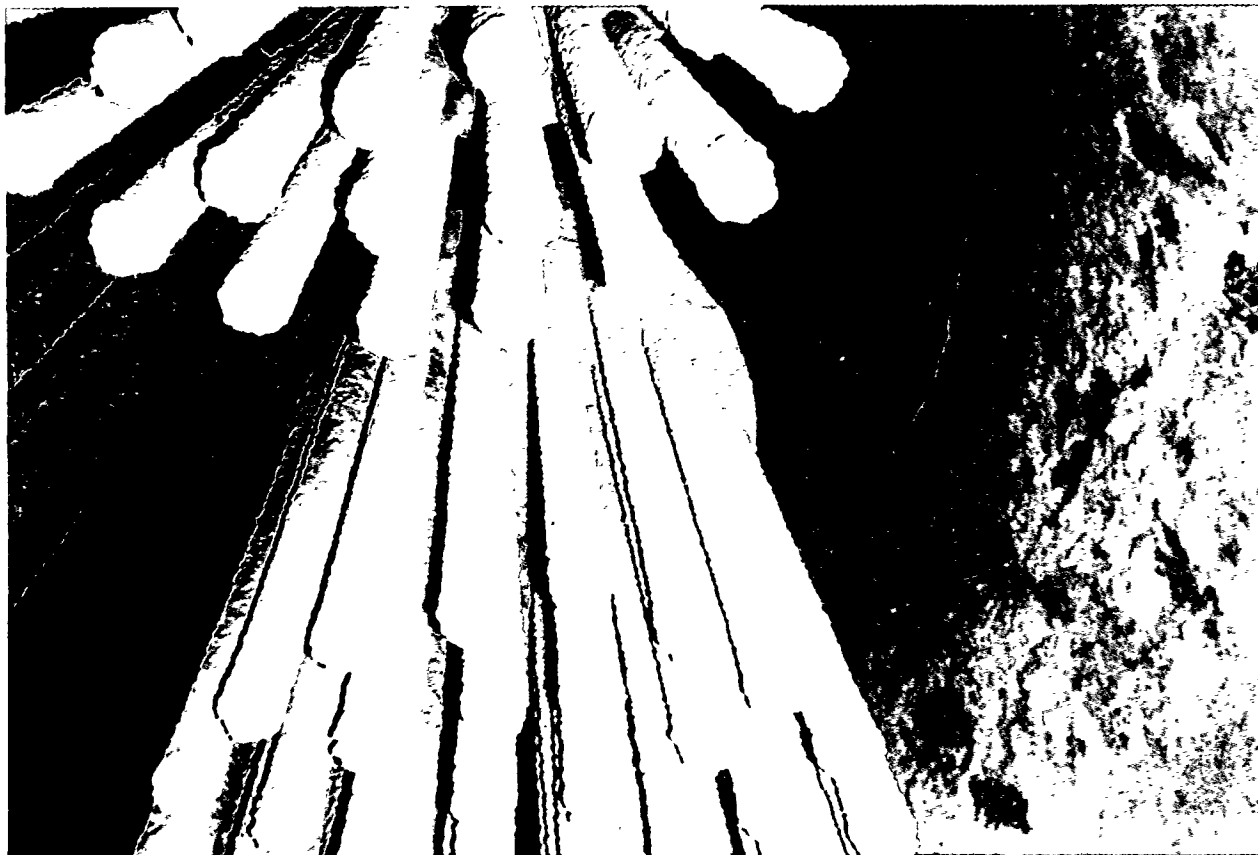
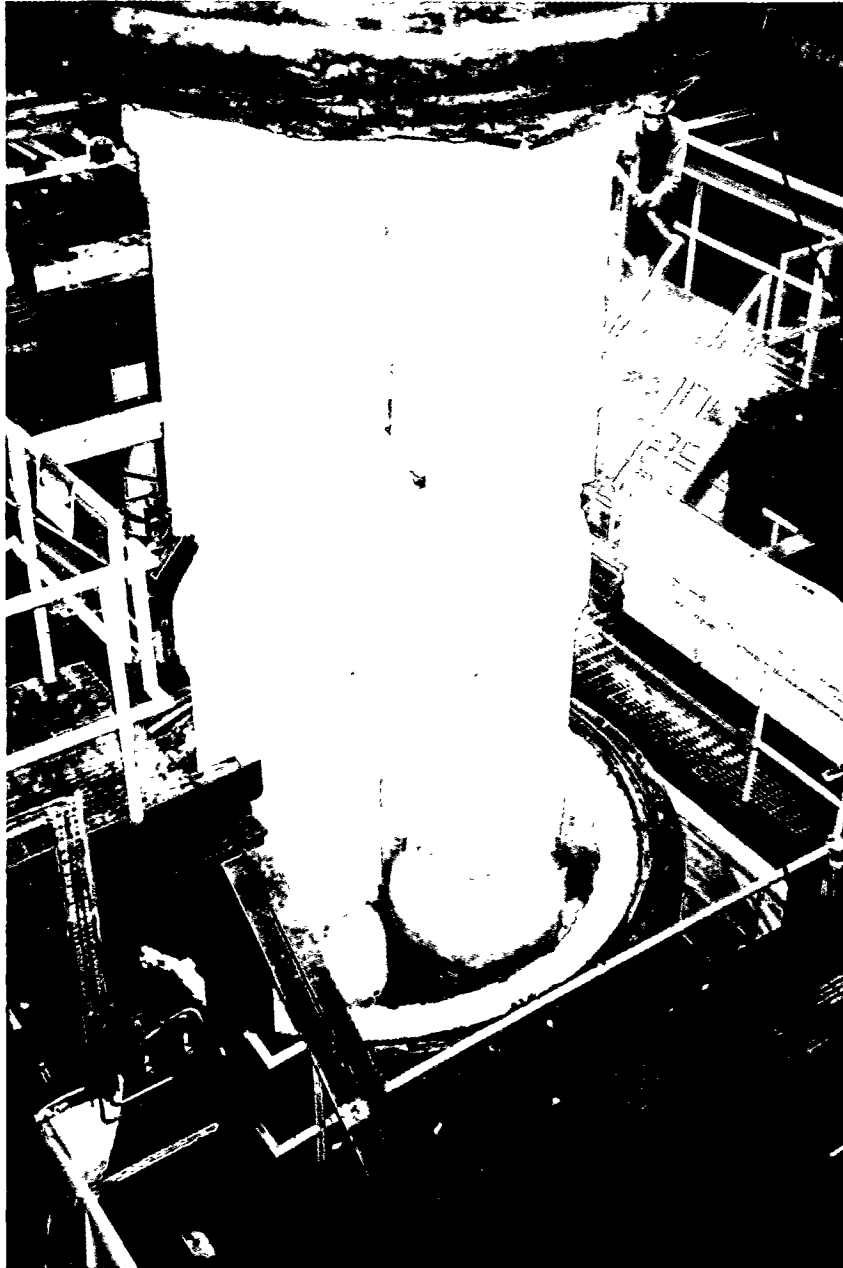
The APF internals were inspected via the instrument ports after this run. The filter candles had a thin layer (about 1/8") of residual ash, however broken candles were observed during this inspection. The filter internals were removed from the APF vessel on 5/5/94 and a more detailed inspection was performed. A total of 28 broken candles were found at the following locations:

The two breaks in the bottom plenum are believed to have occurred during removal of the filter internals from the filter housing. Very heavy ash bridging was observed between the inner rows of candles and the support pipe on the top and middle plenums. Figures 4.5.10 through 4.5.18 are photographs of the candle clusters following Test Period III. The ash build-up extended over the entire length of the inner candles. In some cases the ash bridging extended into the outer rows of candles. Many of the inner candles were bowed outward and in some cases almost contacted the candles in the outer row. All of the candle breaks except one appeared to be fresh breaks judging from the clean fracture surfaces. All of the breaks occurred at the top of the candle just below the candle holder. The breaks appeared to result from bending forces from ash bridging from the inner candles to the outer candles. Only one break was in an inner row; the remainder were in outer rows.

The outlet side of the filter was very clean with virtually no ash deposits. This is further indication that the failures occurred during or after plant shutdown, and that the filter was not leaking ash to the clean side during operation.

**Figure 4.5.10 - Photograph of Filter Internals Following Test Run 18**

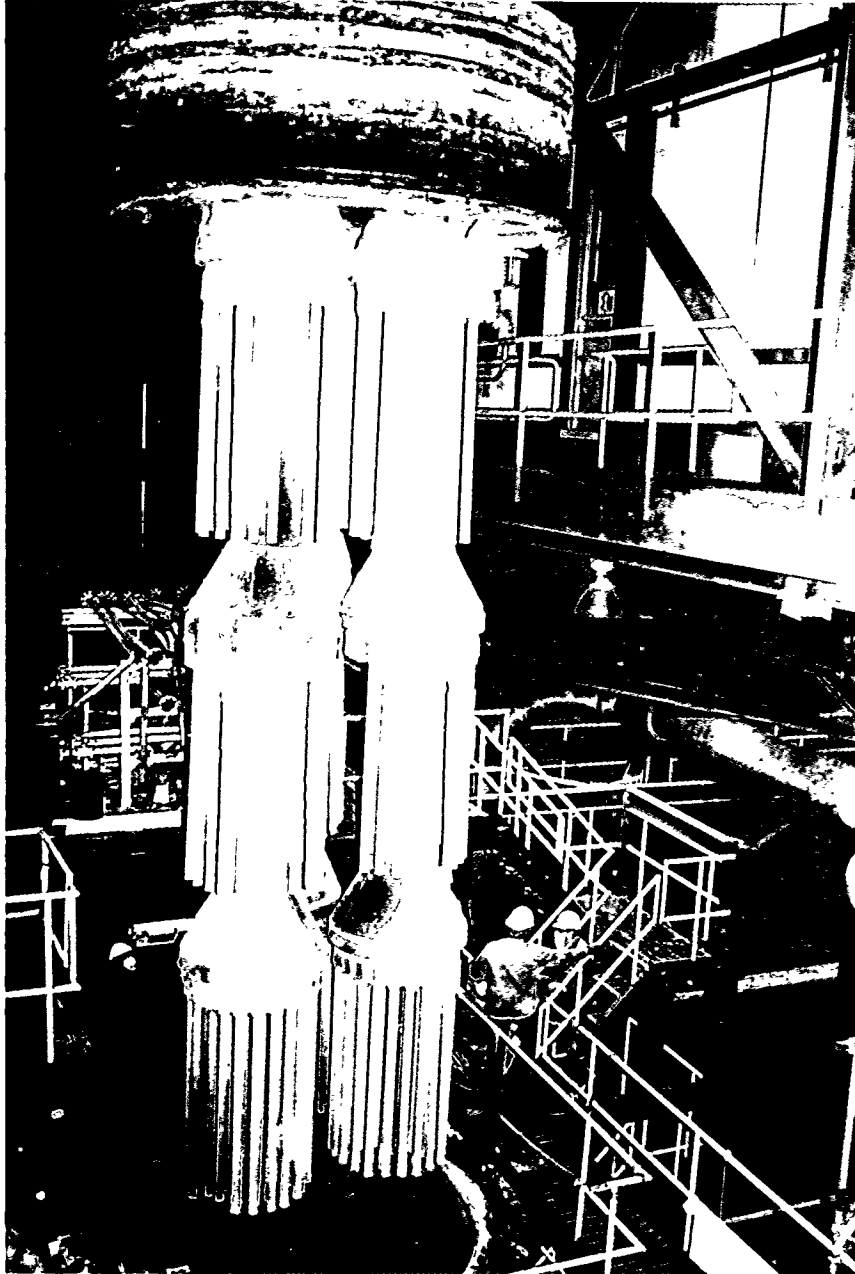
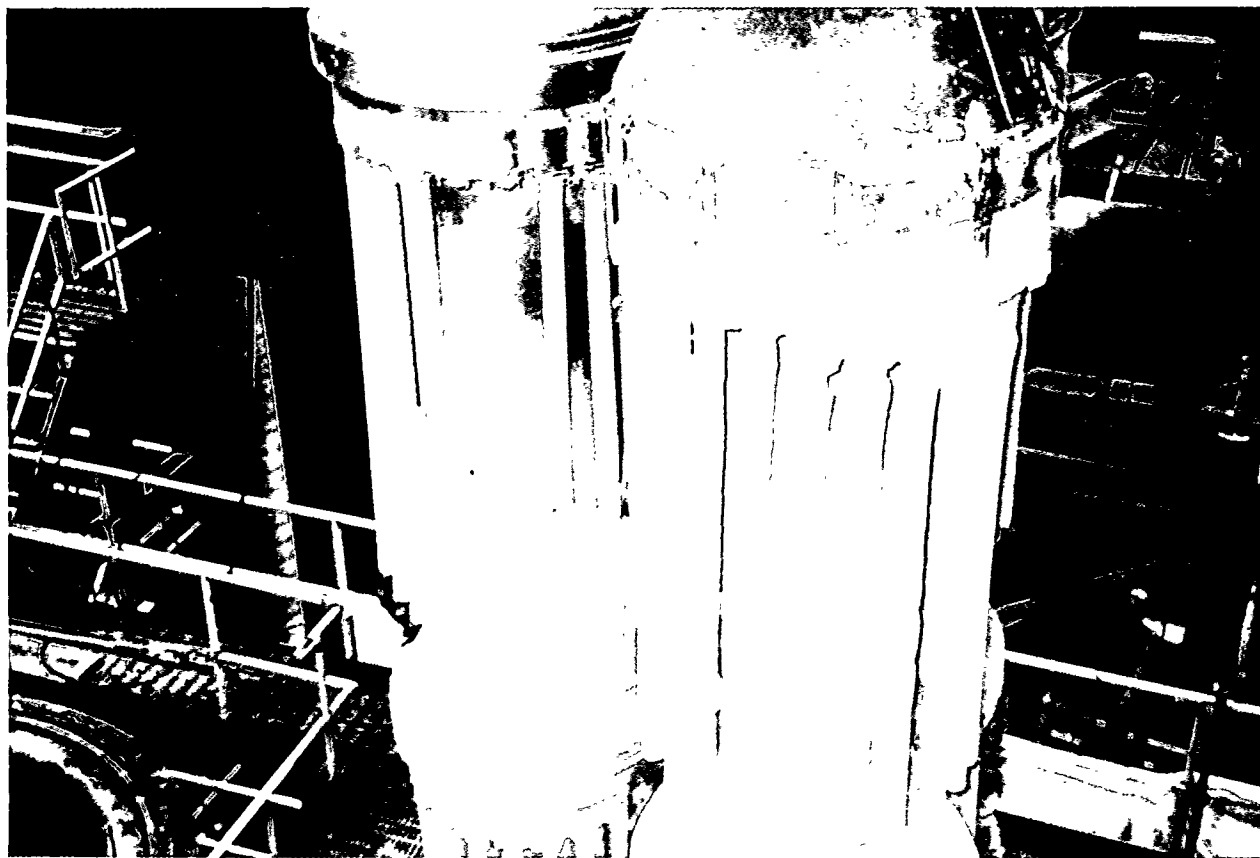
On 10/27/94 the APF internals were removed from the vessel for inspection and candle replacement. A total of 30 candles were observed to be broken, as listed below.

Ten of the 30 breaks had clean fracture surfaces indicating that the breaks occurred after shutdown or during removal from the vessel. Heavy ash bridging was apparent near the bottoms of candles in clusters B Top and B Middle, while light to moderate ash bridging was seen in clusters C Top, A Bottom, and B Bottom. Figure 4.6.8 through 4.6.16 are photos of the candle clusters following Test Period IV. It was evident that the ash accumulation that occurred during the first 600 hours of this run was not removed during the last 90 hours of operation with the cyclone spoiled.

**Figure 4.6.8 - Photograph of Filter Internals Following Test Run 24**

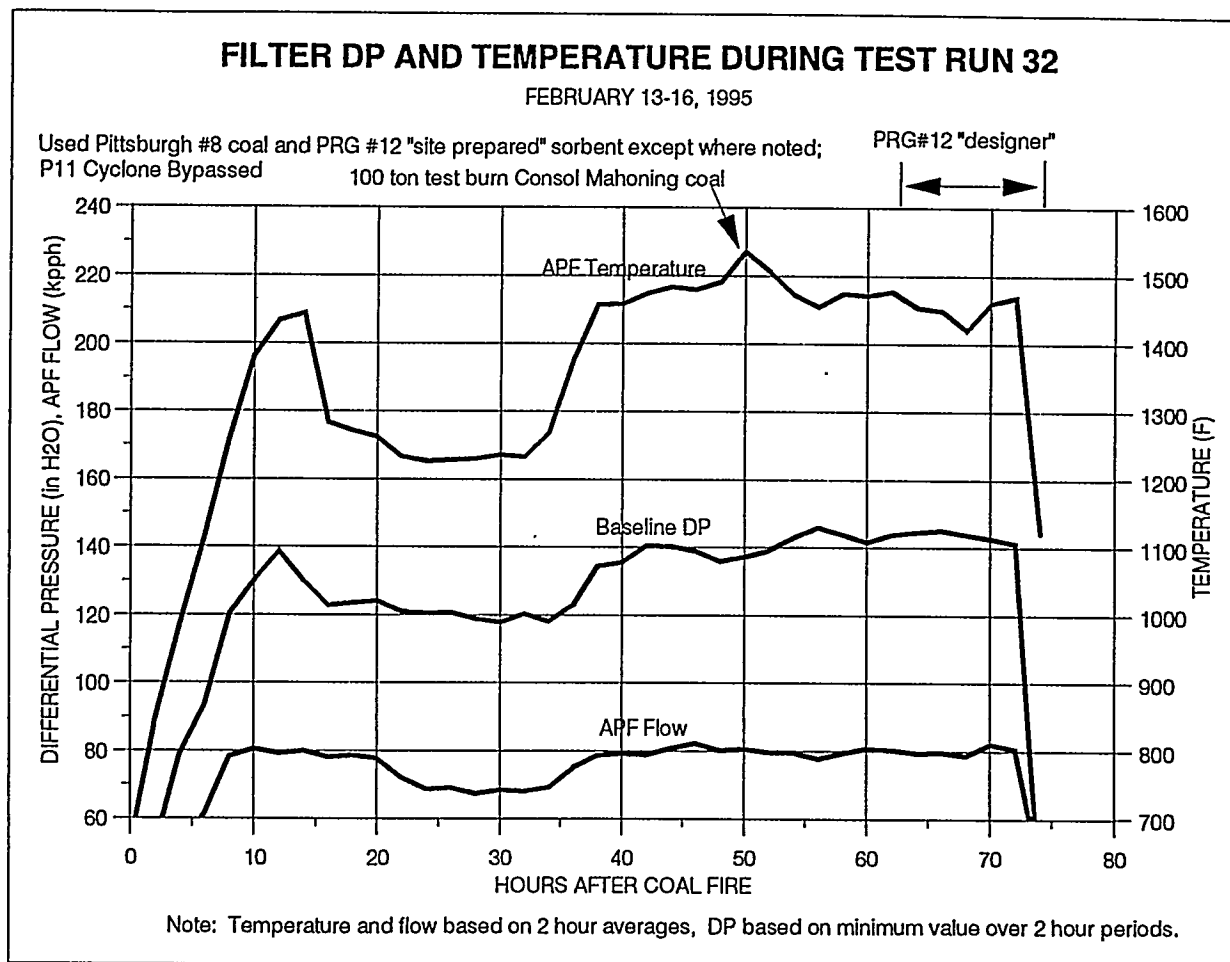
Run 32 was a hot restart of the previous run. This test duration was 73 hours and was terminated due to plugged coal paste pumps. Early in the run the APF head exhibited additional hot spots and another 50 gallons of Fiberfrax insulation were pumped in to correct the problem. Once the gas temperature reached 1450-1500F, the APF DP remained fairly stable as shown in Figure 4.7.6.

Figure 4.7.6 - Filter DP and Temperature During Test Run 32

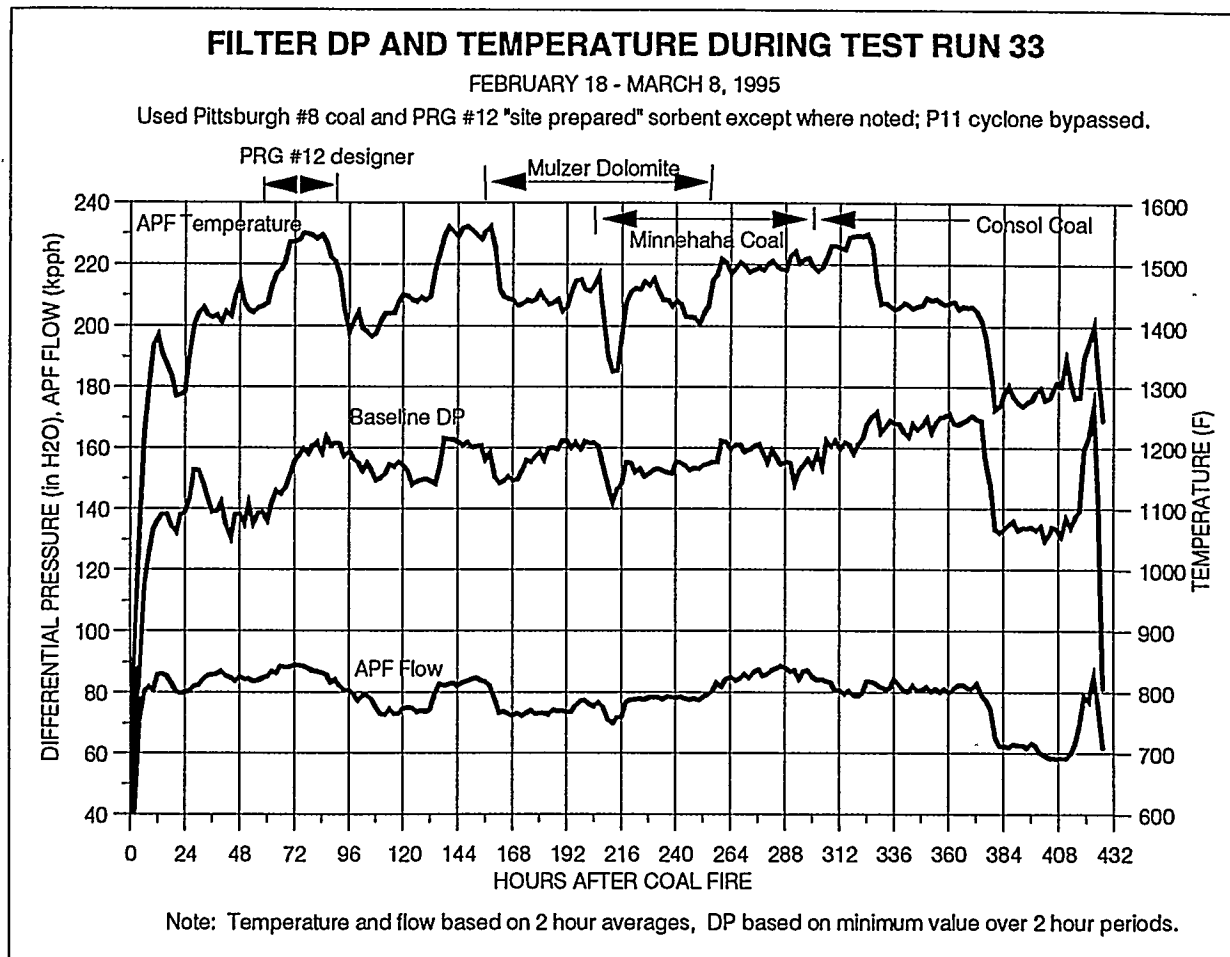
Figure 4.7.8 - Filter DP and Temperature During Test Run 33

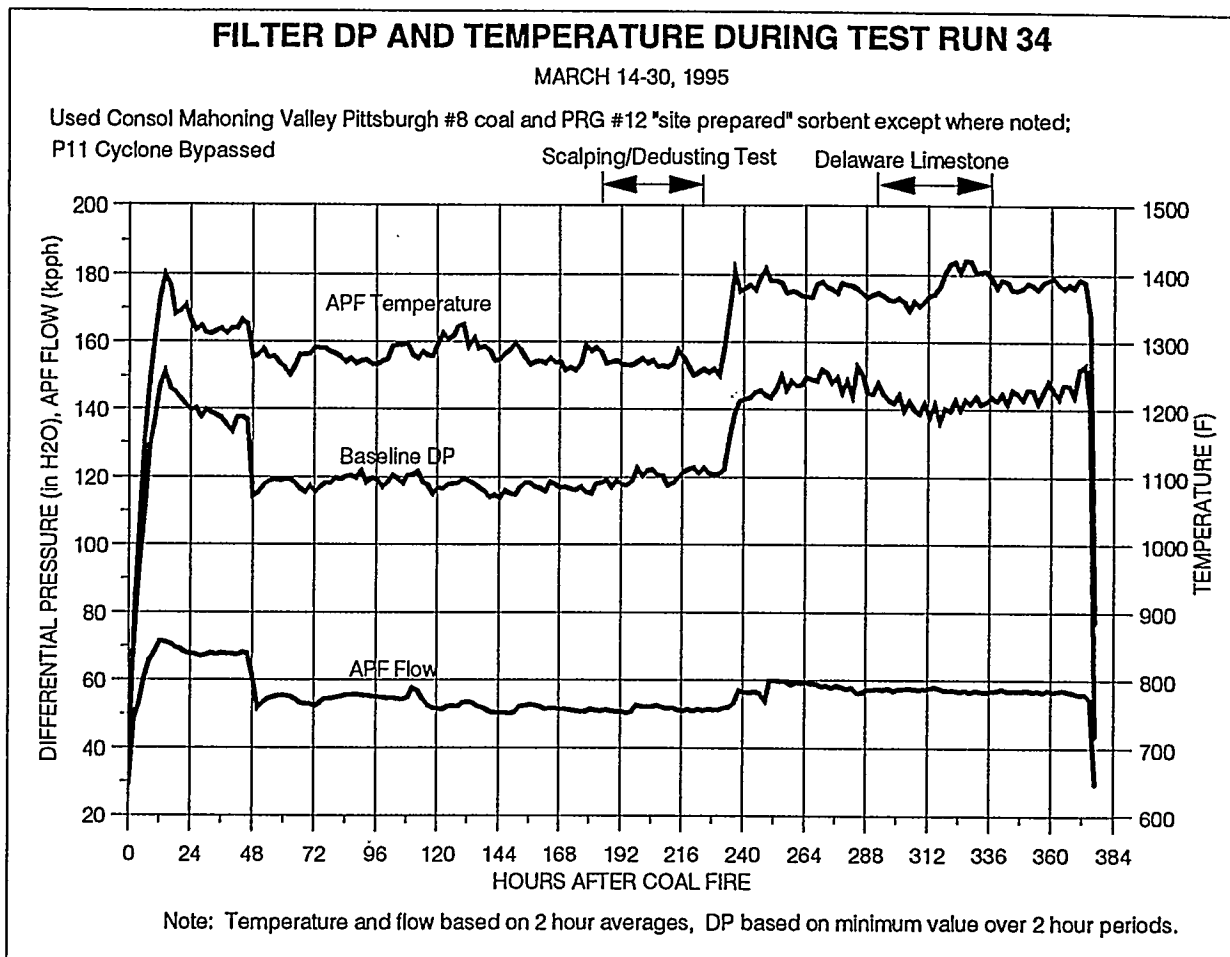
Figure 4.7.9 - Filter DP and Temperature During Test Run 34
