## **Tidd Hot Gas Clean Up Program**

### **Final Report**

October 1995

The Tidd Hot Gas Clean Up (HGPU) system was installed in the Tidd Pressurized Fluidized Bed Combustion (PFBC) Demonstration Plant, which is the first utility-scale PFBC plant in the United States. The plant is owned and operated by Ohio Power Company and is located on the banks of the Ohio River, approximately 75 miles downstream of Pittsburgh, Pennsylvania.

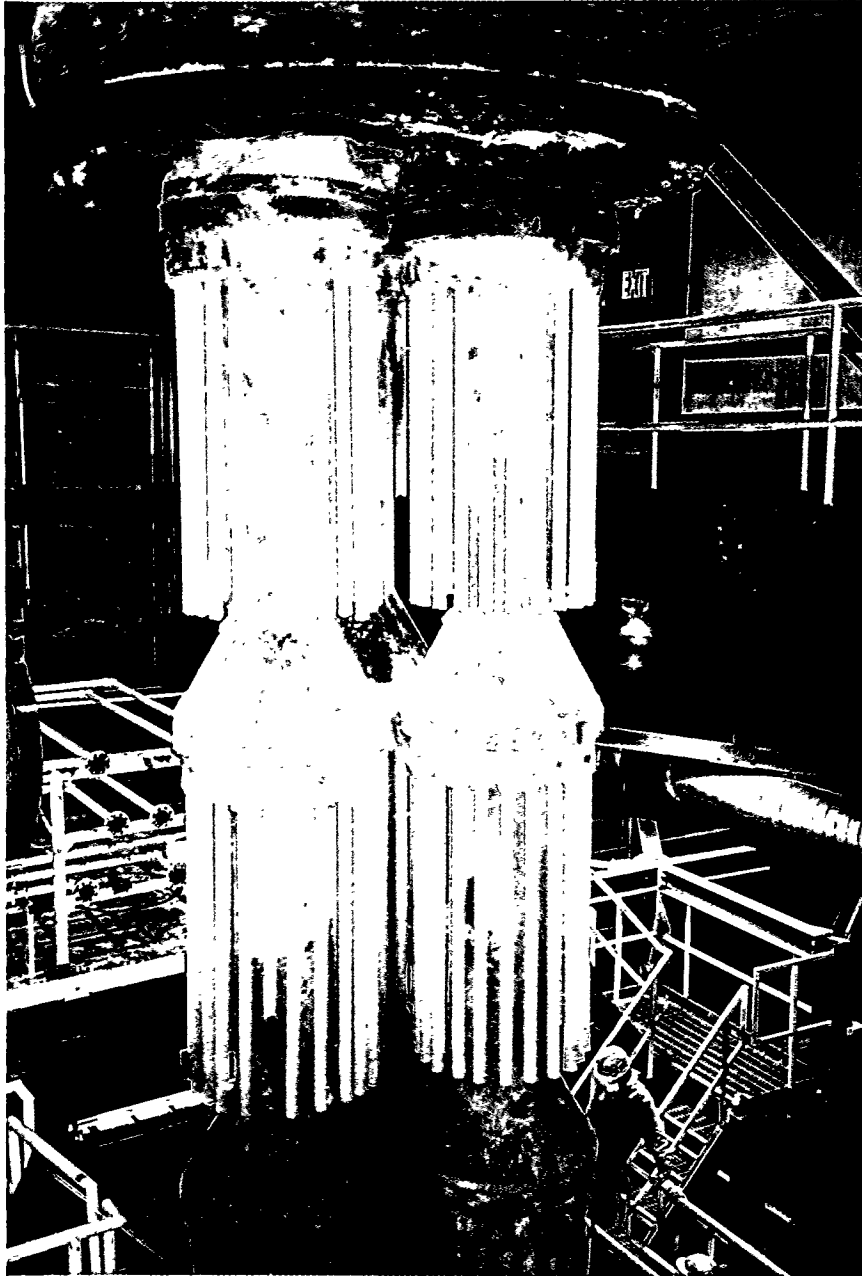
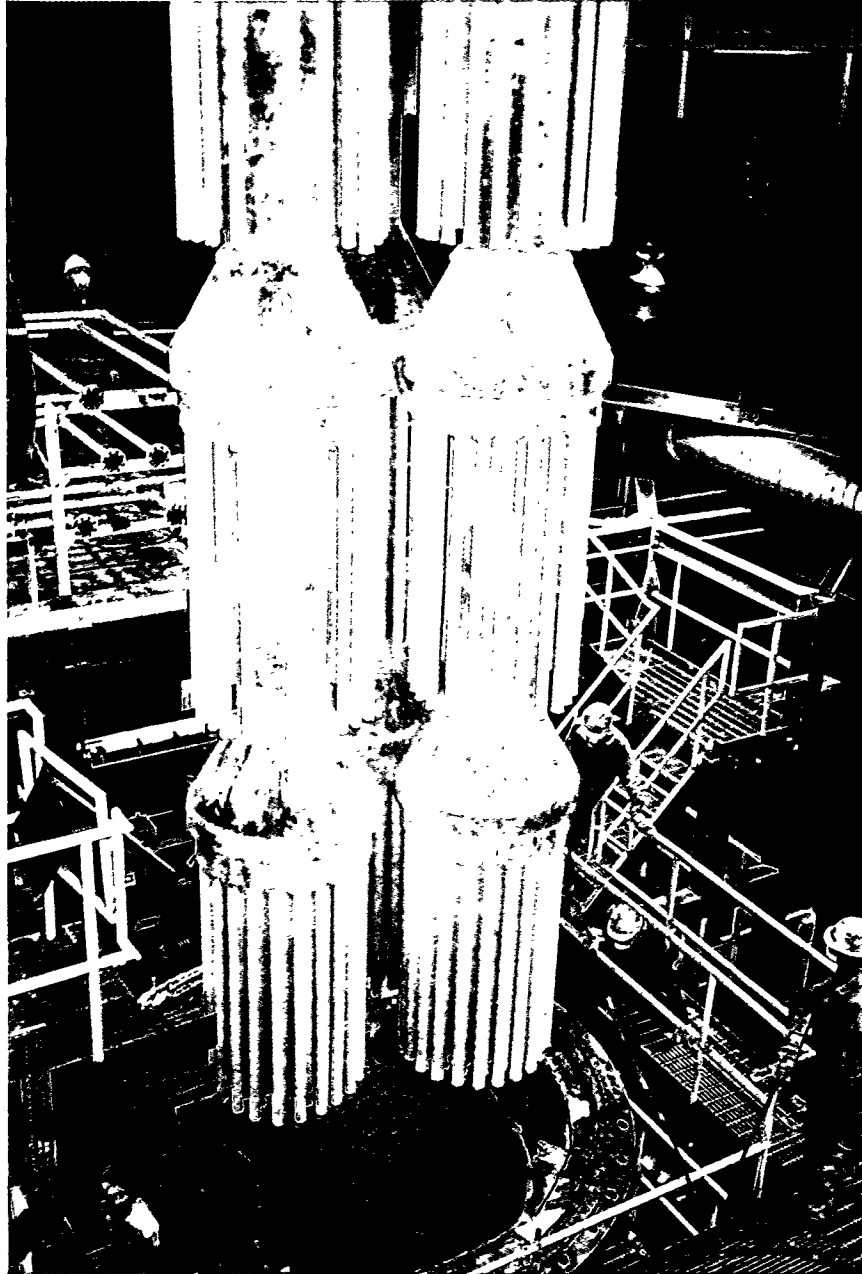
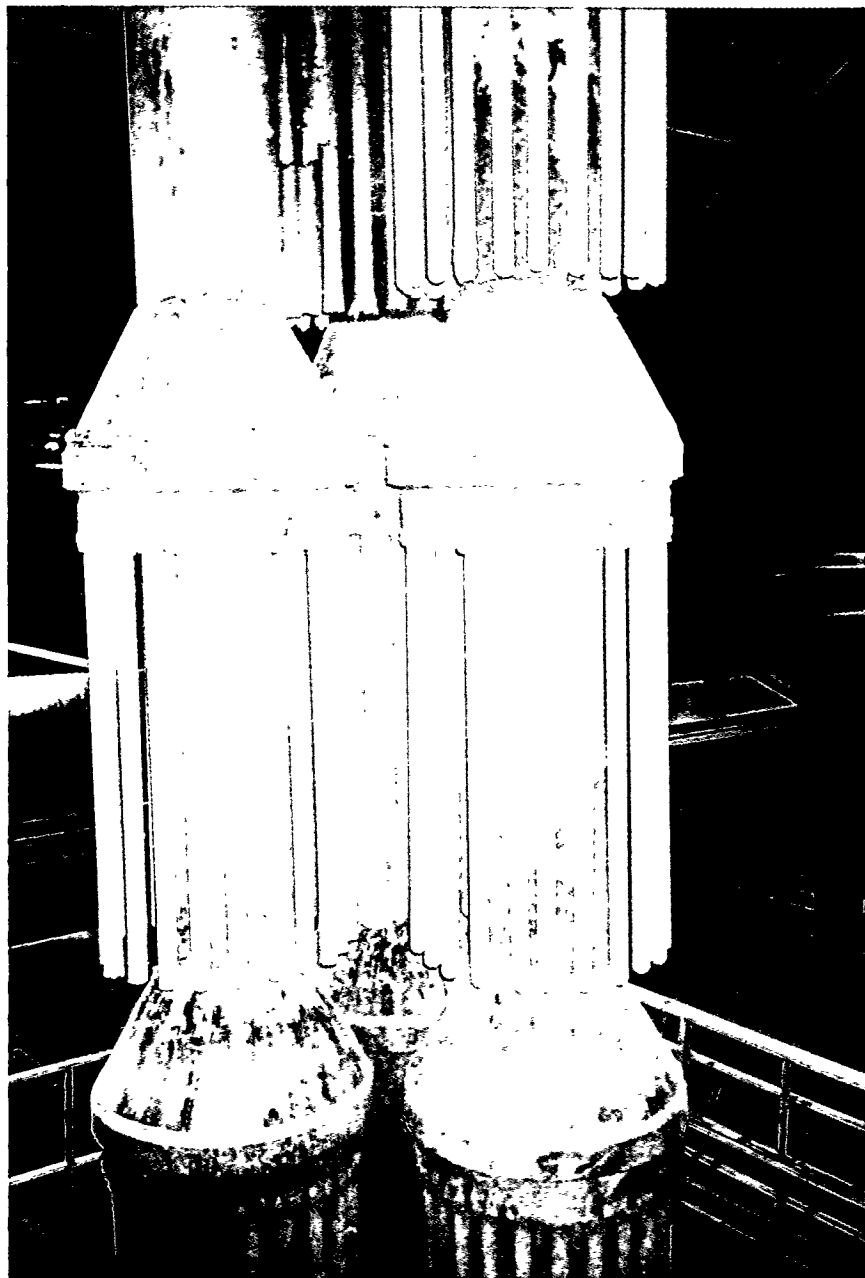
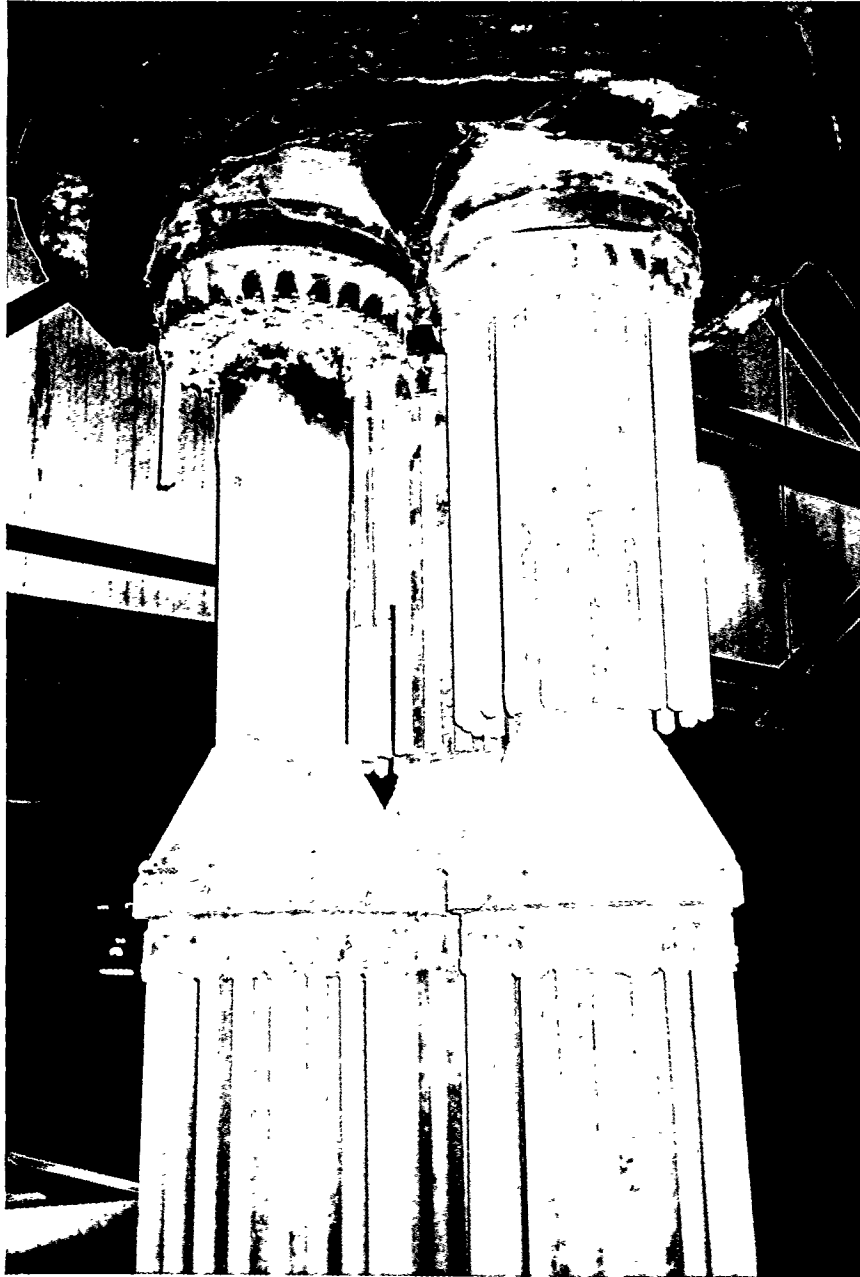
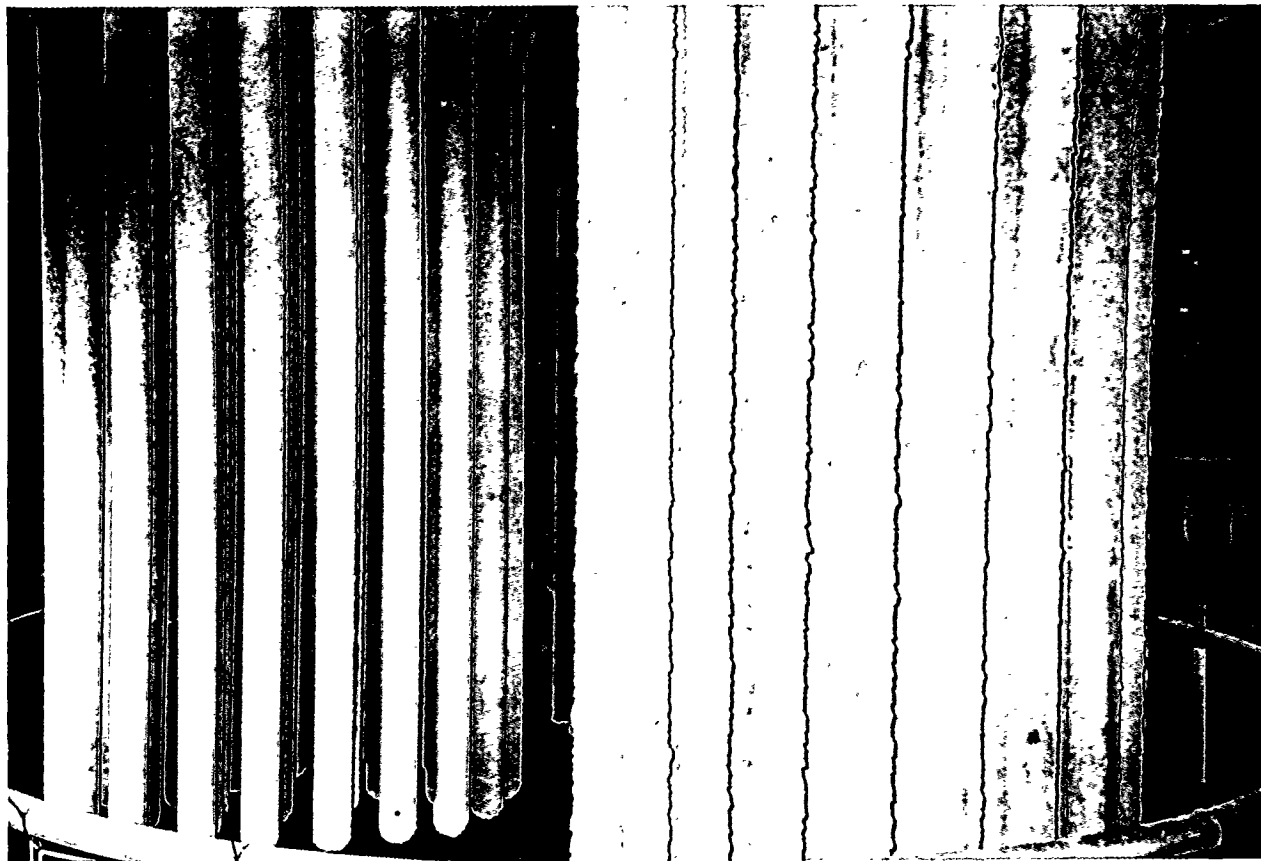
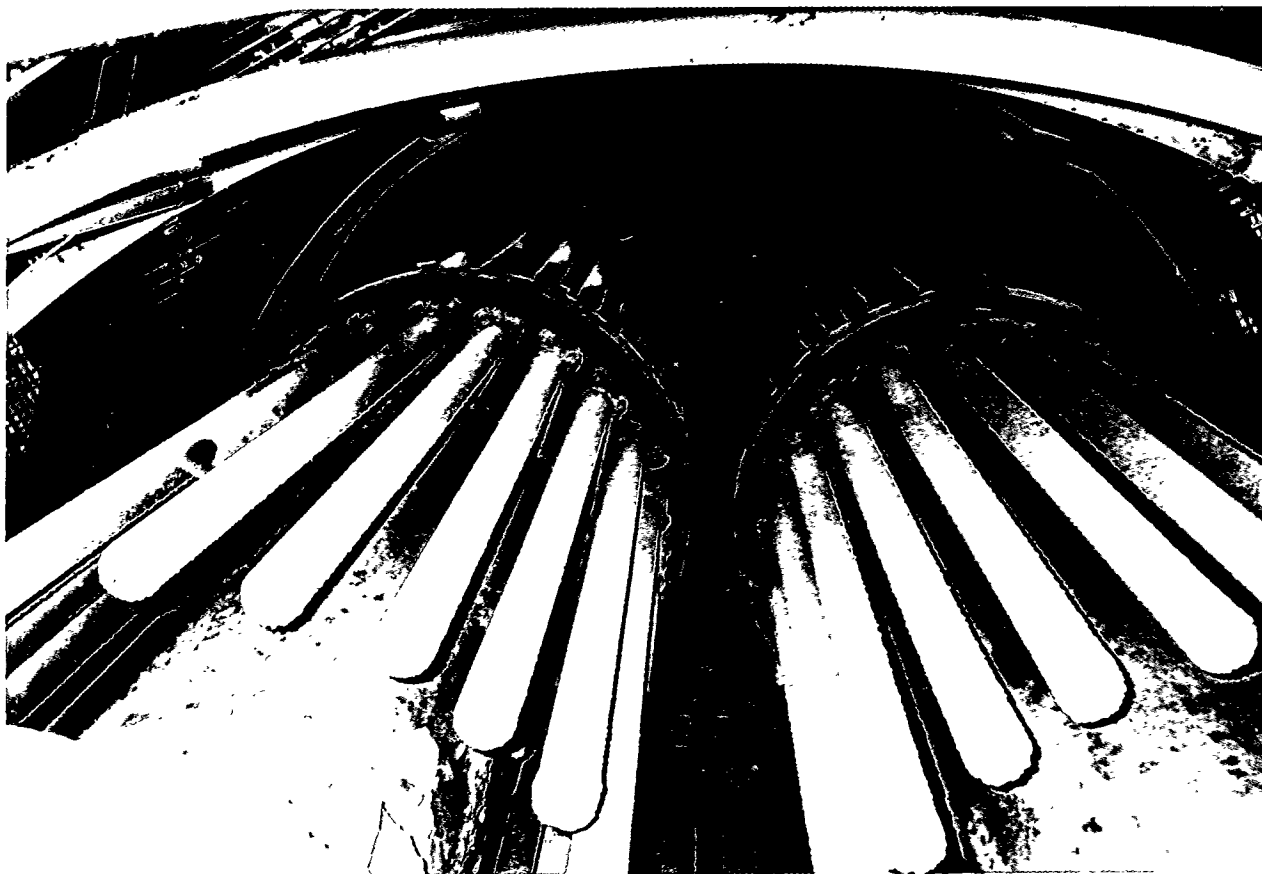
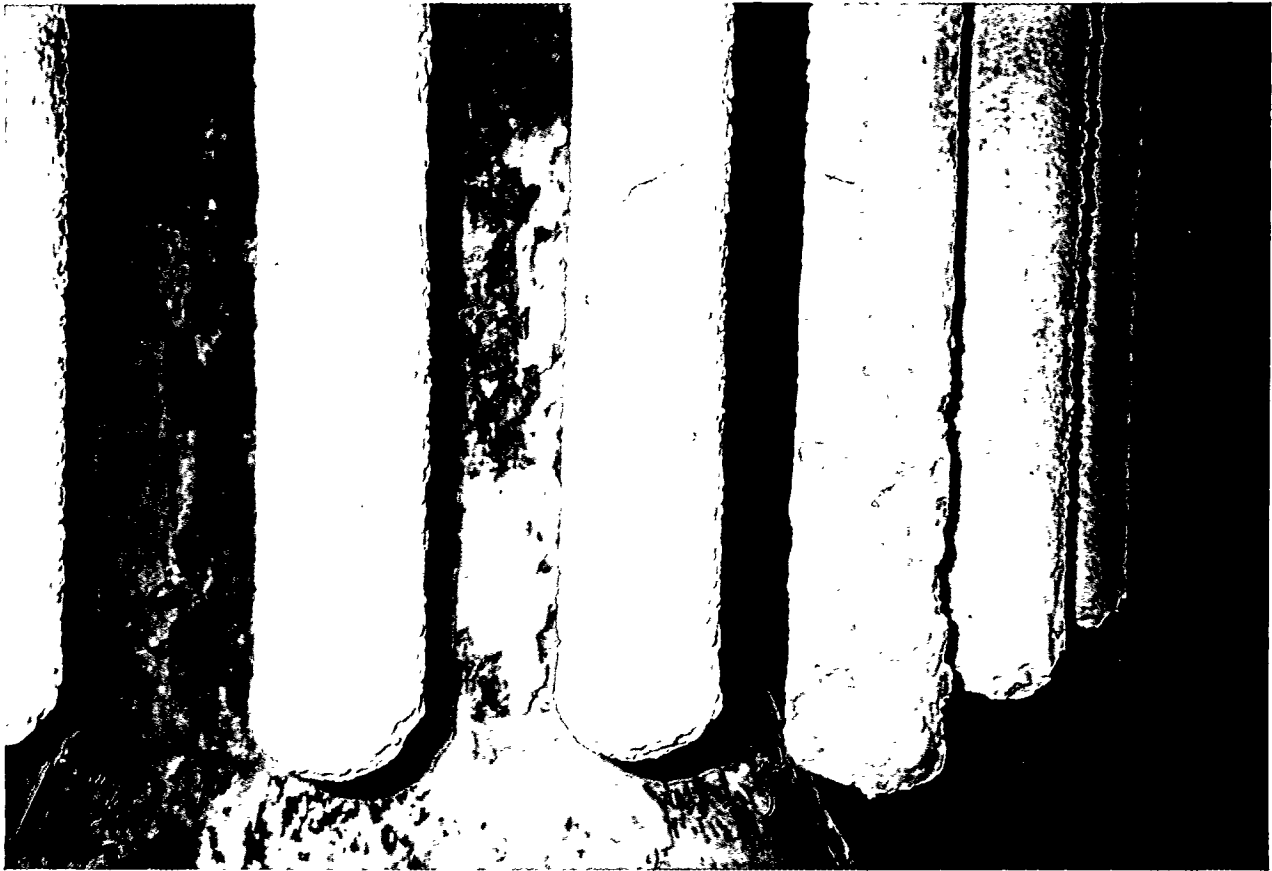
On 5/11 the APF internals were removed from the filter vessel. Figures 4.7.10 through 4.7.18 are photographs of the filter internals after removal. As observed by the boroscopic inspection, 20 of 22 of the Dupont PRD66 candles were broken, all in plenum B Top. In addition, two Coors alumina-mullite candles were broken (rather than one), one near the top in plenum A Top and the other about 2/3 down from the top in plenum A Middle. No ash bridging was seen. The residual ash cake layer thickness on the candles ranged from about 1/8" on the Coors alumina-mullite candles to about 3/8" on the Vitropore silicon carbide candles. During removal, cracks were seen in two candles (Figure 4.7.18), one alumina-mullite the other an original Schumacher silicon carbide surveillance candle. Both candles broke during removal and handling. Hard ash deposits were found in the bottom 6 to 12 inches of these cracked candles. In addition, a 3M candle was found to be cracked near the bottom after it was removed. No indication of an ash leak path was seen at the gasket area of any of these candles, but it appeared that ash accumulated in the bottom portion of these candles which resulted in cracking of the candles.

**Figure 4.7.10 - Photograph of Filter Internals Following Test Run 34**

**Figure 4.7.11 - Photograph of Filter Internals Following Test Run 34**

**Figure 4.7.12 - Photograph of Filter Internals Following Test Run 34**

**Figure 4.7.13 - Photograph of Filter Internals Following Test Run 34**

**Figure 4.7.14 - Photograph of Filter Internals Following Test Run 34**

**Figure 4.7.15 - Photograph of Filter Internals Following Test Run 34**

**Figure 4.7.16 - Photograph of Filter Internals Following Test Run 34**

**Figure 4.7.17 - Photograph of Filter Internals Following Test Run 34**

**Figure 4.7.18 - Photograph of Filter Internals Following Test Run 34**

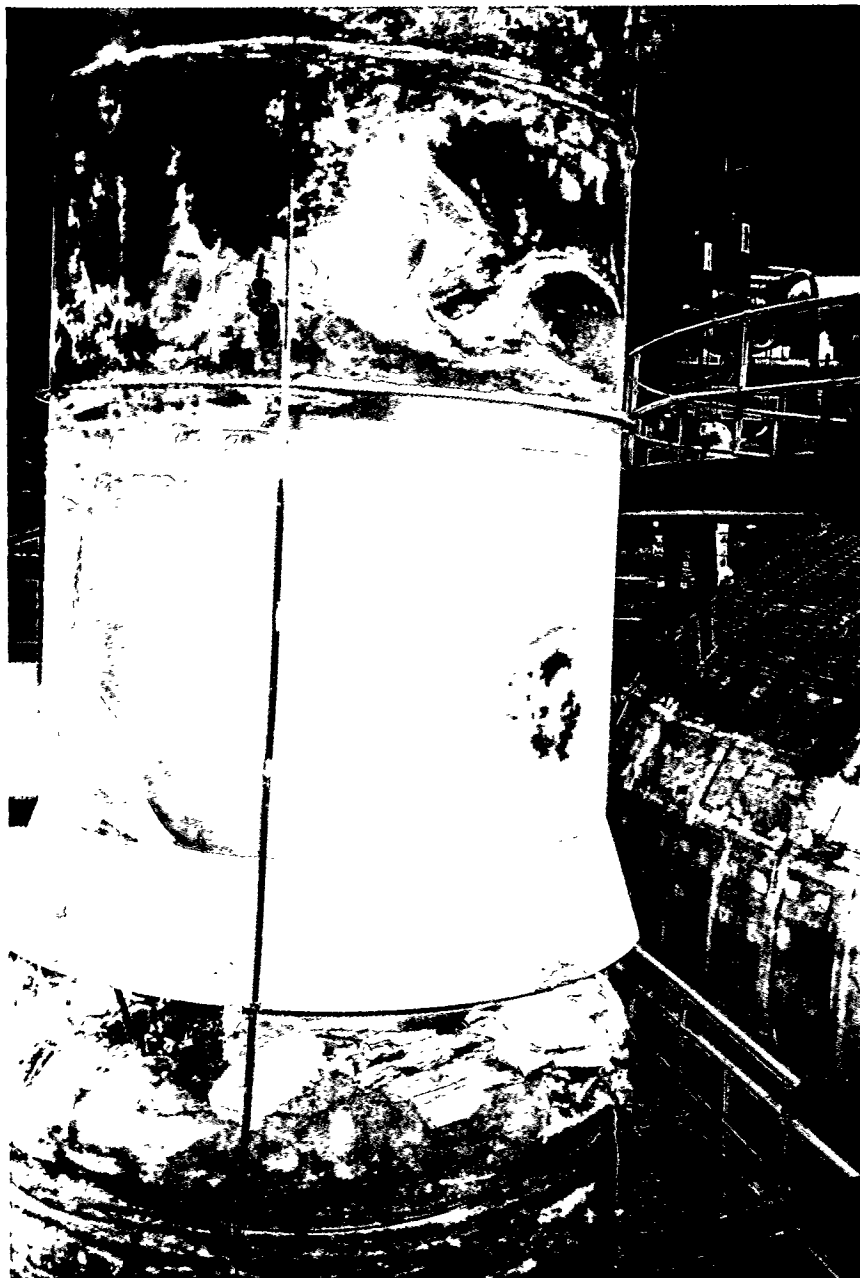
The shroud was removed from the vessel for inspection. It appeared to be in generally good condition as shown in Figure 4.8.2. No erosion was seen on the impingement plate opposite the inlet nozzle. This was of concern after the ash loading and particle size were increased during the last test period. The ash tended to form a deposit and flake off on the impingement plate as shown in Figure 4.8.3. One problem was noted with the shroud. The four support brackets were bent upward due to deformation of the shroud. This occurred even after the shroud material thickness was increased to 1/4 inch and a stiffening ring was added at the top of the shroud to mitigate this problem prior to the last test period. It was apparent that the shroud thickness was still insufficient to prevent distortion.

Figure 4.8.2 - Photograph of APF Shroud During Final Removal

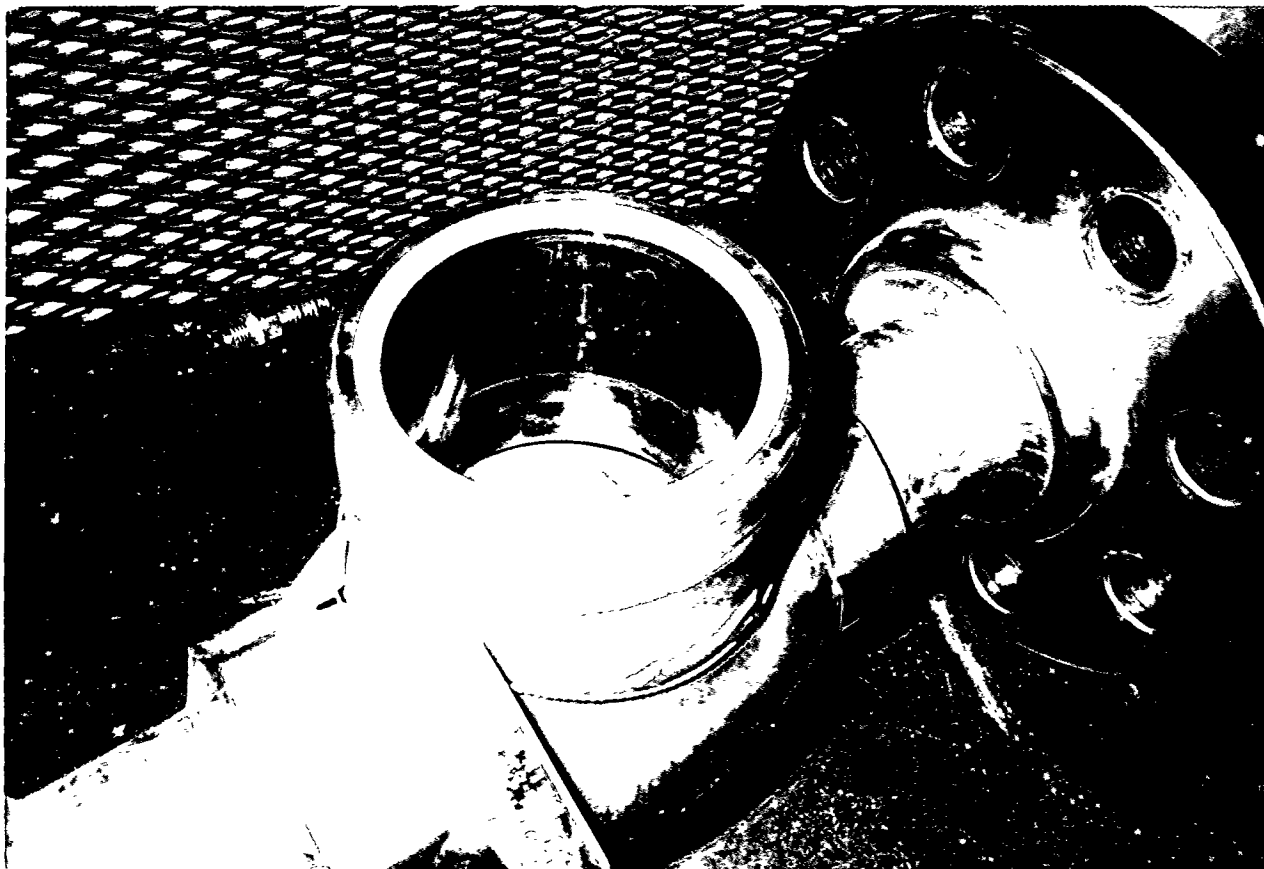
Two of the Atkomatic solenoid valves and the COAX valve (used in the last test period) were disassembled for inspection. The COAX valve did not show any signs of degradation. The two Atkomatic valves appeared to be in excellent condition. Some very minor surface scratches were seen in localized areas on the pistons indicating that the Stellite coating held up very well. The valve body bores showed very minor surface pitting, but felt very smooth. Figures 4.8.7 and 4.8.8 are photographs of the valve internals.

**Figure 4.8.7 - Photograph of Backpulse Valve Internals**

**Figure 4.8.8 - Photograph of Backpulse Valve Internals**

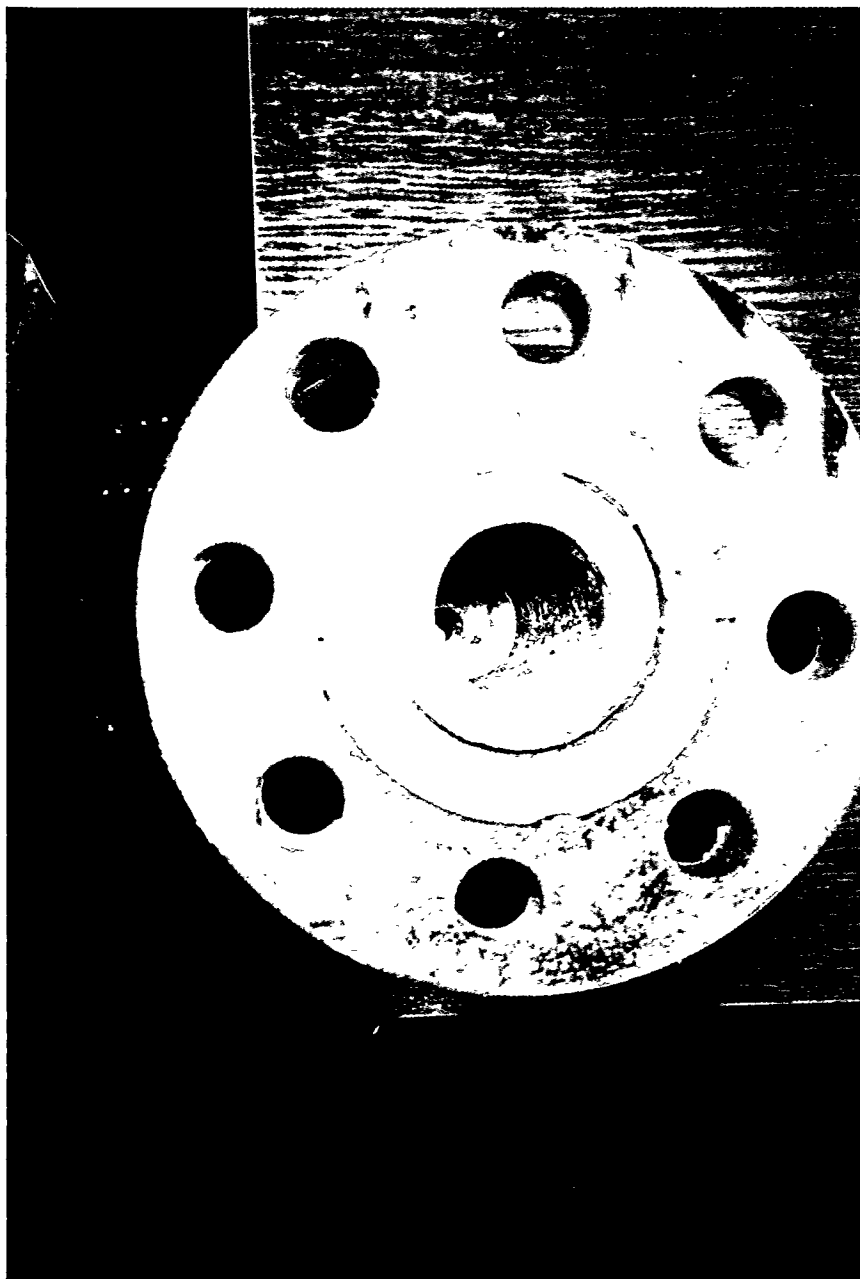
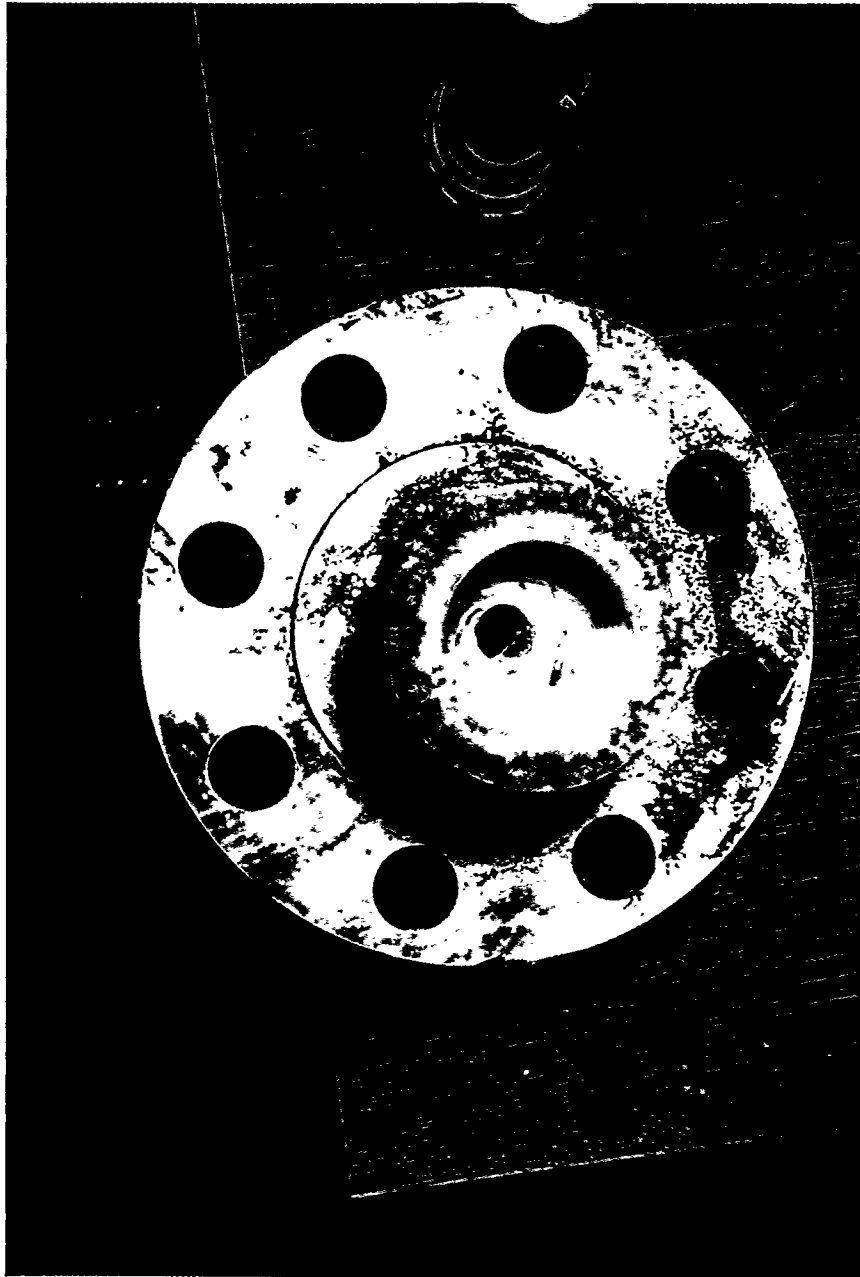
A section of the alternate ash line was removed and sectioned to determine if it had experienced erosion. No erosion was noted. This indicated that ash conveying lines can be properly sized to handle heavy ash loading with coarse particles without experiencing erosion. The restrictive orifice in the alternate ash line was removed and inspected. The orifice, which was a tungsten carbide nozzle, appeared in excellent condition, as shown in Figures 4.8.13 and 4.8.14. Also, the tee downstream of the orifice was inspected and it also was undamaged.

**Figure 4.8.13 - Photograph of Alternate Ash Line Restrictive Orifice**

**Figure 4.8.14 - Photograph of Alternate Ash Line Restrictive Orifice**

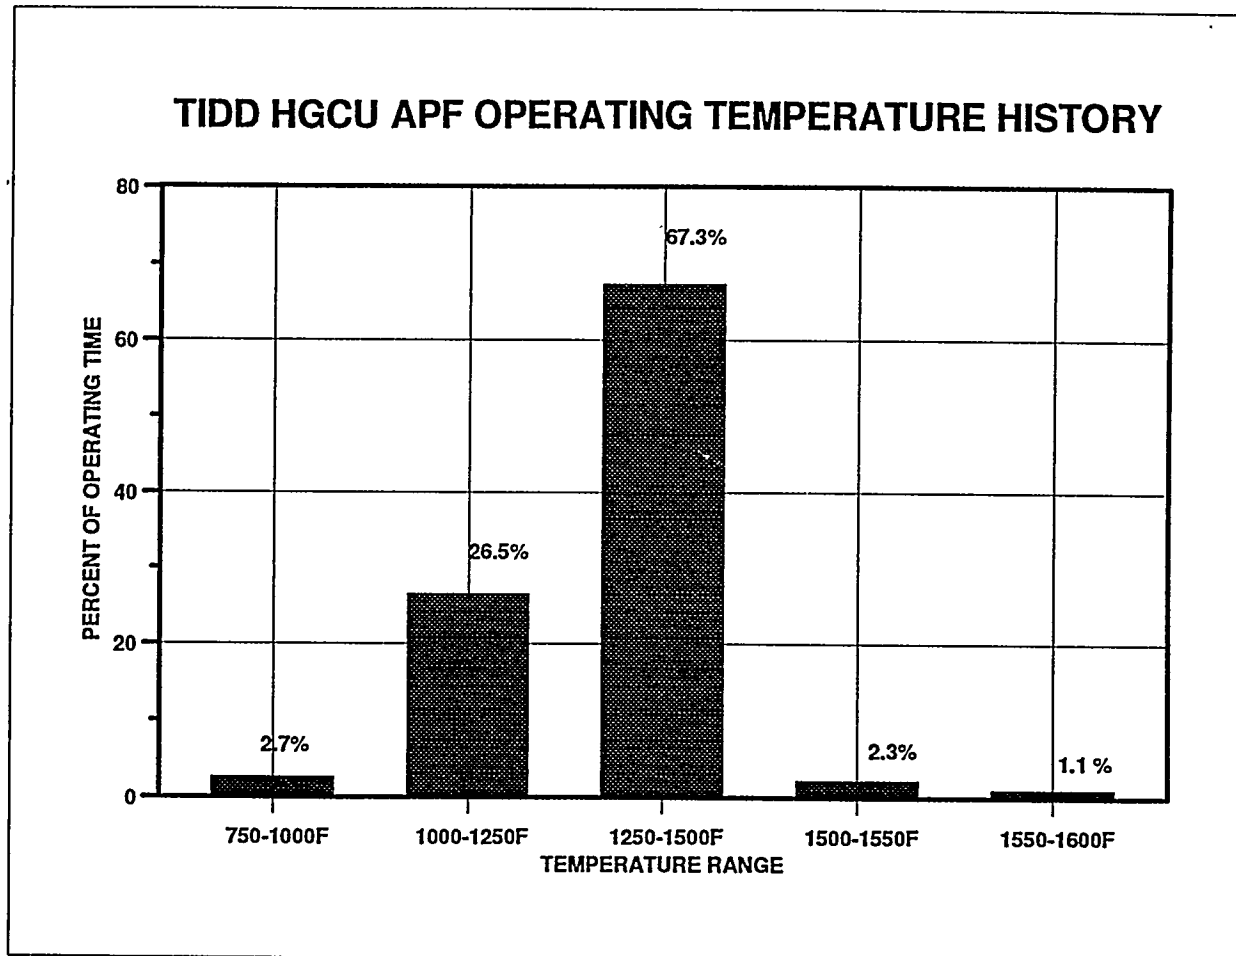
Figure 4.9 is a bar graph which depicts the operating temperature history of the APF. It can be seen that two-thirds of the operating time was in the 1250-1500F range, and about one-fourth of the operating time was in the 1000-1250F range. A comparatively small percentage of the operating time was above 1500F. At the beginning of the project it was planned to operate the APF at full load conditions (1550F) as much as possible during the test program. However, a number of factors limited the operating time at full load conditions. First, Tidd PFBC could not achieve full load except during cold ambient air conditions due to the gas turbine/compressor limitations. Second, much of the operating time, the fluidized bed experienced sintering and/or fluidizing problems which precluded reaching full bed height and load. Third, hot spots on the APF limited unit load on some occasions. Two other factors caused the APF temperature to be lower than the freeboard temperature during much of the test program. Spoiling air supplied from the sorbent air system injected into the dip leg of the primary cyclone for detuning purposes lowered the gas temperature to the APF about 70 to 90F. Tempering (cooling) air was injected upstream of the APF to limit the gas temperature to 1400F during some test periods to mitigate the problem of filter pressure drop instability above this temperature. Only during the final test period when the primary cyclone was bypassed and the ash particle size was much larger did the APF operate above 1550F for sustained periods. It should be recognized that the limited operating time near the full load temperature of 1550F reduced the opportunity to observe long-term high-temperature effects on both ceramic filter elements and the metallic components inside the APF.

Figure 4.9 - Tidd HGCU APF Operating Temperature History

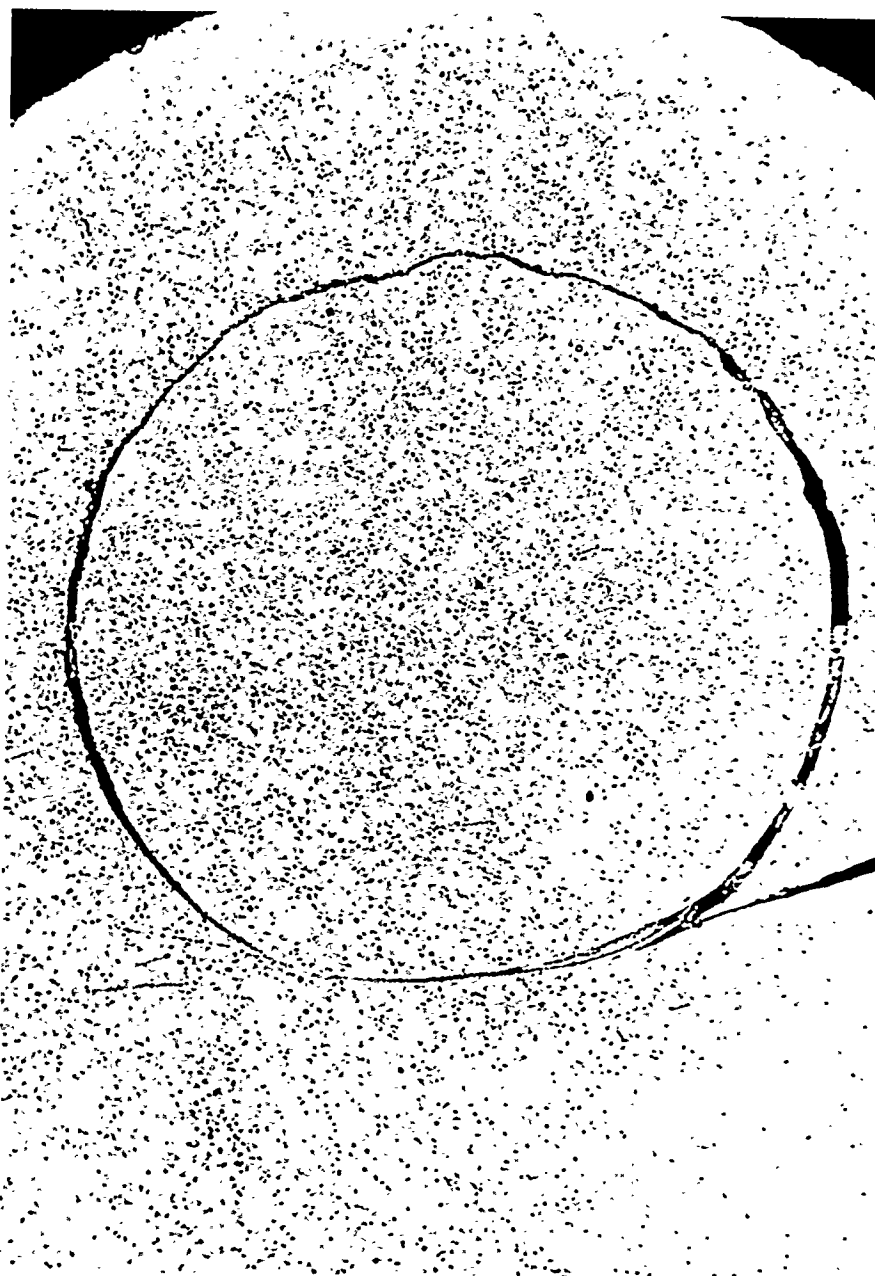
**Figure 4.9.1 - Cross Section of 0.005-inch Wire from Fine Fail-safe Mesh As New-700X**

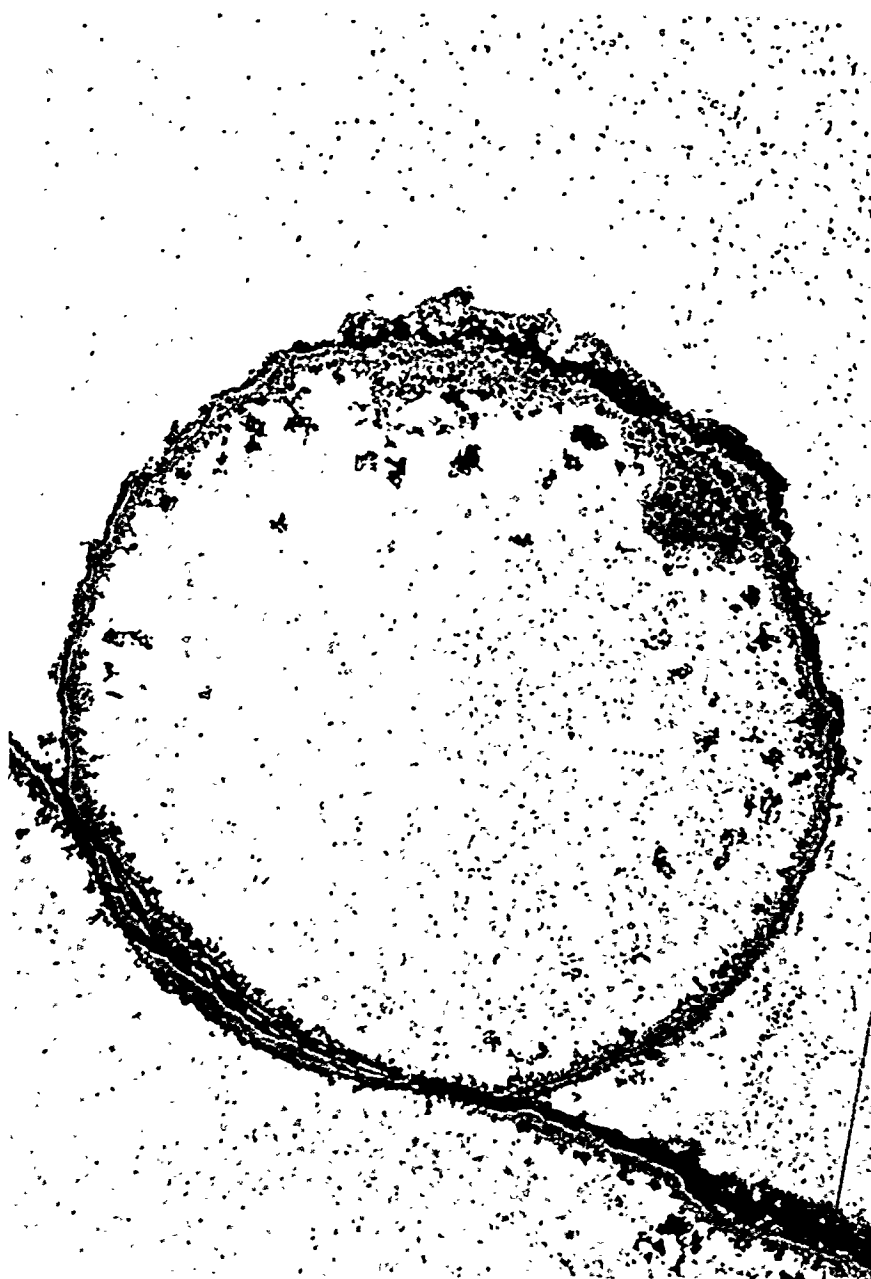
**Figure 4.9.2 - Cross Section of 0.005-inch Wire from Fine Fail-safe Mesh After 1329 hours at Karhula-700X**
