## **Tidd Hot Gas Clean Up Program**

### **Final Report**

October 1995

The Tidd Hot Gas Clean Up (HGPU) system was installed in the Tidd Pressurized Fluidized Bed Combustion (PFBC) Demonstration Plant, which is the first utility-scale PFBC plant in the United States. The plant is owned and operated by Ohio Power Company and is located on the banks of the Ohio River, approximately 75 miles downstream of Pittsburgh, Pennsylvania.

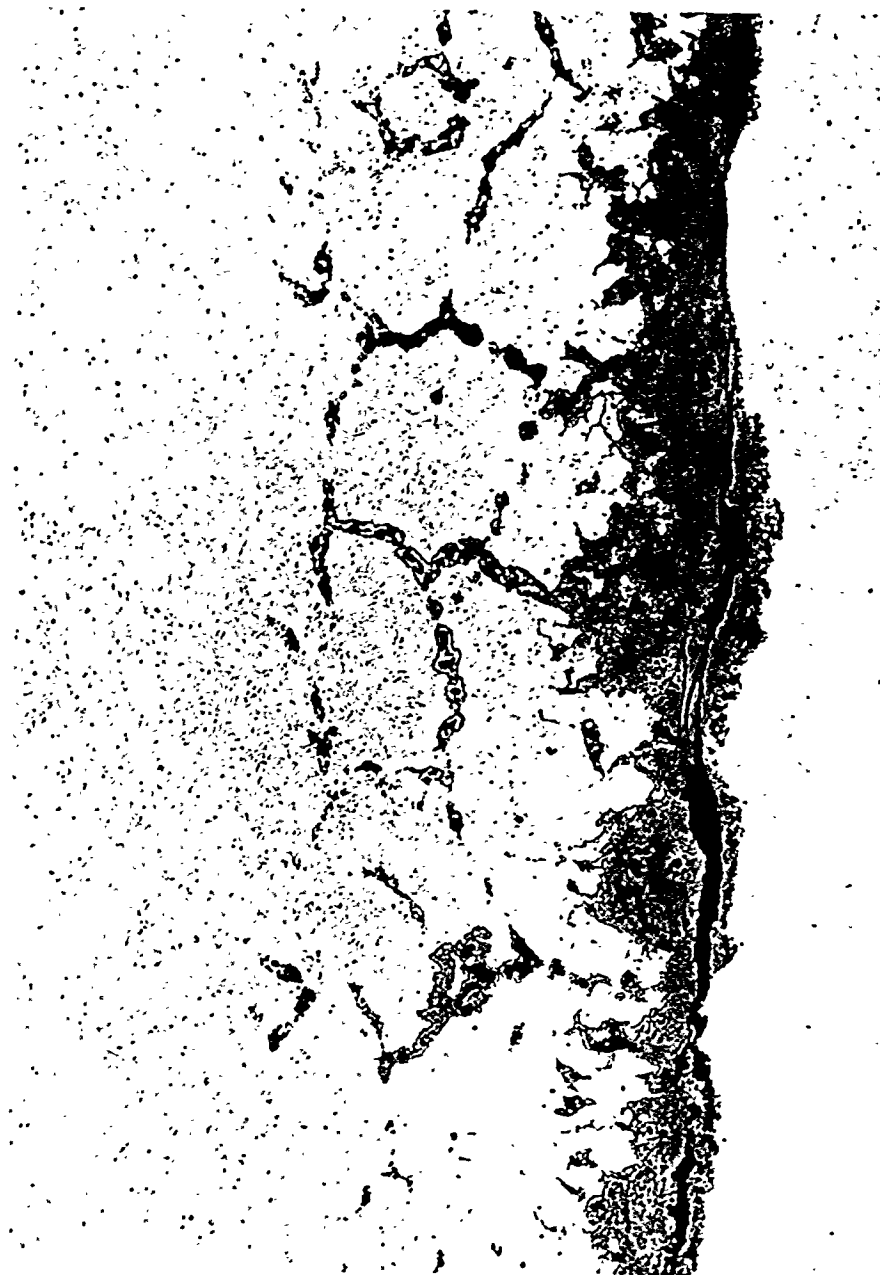
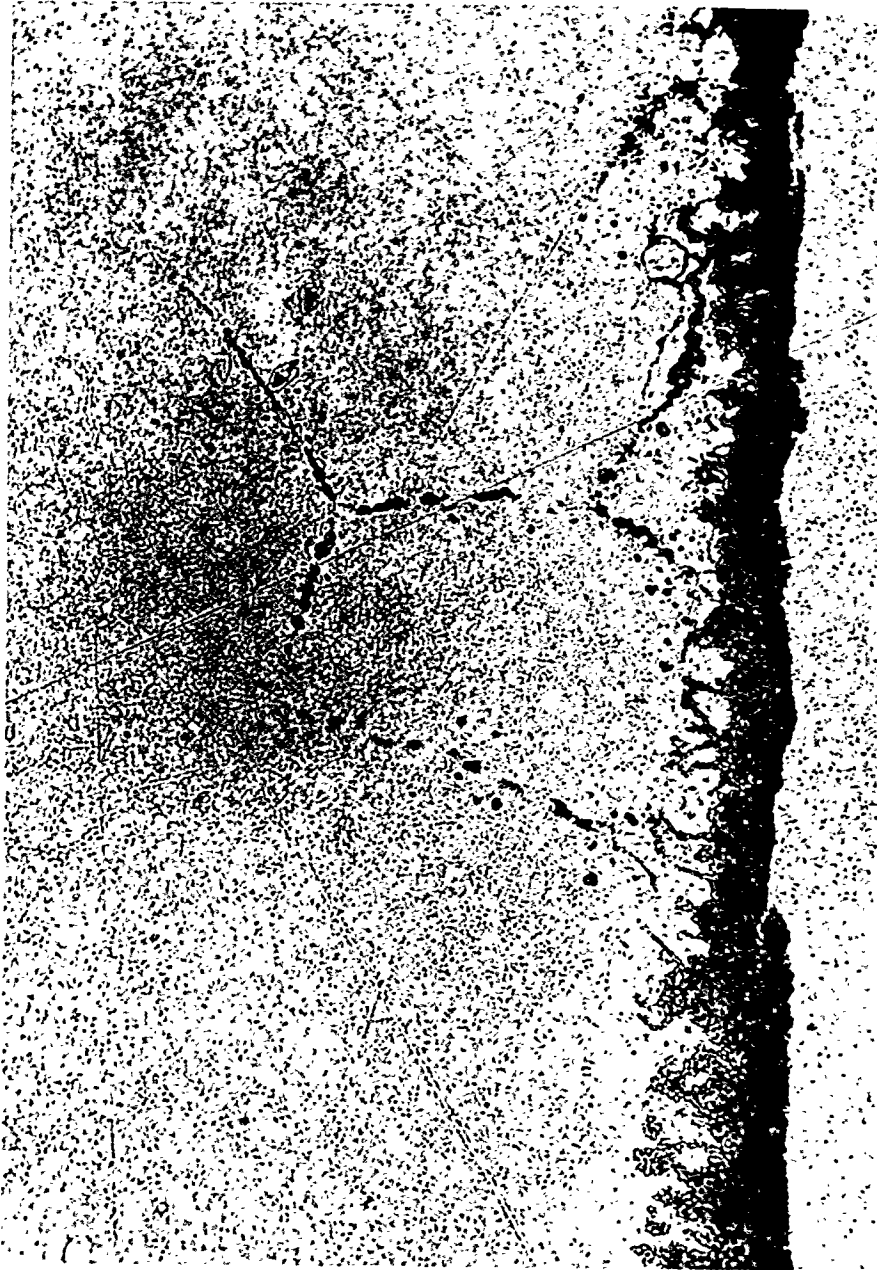
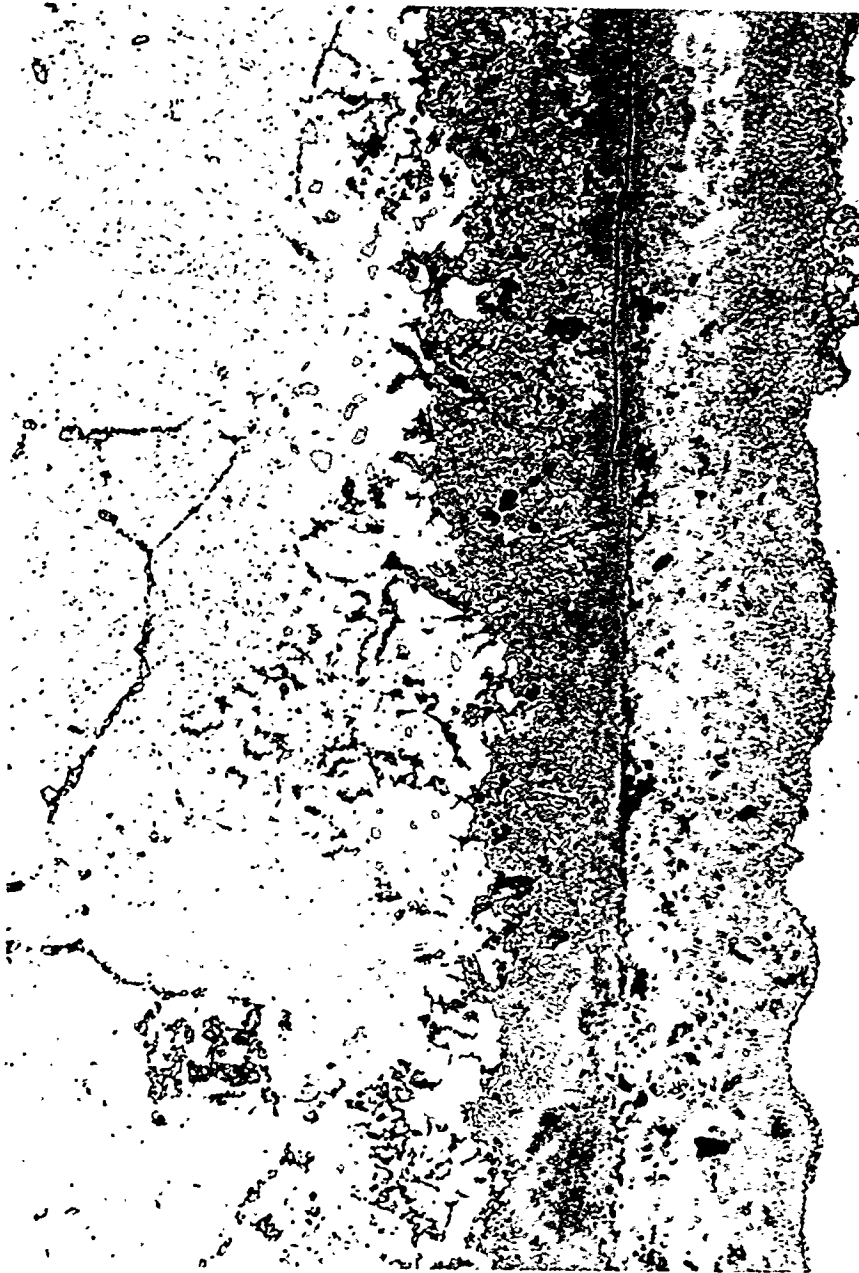
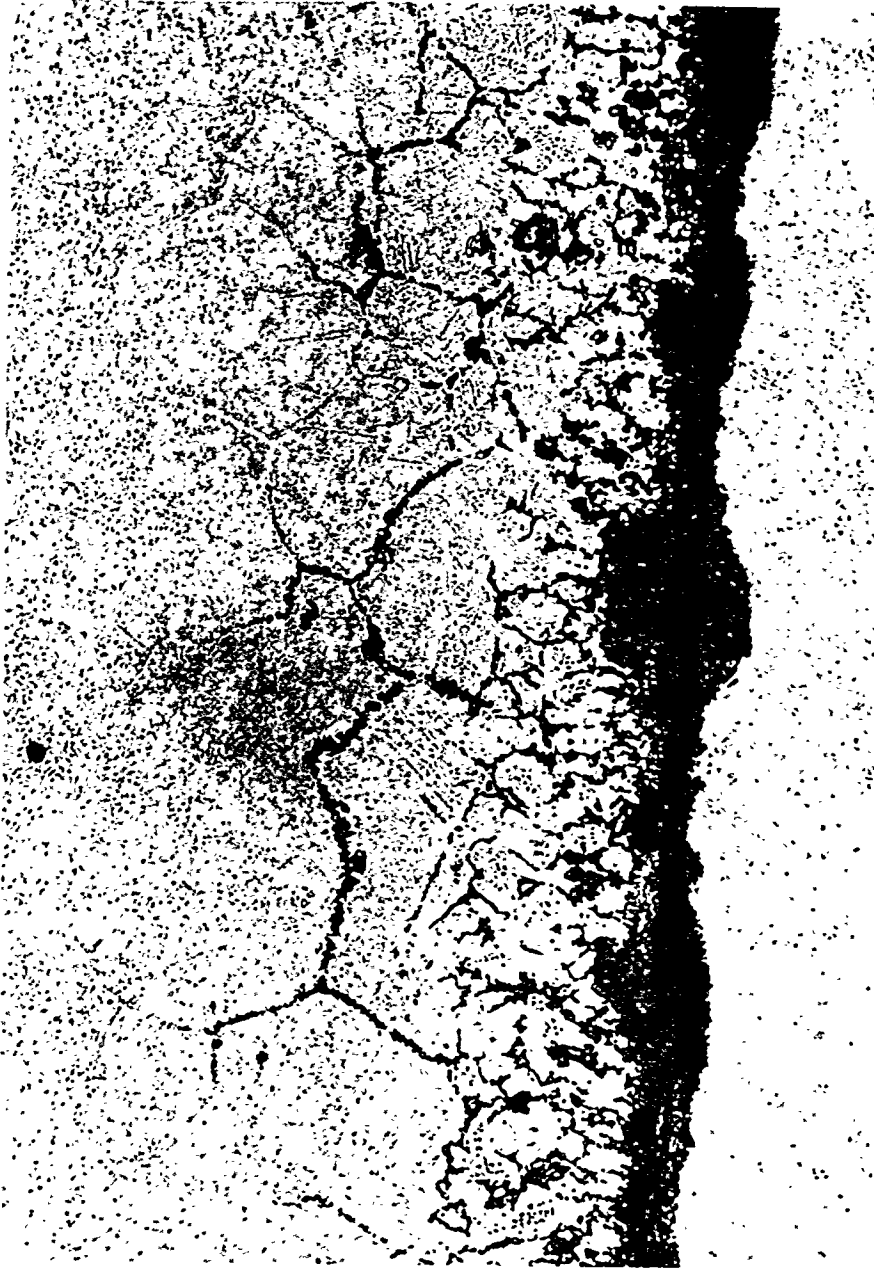
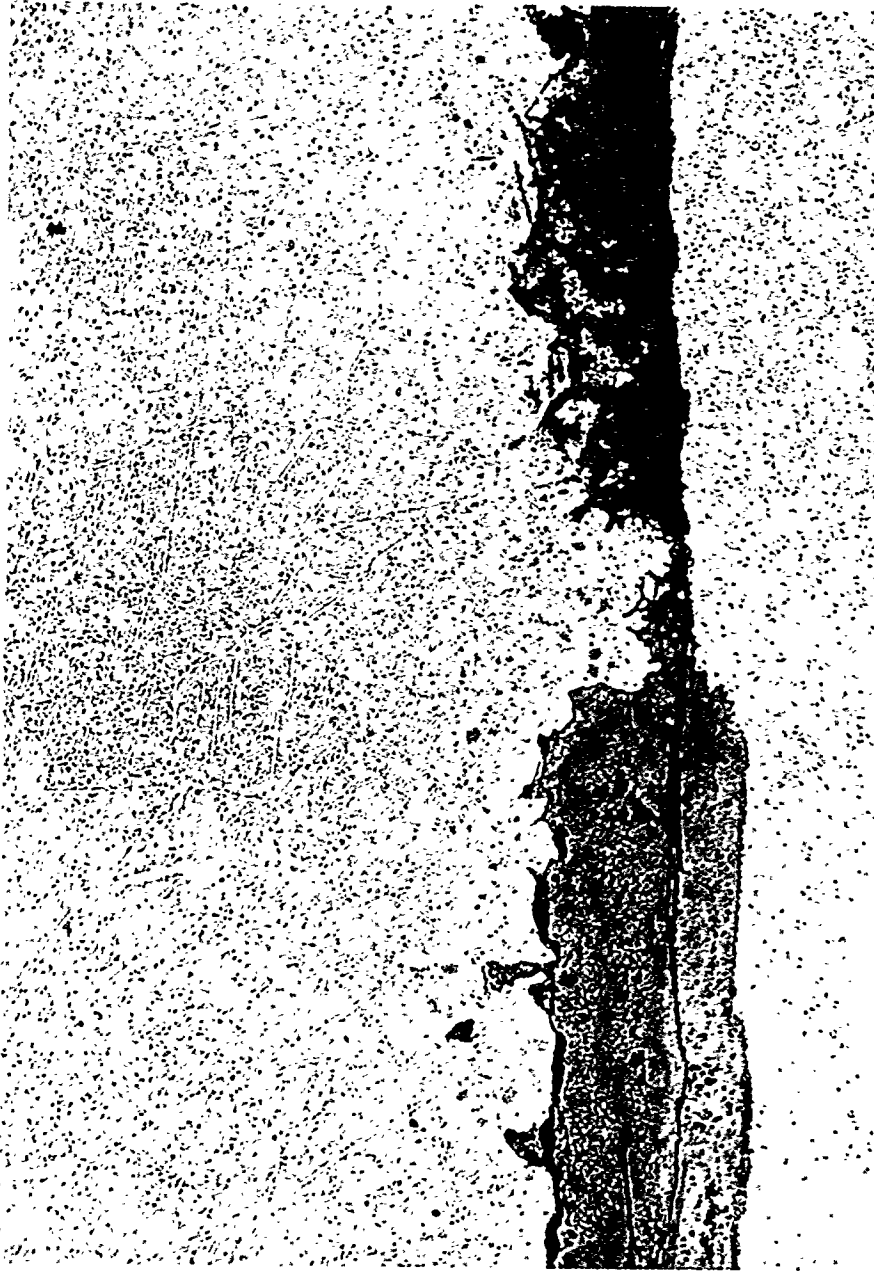
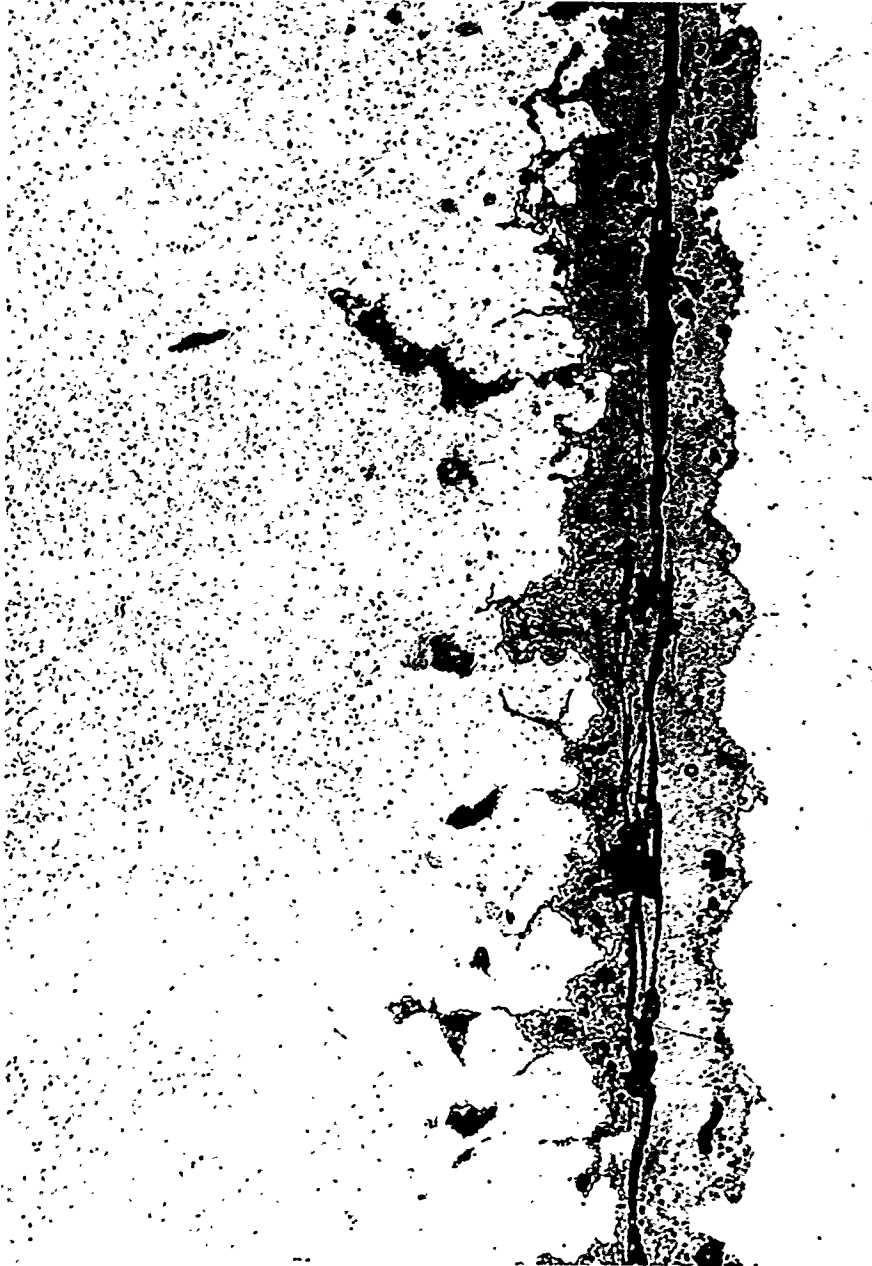
**Figure 4.9.4 - Cross Section of Alloy 333 Coupon-700X**

**Figure 4.9.5 - Cross Section of Alloy 617 Coupon-700X**

Figure 4.9.6 - Cross Section of Alloy 556 Coupon-700X

**Figure 4.9.7 - Cross Section of Alloy 188 Coupon-700X**

**Figure 4.9.8 - Cross Section of Alloy 253MA Coupon-700X**

**Figure 4.9.9 - Cross Section of Alloy 310 Coupon-700X**

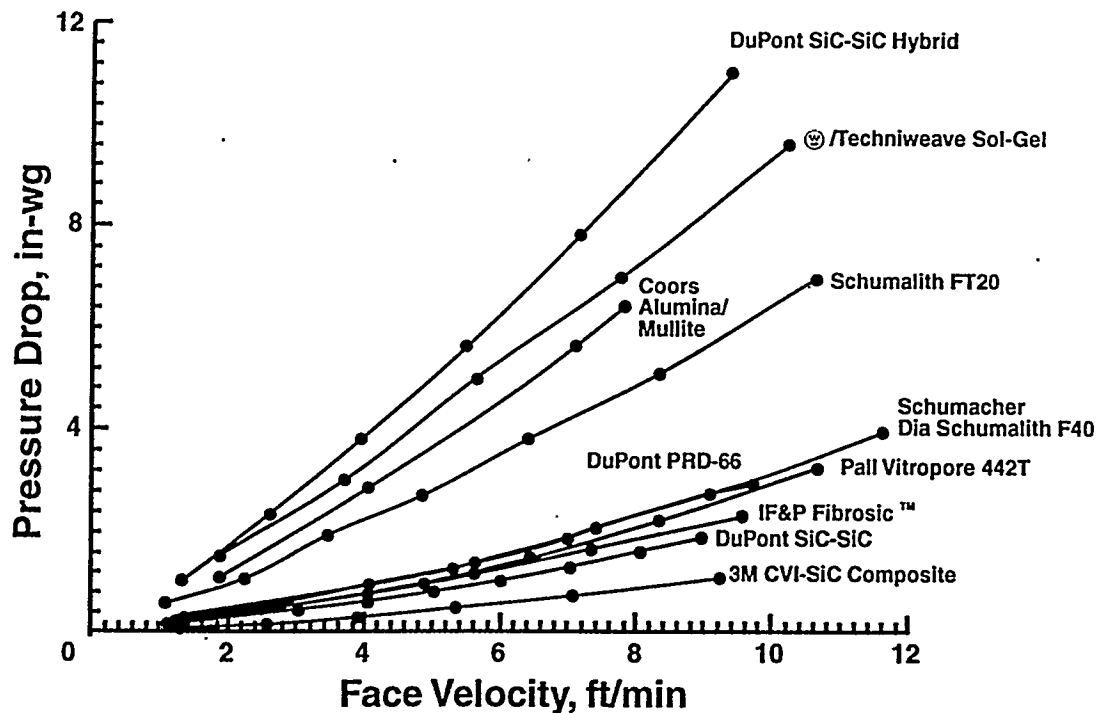
Figure 4.9.10 - Room Temperature Gas Flow Resistance of the First Generation Monolithic and Advanced Second Generation Candle Filters

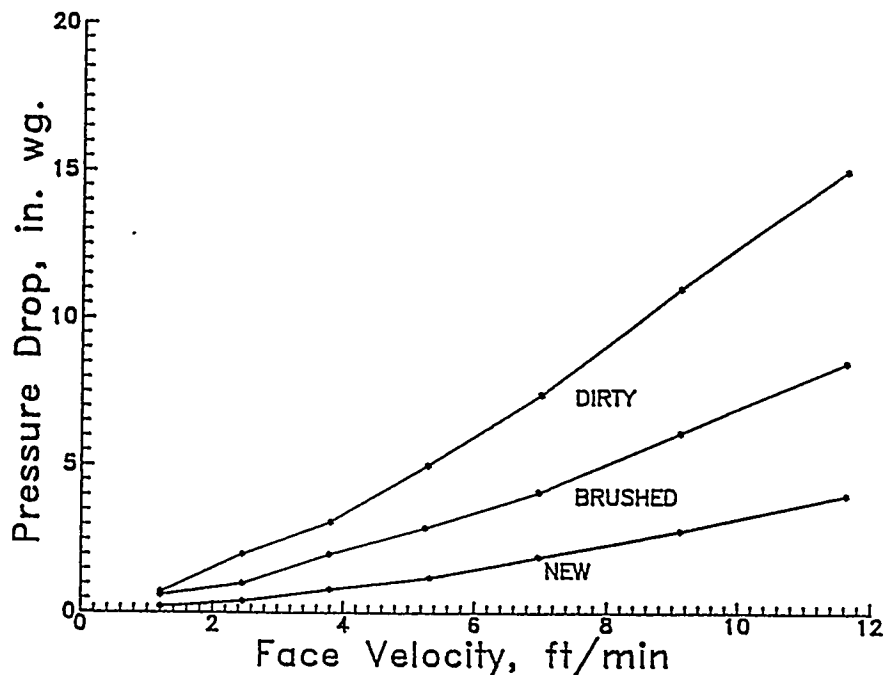
As shown in Figure 4.9.11, the pressure drop or gas flow resistance through the filter element increased as fines collected and remained along the outer surface of the filter elements. Following normal operating conditions, the as-manufactured gas flow resistance was regenerated by simply washing the elements with water and drying. In the event that candles failed and process operation continued, fines released into the clean gas stream were pulsed back into the inner wall of the remaining intact filter elements. Posttest washing of these elements generally did not permit regeneration of the as-manufactured gas flow resistance, since the fines typically blinded the inner wall of the coarse support matrix. Since the ID fines generally could not be removed, the elements were eliminated for continued use.

Figure 4.9.11 - Room Temperature Gas Flow Resistance Measurements Across As-Manufactured Clay Bonded Silicon Carbide Filter Elements. Measurements Were Repeated After Operation at Tidd.

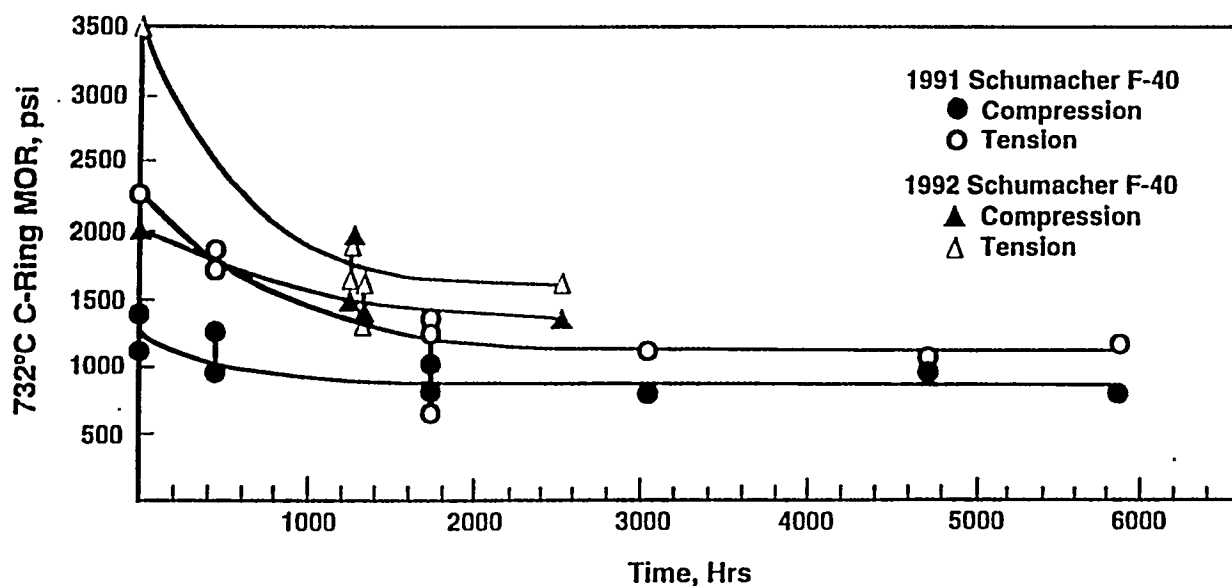
Figure 4.9.13 - Schumacher Strength Profile

Within the entire candle filter assembly, generally 5-16% of the Schumacher Dia Schumalith F40 filter elements failed during operation in Test Periods I through IV, primarily as a result of ash bridging. After removal of the primary cyclone from service in Period V, ash bridging, as well as candle failure were mitigated. Schumacher Dia Schumalith F40 surveillance candles, however, successfully achieved 5854 hours of operation. The residual bulk strength of the Schumacher Dia Schumalith F40 matrix was determined via room temperature and process temperature C-ring compressive and tensile testing. As shown in Figure 4.9.13, the process temperature bulk strength of the Schumacher Dia Schumalith F40 matrix decreased during the initial 1000-2000 hours of PFBC operation. With continued operation, however, the bulk strength of the Schumacher Dia Schumalith F40 matrix remained constant. The residual or "conditioned" strength was considered to result from the complete or nearly complete crystallization of the binder phase that encapsulated the silicon carbide grains, as well as the bond posts or ligament surfaces as shown in the photo micrograph in Figure 4.9.14.

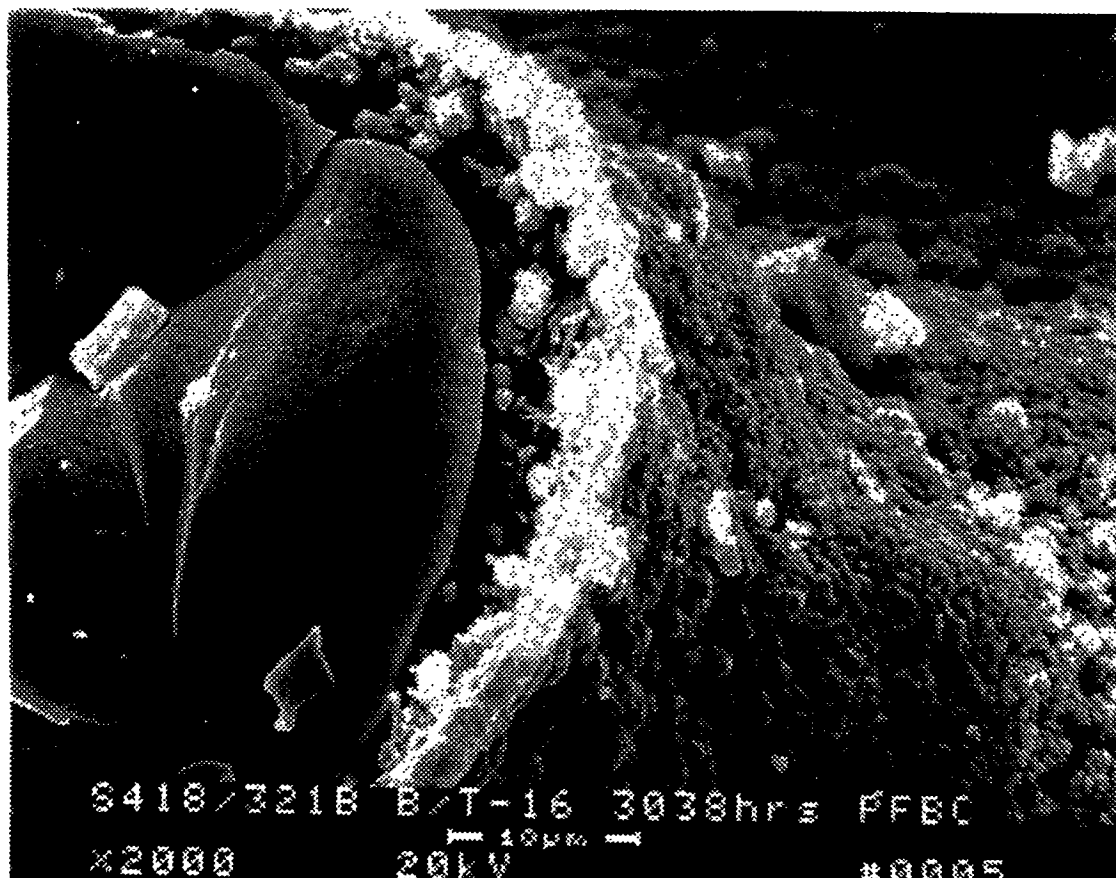
**Figure 4.9.14 - Photo Micrograph Showing Crystallization of the Schumacher Dia Schumalith F40 Filter Matrix**

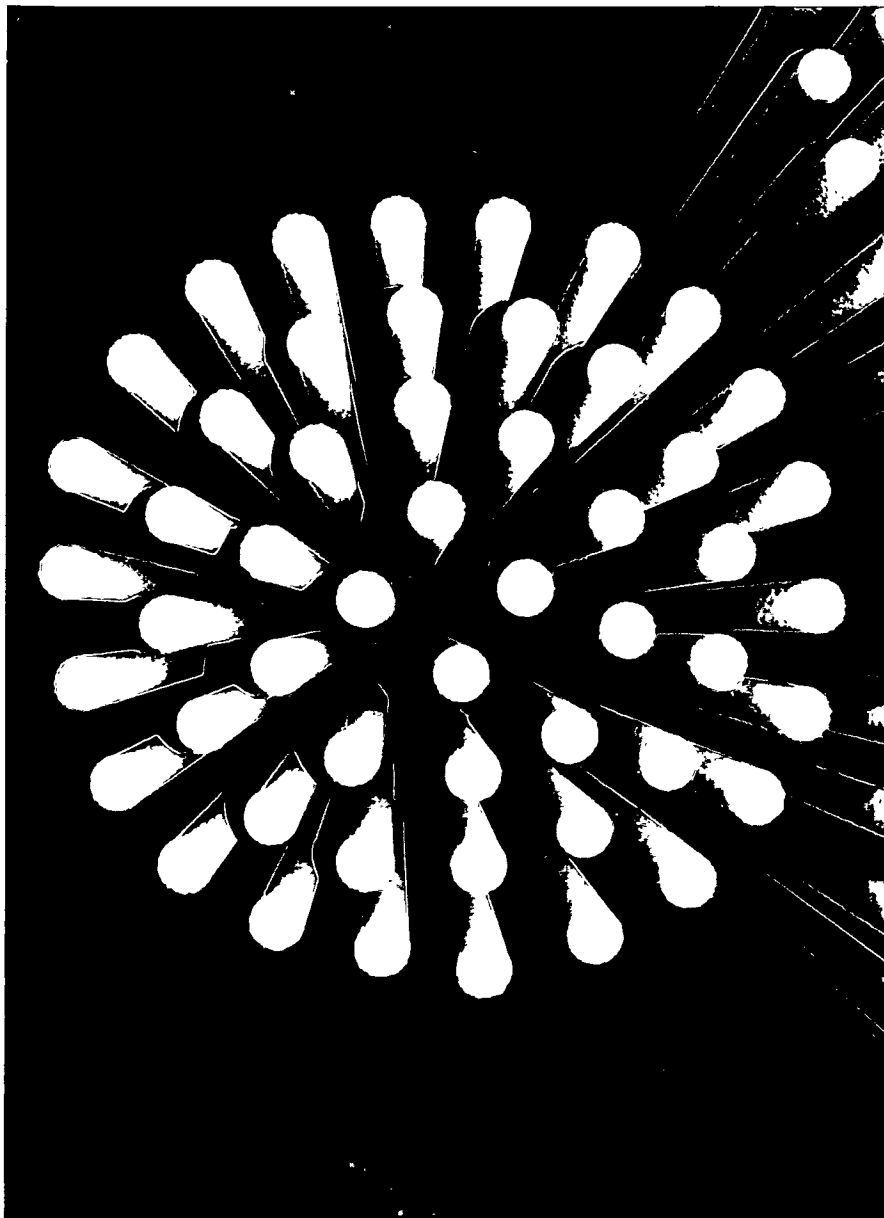
**Figure 4.3.1 - Photograph of Bottom Filter Candles Following Test Run 1**

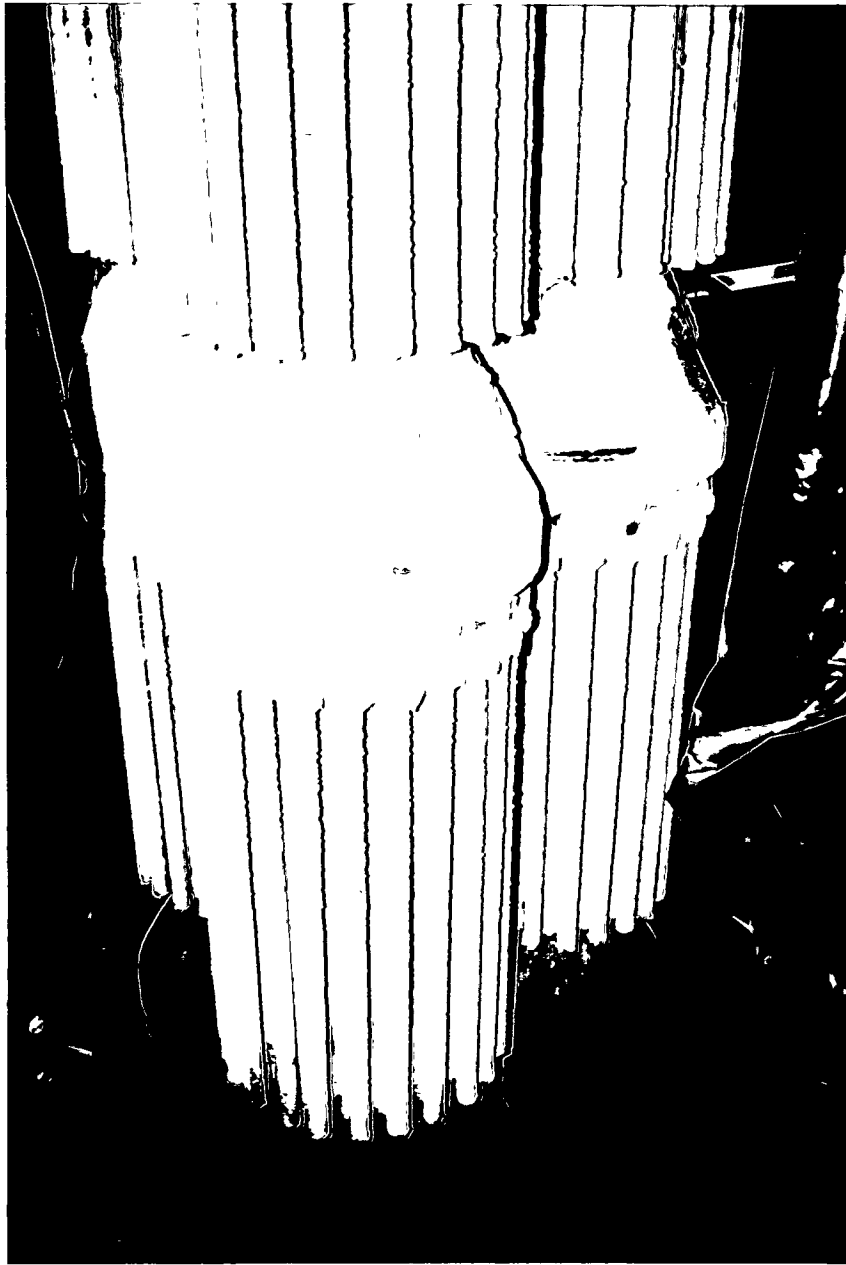
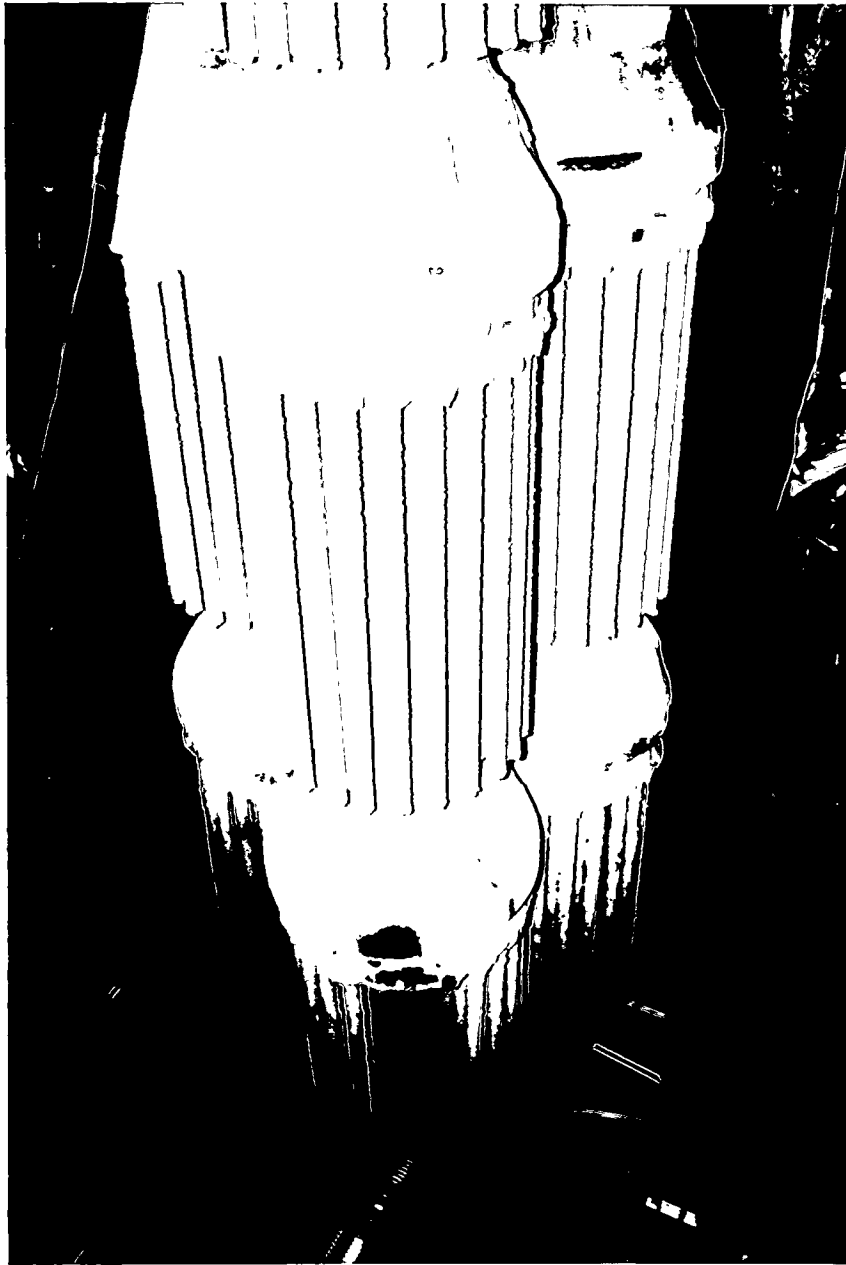
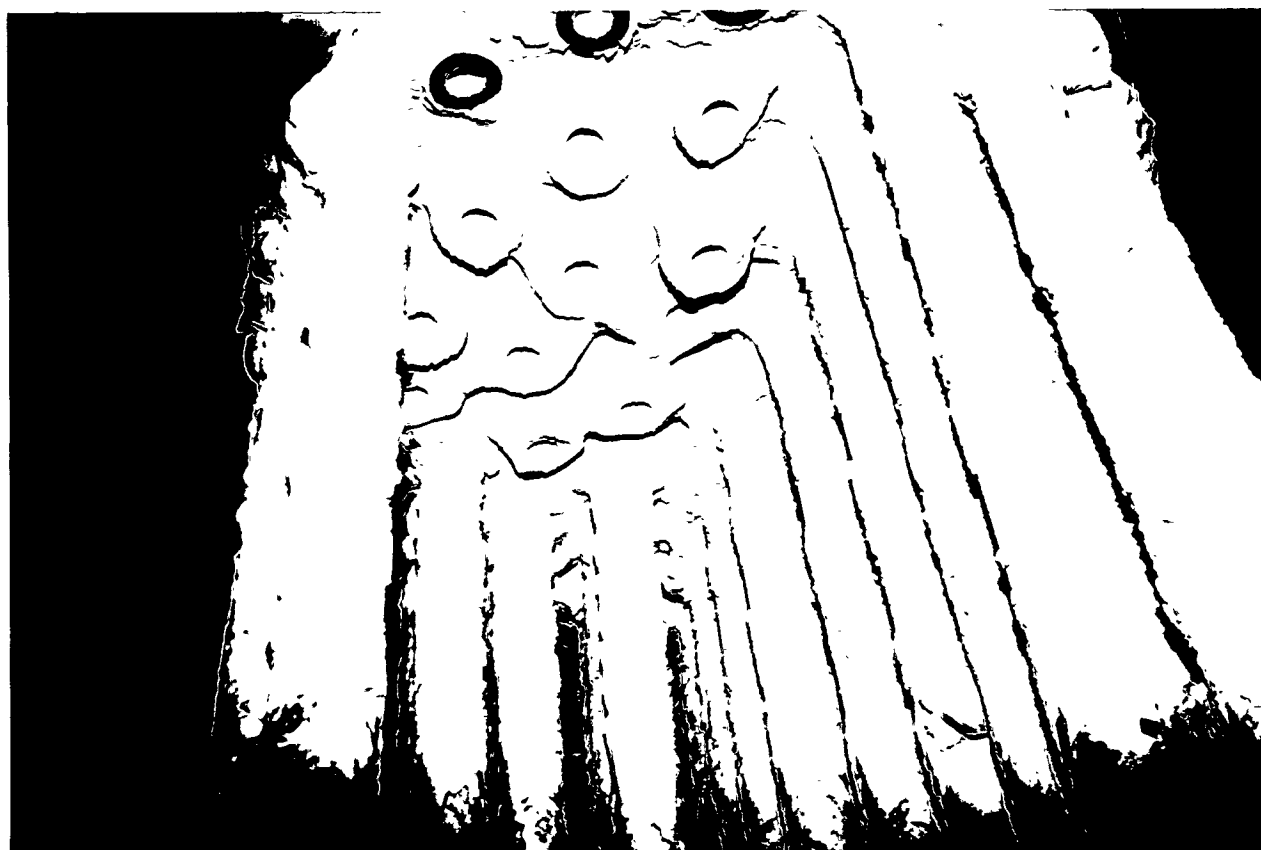
**Figure 4.3.2 - Photograph of Filter Internals Following Test Run 4**

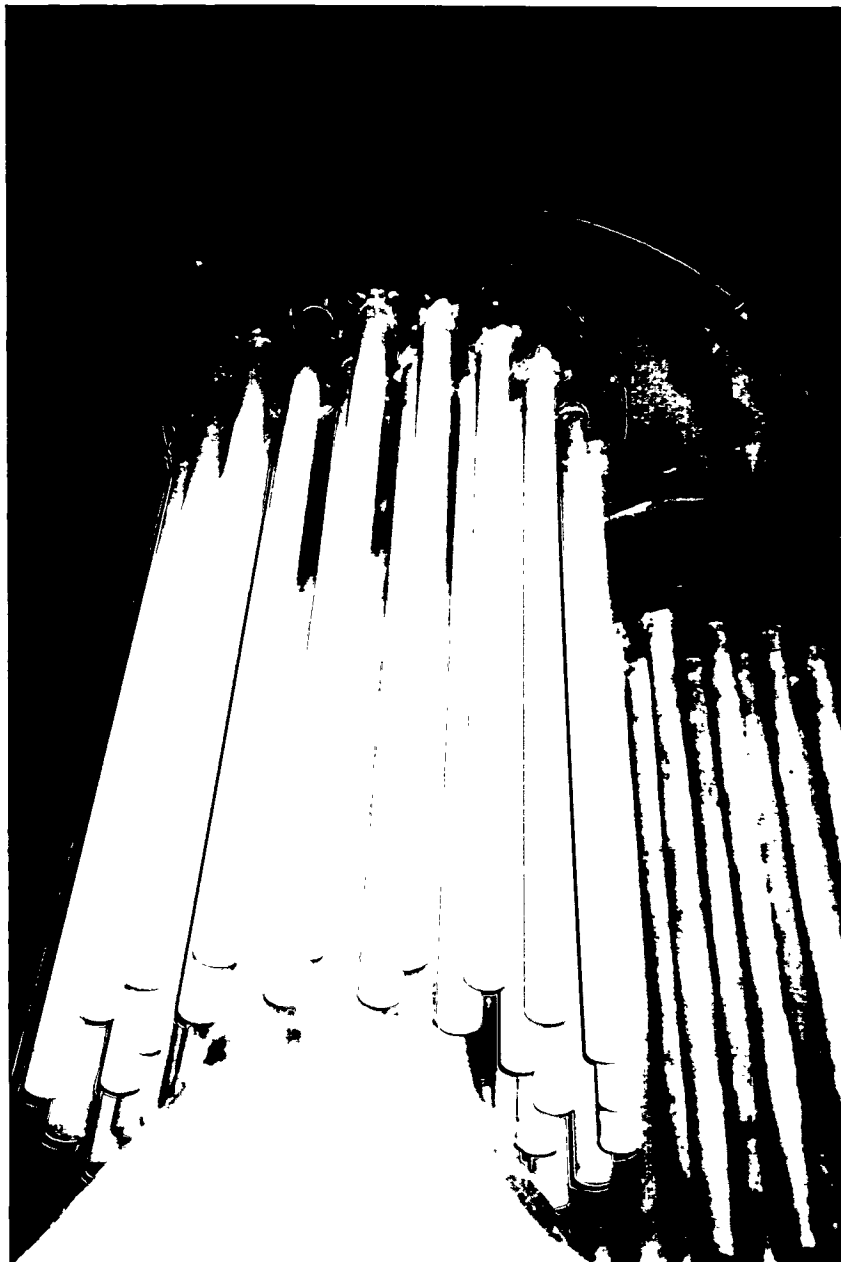
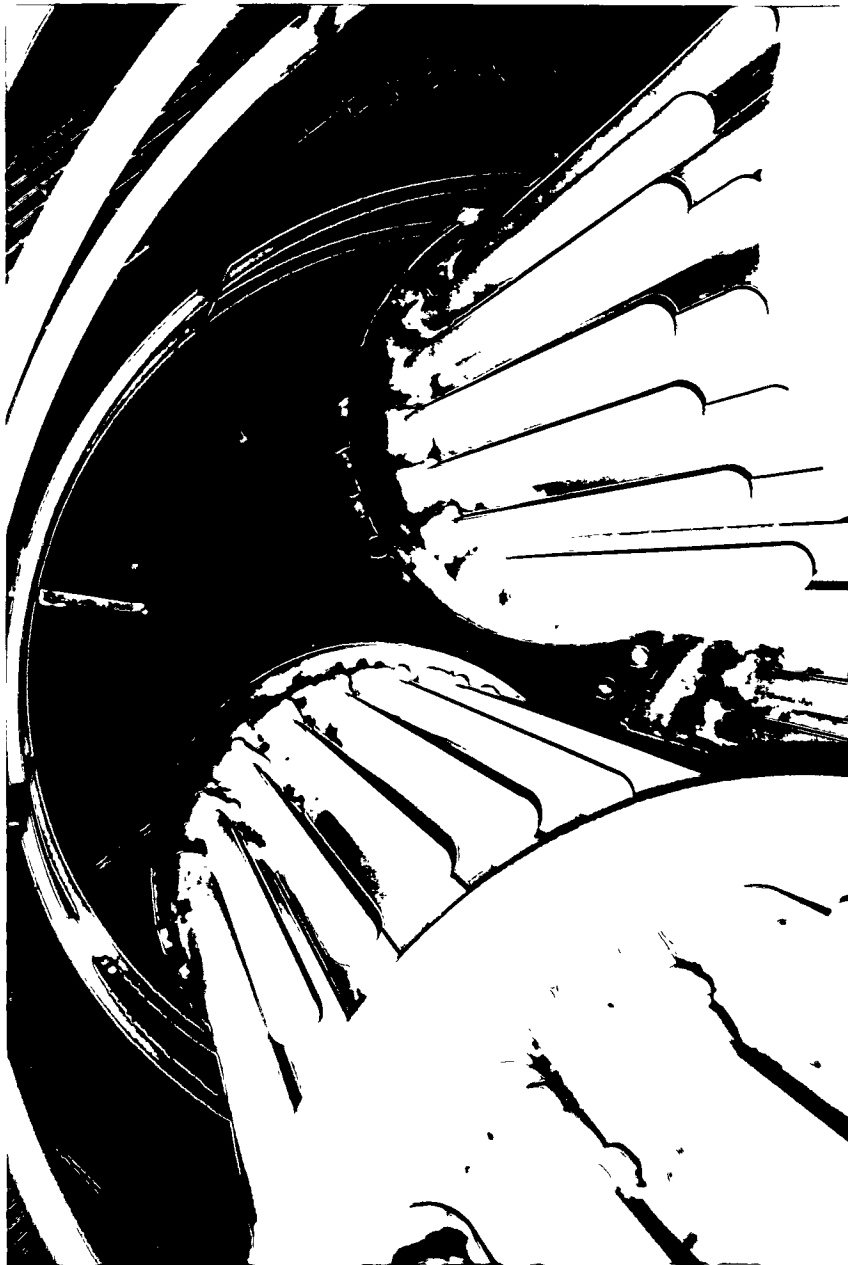
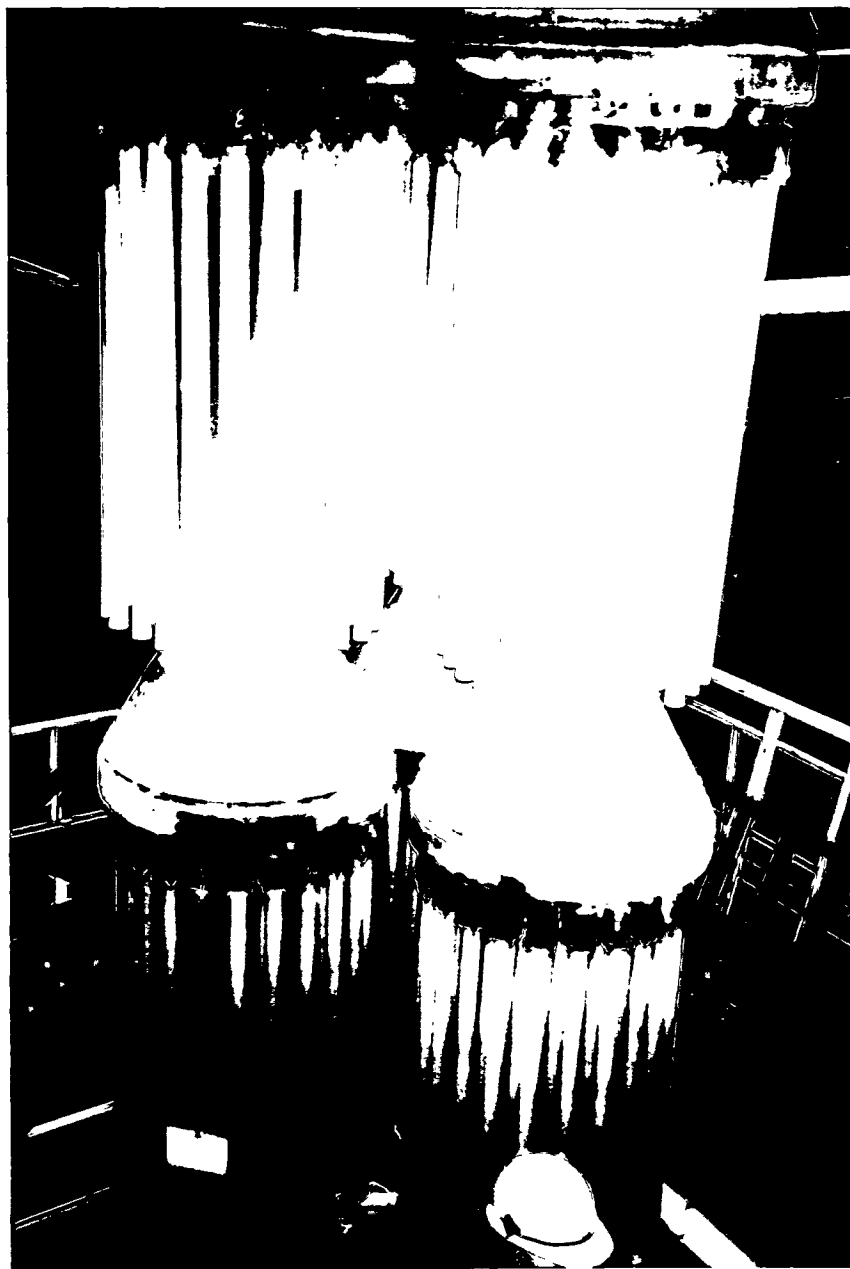
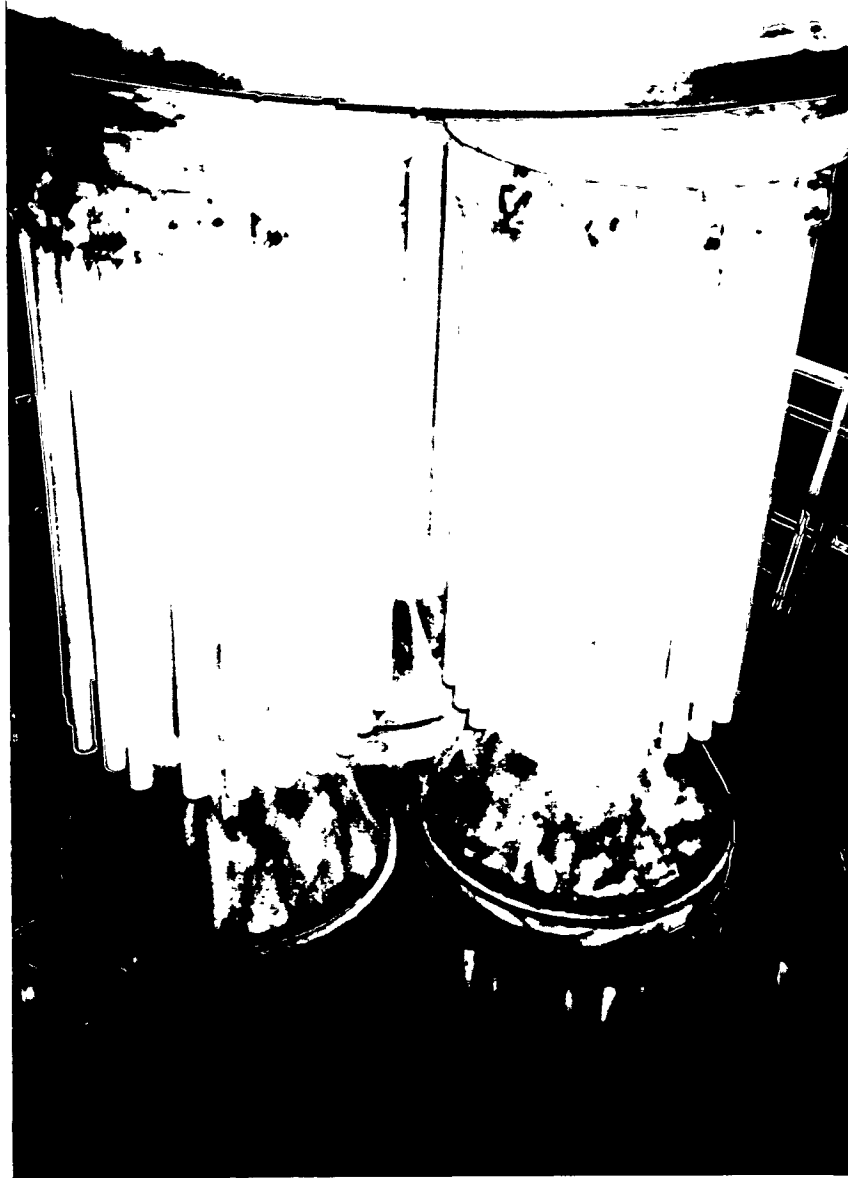
**Figure 4.3.12 - Photograph of Filter Internals Before Test Period II**

Prior to the resumption of testing, all of the filter candles in the bottom plenums were replaced and all of the ash accumulation on the filter candles and metal surfaces in the upper and middle plenums was removed, as shown in Figures 4.3.12 through 4.3.15.

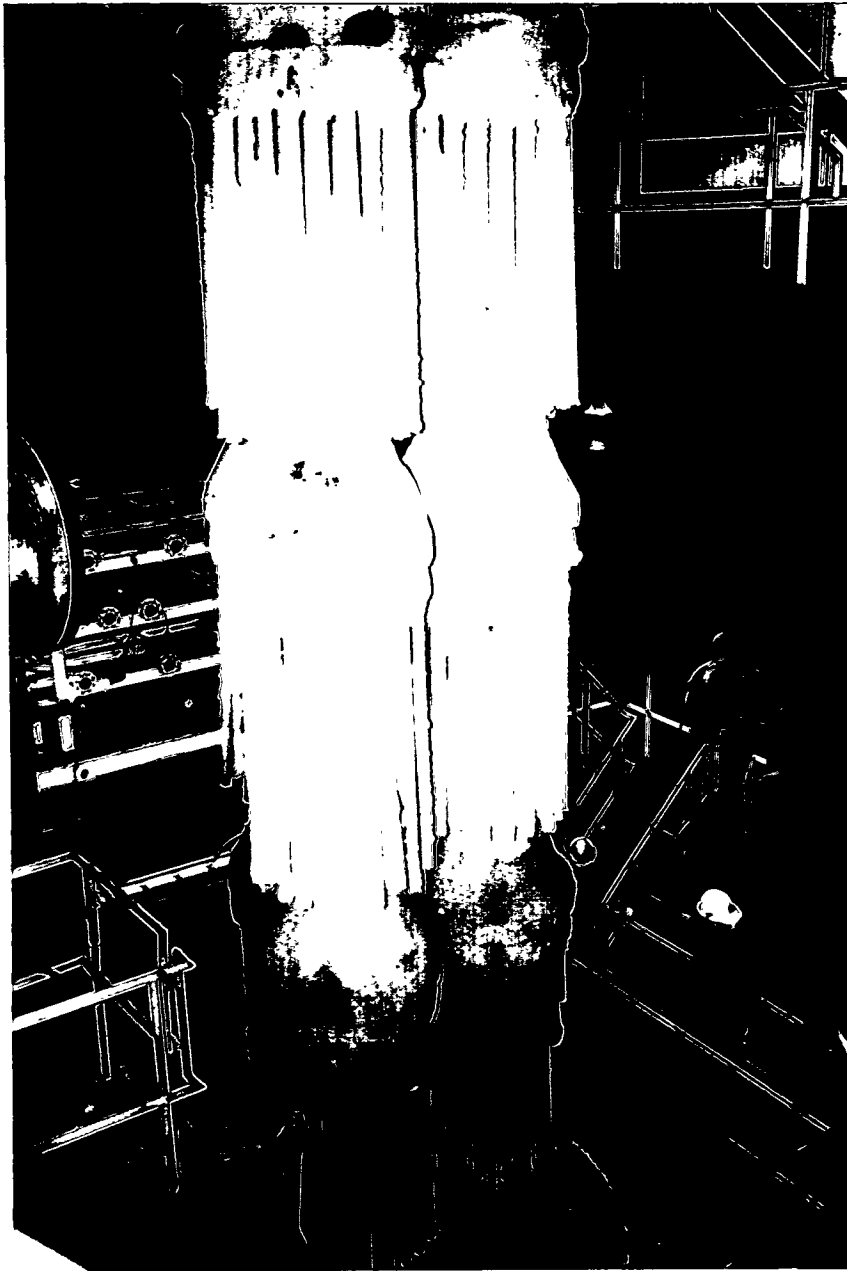
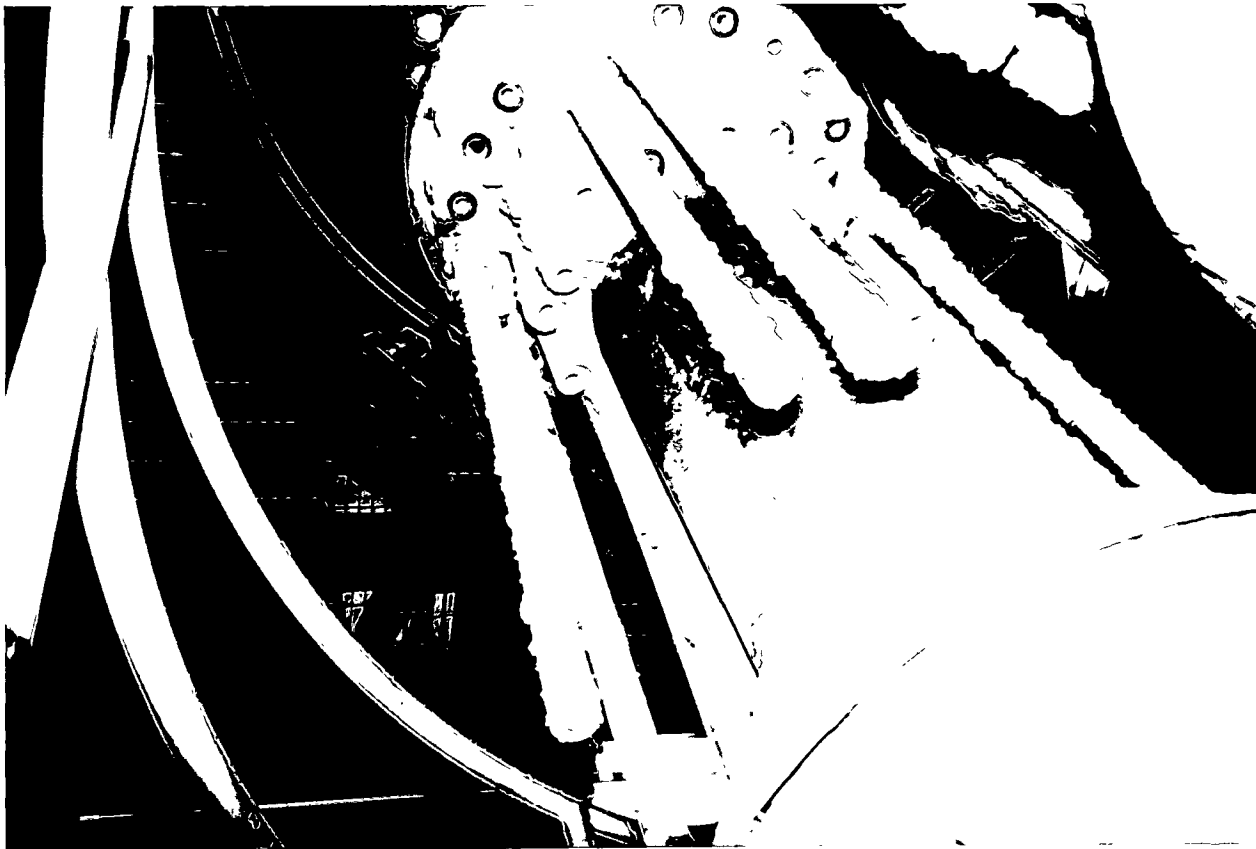
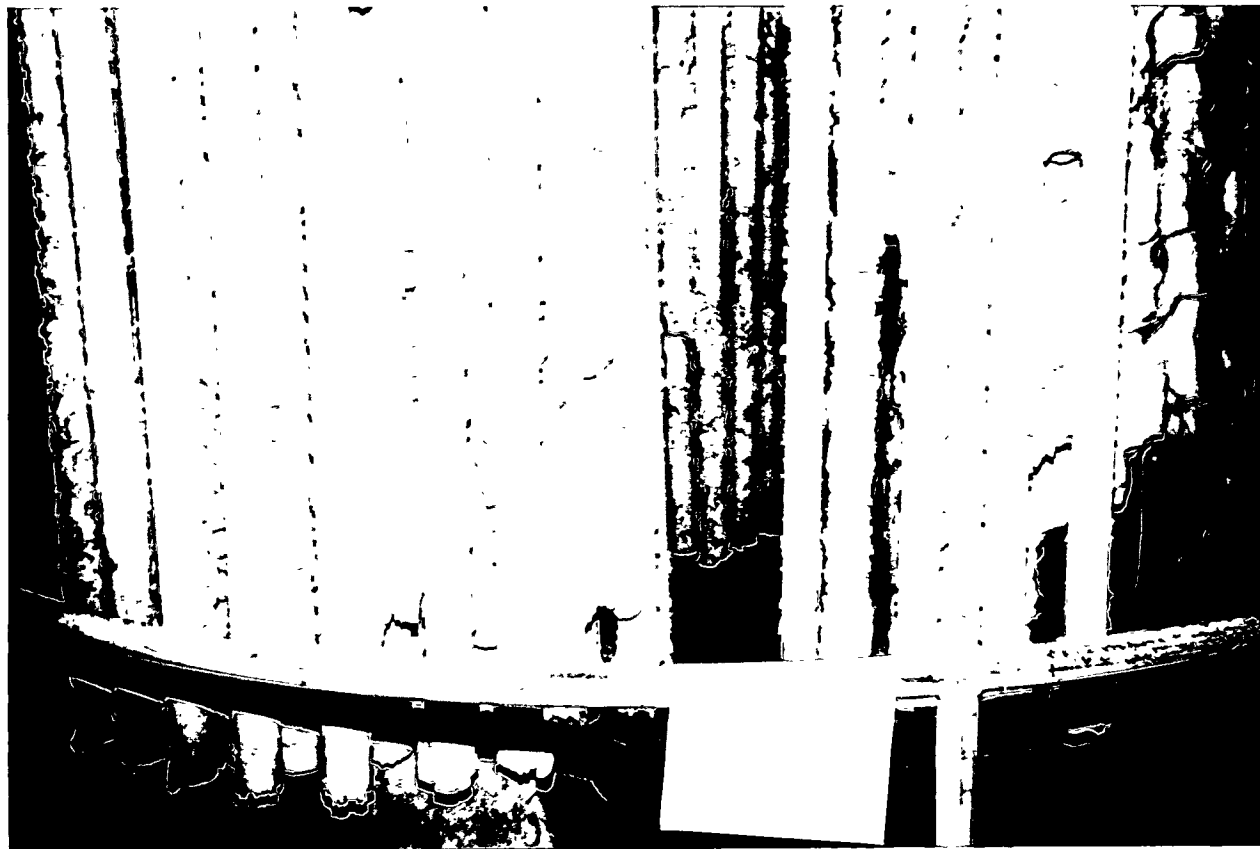
On 9/30, the APF internals were removed from the APF. Upon inspection, 62 candles were found to be broken. Approximately three candles were broken during removal from the APF vessel. The following table shows a summary of the location of the broken candles.

Very heavy ash bridging was apparent between candles and between candles and support pipes. Figures 4.4.6 through 4.4.11 are photographs of the filter internals following Test Period II. The deposits were very hard and difficult to break into smaller pieces. Many candles were also found to be bowed. During subsequent cleaning of the ash deposits from the candles, approximately 40 more candles broke.

All filter candles were replaced with new silicon carbide candles between Test Series II and III, except for nine surveillance candles which were reused.
