## **Tidd Hot Gas Clean Up Program**

### **Final Report**

October 1995

The Tidd Hot Gas Clean Up (HGPU) system was installed in the Tidd Pressurized Fluidized Bed Combustion (PFBC) Demonstration Plant, which is the first utility-scale PFBC plant in the United States. The plant is owned and operated by Ohio Power Company and is located on the banks of the Ohio River, approximately 75 miles downstream of Pittsburgh, Pennsylvania.

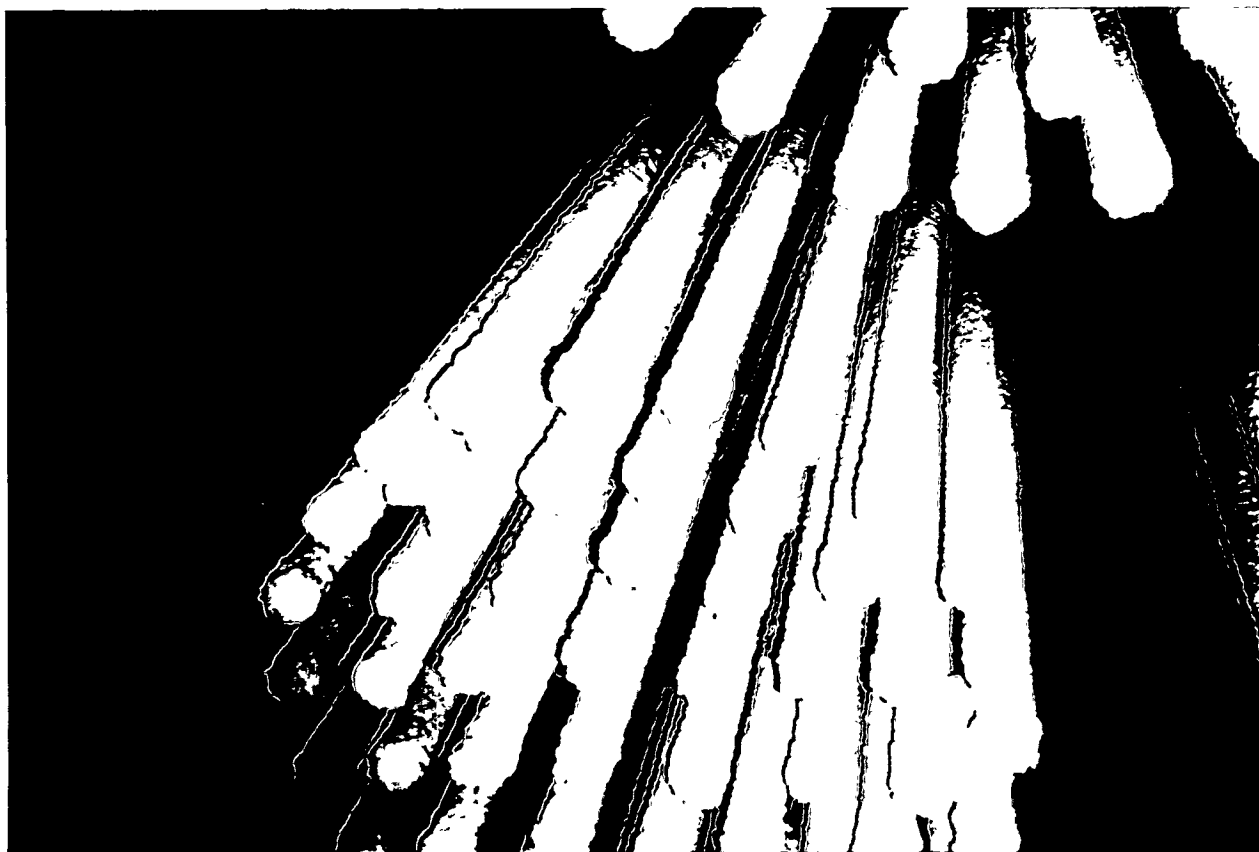
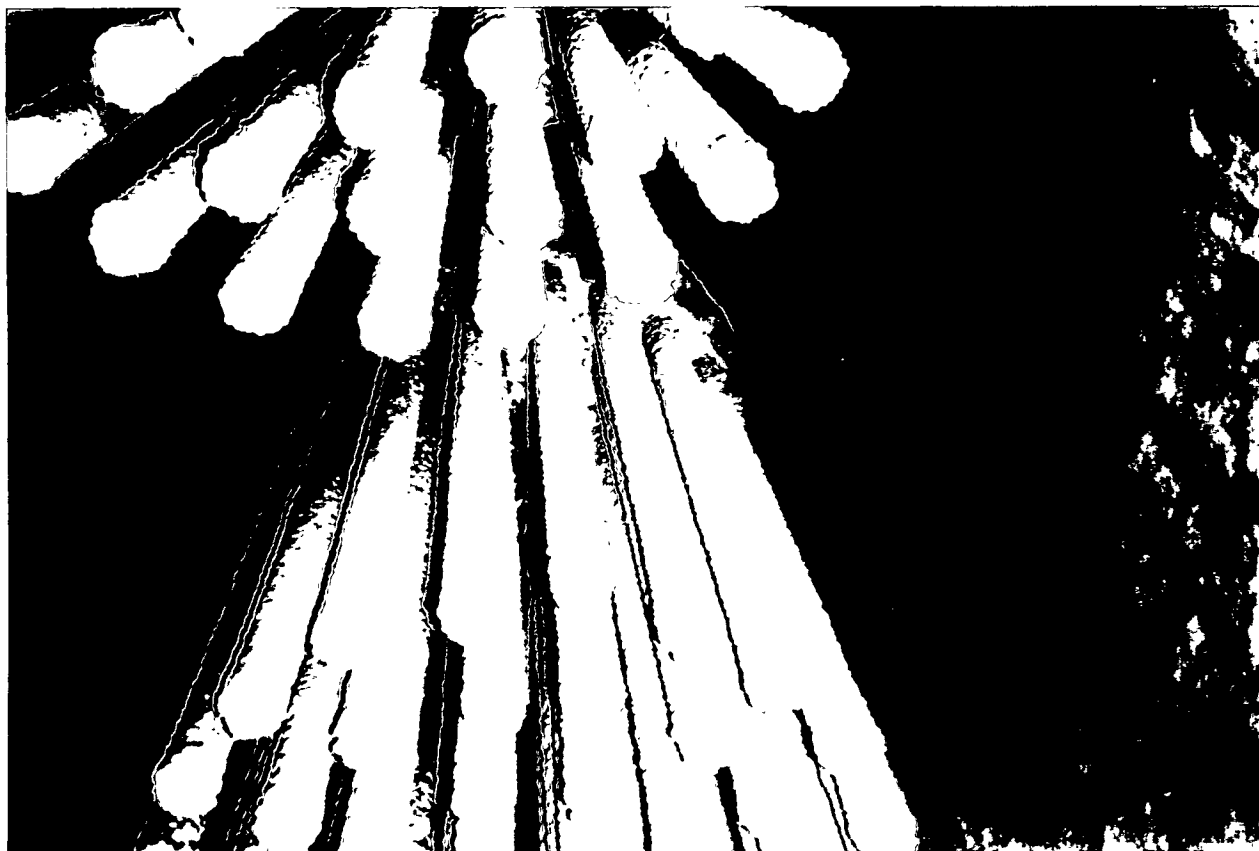
| | Operating Hours | Cumulative Hours | Operating Temp. | Pressure Drop | Inspection Observations |
|---|---|---|---|---|---|
| Run 18 | 444 | 3038 | 1350-1450 °F | Baseline $\Delta p$ increased $\approx$ 20 in. wg | <ul style="list-style-type: none"><li>● 28 broken candles</li><li>● Inner rows of top and middle plenums heavily bridged</li></ul> |

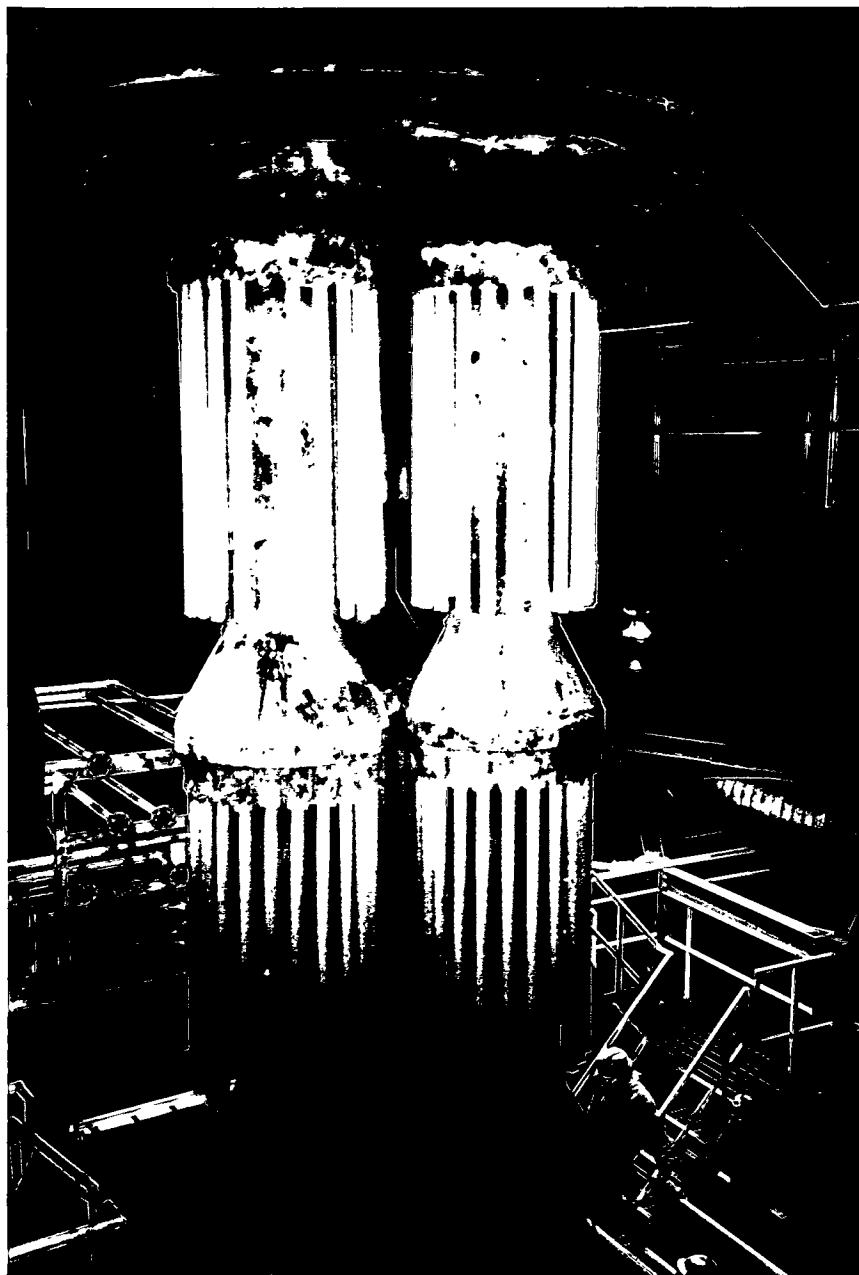
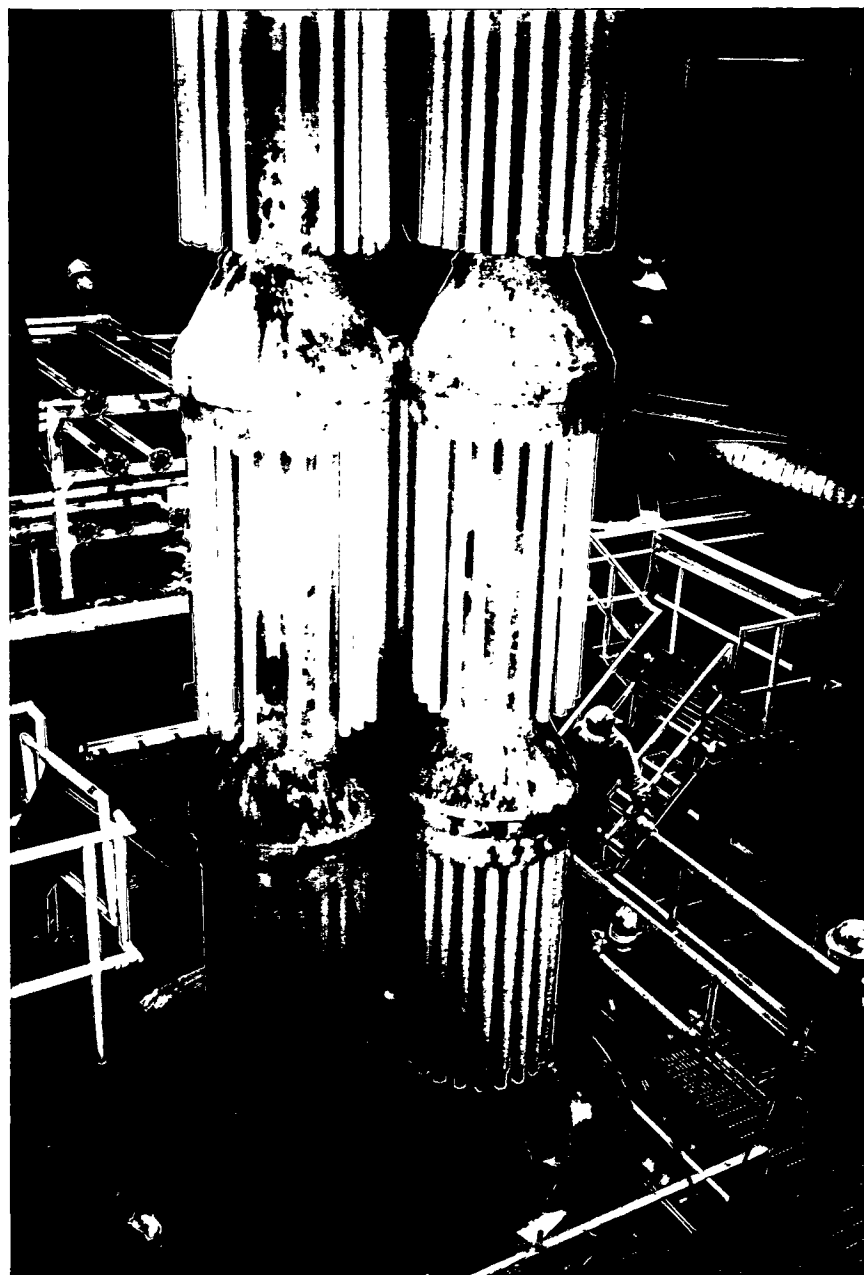
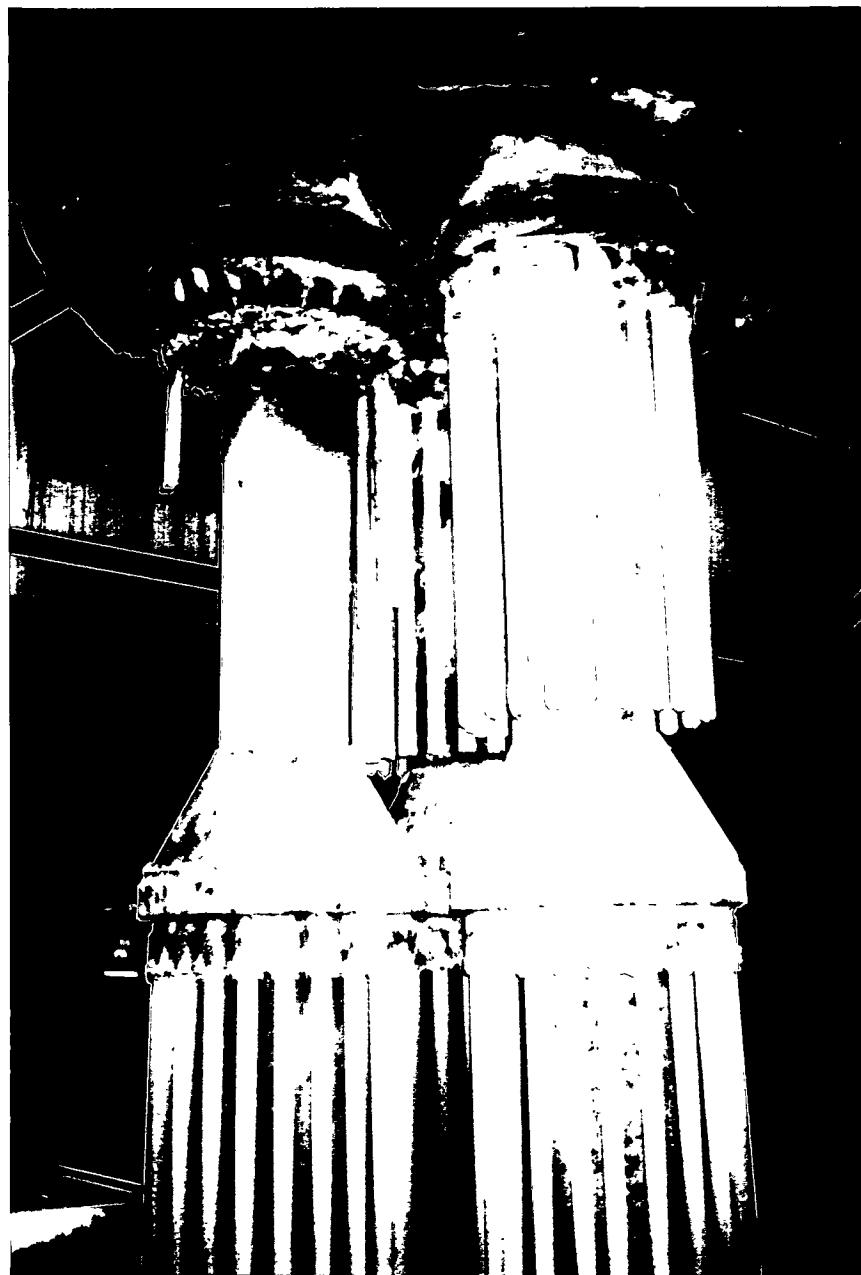
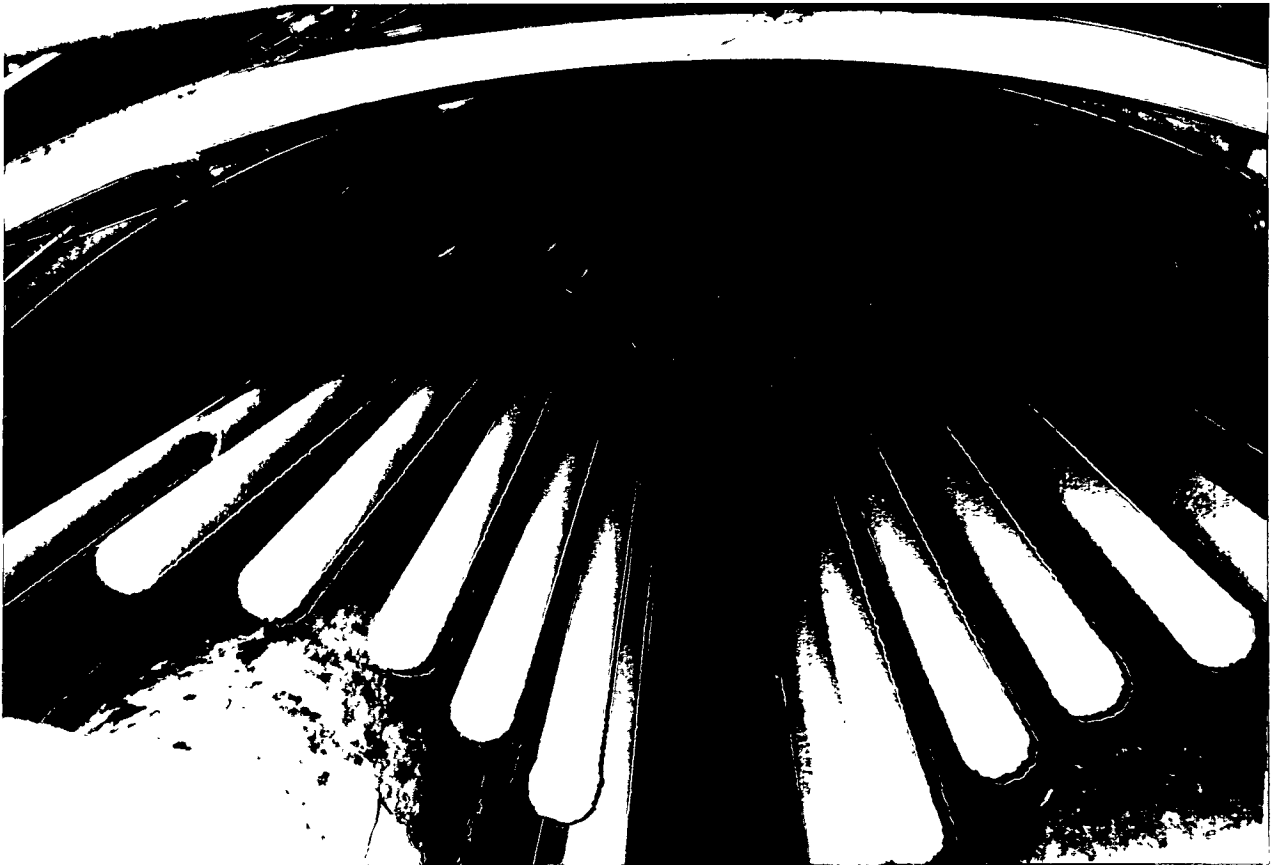
On 5/11 the APF internals were removed from the filter vessel. Figures 4.7.10 through 4.7.18 are photographs of the filter internals after removal. As observed by the boroscopic inspection, 20 of 22 of the Dupont PRD66 candles were broken, all in plenum B Top. In addition, two Coors alumina-mullite candles were broken (rather than one), one near the top in plenum A Top and the other about 2/3 down from the top in plenum A Middle. No ash bridging was seen. The residual ash cake layer thickness on the candles ranged from about 1/8" on the Coors alumina-mullite candles to about 3/8" on the Vitropore silicon carbide candles. During removal, cracks were seen in two candles (Figure 4.7.18), one alumina-mullite the other an original Schumacher silicon carbide surveillance candle. Both candles broke during removal and handling. Hard ash deposits were found in the bottom 6 to 12 inches of these cracked candles. In addition, a 3M candle was found to be cracked near the bottom after it was removed. No indication of an ash leak path was seen at the gasket area of any of these candles, but it appeared that ash accumulated in the bottom portion of these candles which resulted in cracking of the candles.

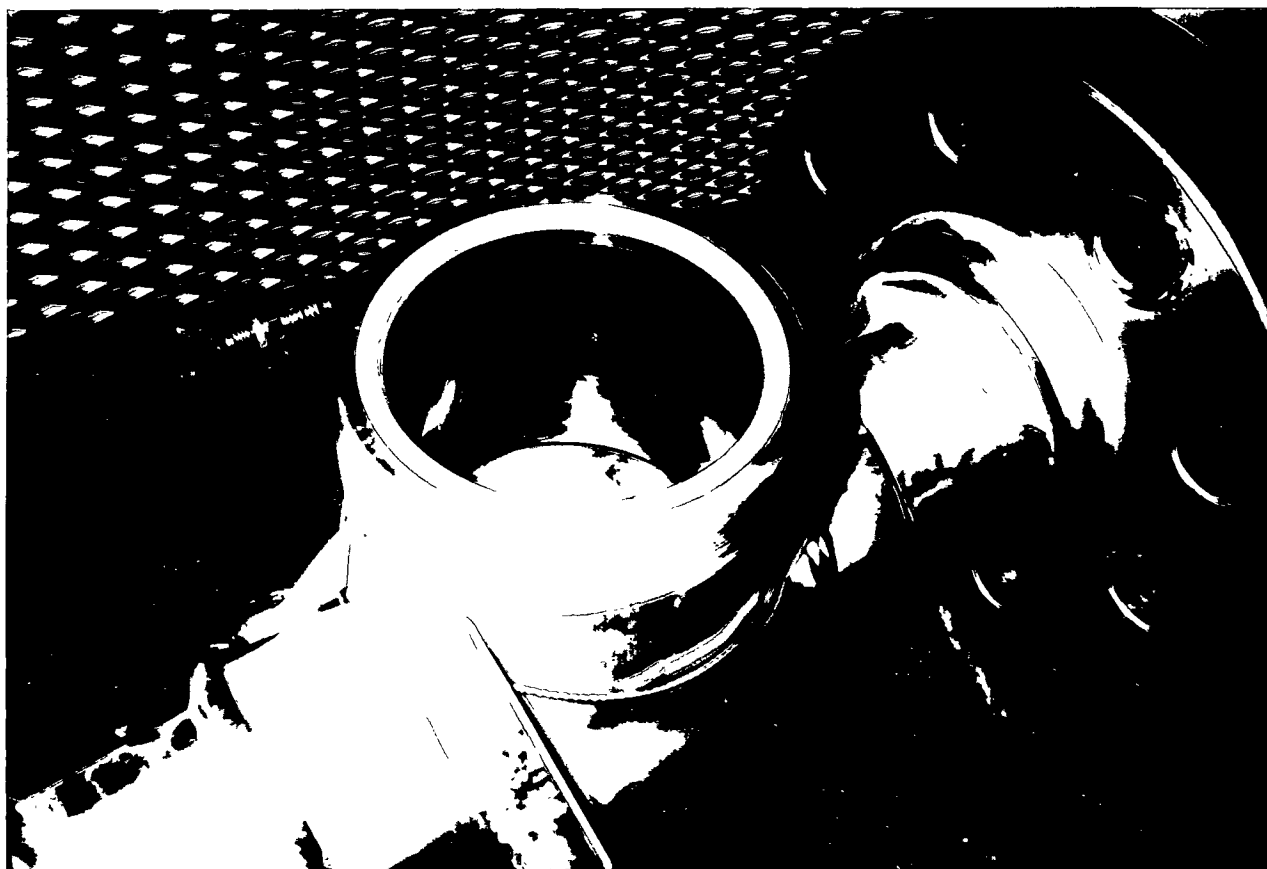
Two of the Atkomatic solenoid valves and the COAX valve (used in the last test period) were disassembled for inspection. The COAX valve did not show any signs of degradation. The two Atkomatic valves appeared to be in excellent condition. Some very minor surface scratches were seen in localized areas on the pistons indicating that the Stellite coating held up very well. The valve body bores showed very minor surface pitting, but felt very smooth. Figures 4.8.7 and 4.8.8 are photographs of the valve internals.

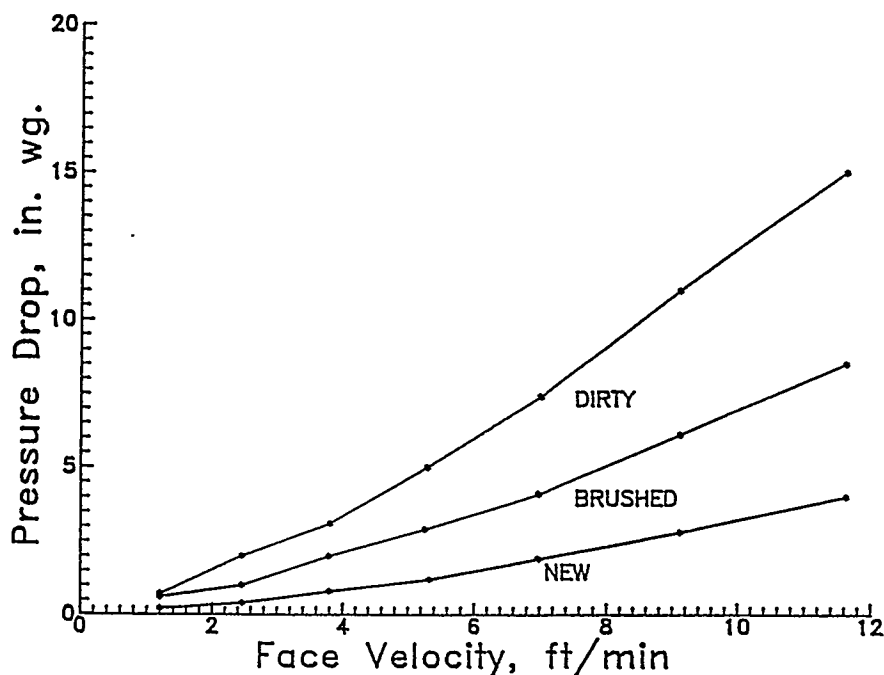
As shown in Figure 4.9.11, the pressure drop or gas flow resistance through the filter element increased as fines collected and remained along the outer surface of the filter elements. Following normal operating conditions, the as-manufactured gas flow resistance was regenerated by simply washing the elements with water and drying. In the event that candles failed and process operation continued, fines released into the clean gas stream were pulsed back into the inner wall of the remaining intact filter elements. Posttest washing of these elements generally did not permit regeneration of the as-manufactured gas flow resistance, since the fines typically blinded the inner wall of the coarse support matrix. Since the ID fines generally could not be removed, the elements were eliminated for continued use.

Figure 4.9.11 - Room Temperature Gas Flow Resistance Measurements Across As-Manufactured Clay Bonded Silicon Carbide Filter Elements. Measurements Were Repeated After Operation at Tidd.
