Title: 43-0434 Bridge Inspection Report 2019

Report Date: 15 August, 2019

- Cover Letter Jauregui to Mondragon, 4 Pages
- Los Alamos Canyon Bridge Inspection and Rating Report Narrative, 94 Pages

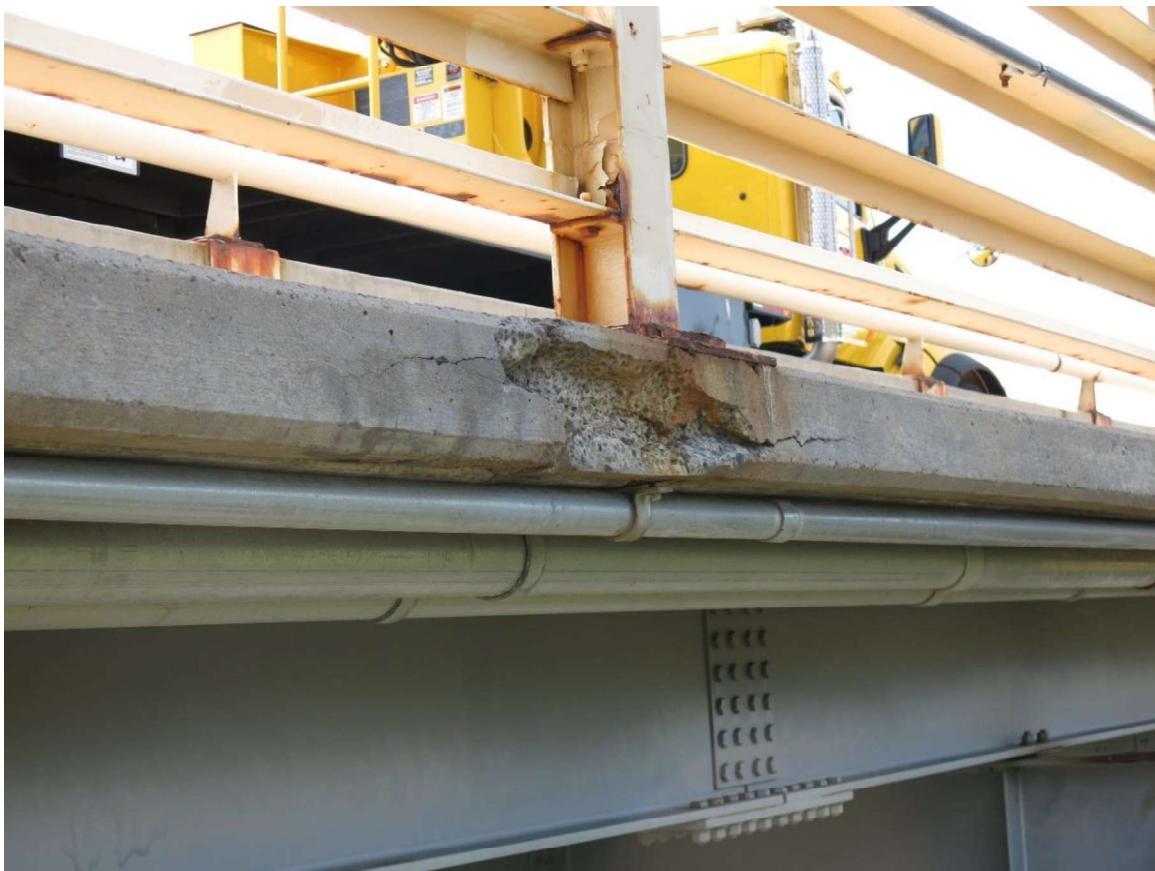
LANL 6 (Picture IMG_5502.jpg) (2017)

Chain dragging the deck identified several areas with delamination. The delaminations are concentrated near the south expansion joint, in the closure joint of the deck near the bridge centerline, and near previously patched areas. **At the south joint**, delaminated areas were found on the adjacent header areas of the bridge deck and approach roadway. See pictures LANL 1, LANL 2, and LANL 3. Patch repairs at both the north and south expansion joints are adhering but there are cracks and delaminations at both joints. See pictures LANL 4 and LANL 5. **In the deck closure joint near the bridge centerline**, there were several delaminated areas found throughout the total length of the bridge; the delaminations usually extend the full width (1-ft., 4-in.) of the closure joint. In addition, corrosion of the stay-in-place deck forms has initiated at spot locations. See picture LANL 6.

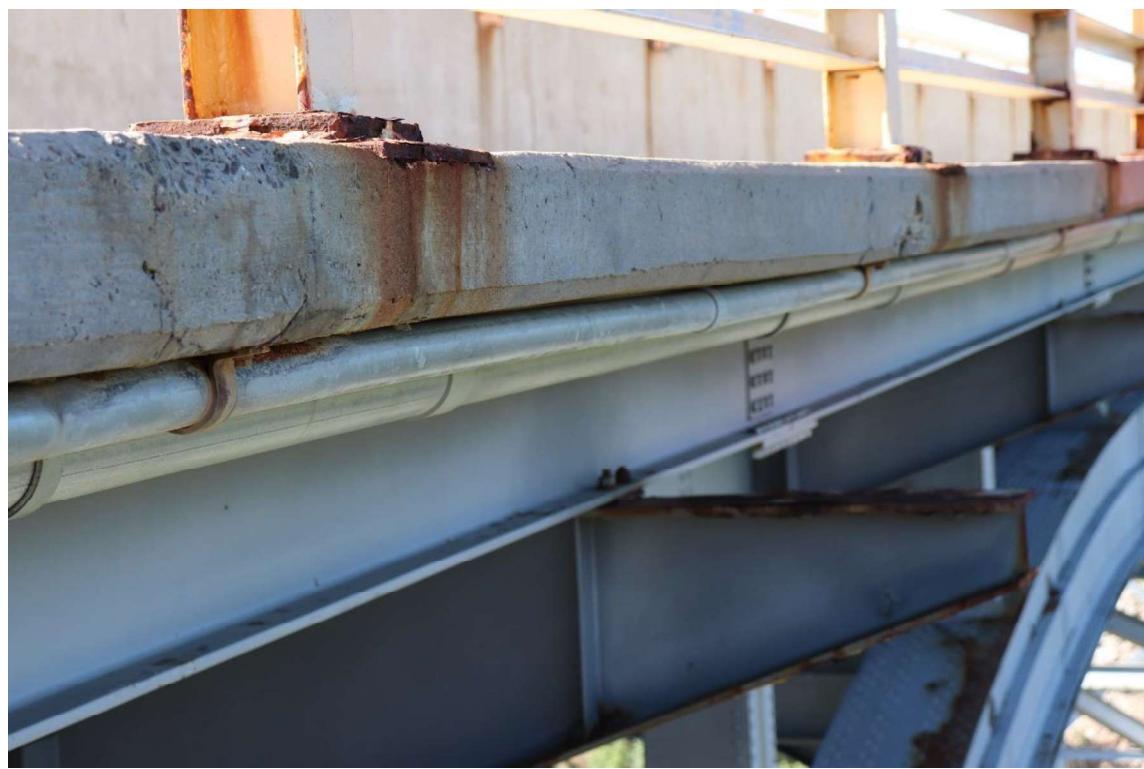
LANL 7 (Picture IMG_5562.jpg [2017]; IMG_0261 [2019])

A chain drag was performed on the deck and the sidewalk during the 2019 inspection. The delaminated area map for the 2019 inspection is attached. In addition, there are several spalls located on the west edge of the deck concentrated at the pedestrian rail post locations. See picture LANL 7.

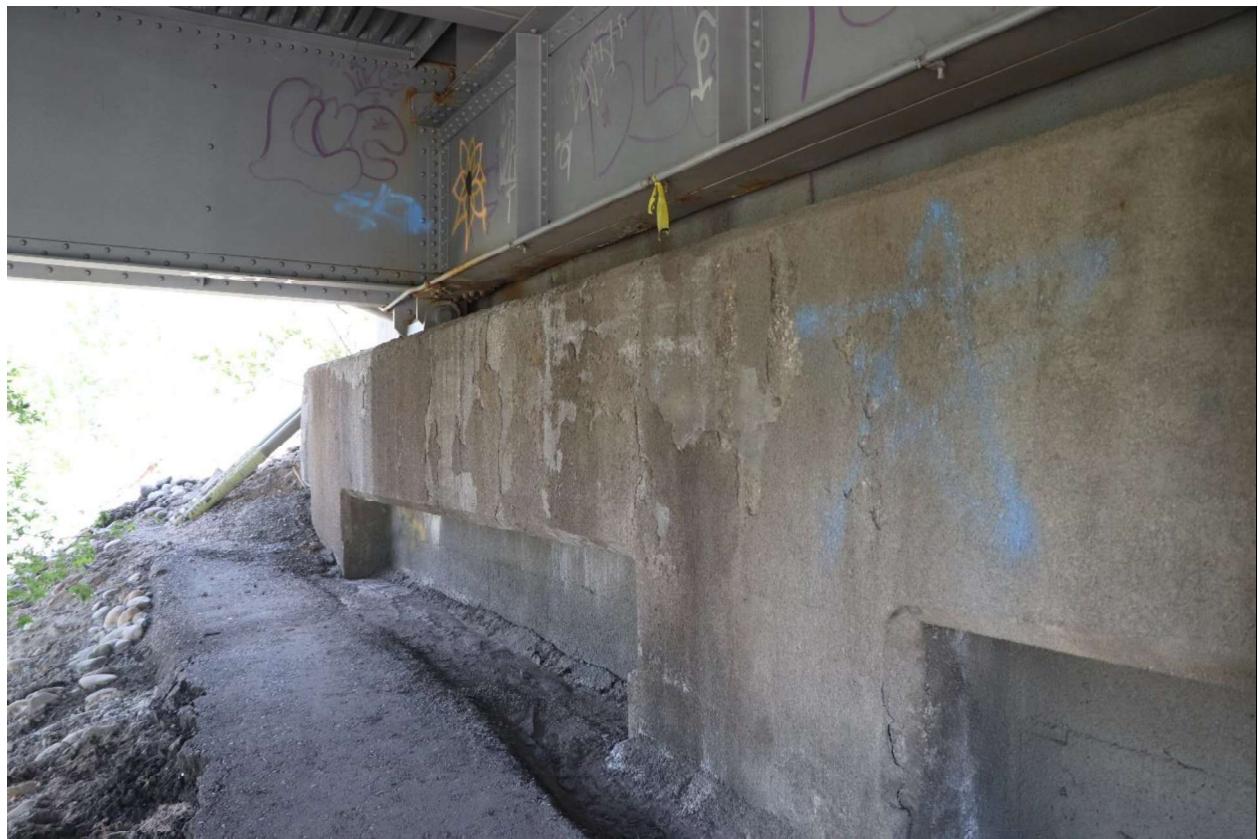
LANL 15 (Picture IMG_1118.jpg)

North Abutment (#2): Abutment was previously sealed with a concrete protective coating which has debonded throughout the length of the breast wall and on the bridge seat resulting in exposure of the original concrete surface and leaching. The debonded areas vary in size. See picture LANL 15. On the east side, debonding was observed on the backwall along with map cracking, leaching, and spalling (greater than 1 in. deep, 6 in. diameter) of the breast wall. Overall, adhesion of protective coating to original concrete is poor. Bridge seat has soil accumulation, and the bearing elements are corroded with paint failure and pack rust exists at the east and west bearings. There is section loss on the base plate on the northwest bearing and the protective coating is no longer effective. Periodic cleaning and repainting of the bearing elements and ultrasonic testing of the pins is recommended. Map cracking exists on east and west sides of the backwall. Cracks in the west wingwall and the east side of the backwall have been sealed with epoxy. The steel top plate just under the expansion joint has cracked through the full thickness between stringers 3 and 4 (initially observed in 2006). See picture LANL 16. East side of breast wall has undermining and the asphalt landing at the top of slope has eroded. See pictures LANL 17 and LANL 18. Slight settlement of the west end of the bridge seat is evident.

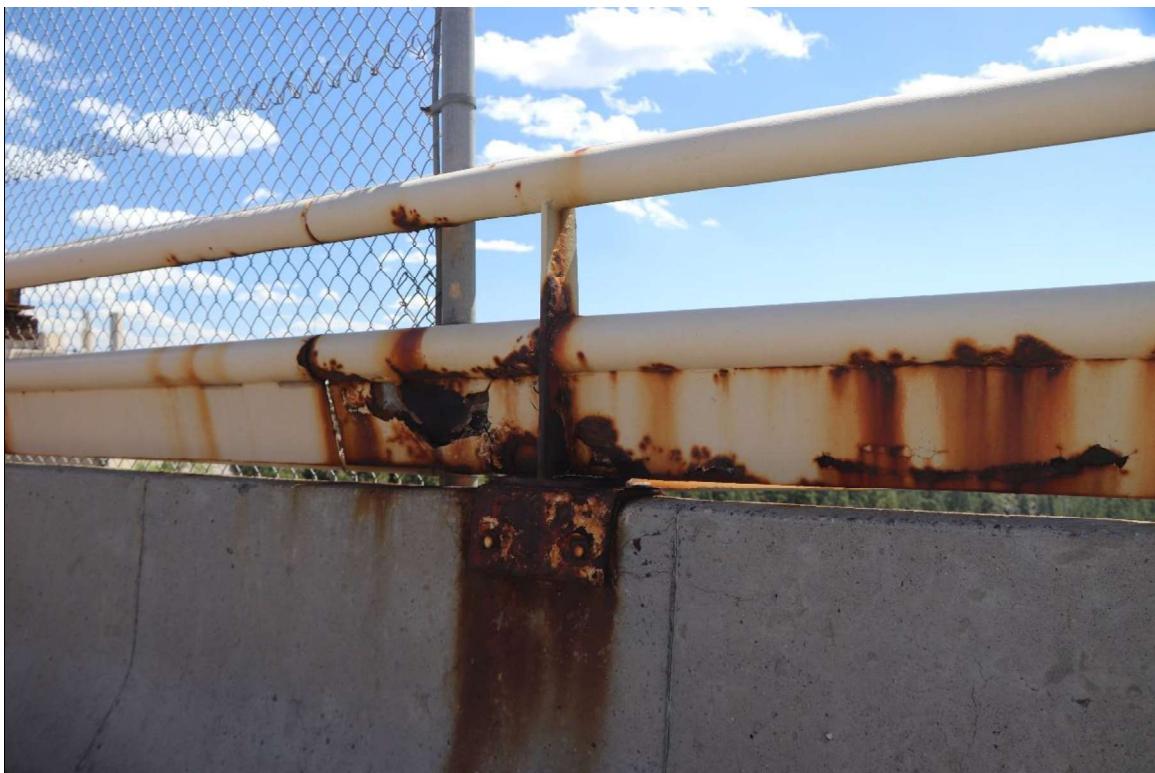
LANL 30 (Picture IMG_0995.jpg)

In general, the concrete barrier rail (CBR) on the east and west sides of the bridge have vertical, horizontal, and map cracks with isolated areas of traffic damage. Additionally, there are several delaminations on the CBR, each approximately 1 ft. in length. Many of the delaminations are near the connections to the steel railing. The vertical cracks are concentrated near the drain holes at the bottom of the CBR and extend the full thickness of the CBR. The top of the CBR has several areas with isolated spalls greater than 6 in. in diameter and map cracks where the metal rail attaches to the CBR. The metal rails have areas of moderate to heavy rust. In particular, the brackets attaching the steel rails to the CBRs have moderate to heavy corrosion (on the side of the brackets exposed to vehicular traffic) along with paint failure; anchor bolts are also missing on the bracket connections at several locations. The concrete has spalled under the connection plates at several locations. **At the west bridge rail**, there is collision damage (consisting of severe cracking, delamination, and spalling) at a location adjacent to the north end of the pedestrian fencing and a longitudinal crack in the rail towards the south end. See pictures LANL 26, LANL 27, and LANL 28. **At the east bridge rail**, there is a large spall (measuring greater than 1 in. deep and greater than 6 in. diameter), a horizontal crack with delamination, and major scaling at the bottom half of the CBR located along the length of the pedestrian fencing. The bridge rail also has scrape marks with moderate corrosion on the north and sound ends and major corrosion on the south side of the pedestrian fencing. See pictures LANL 29 and LANL 30. The steel bridge rail on the east side of the roadway is in worse condition than the west side.

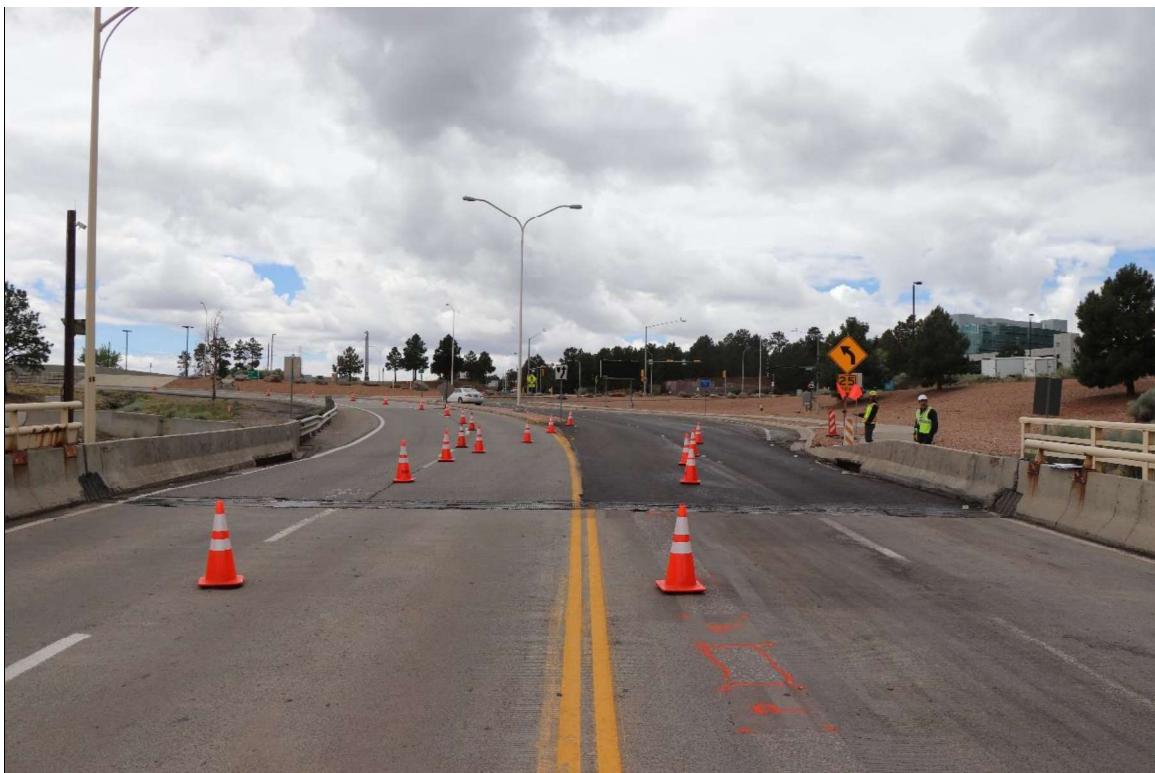
LANL 48 (Picture IMG_6936.jpg) (2018)

At the south approach roadway, the roadway was repaved at the time of the 2018 inspection; the expansion joint seal was replaced prior to the 2015 inspection. Damage to the seal is present, possibly caused by roadway equipment. During the 2018 inspection, free flow of water through the joint was observed as it rained. In addition, several spalls were found on the header areas of the southbound traffic lanes. See pictures LANL 45 through LANL 48. The grate opening for drainage is free of debris on the east and west sides.

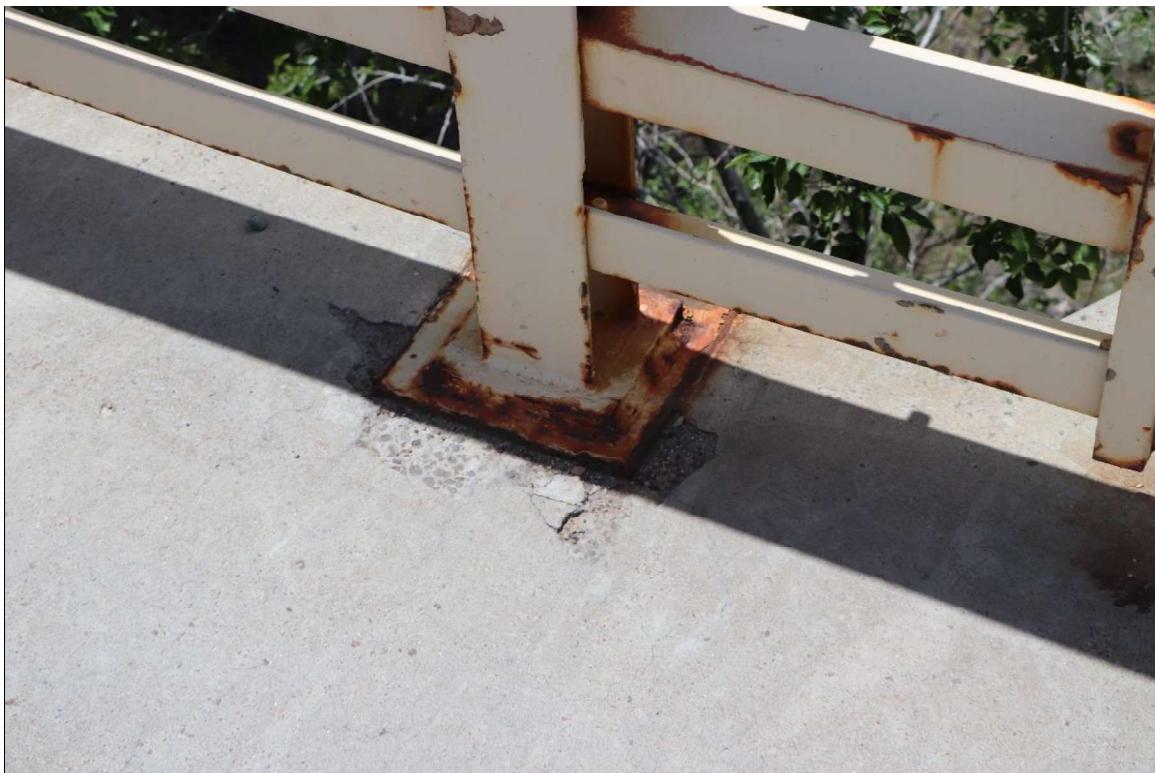
LANL 49 (Picture IMG_1157.jpg)

In general, the concrete sidewalk on the west side of the bridge has areas of abrasion / wear with transverse, longitudinal and map cracks due to environmental (e.g., snow, rain) and human (e.g., pedestrian foot and bike traffic) factors. There are numerous spalls (less than 1 in. deep, 6 in. diameter) and delaminations located adjacent to the base plates of the pedestrian rail connecting to the concrete sidewalk. See picture LANL 49. Other observations include minor leaching and scaling of the concrete sidewalk adjacent to the CBR, minor corrosion of the pedestrian rail, and minor debris buildup on the sidewalk. See pictures LANL 50, LANL 51, and LANL 52.

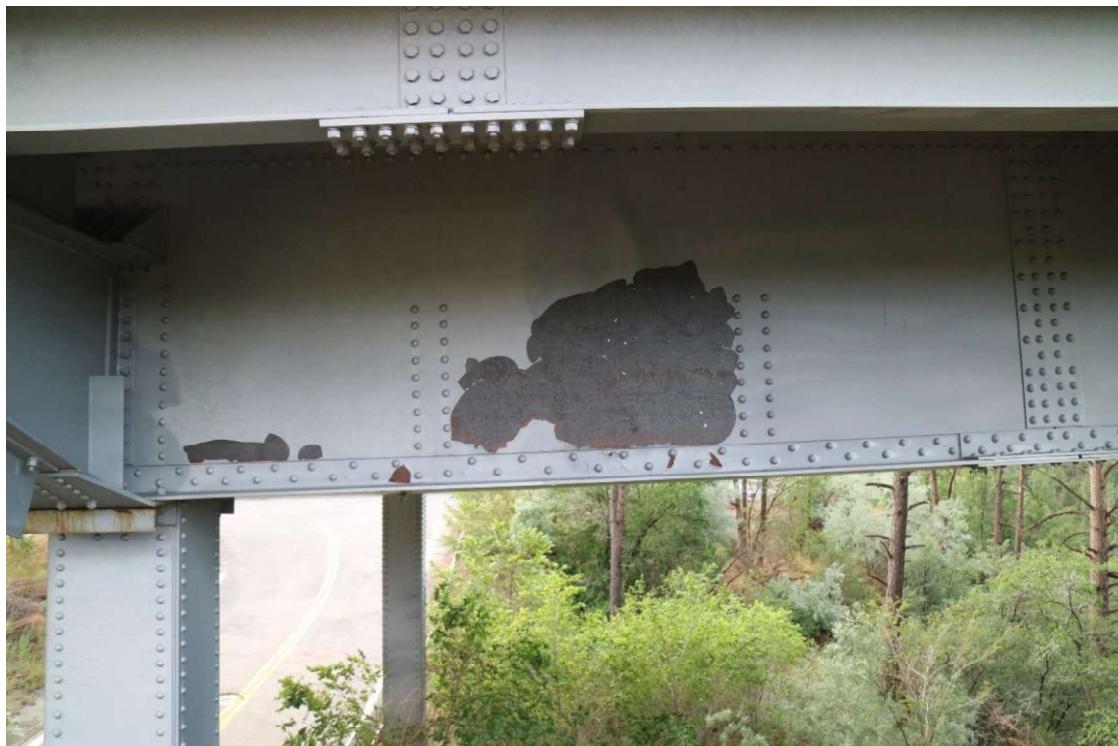
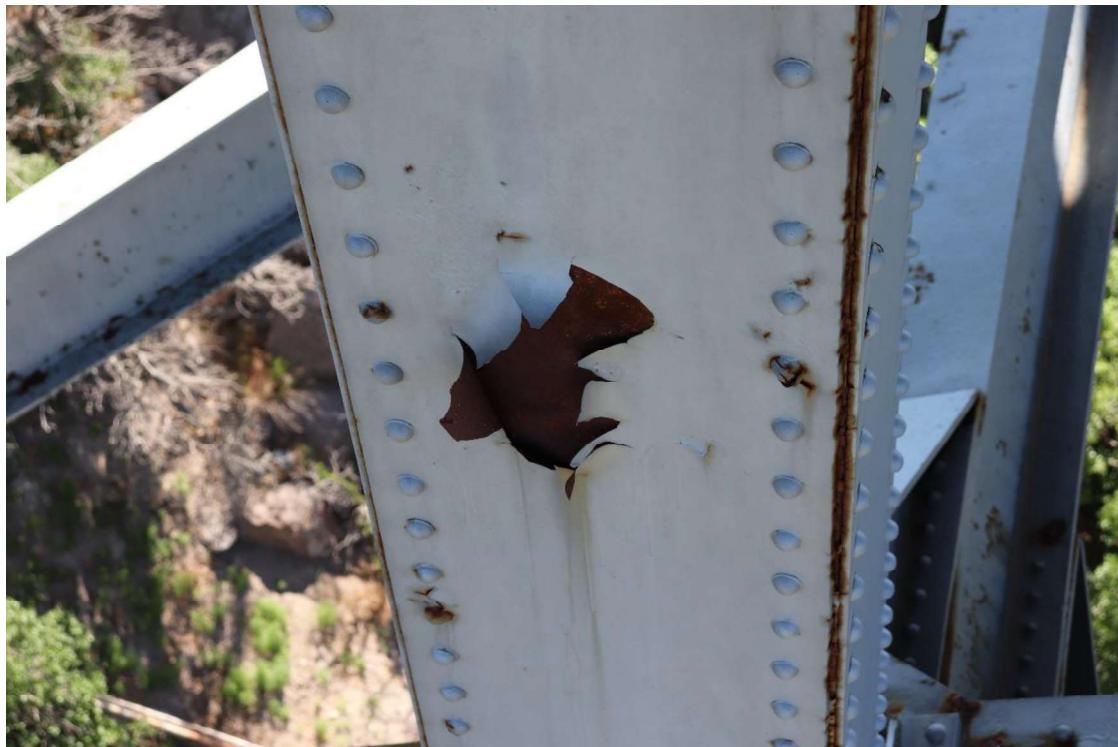
Moderate paint peeling on spandrel girder and column (IMG_8793.jpg (2018) / IMG_0270).

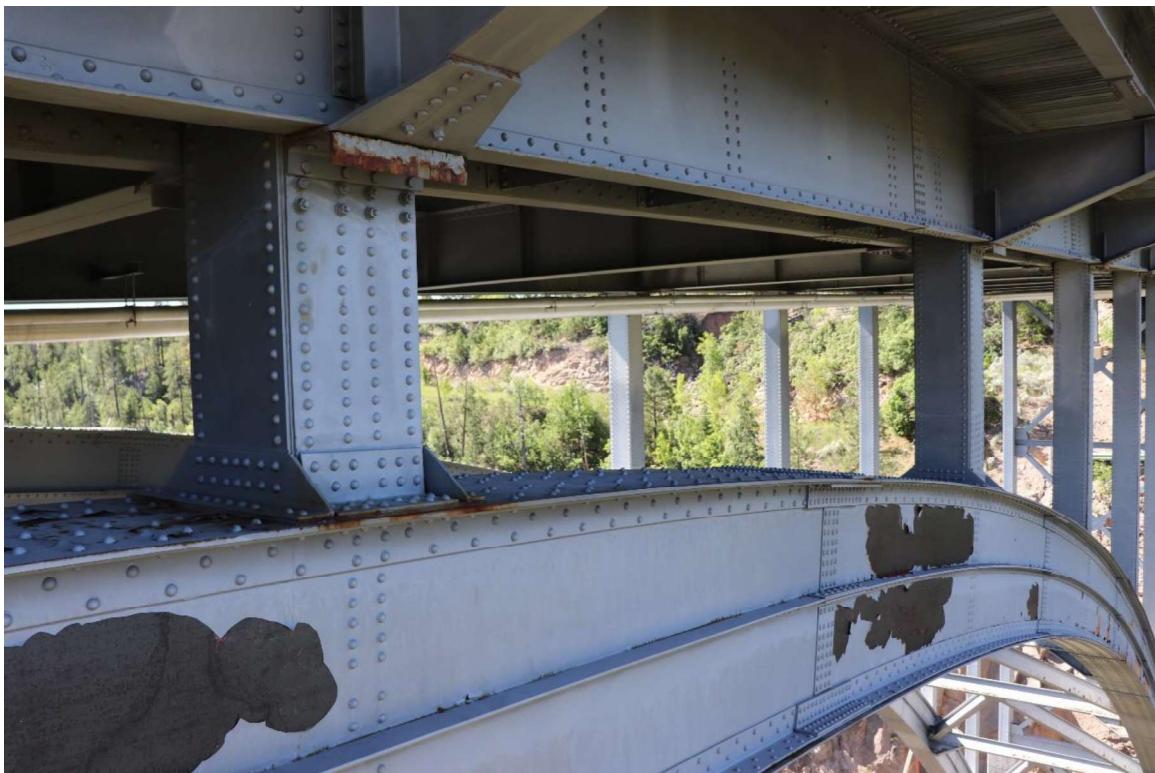
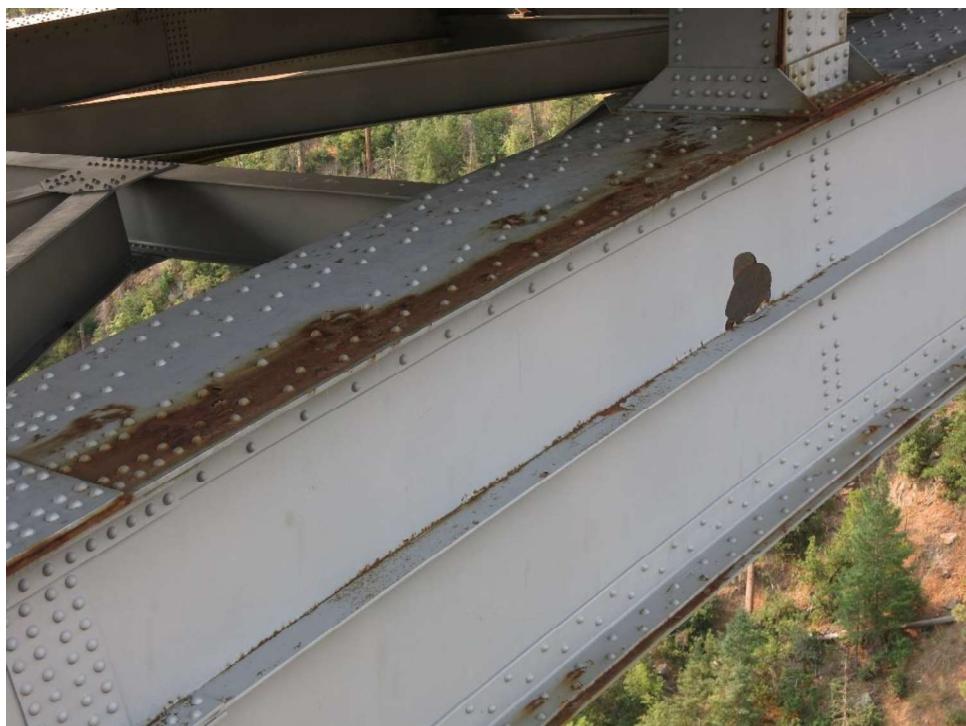
Moderate paint peeling on arch rib (IMG_0278, [2017]).

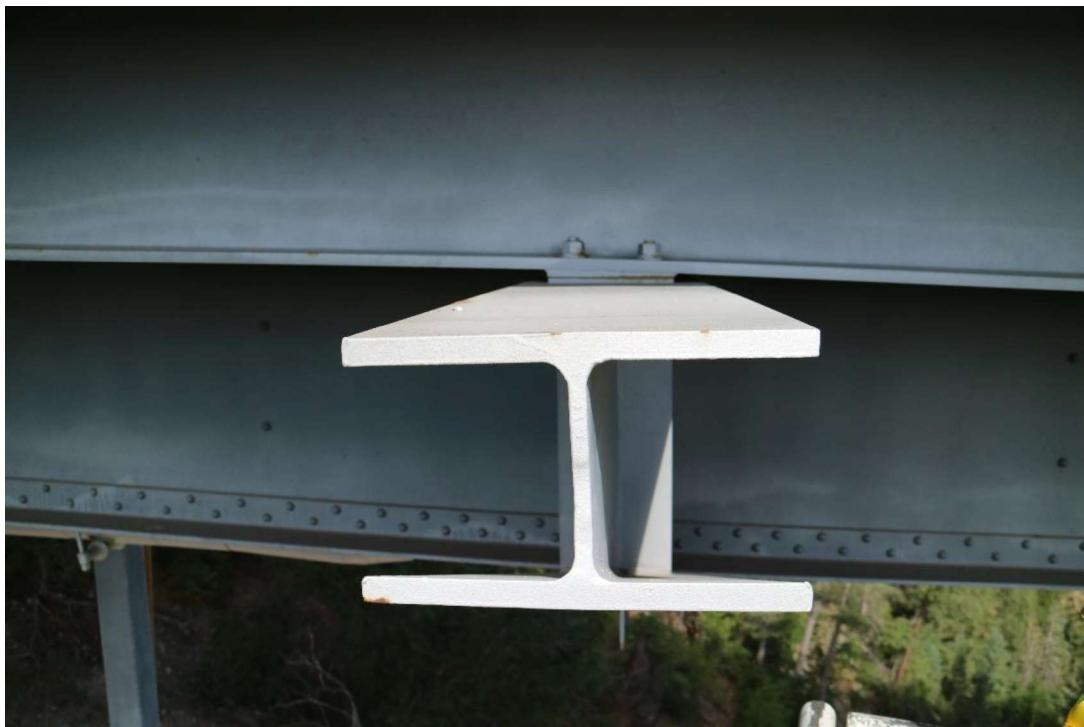
Distortion (typical) of outriggers (2016)
