Microstructure and In-Service Degradation of Baffle-Former Bolts – In-Core Components of Light-Water Reactors

ORNL/TM-2023/3118
M4LW-23OR0402027

**MICROSTRUCTURE AND IN-SERVICE DEGRADATION OF BAFFLE-FORMER
BOLTS – IN-CORE COMPONENTS OF LIGHT-WATER REACTORS**

Prepared under the direction of the
U.S. Department of Energy
Office of Nuclear Energy
Light Water Reactor Sustainability Program
Materials Research Pathway

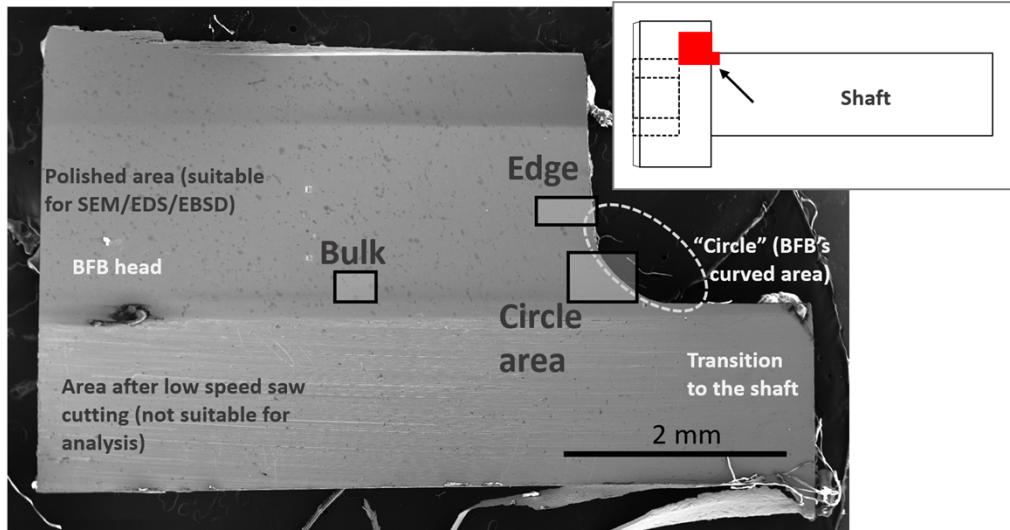
Figure 4 shows the general view of the 4412-CS-1-1 specimen; an insert in the right corner demonstrates specimen origin and orientation concerning the baffle bolt axis. It can be observed that most of the as-prepared specimen surface had a high-quality EBSD-suitable surface. Approximately $\frac{1}{3}$ of the surface (shown in the bottom portion of Figure 4) still had an as-cut surface with low-speed saw marks. EBSD scans were performed at several locations (Figure 3) to investigate microstructure conditions and to target future focused ion beam (FIB) liftouts.

Figure 3. General view of the 4412-CS-1-1 specimen from the BFB head portion.
Bulk, *Edge*, and *Circle area* labels show the locations of EBSD scans discussed herein. The inset at the right top shows the geometry and orientation of the specimen within the source bolt.

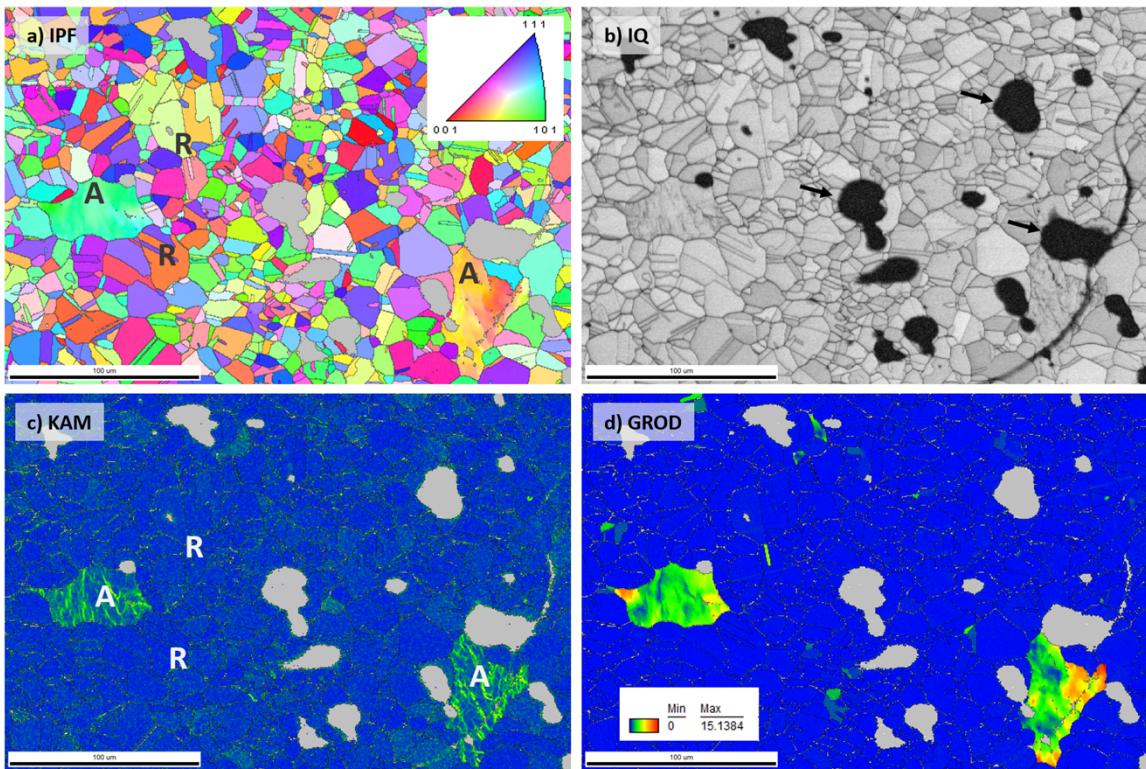
Figure 4. Microstructure of the BFB head (bulk area, ~2 mm from the edge; see Figure 3 for specimen location and orientation). A dominating recrystallized microstructure (several typical recrystallized grains are marked with an *R* label) can be observed, with a few grains with high in-grain misorientation levels (marked as *A* for *abnormal*). Carbon contamination spots are marked with arrows in the image quality (IQ) map. The inverse pole figure (IPF) color key is the same for all images in the document. All IPFs are colored in the horizontal direction.

Figure 4 shows the typical microstructure for the BFB material in the 4412-CS-1-1 specimen. Typical equiaxed austenite grains dominate in the structure; such grains (some are marked as *R*, indicating *recrystallized*; see an enlarged grain view in Figure 5a) have no in-grain color variations, indicating minor misorientation gradients. No or negligible in-grain orientation gradients are present for such grains in kernel average misorientation (KAM) and grain reference orientation deviation (GROD) maps. No retained ferrite was observed in the structure.

Some grains show pronounced in-grain misorientation variations (see IPF map; grains are marked as *A*, indicating *abnormal*, an example is given in Figure 5b). The KAM map for such grains clearly shows in-grain low-angle boundaries (LABs) most likely from dislocation. The GROD maps reveal in-grain misorientation levels up to 15° , suggesting elevated dislocation densities. A population of recrystallized grain fully surrounds such abnormal grains, ruling out the possibility that cold work (occasional or intentional deformation) was a possible source of the elevated in-grain misorientation levels. KAM distribution inside such abnormal grains is also not typical for cold or warm deformation in reference (non-irradiated) steel or strain localization processes in irradiated steel.

These abnormal grains are much larger than the surrounding fully recrystallized grains. The specific shape of grain boundaries (arcs or semicircles) suggests that these grains may be a result of abnormal grain growth (AGG) [7] (sometimes termed also as “anomalous grain growth”). The AGG usually occurs if the material has experienced some threshold deformation level and remained at higher temperatures longer than necessary to complete recrystallization. The presence of some texture components may be a factor influencing AGG. Although there is limited literature evidence, elevated levels of in-grain misorientation may be connected to the AGG phenomenon, such as through the consumption of neighboring grains. An additional focused study may be necessary to understand these aspects.

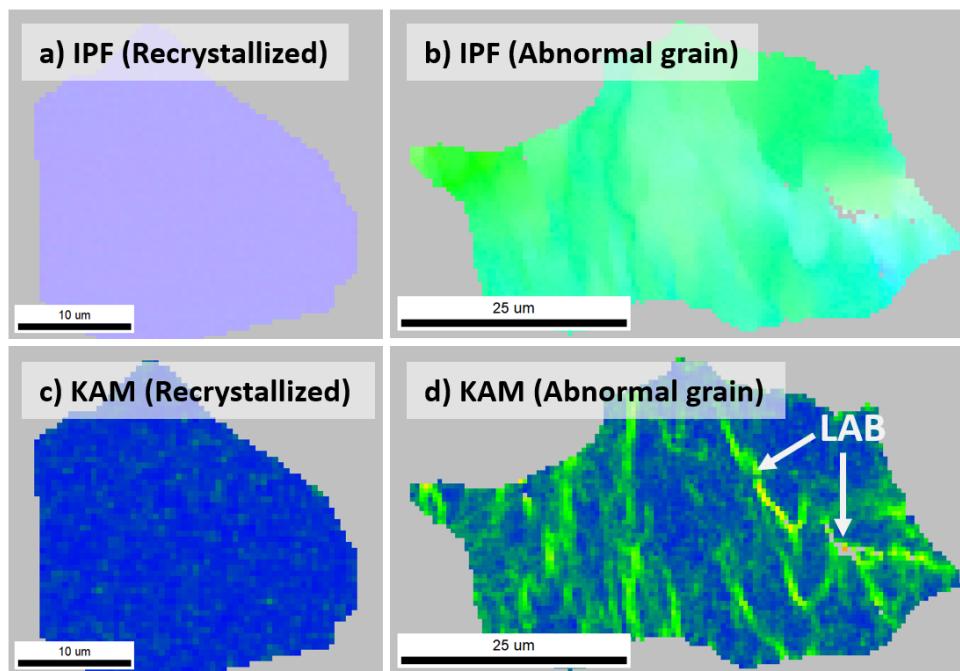
Figure 5. Typical recrystallized (a) and abnormal (b) grains for BFB bulk microstructure shown in Figure 4.(c, d) KAM maps showing in-grain misorientation. LAB: low-angle in-grain boundaries.

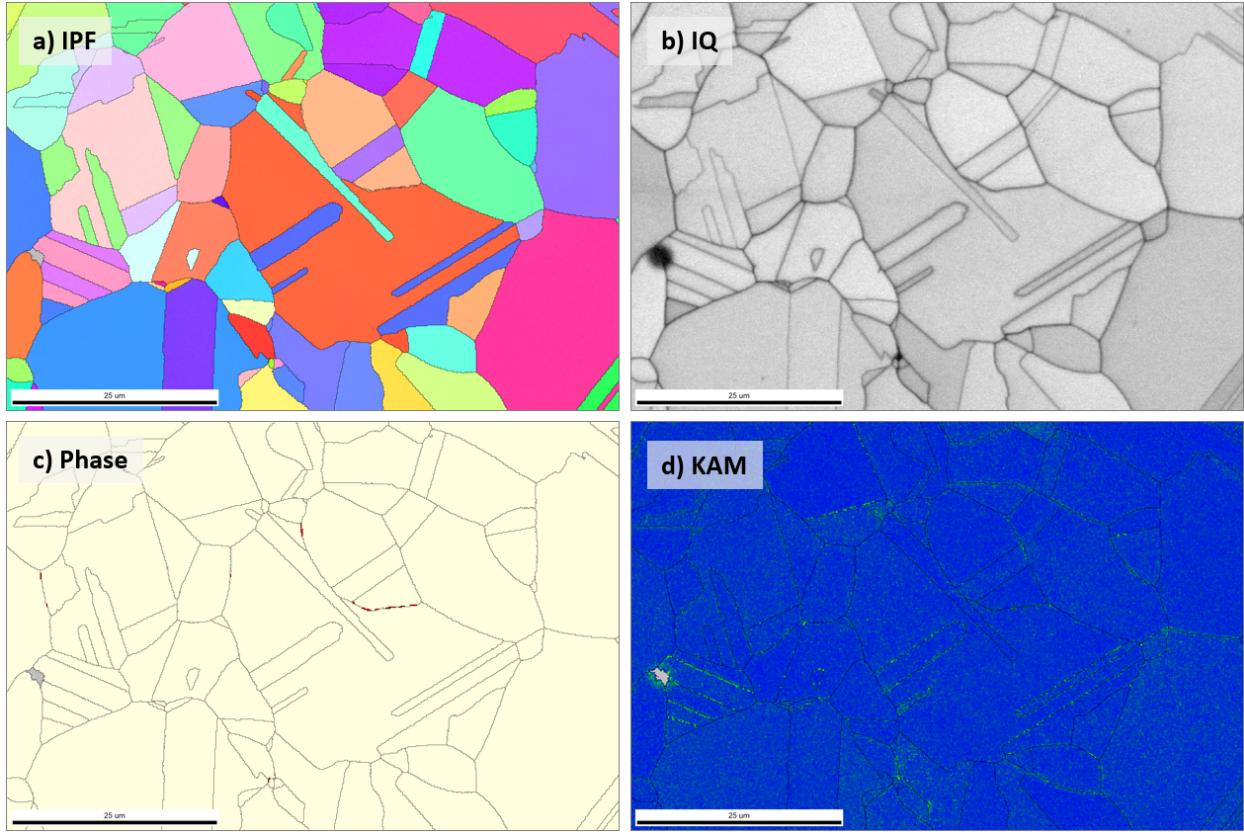
Figure 6. Subarea of bulk EBSD scan seen in Figure 4, rescanned with 125 nm step. An annealed austenite structure with equi-axial grains can be seen. Note the relatively small average grain size of $\sim 20 \mu\text{m}$.

Figure 6 shows the subarea of the bulk EBSD scan. If abnormal grains are excluded, then the remainder of the microstructure consists of typical annealed austenite with multiple annealing twins. No obvious signs of pre- or post-irradiation deformation (e.g., lattice orientation gradients along grain boundaries, fine slip lines, or coarse defect-free channels) are present in the BFB interior.
