HW - 29132

SEVERE PITTING ATTACK OF PILE PROCESS TUBES AND SLUGS

M. LEWIS AND R. A. ROHRBACHER

JUNE 30, 1953

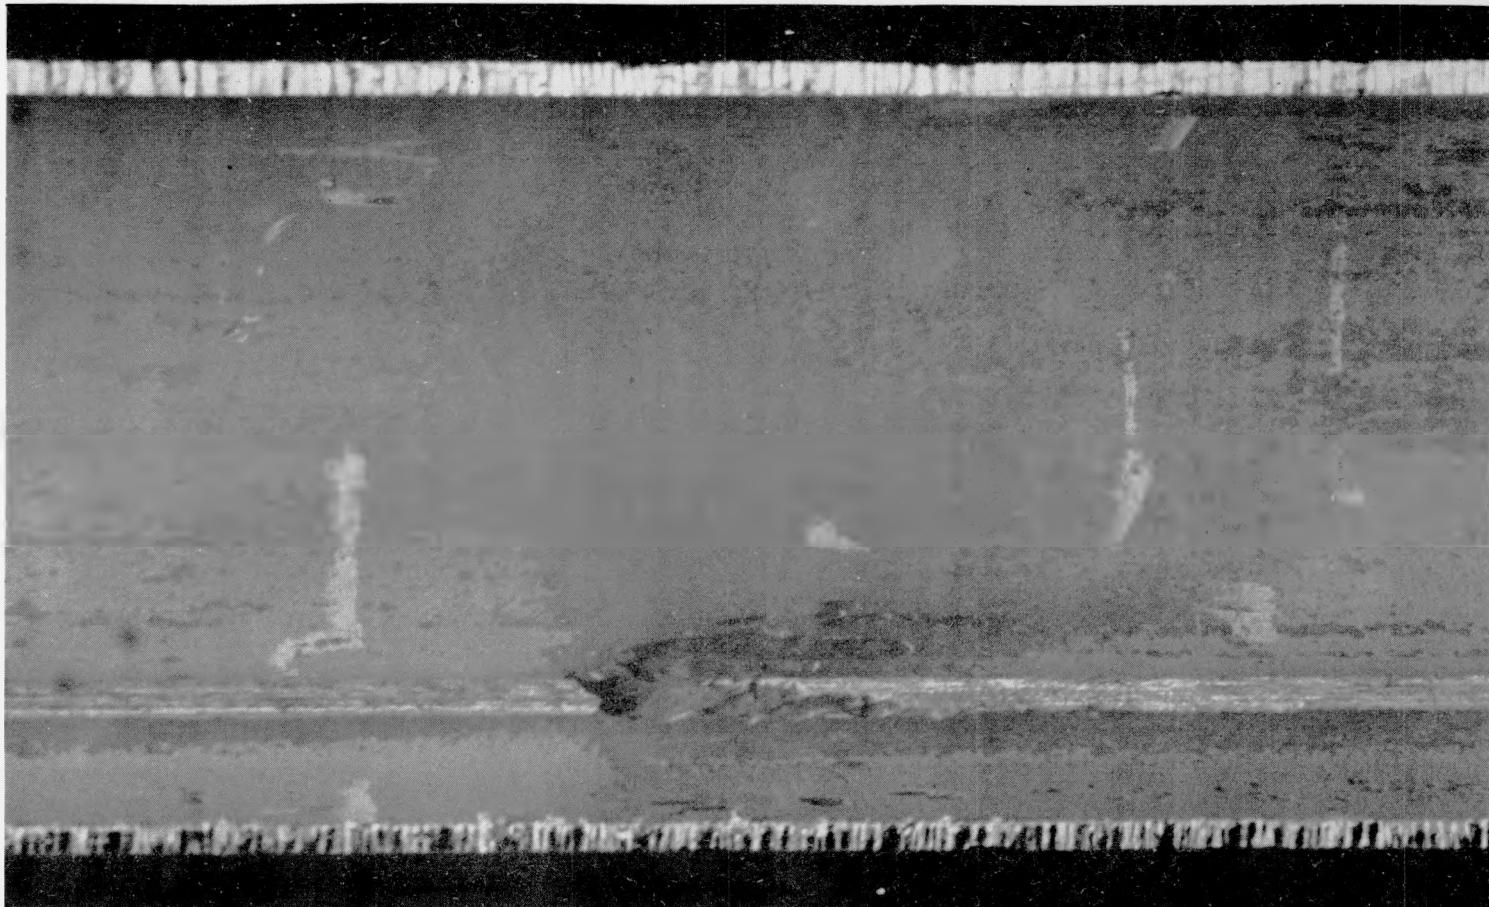
INSIDE VIEW OF TUBE 3684-F, REMOVED FROM THE PILE ABOUT AUGUST 8, 1952

The area where this pit occurred is about nine or ten feet from the rear Van Stone flange. Note that the pit occurred at a "slug junction". Downstream is to the left.

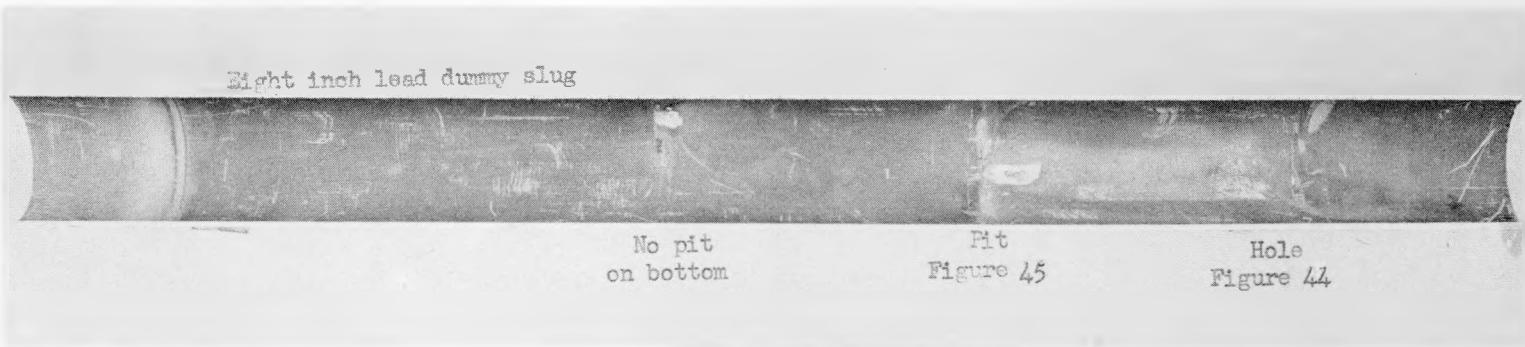
PITS ADJACENT TO RIB INSIDE FLOW LABORATORY TUBE

Same tube as Figure 44. These pits are located on opposite rib and one slug length upstream from the hole in Figure 44. Downstream is to the right.
