PHOTOVOLTAIC LIGHTING SYSTEM PERFORMANCE

Steve R. Harrington
 Formerly of Ktech Corporation at
 Sandia National Laboratories, Dept. 6218
 Photovoltaic Systems Applications.
 Albuquerque, New Mexico USA

Thomas D. Hund
 Sandia National Laboratories, Dept. 6218
 Photovoltaic Systems Applications
 Albuquerque, New Mexico USA

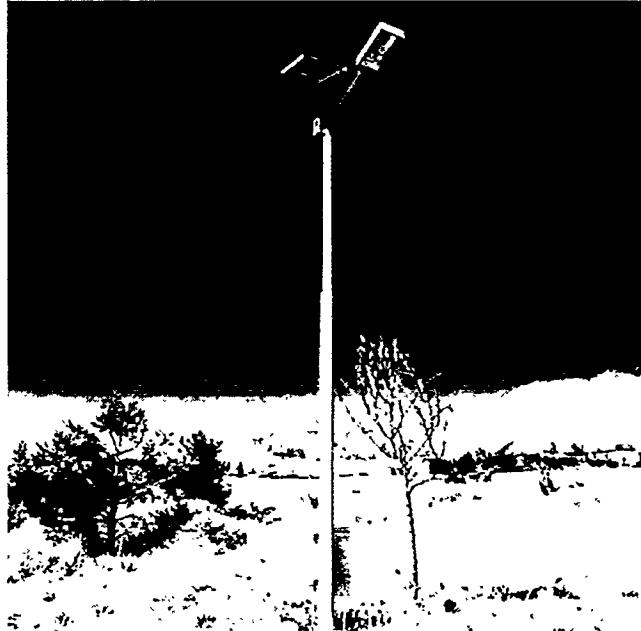
Figure 1, System 11

In April 1992, systems 11 & 12 were refitted with new gel valve regulated lead-acid (VRLA) batteries (2-JCI Dynasty 6v200b). System 11 batteries were installed with a constant voltage PV charging and lighting controller (Polar Products/SLC 12-06-BTHU, Vr=14.1v)
