Mark-18A Cold Runs

June 2024

SRNL-STI-2024-00171, Revision 0

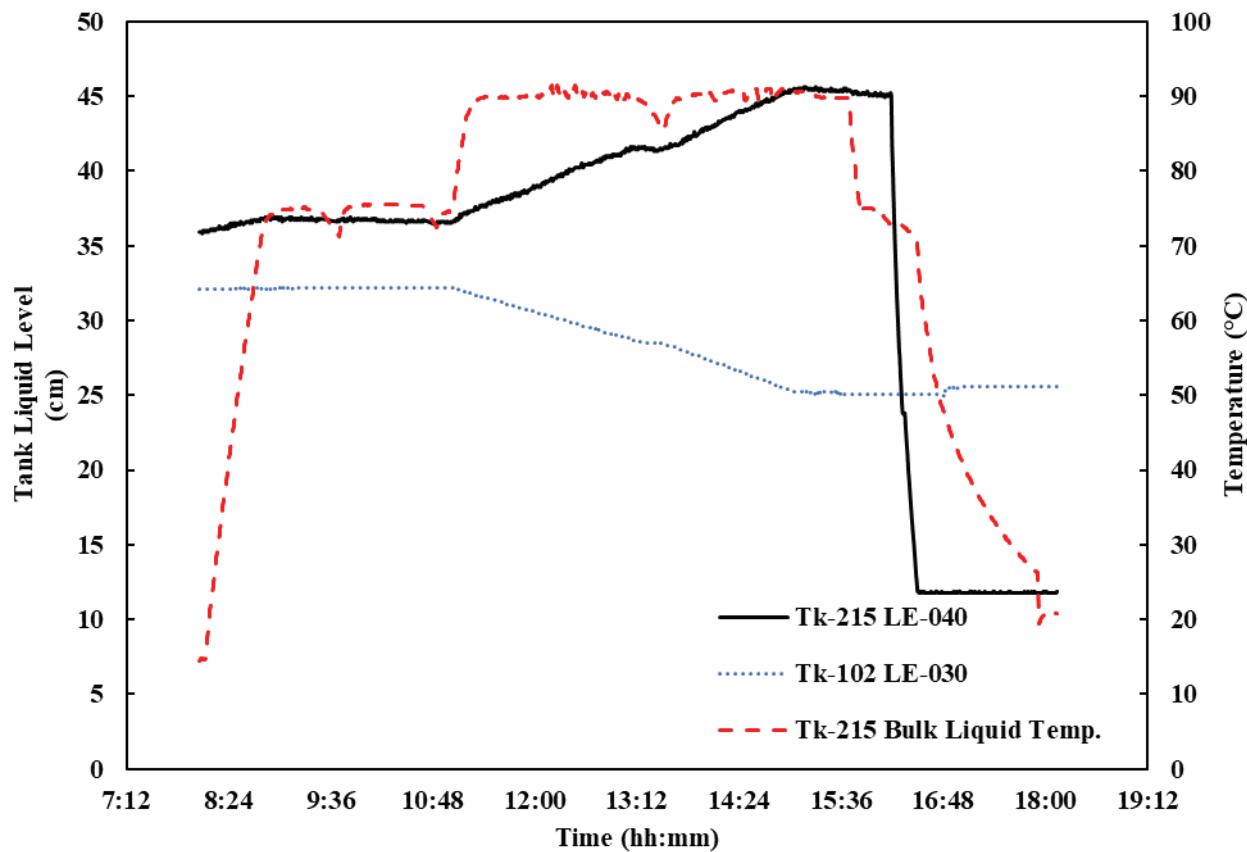
Figure 3-8. TK-215, Caustic Dissolver and TK-102 NaOH Tank Level Indication (cm) and Caustic Dissolver Bulk Temperature (°C) versus time.

At 1101 hours, feed of the second 5.5 L volume of 10 M NaOH from TK-102 to TK-215 was initiated at $22 \text{ mL}\cdot\text{min}^{-1}$. The selected rate of addition was based on past observations of the exothermic aluminum cladding dissolution.⁷ Expectedly, the TK-215 heater decreased in power output and at 1158 hours de-energized (cycled), indicating the exothermic reaction had been initiated and was increasing to a desirable reaction rate. The temperature of the TK-215 bulk liquid was controlled at 90.1 °C and 1.266 L of the 5.5 L transfer volume of 10 M NaOH had been added to TK-215 per the P-030 flow totalizer. Figure 3-8 illustrates the level indications of the Caustic Dissolver (TK-215) and NaOH reagent tank (TK-102) across caustic dissolution and filtration on the primary axis. The secondary axis of Figure 3-8 provides the temperature reading for TE-120, the bulk liquid temperature of the Caustic Dissolver.

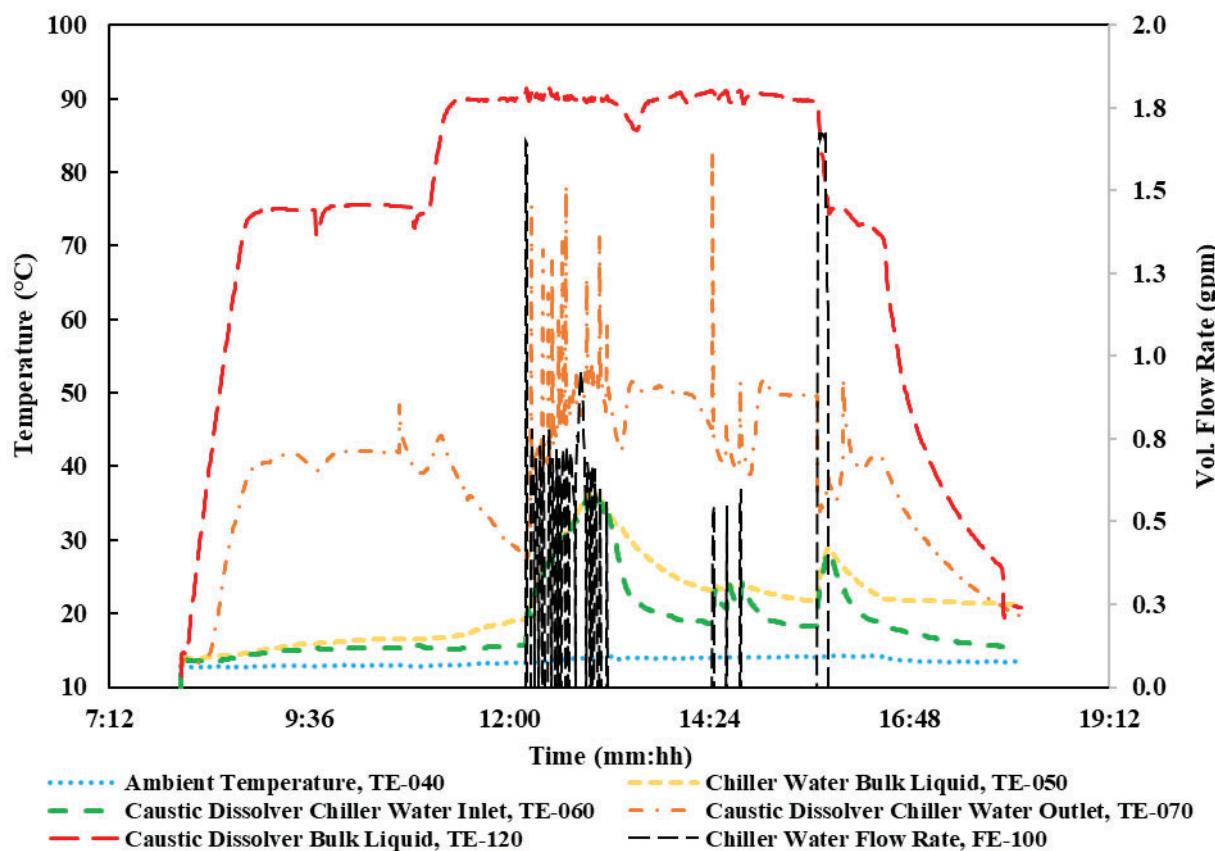
Figure 3-10. Bulk Temperature of Caustic Dissolver, Bulk Temperature of Thermal Reservoirs of Chilled Water System, and Active Cooling of Chilled Water per P-050 to Caustic Dissolver by FE-100

Across the caustic dissolution, the cooling system demonstrated adequate capacity to control the temperature of the aluminum dissolution. P-050, which cools the bulk fluid of TK-215, never exceeded 50% of cooling capacity and the thermal reservoir, TK-123, bulk liquid temperature reached an observed maximum of 35.7 °C. This conclusion is limited to 10 M caustic addition rates of $22 \text{ mL}\cdot\text{min}^{-1}$ to $28 \text{ mL}\cdot\text{min}^{-1}$. Figure 3-10 provides the temperature of the bulk liquid of the Caustic Dissolver per indication of TE-120 and the temperatures of various thermal reservoirs from the Chilled Water system to ambient air, on the primary axis. On the secondary axis of Figure 3-10, on the left-hand side, the volumetric flow rate, indicated by FE-100, is provided.

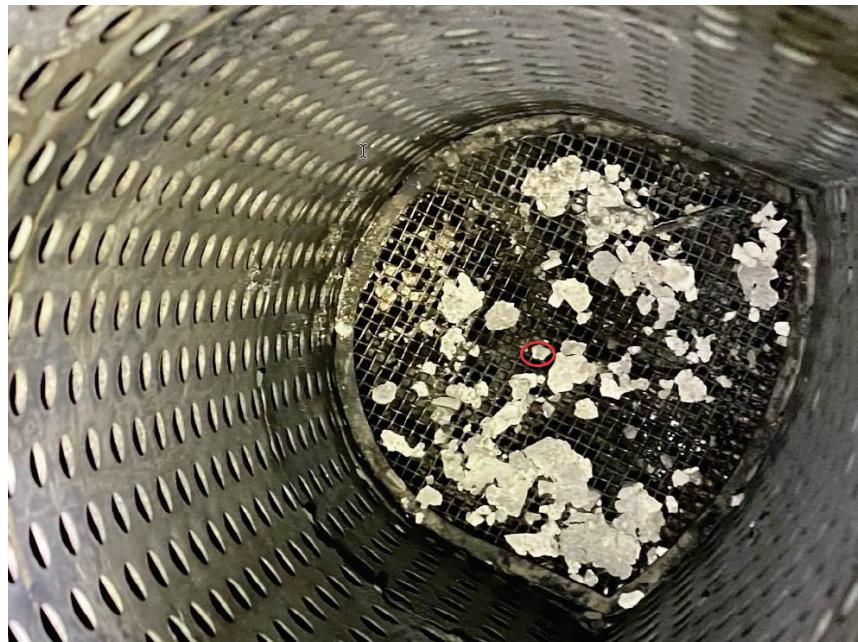
Figure 3-11. Similar Solids from Prior Caustic Dissolution of Aluminum Cladding – Test 6 of SRNL-STI-2020-00264.⁷

than 0.5 inches in diameter. Figure 3-11, illustrates similar undissolved material^c from prior testing of the caustic dissolution processing, but in much larger quantity compared to the Mark-18A Caustic Cold-Run Dissolution.⁷

^c Only two flakes, similar to the flake circled in red remained from the caustic dissolution executed here-in. The purpose of Figure 3-11 is to illustrate the properties of the material.

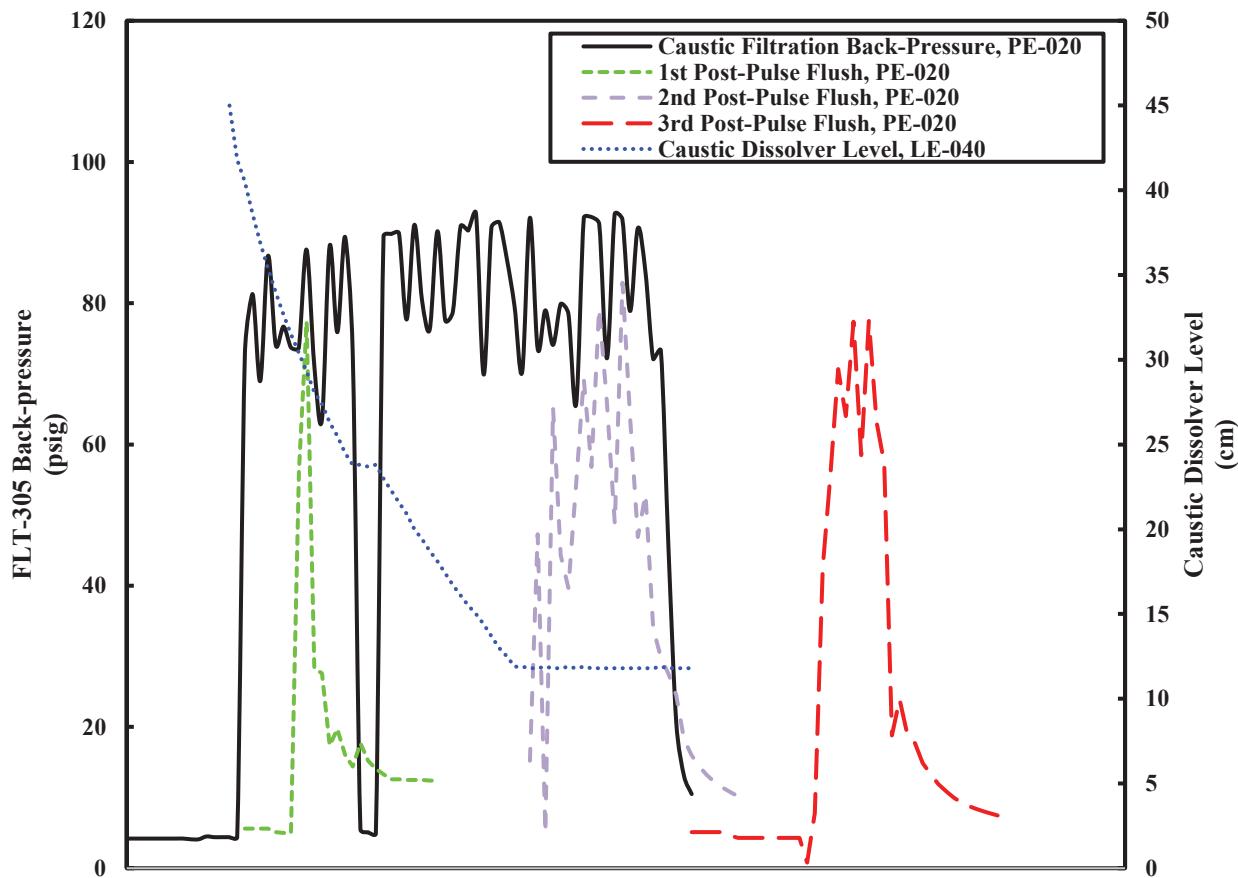
Figure 3-12: Comparison of Back-Pressure Readings from FLT-305 PE-020 following Caustic Filtration and Caustic Back-Pulses

The final evolution of the back-pulses, a flush of FLT-305 was completed at 1213 hours. This resulted in an observed reading of 70-77 psig across FLT-305, which was a reduced pressure drop compared to prior flushes. At 1222 hours Mark-18A Caustic System Cold-Runs were complete, with argon, process air, and Mark-18A systems being isolated and secured for Acid Dissolution. Furthermore, the limited volume of the Acid Dissolver and need to reach an acid concentration of 7-8 M for dissolution of target solids required the volume to be allocated to acid addition.

Figure 3-12 provides the associated pressure readings for the filtration of the Caustic Dissolver contents, at transfer and the back-pressure from flushes following caustic back-pulses from TK-121 to the Acid Dissolver, TK-235.

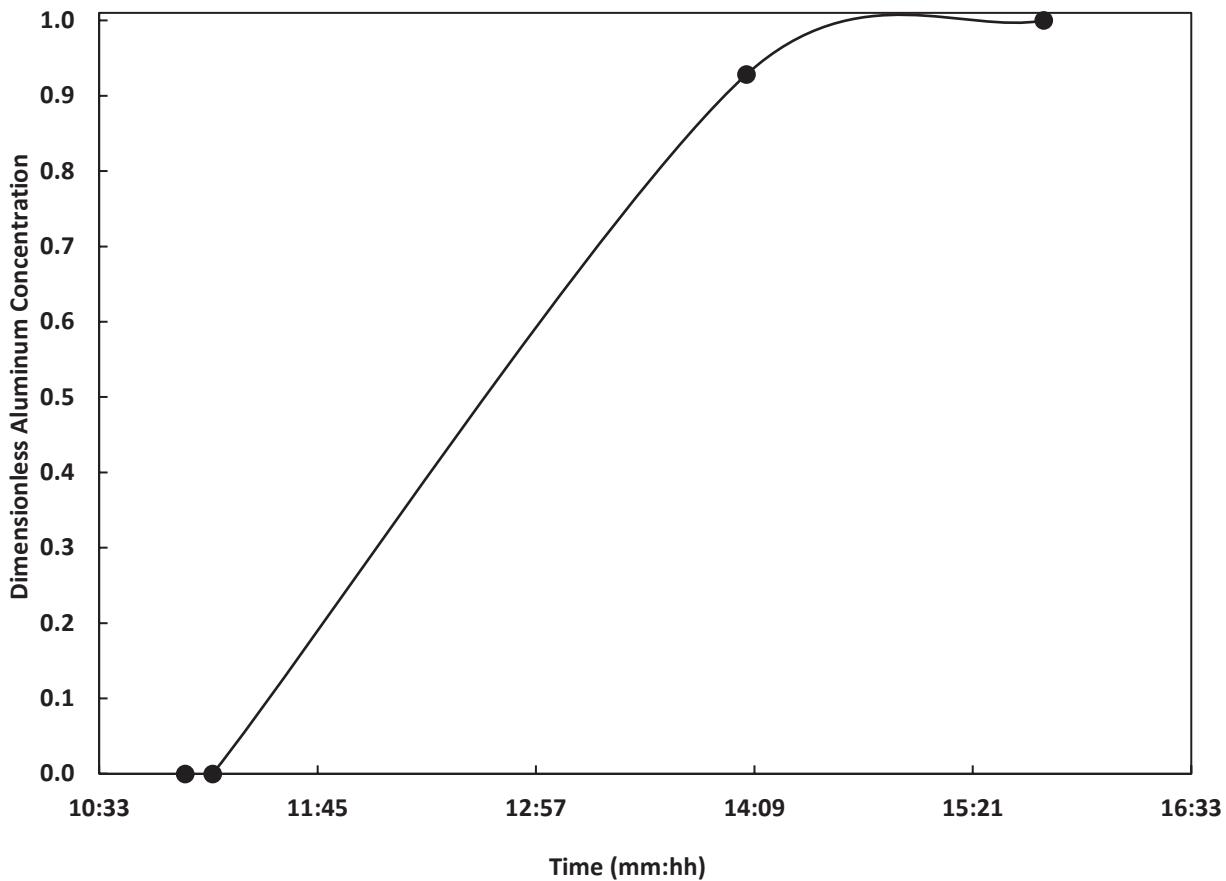
Figure 3-13: Dimensionless Aluminum Concentration versus Caustic Dissolution Sampling

The samples from TK-215 were allowed to cool and were filtered through syringe filters following Caustic Dissolution. During filtration, within the B-wing Shielded Cells, some samples were unable to be filtered. Precipitate build-up had accumulated on the filter. The precipitate was removed but could not be characterized effectively by ICP-ES due to the inability to distinguish between the insoluble and soluble components under operations conditions of the R&D system. Upon pulling the samples, the samples were clear. Although the values for the TK-215 samples are not presented due to the inaccuracy, being unrepresentative of the dissolution, the kinetic curve is illustrated by Figure 3-13. The kinetics of dissolution represent the anticipated progression of the dissolution of aluminum cladding.

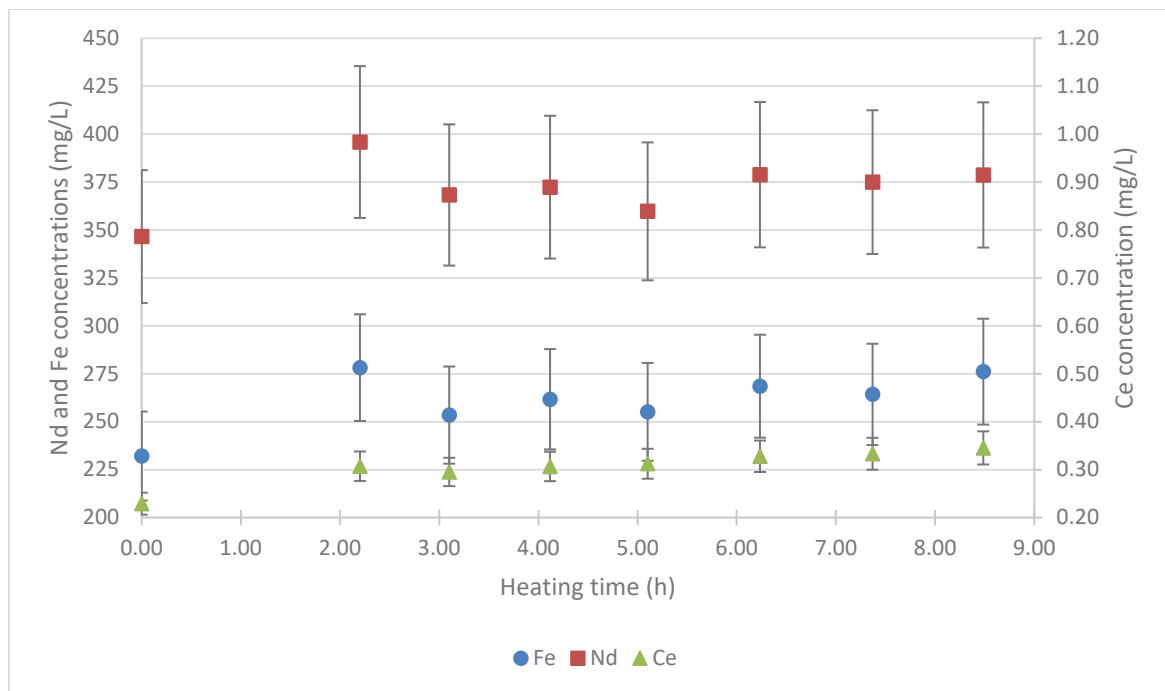
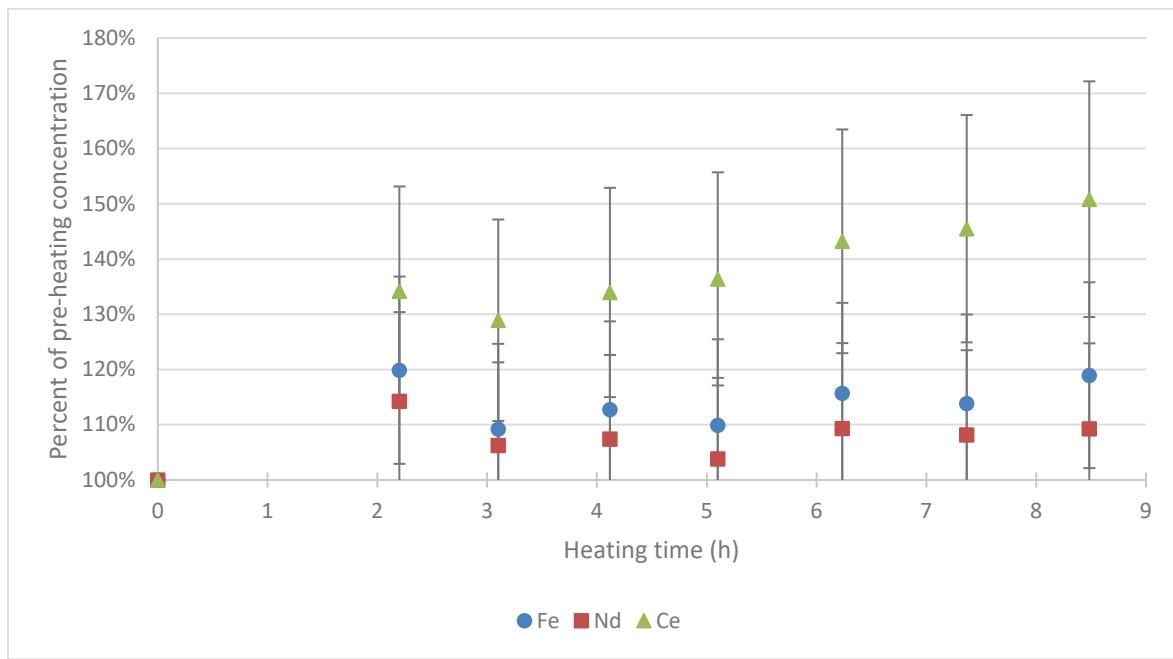
The contents of TK-235 were sampled before and after acid addition, periodically at temperature, and after the gelatin strike (discussed below) / cooling to ambient temperature. Mixing was paused to collect samples during the dissolution, and the hot samples were put in intermediate vials to cool. All samples were filtered through 0.45- μm syringe filters at ambient temperature prior to analysis. The evolution of the dissolved Nd, Ce, and Fe concentrations in TK-235 during the dissolution are shown in Figure 3-15, Figure 3-16, and in Appendix A. Within analytical uncertainty, there is no statistically discernable change in the concentration of these analytes with respect to heating time. Thus, complete dissolution or solubility limits of these components may be achieved within the 8.5 h of heating. Plutonium as PuO_2 may be more resistant to dissolution so the baseline strategy targeting 7 h at temperature will initially be evaluated. With respect to the amounts of Nd_2O_3 and CeO_2 added to TK-215 for caustic dissolution, as listed in Table 3-2, 54% of the added Nd and 0.12% of the added Ce was dissolved in nitric acid in TK-235 after the gelatin strike. CeO_2 is resistant to dissolution in nitric acid so the Ce result is not surprising. Nd_2O_3 is highly soluble in nitric acid and the amount of Nd dissolved in TK-235 is lower than expected.

Figure 3-15. Dissolved concentrations of Nd, Ce, and Fe throughout dissolution

Figure 3-16. Percent change in Nd, Ce, and Fe concentrations throughout dissolution relative to pre-heating concentrations

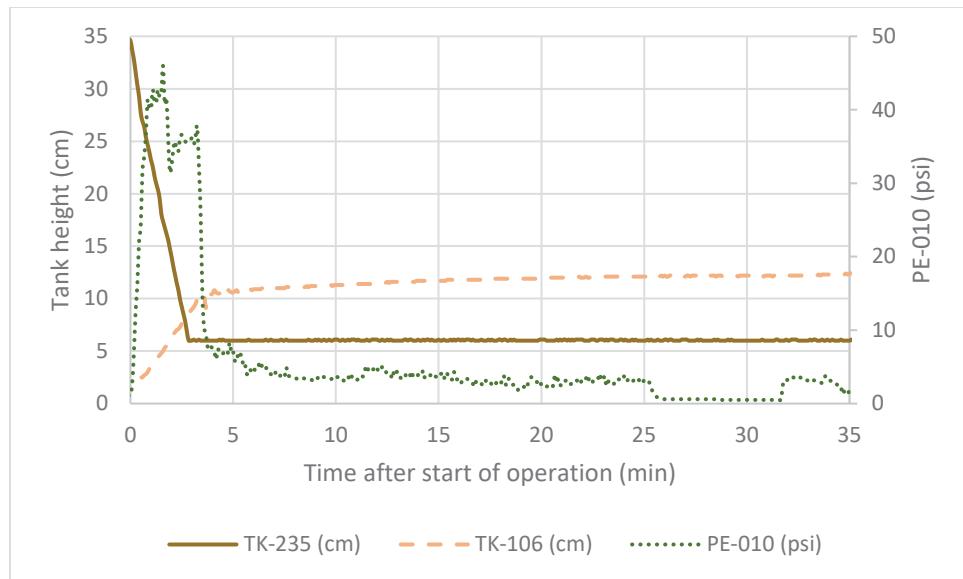
Figure 3-18. Transfer of solution from TK-235 to TK-106 via FLT-310

The TK-235 and TK-106 volume changes and PE-010 (pressure prior to FLT-310/315) measurements are shown in Figure 3-18. It is noted that the LabView data log does not indicate if P-100 is on or off. It was requested that this be recorded in the data log. The contents of TK-235 were easily filtered and transferred to TK-106. This is encouraging as this was the first time that the filtration had been tested with silica/coagulated solids. Only one of the two parallel filters was necessary for the filtration. The filters are rated for 200 psi but the process targets pressures less than 100 psi. The maximum pressure measured during the transfer was 46 psi. Most of the volume contained in TK-235 transferred rapidly to TK-106 (within 5 minutes), but the liquid height in TK-106 continued to slowly increase until 35 minutes after the start of the transfer. As previously discussed, tank volumes are not recorded in the data log (recommend adding this data). However, volume data were recorded from the LabView interface during the evolution. The initial volume in TK-106 was <1.9 L (minimum reading). TK-106 contained a heel from water testing. With a TK-235 volume after gelatin strike of 11.5 to 11.6 L, the expected volume of TK-106 was 11.5 to 13.2 L after the transfer. The measured volume after the transfer was 12.5 L and within range of the expected value. Although significant solids were captured on FLT-315, there is evidence of possible solids breakthrough or bypass to TK-106 due to fouling issues when attempting loading operations of INEX-003. If this was a result of inadequate filtration, it may have been due to slurry bypassing the bag filter when the housing was filled above the bag filter ring during the highest rate of transfer in the first 4 minutes.
