**Type A Accident
Investigation Board Report
on the January 17, 1996,
Electrical Accident with Injury in
Building 209, Technical Area 21
Los Alamos National Laboratory**

**Type A Accident
Investigation Board Report
on the January 17, 1996,
Electrical Accident with Injury in
Technical Area 21
Tritium Science and Fabrication Facility
Los Alamos National Laboratory**

April 1996

**Office of Oversight
Environment, Safety and Health
U.S. Department of Energy**

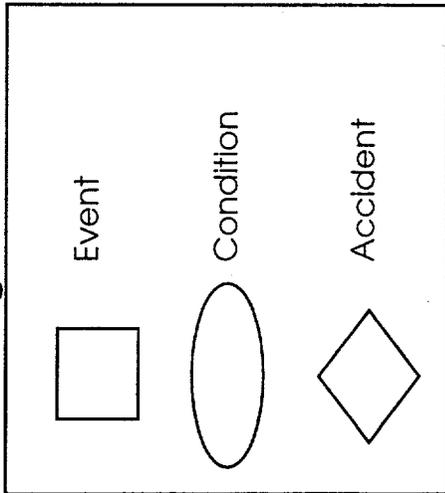
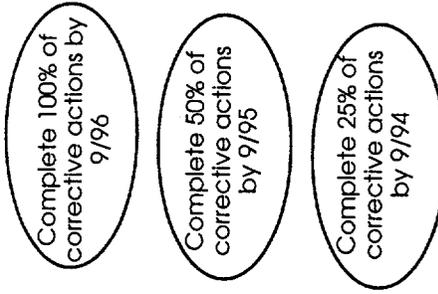
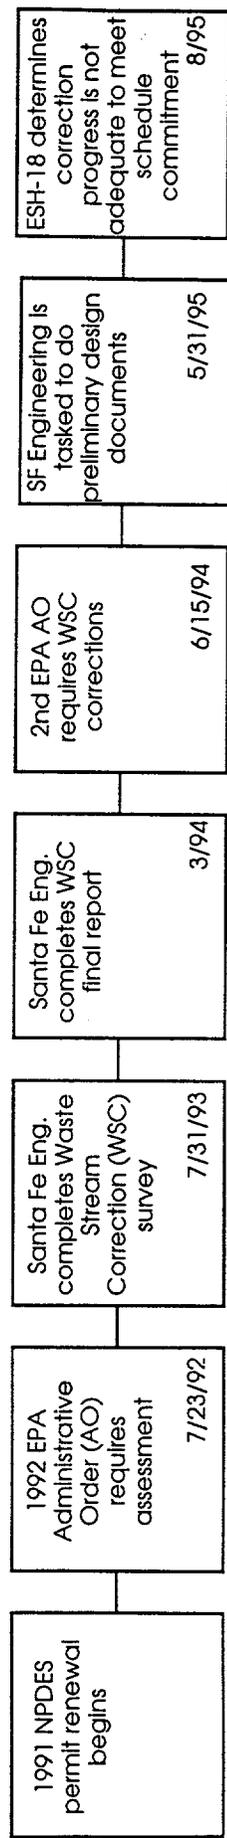
Figure 3-1. Events and Causal Factors Chart (Page 1 of 11)

The events and causal factors chart is used to determine the sequence of events leading to the accident and to show the relationship between events and associated causal factors. A causal factors analysis is shown in Table 3-1, and an events and causal factors chart is depicted in Figure 3-1. Causal factors that arose from analysis of the events and causal factors chart are as follows:

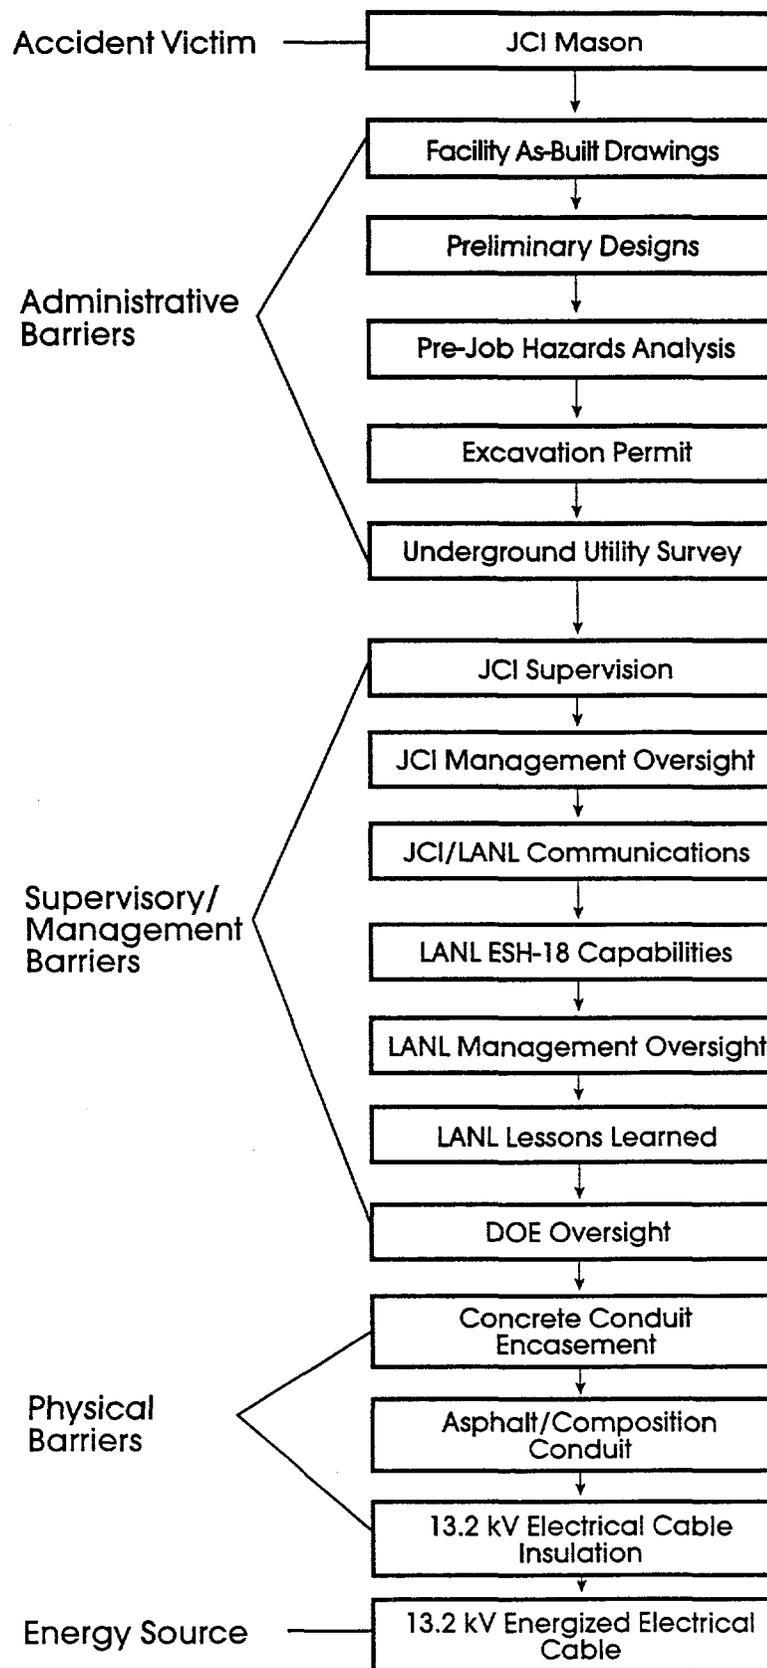
Figure 3-2. Barrier Analysis Summary

Hazard	Direct Barrier or Control Failure	Possible Contributing Factors to Barrier or Control Failures	Possible Root Causes of Failures	Loss or Potential Loss Event	Evaluation
Contact with 13.2 kV electric cable	Lessons learned process failure	<p>JCI did not ensure that crafts personnel were aware of work place hazards (preliminary hazard analysis, excavation, and worker training)</p> <p>JCI Safety did not review "Maintenance" work package</p> <p>LANL management did not ensure that adequate actions were taken resulting from previous occurrences</p>	<p>The corrective action process was not implemented</p>	Contact with 13.2 kV line	Between 1991 and the present there were 5 similar occurrences which referenced the need for training and proper personal protective equipment
	Failure of configuration control	ESH-18 allowed relocation of sump pit without a modification review	ESH-18 was not experienced in project management

Facility Managers were not aware of modifications to facility

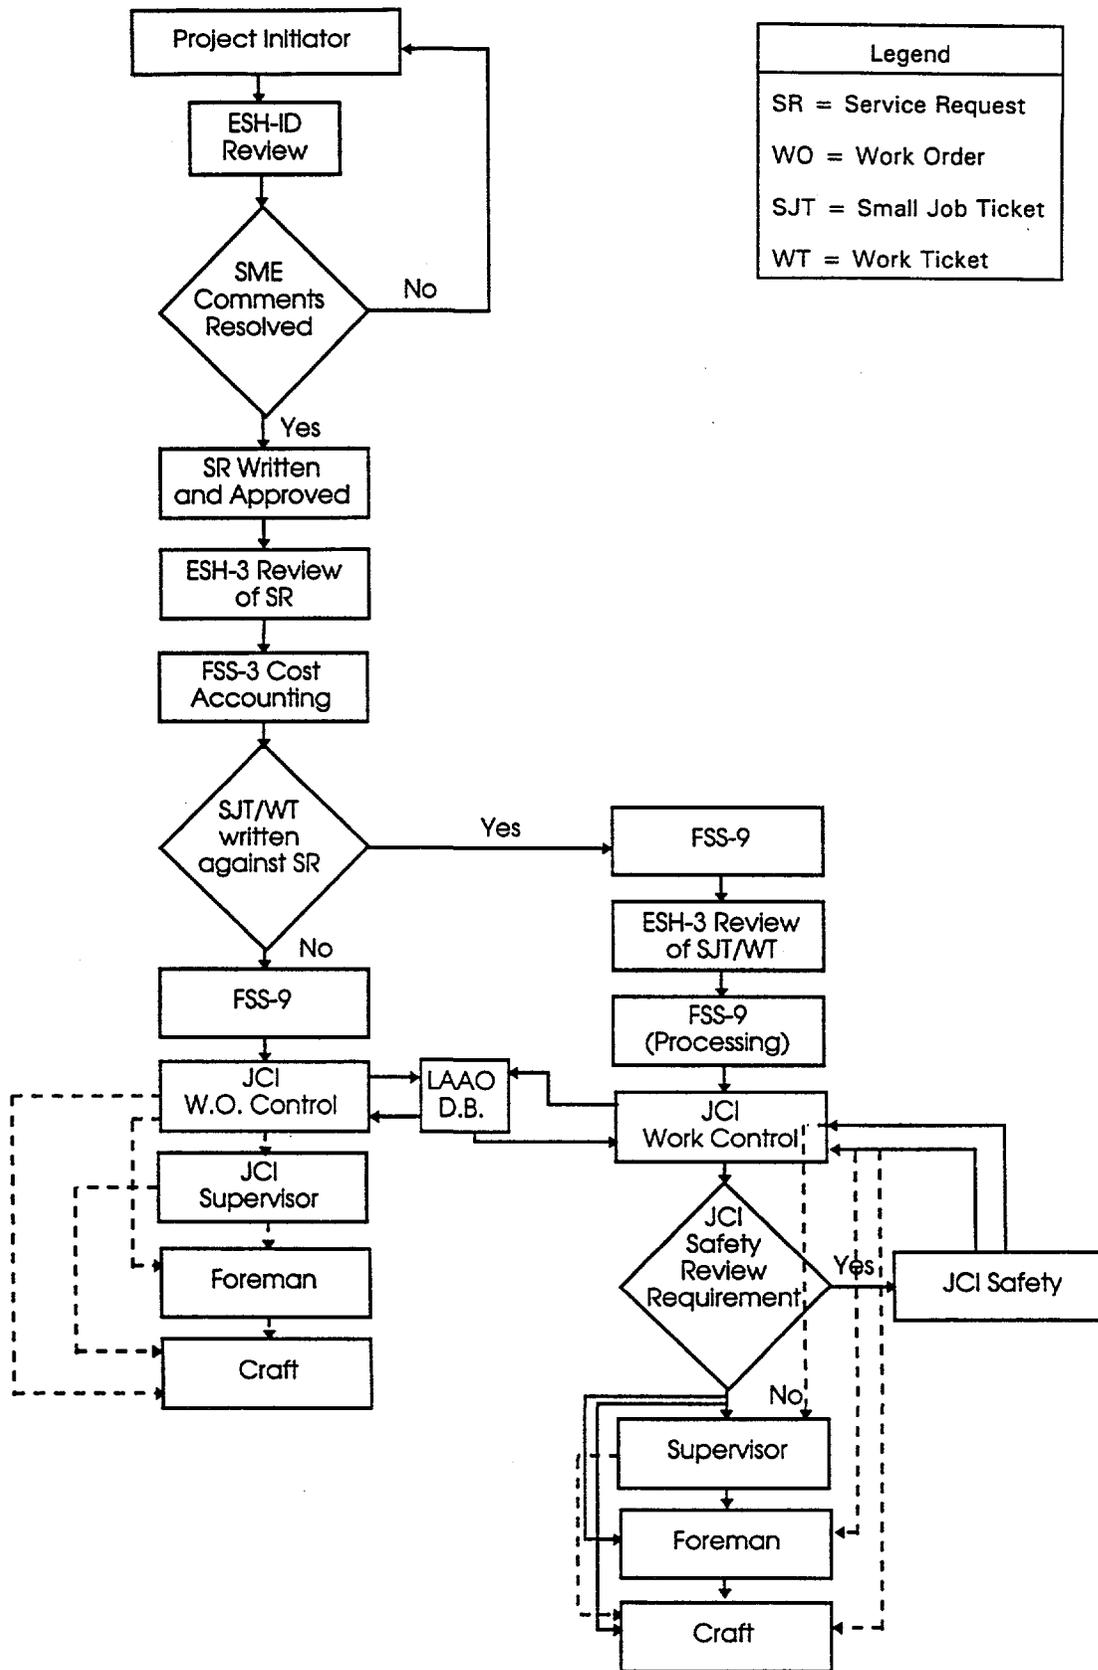
Figure 3-3. Work Control Process as Determined by the Board

The normal work authorization and control process is depicted in the flow diagram included as Figure 3-3. The work authorization and control process utilized for the Waste Stream Corrections Project is depicted in the flow diagram included as Figure 3-4.

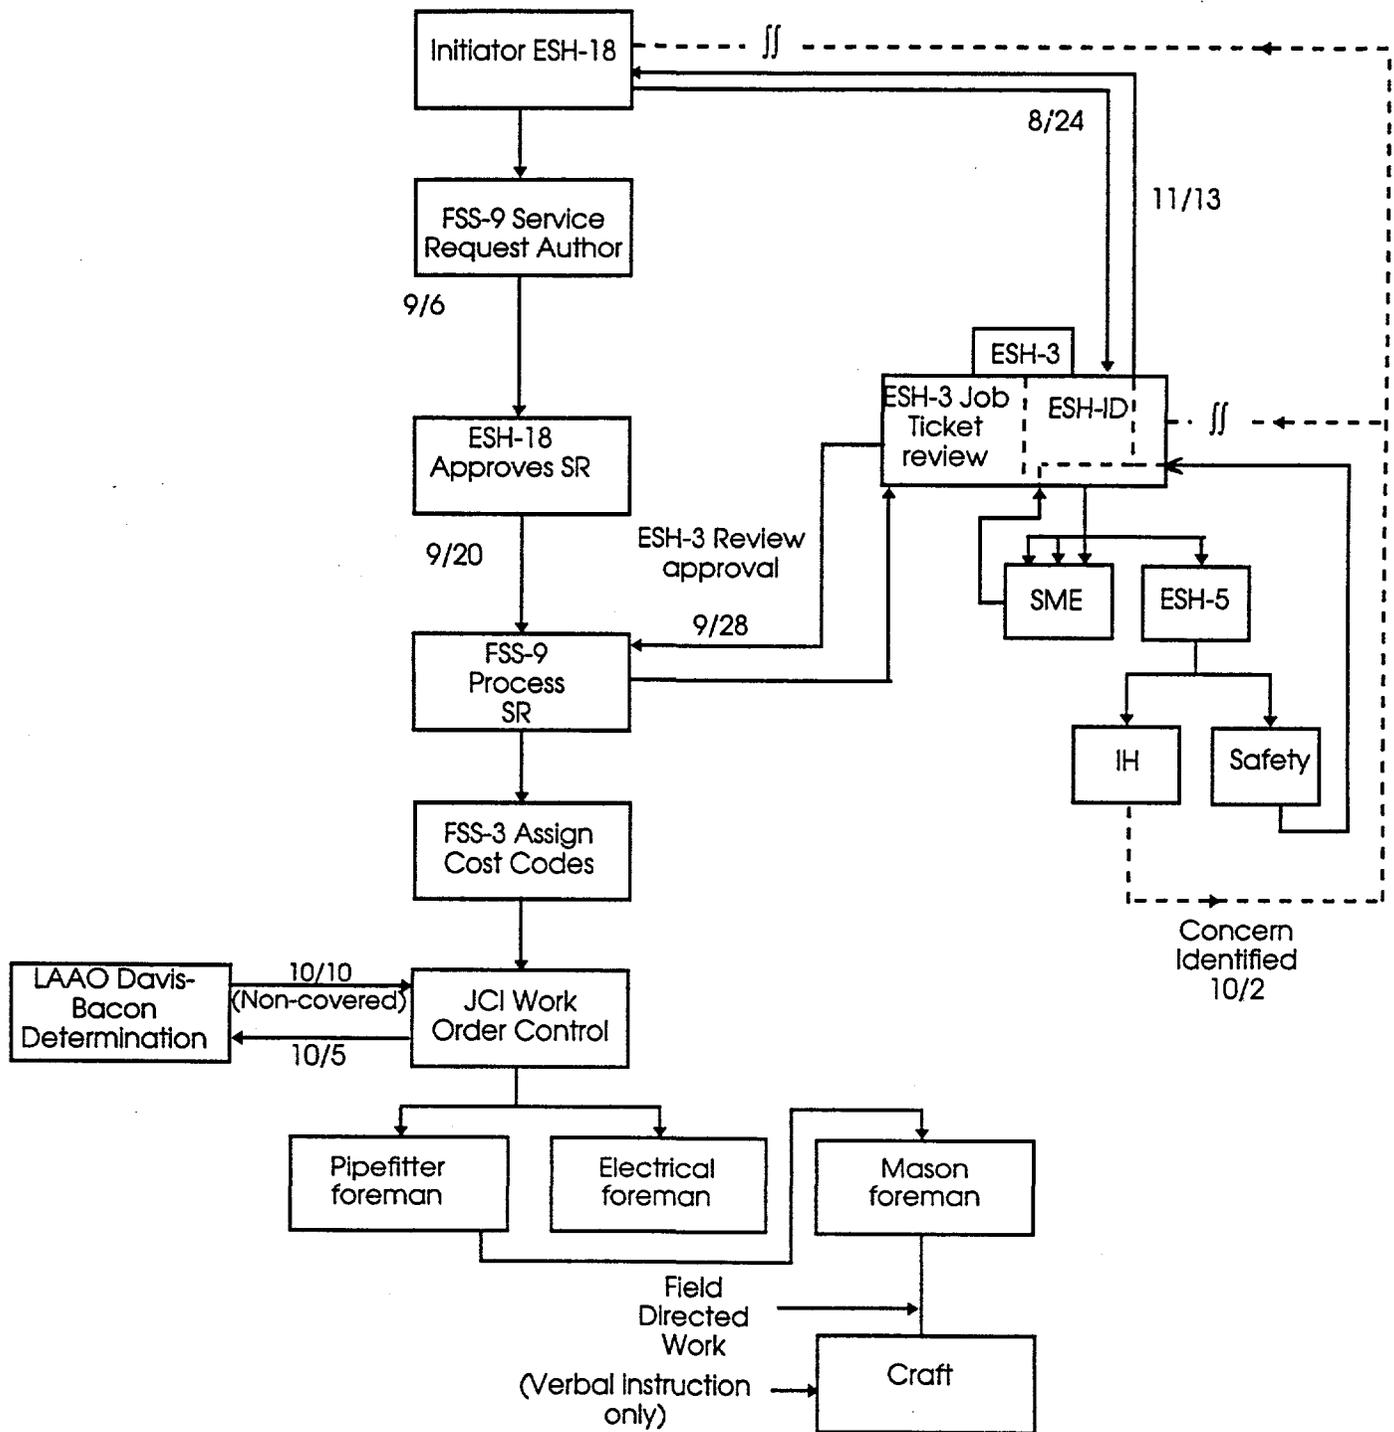
Figure 3-4. Work Authorization and Control for the Waste Stream Corrections Project

No preliminary hazard analyses were conducted.

The Building Manager did not receive specific information regarding project scope and time frame.

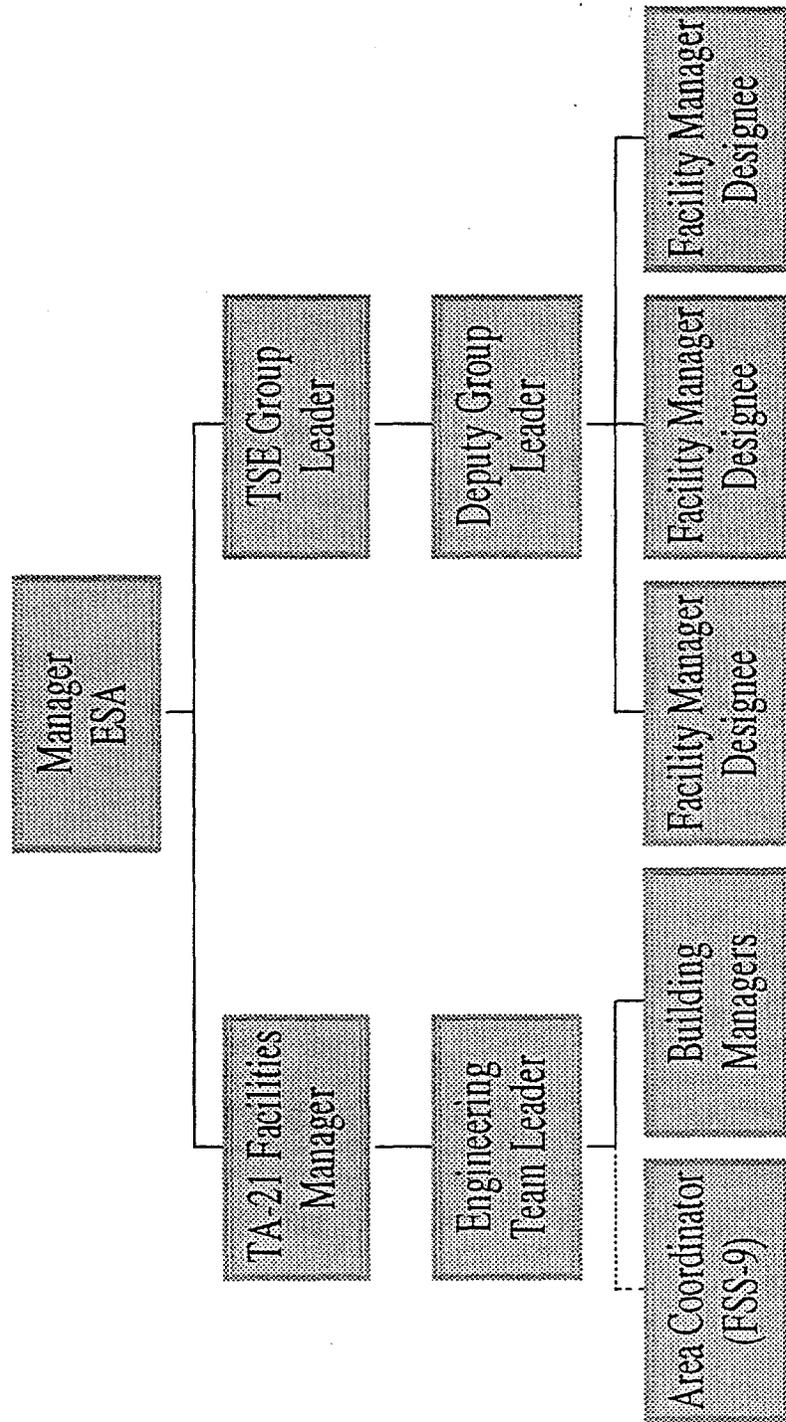
Figure 3-10. Flowdown of Responsibilities for Facility Operations and Maintenance at Building TA-21-209

Because of a lack of direction from LANL senior management, the process for implementing the Facility Management Unit model has not been effective in ensuring that individuals understand their roles and responsibilities during the transition. The logical flow of responsibility as described in the Facility Managers' memorandum of understanding clearly assigns responsibility for facility operations and maintenance activities to the Facility Manager. However, actual implementation of this flow becomes unclear in Building TA-21-209, because there are other individuals involved in a process that is not clearly defined, namely, the Area Coordinator, Building Manager, Facility Manager Designee, and Facility Manager. Figure 3-10 illustrates the reporting relationships of these individuals.

From the structure indicated in Figure 3-10 it is clear that the Facility Manager does not exercise supervision over the "Facility Manager Designees." Interviews revealed confusion over facility responsibility, especially for individuals outside the Engineering Sciences and Applications Division. Internally, the responsibilities of the Facility Manager are not being implemented as described in Director Policy DP-124; the program's organizations do not accept the facility manager role as it relates to their operations. In addition, there is confusion about the requirement to notify the Facility Manager or Building Manager immediately prior to beginning work in their facility. As a result, the following occurred:

The Facility Management Unit model has not been effective in defining and communicating roles and responsibilities.
