UNITED NUCLEAR, INC.  
RICHLAND, WASHINGTON

INVESTIGATION OF N REACTOR SCRAM  
OF  
SEPTEMBER 30, 1970

G. C. Coleman

DUN-7342

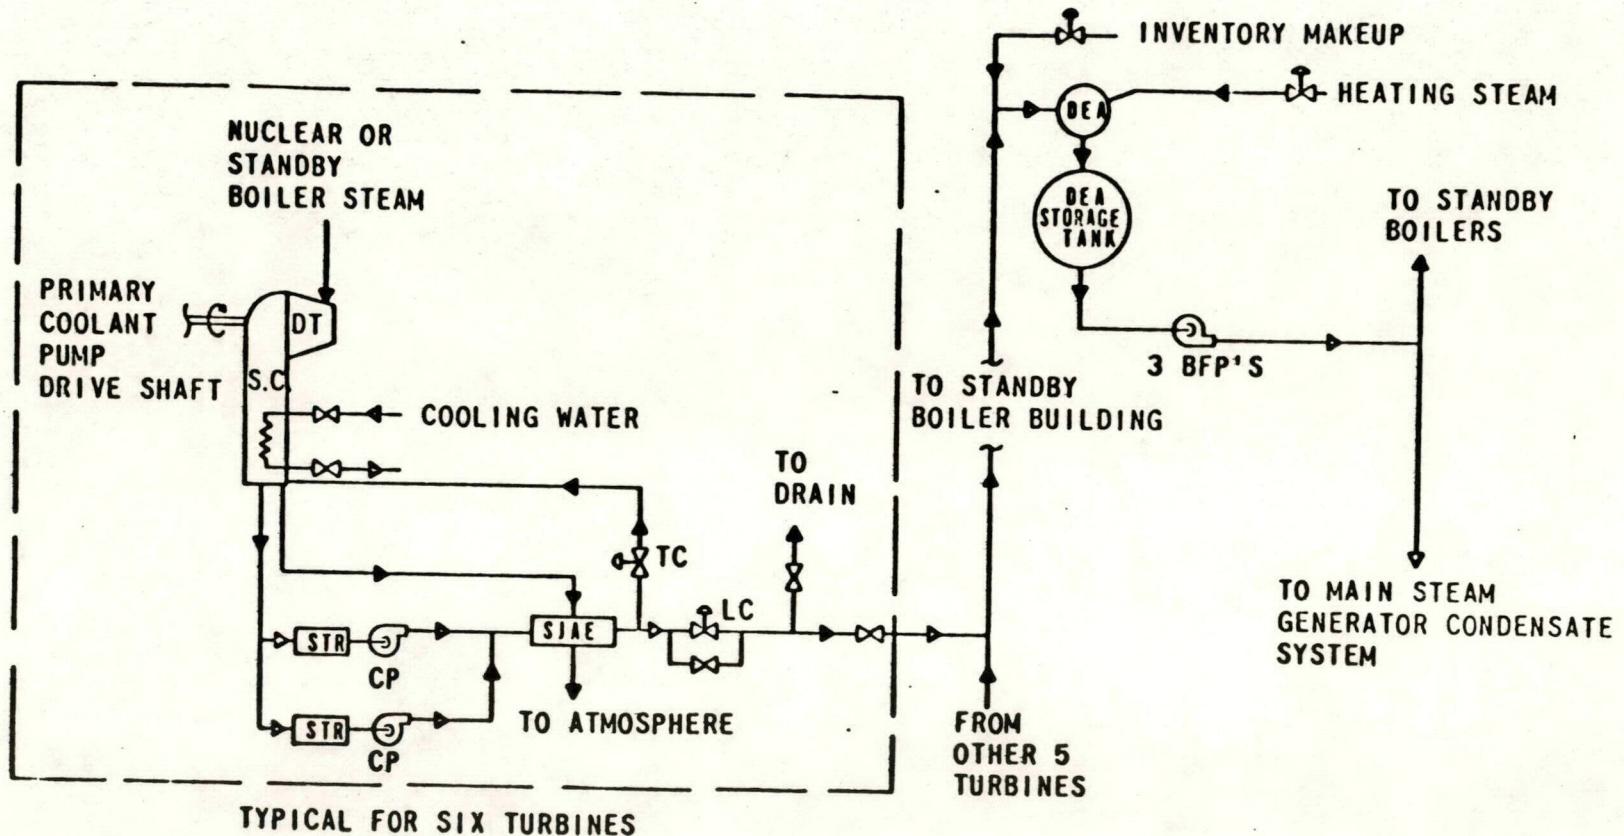
Figure 9.

A second test procedure (reference: DUN-7306, "N Reactor Scram Report September 30, 1970") was prepared to determine the cause for the inability to control hotwell level. This test indicated little or no flow through condensate pump 6A and a significantly high Delta P across the pump's in-line suction strainer. (See Figure 9.) The performance of condensate pump 6B was equal to, or better than, the vendor's rated capacity. The decision was made to inspect the pumps internally.

The insulation was removed from the two surface condenser condensate pump suction headers and the lines were opened for inspection. The in-line strainer to pump 6A was found to be totally plugged with Garlock gasket material (Catalog No. 670). The pump 6B strainer was approximately 60% plugged with the same material. Similar material, along with five 2- to 3-inch sections of welding rod, was also found in a subsequent inspection of the hotwell of the No. 6 turbine condenser.

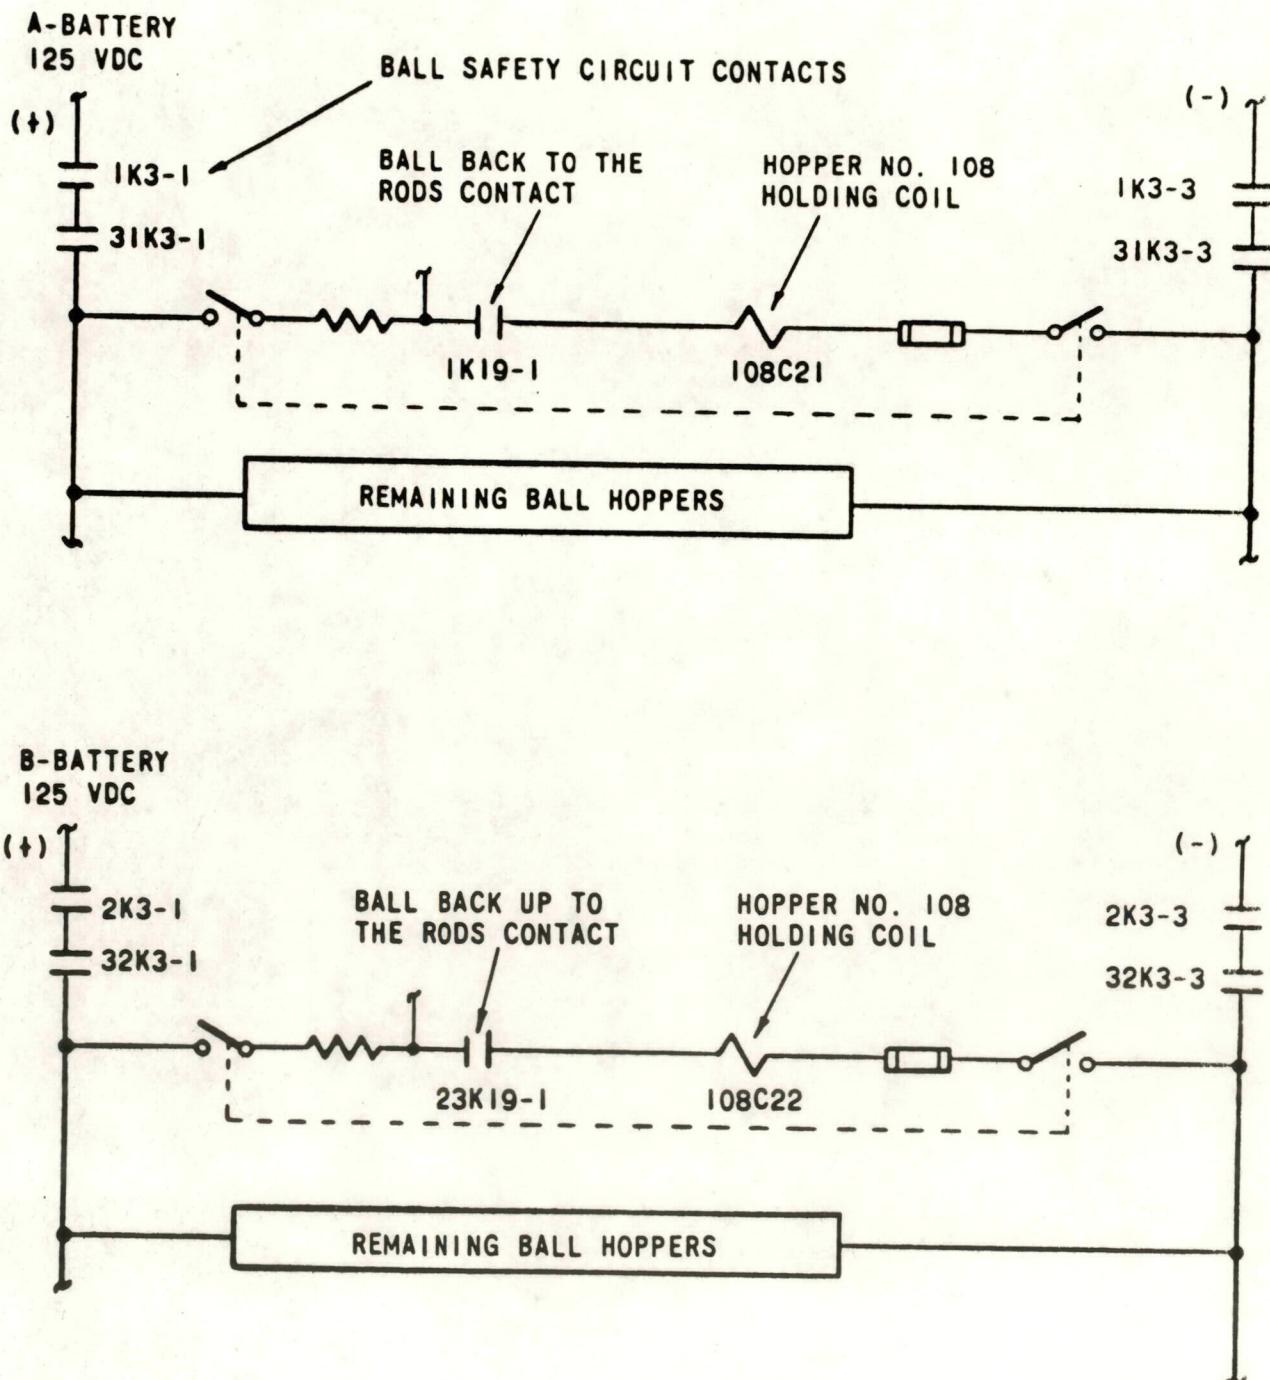
Figure 10. Ball Safety System, Ball Hopper Solenoid Circuits

Each ball hopper has an individual ball dump or trip mechanism which is held closed against an opening spring by two solenoids. Each solenoid is powered by a separate electrical circuit. Both solenoids must de-energize to permit the balls to drop into the reactor. (See Figure 10.)

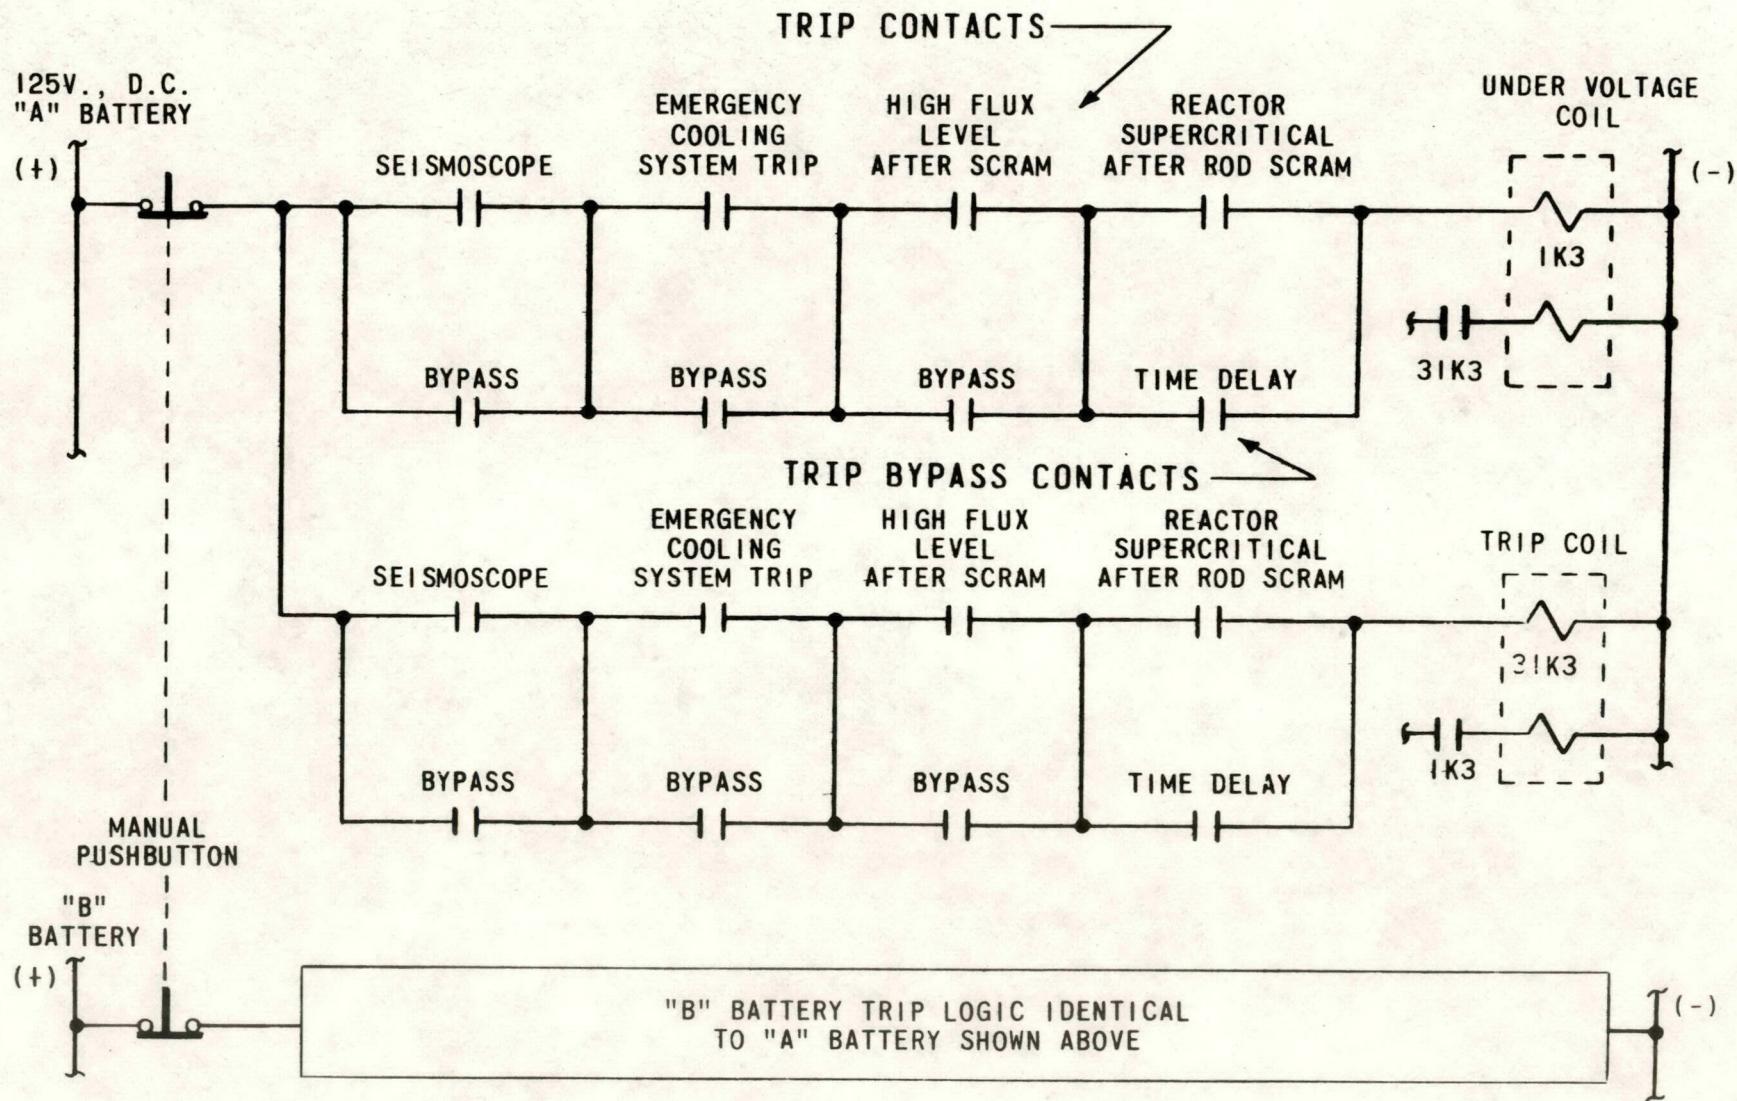
Figure 11. Ball Safety Circuit

Since no rods responded to the scram signal within 1.5 seconds on September 30, the simultaneous functioning of control circuits 6 and 7 above caused all ball hoppers to dump. Reactor shutdown by the ball safety system was, therefore, safely achieved less than two seconds later than it would have been if the rods had scrammed. (See Figure 11.)

Immediately following the September 30 scram signal, control room instrumentation on the open position of each ball hopper gate indicated that all ball hoppers had dumped except Nos. 3, 7, 19, 40 and 48. Ball hopper No. 40 was known to have been taken out of service for maintenance and, therefore, should not have dumped. A visual inspection of all ball hoppers immediately after the scram revealed that only ball hopper No. 3 had actually failed to function as expected.

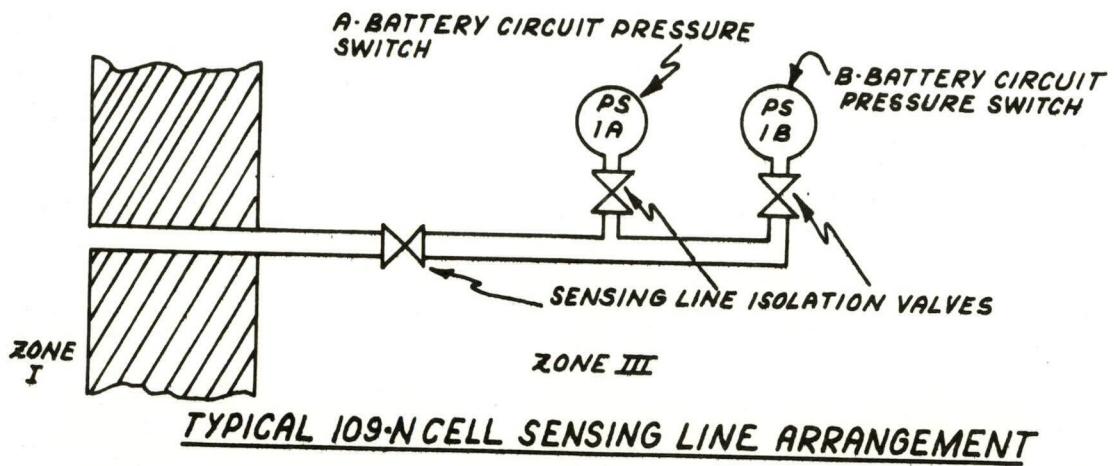
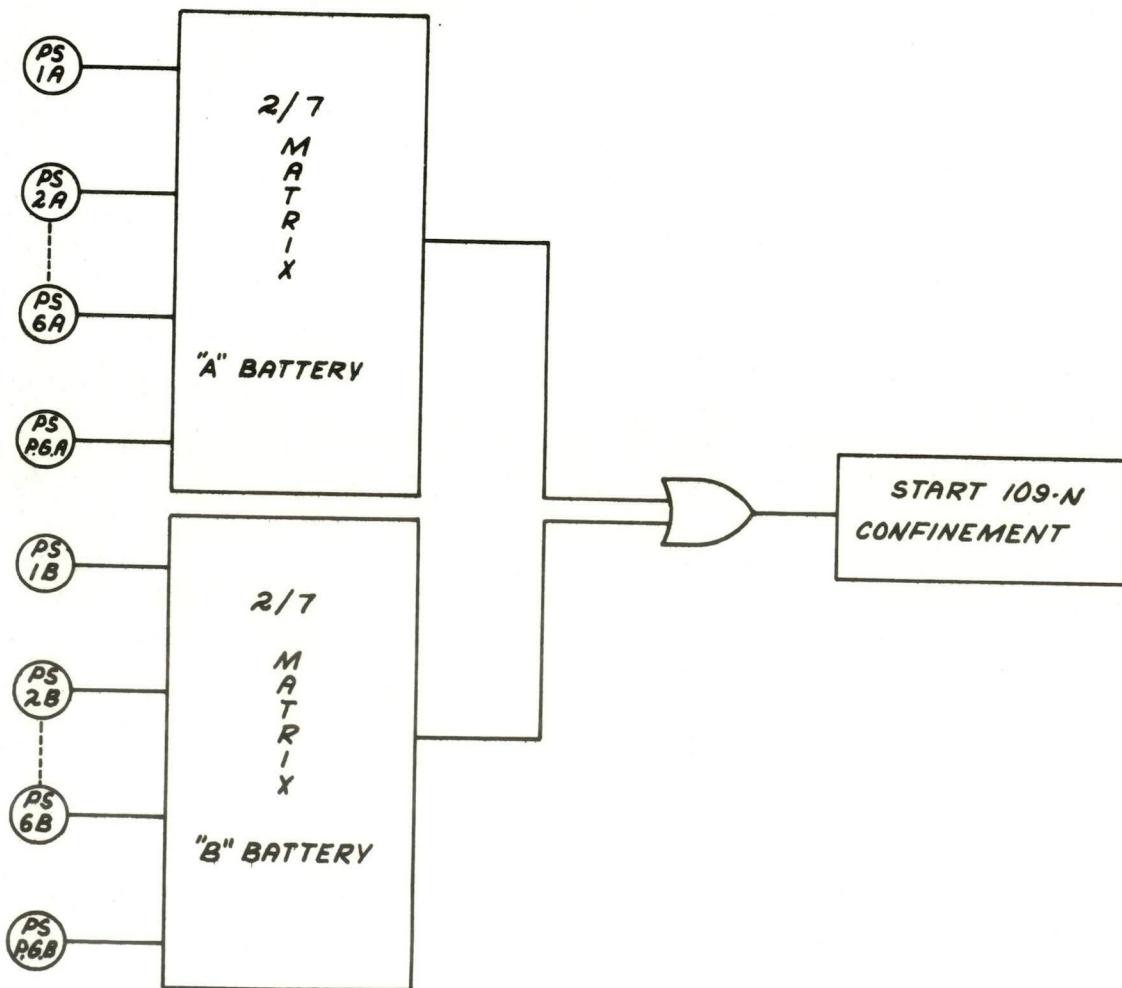
Figure 13. 109 Confinement Trip Circuit

Zone 1 atmosphere sensing pressure switches in the 105-N and 109-N Buildings are used to detect reactor incidents requiring activation of the fog spray and confinement systems. In the 109-N Building, there are two ambient pressure sensing lines in each of the six cells and in the pipe gallery with two pressure switches on each line. The two pressure switches on each line are powered from different DC power sources for redundancy. The two switches on one line actuate at 2 inches of water pressure and provide inputs to redundant two out of seven trip logic circuits which initiate the Zone 1 confinement sequence. The two pressure switches on the other sensing line actuate at 10 inches of water pressure and provide inputs to redundant two out of seven trip logic circuits which activate the fog spray system. (Reference: Figure 13.)

As a result of the special test, all eight sensing lines for the fog spray and confinement pressure switches in cells 1, 2, 4, and 5 were inspected and found sealed off. (Reference: DUN-7395, dated October, 1970.) One line in cell 1 was sealed off with self-tapping screws and rubber gaskets in each of the 21 holes in the specially made probe of the sensing line. (See Figure 14.) The other seven lines were sealed by wrapping the sensor heads with black plastic electrical tape. The sensing lines in cells 3 and 6 and the pipe gallery were unobstructed. However, tape marks were visible on the cell 3 sensing lines.

The evidence of cell wall elastomer coating on the outside of the tape indicates that the taping was done prior to the coating of the cell walls prior to initial reactor startup in 1964. Initial cell leak-tightness tests or pressure or vacuum tests during initial startup may have been the type of activity for which sealing of the pressure sensing lines was necessary.

1. Testing of these pressure switches should be covered in the future by proposed EMS-603, which in its present form should detect any capped sensing lines. It is recommended that EMS-603 be modified to also detect closed isolation valves.
2. Signs should be placed at all the sensing lines and isolation valves to warn against inadvertent closing or plugging.
3. Isolation valves for pressure switches which provide control inputs to safety systems should be included in the "N Plant Operations Subsection Equipment Status Control System," DUN-7201, DL Howard, dated August 31, 1970.
4. Confinement Backup Devices

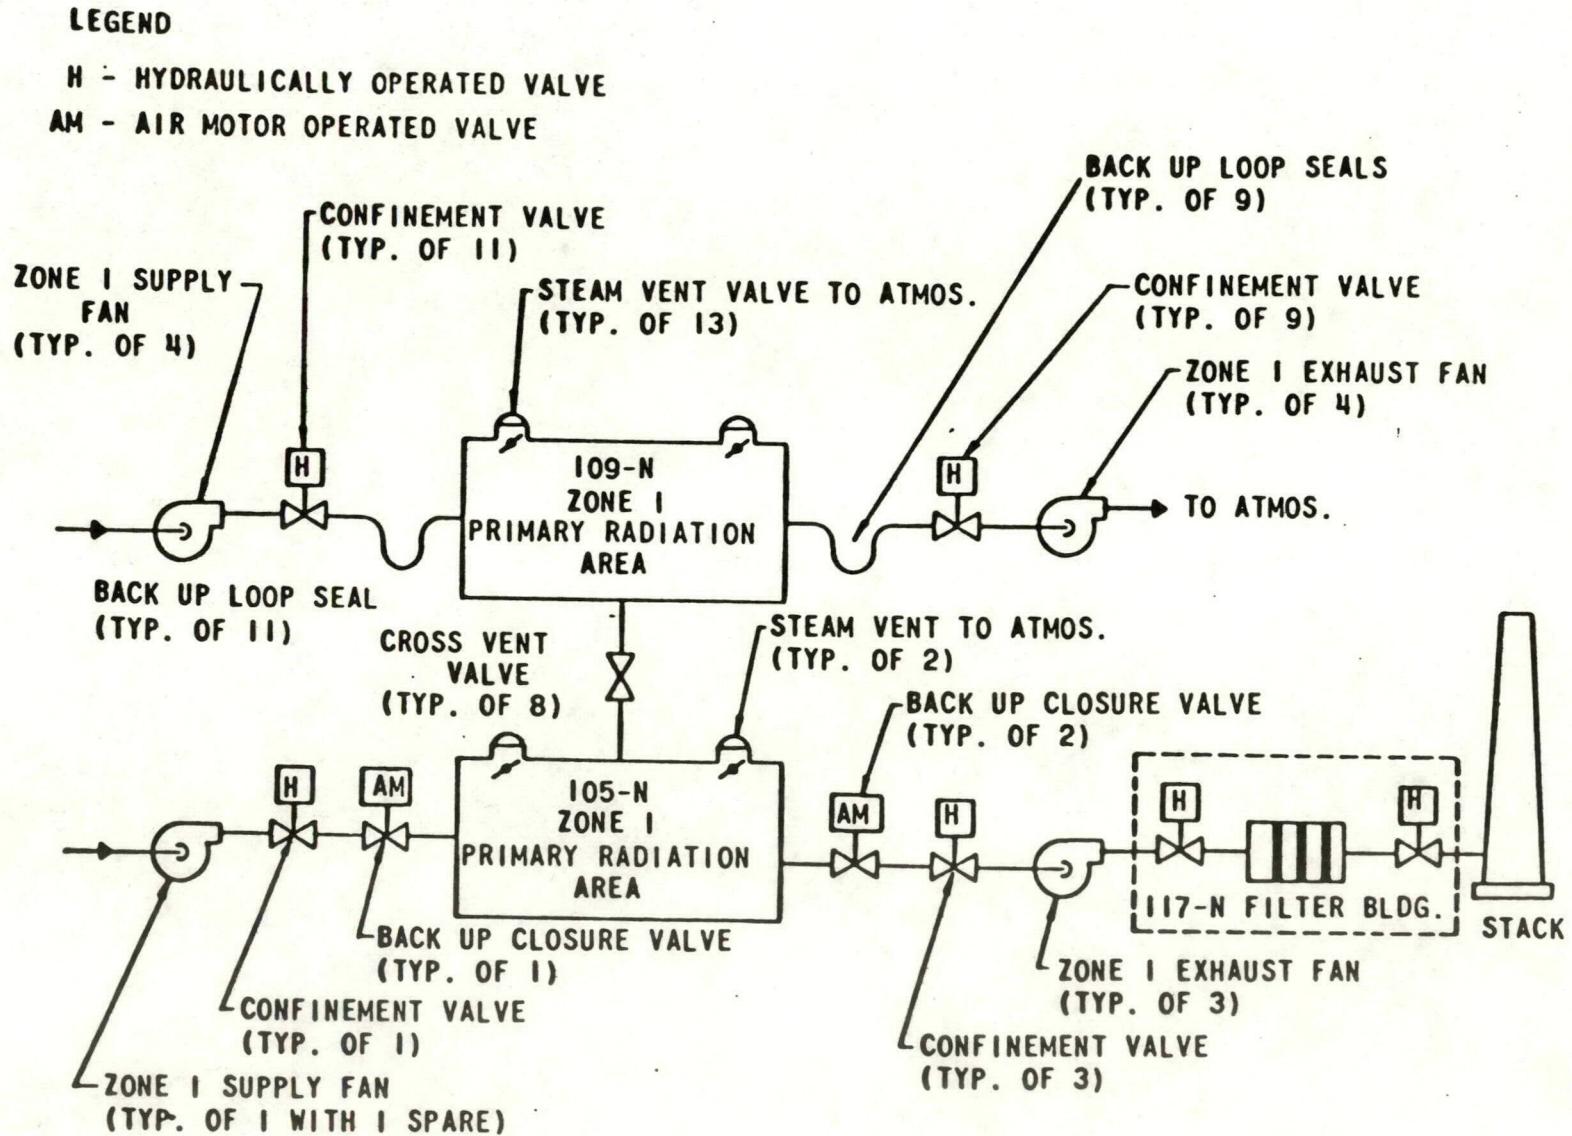
Figure 15. Confinement Ventilation System - 105 - 109-N

Backup to the 105-N Zone 1 exhaust confinement valves is supplied by vertically sliding, piston-operated gates. (Reference: Figure 15.) These gates are held open by the application of pressurized gas against the piston operators. Normal supply of gas is supplied by on-line nitrogen cylinders. The recommendation was made to remove the normal supply of instrument air from the gates and verify that the backup nitrogen system develops sufficient pressure to maintain the gates in the raised positions. Observations of gate slippage have been made when the normal air supply to the gates was removed. If these gates were to close (which would be their failsafe mode), they would prevent establishing a filtered fission product release to the confinement filters.

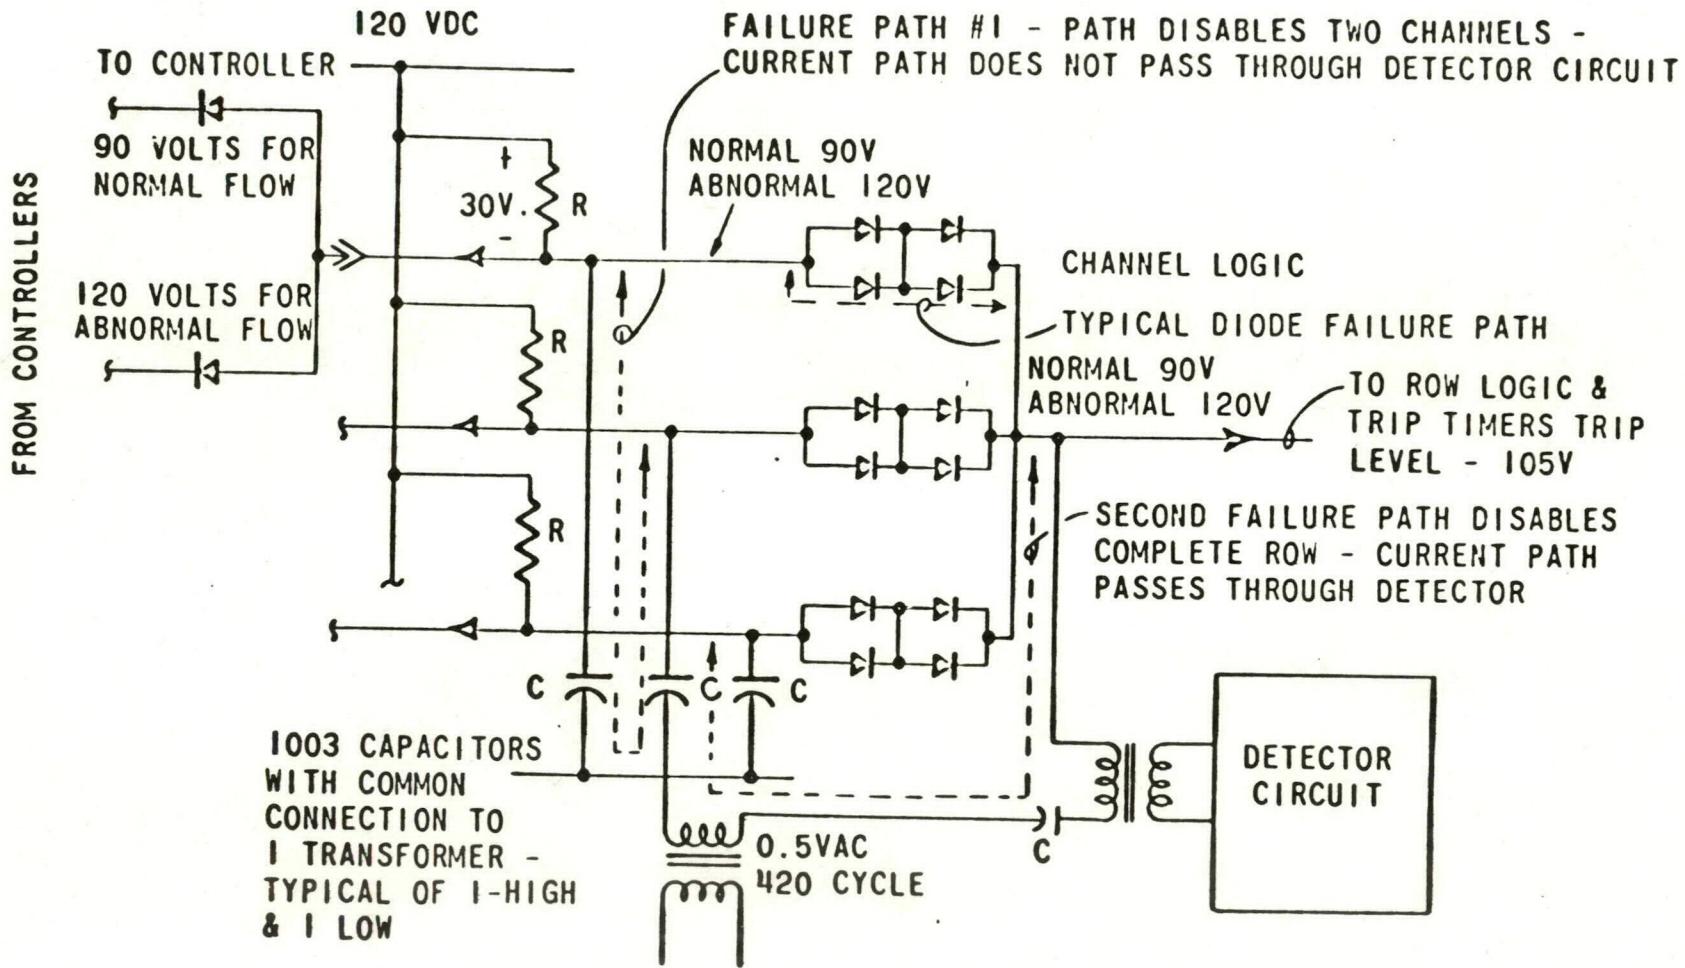
Figure 16.

The flow monitor system has a circuit which continuously checks for shorted diodes by inserting a 400 cps sine wave upstream of the diodes and monitoring downstream to insure that the sine wave is rectified. The shorted diode detector has capacitors installed in it that have been calculated to be about 200 times more likely to fail than the diodes which the detector is installed to monitor. (See Figure 16.) A complete shorting failure of the diode quads would be detected by the shorted diode detector. However, since a combination of two capacitors shorting will produce the same event [negation of trip function for that row of process tubes by bleeding off trip level voltages (120 volts) back into the 90-Volt sink created by the controller whose capacitor is also shorted], it was questioned whether the shorted diode detector should be removed from the system or modified to be made more reliable. The Working Committee hesitated to remove the shorted diode detector
