ORNL/ER-374

### Technical Evaluation Summary of the In Situ Vitrification Melt Expulsion at the Oak Ridge National Laboratory on April 21, 1996, Oak Ridge, Tennessee

**Date Issued—July 1996**

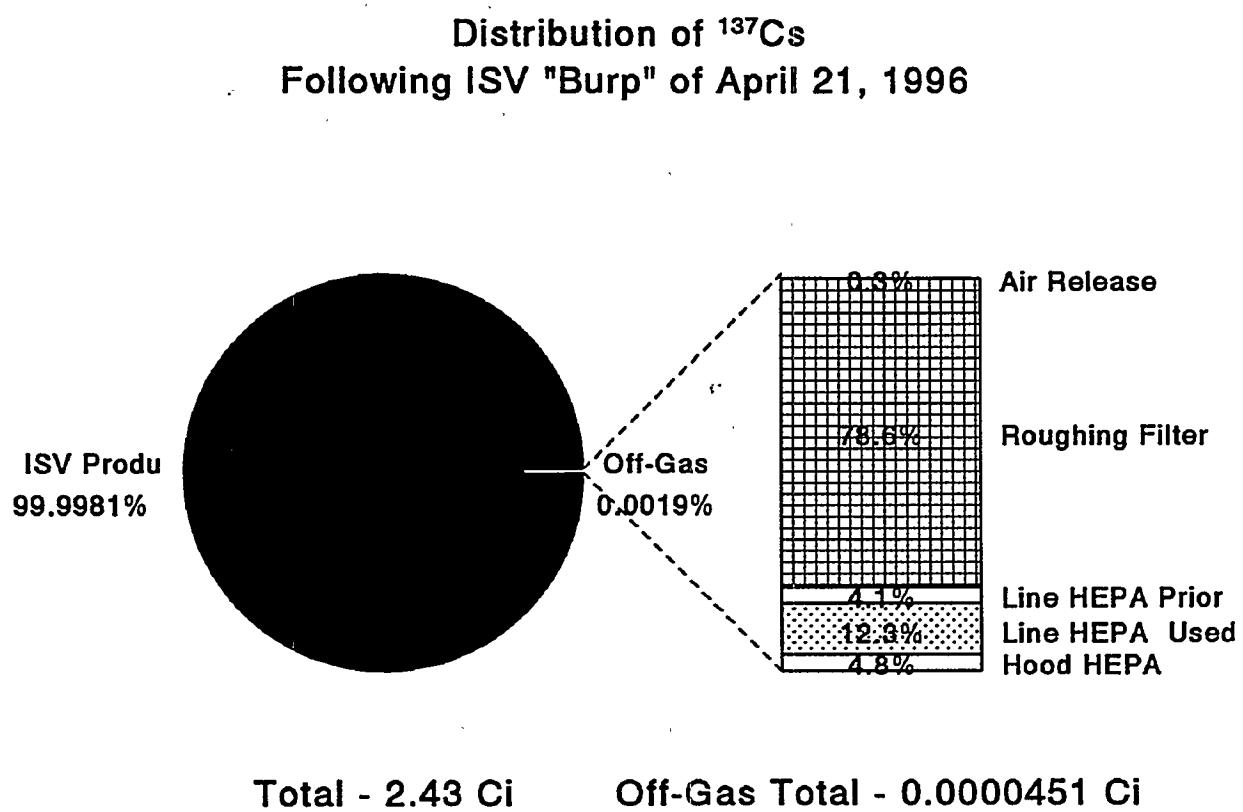
Fig. 3. Distribution of  $^{137}\text{Cs}$  in ISV off-gas and equipment following the incident of April 21, 1996

Results of the distribution of  $^{137}\text{Cs}$  are depicted in Fig. 3. Most notably, 99.9981% of the  $^{137}\text{Cs}$  was retained in the ISV molten body subsequent to the melt expulsion incident. Of the 0.0019% of the  $^{137}\text{Cs}$  activity that was released into the process off-gas, most was retained on the hood's roughing filter. Of the fraction that passed the roughing filter, all was retained on the HEPA prefilters as no  $^{137}\text{Cs}$  was detected in the off-gas scrub system solutions. Measurable activity, found on the HEPA prefilters switched out of the off-gas flow about two days prior to the melt expulsion incident, indicates that  $^{137}\text{Cs}$  was being incorporated into the growing ISV molten mass for several days before the melt expulsion incident. The HEPA filters on the hood's off-gas backup blower also contained a significant fraction of the total off-gas inventory. Field surveys of the smear samples from various hood panels and the off-gas pipes did not reveal detectable activity; these samples will be assayed in the low-background laboratory environment for quantification of their low-level activity. Their contribution to the total off-gas inventory and distribution would be trivial compared to the various filter samples, which yielded readily detectable activities with field survey instruments and during short (10 min) counting intervals in the low-background laboratory environment.

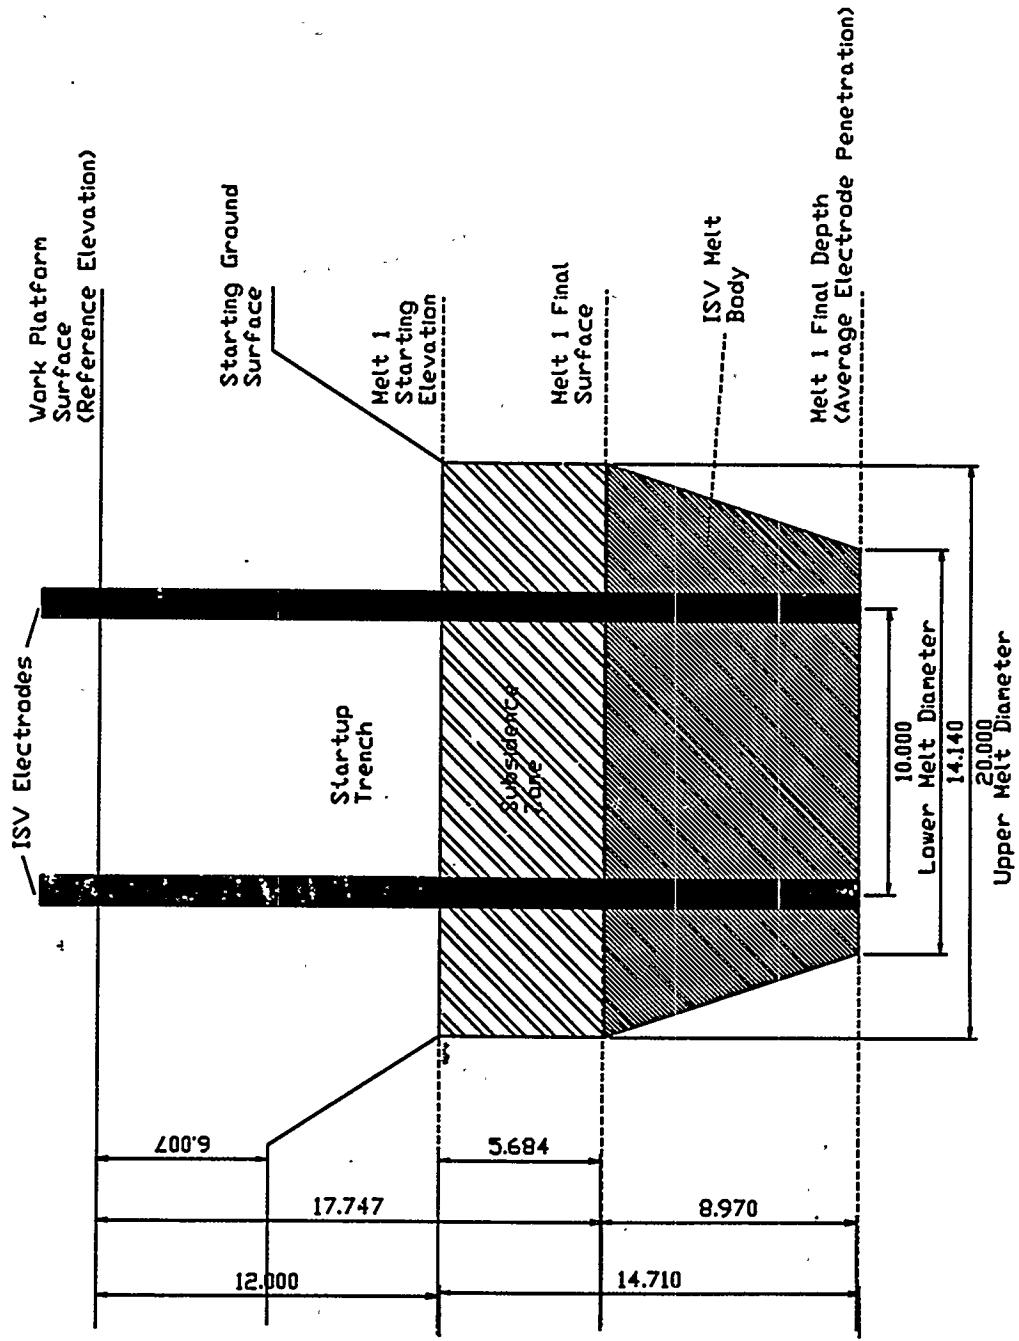
Fig. 9. Geometric configuration and dimensions assumed for calculation of ISV melt body size

Melt mass was estimated from 1) determining the amount of electrical energy applied to the melt assuming certain melting efficiencies, 2) determining the size of the melted or solidified body and assumptions about the product density and 3) measuring the final concentrations of the conservative tracers in the product and dividing this into their known additions to the soil. The best estimate of the mass of ISV product was 196 Mg (216 tons) based on the rare earth dilution method. The final estimate of melt size is depicted in Fig. 9.

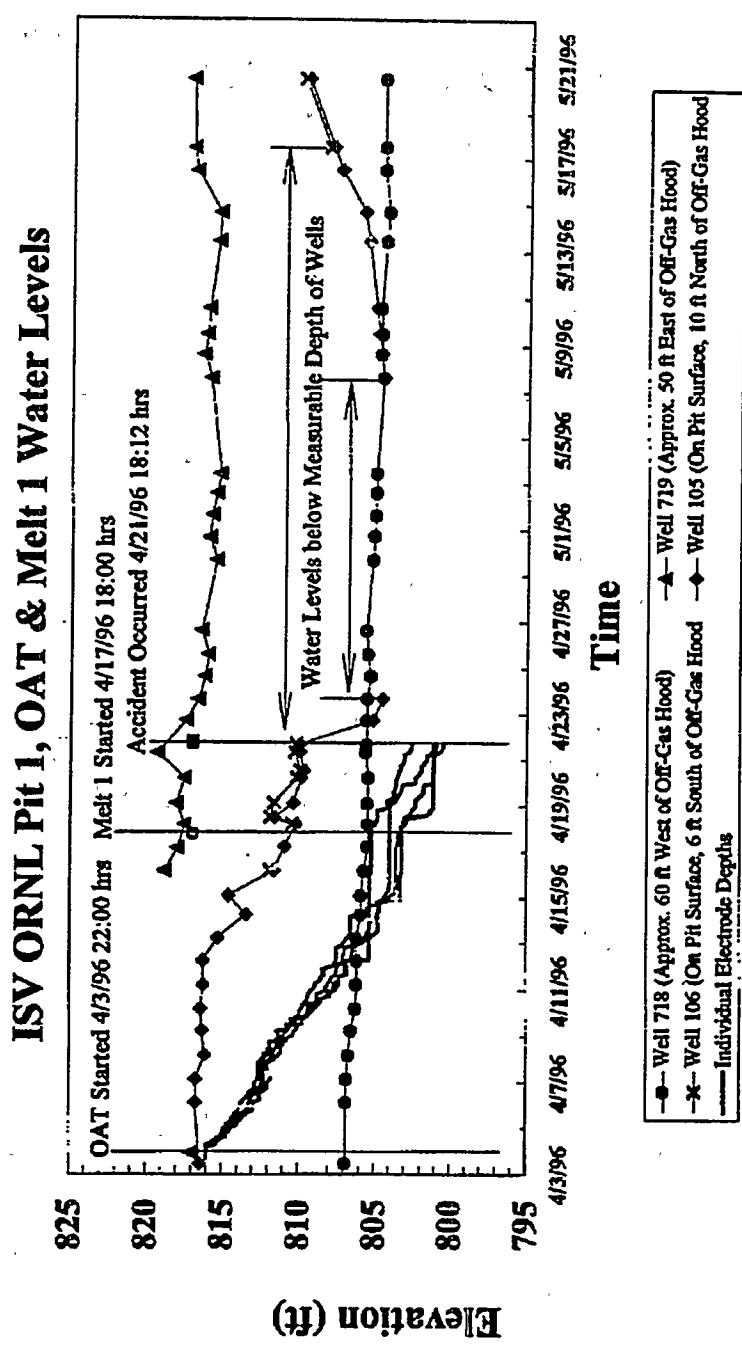
Fig. 10. Depth of ISV electrode penetration into the ORNL melt as a function of time and its relation to groundwater elevation within and around pit 1.

The manually collected data on the penetration of the four electrodes into the melt body as a function of time is presented in Fig. 10. At the time of the melt expulsion incident, two characteristics of the electrode penetration information would seem worthy of note. First, the average electrode depth was approximately 10 ft below the elevation of perched groundwater within pit 1 at the two monitoring wells immediately to the north and south of the off-gas hood. Pit 1 ISV had been operating under such conditions relative to the pit's perched water since the start of operations when seeping water had to be pumped out of the startup trench.

Second, one electrode had been lagging significantly behind (approximately 1 ft less penetration) the other three electrodes. At the time of the melt expulsion incident, this lagging electrode was

continuing to make depth progress, like the others, indicating that it was not stuck or frozen into a cold cap on the melt body. Such an electrode profile and the breakage of the other three electrodes earlier in pit 1 operations was not considered unusual for large-scale ISV melts by the experienced PNNL or Geosafe staff.

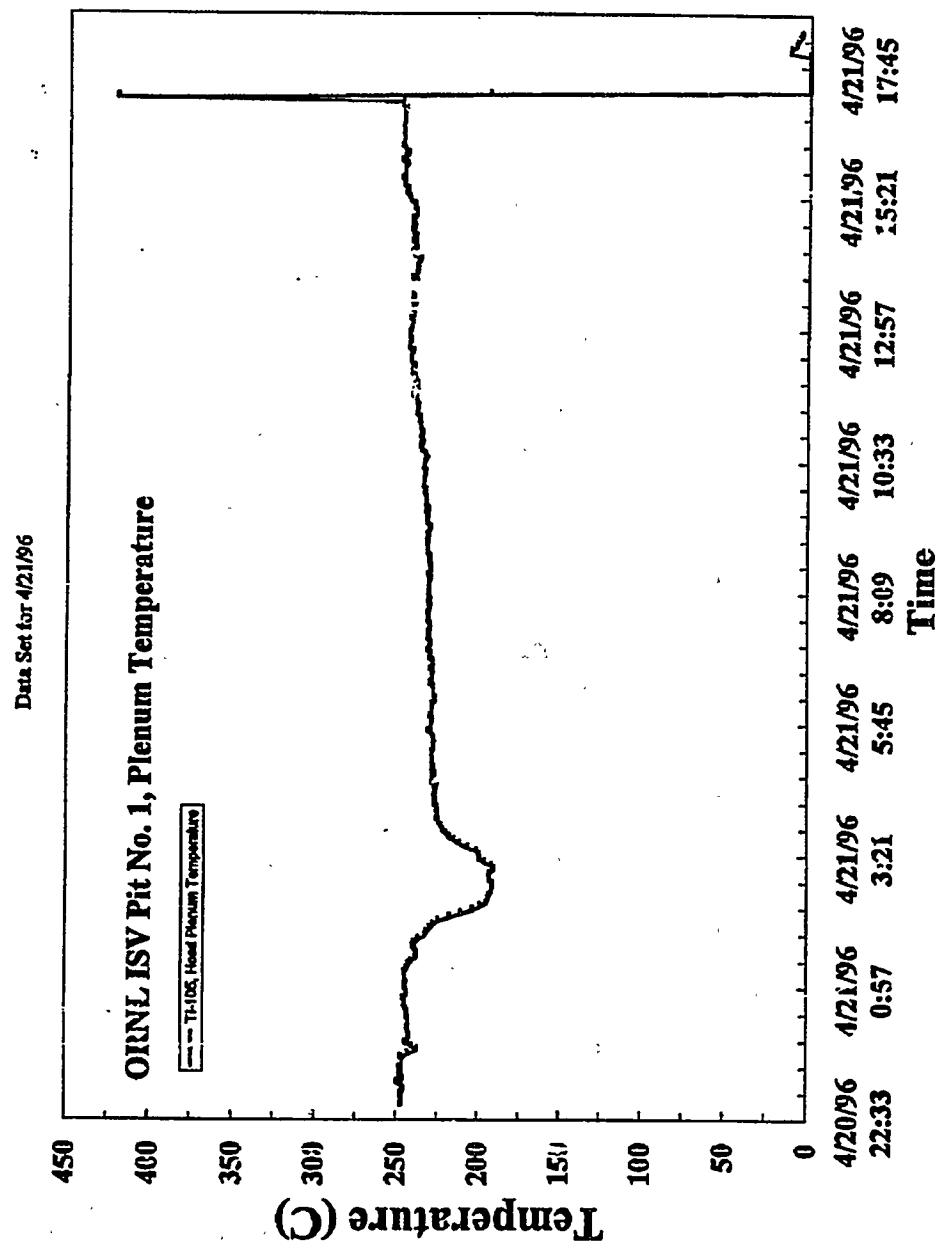
Fig. 11. Off-gas hood plenum temperature during the 20 hours immediately before the ISV melt expulsion incident of April 21, 1996, 18:12

The archived data are useful to determine if trends that indicated something unusual was about to occur were apparent. However, the data both in the short term and over the entire length of ISV operations at pit 1 show no obvious indicating trends. For example, the temperature of off-gas in the hood plenum (Fig. 11) indicated quite stable conditions during the 20 h prior to the event. Small fluctuations like that which occurred around 3:21 p.m. on April 21 were the result of adjustment of the hood's air-intake valve (PIC-101) or a change in HEPA prefilters. There is no trend of increasing or decreasing hood off-gas temperature prior to the melt expulsion. The "spike" in the off-gas temperature near the end of the data collection period shows the influence of increased off-gas temperature on a 4-min average much-dampened intensity. (Fig. 11).

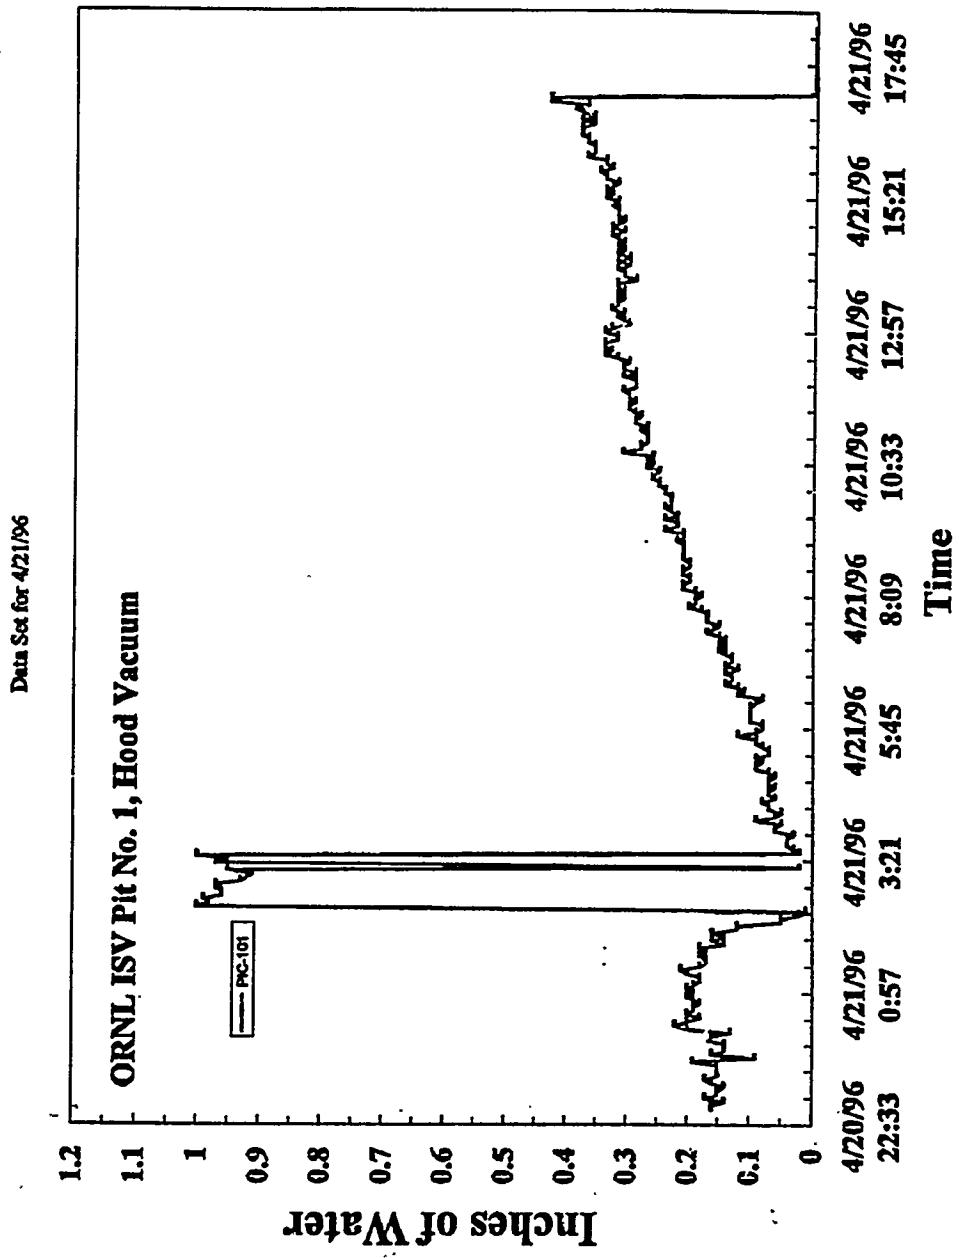
Fig. 12. Vacuum within the ISV off-gas collection hood during the 20 hours preceding the ORNL ISV incident of April 21, 1996, 18:12

The vacuum in the off-gas collection hood obviously went considerably positive, i.e., pressure, when the hood was lifted off the ground during the expulsion event. Routinely, the hood was maintained under slight vacuum (i.e., 0.25-0.50 in. of water column). Hood vacuum was varied over the duration of the melt operations due to operator adjustment of the air-inlet valve or application of water by hose or rainfall to the soil and sand around the hood base to improve its seal to the ground. Examination of detailed data during the 20 hr before the melt expulsion (Fig. 12) reveals the same lack of indicating trend prior to the melt expulsion incident.

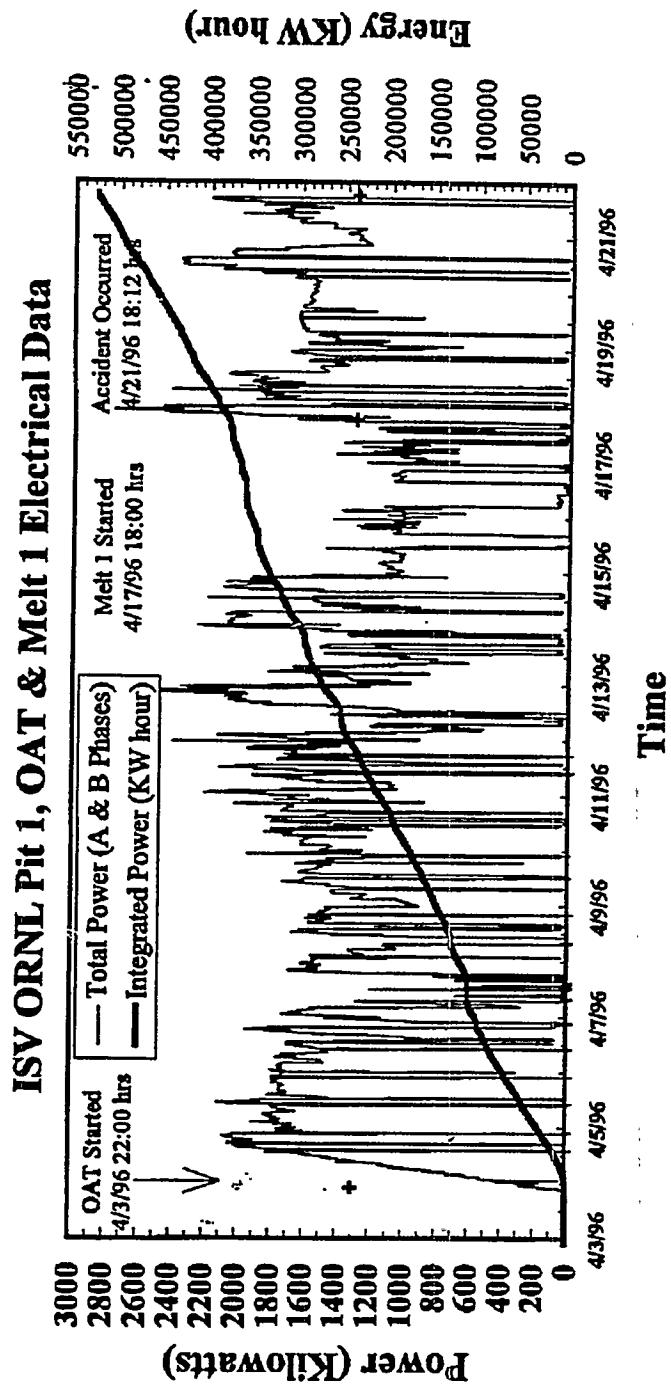
Fig. 13. Electrical power and cumulative energy applied to the ORNL ISV melt over the duration of operations

Power is turned on and off quite frequently during any ISV operation for a variety of equipment adjustments in the electrical safety zone on the hood work platform. The level or amperage and voltage to each of the two phases to the melt body did not show any unusual fluctuation or trend during the entire 18-day interval of ISV operations; the ISV shift engineer, at the time of the melt expulsion incident, did report unquantified fluctuations in the voltage and current immediately before or during the melt expulsion but these are not reflected in the 4-min average parameters collected by the data acquisition system. The power to the melt (the product of current and voltage for both phases) showed an obviously similar trend over the 18-day interval (Fig. 13). It can also be seen that the level of power, which was

being delivered to the pit 1 melt at the time of the melt expulsion incident, was not the most elevated; many other times previous to the melt expulsion incident, power levels had been significantly higher. Power was usually adjusted in response to hood off-gas temperature; when hood plenum temperatures exceeded about 300°C, power was routinely reduced to a level that would maintain off-gas temperature below that level.

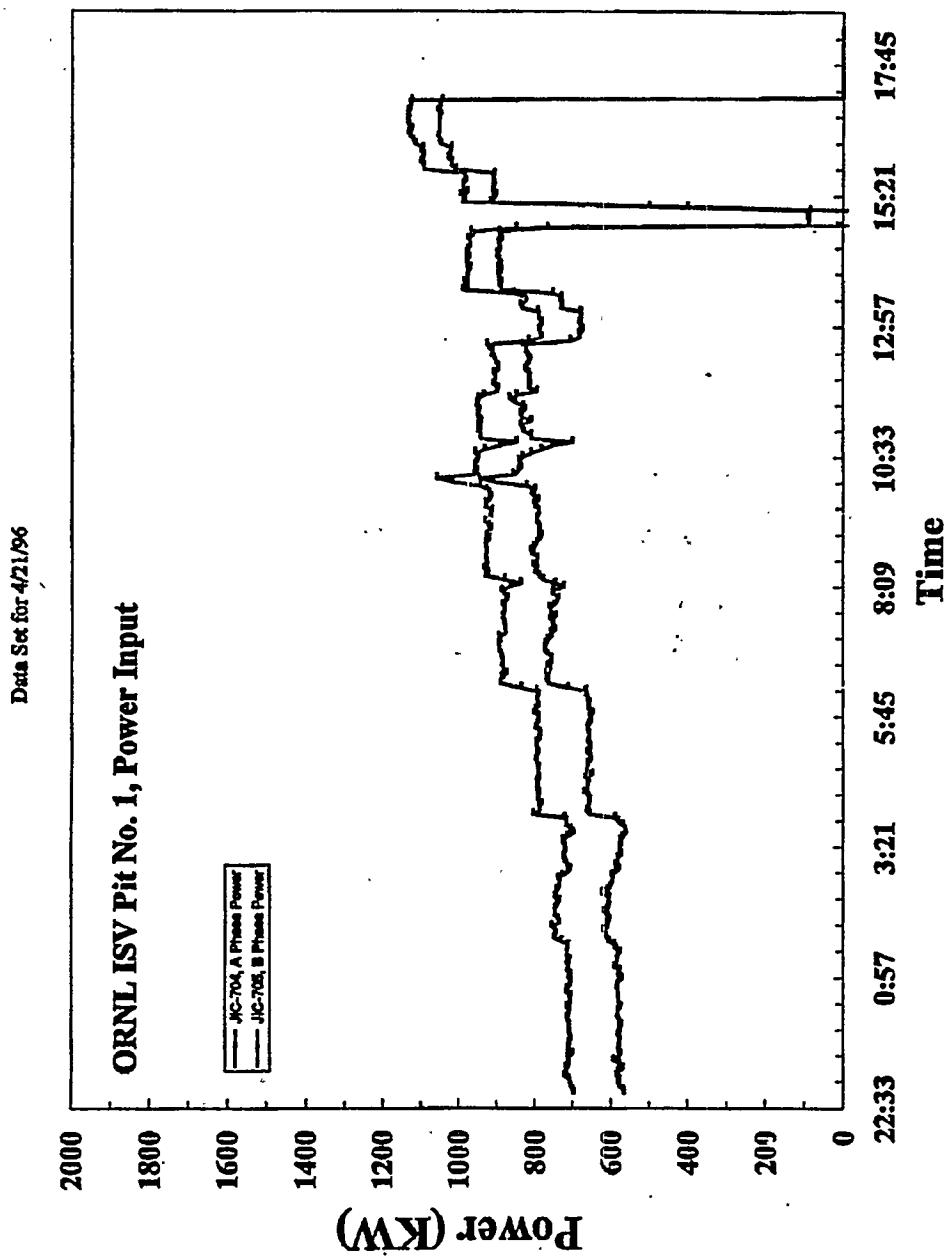
Fig. 14. Electrical power applied to the ORNL ISV melt during the twenty hours preceding the expulsion event of April 21, 1996, 18:12

Examination of electrical power characteristics during the 20 hr immediately before the melt expulsion (Fig. 14) does not reveal any obvious trend other than a gradual stepping up of power. The brief period of power outage about 2 hr before the melt expulsion was due to entry to the hood's work platform to perform a radiation survey and to adjust electrodes. Four personnel were on the work platform at that time and this graph indicates that these personnel could likely have been on the work platform during the melt expulsion had tasks been delayed.

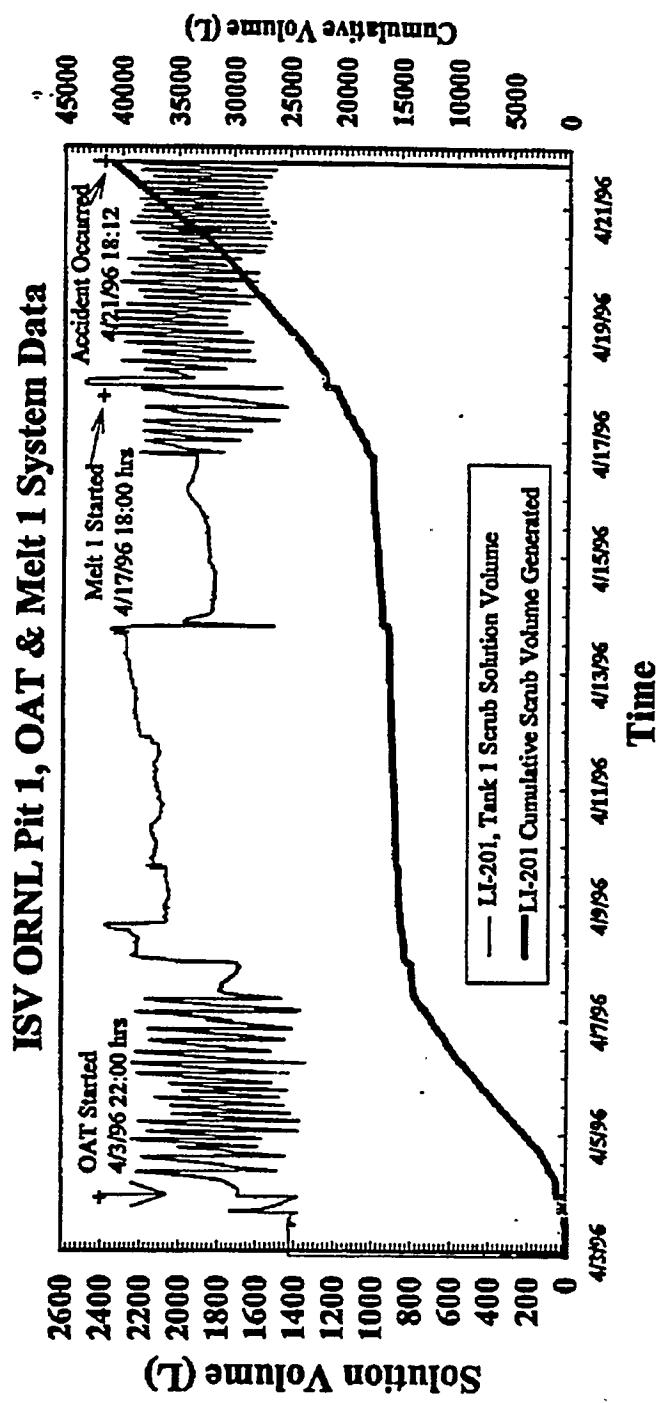
Fig. 15. Cumulative volume and solution levels in ISV off-gas scrub system 1 during operations at pit 1

The water distilled from the ISV melt zone was condensed by the off-gas scrub system, collected, and transferred to a tanker, which was used to transport it to wastewater disposal facilities at ORNL. The limited capacity of the ISV scrub system collection tank necessitated frequent transfers of accumulated liquid, which generated considerable data on liquid accumulation versus time (Fig. 15). The ISV equipment has two identical off-gas scrub systems to provide backup or expanded off-gas processing capacity should a problem develop with one of the two systems. The slope of the cumulative liquid volume collected in Fig. 15 is a direct measure of the rate of generation of water from the melt. Although the slope of liquid accumulation indicates a slightly greater generation rate (approximately 505 L of water per hour) during the 2 days before the melt expulsion incident, there was no dramatic increase in liquid generation rate, which could have been interpreted to indicate a major influx of water into the thermally active zone around the melt.

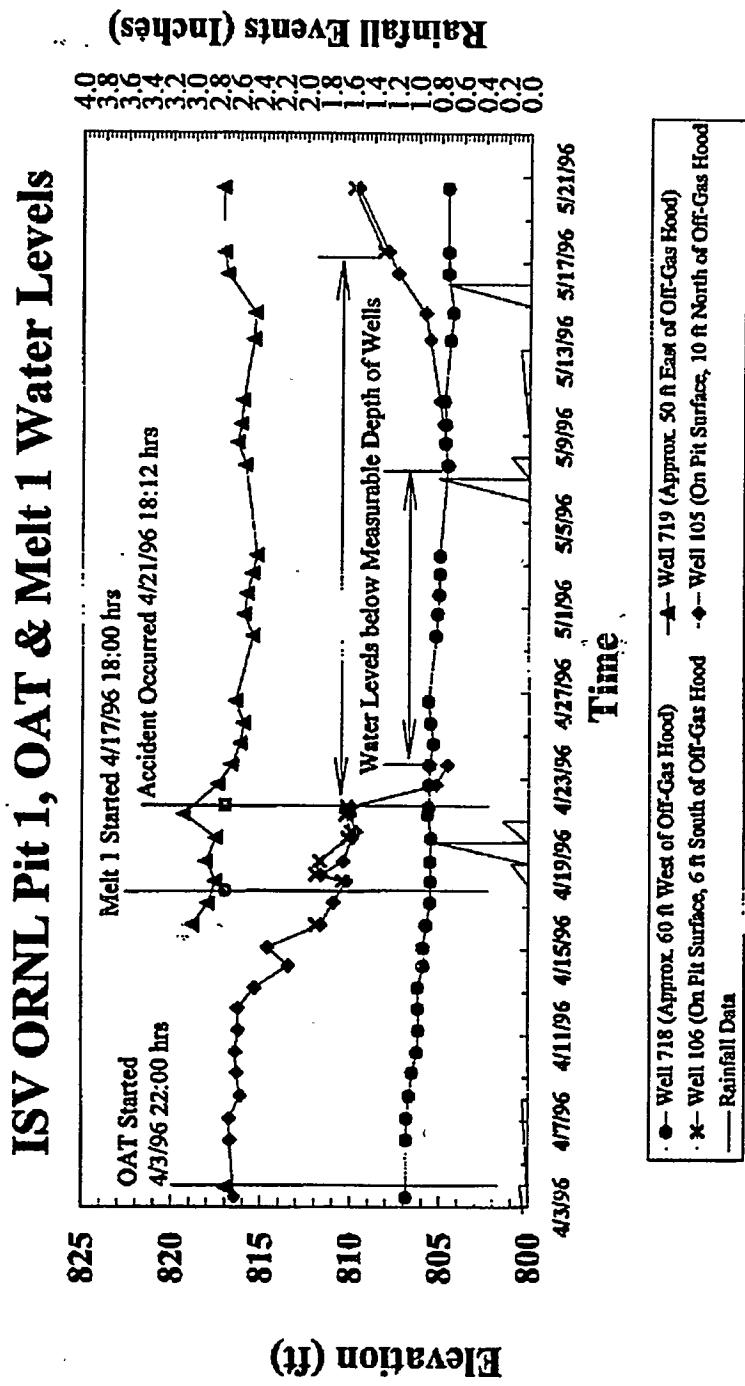
**Fig. 16.** Watertable elevations within and around ORNL pit 1 and precipitation during ISV operation relative to the April 21, 1996, explosion incident.

As discussed in detail under the section on the mechanism of melt expulsion, the elevation of perched water in pit 1 was being drawn down gradually by its distillation over the entire 18-day interval leading up to the melt expulsion (Fig. 16). However, when measurements of the water levels in the two wells immediately north and south of the off-gas hood were attempted on the day after the melt

expulsion, no water was found in either well indicating that the levels had dropped at least 6 ft since the previous day's measurement to below the bottom of the each well. In contrast, water levels in the two wells outside pit 1 to the east and west of the pit indicated no fluctuation relative to the melt expulsion incident. Water levels as of May 30, 1996, are now high enough to cover the top of the melt surface in the residual startup trench/subsidence crater.

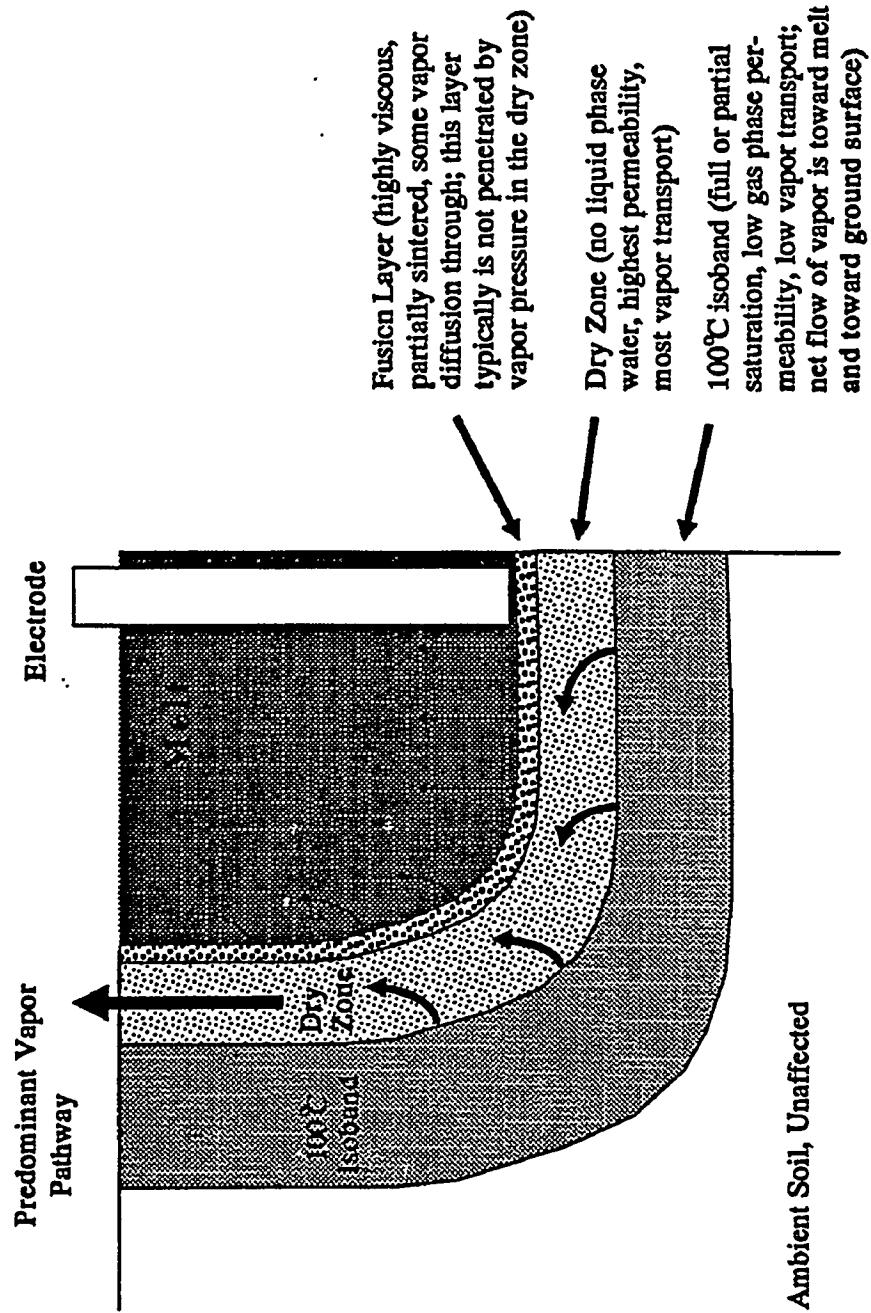
Fig. 18. Conceptual model of ISV off-gas vapor pathways around a body of molten soil

As in past incidences of molten glass expulsions during ISV operations, the ORNL expulsion was caused by steam pressurization at some depth beneath the molten body in excess of the static hydraulic pressure or the molten body plus any structural strength resident in the melt's cold cap and surrounding sintered zone (Geosafe Corporation 1993, Roberts et al. 1992). To understand how these various components interact to conduct steam around the melt body rather than through it, the normal ISV melt body conditions need to be reviewed (Fig. 18). As can be seen from Fig. 18, the molten body is believed to have several transition zones between it and unaffected soil usually within a few inches of actual molten product. It is generally thought that the layer or rind of dry soil surrounding the molten body is very important as a conduit for steam and other hot gas to move from beneath and around the molten body to the ground surface where it collected in the ISV off-gas hood. The total soil porosity in this dry rind is thus available for gas conductivity.

Perhaps the only salient difference between the conceptual model in Fig. 18 and actual conditions in ORNL pit 1 is that the unaffected soil zone would have been completely saturated with water. This difference could be a significant factor in contributing to the expulsion incident in pit 1. As depicted in Fig. 18, pressurization of steam in the dry zone has an additional potential release through the saturated 100°C isoband zone into ambient unsaturated soil; such release would require only a nominal pressure to displace enough water to open some unsaturated zone to the outside. However, in the case of pit 1, the unaffected soil was saturated and, thus, had no residual gas-filled porosity through which to conduct

any steam. Obviously, some residual gas-filled porosity in the unaffected soil, i.e., unsaturated conditions, would be a desirable condition to maintain this potential pressure venting pathway.
