PLASTIC DEFORMATION PROCESSES ACCOMPANYING STRESS CORROSION CRACK PROPAGATION IN IRRADIATED AUSTENITIC STEELS¹

M.N. Gussev¹, G.S. Was², J.T. Busby¹, K.J. Leonard¹.

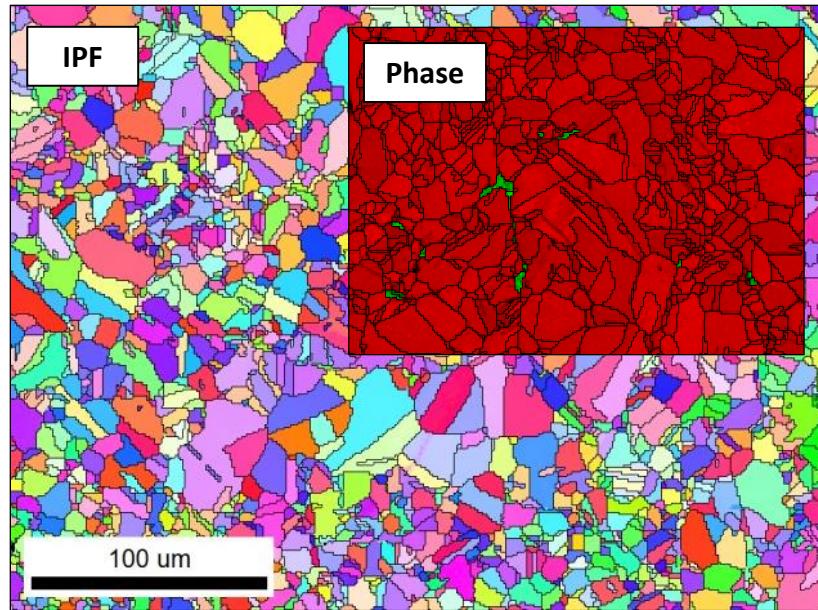
After sample preparation, several EBSD scans were performed at a depth of ~1.5–1.7 mm from the fracture surface, below the SCC and other deformed areas, to analyze the material structure and phase composition. Figure 3 shows typical EBSD data for the bulk material. The irradiated material had relatively small average grain size, about 10 μm , and a pronounced bimodal grain size distribution. Small grains formed specific clusters and bands, and large grains often grouped together. Whereas the bimodal grain distribution was observed for all analyzed areas, the fraction and the average size of large grains varied slightly across the structure suggesting some minor structure inhomogeneity.

Figure 3. EBSD IPF map showing grain morphology for the investigated material. Insertion demonstrates the Phase map for the same area (austenite is red, delta-ferrite is green).
