Developing Technologies for Composite Overwrapped Pressure Vessels (COPV)

Comparing Traditional Inspections to Advanced 3-D Rendering Techniques

John Miers, PhD.

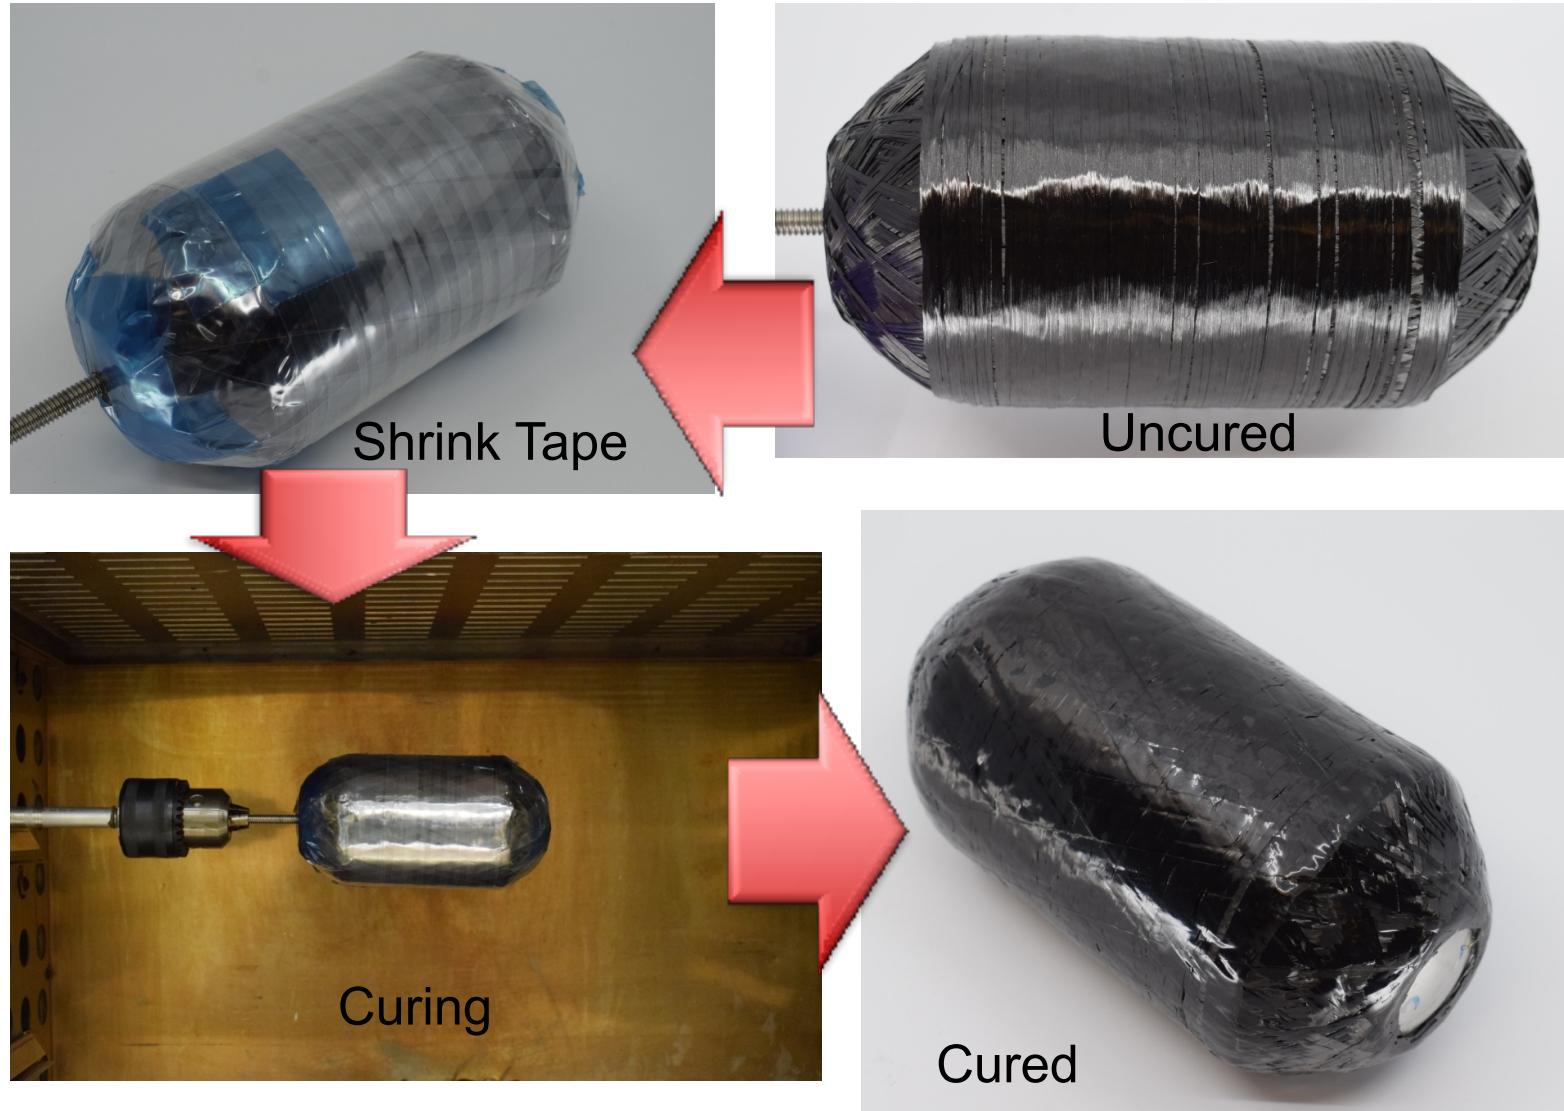
Curing Process

- Wrapped in heat shrink tape to aid with compaction
 - Developing vacuum bagging technique
- Cured in an oven with a “rotisserie” action
- Experienced some audible popping after cure
 - The composite is disbonding from liner due to residual thermal stresses (difference in linear coefficients of expansion).

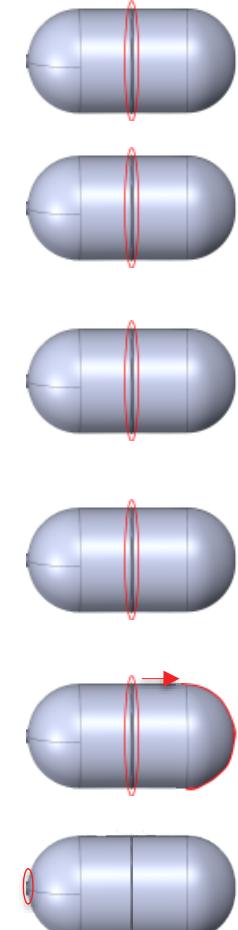
SN	Float Type	Burst Pressure psi	Time elapsed	Location of failure
01	Liner	3873psi	12: 05 min	Waist weld
02	Liner	3733psi	8:55 min	Waist weld
03	Liner	3601psi	6:54 min	Waist weld
04	Overwrap marked "1"	7413psi	10:00 min	Waist weld
05	Overwrap w/adhesive marked "3"	5250psi	~5 min	Waist weld (bleed out to top curve)
06	Overwrap marked "2"/Flawed	No burst; leaked around 7ksi	~10 min	Nozzle weld

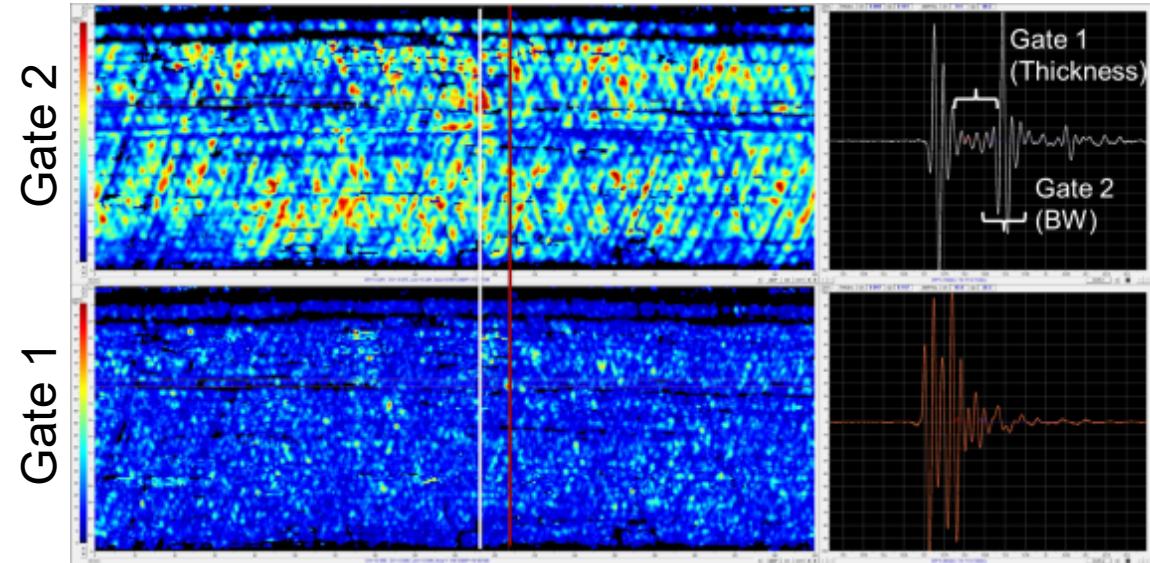
- Ultrasonic C-scan images reveal the weave pattern of sample 04 (barrel section only)

- Top image shows the backwall signal amplitude – (interface of the composite and metal liner)
- Bottom image shows amplitude between surface and backwall of composite (composite thickness)

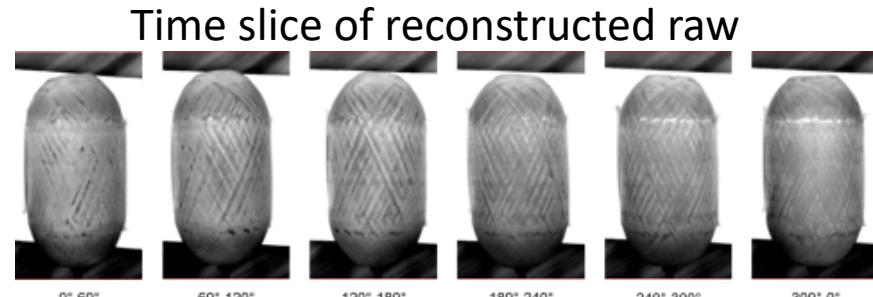
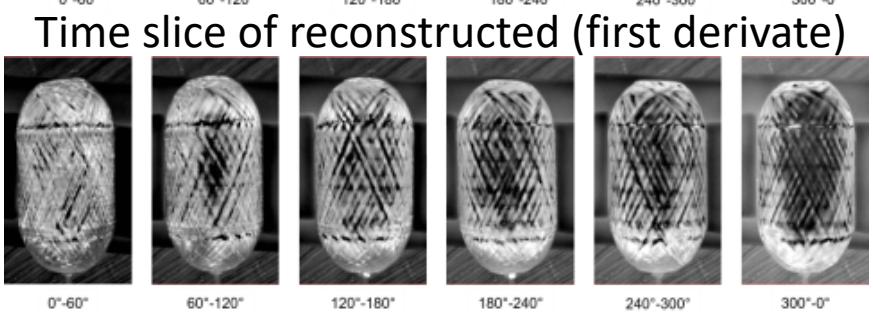
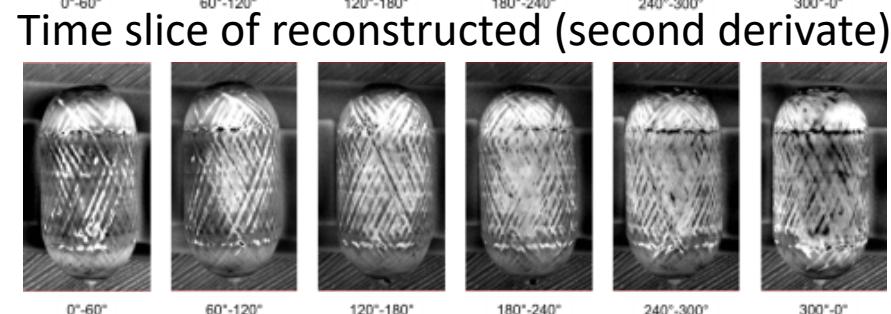
■ Thermography

- All images taken 12.9 seconds after flash

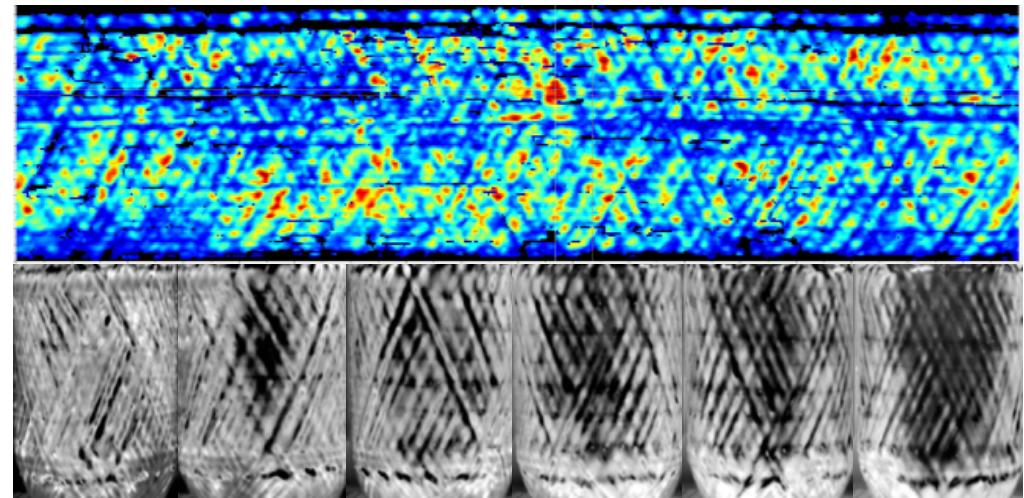
■ UT vs IR

- Bonded area transmits sound into the liner (blue)
- Poorly bonded area reflects sound to the probe (red)
- Correlation between UT and thermographic results

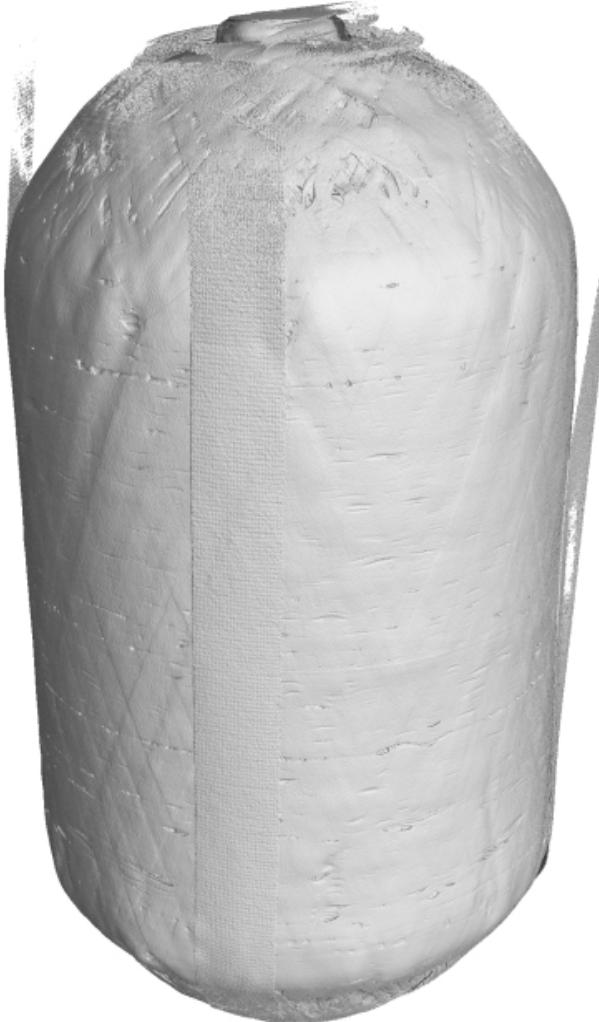
Composite

- Porosity/voids
- Well bonded to liner
- Quality decreases at transition from cylindrical to spherical surfaces of the liner

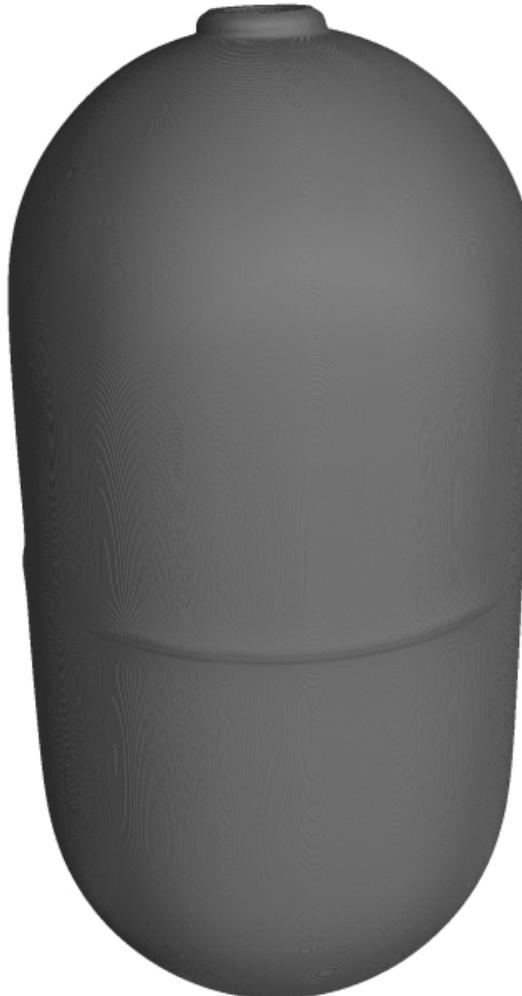
Metal

- No major defects
- Minor splatter in waist weld
- Minor misalignment in regions of waist weld

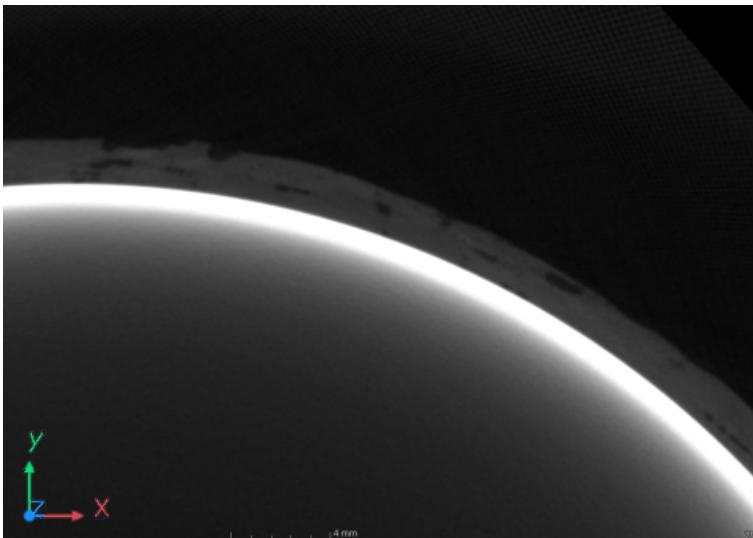
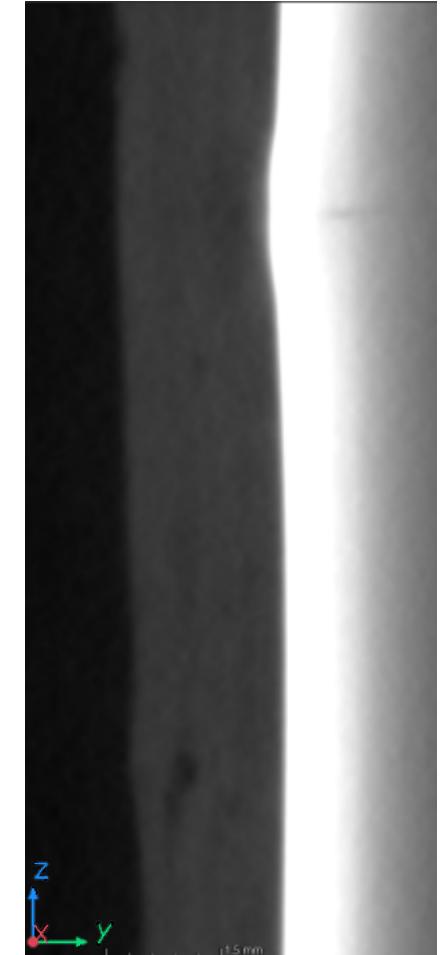
COPV-05

- Low pressure failure is due to break/gap in the waist weld
- Propagation of pressurized fluid along the poor bond between the liner and composite

- Low pressure failure of COPV-5 is due to break in the liner weld over significant portion of circumference
 - Curvature of the liner near the weld line suggests post test blow out

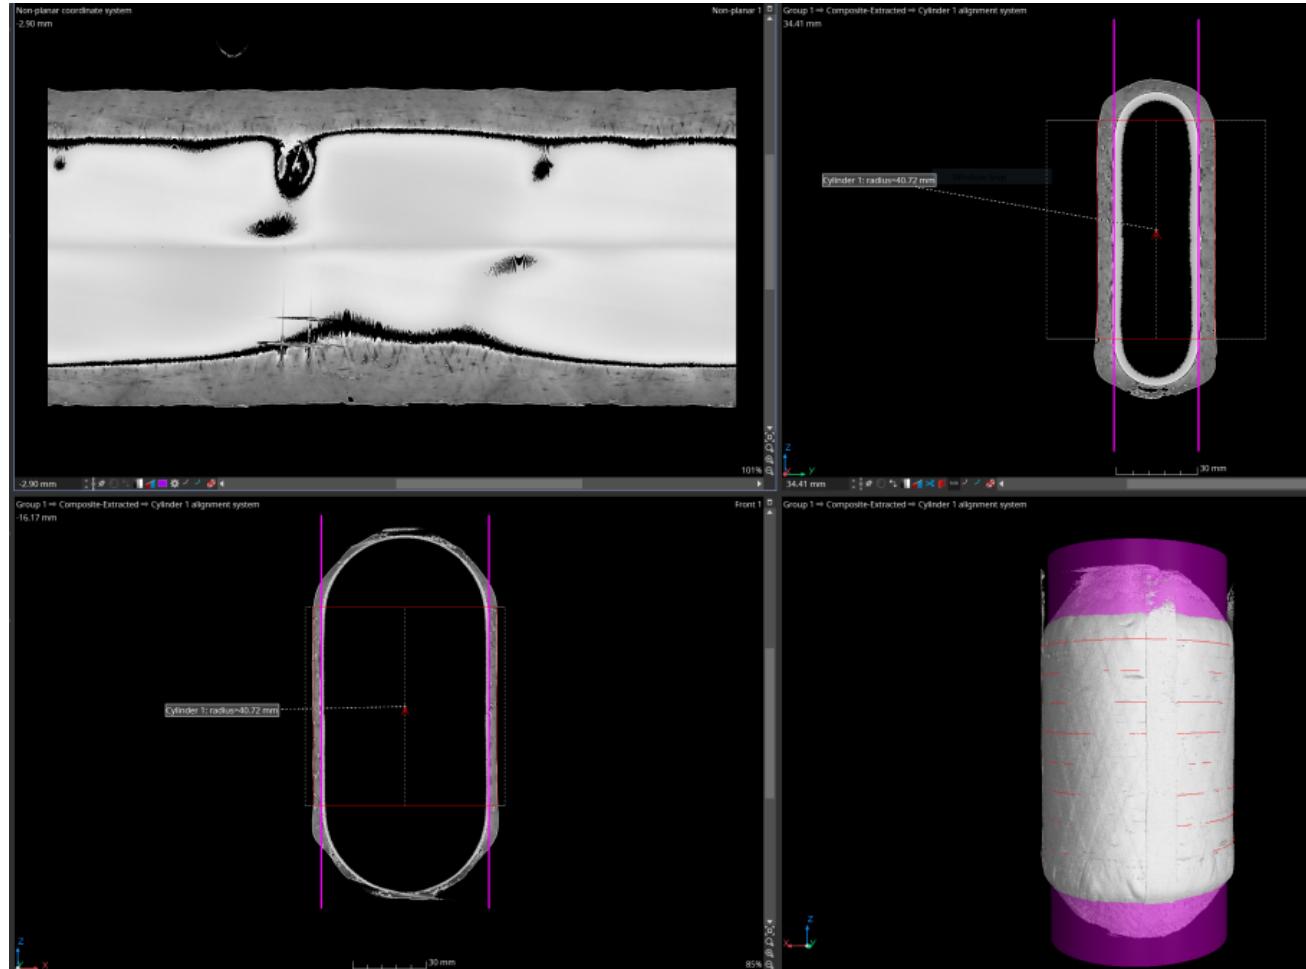
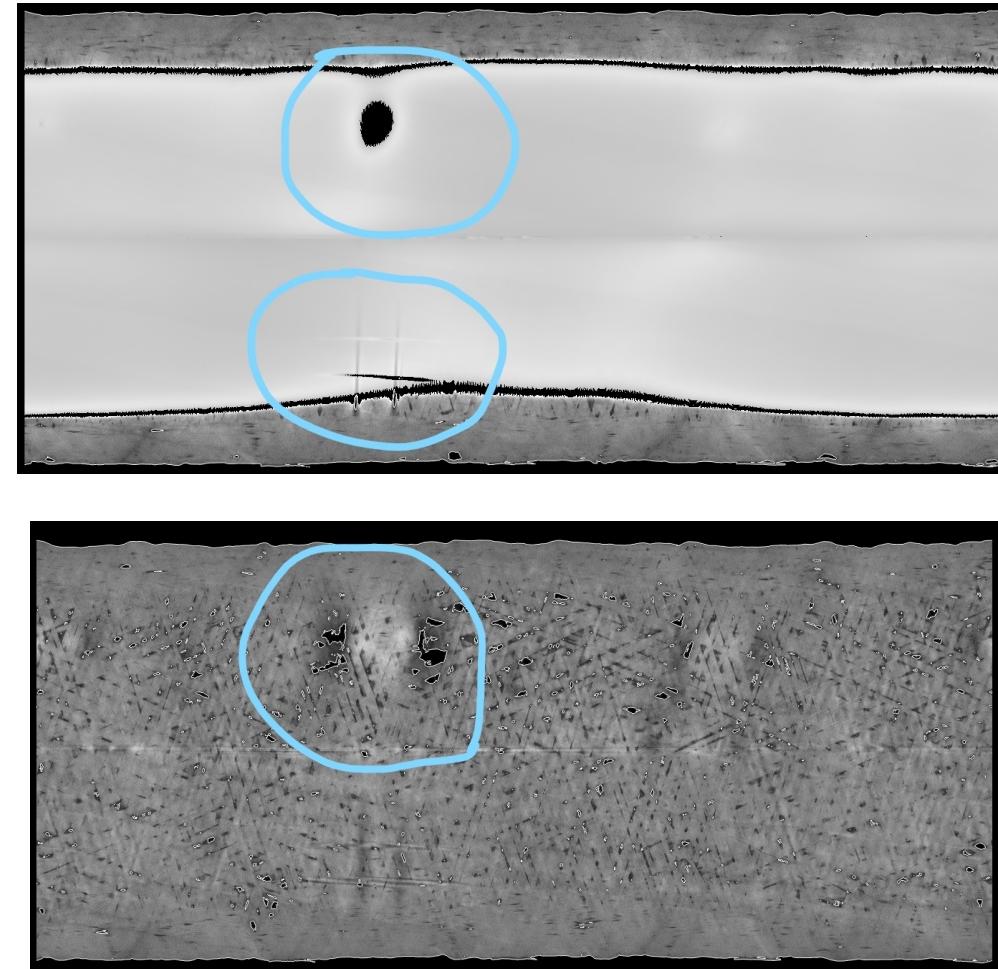
COPV-06: Detection of Intentional Defects

- Detection of non-intentional defects
 - Waist weld quality
 - Cracking in nozzle weld
 - Culprit for leaking in burst test

- Poor weld penetration depth
- Possibly culprit of leaking during testing

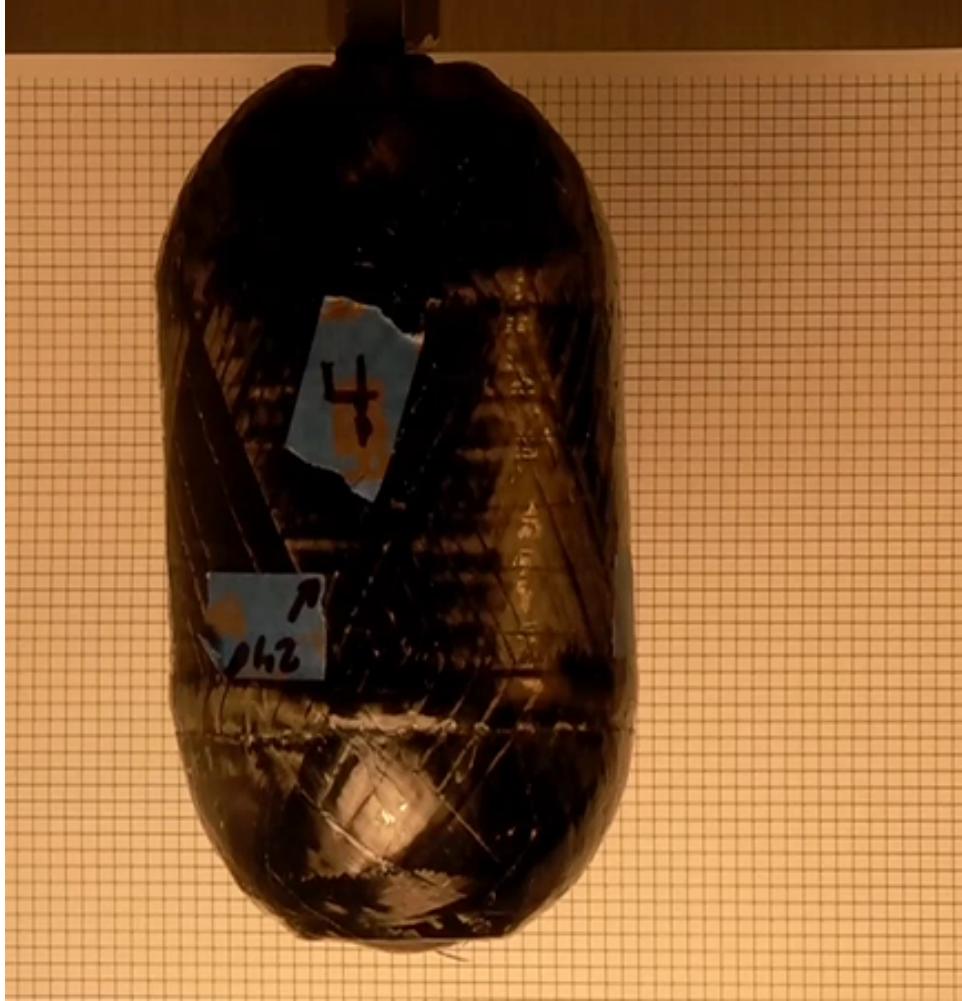
COPV 4 (real time)

- Initial waist weld quality was among the best inspected
- Only minor defects and porosity in the composite overwrap
- Consequently the sample performed the best in the burst test
 - Yielded a 22 kJ/kg increase in pressure vessel efficiency over solo liners tested
- Waist weld failed at liner offset and region of minimal weld depth
- Ductile deformation in weld due to pressurization (thinning)
 - Ductile thinning → weld failure
 - Potential for modelling

- The weld does not fail in the region where the weld was rough (high variation in weld depth along the circumference) but instead failed in a region where the 2 liners were slightly offset
- The weld appears slightly thinner than average in the region where failure occurred
- The non-ruptured regions of the weld in the post-test scan show signs of the weld being stretched along the length of the sample and thinning
- This gives some indication of the type of failure mechanism
 - Ductile thinning of weld >> failure

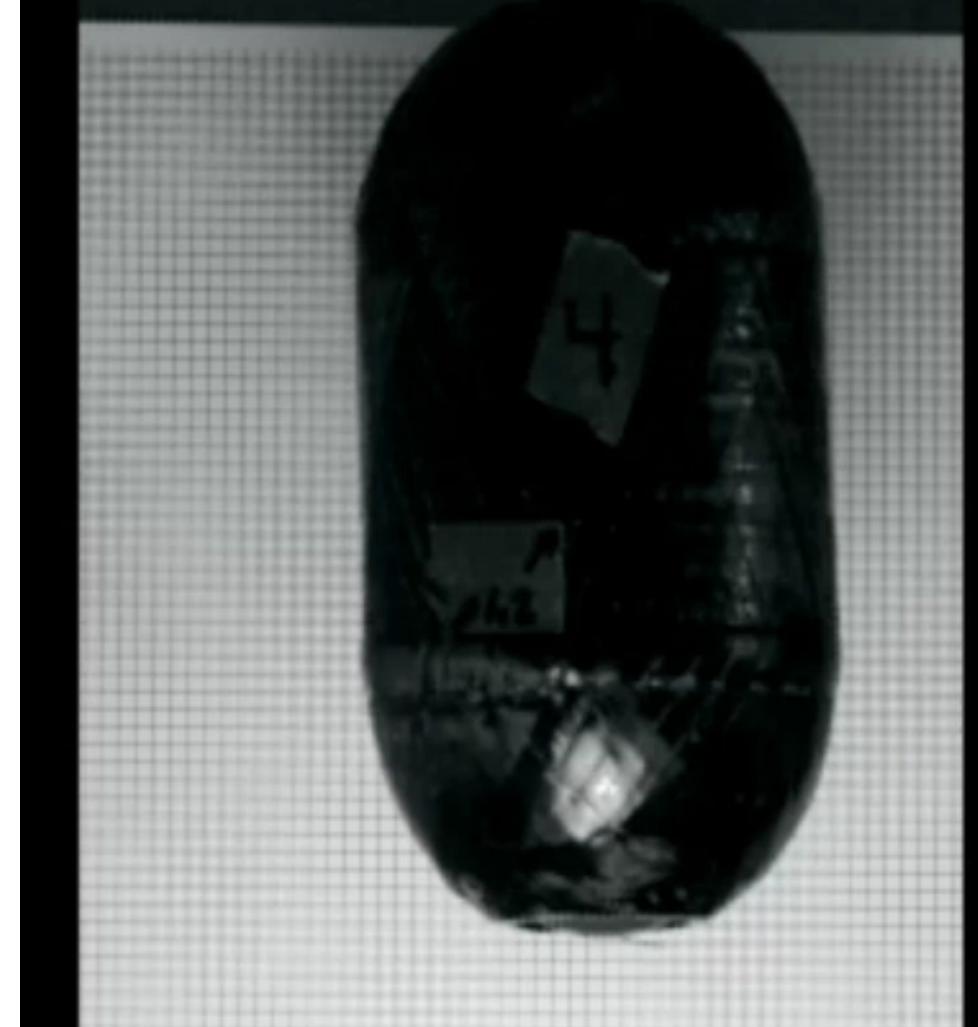
COPV 4 (high speed video)

Edgertronic Camera: frame rate was 10k frames per second with a camera resolution of 1280 by 1280.

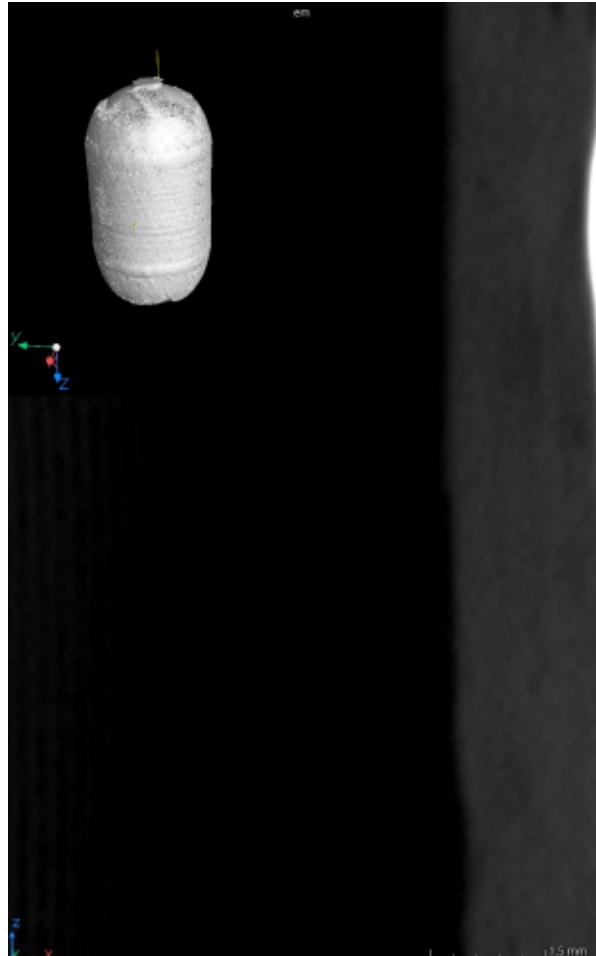
- Pre-test weld line
 - Rotation fly-thru

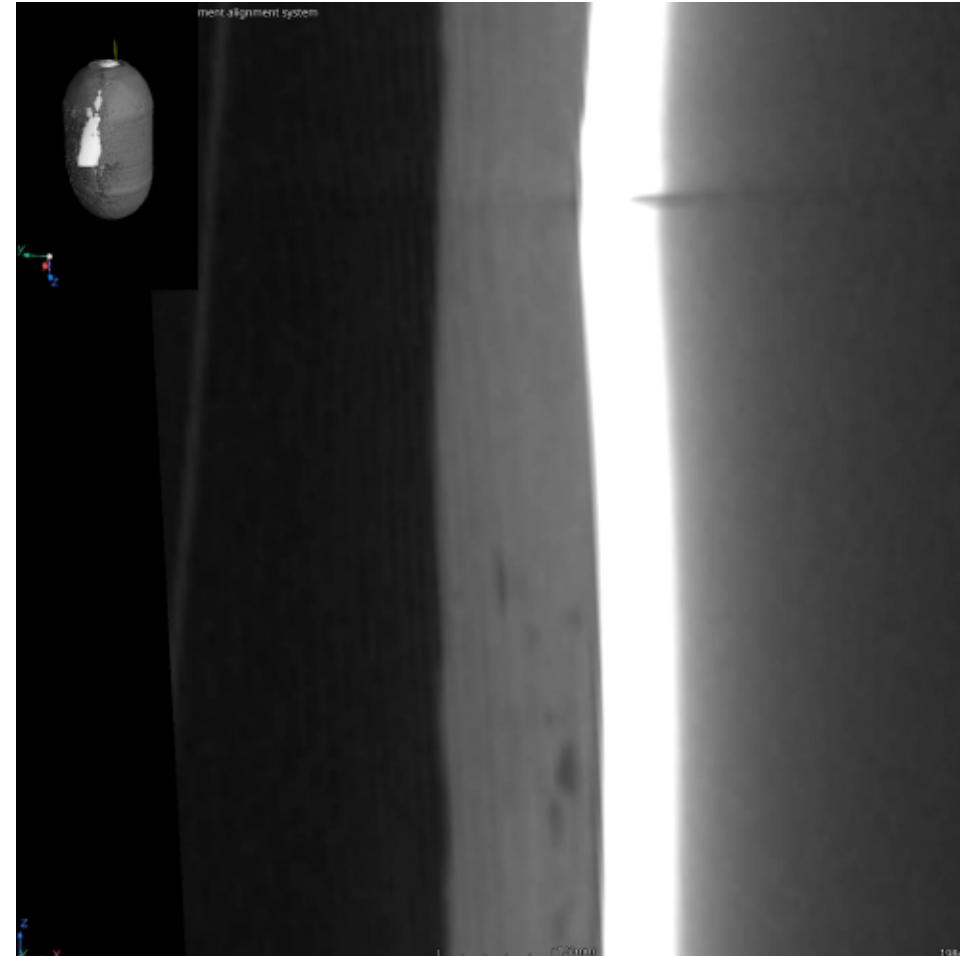
- Post-test weld line
 - Rotation fly-thru

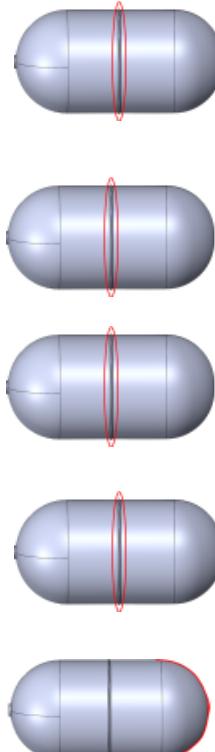
SN	Float Type	Burst Pressure psi	Time elapsed	Location of failure
01	Liner	3873psi	12: 05 min	Waist weld
02	Liner	3733psi	8:55 min	Waist weld
03	Liner	3601psi	6:54 min	Waist weld
04	Overwrap marked "1"	7413psi	10:00 min	Waist weld
05	Overwrap w/adhesive marked "3"	5250psi	~5 min	Top Curve
06	Overwrap marked "2"/Flawed	No burst; leaked around 7ksi	~10 min	Inside

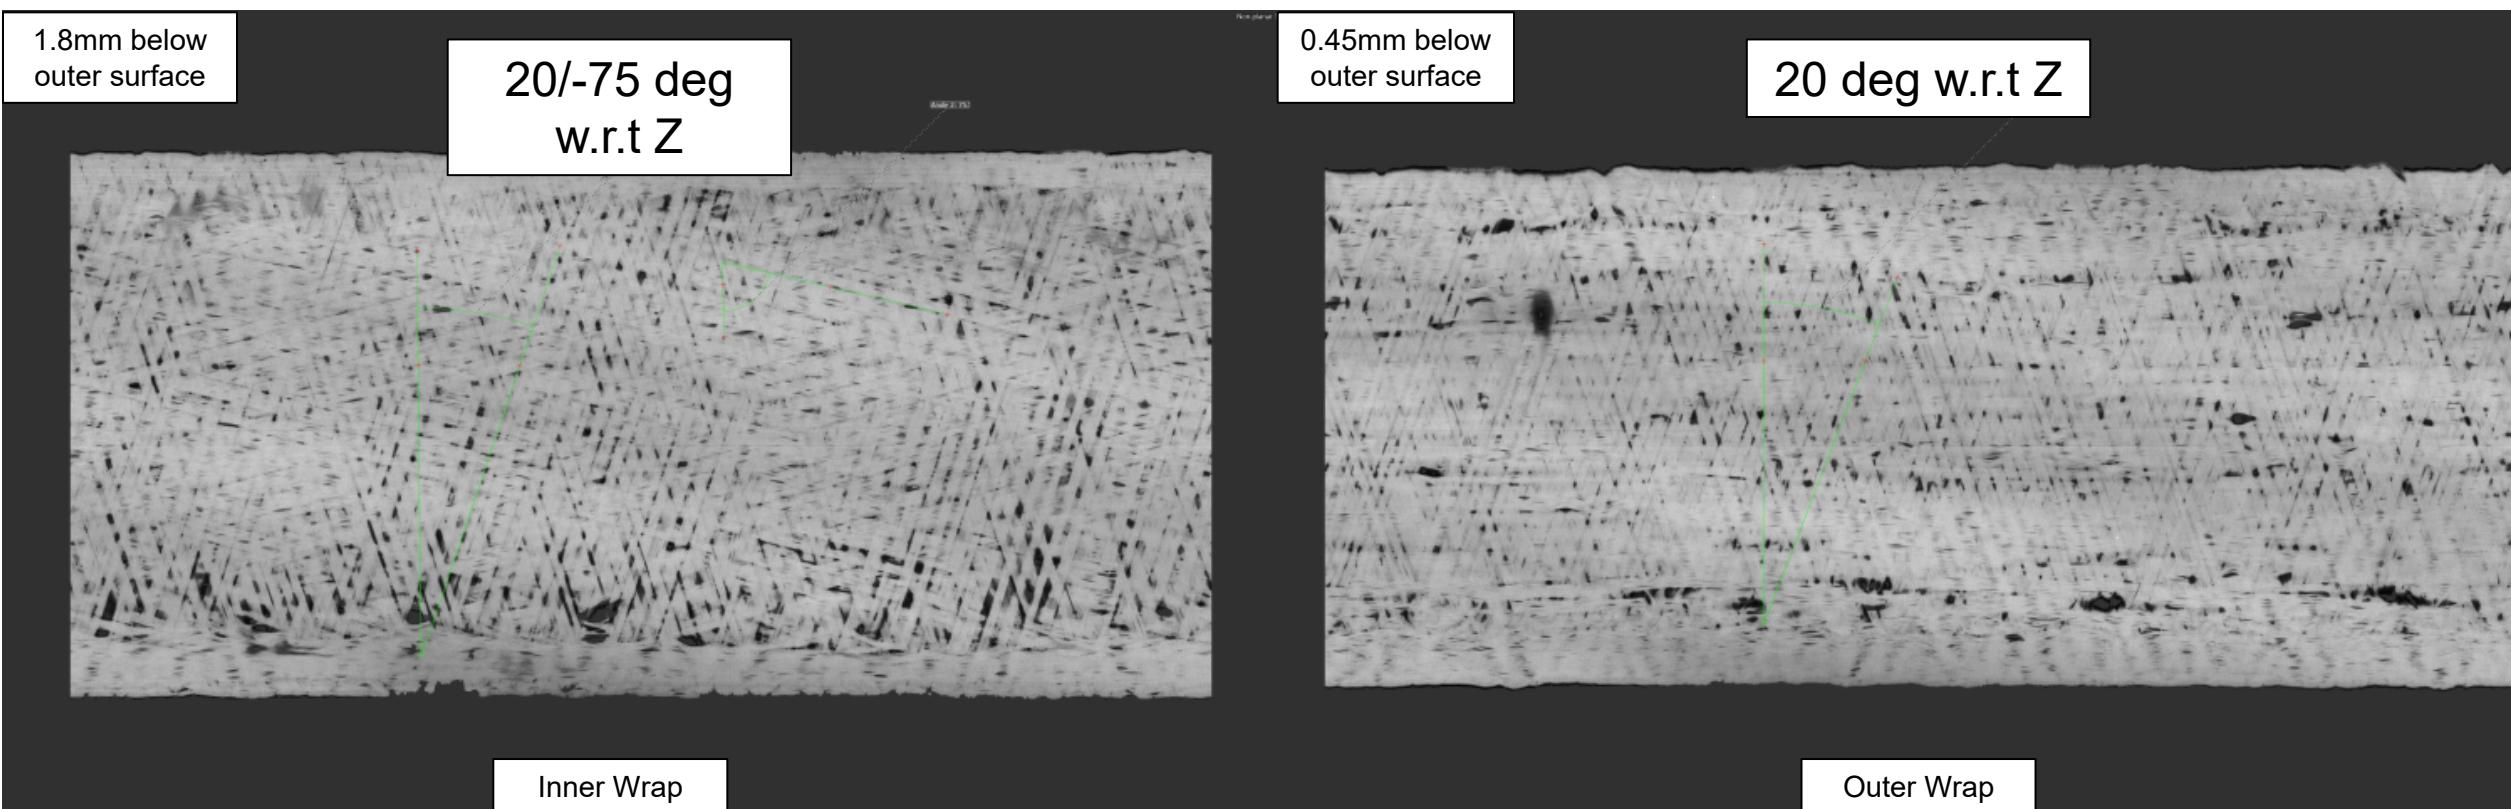
Wrap pattern on inner layers is a 20/75 degree pattern (left), whereas it moves to just a 20 degree pattern on the outer layers (right).

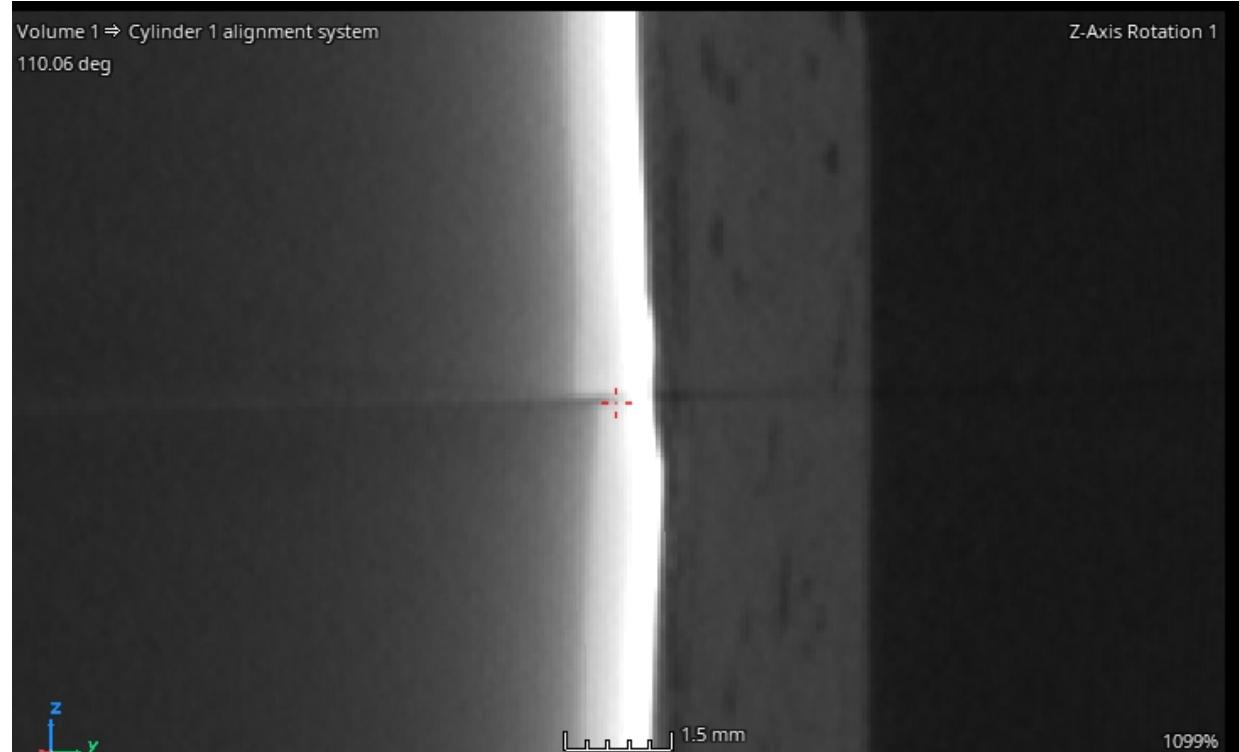
- Minor liner misalignment
- Porosity in composite wrap
 - Poorest quality near transition between cylindrical and spherical regions

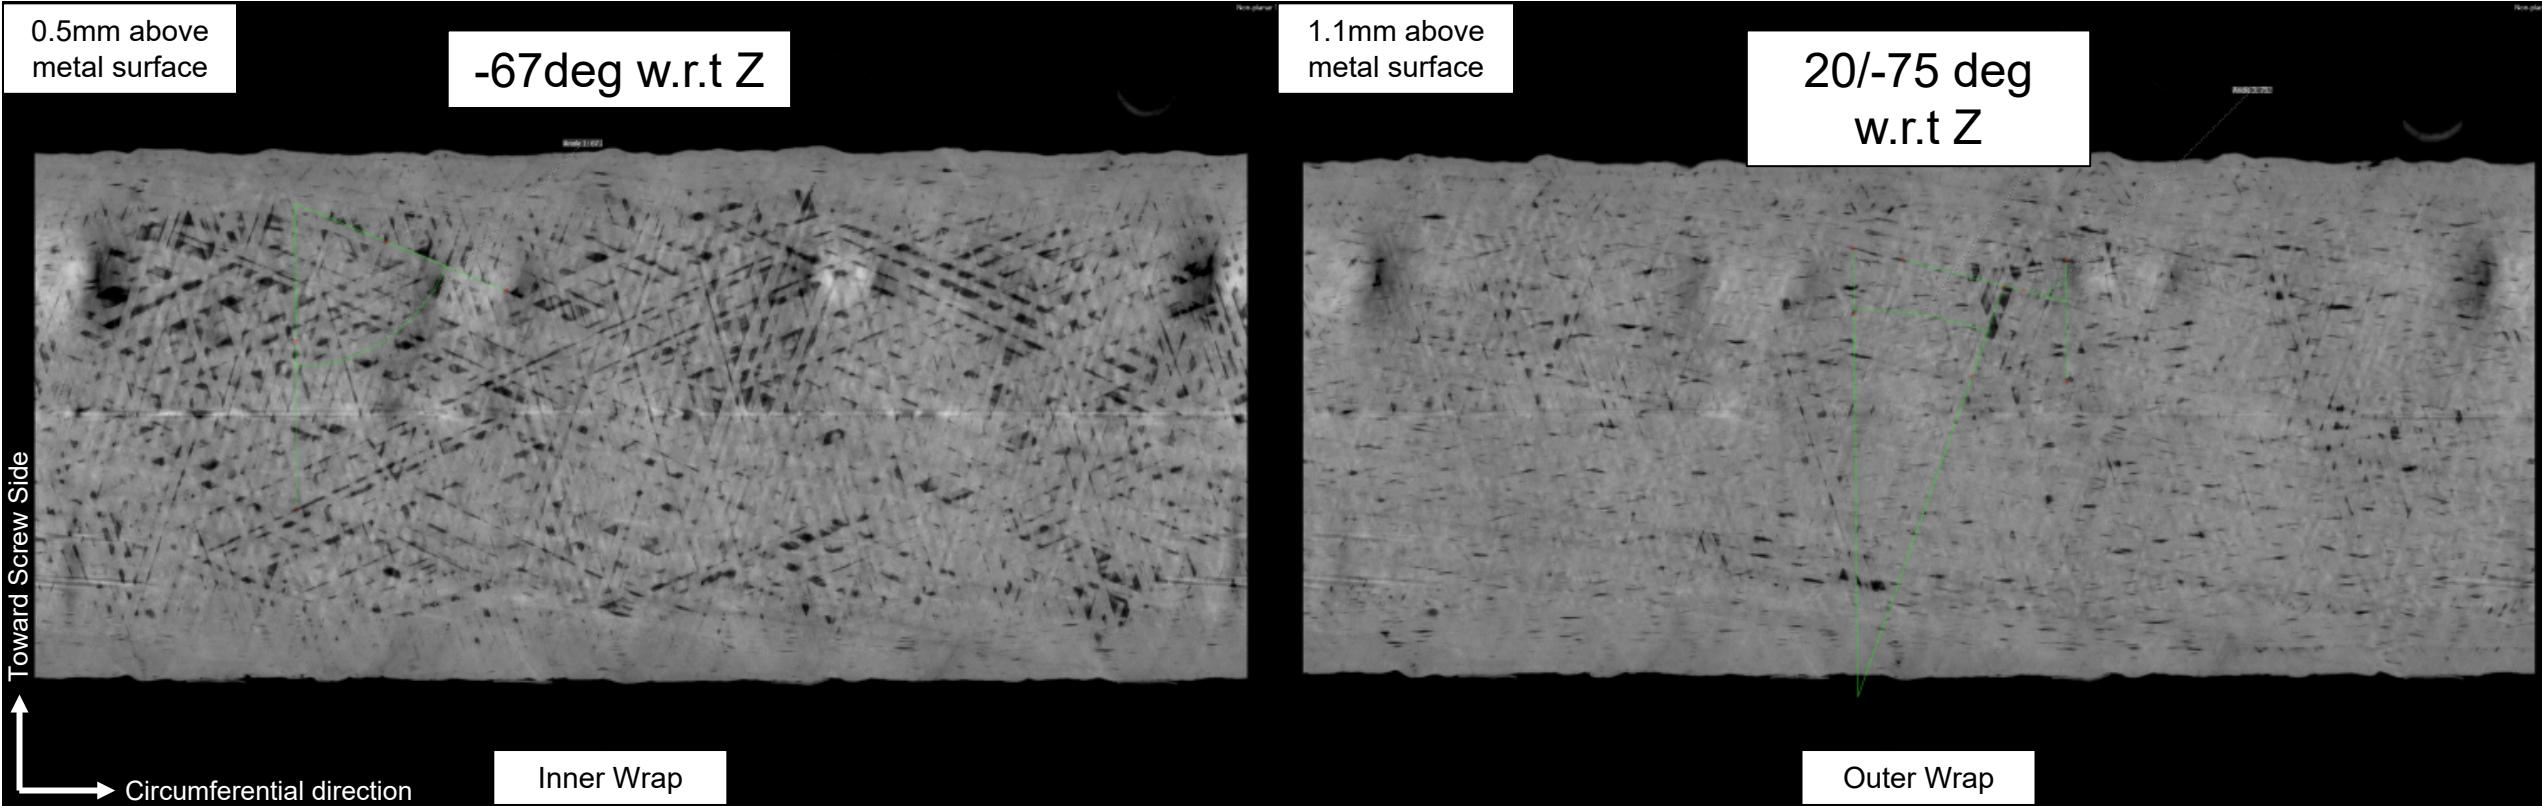
Wrap pattern on inner layers is -67 degree pattern (left), whereas it moves to a 20-75 degree pattern on the outer layers (right).

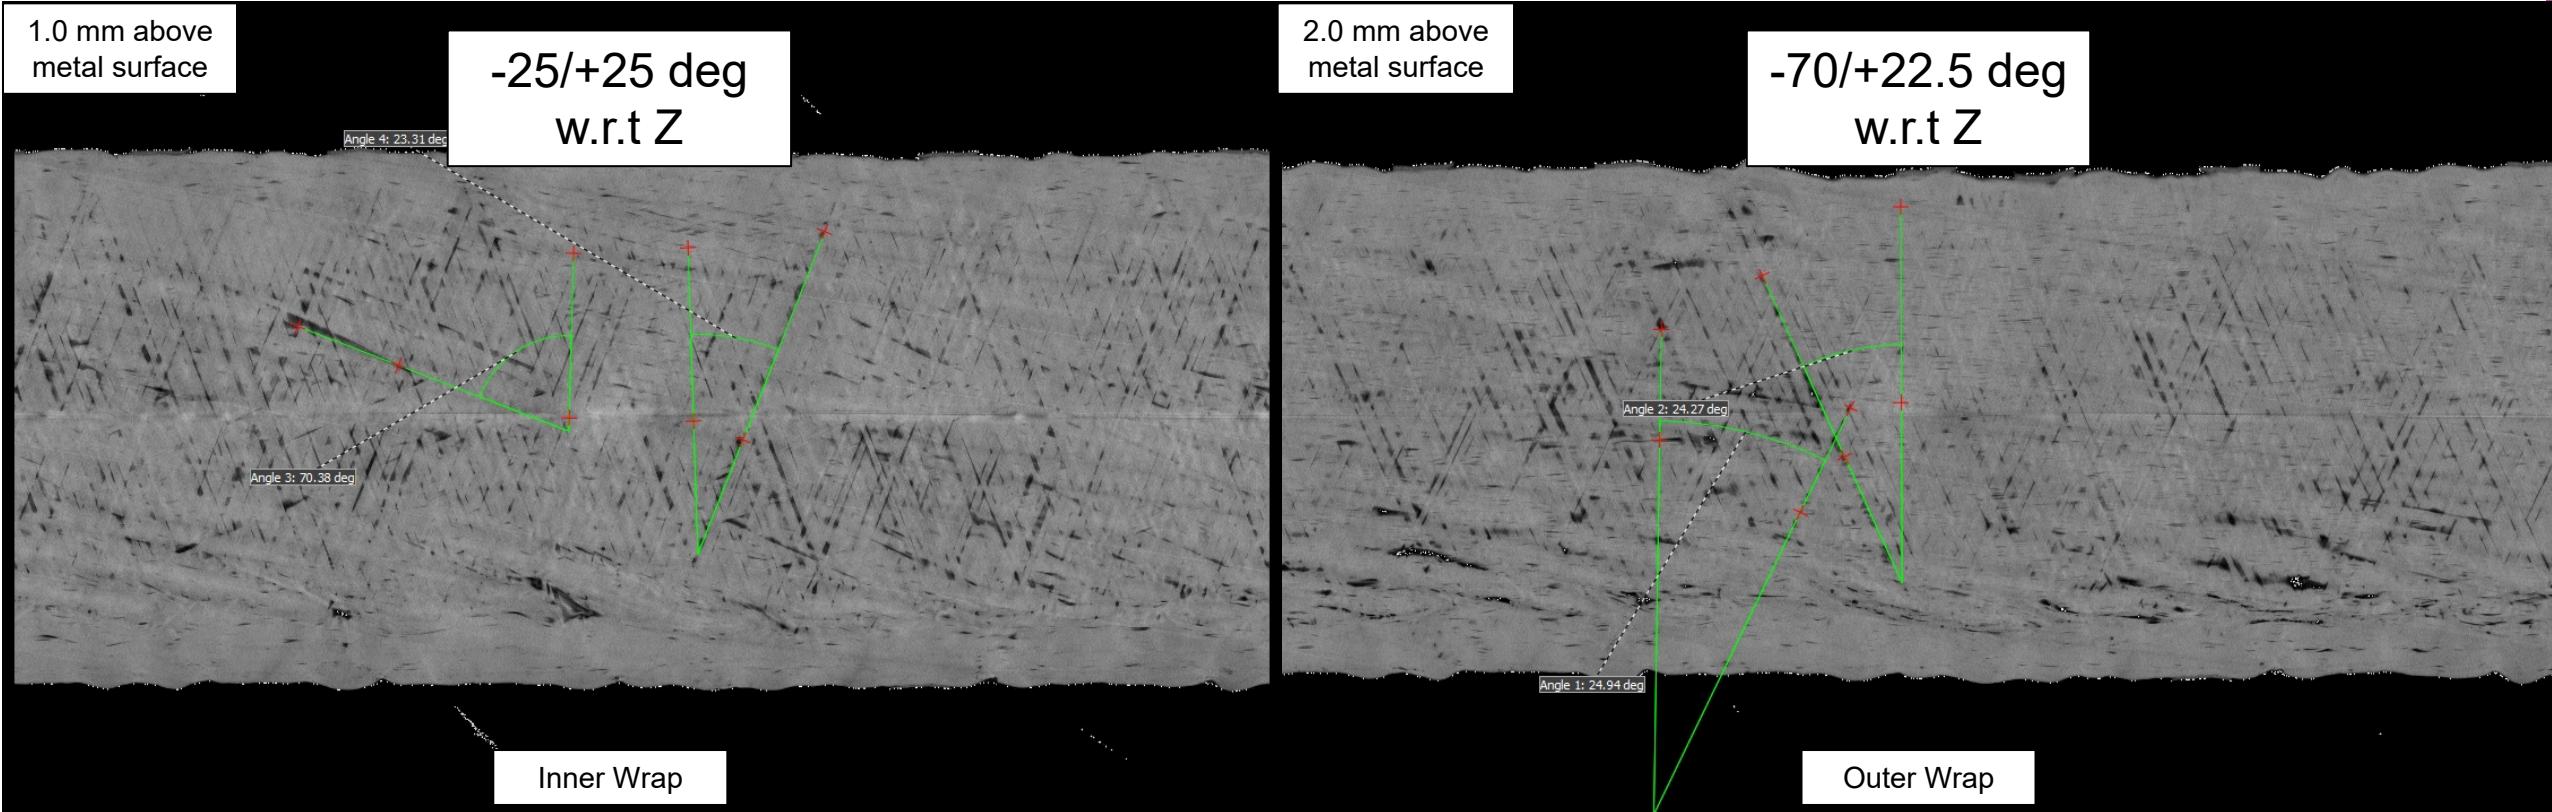
Wrap pattern on inner layers is a $-25/+25$ degree pattern (left), whereas it moves to just a $-70/+22.5$ degree pattern on the outer layers (right).

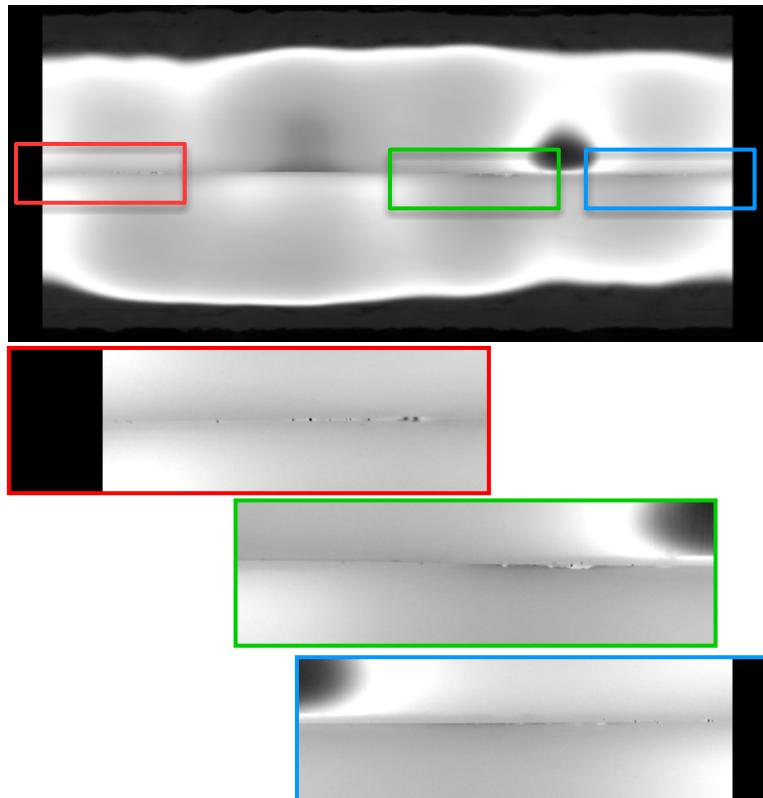
- Pre-UT porosity seen in the liner weld
