2024 Annual Site Inspection and Monitoring Report

Uranium Mill Tailings Radiation Control Act Title I Disposal Sites

MARCH 2025

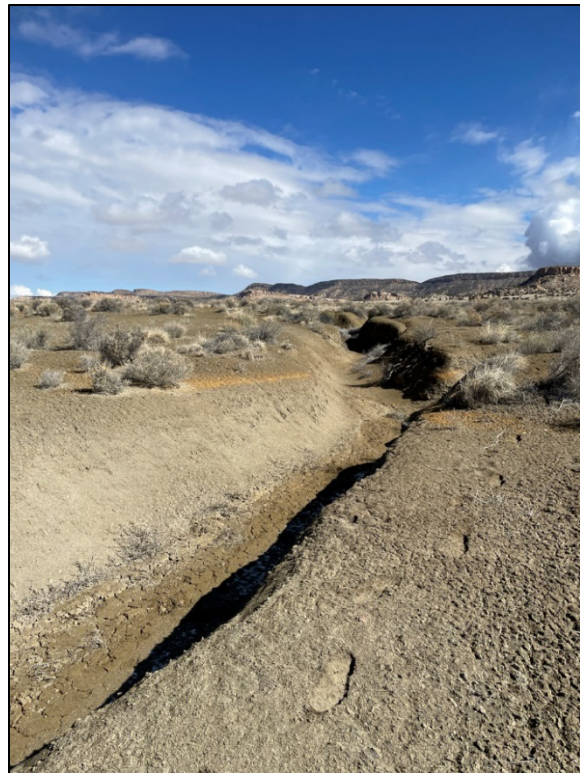
PL-8. Gully Northeast of Disposal Cell

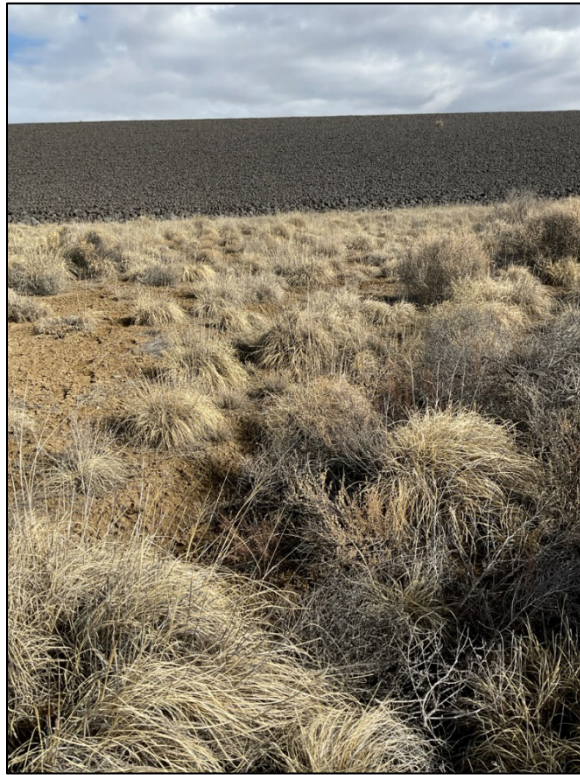
PL-9. Gully South of Disposal Cell

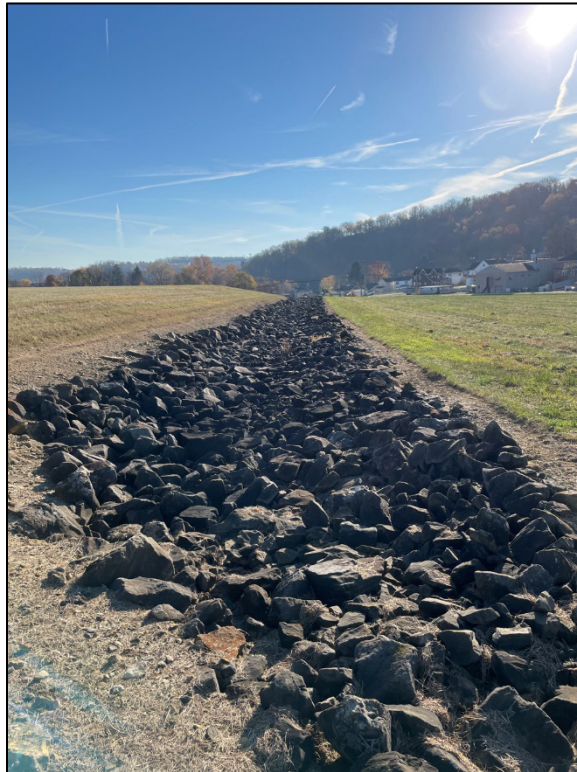
PL-5. Riprap-Armored Diversion Channel

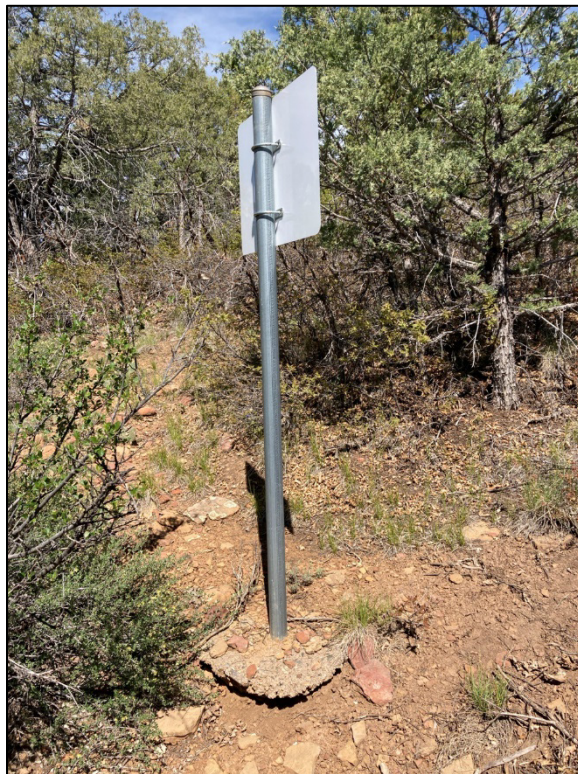
PL-6. Perimeter Sign P62 with Undercut Base and Unstable

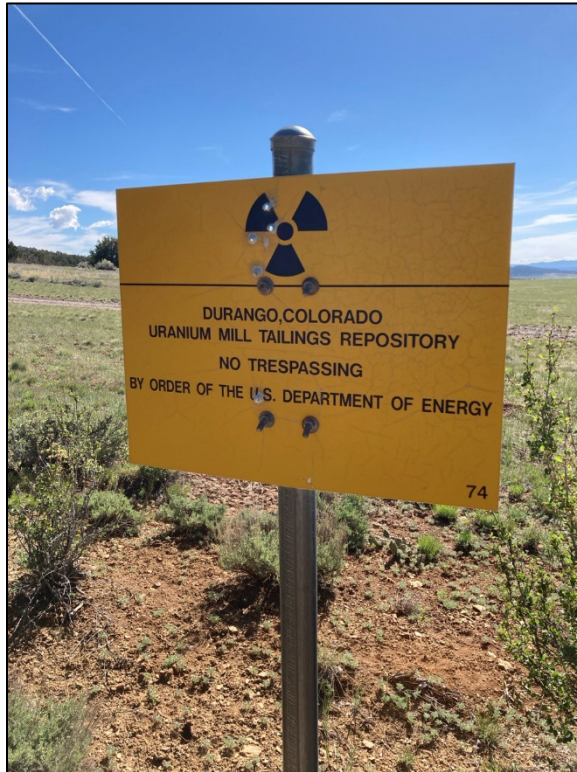
PL-7. Perimeter Sign P74 with Bullet Holes

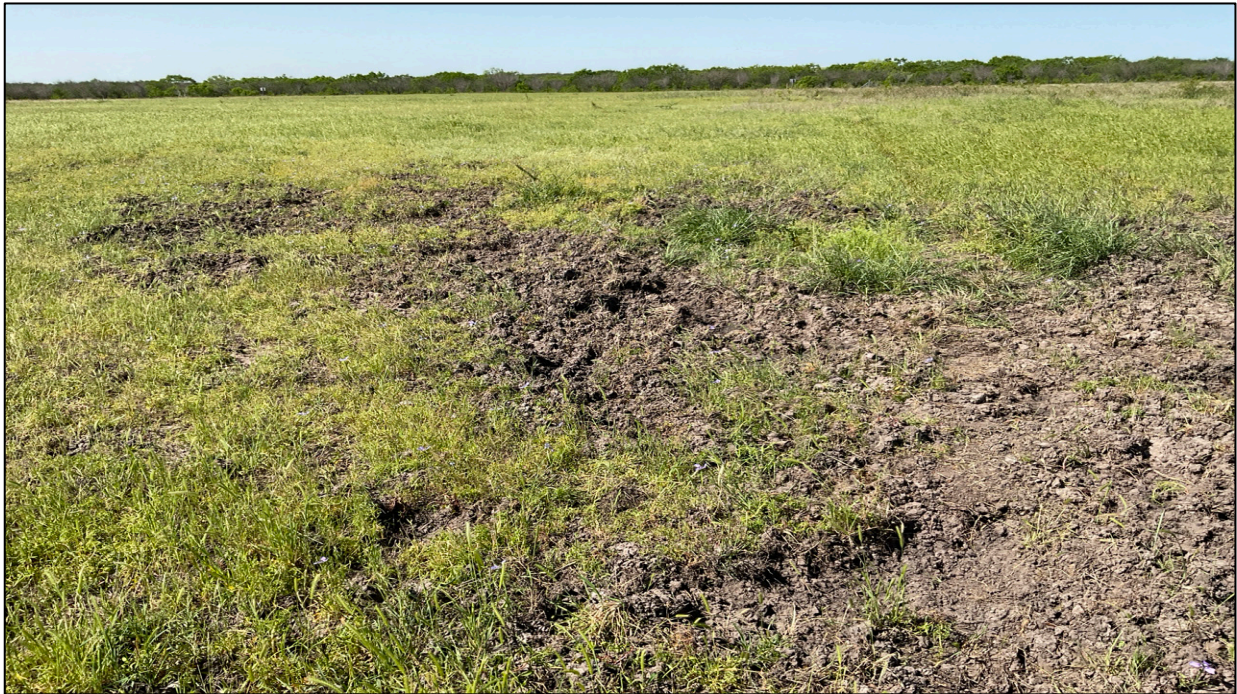
PL-7. Hog Rooting at Base of Ramp

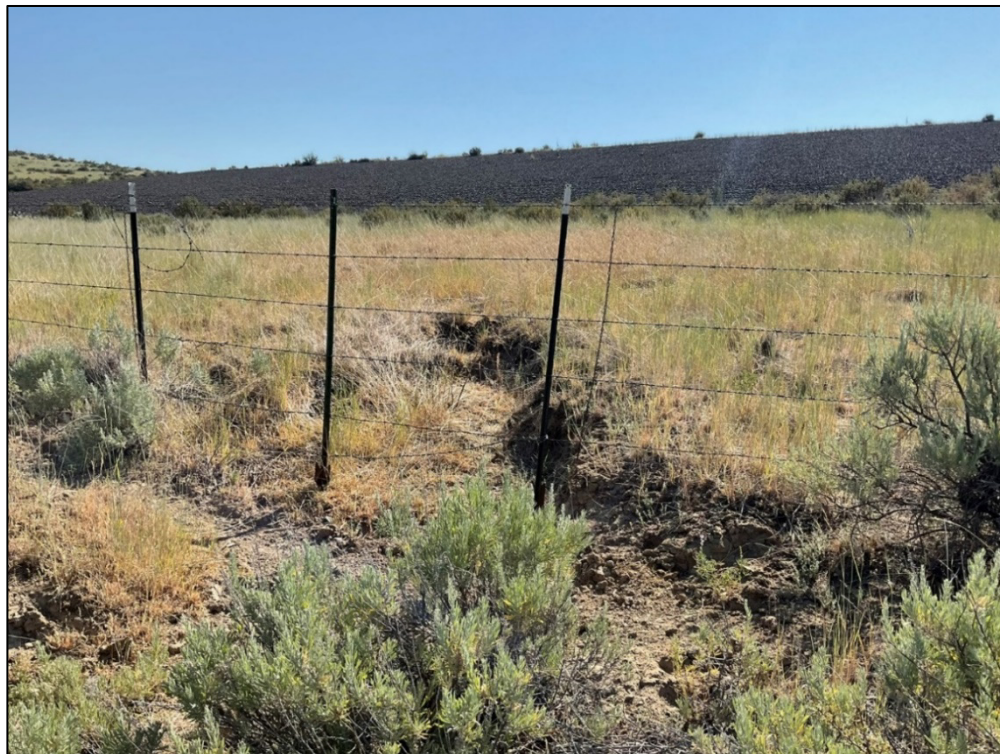
PL-9. Headcutting at Apron Toe Drain 3

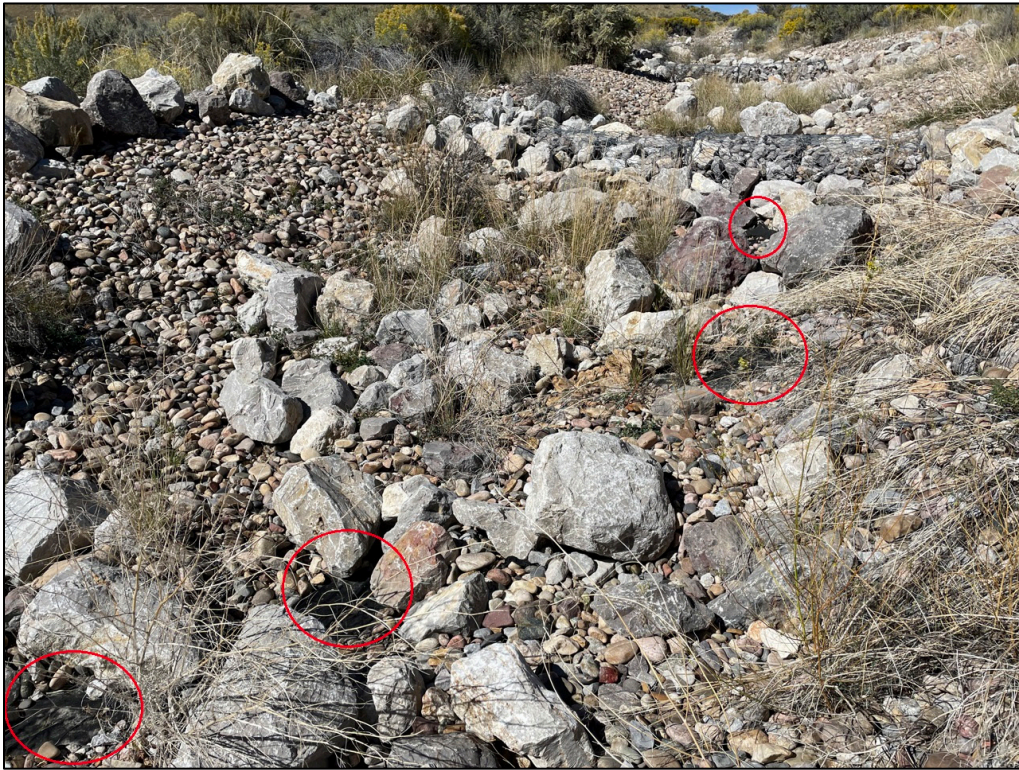
PL-7. Geofabric Exposed in Channel

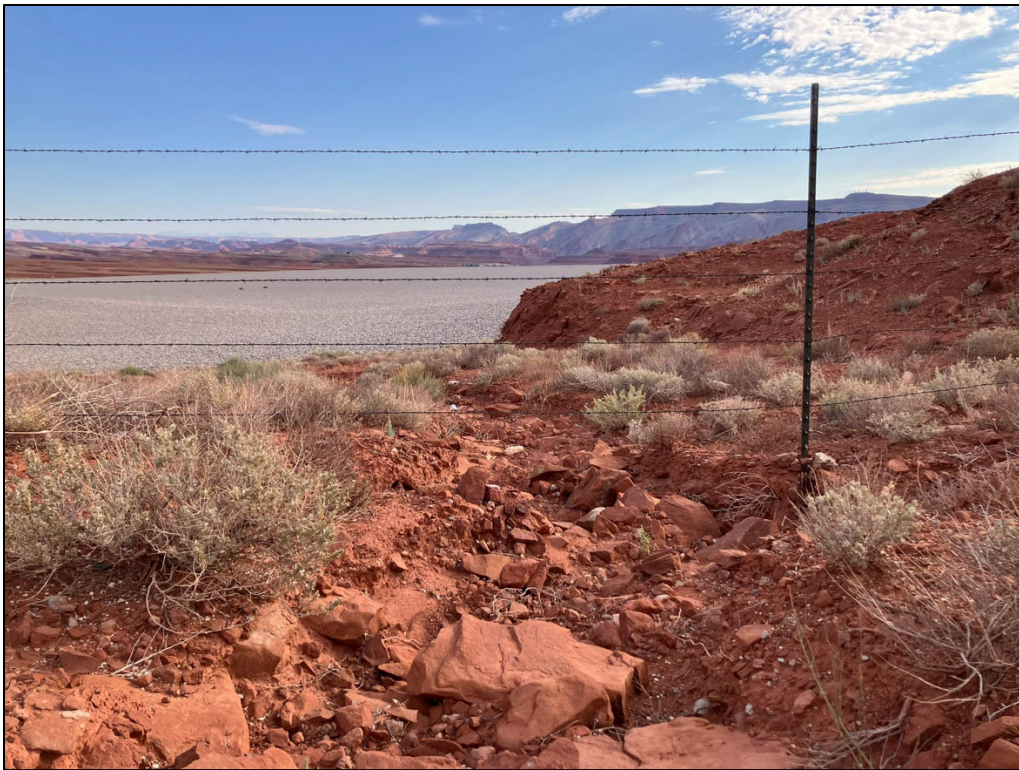
PL-2. Erosion Under Fence

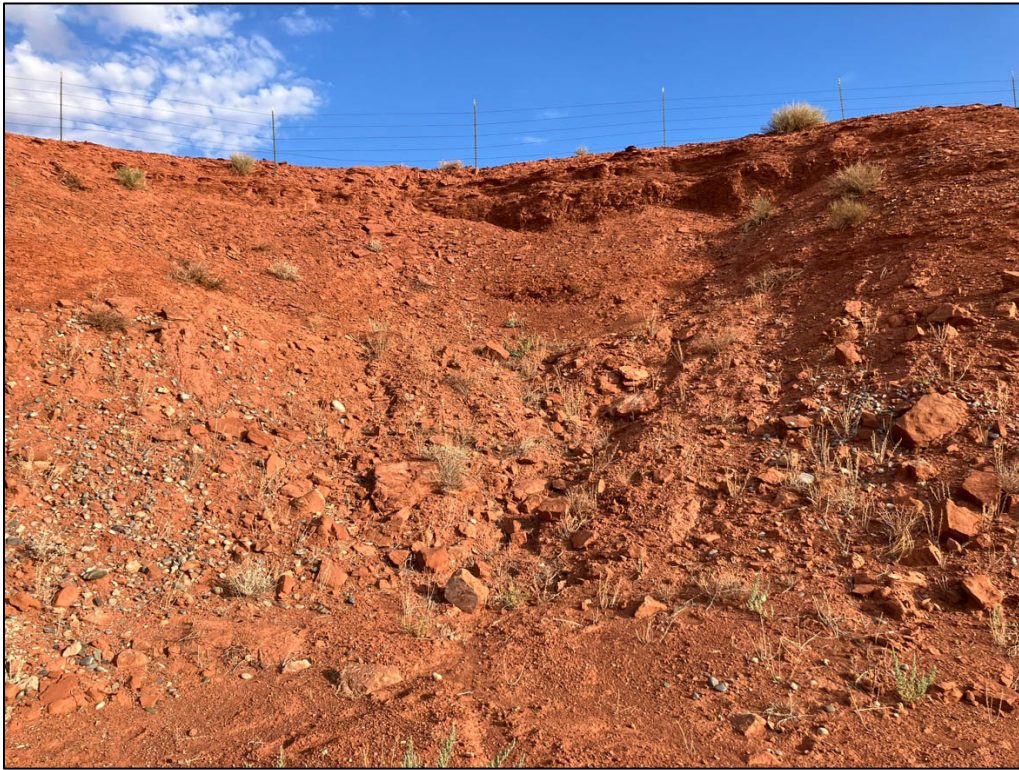
PL-3. Erosion Under Fence; Concrete Base Exposed

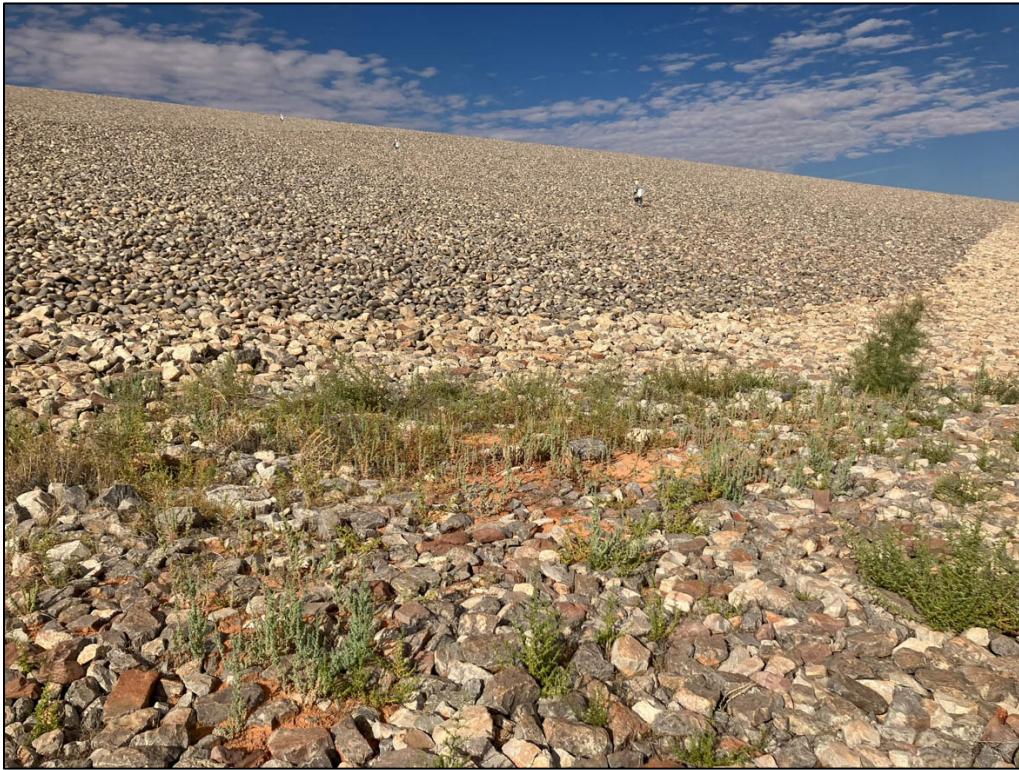
PL-11. Sediment and Vegetation Accumulation in Northeast Toe Drain

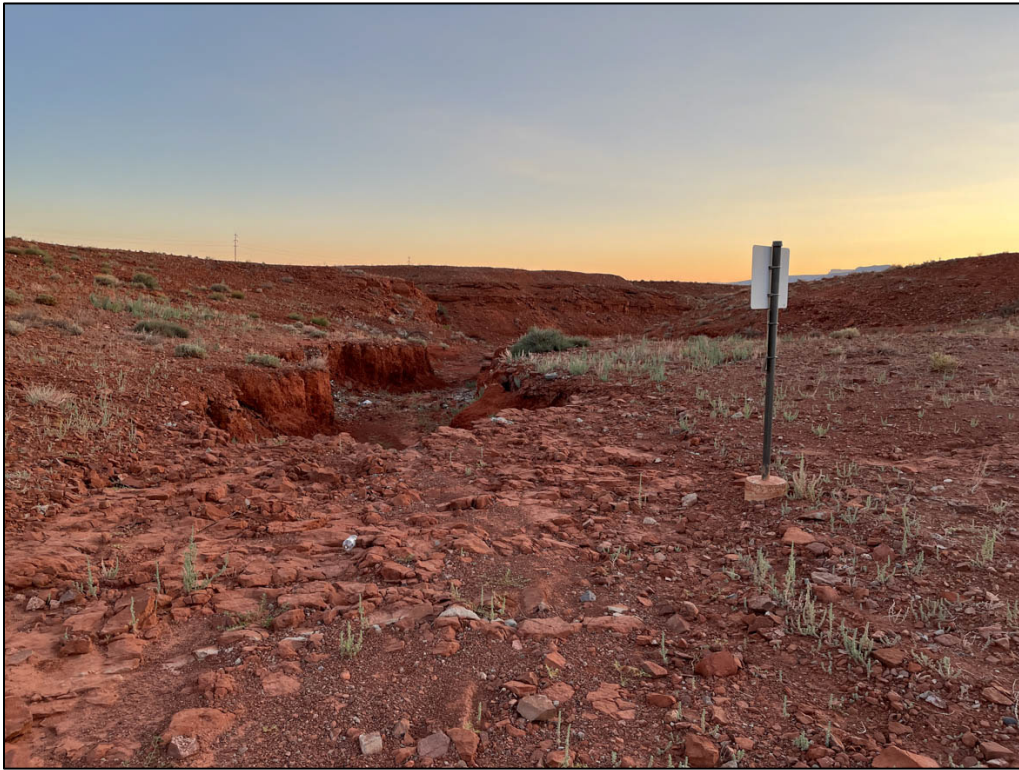
PL-13. Headcutting Encroaching on Perimeter Sign P43

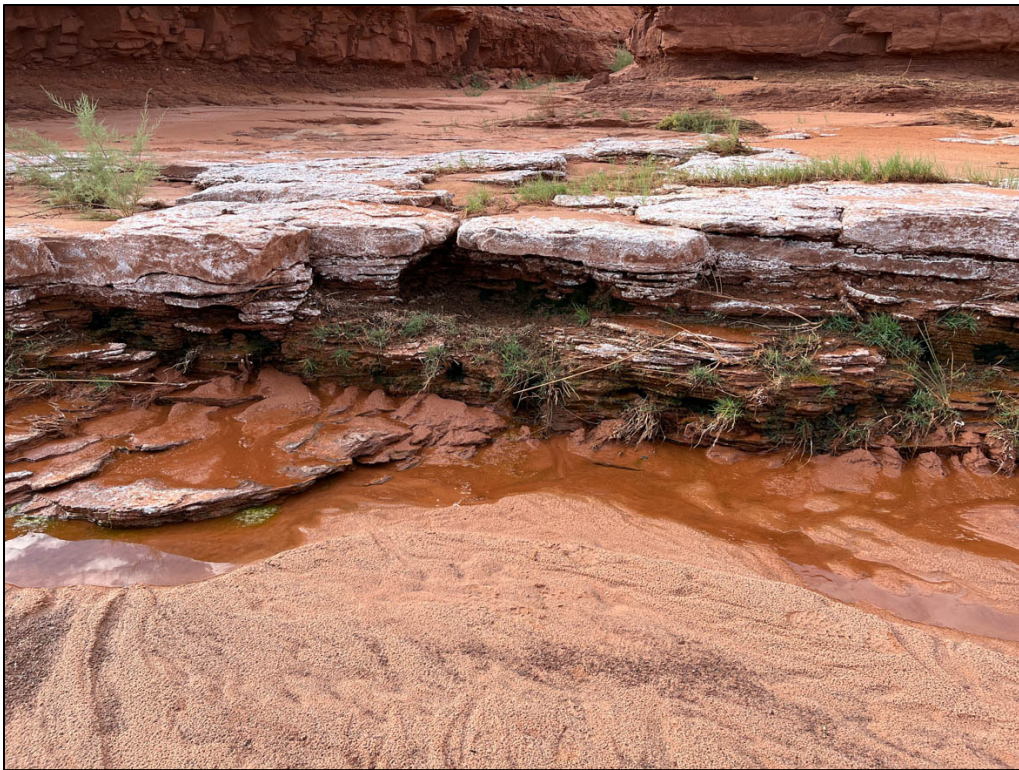
PL-20. Seep 0261, Background Seep, Dripping

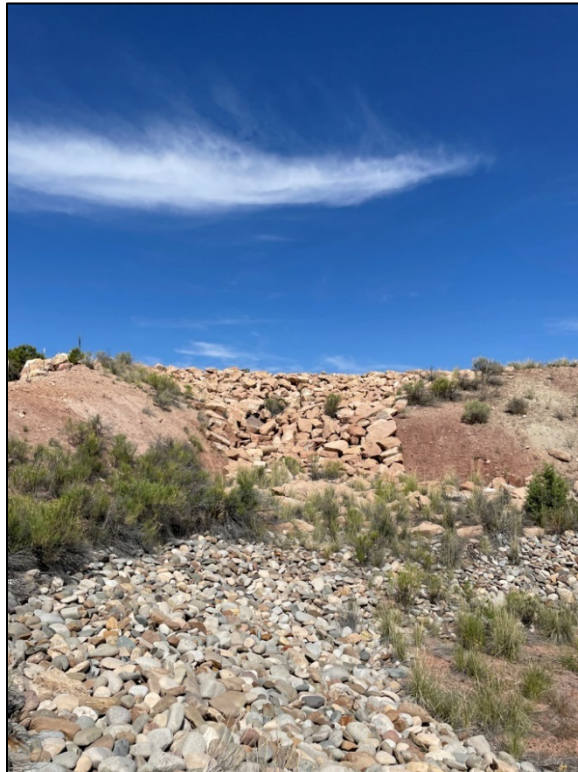
Headcutting erosion has been observed within the spillway channel below the sedimentation pond on the outlying area northwest of the site. Inspectors noted minor increases in rock slumping in this area during the 2023 inspection and will continue to monitor this area (PL-7).

PL-7. Rocks in Spillway

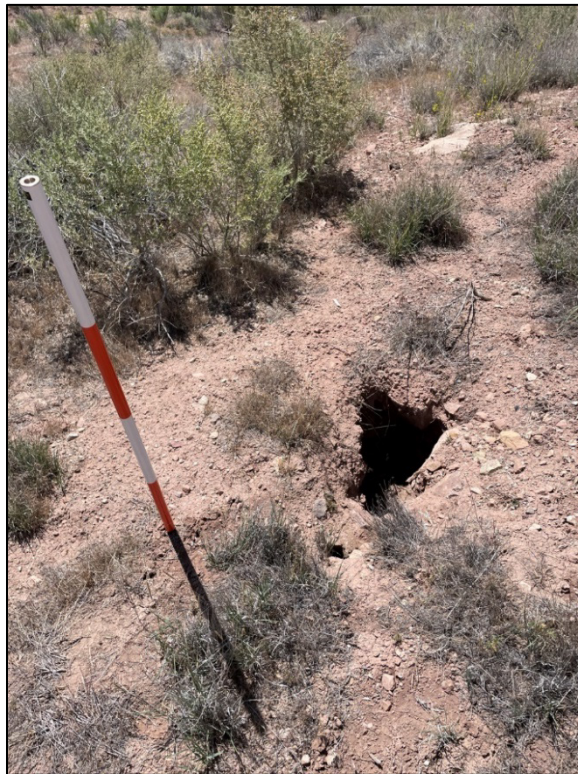
PL-8. Soil Piping West of Access Road

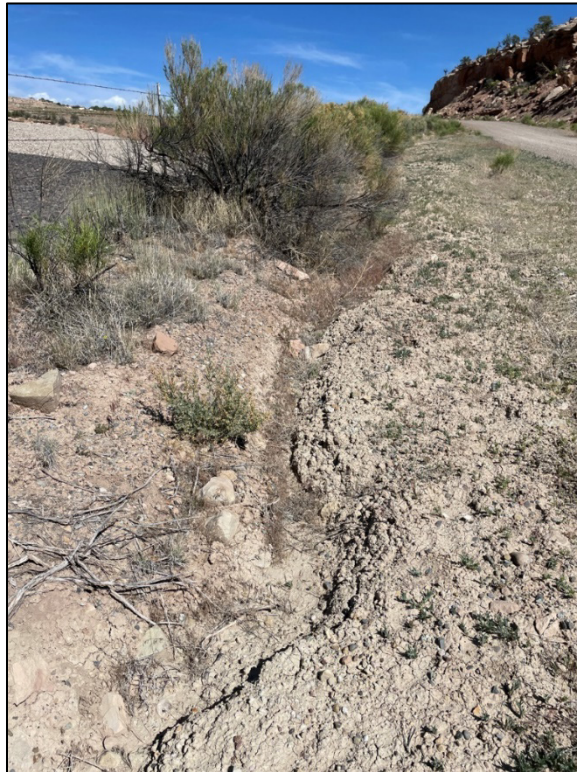
PL-9. Gully near Southeast Fence Line

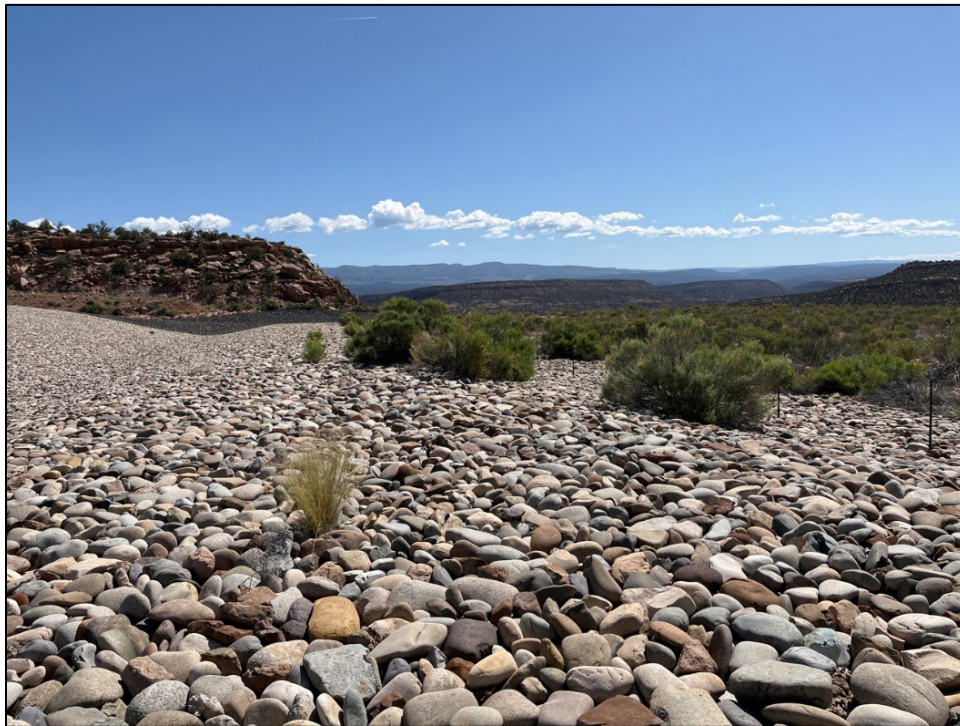
PL-10. Woody Vegetation Growth on Southeast Slopes of Disposal Cell

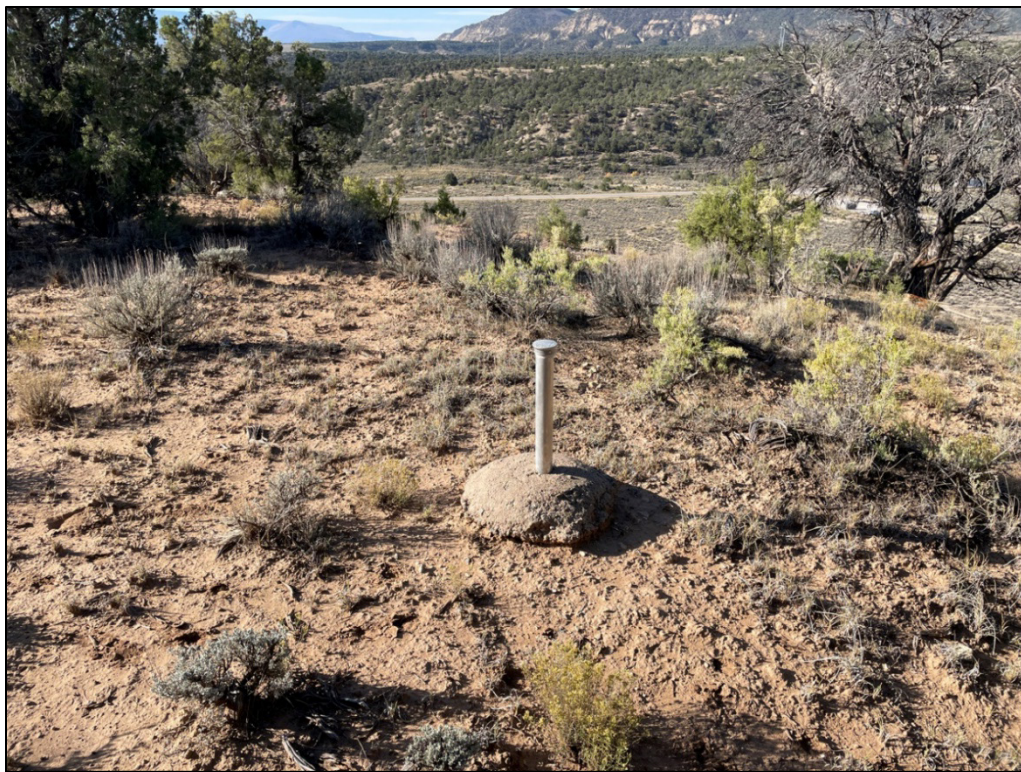
PL-4. Boundary Monument BM-16 with Undercutting

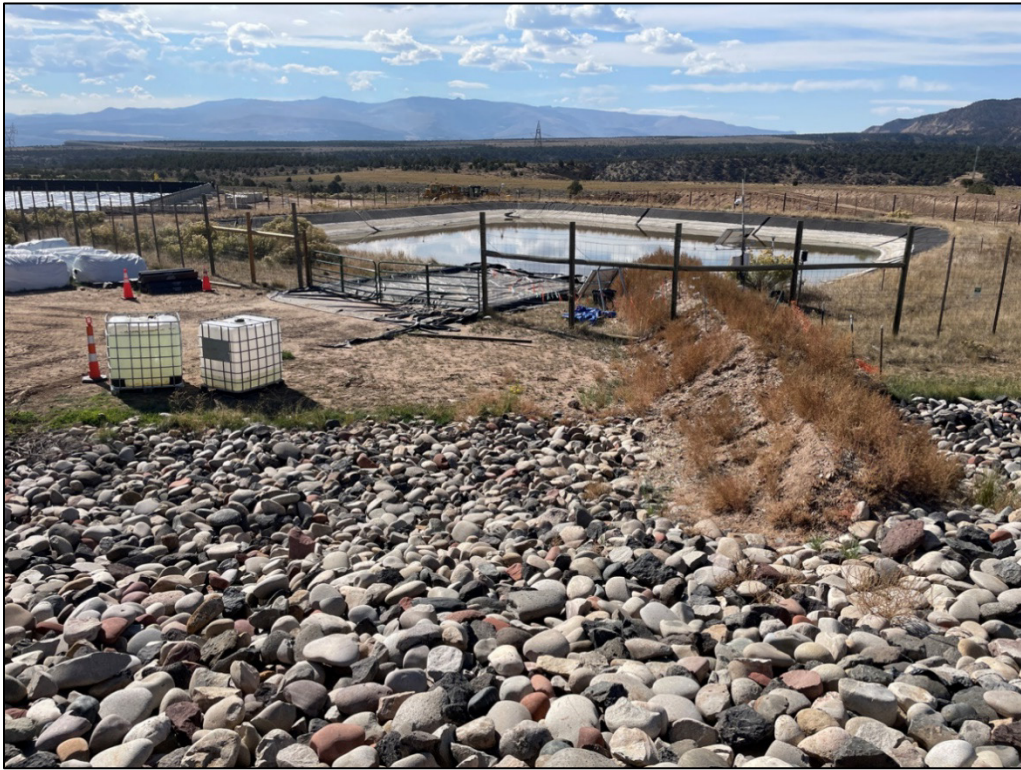
PL-5. Buried Discharge Line for Standpipes MW02 and MW03

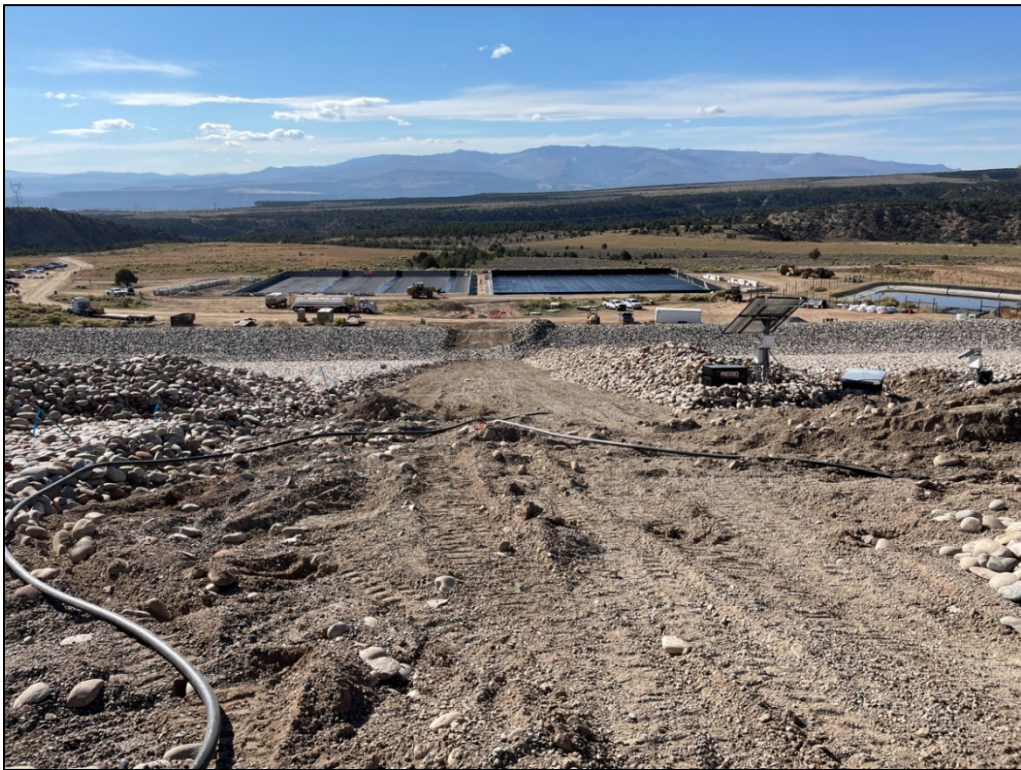
PL-6. Newly Installed Modular Tanks and Construction Overview

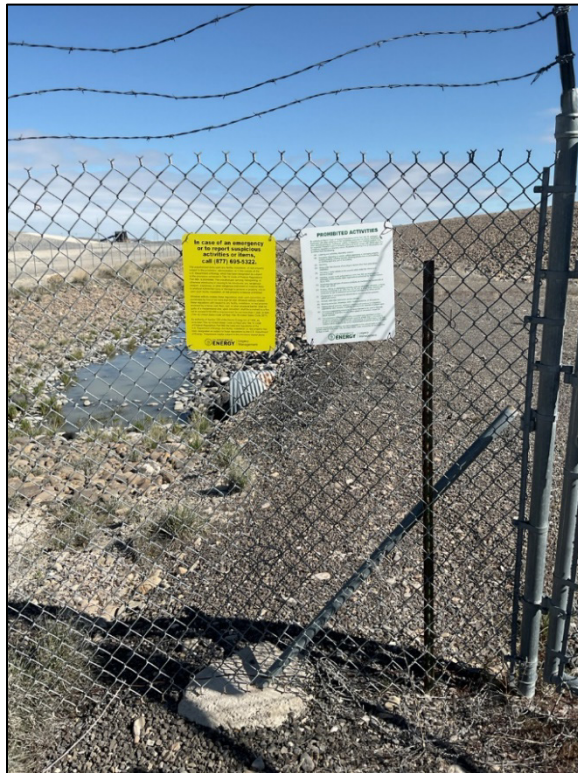
PL-2. Newly Installed Signs on DOE Security Fence near the Site Entrance

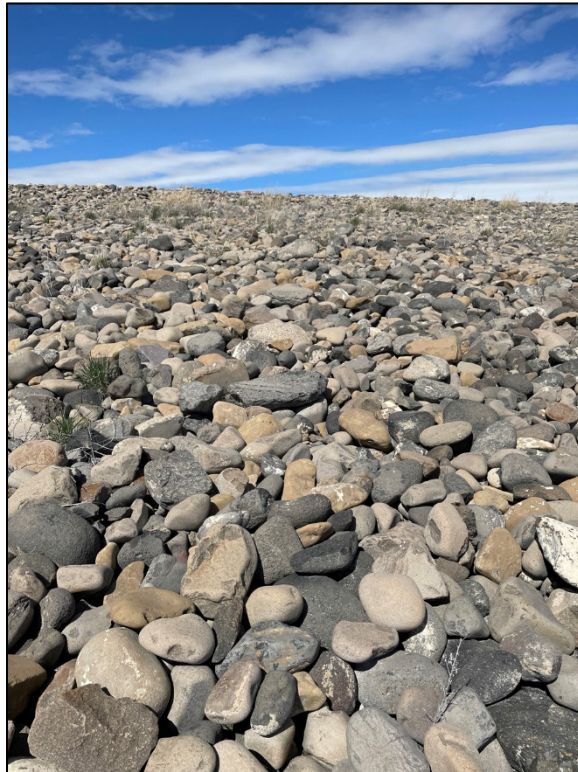
PL-8. Soil Infilling in Riprap Along East Side Slope

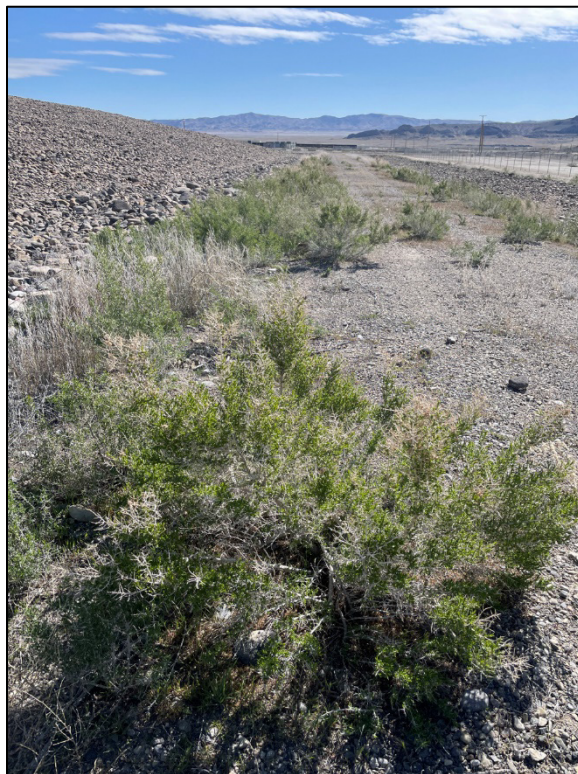
PL-9. Vegetation Along Access Road South of the Disposal Cell

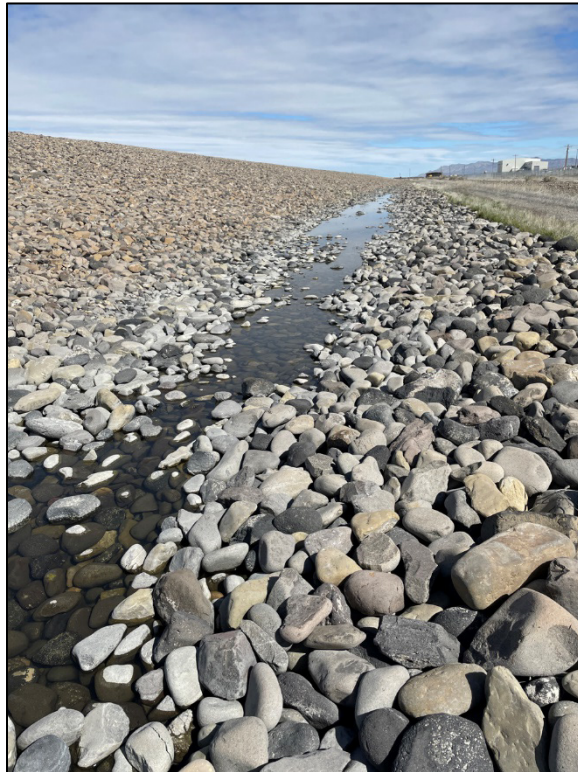
PL-10. Standing Water in Toe Drain near Southeast Corner of the Disposal Cell

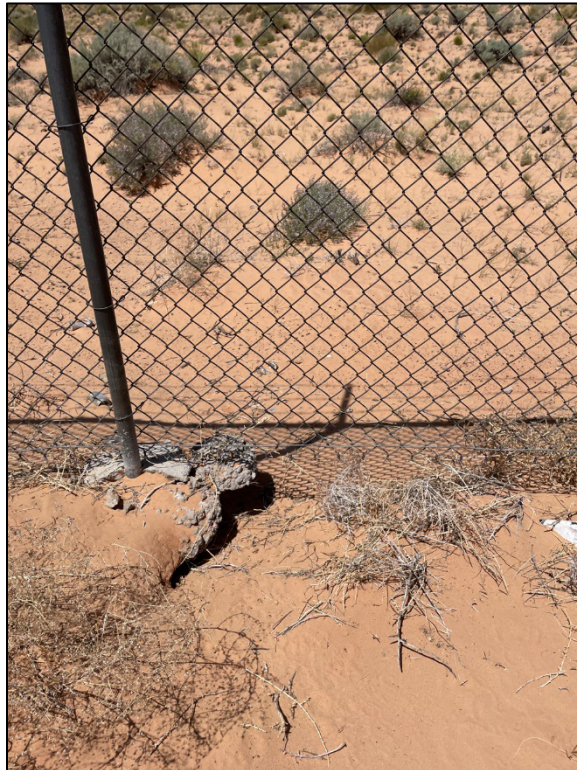
PL-1. Gap Under Fence near Perimeter Sign P9

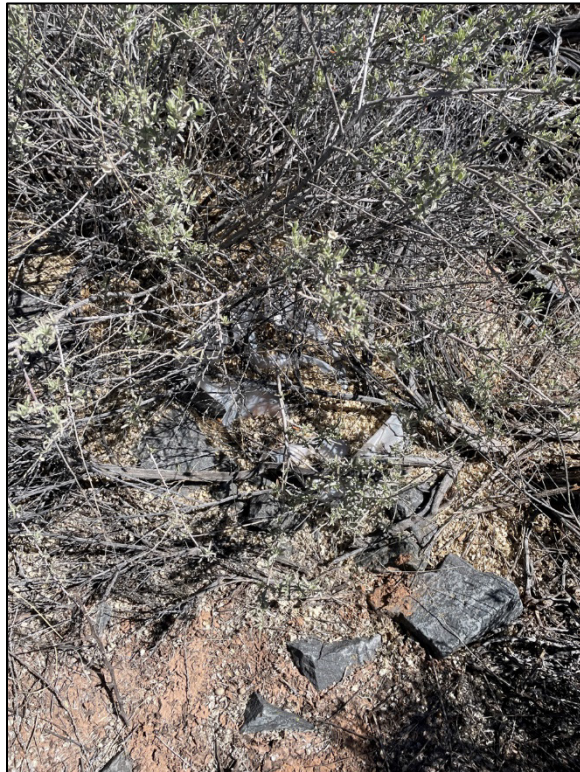
PL-11. Debris on the South Slope of Disposal Cell

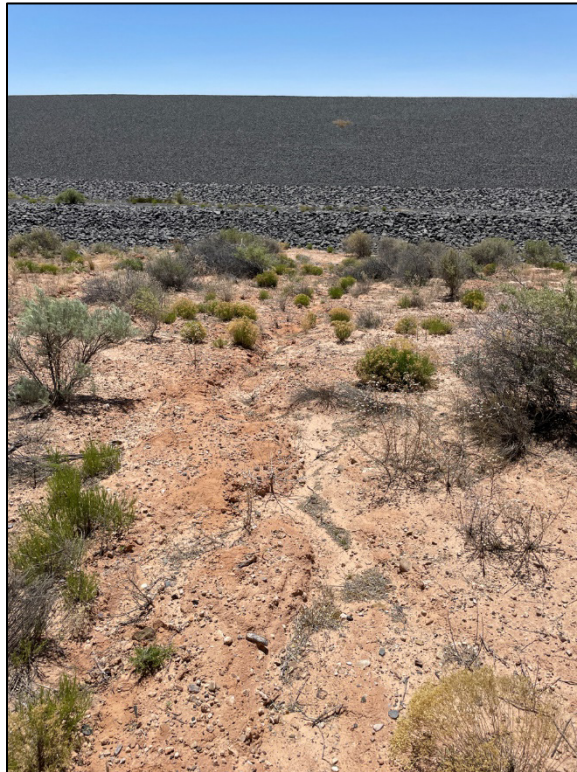
PL-13. Erosional Gully and Soil Accumulation in Diversion Ditch North of Disposal Cell
