Document #: SD-TD-TRP-005

POST DELIVERY TEST REPORT FOR THE LDUA OPTICAL  
ALIGNMENT SYS

## Post Delivery Test Report for the Light Duty Utility Arm Optical Alignment System (OAS)

Allan F. Pardini

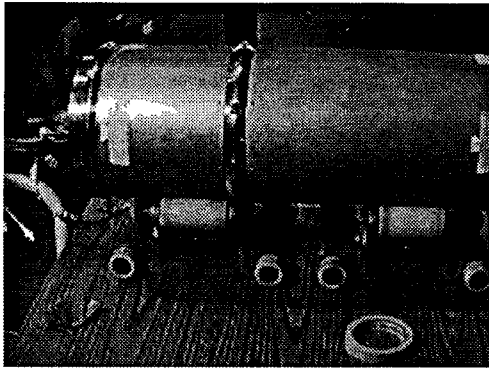
**FIGURE 1 OPTICAL ALIGNMENT SYSTEM  
(OAS) END EFFECTOR**

The system under test is the LDUA system 6250, OAS. The property number is a Westinghouse Savannah River Company number, 00375309. The system tested included the OAS end effector, common video end effector electronics (CVEE), and the CVEE power supply. The OAS is the first alignment system developed for the LDUA program as part of the new technologies initiated through the Department of Energy's Office of Science and Technology. Figure 1 shows the OAS end effector which includes an internal camera, laser projectors, and proximity sensors.
