ANALYSIS OF COMPOSITE TUBE CRACKING IN RECOVERY BOILER FLOORS *

J. R. Keiser, B. Taljat, X.-L. Wang, P. J. Maziasz,
 C. R. Hubbard, and R. W. Swindeman
 Oak Ridge National Laboratory
 Oak Ridge, Tennessee

D. L. Singbeil and R. Prescott
 Pulp and Paper Research Institute of Canada
 Vancouver, British Columbia

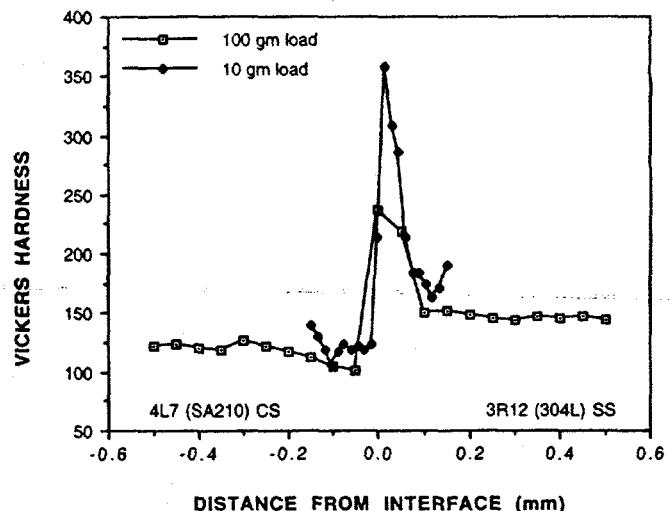
As part of the characterization, the hardness in the vicinity of the interface was also determined. The hardness measurements were made using both a 100 gm load to determine the hardness over a wide area and a 10 gm load to get a better indication of short range hardness variations since the hardness indentation covers a much smaller area and thus samples a smaller volume. The hardness measurements shown in Fig. 2 indicate a maximum occurs in the stainless steel immediately adjacent to the interface. With increasing distance into the stainless steel from the interface, the hardness decreased fairly rapidly. In the carbon steel near the interface, the hardness showed a minimum value in the area of the decarburized zone. Comparison of the results for all six samples show the results are qualitatively similar.

Fig. 2. Vickers hardness versus position in the vicinity of the stainless steel/carbon steel interface in a 304L/SA210 composite tube.

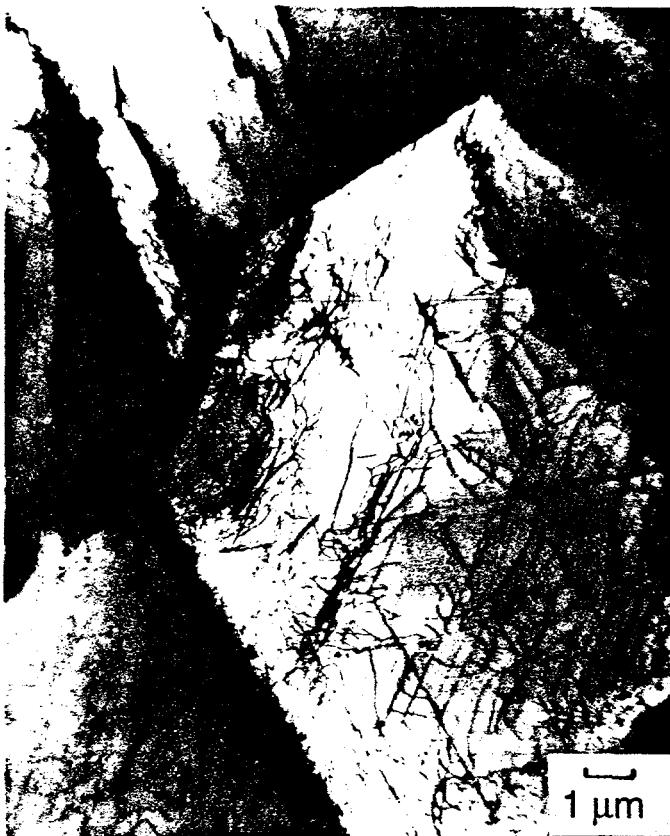
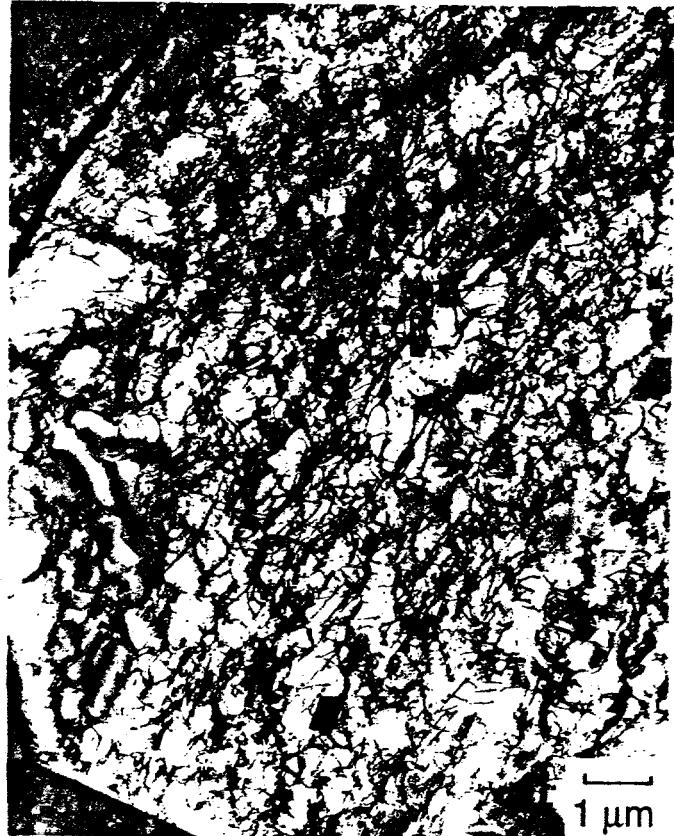
Currently, the two specimens have been examined from the reference material and the samples taken from near the center of the cladding of the three different tube samples. The samples from the fatigue-control specimen clearly displayed the characteristic cellular dislocation network typical of fatigue. The shoulder sample had a relatively low density of dislocations typical of solution annealed material as shown in Fig. 10. The sample taken from the gage section had a much higher dislocation density with a) cellular network structure containing dislocation dissociation into partial dislocations bounding stacking faults, and b) with dislocation loops (see Fig. 11). Two of the samples taken from the center of the stainless steel layer were from tubes that were put into service much more than ten years ago, and which had many years of exposure. Both of these samples had dislocation structures typical of heavily cold worked (>20%) stainless steel. Because of the dense dislocation structures (see Fig. 12 for typical example), any evidence of additional fatigue damage was obscured. The third sample was taken from the center of the stainless steel layer of the tube shown in Fig. 7. This tube was relatively new (boiler operation began in 1993) and had a relatively short (18 months) exposure. As shown in Fig. 13, the dislocation structure of this tube showed much less evidence of cold work and did have some evidence of stacking faults that would be consistent with a small fatigue component to the strain. However, fatigue does not appear to have been a dominant influence on development of the microstructure observed.

Fig. 10. Microstructure in sample taken from shoulder of a fatigue sample. Note absence of extensive dislocation structure.

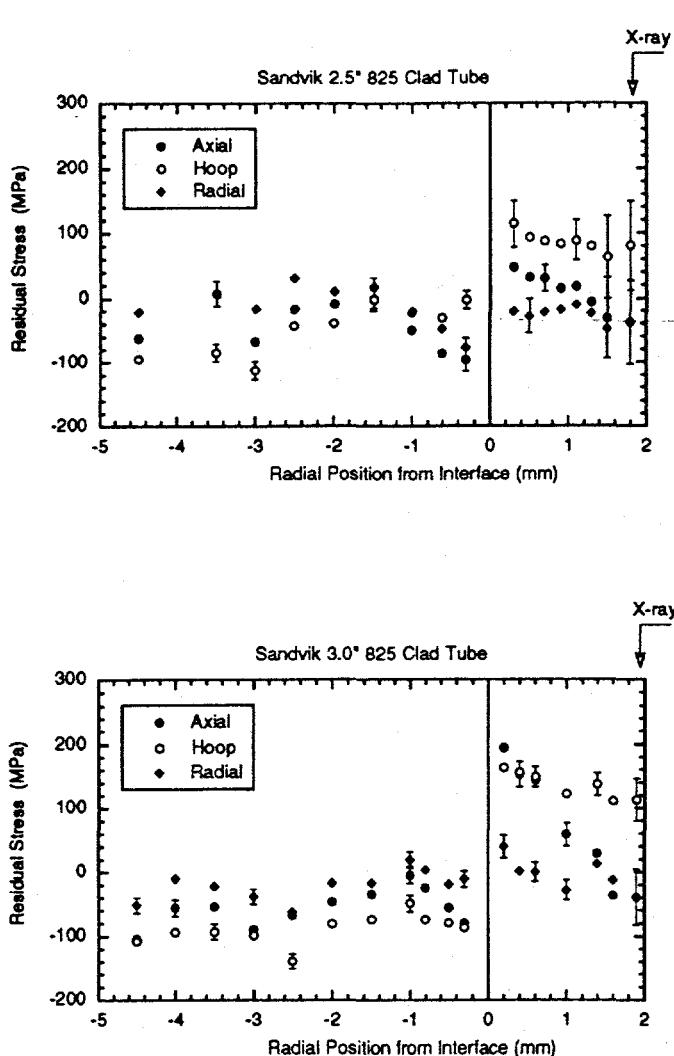
The difference in the stress distribution between the tubes produced by the two principal manufacturers are likely due to differences in fabrication processing. Evidence supporting this observation is shown in Fig. 15 for measured residual stresses in the Swedish manufacturer's 2½ and 3 in. OD 825/SA210 tubes. As can be seen, the residual stress patterns in these two tubes are similar and also consistent with surface residual stress data obtained by X-ray measurements. Qualitatively, the stress patterns in the Swedish 825/SA210 tubes are much more similar to the Swedish 304L/SA210 tube [Fig. 14(a)] than to the Japanese 304L/SA210 tube [Fig. 14(b)]. It should be noted that while the residual stresses measured at room temperature in a single tube will contribute to the evaluation of the residual stresses at operating conditions, they do not provide sufficient information or justification for selection of the tubing from one manufacturer over that of another manufacturer.

Fig. 15. Residual stresses calculated from strain measurements for unexposed Sandvik SAN 38/4L7 with 2½ and 3 in. ODs.

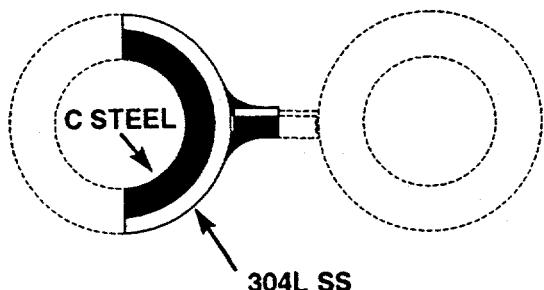
The results of neutron diffraction residual stress measurements provide some of the needed data, but stresses resulting from weld attachment of membranes, internal pressurization of the tubing, and heating on the fireside of the tubes must also be taken into account. To consider these other influences, a two-dimensional model was constructed that assumed the symmetry of a tube panel was such that a tube could be sufficiently represented by a model utilizing one half of the composite tube and one half of the membrane as shown in Fig. 16. The model was first used to take into consideration the effects of membrane weld attachment. This model, when the residual stresses from tube fabrication are taken into consideration, predicts that compressive stresses develop on the stainless steel surface of the composite tube.

Fig. 16. Configuration used for two-dimensional model of recovery boiler floor panel.
