SNAP 10A-PSM-1 TEST RESULTS

By
R.M. OLIVA

CONTRACT: AT(11-1)-GEN-8
ISSUED: JUL 15 1964

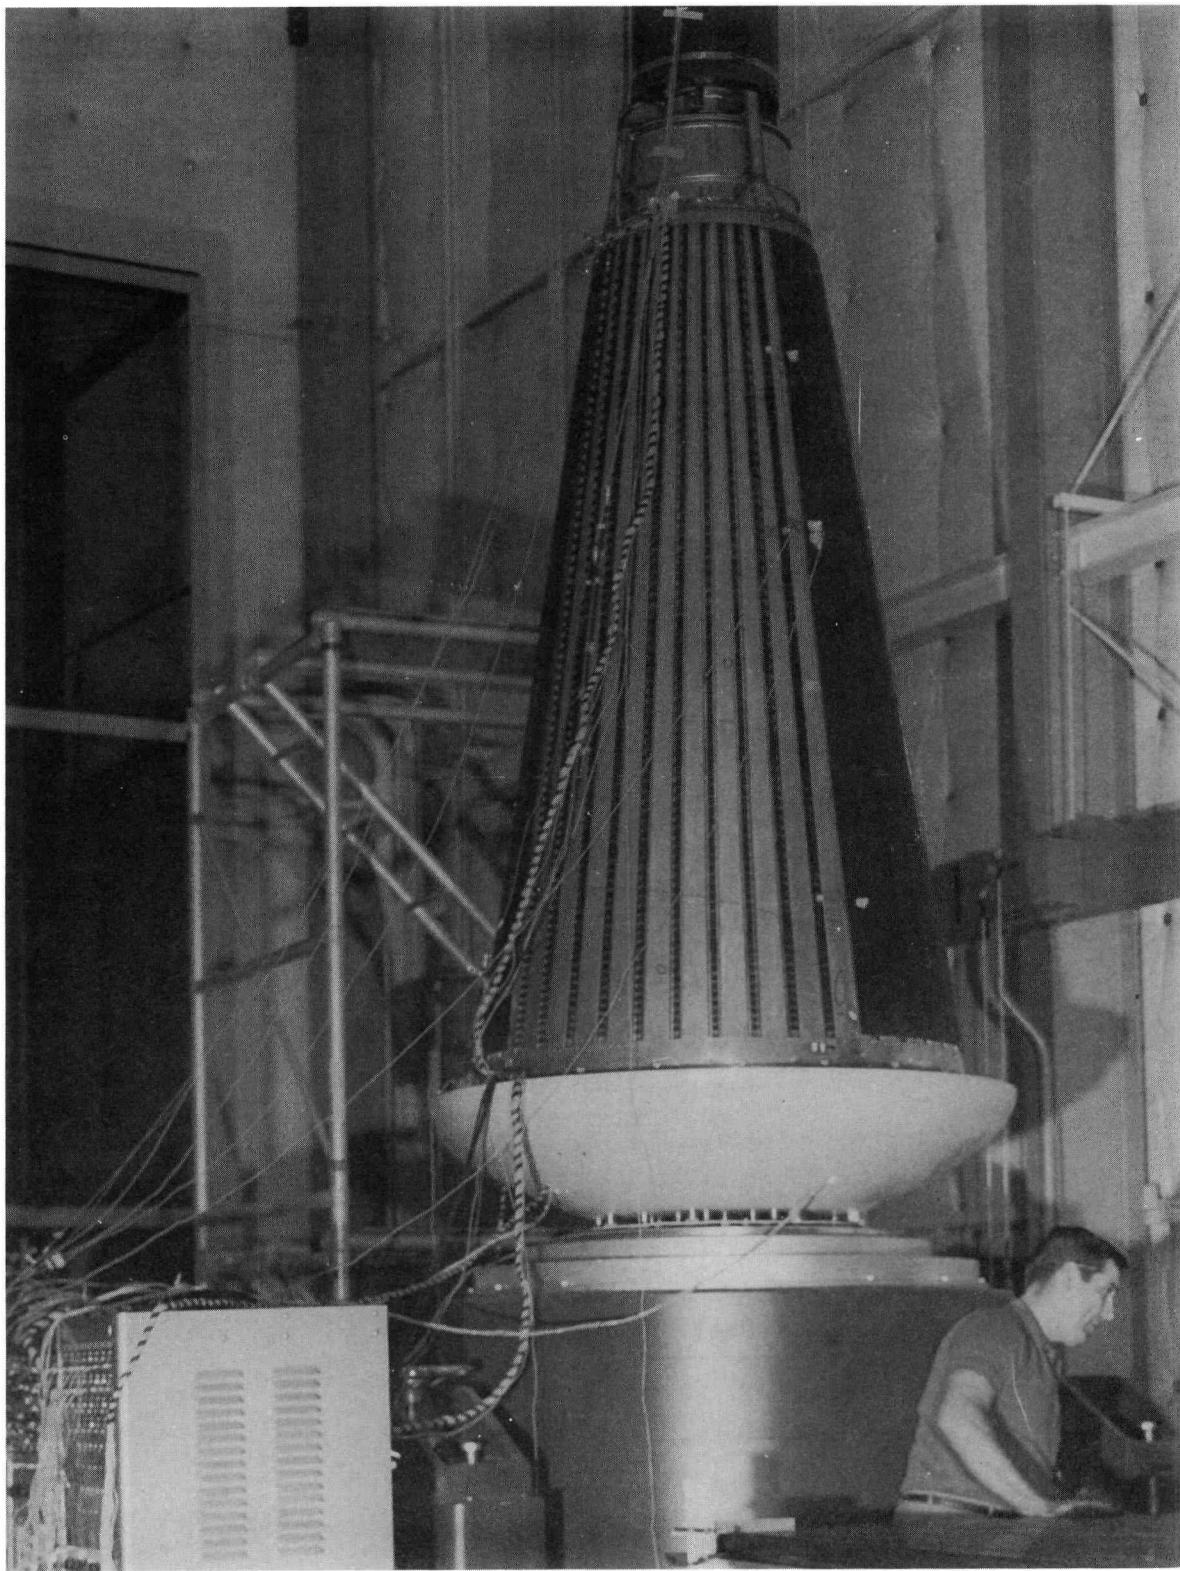
Figure 1. Specimen Installation on Upright 30,000-lb Shaker

Prior to making recorded test runs, low-level vibration surveys were made with the vehicle mounted on the upright shaker (Figure 1) in order to find vehicle resonances and to note whether any peculiar response conditions occurred which might require special attention or monitoring techniques during later tests. Generally, all low-level surveys were scanned at a constant octave sweep-rate from low to high frequency at a rate requiring $\sim 11.5 \text{ min}$ for a 5 to 3000-cps sweep. Vibration inputs to 3000 cps were $\sim 10\%$ of the specified vibration inputs. The 100% vibration levels are reproduced in Table 1 of this report. A deviation to these inputs was to be made at the first fundamental resonance in each axis with the table input being reduced so that the vehicle's center of gravity response would not exceed specified limitations (longitudinal : 2.5 g under 200 cps, lateral and normal: 2.0 g under 250 cps).

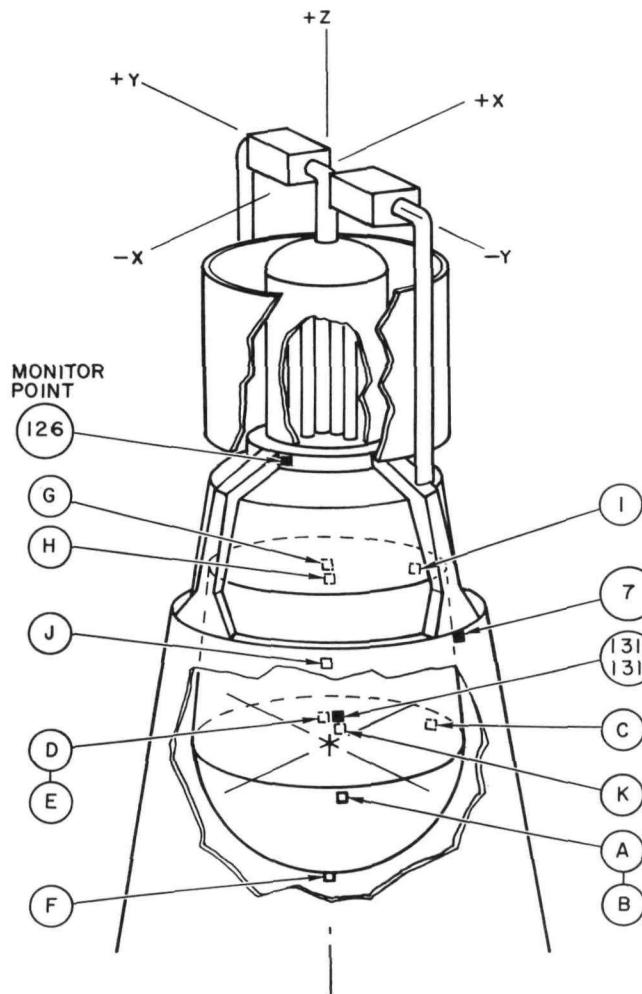
Figure 3. Accelerometer Locations Used During Shield Survey

(1) the bolts supporting the shield had loosened, (2) the shield support bracket on the converter shell had failed, (3) the accelerometer on the shield ring (131) was loose, (4) a crack in the lower shield ring (present before testing began) propagated, or (5) internal shield damage had occurred.

Visual inspection was performed and all shield support bolts were checked for tightness; none of the four main support bolts were loose. The accelerometer was still mounted rigidly and apparently in good working order. There was no indication of crack propagation in the shield ring, and no evidence of converter shield support bracket damage. Only internal shield damage could have caused the trouble.

The results of a run made with the instrumentation noted in Figure 3 are listed in Table 6. It should be noted that the 65 cps value was not the resonant frequency but a point within the general resonance range at which a clear relationship between the outputs from the various sensors could be obtained.

Usually, the source of high-frequency response from low-frequency input, as noted on the shield, is the result of loose parts hammering or rattling in or on a structure. At this point in the test, it was deduced that somehow the lithium hydride mass in the shield had become loose and was bouncing on the steel support straps which in turn dumped the ringing response into the shield housing at the lower ring. Because internal shield damage was almost a certainty, the unit was replaced with a dummy. Prior to removal, one lateral test run was made on the vehicle to check the system for lateral first fundamental mode frequency and to gather data on magnification factors at various vehicle locations. The test was intended not to rule out the need for shield removal but rather to obtain the noted data with the actual shield still in place.

- 1) In the upright position, cavitation of about one inch was found between the top of the shield containment vessel and the lithium hydride mass. X-ray disclosed that the internal mass had dropped approximately straight down.

- 2) X-rays were taken at 90° intervals perpendicular to the support ring in the areas of the lithium hydride support strap attachments. These shots revealed that the two positioning lug assemblies had become detached from the lug supports owing to failure of the welds.
- 3) The hydride mass was prevented from dropping to the bottom of the containment vessel by the remaining two positioning lugs that did not fail. Originally, cavitation was built into the hydride mass at these points to prevent complete slippage of the mass past this point, even though support failed on correspondingly opposite sides.

X-ray substantiated the fact that the support straps for the lithium hydride did not fail, but that failure had occurred at the weld between the positioning lugs and the shield containment vessel. Dissection of the shield several months later completely verified the X-ray diagnosis. Examination of the failure at that time revealed that the welds were little more than tack welds which were the result of the welder's inability to gain proper access to the weld area. This fact was instrumental in effecting a design change in the shield strap support system for all future shield assemblies.

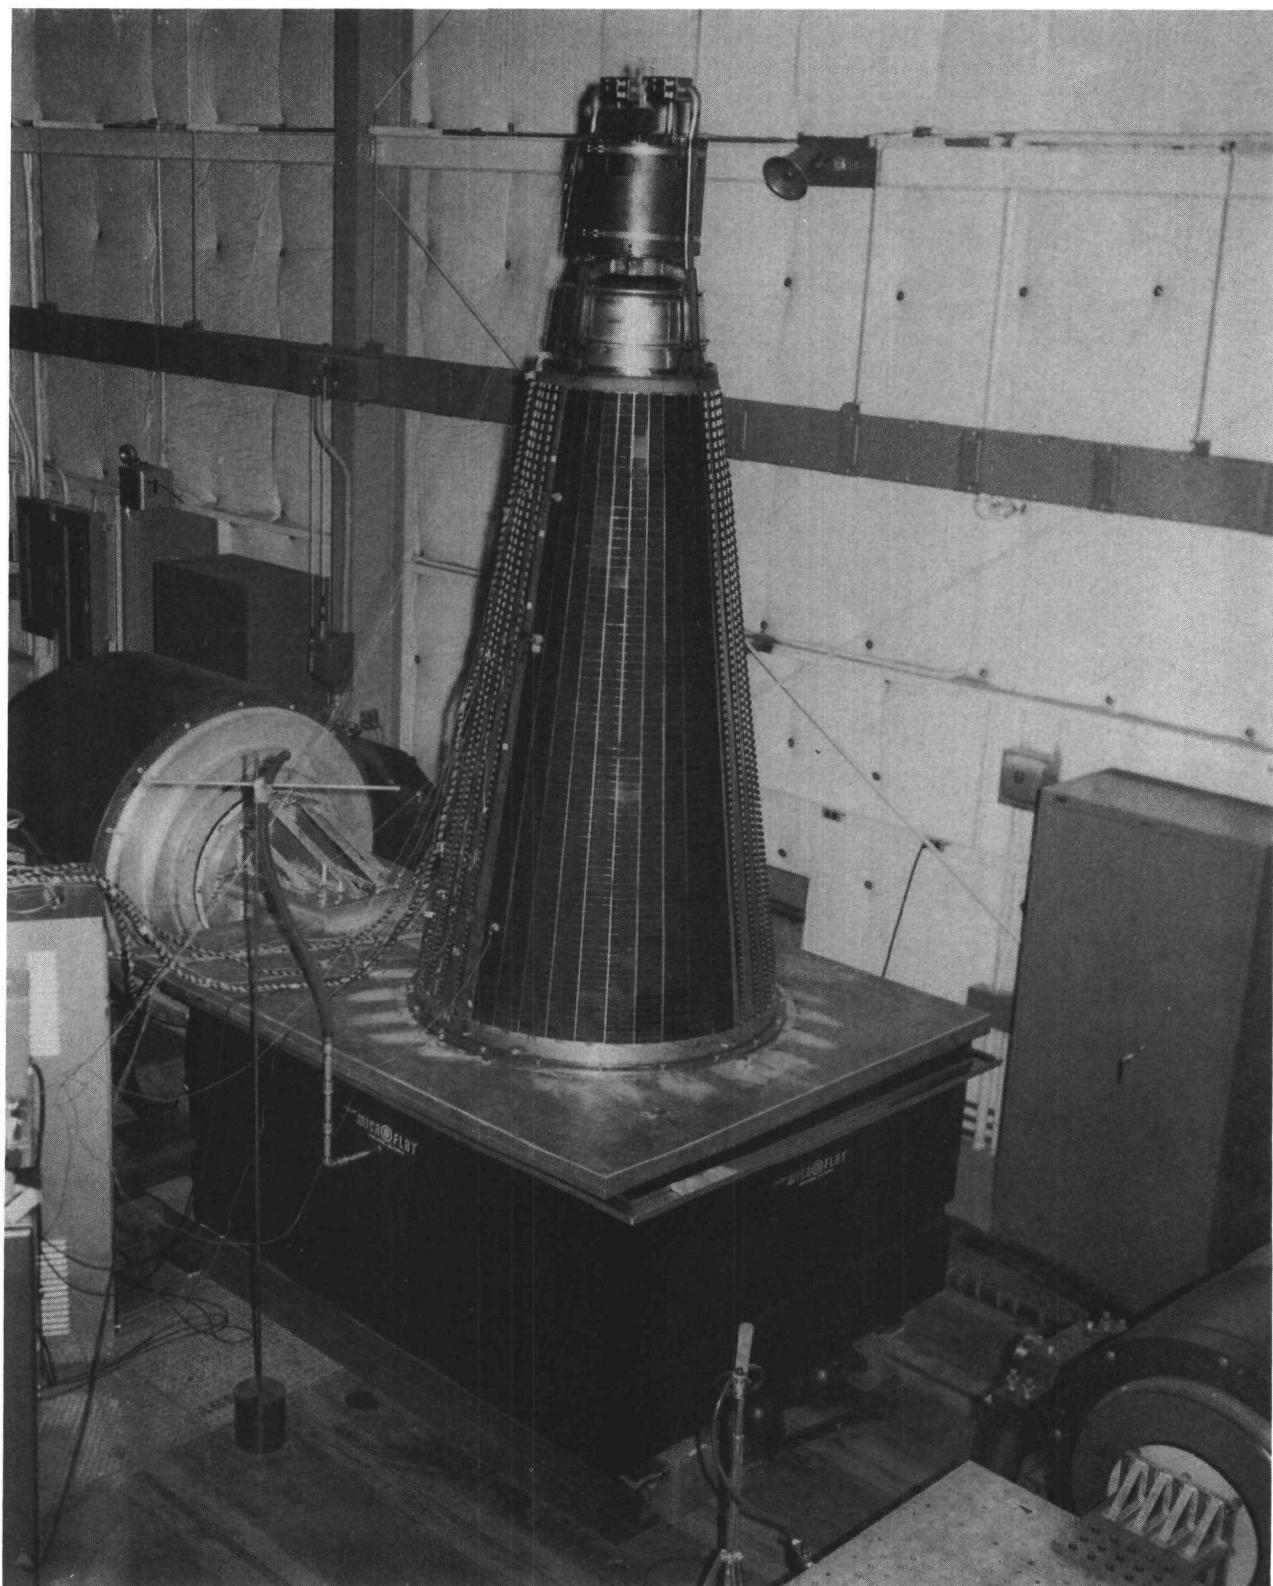
Figure 5. S10A-PSM-1 Vehicle Mounted on the Slip Table
for Lateral Excitation

inputs were applied through the Y-Y axis. Two important resonances of basic vehicle structure were observed. The first fundamental resonance (1st bending) occurred at ~ 17 cps. A second significant resonance of unknown mode shape was observed at ~ 420 cps. In addition to these two, a converter tube bundle resonance occurred at ~ 42 cps. Preliminary test runs in this attitude were low-level surveys scanned at the same sweep rates followed in the longitudinal direction with test inputs of ~ 10 to 15% of the values noted in Table 1. An exception to this occurred at 15 to 18 cps (resonance) when the vehicle's center-of-gravity response points became the controlling factor. The monitor points depicted in Figure 3 were used as control locations, except that the Y-Y component of acceleration became the controlling signal and was restricted to 2 g below 250 cps.

During the converter tube bundle resonance at ~ 42 cps, excessive tube response and displacement was visually observed on some tubes, particularly on those near the vehicle X-X axis. On two separate tubes, double amplitudes (D.A.) of 1/16 in. were observed at converter midspan, with motion occurring sideways parallel to the support shell surface. This amplitude when related to shaker input represented a magnification factor of 60 and was well above those readings indicated during two separate runs by accelerometers mounted on the tube selected for instrumentation (Table 10).

and thus gave rise to the high value. None of the three clip designs was found to be a completely satisfactory support device and so a redesign of tube support for future vehicles was started by the Project. Because this test program obsoleted the existing attachments, a discussion of their design is not included in this report.

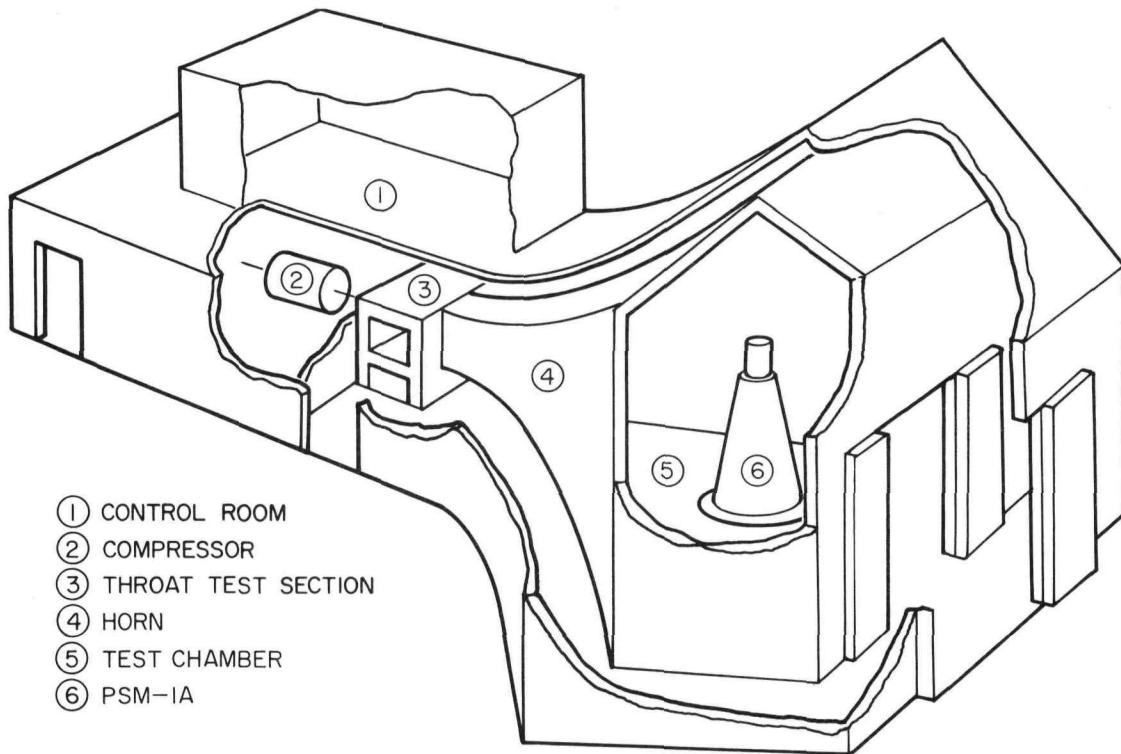
Figure 13. Acoustic Test Facility

No damage to the structure was observed during testing. The cracked portions of the repaired structure were closely observed during testing, and no propagation of the cracks was noted.
