BNWL-CC-1401

CORROSION EVALUATION OF
N REACTOR PRESSURE TUBE 1756

Surface and Coolant Chemistry Section

CHEMISTRY AND CHEMICAL ENGINEERING DEPARTMENT

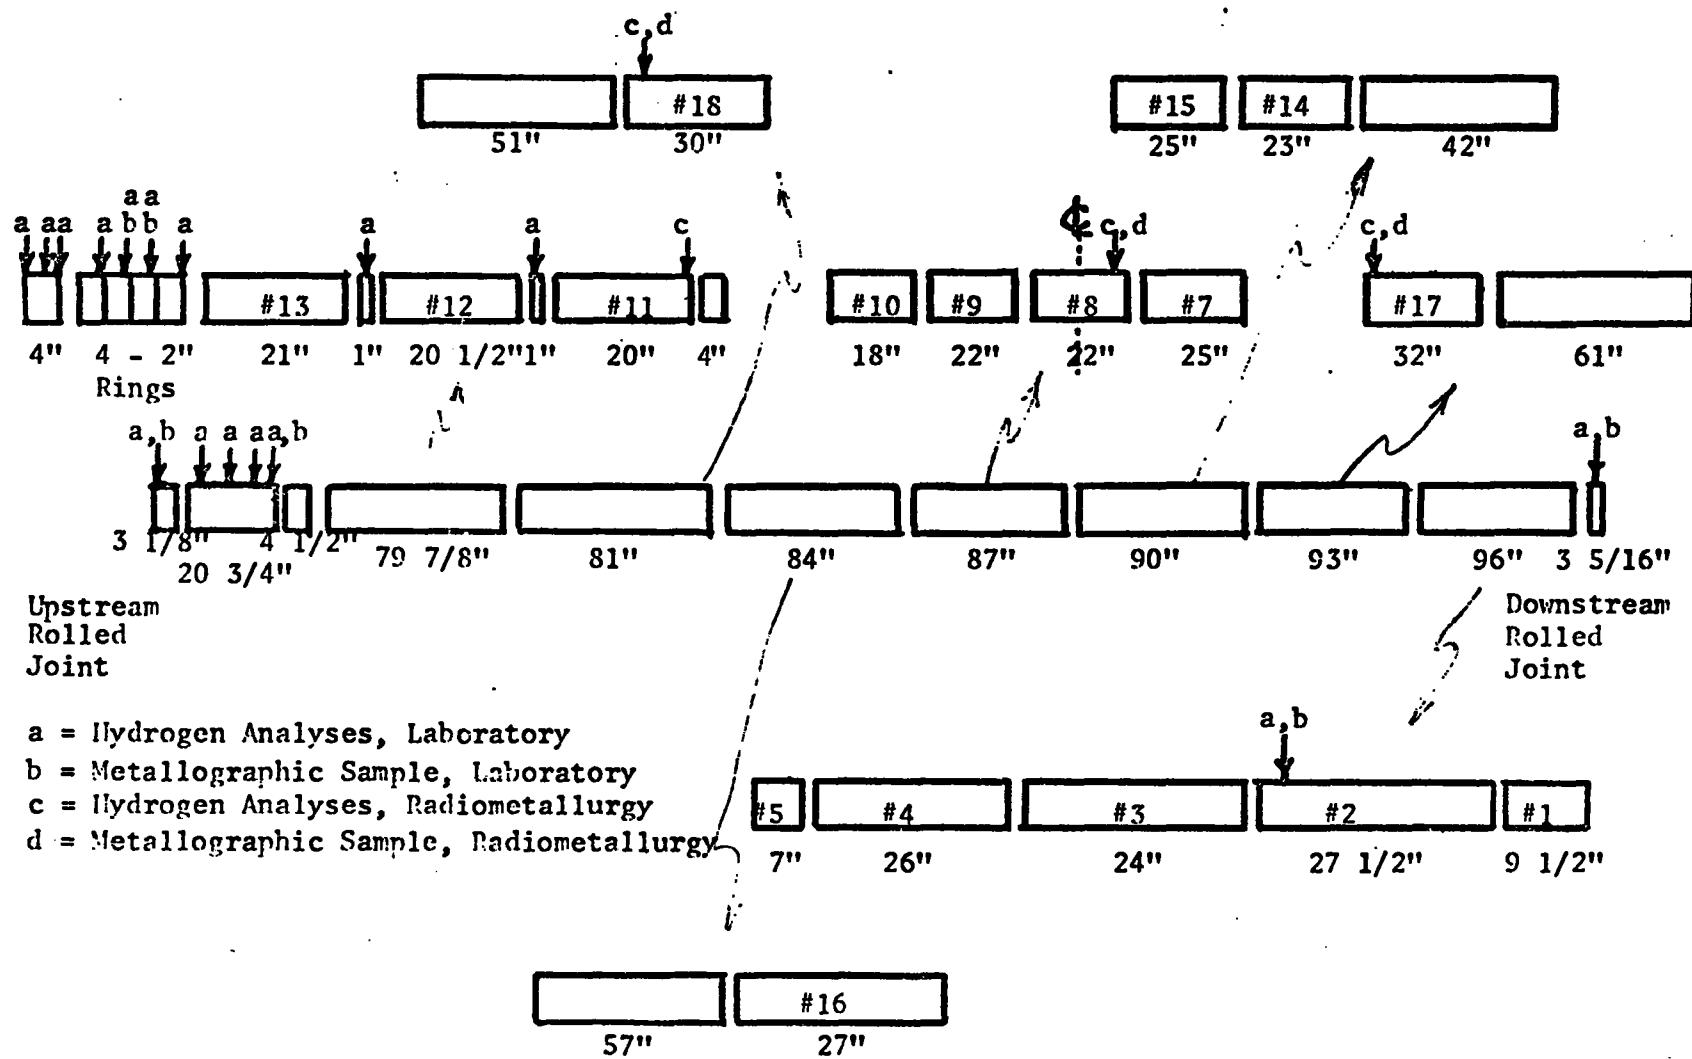
FIGURE 1

The pressure tube was cut into several pieces at N Reactor. The more radioactive pieces were sent to the Radiometallurgy Laboratory and the less radioactive pieces were examined in the Corrosion Laboratory. A diagram showing where the various test samples were removed from the pressure tube is shown in Figure 1.

Sample Locations - N Reactor Pressure Tube 1756

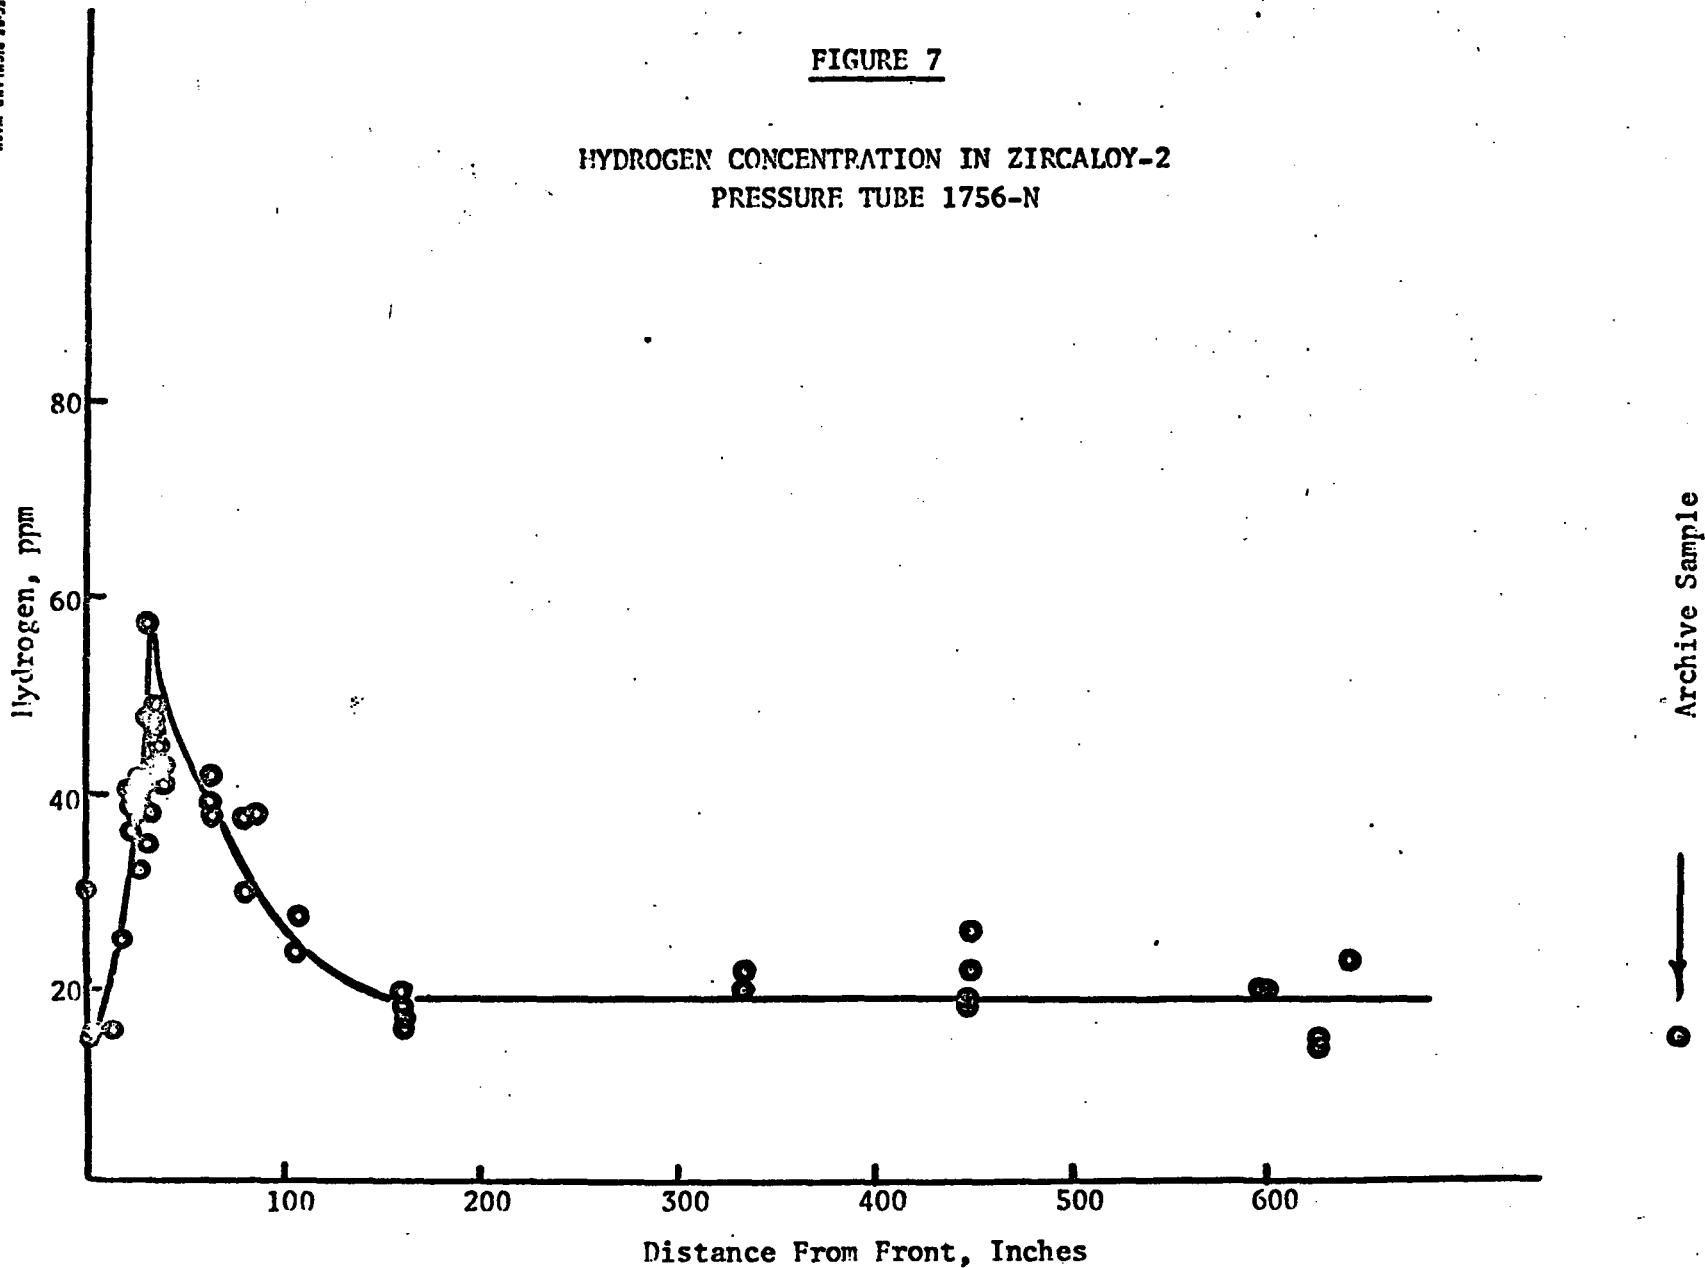
Hydrogen analyses were conducted by hot vacuum extraction of samples taken at several intervals along the length of the Zircaloy-2 pressure tube. The more radioactive center sections were analyzed in the Radiometallurgy Laboratory and the less radioactive end sections were analyzed in the Analytical Laboratory. The results are shown in Figure 7. Except for one location, the hydrogen content was nearly uniform along the tube length. Hydrogen levels for most of the tube length, including the areas exposed to the maximum neutron flux, ranged from 15 to 26 ppm with an average of about 19 ppm. This compares to a hydrogen content of 15 ppm on an archive sample cut from the tube before reactor operation. The exception was a very pronounced peak which occurred at approximately 30 inches from the front of the tube. Hydrogen levels up to a maximum of 58 ppm were observed at this location. Numerous samples at closely spaced intervals on either side of the peak confirmed that a peak definitely existed at this location but did not provide any evidence on why the peak occurred. An enlarged view of Figure 7 at the area near the hydrogen peak is shown in Figure 8. Samples for hydrogen analyses were taken at three locations circumferentially around the pressure tube; Figures 8b and 8c show the analyses at two locations 90 degrees apart in the scratched area at the bottom of the tube and Figure 8a shows the analyses 180 degrees from one of the scratched areas at a location near the top of the pressure tube where scratching did not occur. The scratching in the pressure tube was caused by charge-discharge operations involving the reactor fuel and spacers. The hydrogen peak occurred at all three locations and was of similar magnitude indicating circumferential distribution was fairly uniform.

HYDROGEN CONCENTRATION - EXPANSION OF FIGURE 7

Data At High Hydrogen Concentration Area

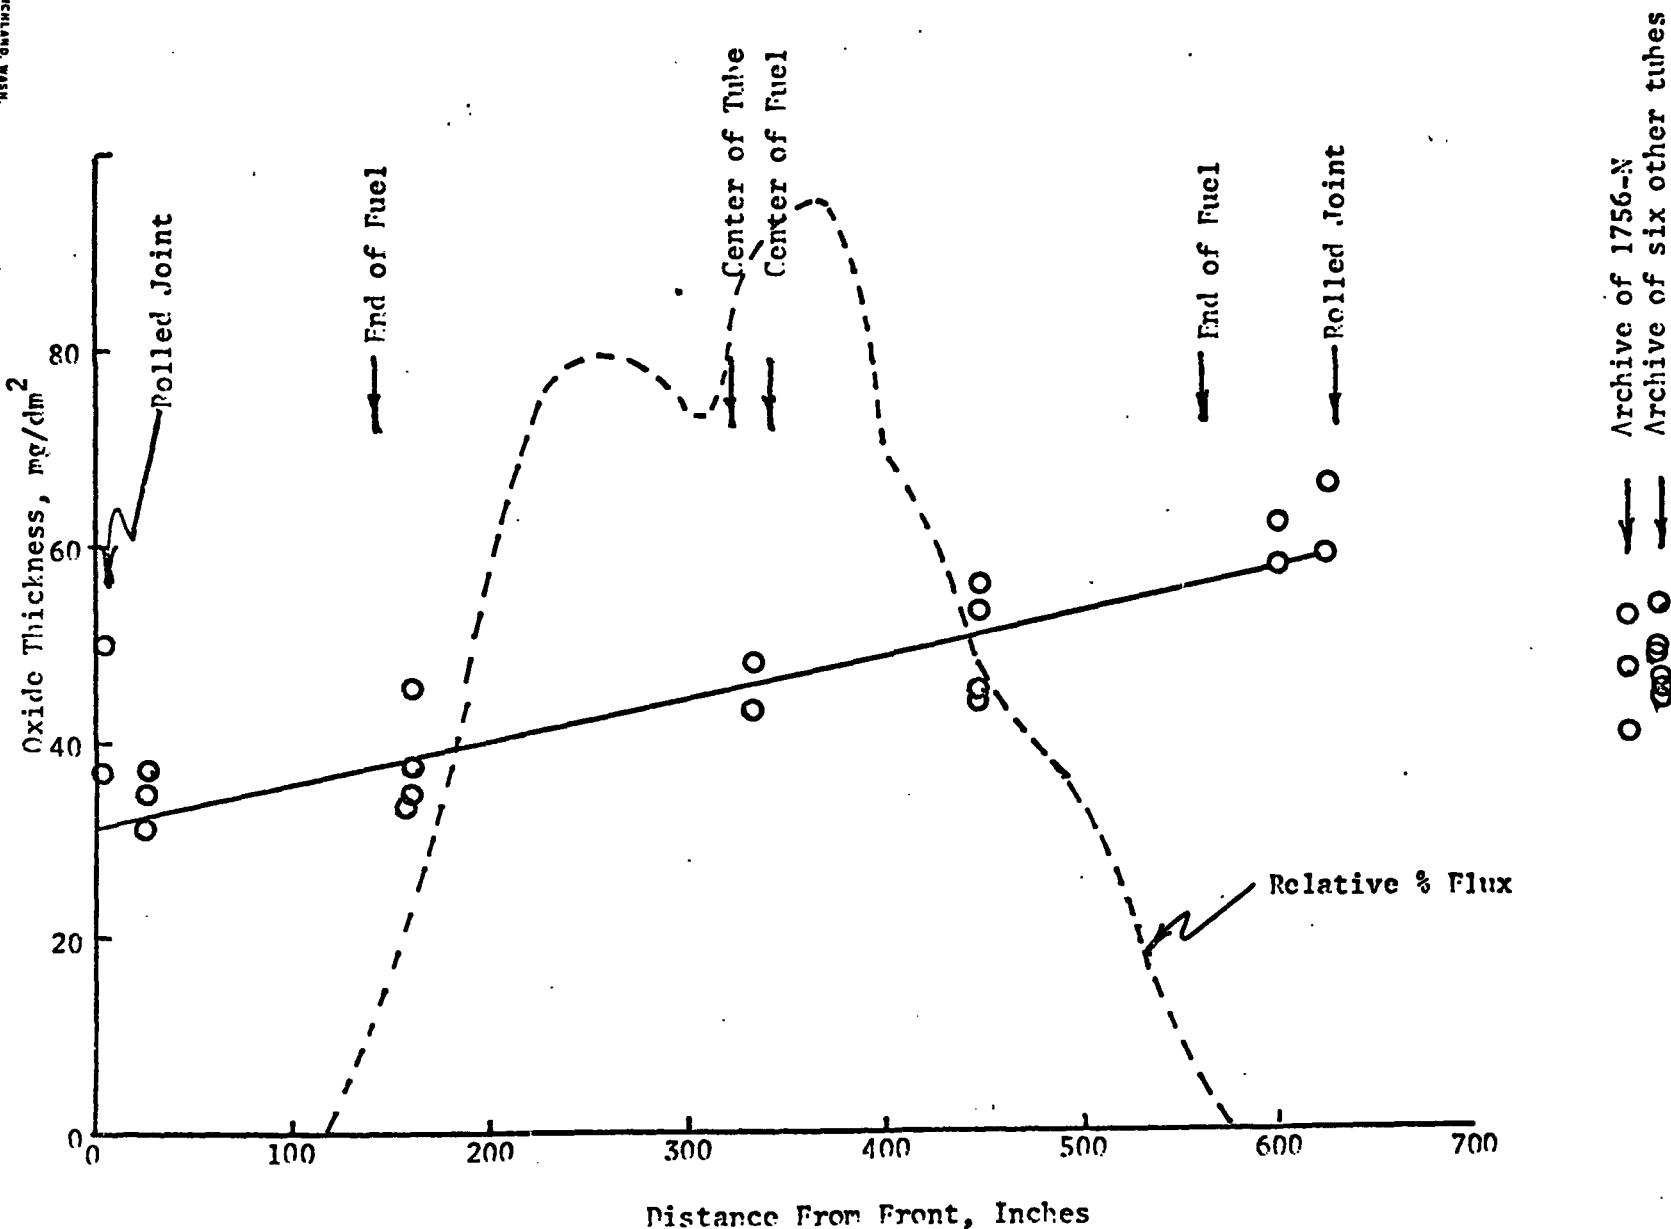
FIGURE 10
OXIDE THICKNESS ON ID SURFACE

Measurements of oxide thickness were made at several locations along the pressure tube length by mounting a metallographic sample in mounting compound and carefully polishing perpendicular to the tube surface. Oxide thicknesses were measured through a microscope with a calibrated Filar eyepiece and these thicknesses were converted to mg/dm^2 weight gain by multiplying by the theoretical density of ZrO_2 and a correction factor consisting of the weight ratio of O_2 to ZrO_2 . The results are shown in Figures 10 and 11. Figure 10 shows the weight gains observed on the tubing ID surfaces which were exposed to the water coolant and Figure 11 shows the weight gains observed on the tubing OD surfaces which were exposed to the reactor gas atmosphere. Each point on the curve is an average of five to ten measurements taken at arbitrary intervals along a small segment of the sample.
