ANL-6632
Metals, Ceramics,
and Materials
(TID-4500, 26th Ed.)
AEC Research and
Development Report

NONDESTRUCTIVE TESTS OF COMPONENTS
OF EBR-I, CORE IV

October 1963

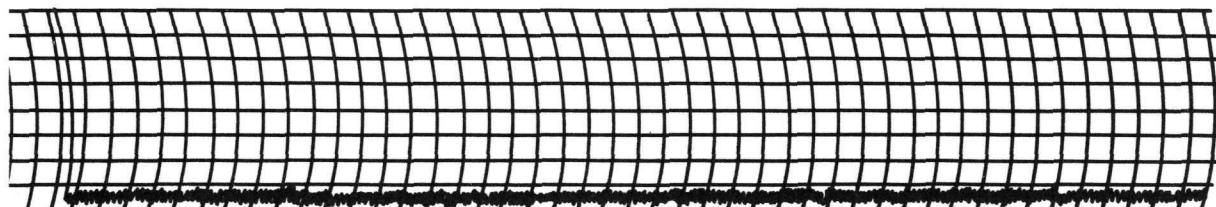
Normal Trace - Acceptable Rod

Figure 3. Pen recordings of the reference standard and acceptable rod

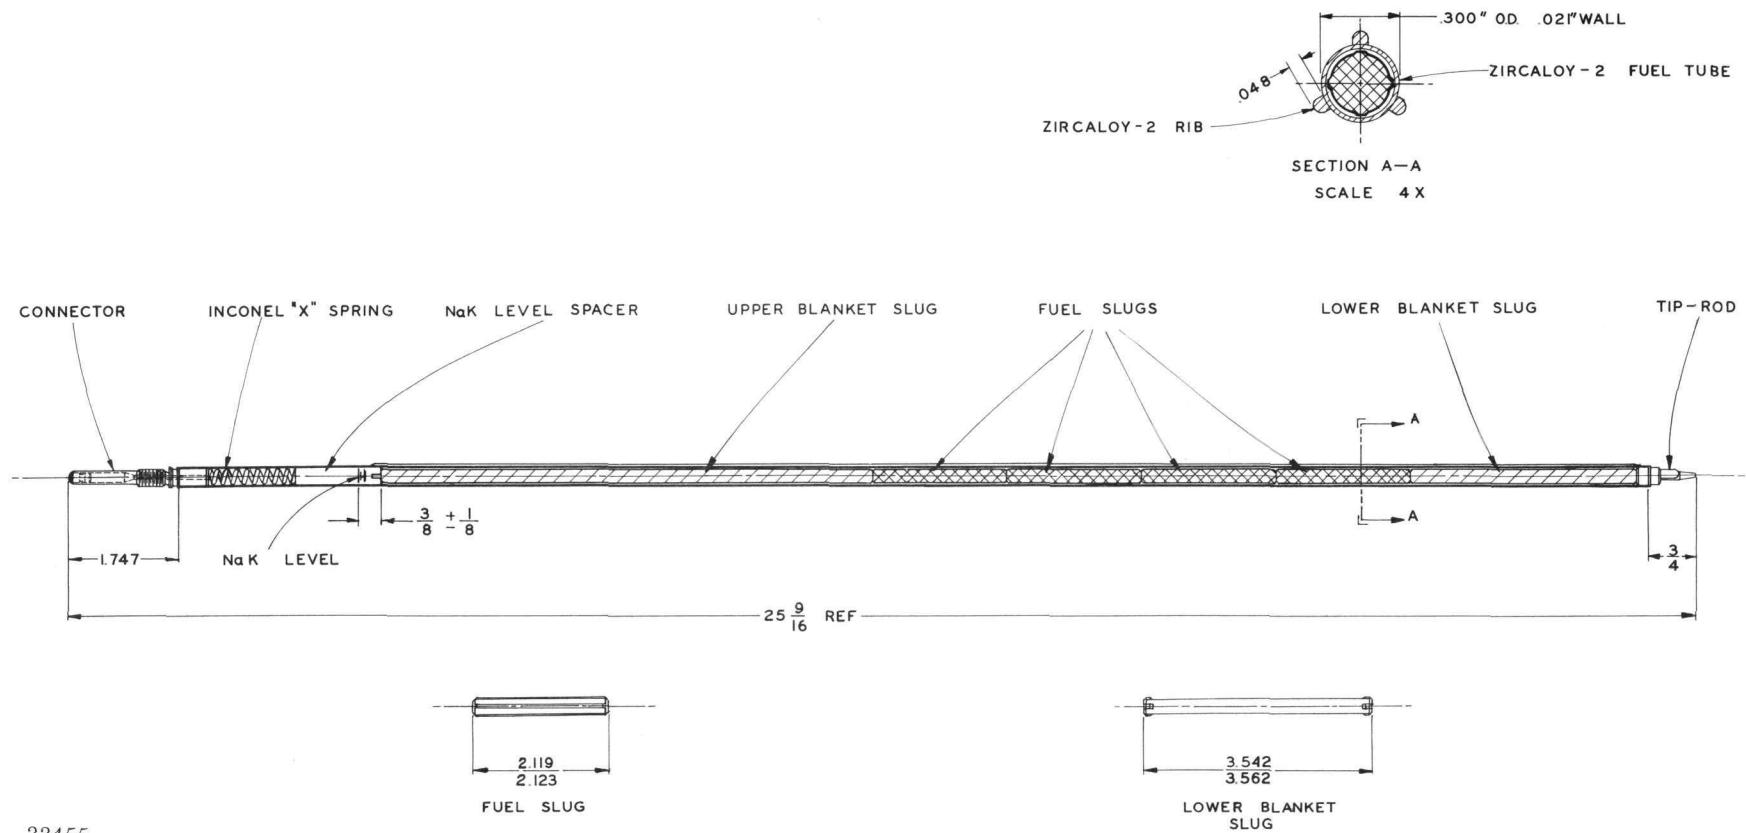
EBR-I Mark-IV fuel and blanket elements contained NaK distributed in an annulus between blanket slugs and the Zircaloy-2 jacket. The NaK level in the elements extended $\frac{3}{8} \pm \frac{1}{8}$ in. above the end of the upper slug at room temperature, as shown in Figure 16. The ID of the jacket tube was 0.257 ± 0.005 in. and the slug diameter was 0.235 ± 0.001 in., leaving a NaK-filled annulus of 0.011 ± 0.003 in. The blanket slugs had four spacer ribs at each end, 90° apart, of 0.006-in. height. The fuel slugs had similar ribs which aided in centering the slugs in the jacket. To maintain good heat transfer between the fissionable material and the jacket the NaK annulus had to be free of large voids.

Figure 16. EBR-I Core-IV fuel element.

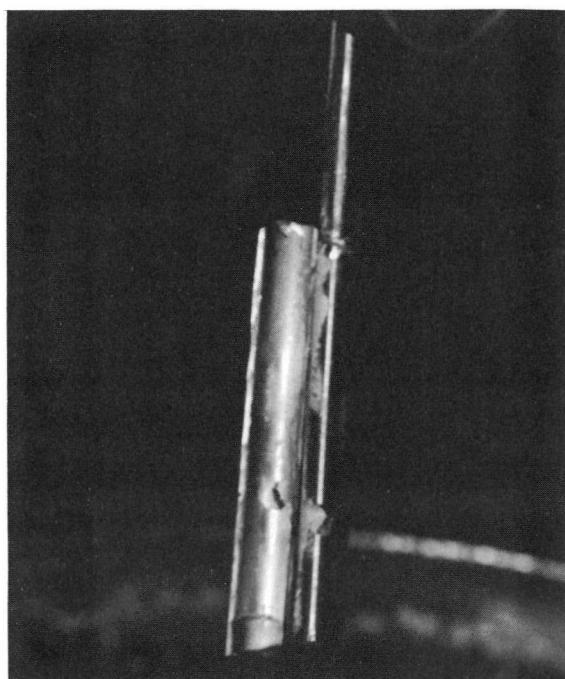
Figure 19

been heat treated and no wetting is evident. Note also that the end of the slug has only a thin layer of NaK. Before heat treatment the ends of the slugs could easily be located on the eddy current test trace by the large signal developed at this point, as shown in Figure 18b. Evidence that the space between the chamfered ends of adjacent slugs was filled with NaK was given by the ridge of frozen NaK that can be seen on the jacket at the bottom of Figure 19.
