SNAP I
DYNAMIC MERCURY LOOP TESTS
OF SELECTED MATERIALS

MND-P-2128

January 1957-June 1959

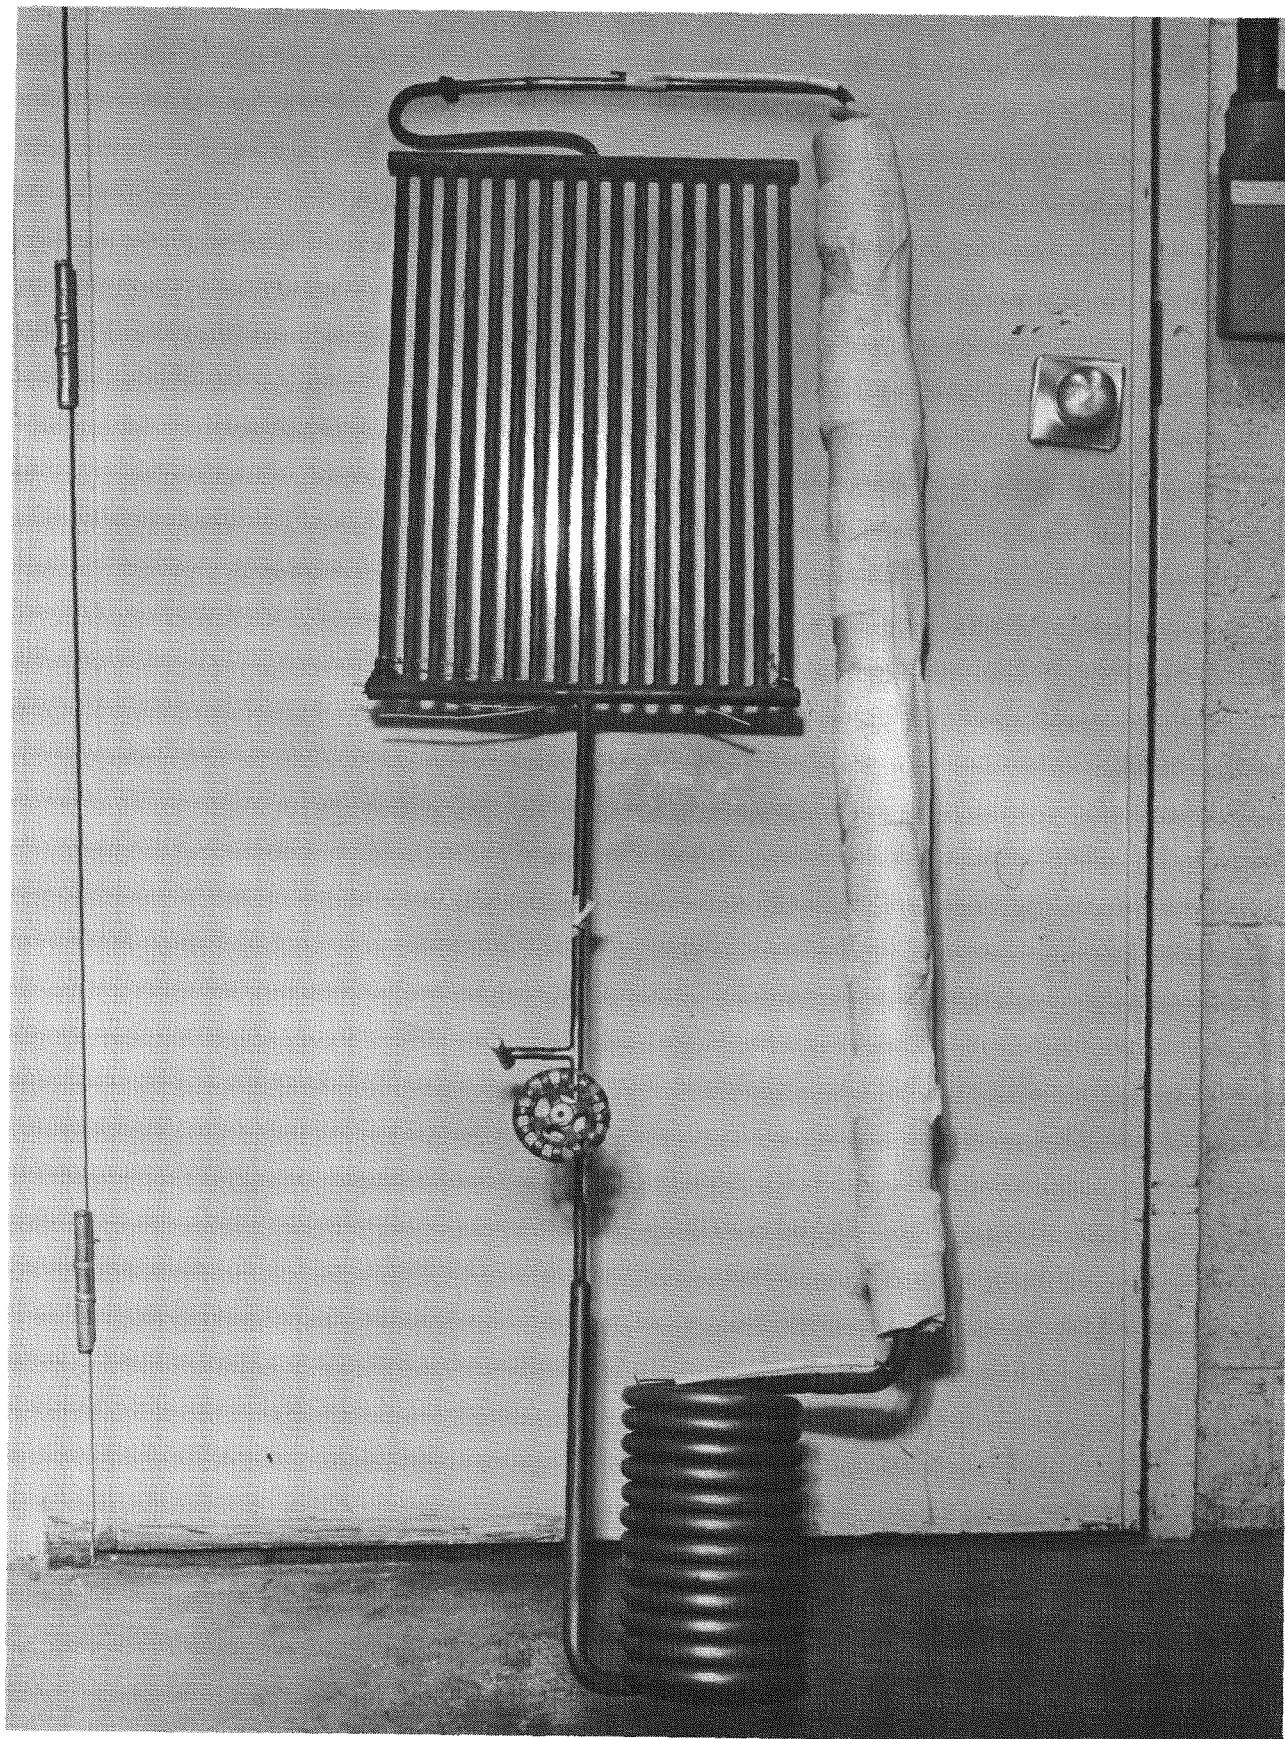
Fig. 1. Croloy-5 Si Loop Before Test

After a short run of eight hours, it was discovered that the design parameters could not be reached in either loop. Even at very low flow rates, it was impossible to reach the desired boiler temperature. Consequently, the superheat temperature could not be reached. Excessive heat losses in the upper superheat section caused refluxing of the mercury vapor. It was also found that the condenser cooling system did not provide adequate temperature control. The cooling system consisted of the condenser grid (the upper loop components shown in Fig. 1), a water-cooled flat plate which was blackened on the side parallel to the

condenser grid, and a half-moon disc, located between the grid and the plate. The disc covered about one-third of the radiating area and was actuated by an automatically controlled air motor, exposing the supplemental cooling surface. Shaft slippage and shutter binding due to disc warpage contributed to the poor temperature control. During an attempt to reach and maintain the design temperatures, the boiler heaters burned out.

The boilers were rewound with higher output heater wire and the thermal shutters modified to prevent slippage and ensure smoother operation. Sections of the shutters were riveted together to decrease high temperature warpage. The superheater section itself was decreased in length by rewinding the heater elements in a shorter space to concentrate the heat output. Heater wire was wound over the entire length of tubing from the boiler to the condenser in an effort to prevent refluxing in the superheat section. Finally, the valve was moved from the original position shown in Fig. 1 to that shown in Fig. 3, which shows one of the loops after test. All of these changes were made on both loops. Both loops were again chemically cleaned before startup.

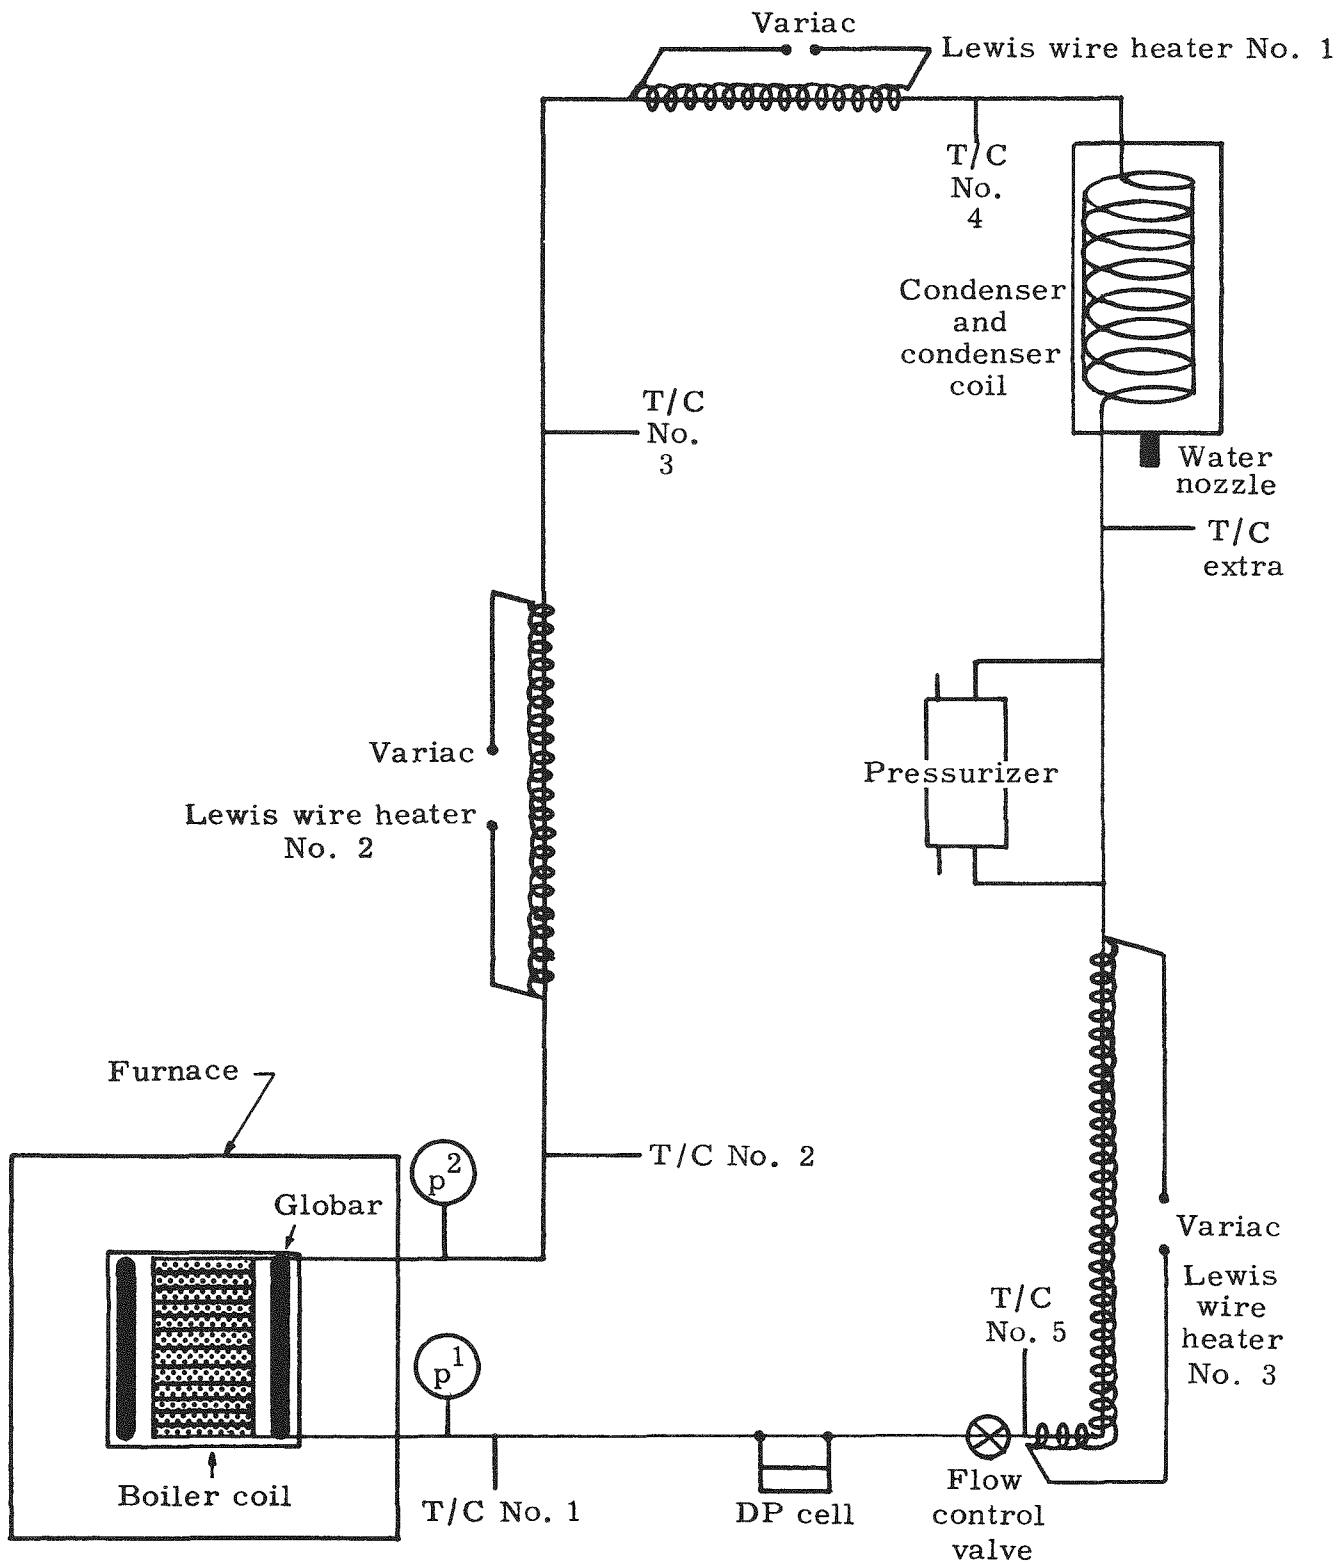
Fig. 4. Schematic of Design for Types 347 and 446 Stainless Steel Loops

The design specifications for the new loops were outlined only after due consideration of experience and data from the first three loops. Figure 4 shows the new design. The loops were designed so they could be easily changed in case of failure. Either the entire loop could be changed if the system was to be kept unimetallic, or just the coil replaced. The new loops were fabricated of 0.065-inch wall tubing with a 3/8-inch outside diameter. The boiler consisted of 28 feet of tubing coiled on a 2-1/4-inch radius. This resulted in 20 coils. Since a natural convection loop has no pump, the tubing lengths had to be greater than those in the actual power unit. The height of the condenser (liquid level) was governed by the head required to overcome the pressure drop of the boiler coil. The condenser was 11 feet above the coil. The tube

from the coil to the condenser was constructed in one piece. The entire length was wound with two Lewis wire heaters. These provided the 1.5 kilowatts of power needed to maintain temperature and prevent the dry mercury vapor from condensing before it reached the condenser. When the rest of the loop was functioning properly, this proved to be a very effective means of controlling heat loss. Heat resistant electrical insulating tape was wound onto the tubing under all of the Lewis wire heaters. Three inches of Super-X insulation were applied to the full length of the hot leg of the loop. The condenser consisted of 6 feet of tubing coiled on a 2-1/4-inch radius which resulted in 5 coils. The condenser coil was placed in an aluminum chamber 8 inches in diameter and 26 inches long. A water spray nozzle was located in the bottom of the chamber. The water spray cooled the mercury below 330° F; therefore, a 0.4 kilowatt Lewis wire heater was provided to assure the correct boiler feed temperature of 330° F. One inch of Super-X insulation was used on the cold leg of the loop. Between the condenser and the inlet leg of the boiler coil were two tees, one for filling and evacuating the loop and the other for the pressurizer which also served as the mercury reservoir; a pneumatically operated needle valve to control the flow; and a differential pressure cell to measure the flow rate and actuate the control valve. Five thermocouples and two pressure tees were located as shown in Fig. 4. A sixth thermocouple was provided, but not used, at the condenser exit. All hot leg joints were welded. The cold leg joints consisted of Swagelok fittings.

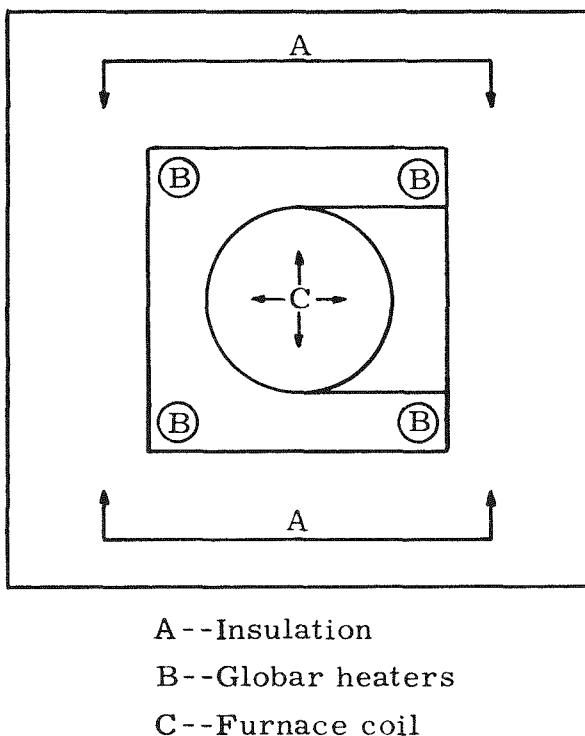
Fig. 5. Furnace--Cross Section of Overhead View

The furnaces were a radiant heat type (Globar) with a 20-kilowatt capacity. Although they were designed to operate with eight heaters, four proved ample. The Globars were wired two in series with each pair connected to a saturable core reactor. Control was effected by a Martin-made d-c power supply regulated by a Wheelco on-off type controller. The entire package was wired such that in the "off" position the d-c power was at an intermediate position rather than off, thus supplying some heat to the furnace to avoid excessive cycling of the Globars. In the "on" position, the power level could be preset to supply the heat required to "drive" the boiler coil. Figure 5 shows the furnace design. The boiler coil was supported in the furnace chamber by fire bricks and surrounded by four Globar heaters. The furnace door was made in two sections with a slot in each for the inlet and outlet legs. After the coil had been positioned, the doors were closed and the slots packed with insulation to prevent excessive heat loss.

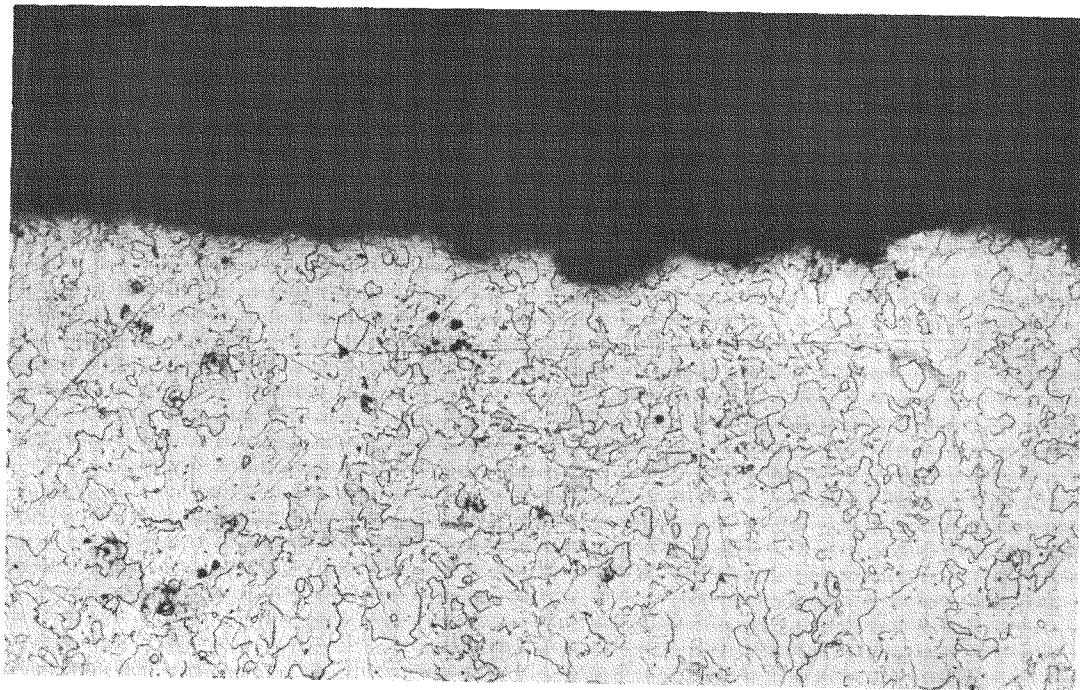
(Exposed to mercury at 1000° F) 250X

Fig. 12. Croloy-5 Ti Loop--Section Through the Cold Leg Return to the Boiler

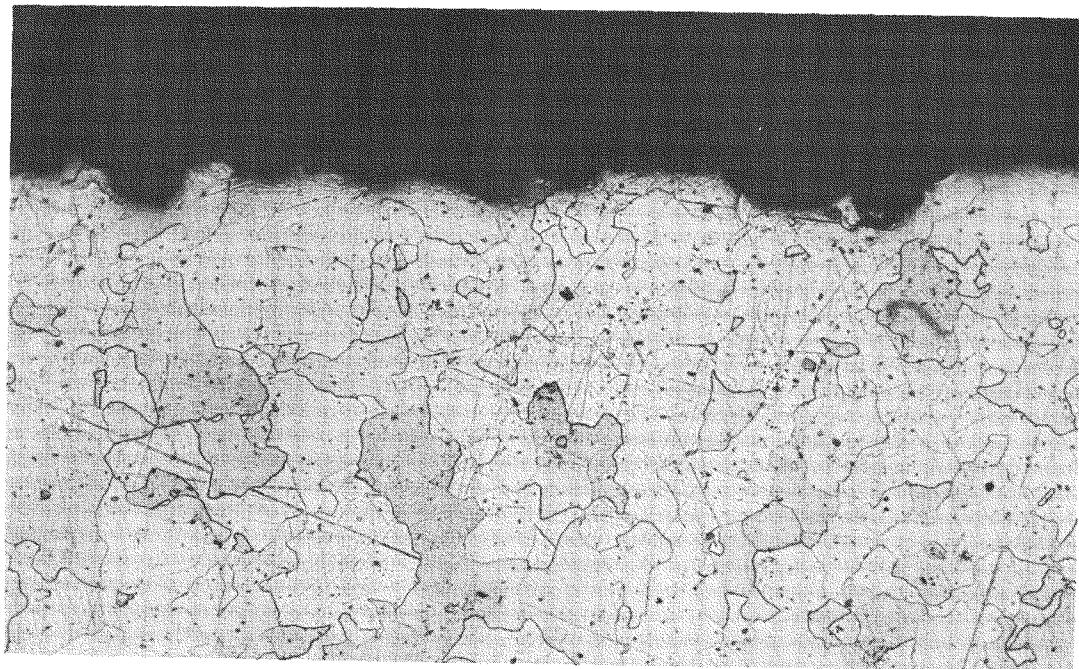
(Exposed to mercury at about 1025° F)

Fig. 13. Croloy-5 Ti Loop--Section Through the Middle Coil of the Boiler

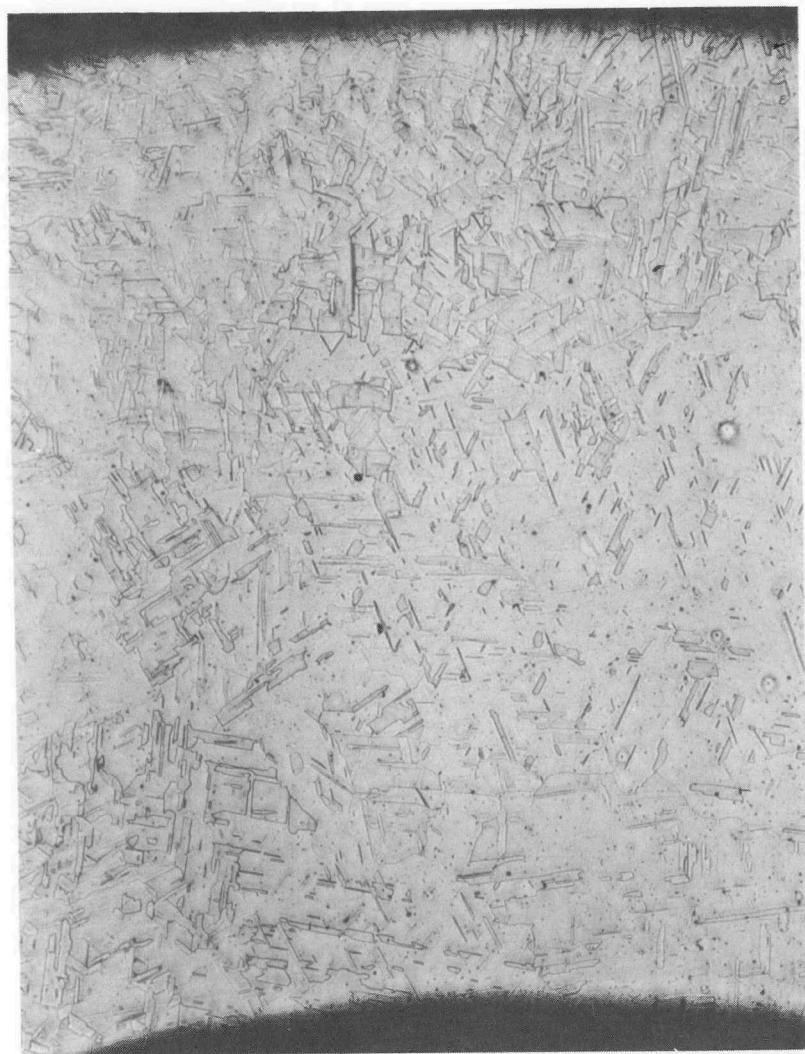
(Exposed to mercury at 350° F) 75X

Fig. 16. Type 347 Stainless Steel Boiler Two Coils from Bottom
(cold end about 350° F)

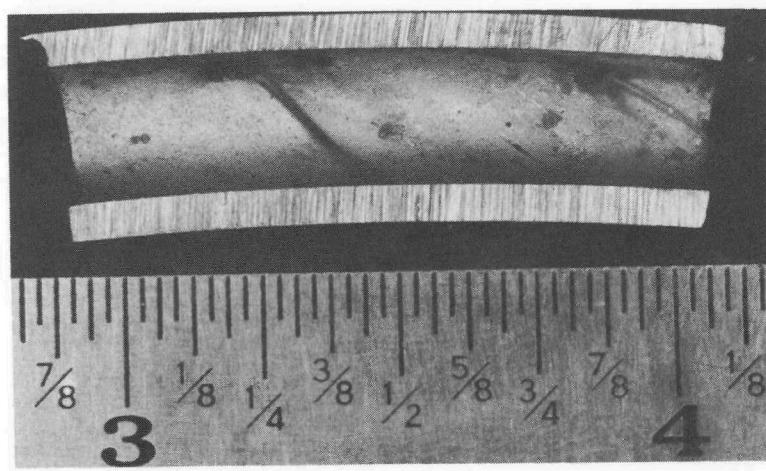
Fig. 17. Type 347 Stainless Steel Inside Surface of Tube At Same
Locations as Fig. 16

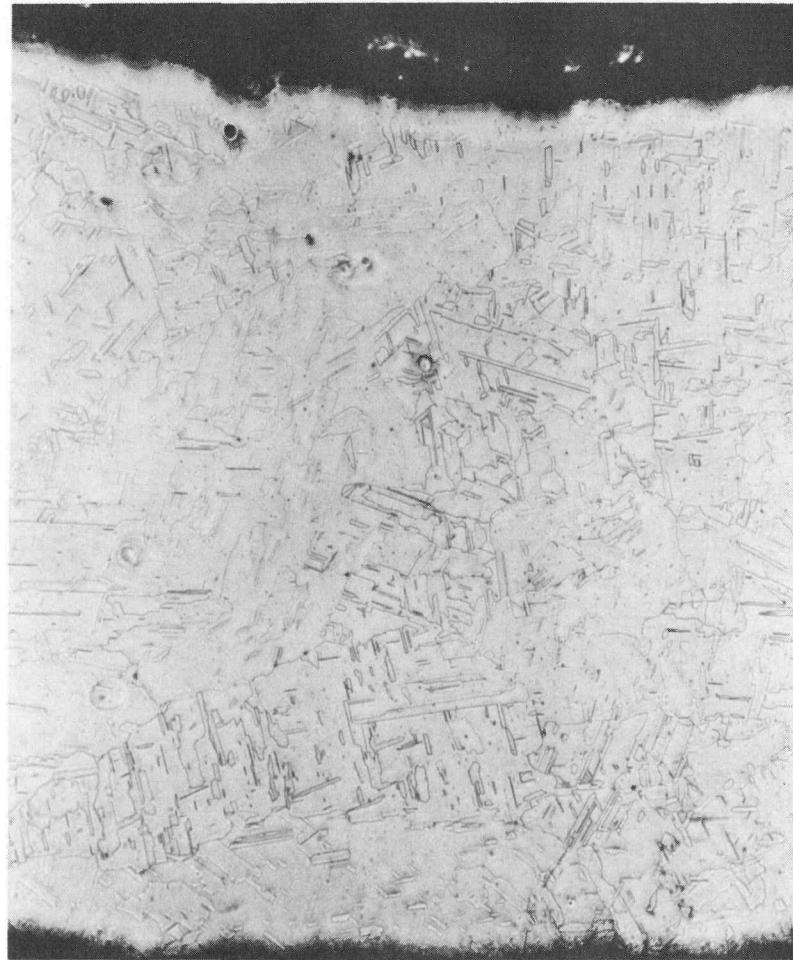
(Exposed to mercury at about 1050° F) 75X

Fig. 18. Type 347 Stainless Steel Boiler--Middle Coil

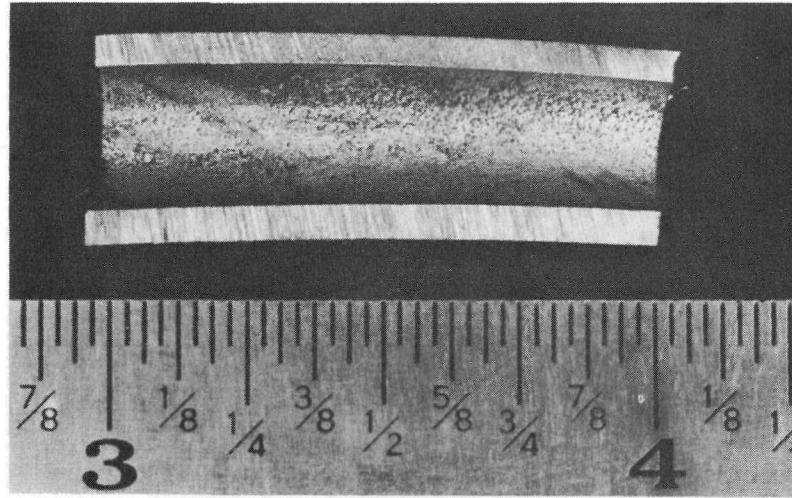
Fig. 19. Type 347 Stainless Steel--Inside Surface of Stainless Steel Tube at Same Location as on Fig. 18

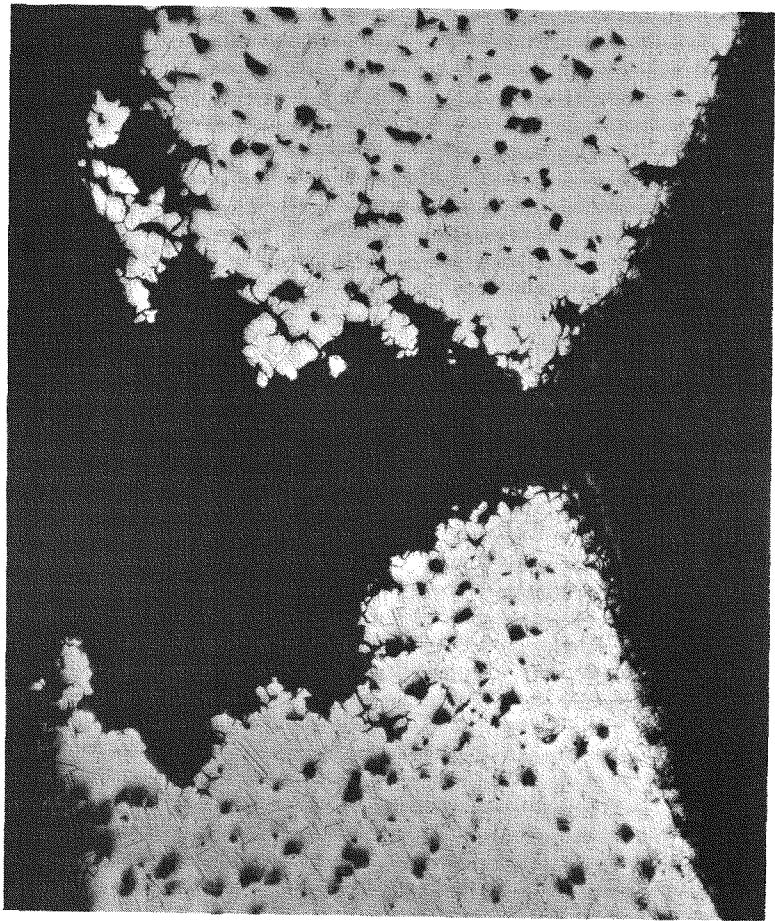
The ruptured area is shown in Fig. 23. The numerous cracks that appear in the photograph are attributed to the overall expansion of the tubing just prior to its rupturing. Figure 24 shows a transverse section through the rupture. The continuous crack in the upper boiler area was attributed to the severe cold work of the tubing. The crack was located along the outer wall of the tube where the greatest amount of cold work occurred. It appears that this area which was cold worked extensively was susceptible to mercury corrosion.

Fig. 24. Type 347 Stainless Steel Boiler--Transverse Section Through One End of Rupture on Exit Leg

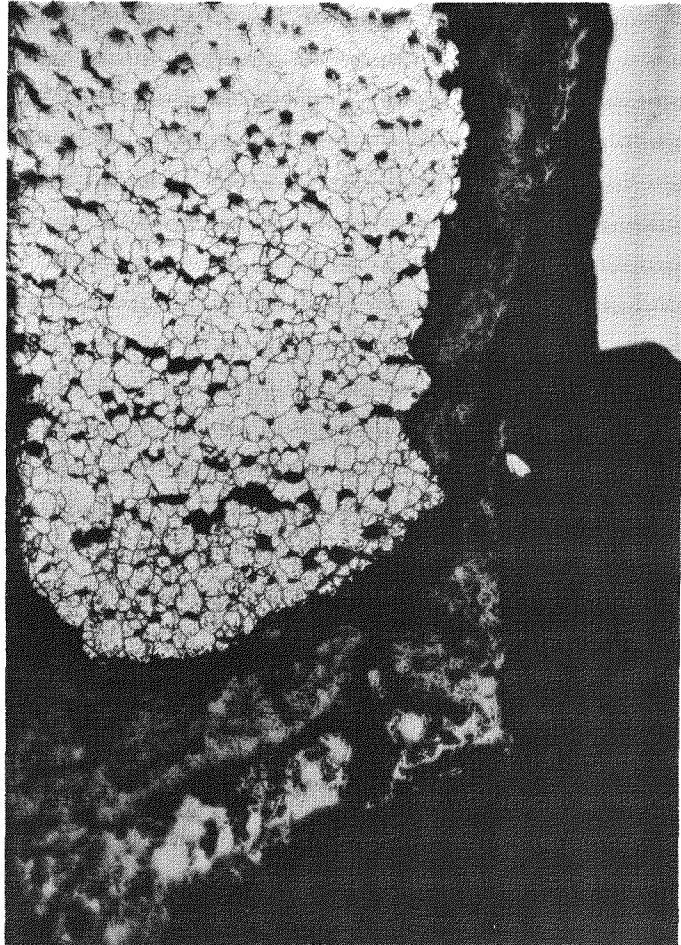
The niobium boiler ruptured after 50 hours, two coils below the top. Figure 28 shows the outside of the Type 347 stainless steel clad at the rupture point. Figure 29 shows the perforated niobium tube with the stainless steel clad removed. A transverse section of the rupture area, Fig. 30, shows some of the remaining corrosion products between the tubes. The probable cause of failure was atmospheric oxidation from outside the tubing--not mercury corrosion. The argon blanket normally maintained in the furnace was somehow reduced in depth, exposing the upper loops of the boiler coil to atmospheric oxygen. Figure 28 shows that considerable external oxidation occurred. An imperfection in the stainless steel clad perforated, allowing oxygen to contact the niobium with resultant oxidation and the deposition of the reaction products. Examination of the as-received material showed that the stainless steel clad was weld-drawn tubing rather than seamless tubing. The failure occurred along this seam.

(Exposed to mercury vapor at approximately 1350° F)

Fig. 30. Niobium Liner Clad with Type 347 Stainless Steel--Sample Taken Two Turns from Top of Coil at Point of Rupture

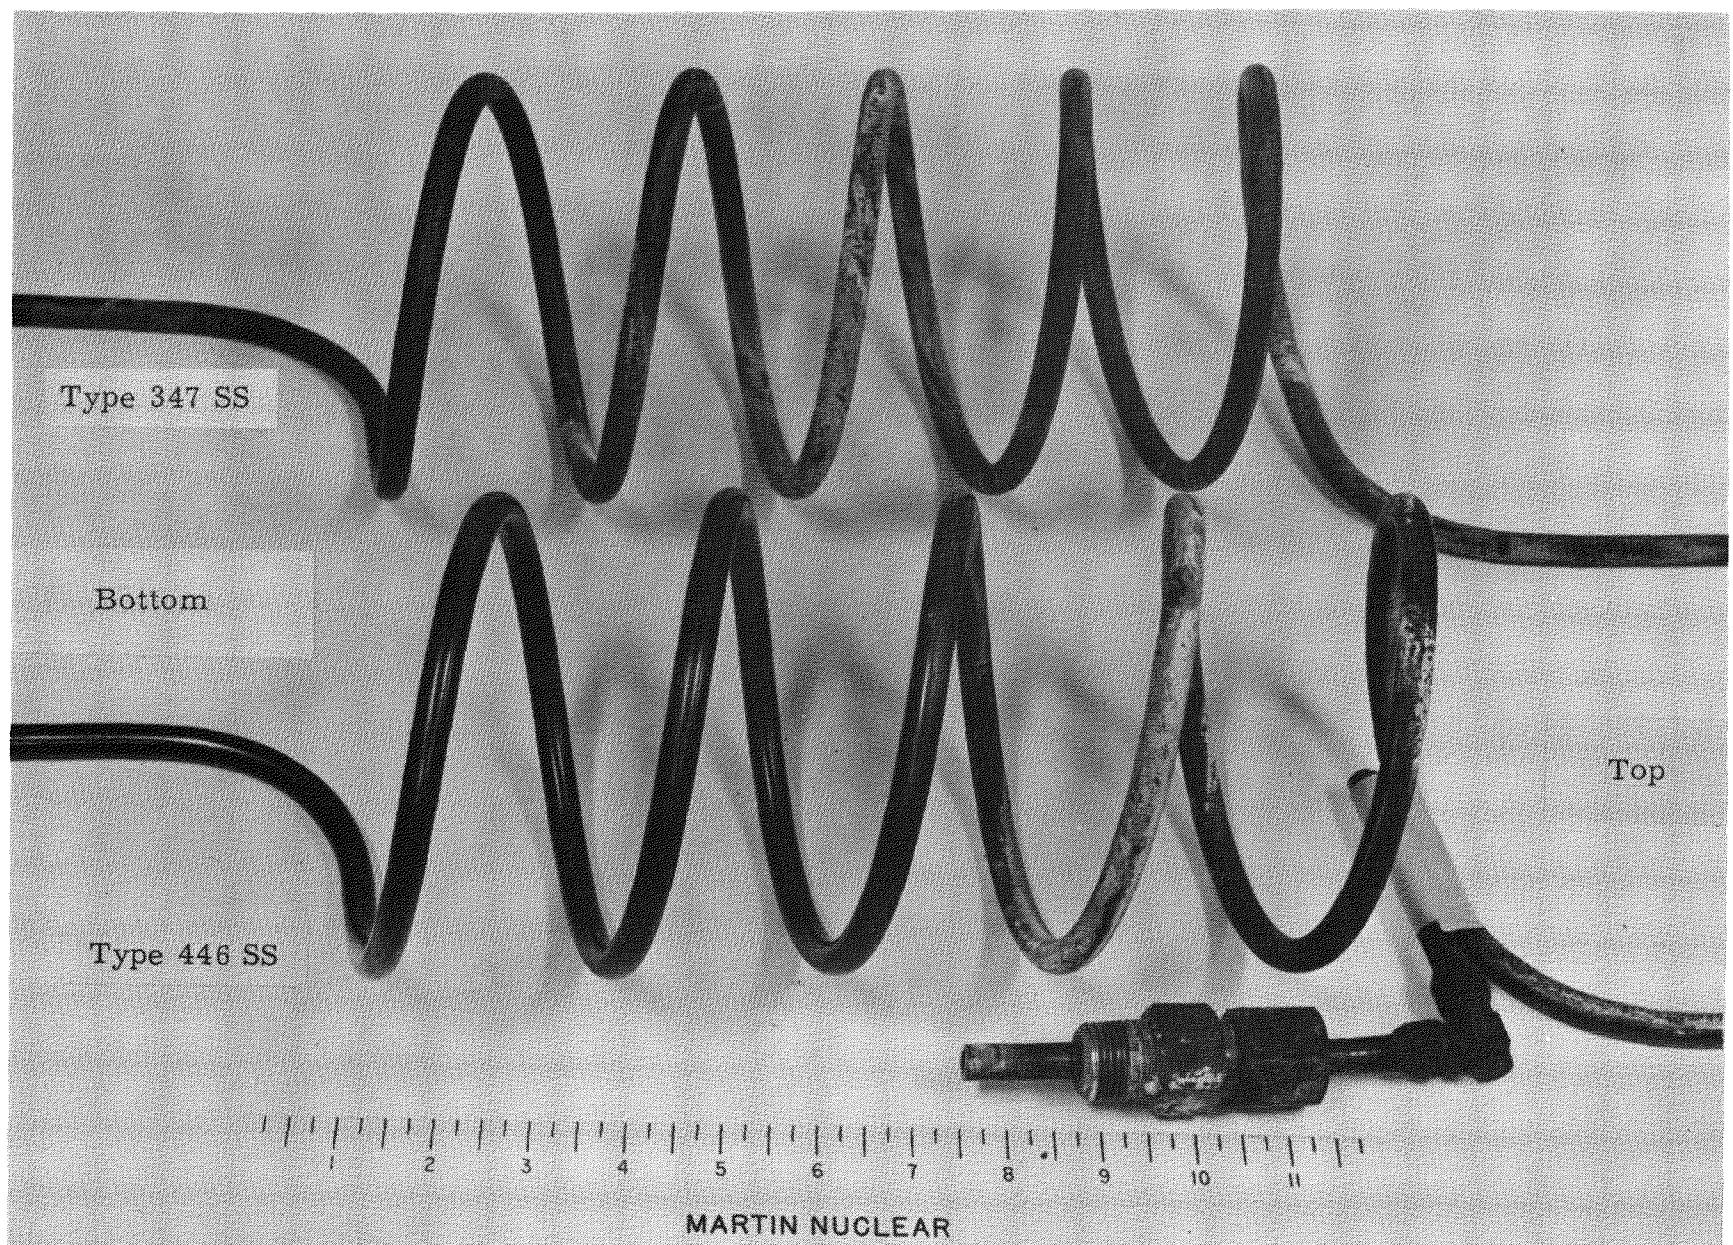
Fig. 35. Condenser Coils

The condenser coil is shown in Fig. 35. A metallographic section from the top condenser coil, Fig. 36, shows the continuation of the attack noted in Fig. 33. Farther down the coil the metal is unattacked. Figure 37 shows the middle of the coil, and Fig. 38 pictures the bottom of the coil where the temperature was about 350° F. The remainder of the cold leg was also unaffected.

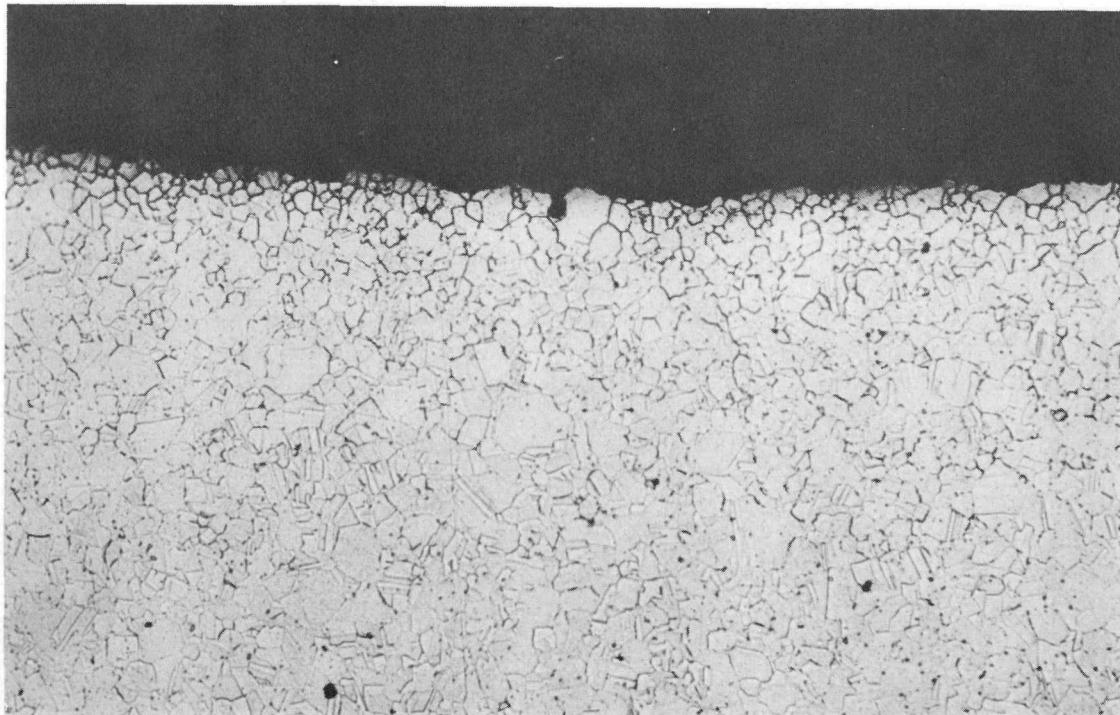
Fig. 37. Type 347 Stainless Steel Condenser--Middle Coil, Exposed to Mercury Droplets and Mercury Vapor in 500° to 700° F Range 250X

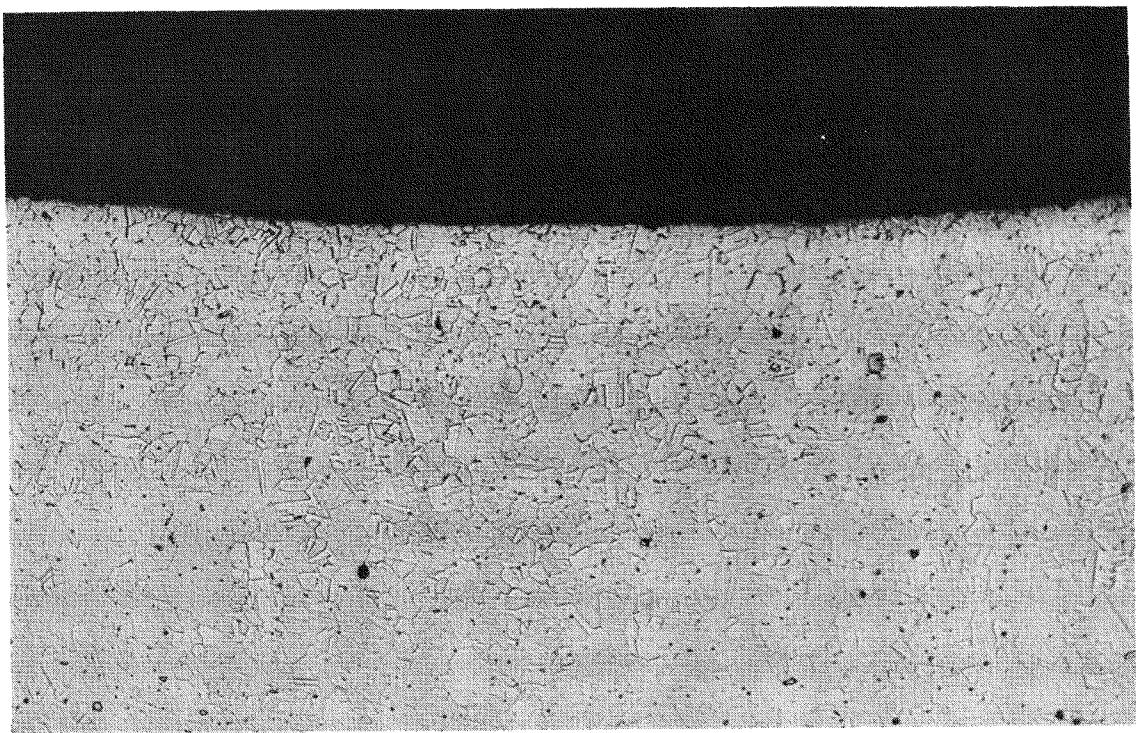
Fig. 38. Type 347 Stainless Steel Condenser--Bottom Coil, Exposed to Mercury at About 300° to 350° F
