**GREENHOUSE**

SCIENTIFIC DIRECTOR'S REPORT  
ANNEX 3.5

THE EFFECTS OF ATOMIC WEAPONS ON GLAZING AND  
WINDOW CONSTRUCTION

by  
WALTON C. CLARK  
of  
PUBLIC BUILDINGS SERVICE

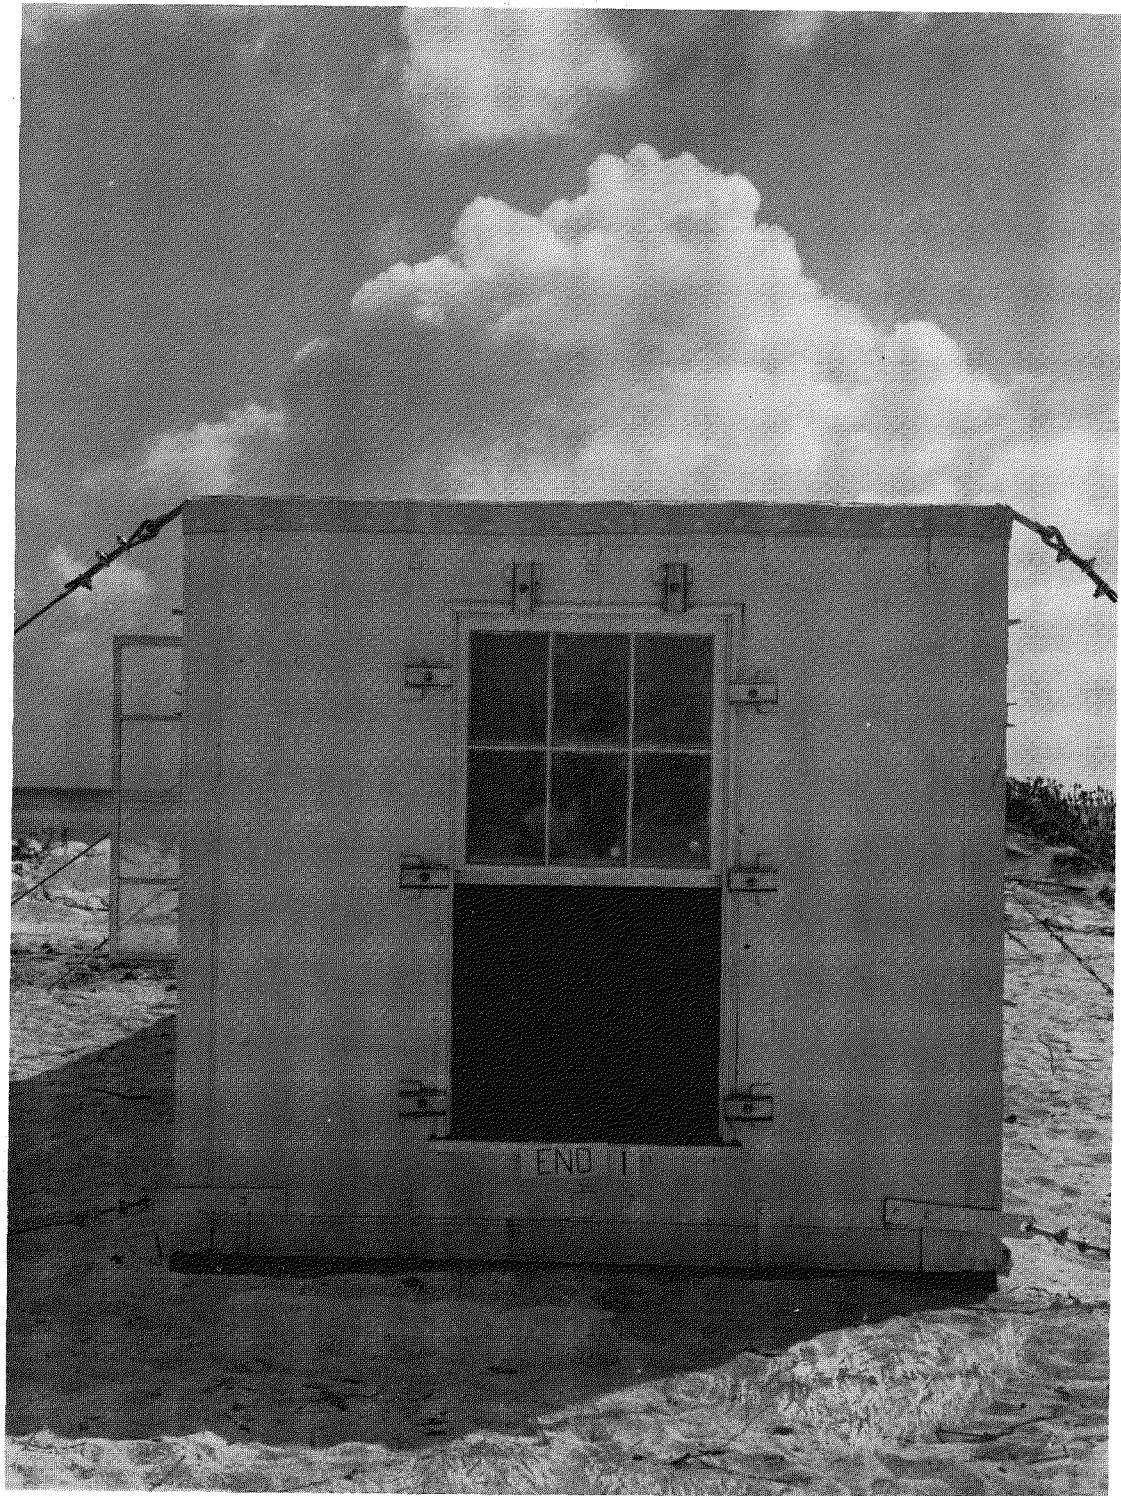
FIG. 3.7 Outside of Double-hung Wooden Window 1 before the Blast. This was a commercial-grade wooden window such as is used in moderately priced residences. The frame was made of members 1½ in. thick and glazed with double-strength glass 10½ by 15 in. The lower sash was raised before the blast.

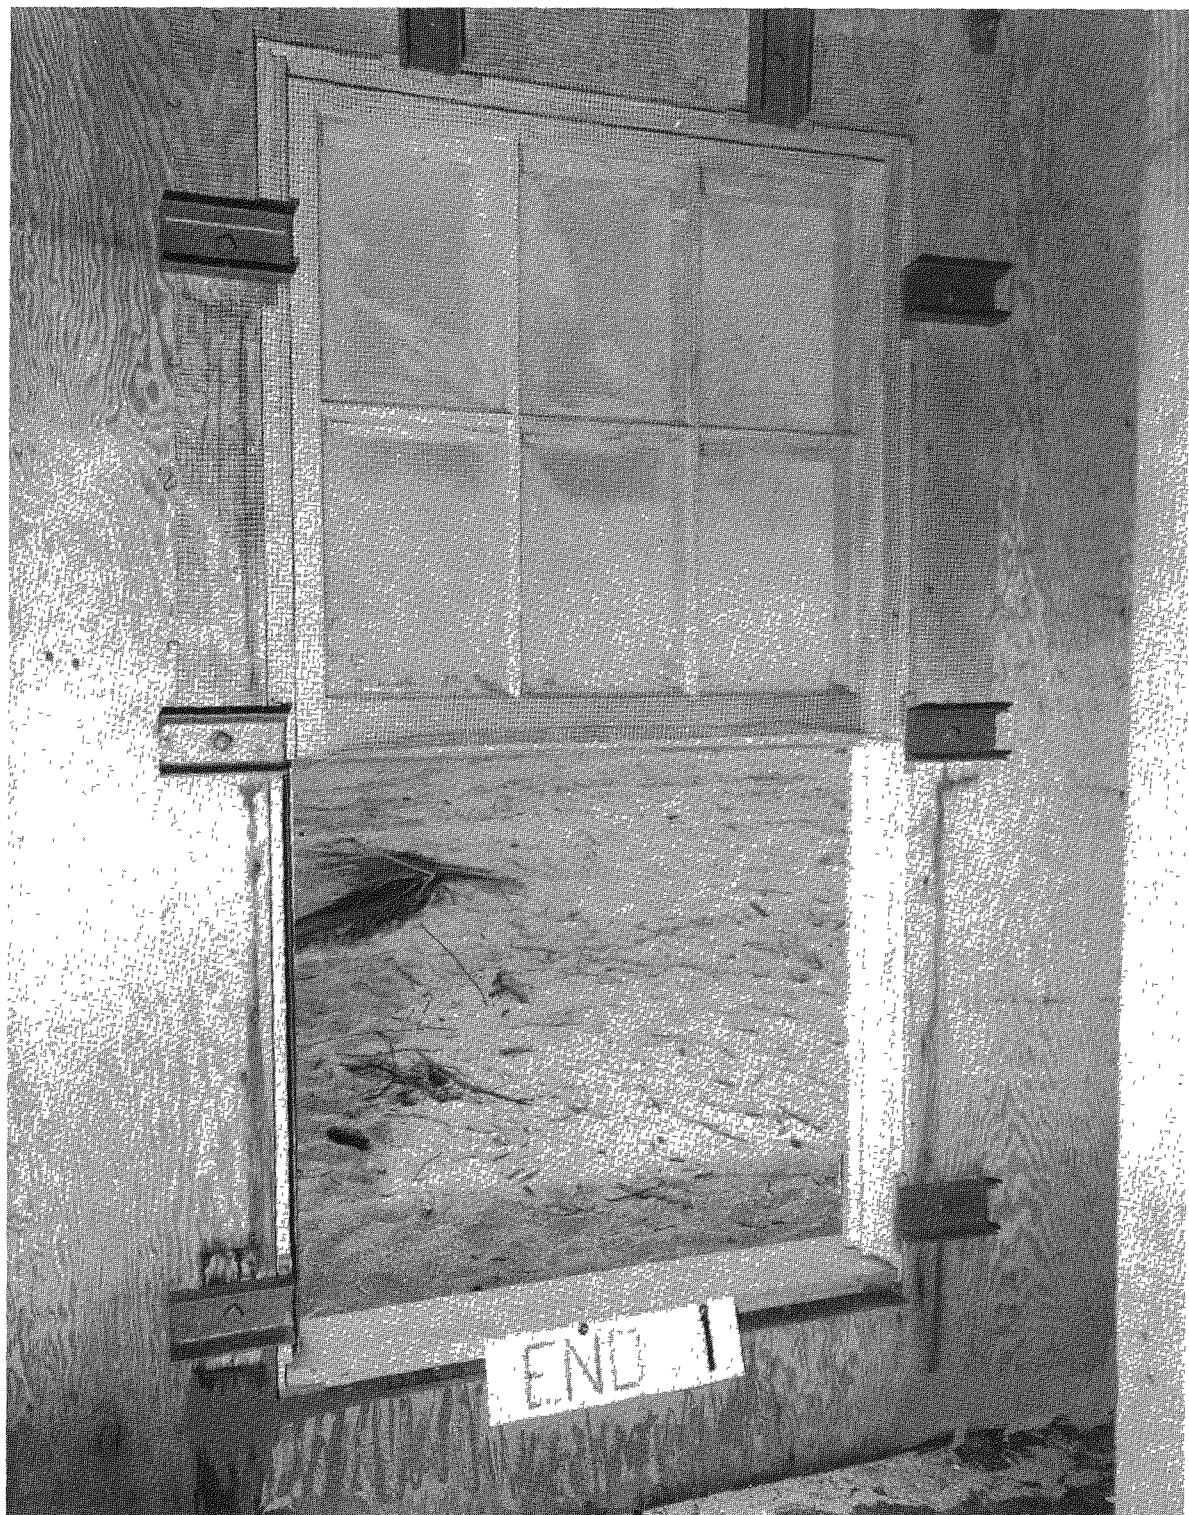
FIG. 3.9 Inside of Double-hung Wooden Window 1 before the Blast. Wire netting with  $\frac{1}{4}$  in. mesh was mounted on the inside to stop flying fragments from entering the room.

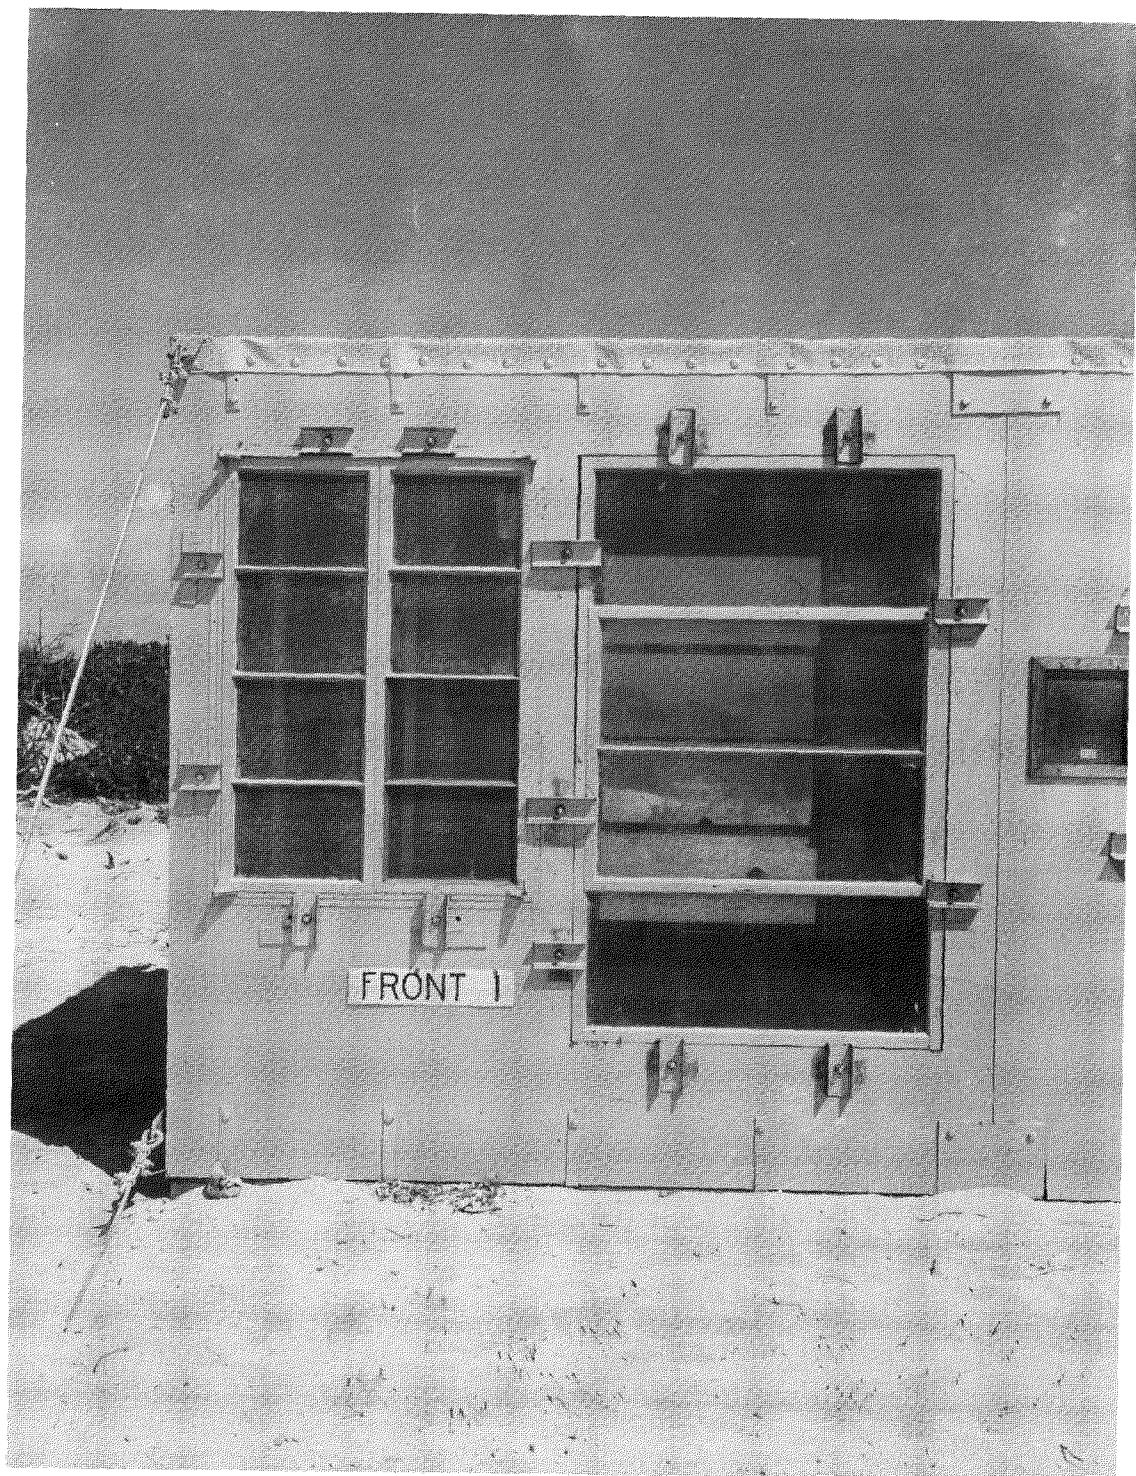
FIG. 3.11 Outside of Casement Window 2 and Architectural Projected Window 3 before the Blast. Window 2 is a lightweight aluminum, outswinging casement window used principally in small residences. Window 3 is an architectural projected steel window with two center panes of safety glass mounted in the ventilator section. The top pane was plate glass  $14\frac{5}{8}$  by  $37\frac{5}{8}$  in., and the lower pane was polished wire glass.

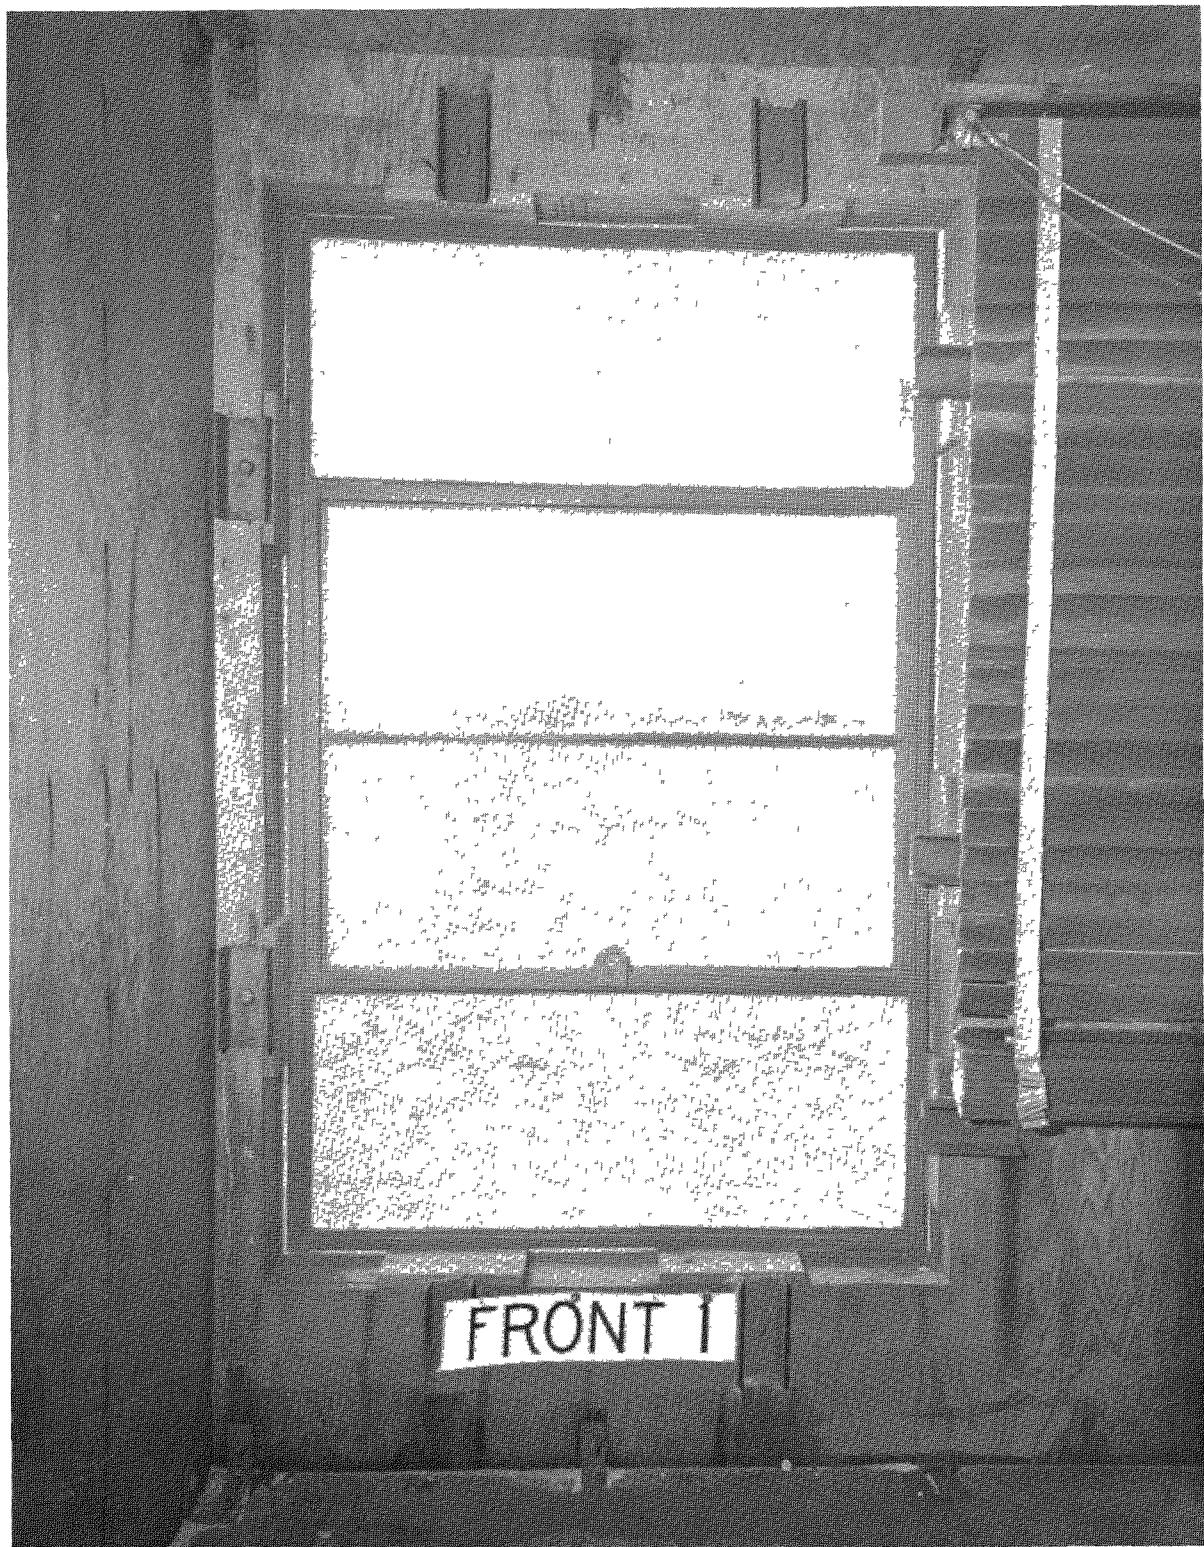
FIG. 3.13 Inside of Architectural Projected Window 3 before the Blast. Wire netting with  $\frac{1}{4}$  in. mesh was installed on the inside of the opening.

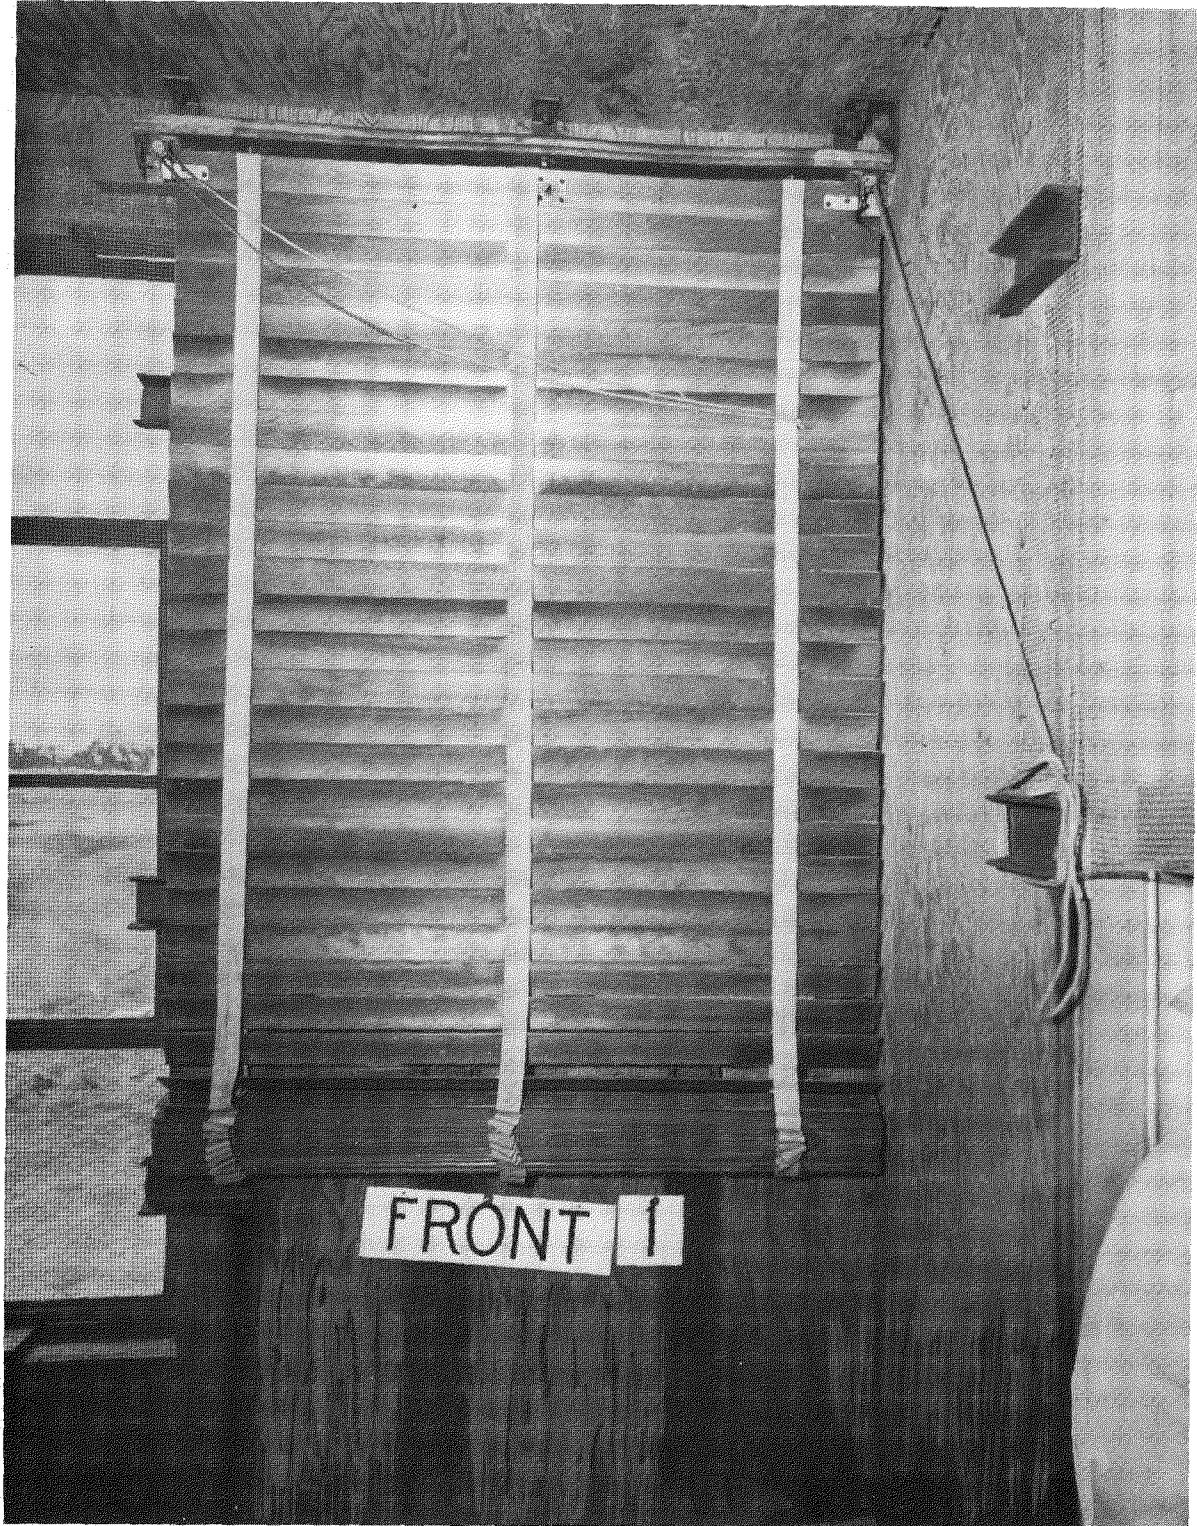
FIG. 3.15 Inside of Casement Window 2 before the Blast. A wooden Venetian blind was mounted over the opening.

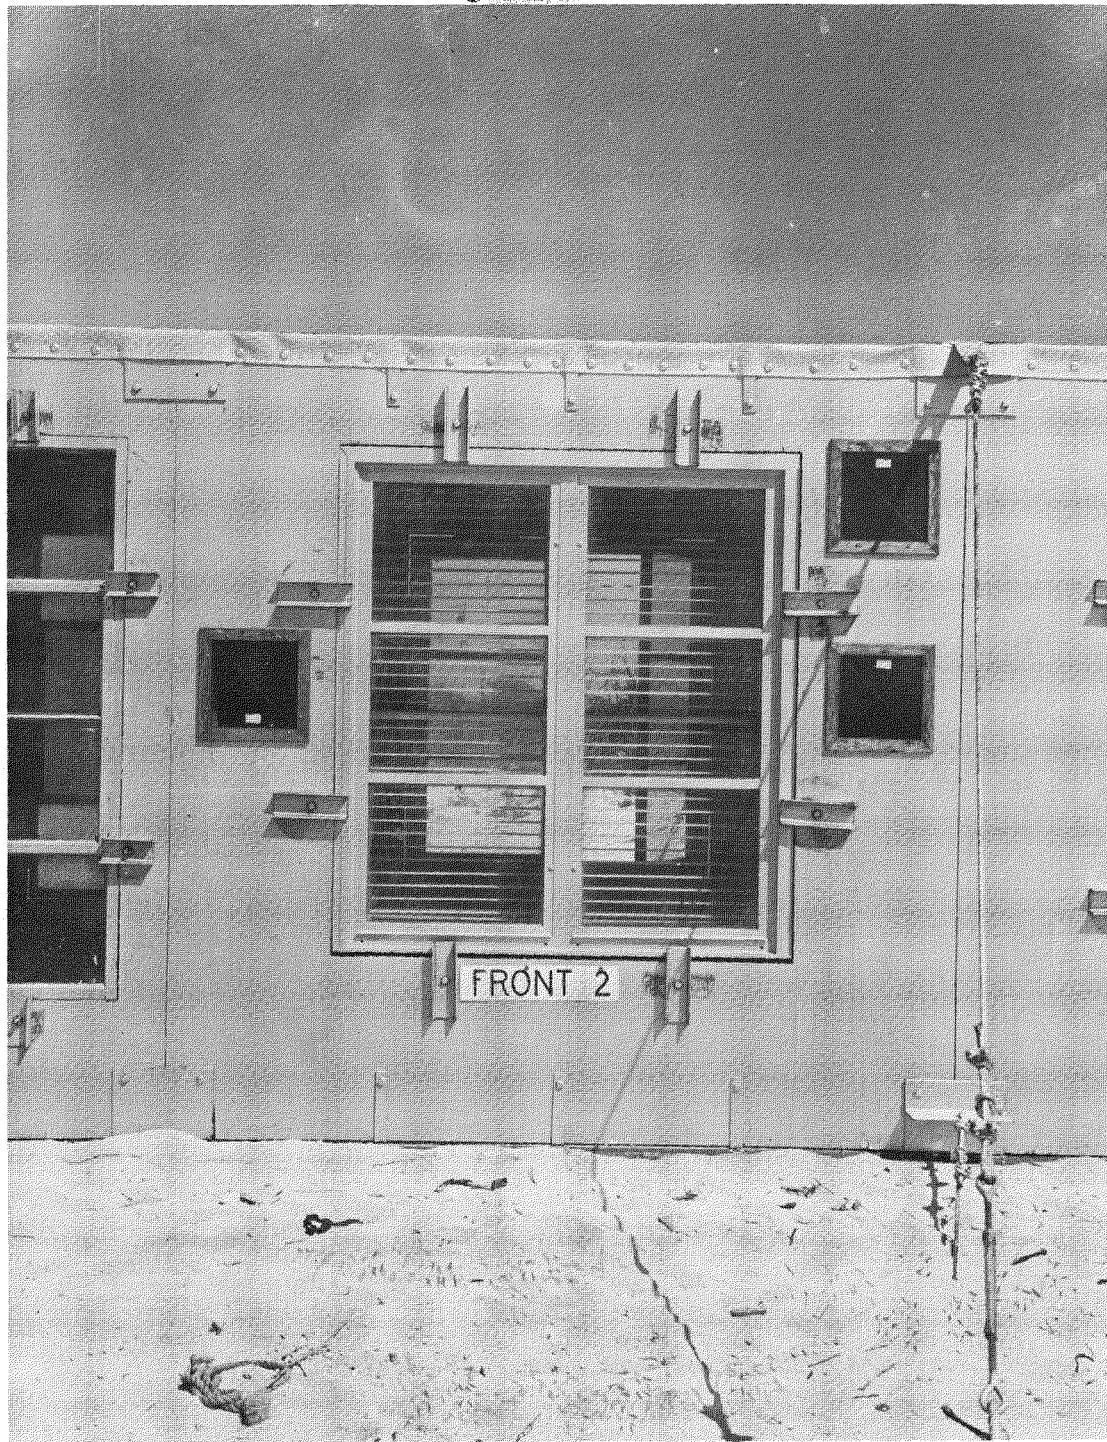
FIG. 3.17 Outside of Heavy Inswing Casement Window 4 before the Blast. This aluminum casement is designed for office buildings and hospitals. The sash on the left was glazed with plate glass in the top and bottom openings and double-strength glass in the center. The sash on the right side was glazed with tempered glass. All pieces of glass were  $17\frac{5}{8}$  by  $22\frac{1}{2}$  in. In the three openings in the wall surrounding this window were installed pieces of specially prepared glass panels known as "Flex-Duplate" made by applying  $\frac{1}{8}$  in. plate glass on both sides of a plastic sheet. (See Sec. 2.3.)

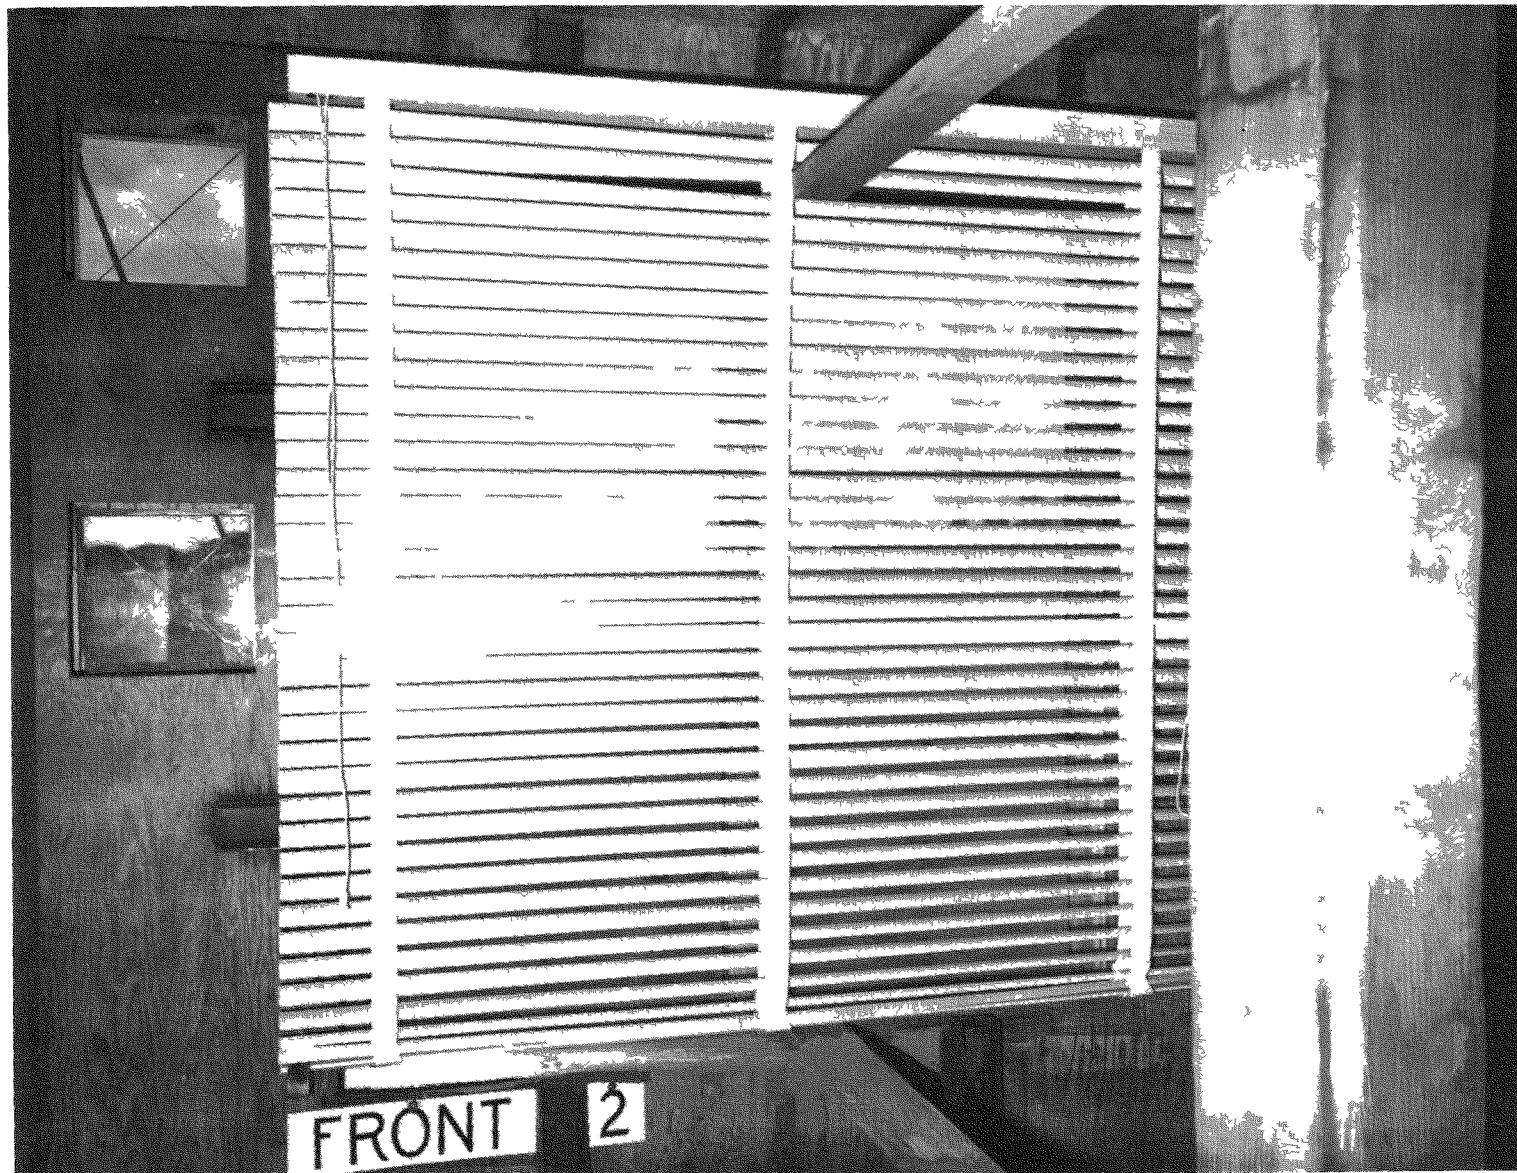
FIG 3 19 Inside of Inswinging Casement Window 4 before the Blast A metal Venetian blind was mounted over the opening One sash was blocked in place by means of two pieces of 2 by 4 in planks shown in the photograph

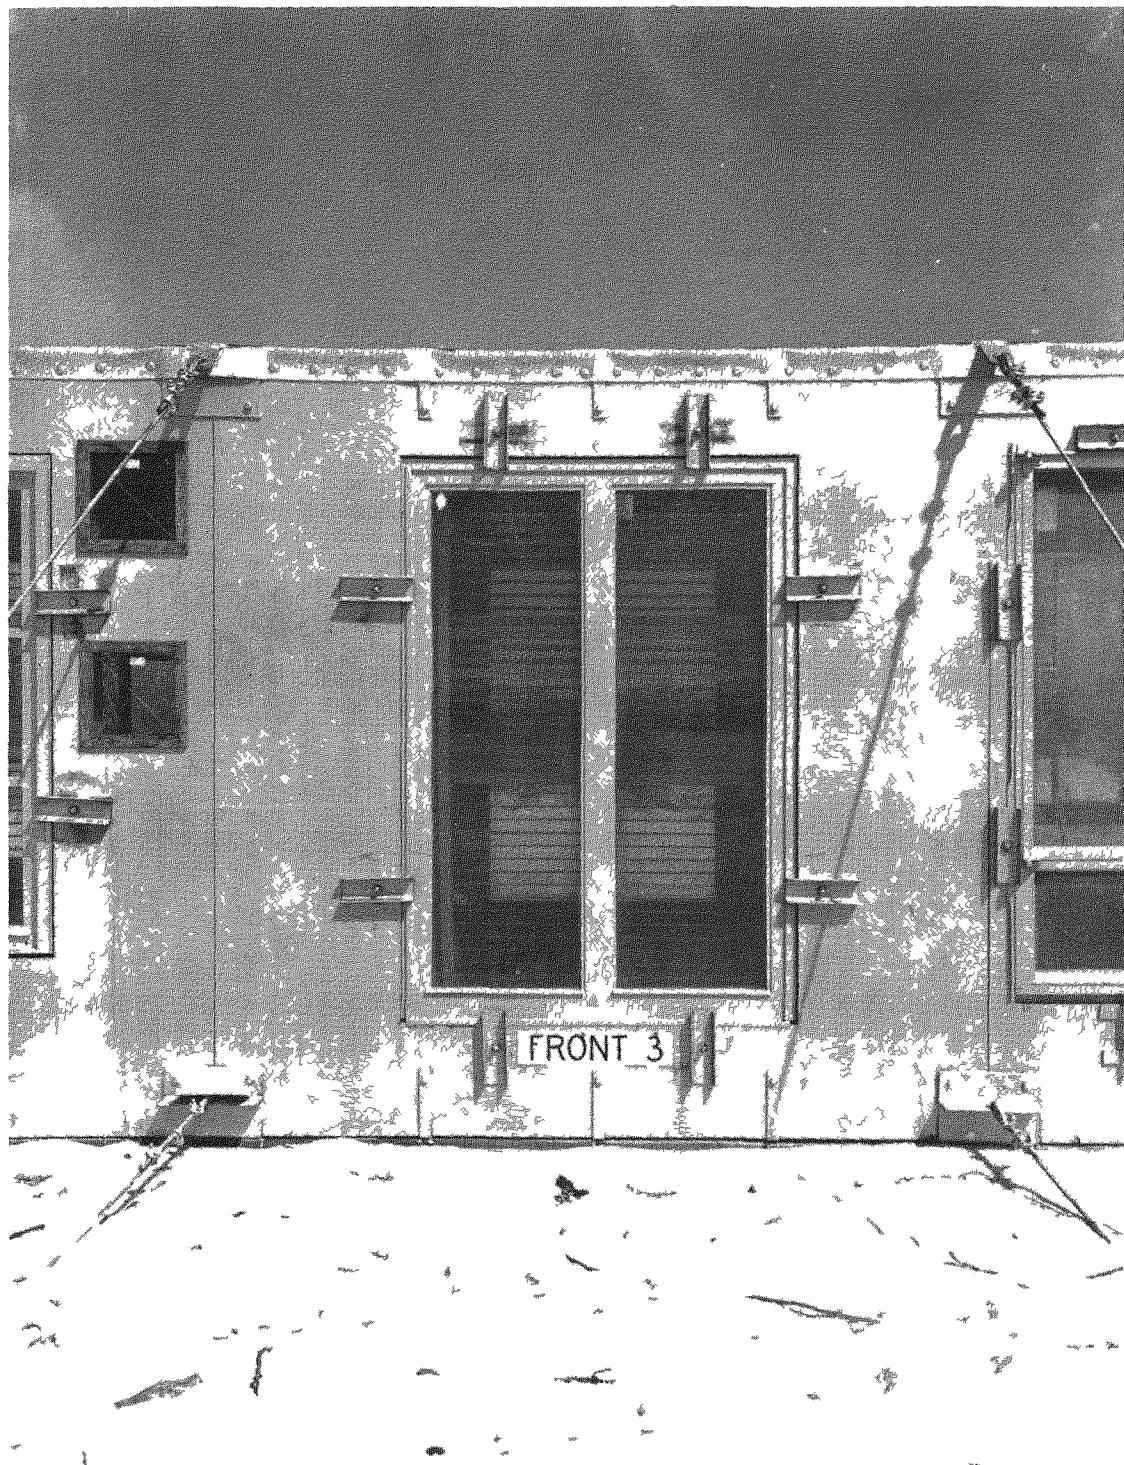
FIG 321 Outside of Inswing Casement Window 5 before the Blast. This window was constructed of heavy weight aluminum sections with hinges spot-welded to the frame and to the sash. The left-hand sash was glazed with tempered glass and the right-hand sash with wine glass. The glass sections measured  $19\frac{5}{8}$  by  $61\frac{5}{8}$  in.

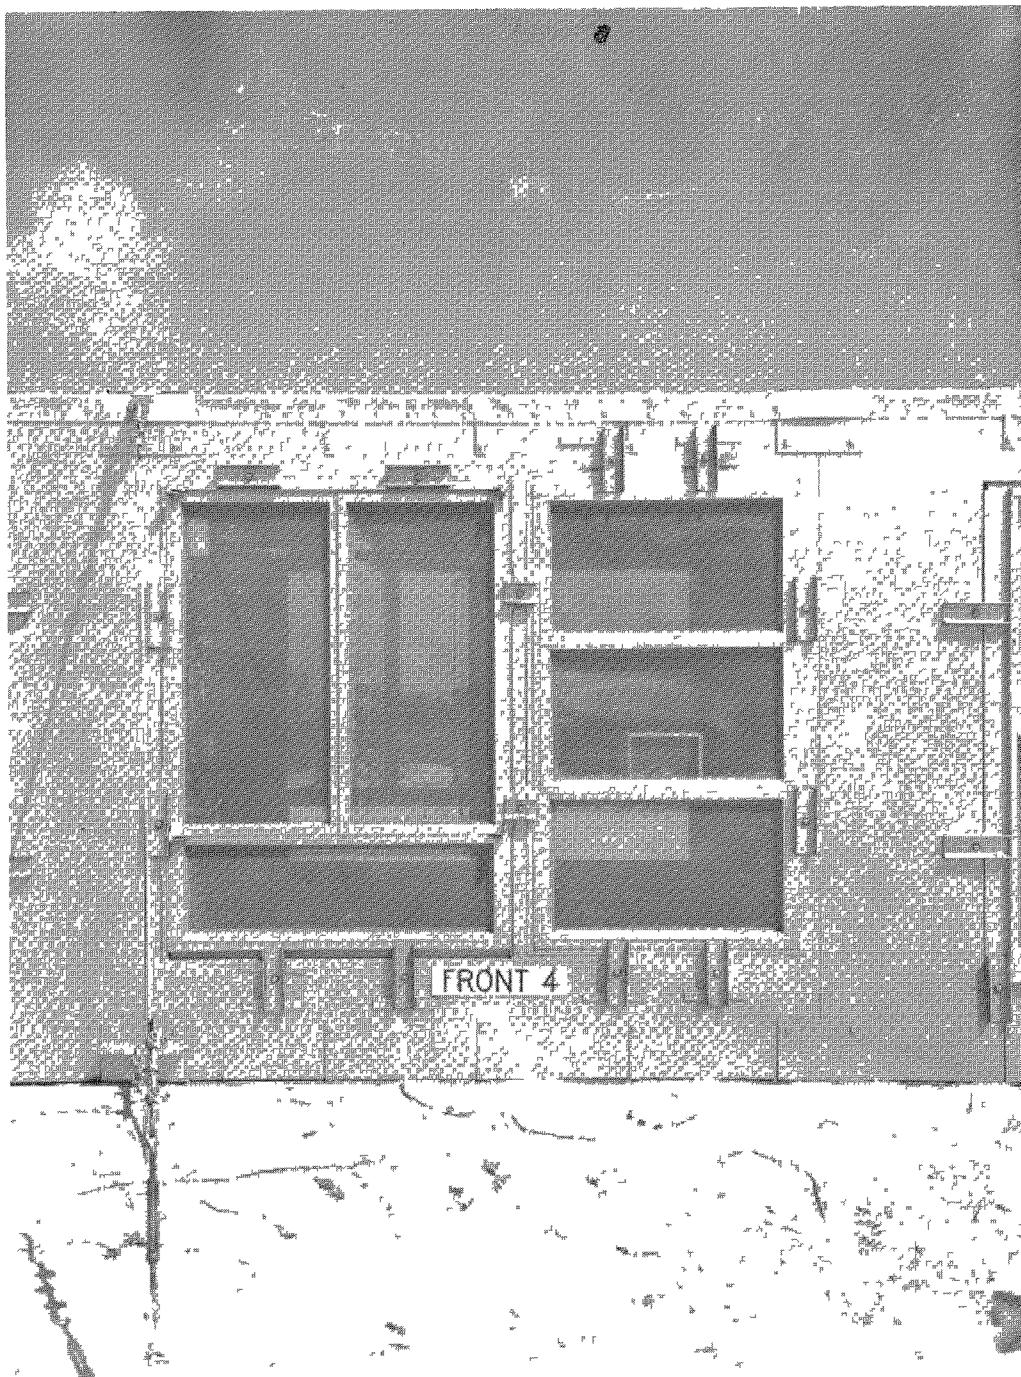
FIG. 3.25 Outside of Casement Window 6 and Canopy Window 7 before the Blast. Window 6 is a heavy-weight aluminum inswinging casement, with an inswinging hopper vent at the bottom. The left-hand sash of window 6 was glazed with safety glass and the right-hand sash with wire glass. Plate glass was used in the hopper vent. Before the blast the right-hand sash of the casement was opened so that it would be parallel to the blast. Window 7 was a lightweight aluminum canopy window with two upper sections swinging outward and the lower section swinging inward. Plate glass, wire glass, and safety glass, 18 9/16 by 32 15/16 in., were installed in the frame.

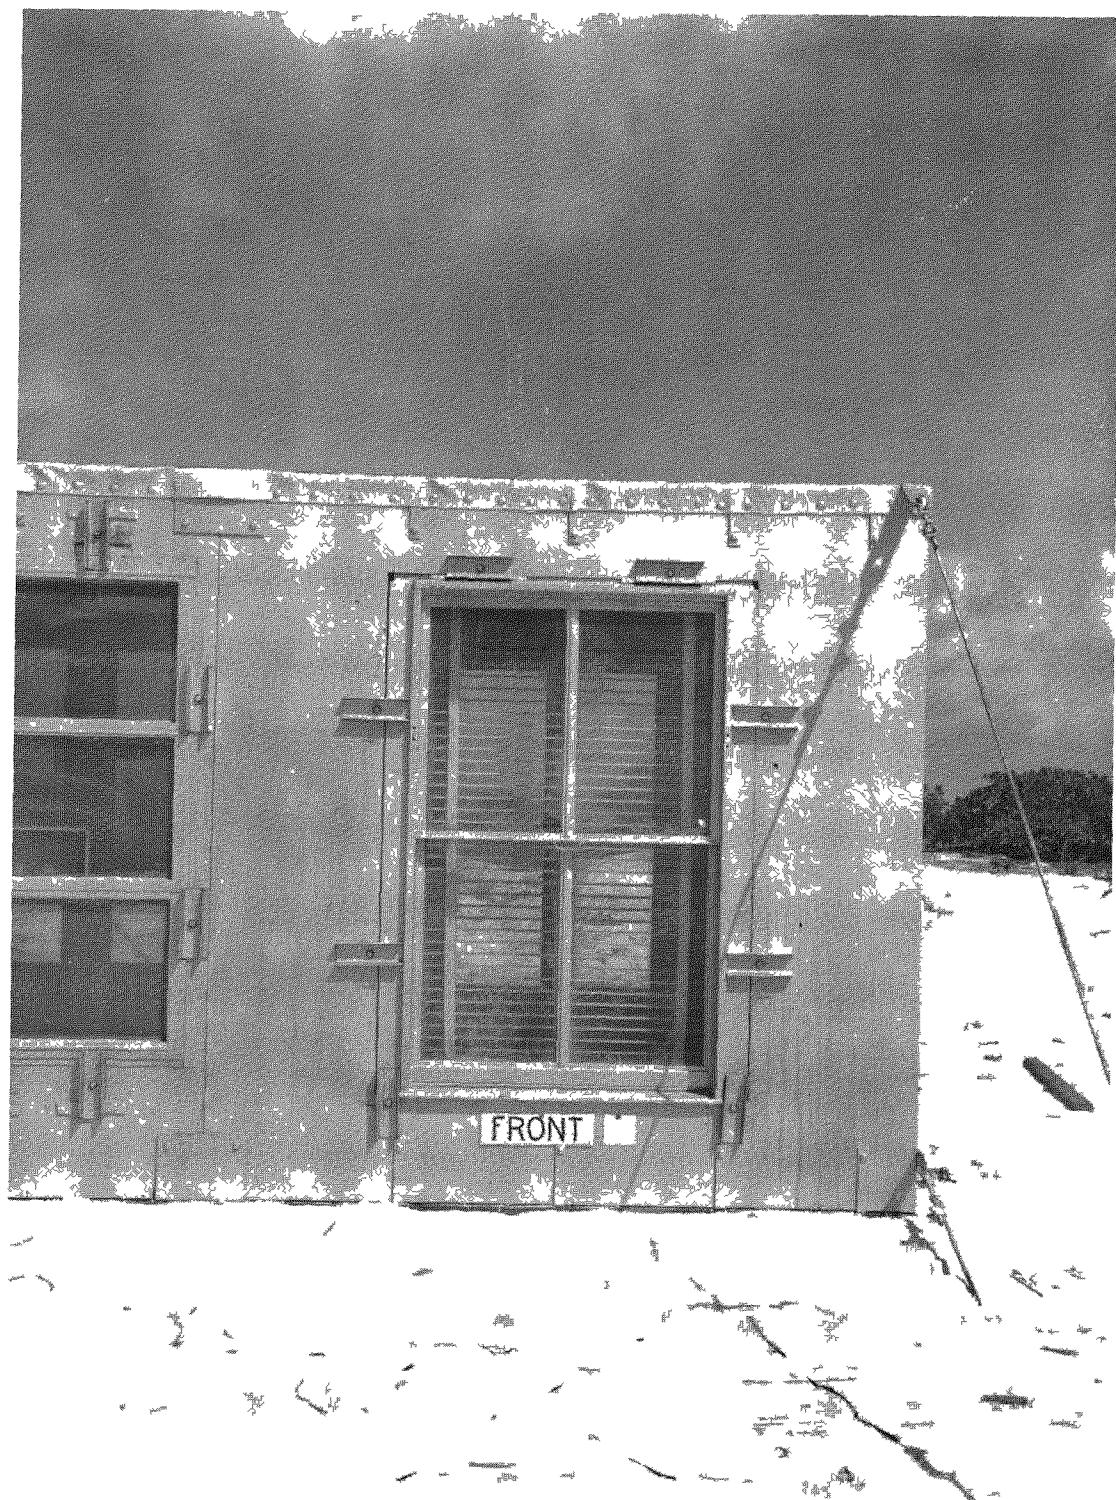
FIG 331 Outside of Double-hung Steel Window 8 before the Blast This was a heavyweight steel double-hung window glazed with double-strength and plate glass in the upper sash and safety and wire glass in the lower sash Panes were  $19\frac{1}{2}$  by  $30\frac{3}{4}$  in

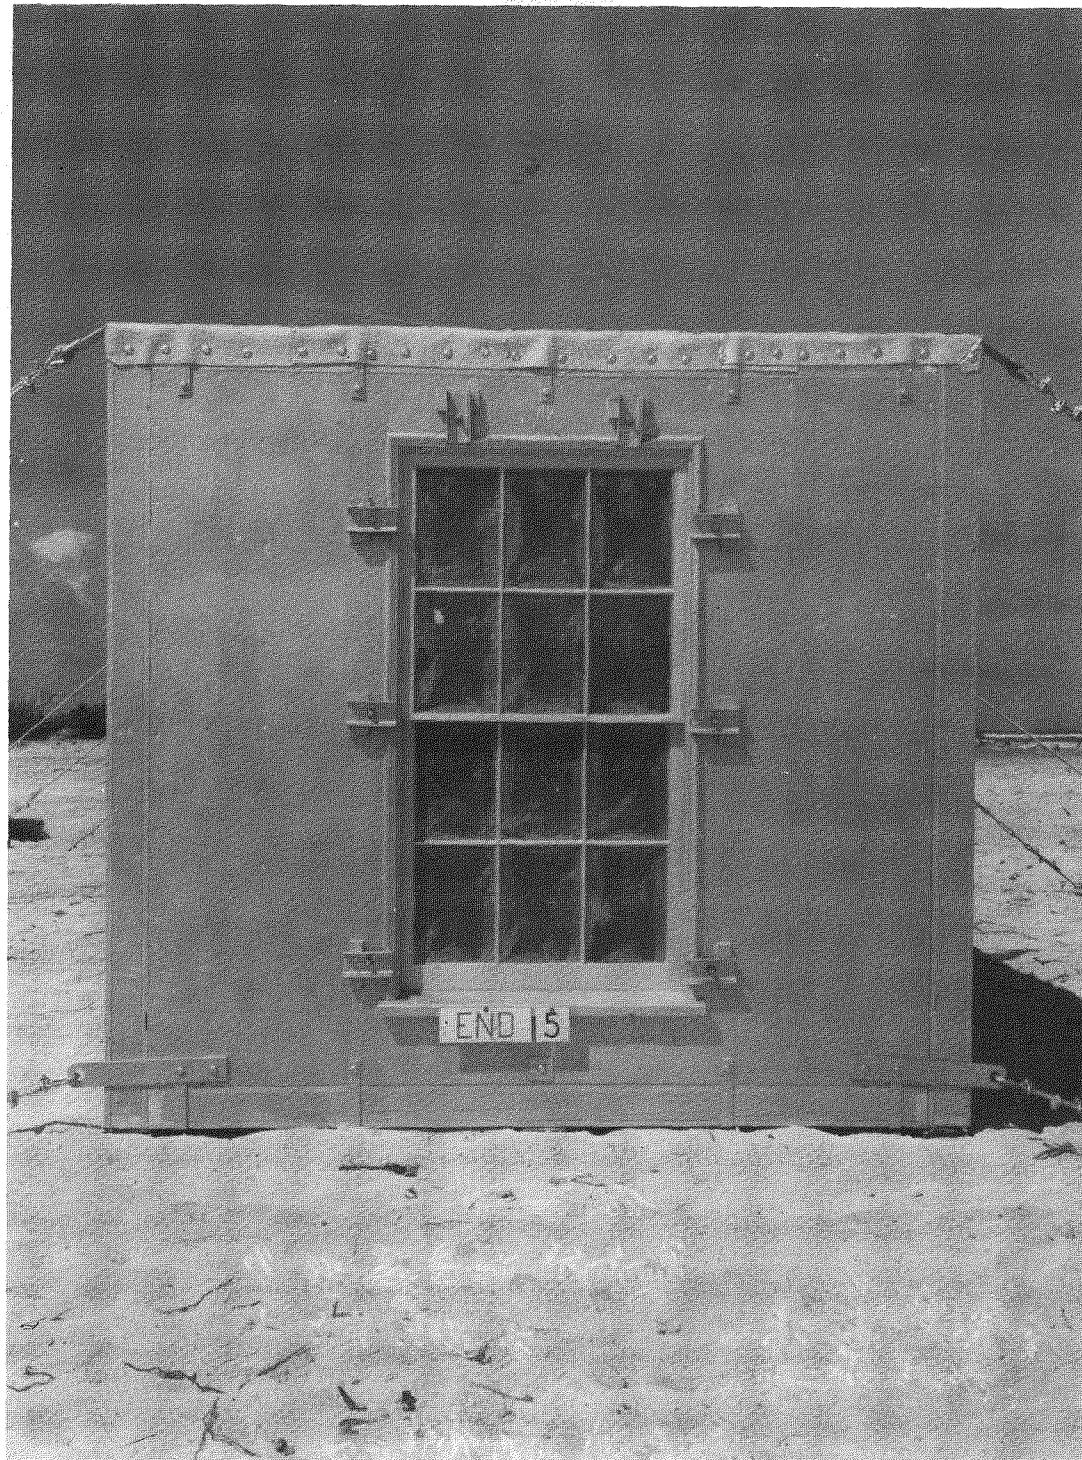
FIG. 3.33 Outside of Double-hung Window 9 before the Blast. This was a commercial-grade, wooden, double-hung window like window 1 at the other end of the building. It was glazed with double-strength glass. On the inside of the window opening,  $\frac{1}{4}$  in. mesh wire netting was mounted to prevent the glass from flying into the building.

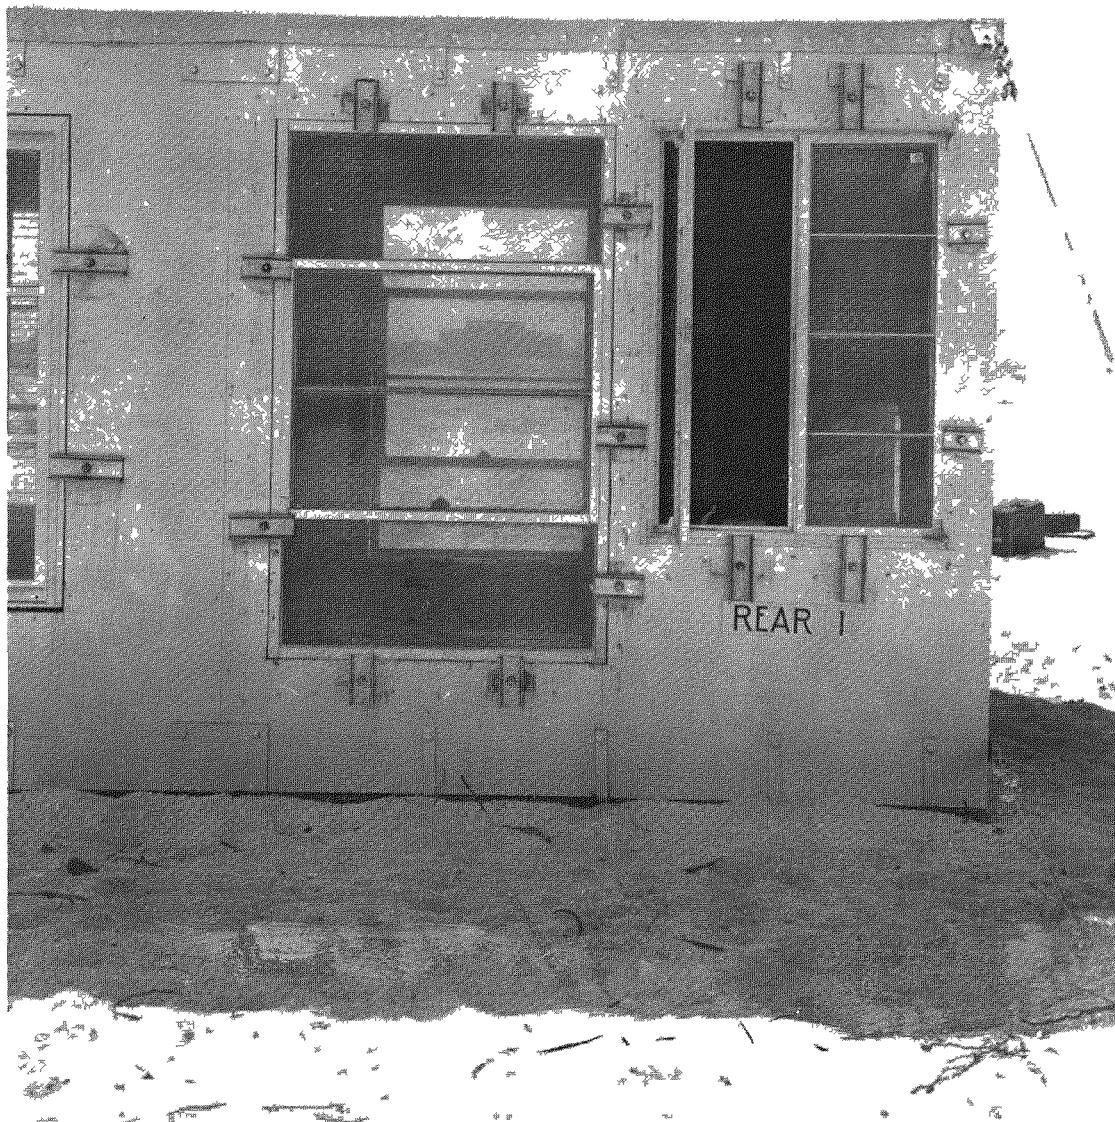
FIG 337 Outside of Casement Window 10 and Architectural Projected Window 11 before the Blast Window 10 was a duplicate of window 2 except that the right-hand sash was glazed with plate glass and the left-hand sash with double-strength glass. The left-hand sash was opened at right angles to the building before the blast. Window 11 was a duplicate of window 3 except that the top pane was plate glass and the ventilator panes were double-strength glass and the lower pane was wired glass.

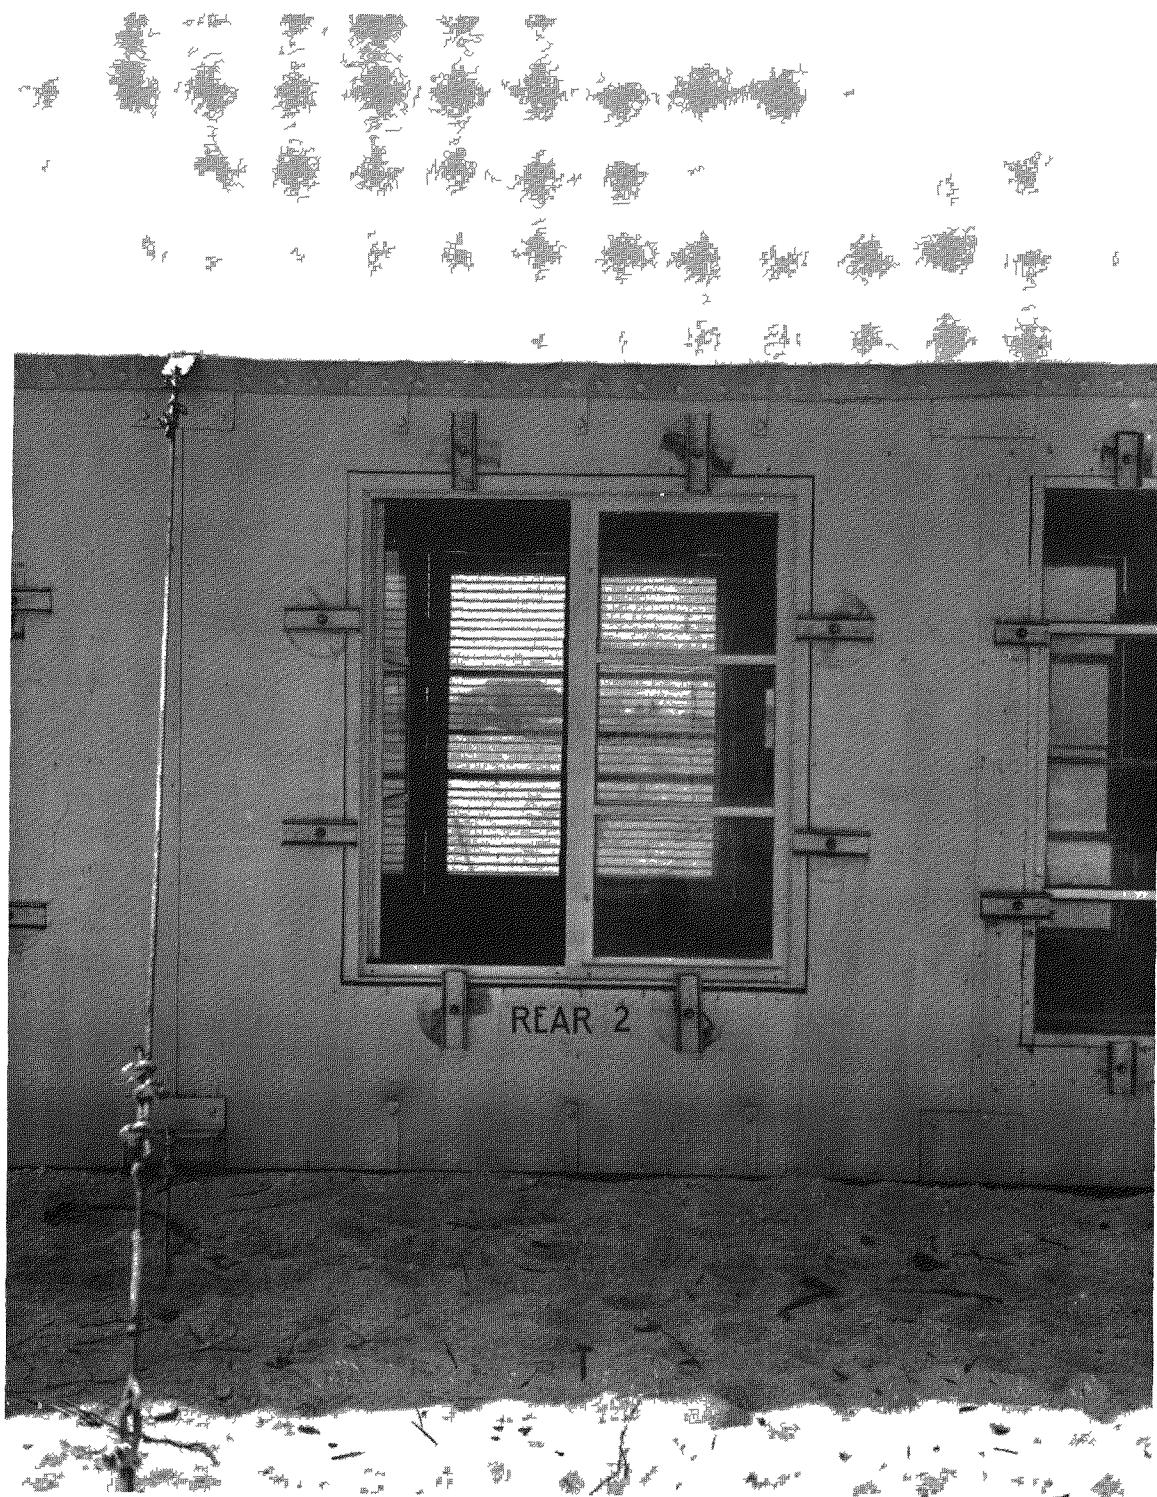
FIG 343 Outside of Inswingng Casement Window 12 before the Blast. This was a duplicate of window 4 except that the left-hand sash was glazed with tempered glass and the right-hand sash was glazed with double-strength glass at the top and bottom, with a plate-glass unit in the center opening. The sash on the left was opened inward prior to the blast.
