**GREENHOUSE**

SCIENTIFIC DIRECTOR'S REPORT  
ANNEX 3.5

THE EFFECTS OF ATOMIC WEAPONS ON GLAZING AND  
WINDOW CONSTRUCTION

by  
WALTON C. CLARK  
of  
PUBLIC BUILDINGS SERVICE

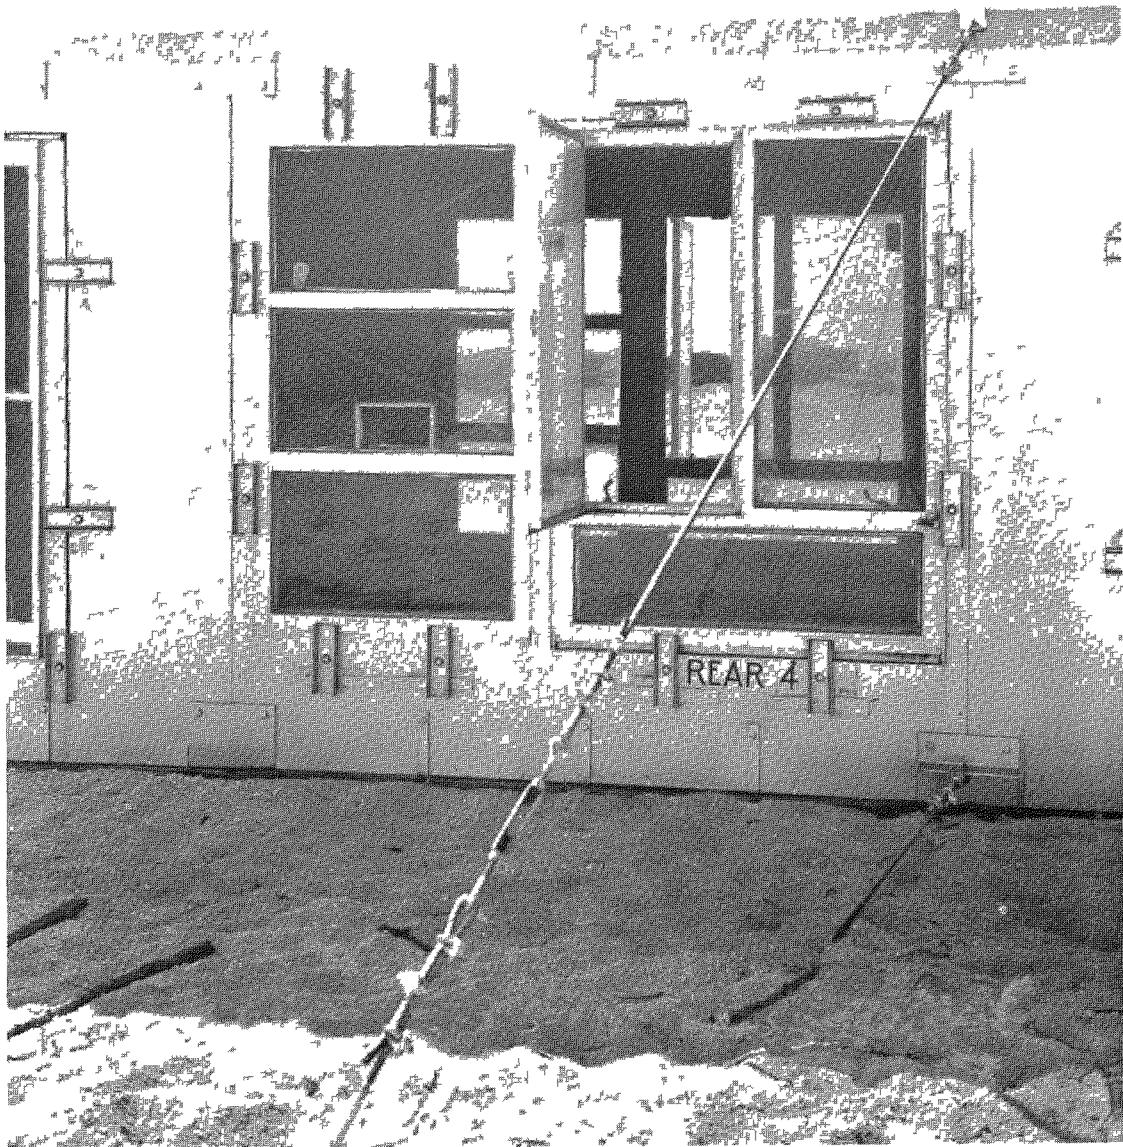
FIG 349 Outside of Casement Window 14 and Canopy Window 15 before the Blast Window 14 was a duplicate of window 6 except that the left-hand sash was glazed with double-strength glass and the right-hand sash with wire glass The hopper vent was glazed with safety glass. The left-hand sash of the casement was opened before the blast Window 15 was a duplicate of canopy window 7 except that the upper pane was of double-strength glass, the middle pane of plate glass, and the lower pane of wire glass

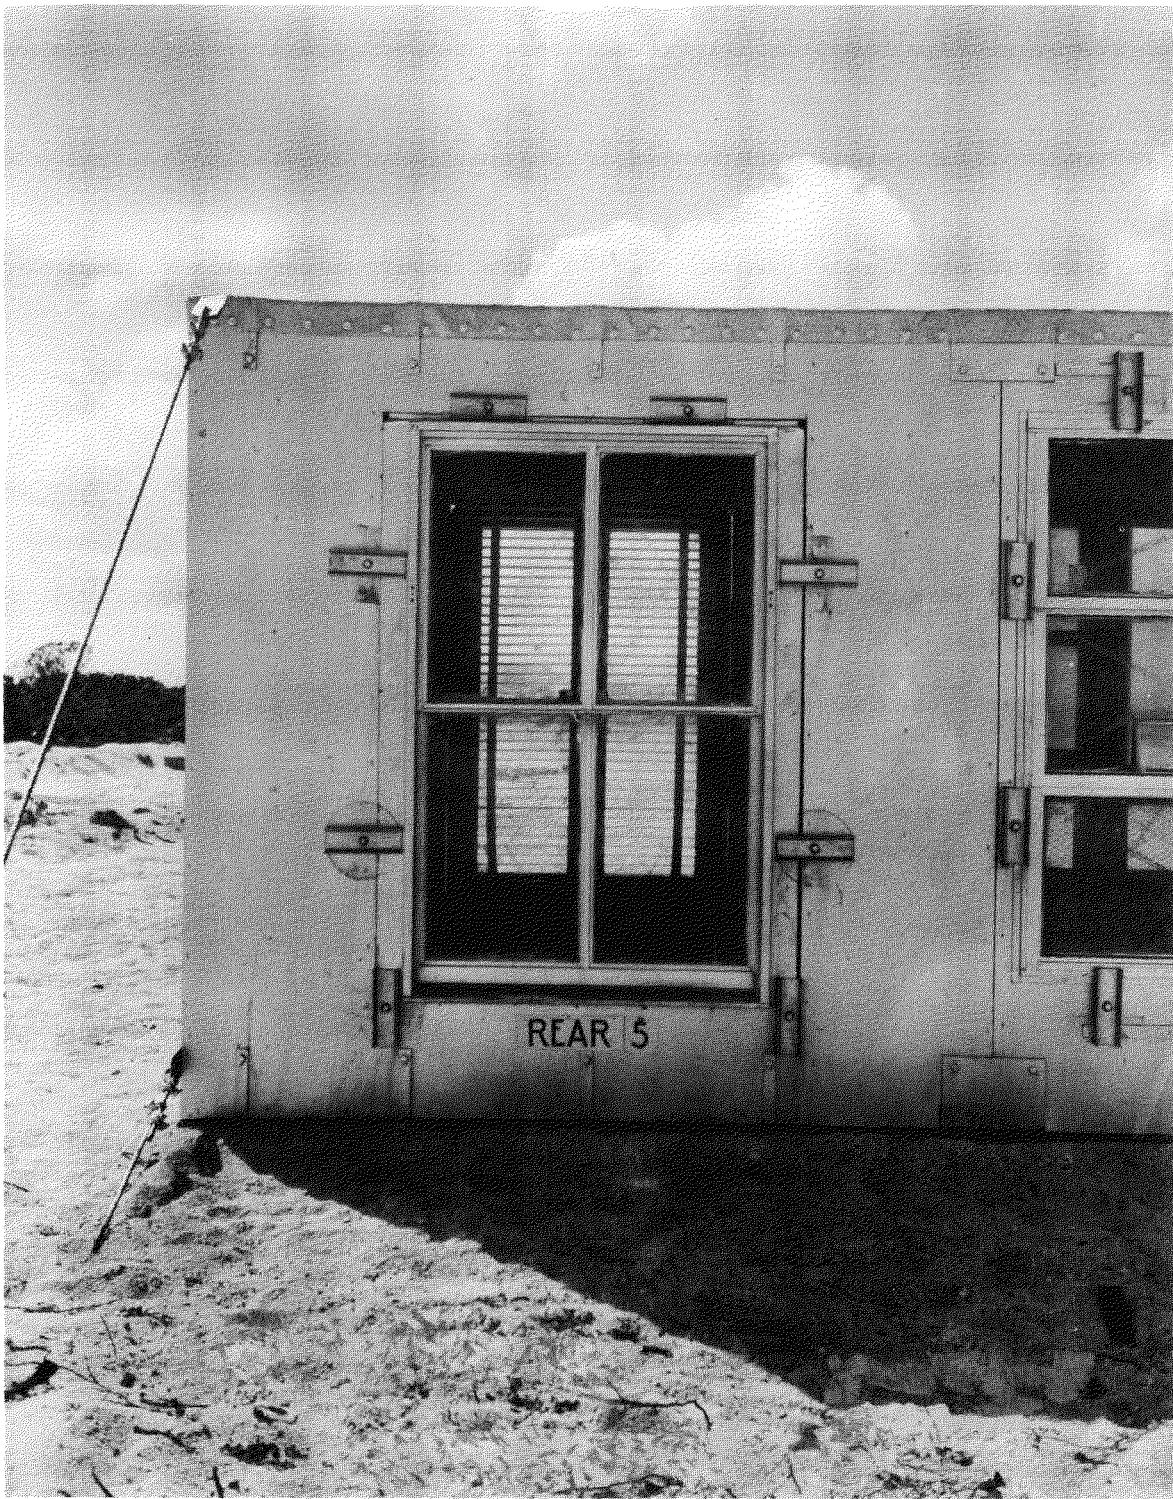
FIG. 3.56 Outside of Double-hung Window 16 before the Blast. This was a duplicate of window 8, except that the upper sash was glazed with plate glass on the left and double-strength glass on the right. The lower sash had wire glass on the left and safety glass on the right.
