Nondestructive Evaluation (NDE) of Composite-to-Metal Bond Interface of a Wind  
Turbine Blade Using An Acousto-Ultrasonic Technique.

John H. Gieske and Mark A Rumsey

Sandia National Laboratories

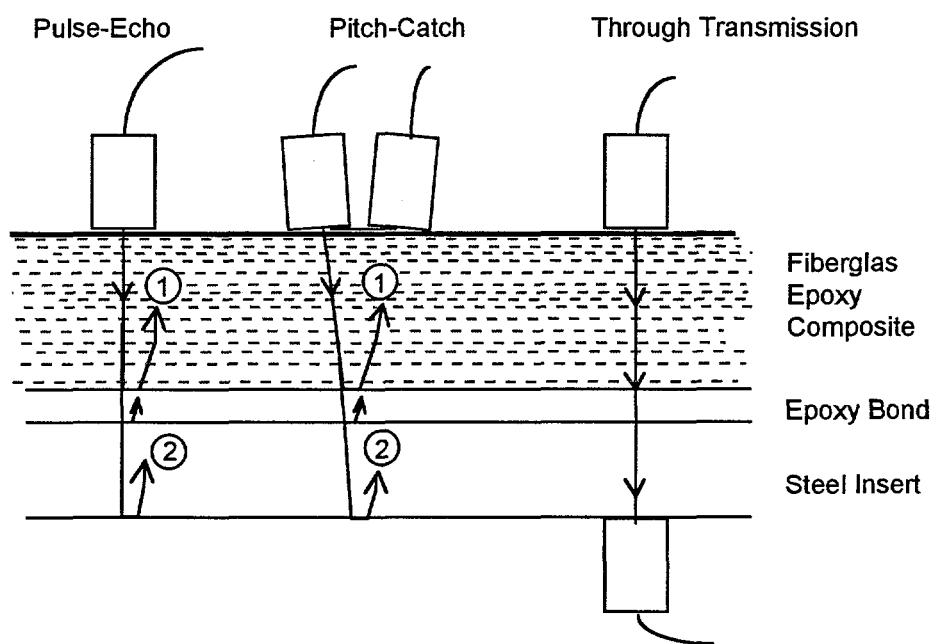
Pulse-echo and pitch-catch techniques were investigated with limited success. Clear back-surface echoes from the bond interface ① as shown in Figure 2 or from the back-surface of the steel insert at ② were not distinct from all the echoes generated from the multiple interfaces of the composite. In general, ambiguous results were obtained with the pulse-echo and pitch-catch techniques. However, a through transmission (TT) technique proved to show unambiguous results where areas of disbonds, delaminations, and voids could be mapped out and detected with certainty.

Figure 2. Ultrasonic transducer arrangement for pulse-echo, pitch-catch, and through transmission techniques.

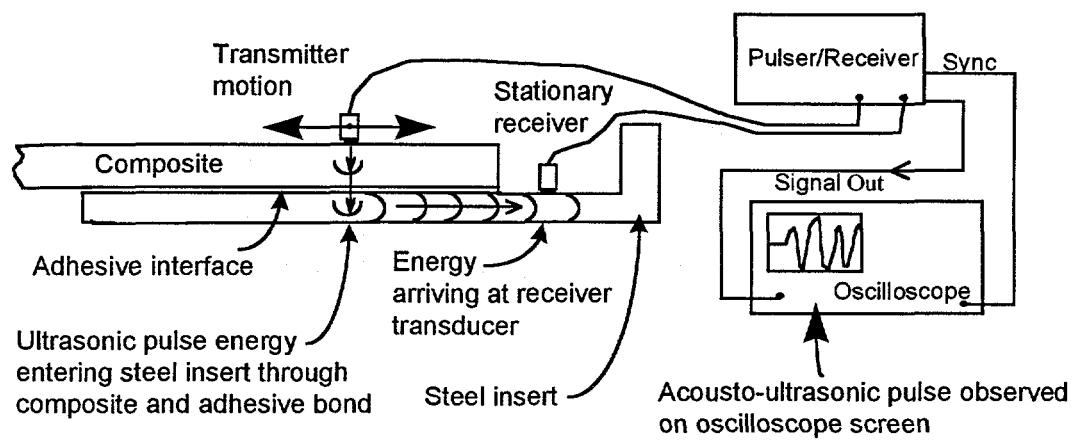
The AU technique developed is illustrated in Figure 4 where contact transmitter and receiver ultrasonic transducers are used at the OD surface of the turbine blade. The receiver transducer is attached to the OD surface of the steel insert inboard of the fiberglass composite. As illustrated in Figure 4, the ultrasonic pulse generated by the transmitter enters the composite, travels through the composite thickness, and then enters the steel insert where it propagates down the insert and finally arrives at the receiver transducer. The first arrival of the pulse at the receiver is most sensitive to the energy entering the steel insert directly below the transmitter since the acoustic wave velocity in the steel is faster than that in the composite and very little energy is lost in the steel.

Figure 4. Schematic diagram of the acousto-ultrasonic technique as applied to the root bond area at the steel insert of a wind turbine blade.
