for presentation 2⁺
the AIAA / ASME 1997 Spring Meeting
Wind Energy Jan 6 - 9 1997 Rowan University

A.G. Beattie
Department 9742
Sandia National Laboratories
Albuquerque NM, 87185-0615

Abstract

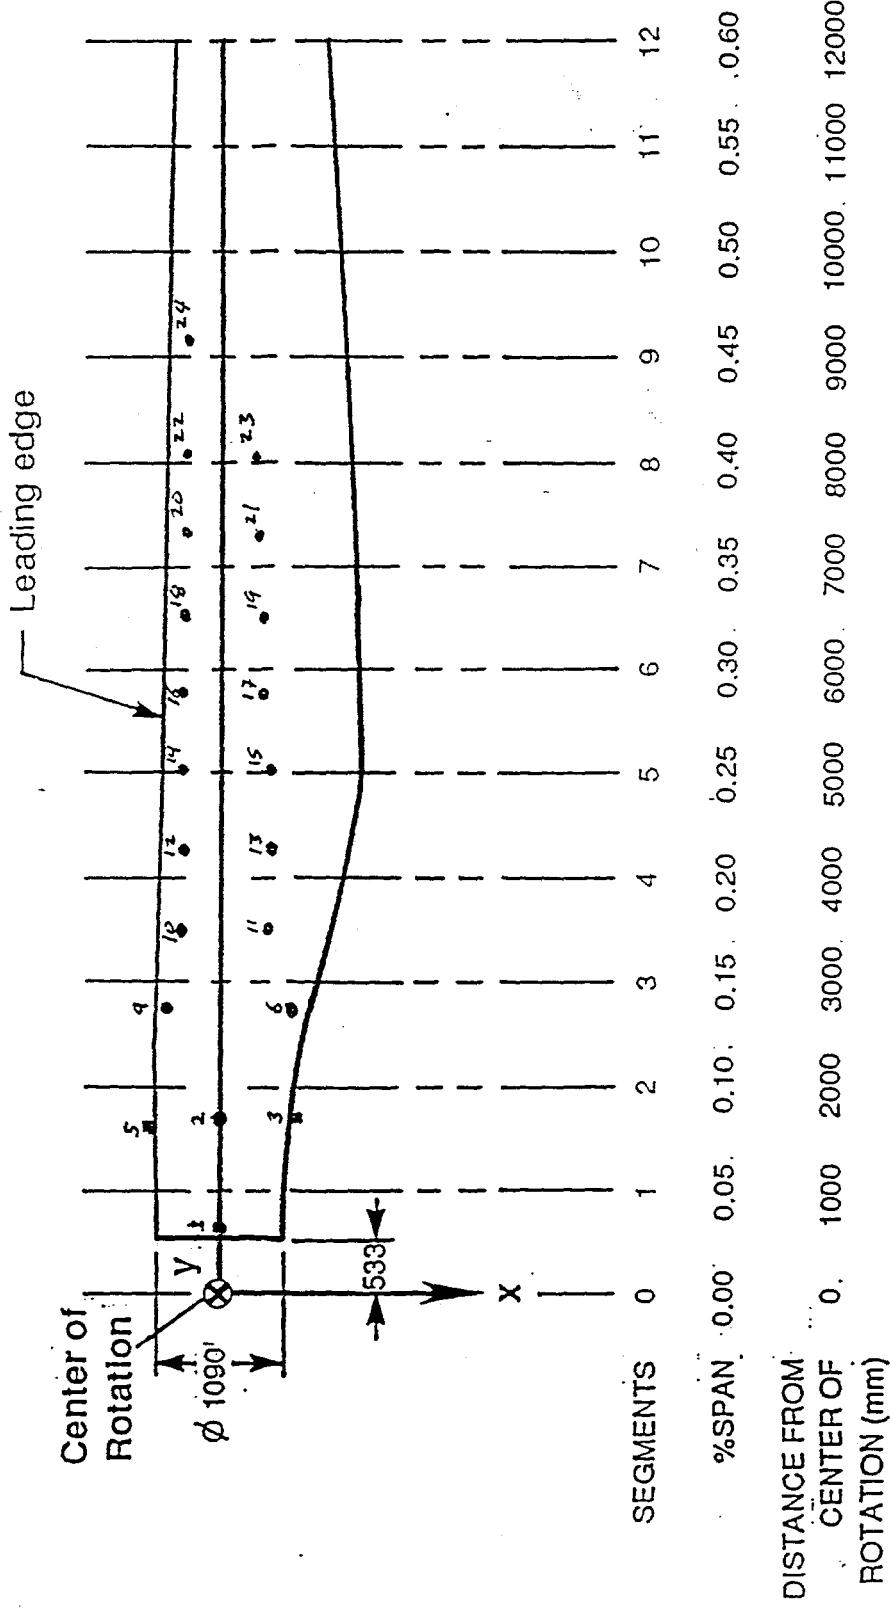
Figure 1. Blade and Sensor Layout

A brief run at the new load showed that oil canning of the upper blade skin was taking place in two areas. The acoustic emission sensor array was then designed to cover these two areas as well as the root region just outside of the reinforced region. The complete sensor layout is shown in Figure 1. Sensor 24 was placed 60 inches past the top surface array to detect any acoustic signals traveling down the blade from the actuator.

Blade centerline is positioned at the 30% chord

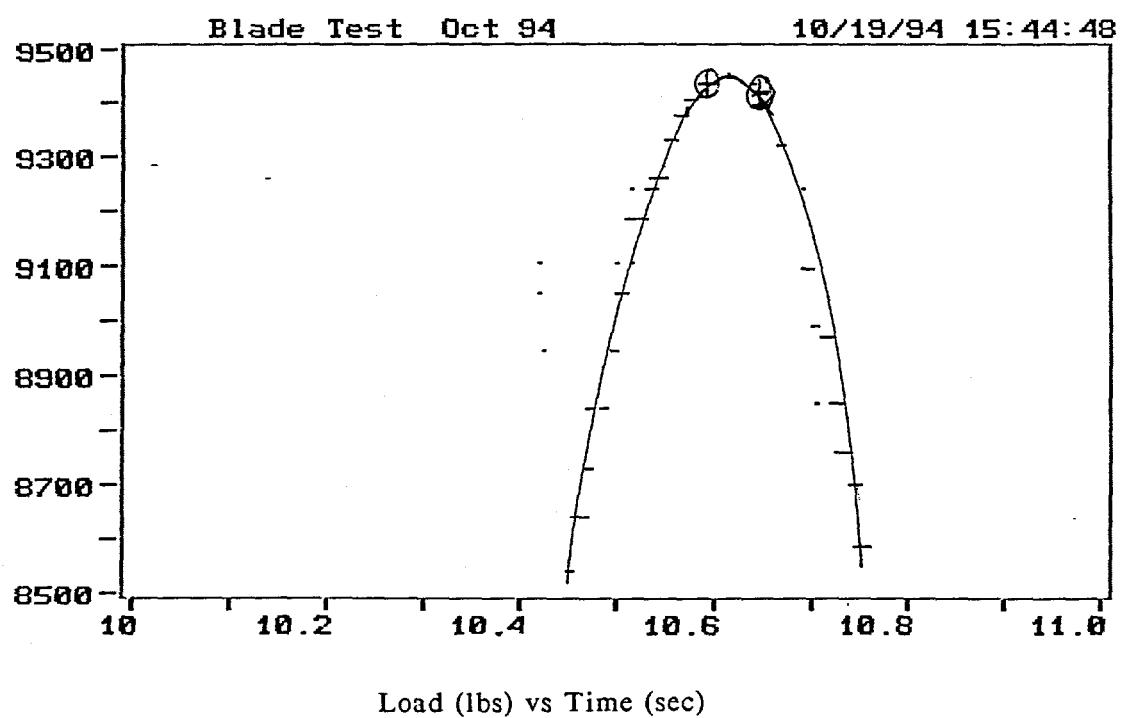
Figure 2. Load values as a function of time for the peak of a load cycle. Horizontal lines are multiple points.

A previous fatigue test of a wind turbine blade had shown that many acoustic signals were detected during a single fatigue cycle. The largest number occurred during the times of the maximum rate of the load change, both on increasing and decreasing loads. These events were thought to be caused, at least in part, by rubbing of non-bonded surfaces in the blade. In any case, they did not arise from fatigue damage in the previous test. For this blade, initial measurements showed a data rate of about 40 megabytes per hour. To reduce the amount of data collected and to keep primarily signals that were produced by fatigue damage, a voltage controlled gate was used with the system. The gate was triggered off the load cell and permitted the system to take data only when the load was above 8500 lbs. This procedure reduced the collected data rate to about 10 megabytes per hour. While this is still far too high, it did allow the collection of four days' worth of data at this rate before the disk was full. Figure 2 shows the assigned load of all the hits collected on one cycle for assigned loads above 8500 lbs. The loads are plotted as a function of test time. The two located events on this cycle are given as circled crosses. The approximate load curve is shown as a solid line. It is apparent that the assigned loads were close to the actual loads, but both the quantization errors and some scatter are present. Both located events occur very close to the peak load as was expected. This curve suggests that no significant data would be lost by raising the minimum load for event acceptance to a value of 9000 lbs. This was done for the later test stages.
