ANL-6048
Metallurgy and Ceramics
(TID-4500, 15th Ed.)
AEC Research and
Development Report

EXAMINATION OF JACKETED URANIUM SLUGS FROM THE
LOS ALAMOS FAST REACTOR "CLEMENTINE"

S. H. Paine, W. F. Murphy and F. L. Brown

Final Report of Metallurgy Division Program 6.1.5

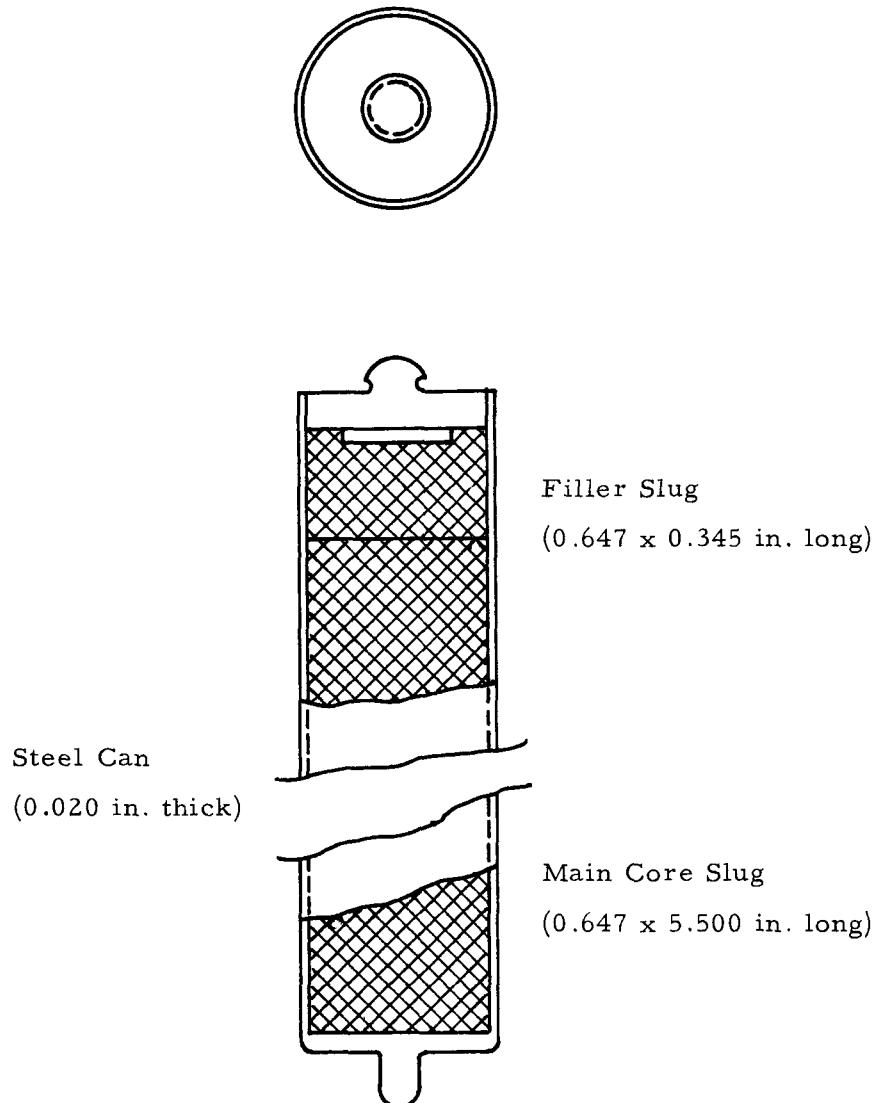
Figure 1. Sectional Drawing Showing Slug Assembly

The basic slug assembly is drawn in Figure 1, and the technical details of its fabrication, as reported in the literature,⁽¹⁾ are given in Appendix A. The main core was a $\frac{5}{8} \times 5\frac{1}{2}$ in. slug augmented by a filler piece, approximately $\frac{3}{8}$ in. long, both probably of gamma-extruded uranium. The can was of mild steel, machined to 0.020-in. thin-wall dimensions from round stock. There were some uncertainties in metallurgical definition of the materials used.⁽³⁾
