The Fabrication of a Vanadium-Stainless Steel Test Section for MHD Testing of Insulator Coatings in Flowing Lithium

**Claude B. Reed, Richard F Mattas, Dale L. Smith, Hee Chung,
and Hanchung Tsai**
Fusion Power Program, Argonne National Laboratory

Presented at the 12th Topical Meeting on the Technology of Fusion Energy
June 16-20, 1996 Reno Nevada

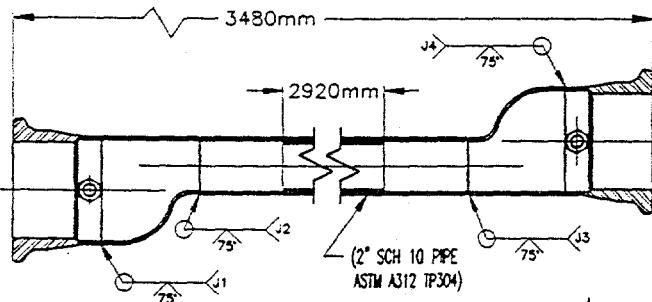
Figure 1. V/SS duplex test section.

Figure 1 is a fabrication drawing of the V/SS duplex test section, intended for MHD testing of insulator coating materials in flowing liquid lithium in the Argonne Liquid Metal Experiment (ALEX). The test section ID/OD were 48.4/58.6 mm; the wall thickness of the vanadium liner/stainless steel pressure boundary were 2.3/2.8 mm. The V liner occupied the central 2.9 m of the 3.5 m test section length. The lithium pressure boundary is a 60 mm dia. 304SS pipe (2 inch schedule 10) welded to schedule 10 300 series SS eccentric reducers; all welding was performed to the ASME B&PV Code. The end flanges, which were welded to eccentric reducers, and which connect the test section to ALEX loop piping, are a proprietary design (OTECO[®], Inc.), having a metal-to-metal seal between two 316SS hubs using a 17-4 PH SS seal ring; their pressure and temperature ratings are 12.7 MPa; 540°C, respectively. OTECO[®] flanged connections have been successfully used previously in ALEX at 0.14 MPa; 200°C NaK. The present application, at 33 kPa and 550°C Li, resulted in no leaks.

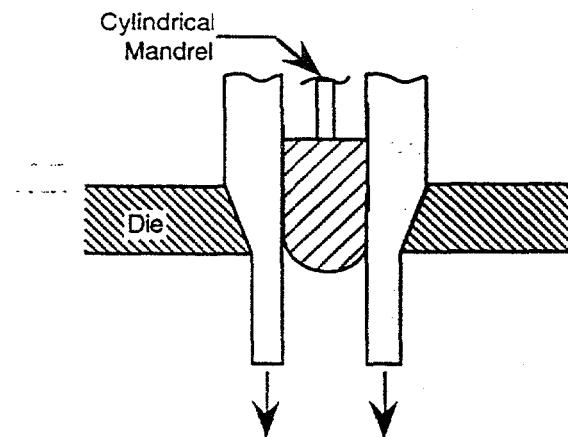
Figure 2. Tube drawing operation.

Following the first annealing step, the tube blanks were put through the first draw cycle, see Table 2. For this part of the fabrication, a mandrel is first inserted into the tube, and hammered in using a light sledge until the forward end of the mandrel exits the front end of the tube. Then the tube is swabbed with die lubricant (a plastic material contained in a solvent which after drying leaves a thin acetone-soluble plastic film on the tube), and pulled through the die (see Fig. 2). The mandrel is then removed.
