METALLURGICAL EXAMINATION OF
GUN BARREL SCREWS

E. L. Bird
T. L. Clift

June 1996

Y-12 Development Division

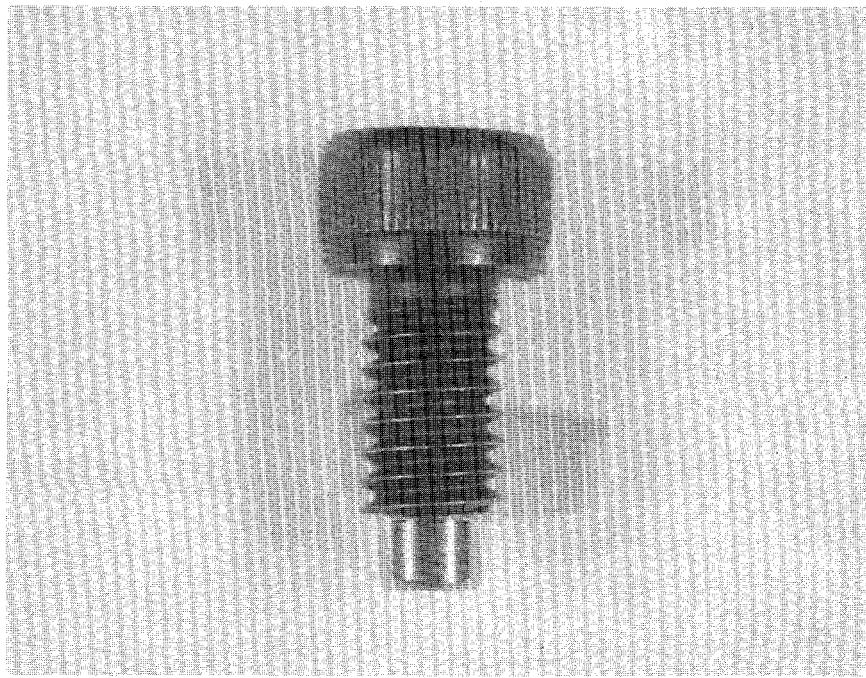
Small screws, such as the one shown in Fig. 1, are used to prevent live rounds of ammunition from entering the firing chamber when certain firing exercises are performed. The blunt tip of the screw, including one or two threads, lies inside the barrel and is exposed to the explosive reaction and stresses of firing a blank round. Blank rounds do not contain a live projectile. The metallurgical integrity of these screws must be maintained to ensure that the screws function as intended and do not fracture or fragment. The authors examined several screws that had been exposed to the firing of 100, 200, and 300 rounds to determine if any degradation had occurred. Of primary concern was any indication of brittleness, wear, or cracking that might indicate a degradation in the life expectancy of the component.

Fig. 1. Screw used to prevent a live round of ammunition from entering the firing chamber (5X).
