SAND97-0497 • UC-704

# Characterization of the Mechanical Properties of LTCC "Green Tape"™ for the MC4352 MET

Fernando Uribe, Stephen Garrett, Saundra Monroe, Steven Burchett

## Abstract

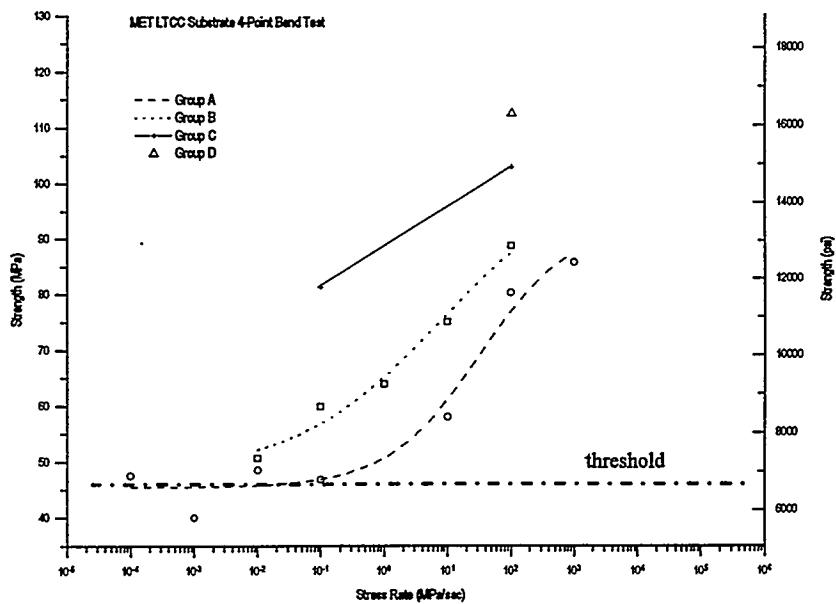
Results from testing are plotted in Figure 3. At high stressing rates, the measured strength of the .030-inch-thick substrates, Group A samples, was 12.5 Kpsi (85 MPa), and as the stressing rate decreased, the strength decreased to 6.5 Kpsi for all stressing rates below 1 MPa/sec. In test Groups B and C, the curves are shifted to a higher value of failure strength for a given stressing rate. The fast fracture strength of group D, the .050-inch-thick substrates, was 16 Kpsi (113 MPa). Fractographic analysis for each of the substrates, summarized in Table 1, revealed that failure origins were different from group to group.

**Figure 3.** Threshold stress measured on non-populated MET substrates.

The results of these tests confirm the anticipated SCCG behavior of the 951 LTCC substrate material. Slow stressing rates allow the environment, particularly moisture, sufficient time to reach the crack tip and initiate subcritical crack growth. Final failure occurs once the crack has reached a critical size. The shape of the Group A curve in Figure 3 is similar to that reported by DuPont. The strength decreases with decreasing stressing rate and a SCCG threshold plateau is defined. The threshold plateau, below which SCCG does not occur, is 2.2 Kpsi lower in the Group A than that reported by DuPont for unmetallized 951 material. Failure origins for the A and B group were generally at the 4596 conductor/resistor/glaze interface.

These results show that the presence of metallization slightly reduces the SCCG threshold plateau in 951 LTCC. The higher plateau strength reported for Group B suggests there is a small effect of fixturing on the test. Group C samples failed from intrinsic defects in the LTCC and from the LTCC/4596 metallization interface. These data indicate that Group C defects were smaller than the resistor flaw origin location in Groups A and B. Group D fast fracture strength was higher than the other groups. Nominally, groups C and D should have been the same because the processing was equivalent; however, the apparent difference could be within the error of the measurement. A larger number of samples would have to be tested to establish statistically relevant differences between groups C and D.

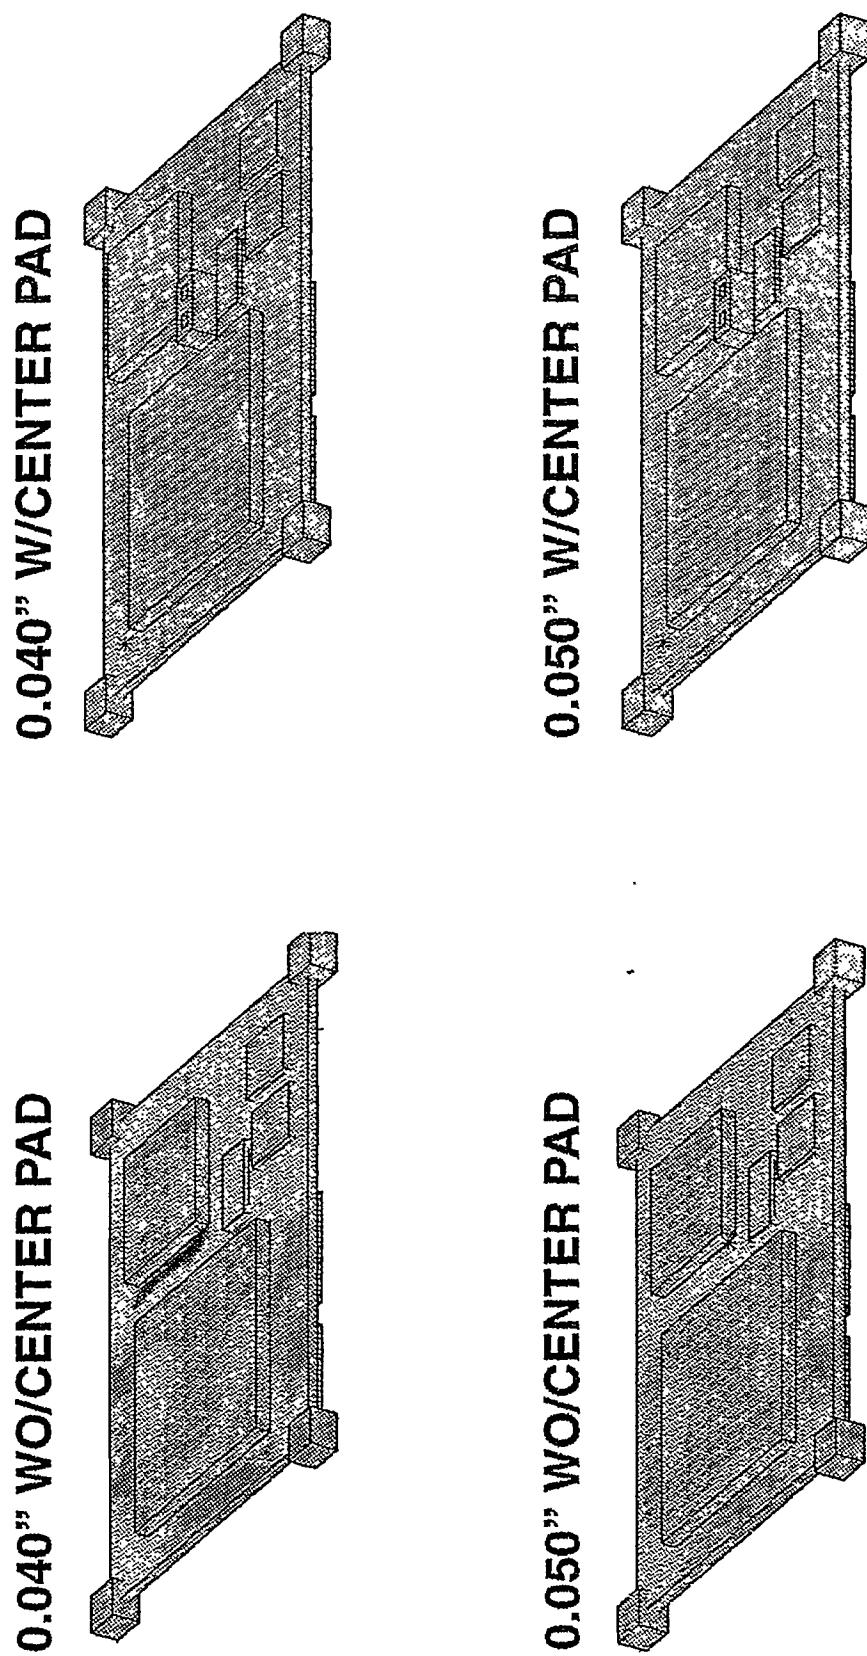
The stress in the MET substrate assembly for an applied constant acceleration load in both the +Z and -Z direction was computed using the general purpose finite element code ABAQUS. The shock load of most concern (142 G's @ 6.5 ms) is of sufficient duration that the acceleration can be considered to be applied statically. In Figure 8, contours of the computed maximum principal stress in the assembly for the applied acceleration load in the -Z direction (tending to bow the substrate up) are plotted. The peak stresses in the substrate are summarized in Table 6. These results indicate that the computed peak stresses are sufficiently below the slow crack growth threshold of 6500 psi even for the 0.040-inch-thick substrates.

Figure 8. Computed Maximum Principal Stress in Assembly Due to Acceleration Load

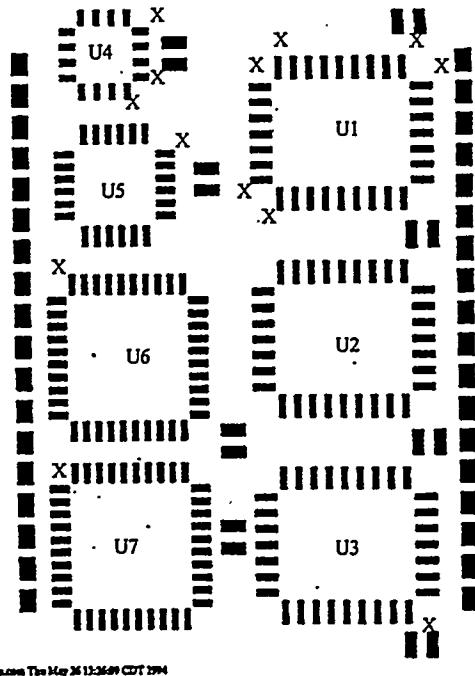
**Figure 13.** Schematic of locations where LCC packages are soldered to the LTCC substrate. "X" marks the location where the soldered and thermally cycled substrate was loaded in bending and fractured. The fracture surfaces at 13 locations were examined for evidence of small cracks that served as failure origins; none were found.

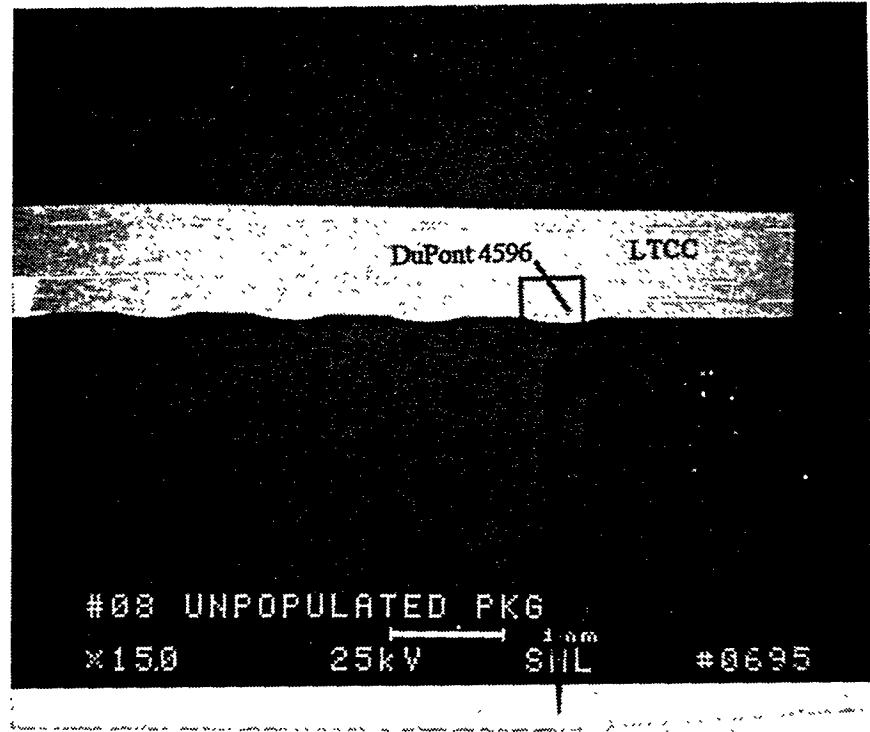
Unpopulated TV #8A is a substrate that had not been exposed to any solder assembly operation or environmental conditioning. This part provides baseline information about the characteristics of the DuPont 4596 Au-Pt metallization before any solder processing and allows examination of the opposing surfaces of the LTCC, which have a different number of metallization firings. SEM micrographs of the cross-section of TV #8A are shown in Figure 20A and 20B. The low magnification image in Figure 20A shows the LTCC substrate, vias, internal conductors, and Au-Pt surface conductors.

**Figure 20A.** Low magnification image of cross-sectioned #8A, the unsoldered, unaged MET Test Vehicle.

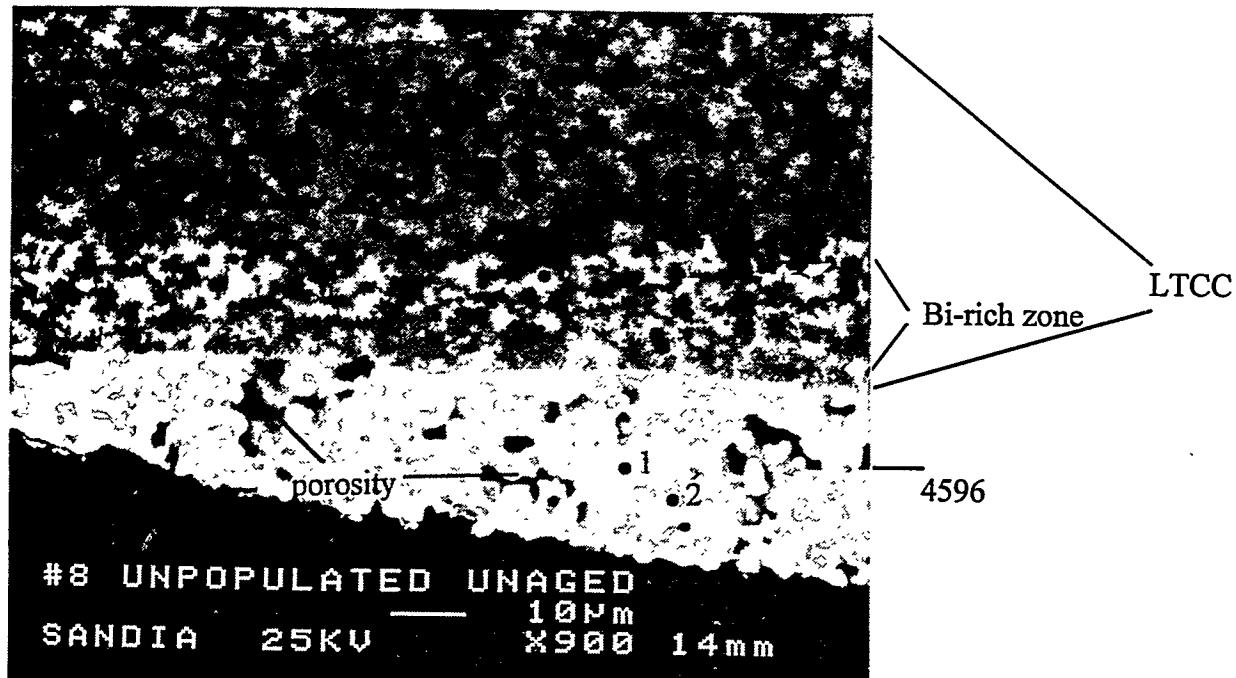
Cross-sections were made of the conductors over vias on both the front and back surfaces of the LTCC substrate. The higher magnification micrograph in Figure 20B is typical of the DuPont 4596 microstructure in both surfaces. The image in Figure 20B, taken using SEM backscatter mode, shows contiguous porosity in the Au-Pt conduction layer and little or no porosity in the LTCC. Five different areas, shown in Figure 20B, were analyzed using EDS.

**Figure 20B.** Higher magnification of boxed area in A shows five locations where EDS spectra were taken. EDS spectra are in Figure 21.

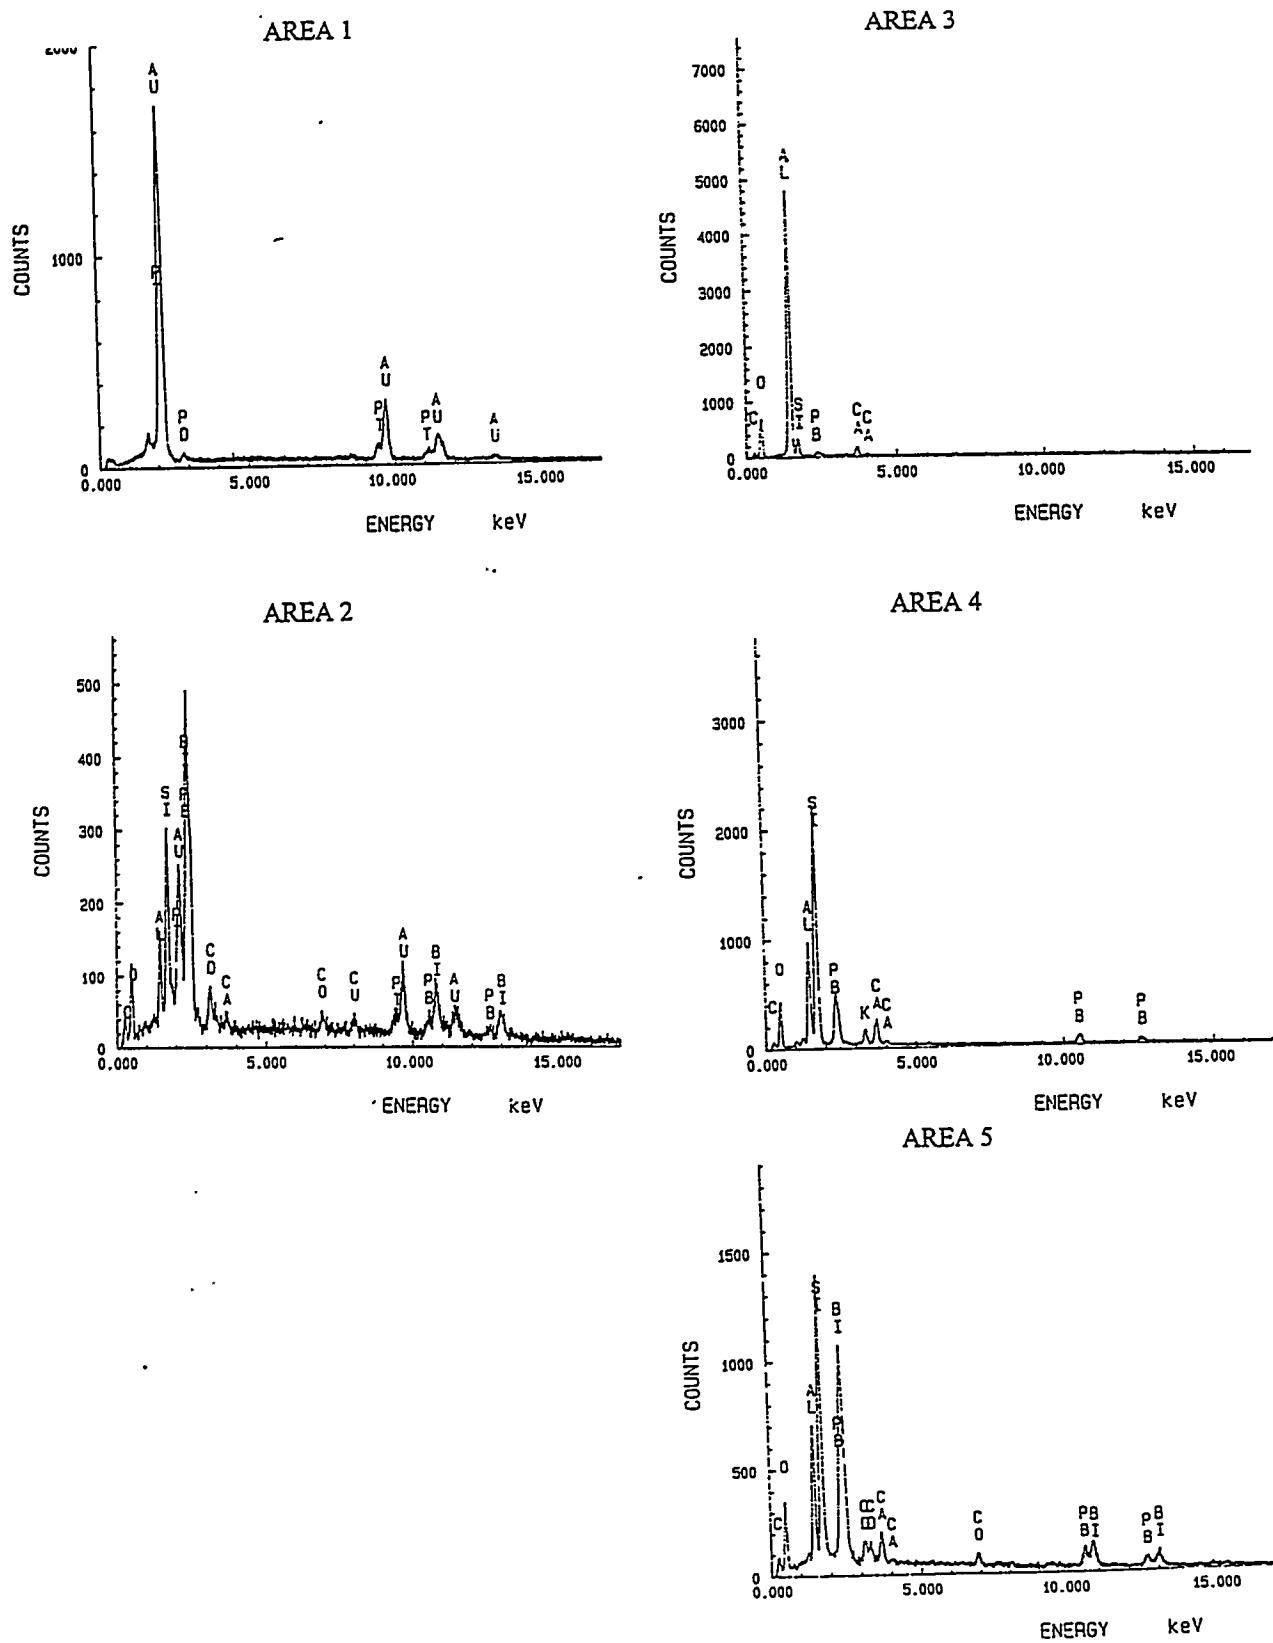
EDS spectra of areas 3, 4, and 5 show the bulk chemistry of LTCC and the LTCC chemistry near the LTCC/Au-Pt interface. Area 3 is the dark phase of the LTCC containing primarily Al with traces of Si, Ca, and Pb, and area 4 is the lighter phase containing primarily Si, with Al, Pb, Ca, and K. Both of these analyses were taken sufficiently far away from the Au-Pt interface to represent the composition of the monolithic LTCC. The bright band in the LTCC (Figure 20B) is limited to the area between the LTCC and Au-Pt. The brightest phase in that band, area 5, was analyzed and the spectra are shown in Figure 21, area 5. The spectra reveals that glassy constituents from both the LTCC and DuPont 4596 are present, in particular the presence of the large bismuth and lead peaks indicate interaction has occurred between the glass phases of the DuPont 4596 into the LTCC substrate. The thickness of the bismuth-rich layer, 16 to 20 microns, was measured on the front and backside surfaces of the LTCC and no substantial difference was observed. These micrographs and analyses, of the baseline part (TV #8A), show the interaction of some glassy constituents has occurred between the LTCC and DuPont 4596, and that multiple firings and processing to this stage have not caused any segregation of a phase or an isolated layer that would cause a weakened interface.

**Figure 21.** EDS spectra from areas identified in micrographs in Figure 20B from TV#8A.

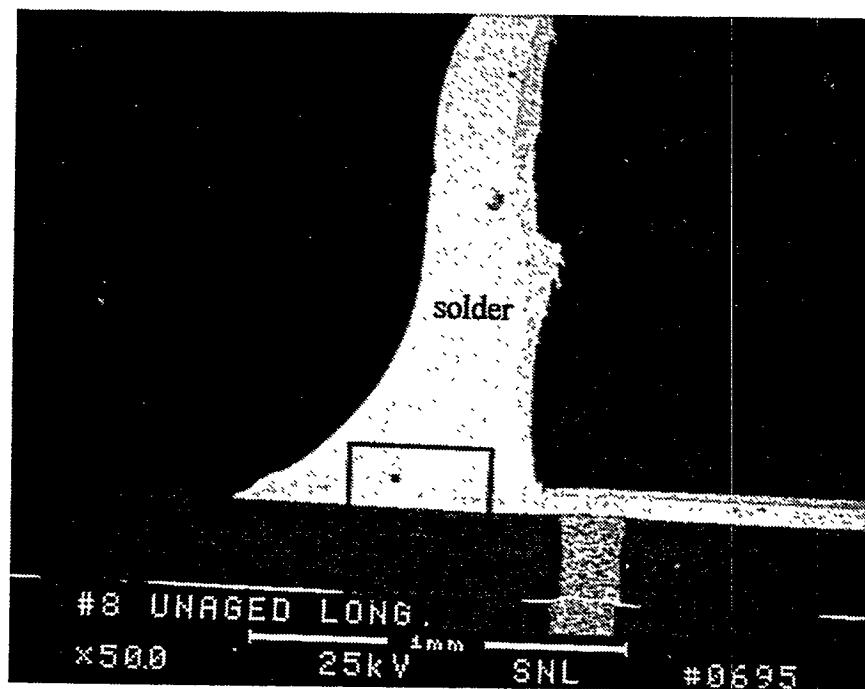
Test Vehicle #8, a substrate with soldered LCC packages, but unaged, shows the characteristics of the solder/Au-Pt/LTCC interfaces before exposure to the accelerated aging environment. The cross-section of TV #8 was examined and micrographs are shown in Figures 22A, 22B, and 22C. EDS spectra were taken from areas marked on Figure 22C. Again the bismuth-rich band in the LTCC, area 5, occurred only adjacent to the DuPont 4596 and the layer was about 20 microns thick.

**Figure 22A.** Low magnification of the solder fillet connecting LCC with LTCC substrate.

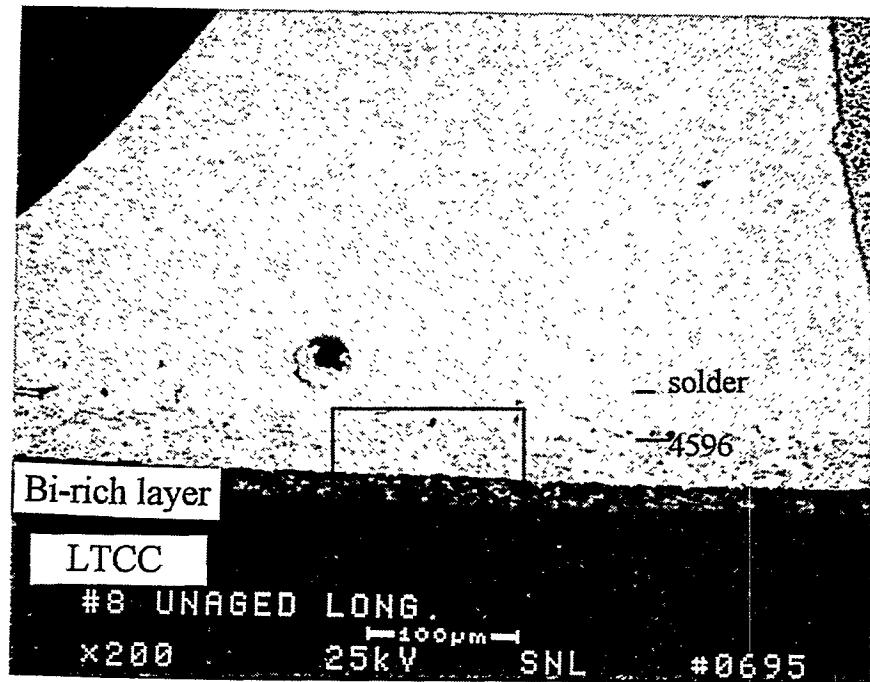
**Figure 22B.** SEM backscatter image of solder LTCC interface.

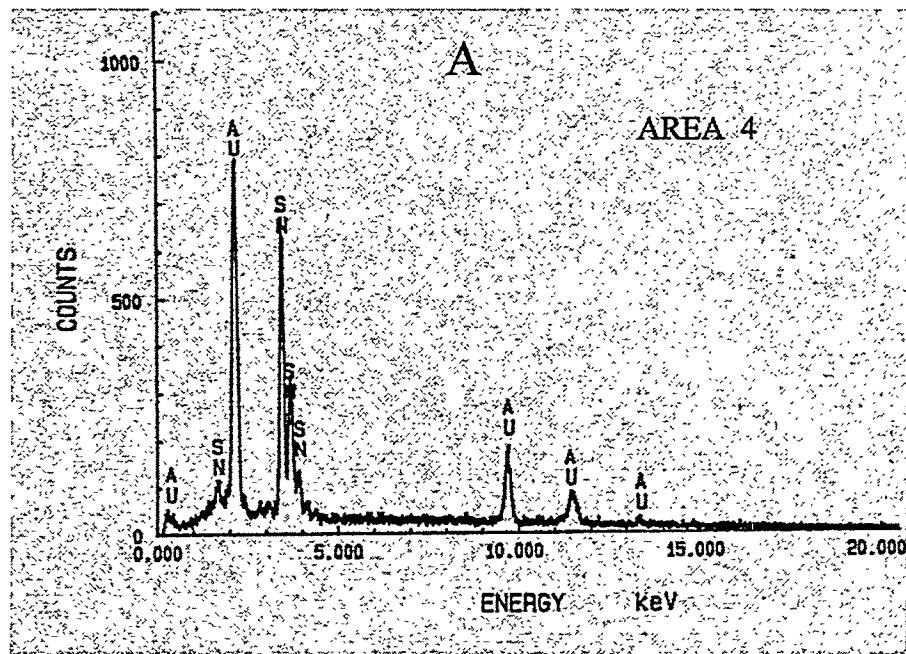
There were two additional distinct phases identified in the Au-Pt layer, areas 4 and 6 of Figure 22C. EDS spectra shown in Figure 23A of area 4, contains Au and Sn, indicating formation of the intermetallic compound. The extent of penetration of this compound, close to the interface, was surprising for a part that had not been aged. Other studies have shown that the Au-Sn intermetallic will form to some degree during the solder reflow process, but it is usually limited to a 1-2 micron thick layer between the solder and Au-Pt metallization.<sup>4</sup>

**Figure 23A.** EDS spectra of intermetallic compound found in the 4596 metallization.

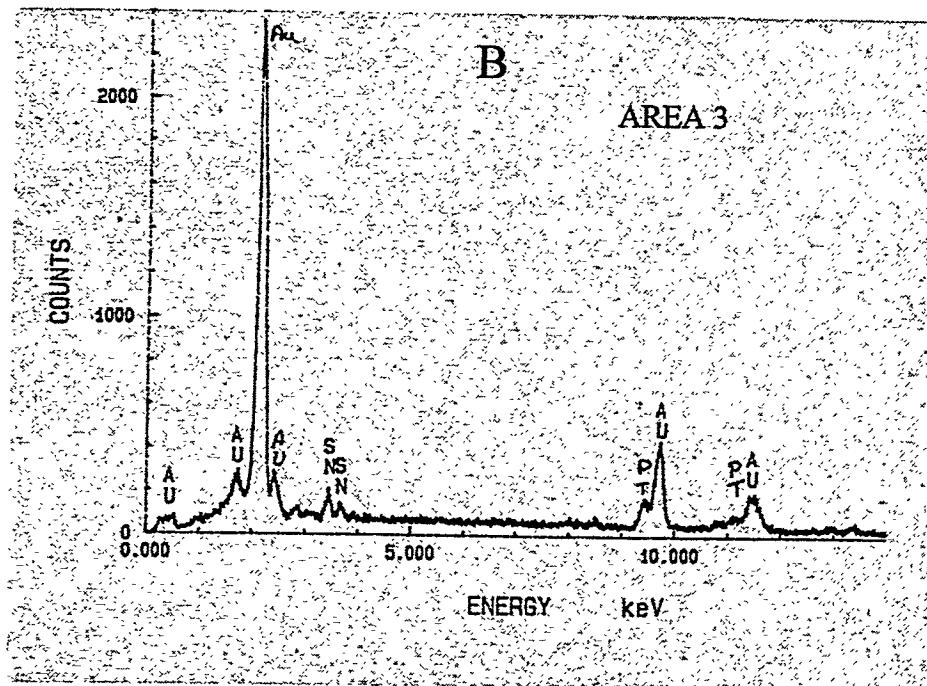
**Figure 25B.** EDS spectra of the islands of residual 4596 metallization.
