# ENRICO FERMI ATOMIC POWER PLANT

## CURRENT EXPERIENCE SERIES

### COMPILED OF CURRENT TECHNICAL EXPERIENCE AT ENRICO FERMI ATOMIC POWER PLANT

APRIL 1968

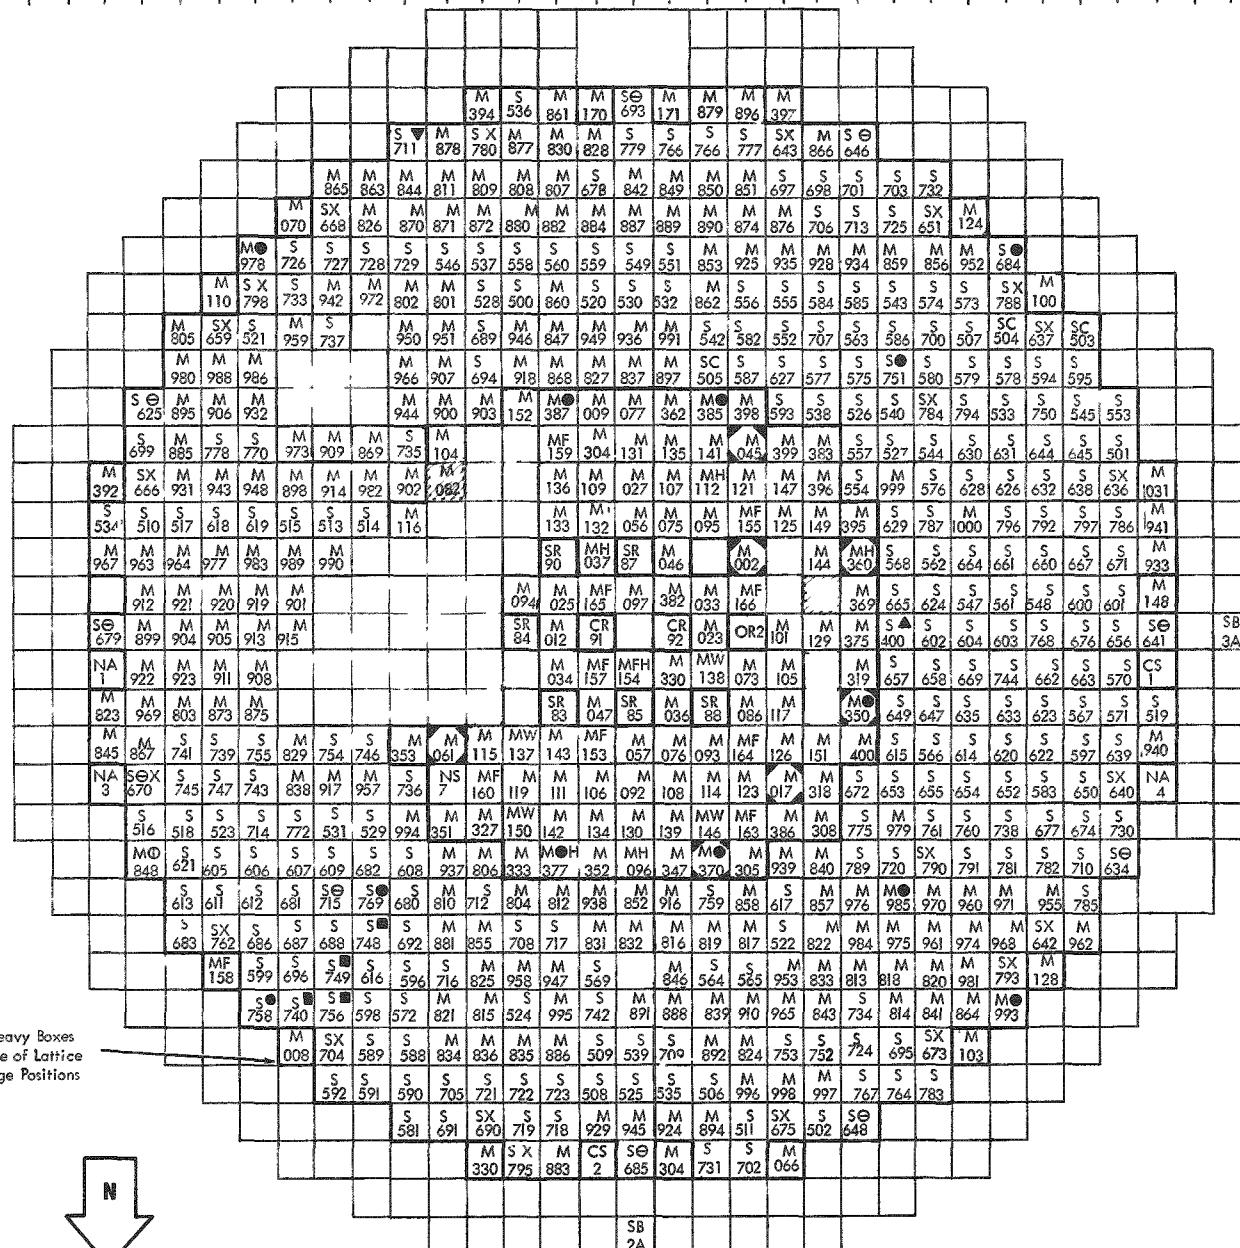
FIG. 13 REACTOR LOADING ON 4-30-68

As shown in the reactor loading diagram (Figure 13), one core sub-assembly was moved to a different position in the reactor during April. Core subassembly M082 was moved from PO5-PO1 to NO5-PO4 for the purpose of opening up an additional support plate position for insertion of the spine-type manipulator with the borescope and light source for removal of the small foreign objects sighted on the west side of the inlet plenum.

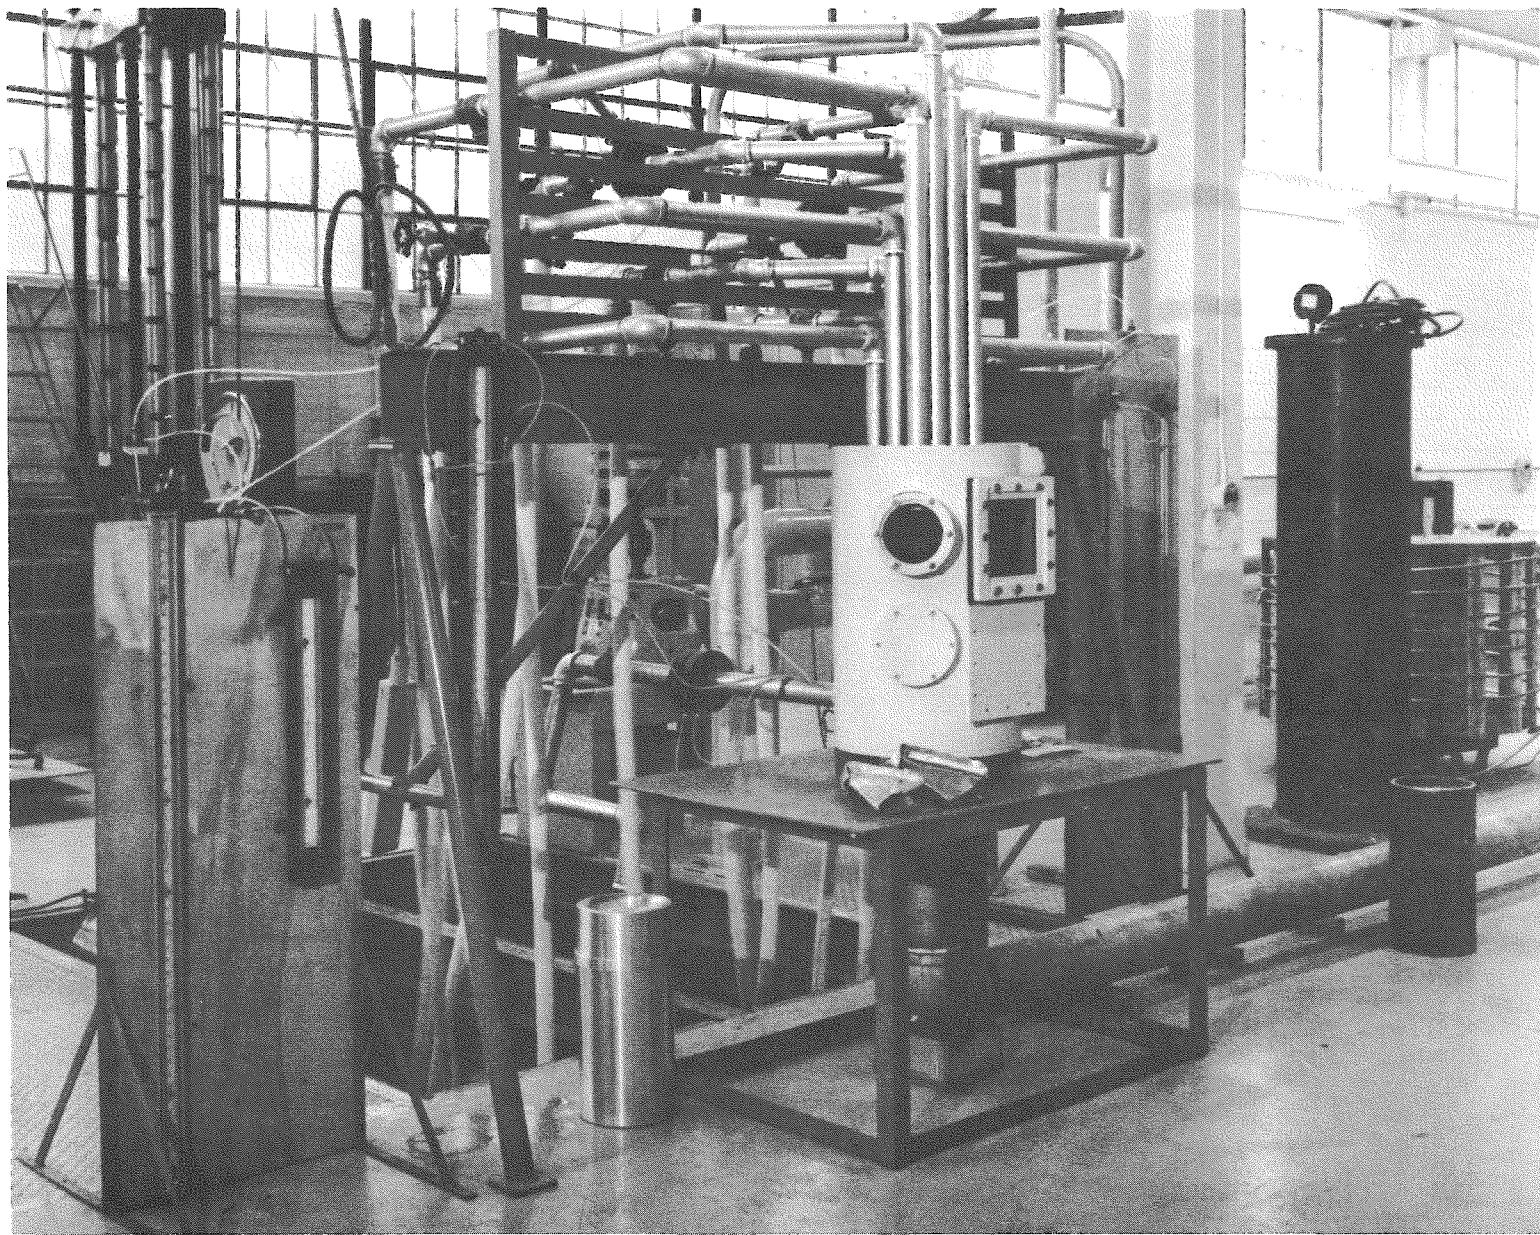
FIG. 14 HYDRAULIC LOOP AND TEST CHAMBER FOR SUBASSEMBLY FLOW BLOCKAGE TESTS

An available hydraulic test loop was adapted to include a windowed chamber which simulated the core inlet plenum and contained a 12-hole mock-up support plate with individual discharge pipes. The model of the object was located at the bottom of the mock-up support plate aligned in positions believed to be practical for preventing flow. Figure 14 is a photograph of the hydraulic loop and equipment; Figure 15 is a schematic of the test loop, and Figure 16 shows the actual object, following its removal from the reactor, against the bottom of the mock-up support plate. Reactor flow conditions of 100 gpm through each support plate opening and a pressure differential of 22 to 23 psi were established as initial test conditions. It was possible to accurately measure the flow through individual channels to determine the degree of blockage.

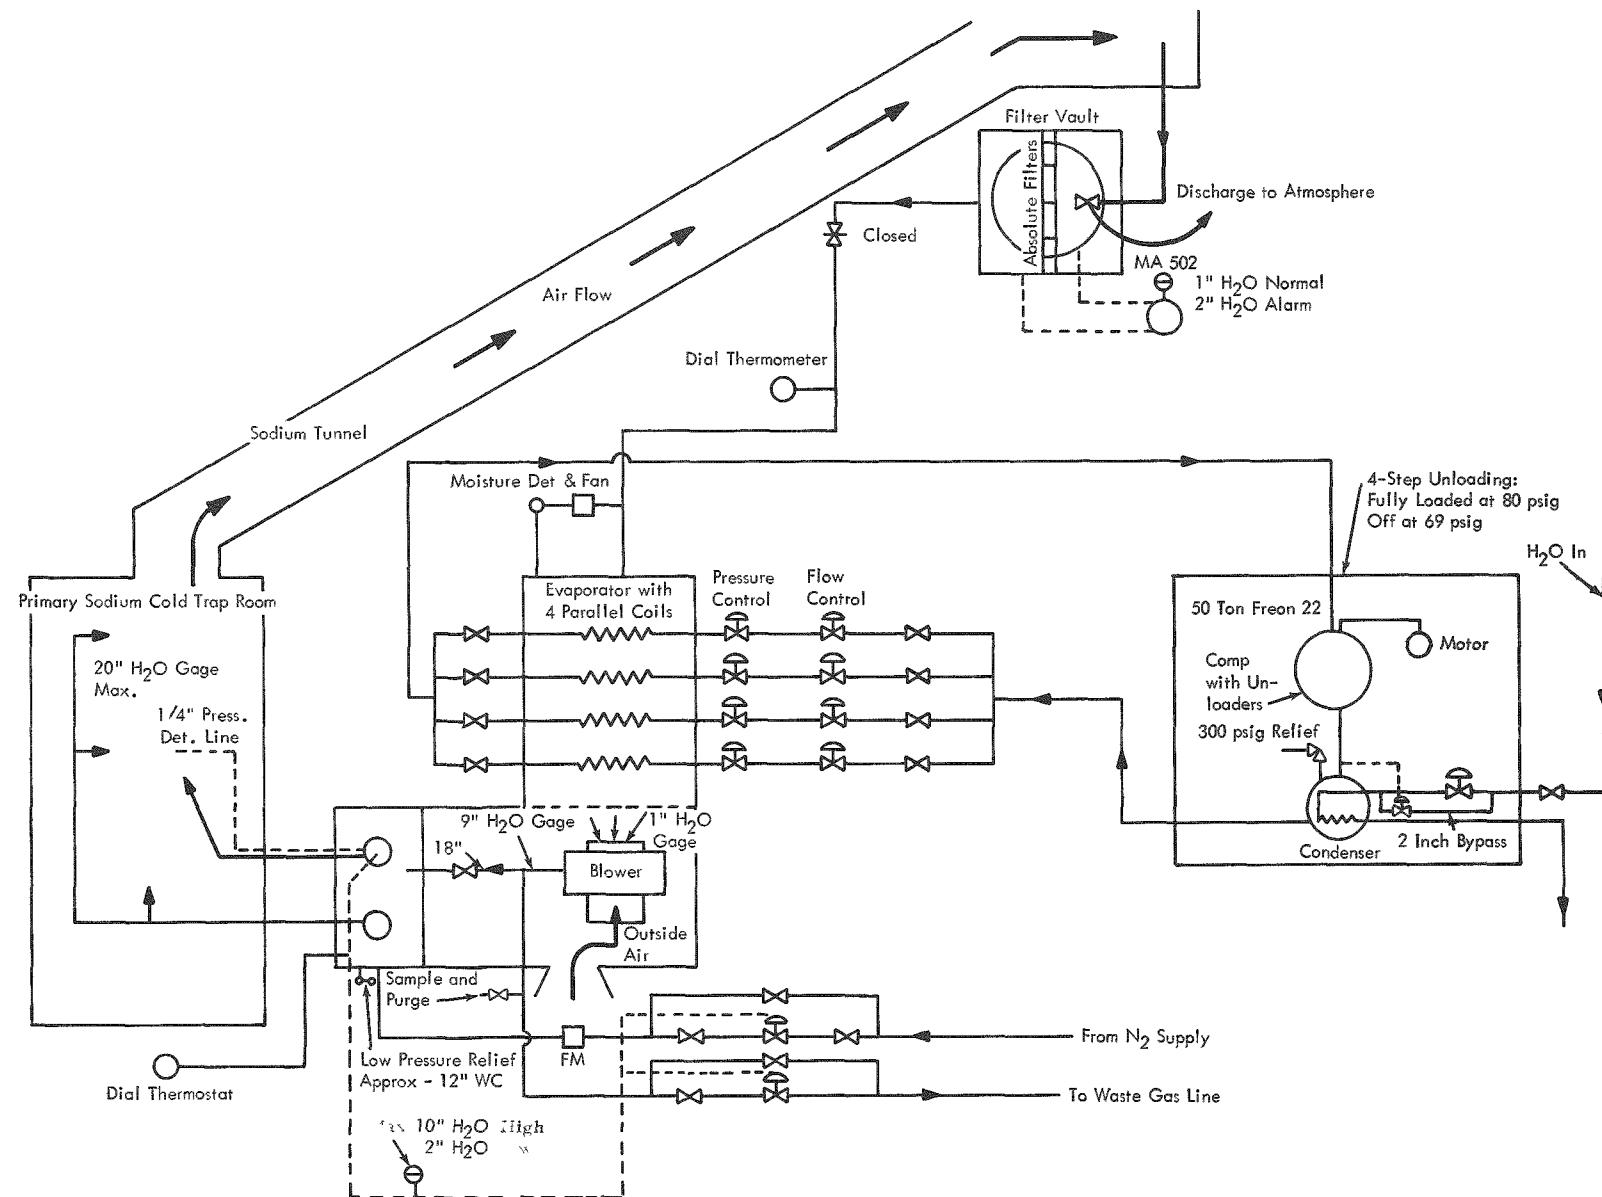
FIG. 21 SCHEMATIC OF VENTILATION SYSTEM FOR COLD TRAP ROOM AND TUNNEL

Before the bellows valve repair (above) was undertaken, routine inspection and maintenance and repair of a freon-22 leak in the refrigerant cooled ventilation system for the cold trap room and sodium tunnel to the reactor building were completed. The function of the ventilation system, shown schematically in Figure 21, is to maintain a recirculated nitrogen atmosphere below 150 F in consideration of the structural properties of the concrete walls enclosing the cold trap room and the tunnel. The nitrogen atmosphere maintained at less than 5% oxygen and at a positive differential pressure of 0.5 inch water column minimizes the hazard of fire from sodium leaks.

through a temporary opening in the blower housing and discharged through the cold trap room and the tunnel and out to atmosphere through a temporarily-opened manhole in the top of the absolute filter vault (Figure 21). The valve bellows repair (Section VII.A) was accomplished also during this period of air circulation. When the maintenance work was completed, nitrogen recirculation was re-established to restore the ventilation system to its normal operating condition.
