ENRICO FERMI ATOMIC POWER PLANT

CURRENT EXPERIENCE SERIES

COMPILED OF CURRENT TECHNICAL EXPERIENCE AT ENRICO FERMI ATOMIC POWER PLANT

APDA-CFE-20
ISSUED: JUNE 1968

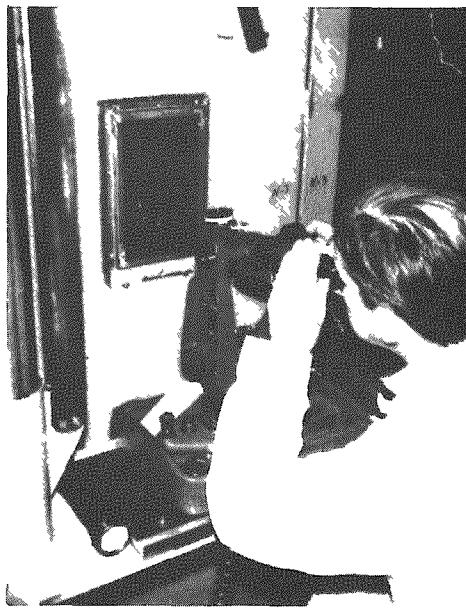
Figures 19 and 20 show the transit set up in front of the center window for a dimensional survey, and a view of the subassembly through the center window.

**FIG.19 TRANSIT VIEWING THROUGH CENTER
WINDOW OF EXIT PORT INSPECTION
FACILITY**
