SANDIA REPORT

SAND94-8235 • UC-404
Unlimited Release
Printed January 1995

NaK Pool-Boiler Solar Receiver Durability Bench Test, Vol. 2: Metallurgical Analysis

S. H. Goods, R. W. Bradshaw

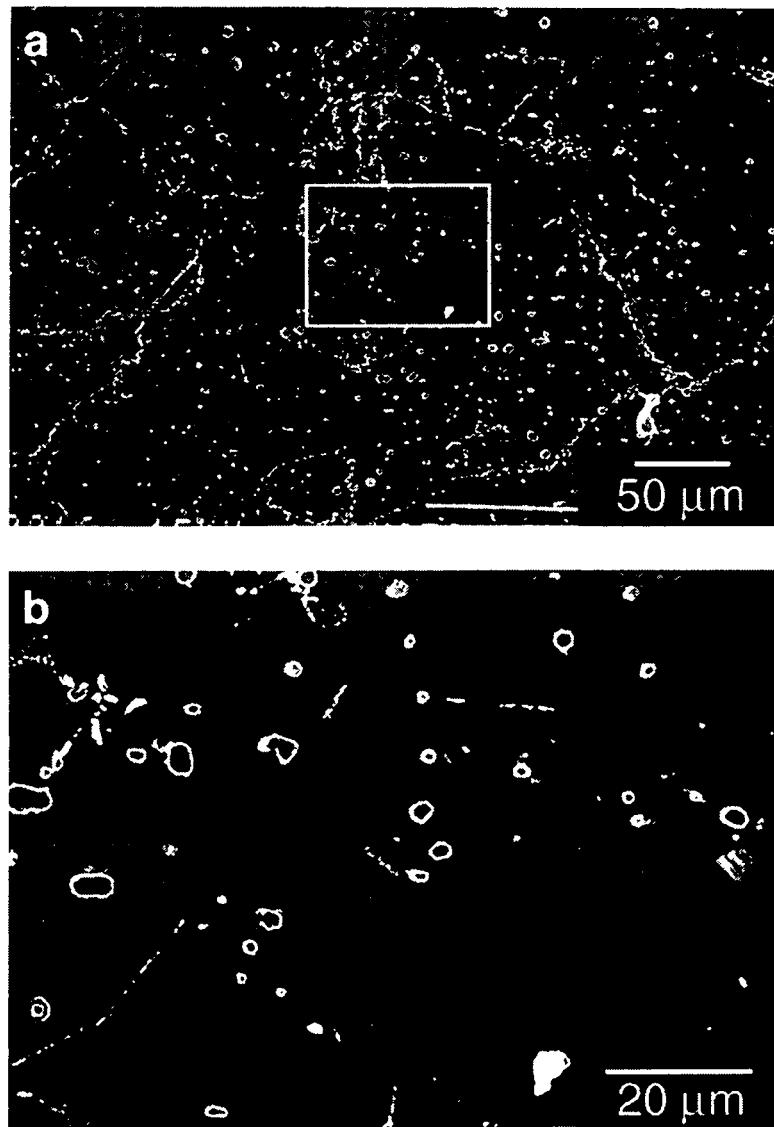
A second phase microstructure remains after solution heat treatment. This is shown in Figures 4a and b which are scanning electron micrographs (SEM) of a polished and etched cross-section of the as-received alloy. The micrographs reveal that the material contained a relatively uniform distribution of second-phase particles. This "primary" precipitate microstructure in the solution heat treated condition consists of face-centered cubic M₆C particles (as Ni₃W₃C). Chromium or other alloying elements may substitute for nickel in the carbide. These precipitates are stable and do not revert to solution. Extended high temperature exposure results in the formation of "secondary" chromium

Figure 4. a,b) Scanning electron micrographs of as-received microstructure of solution heat-treated Haynes 230 alloy used in construction of pool-boiler. Solution heat-treated alloy contains tungsten carbide precipitates.

tungsten carbides of the form $M_{23}C_6$. These precipitates have minimal impact on the performance of the alloy.

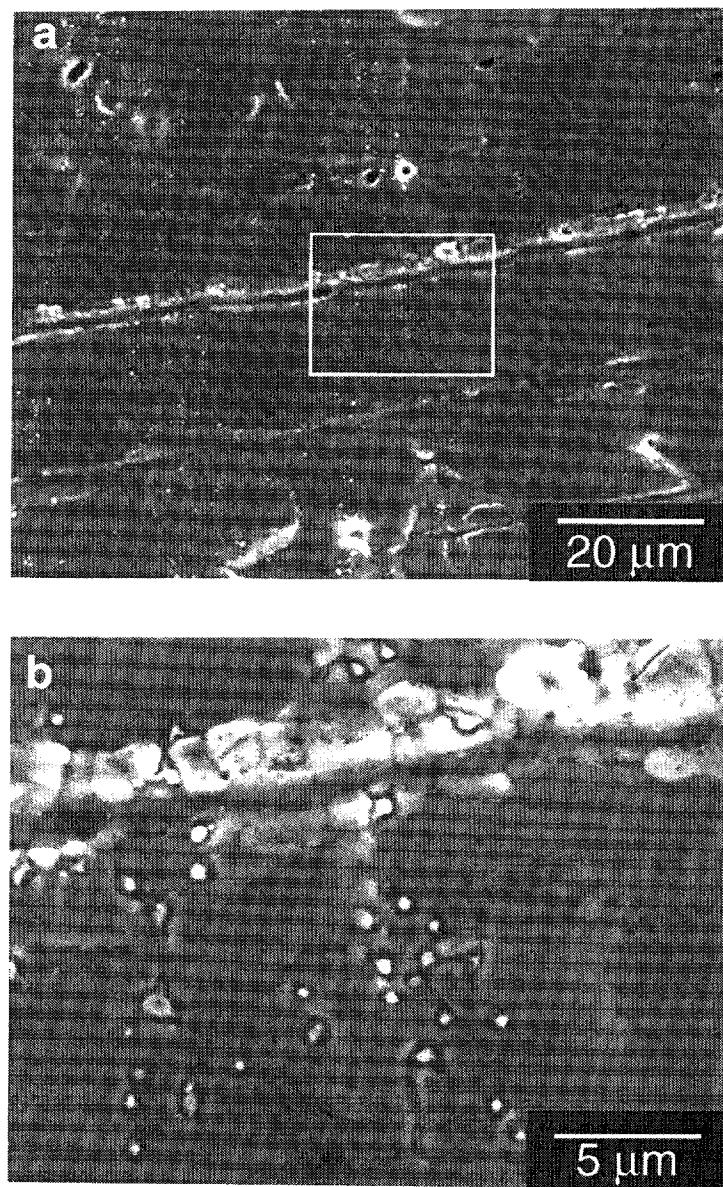
Figures 5a and b are scanning electron micrographs of the ID of the as-received tubing. Marks from the tube forming process are evident in Figure 5a. The particulates and grain boundaries that are shown in Figure 5b are revealed as the result of the chemical descaling procedure. The particulates on the tube surface have essentially the same composition as that indicated in Table II for the second phase particulates.

Figure 5. a) Internal surface of as-received Haynes 230 tubing. Parallel striations result from the tube forming process. b) Higher magnification image reveals presence of W-rich precipitates at the tube surface.

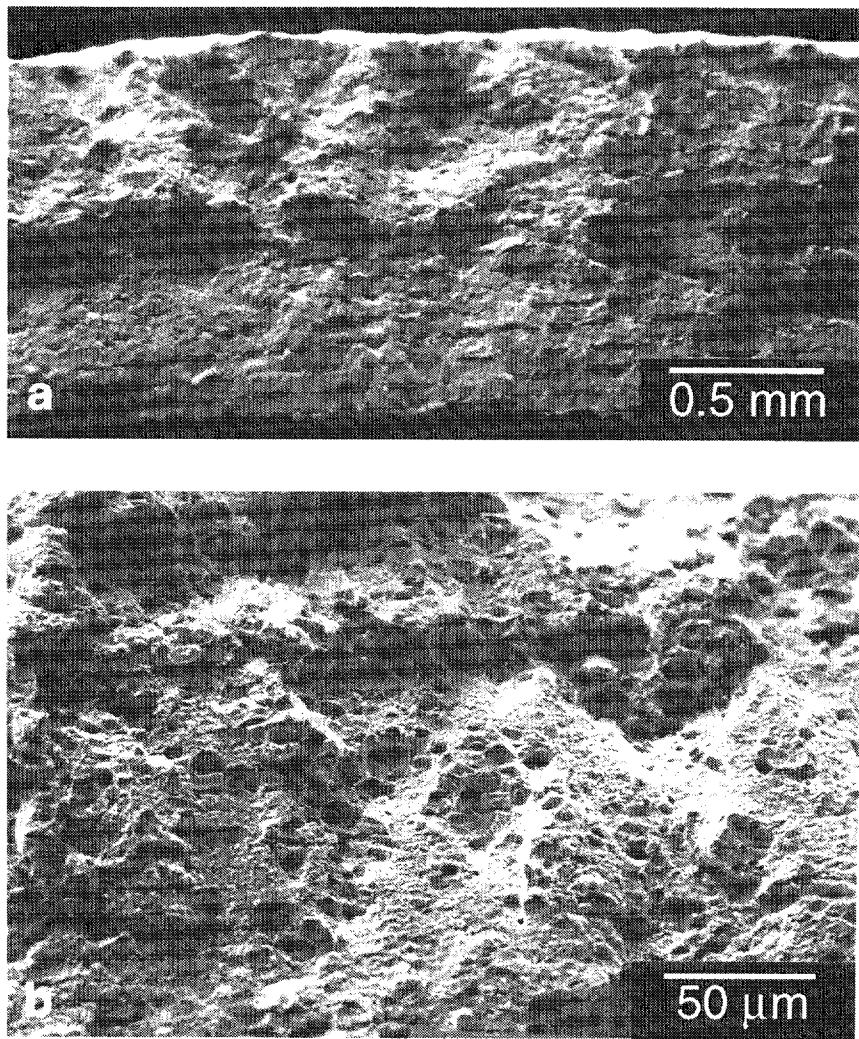
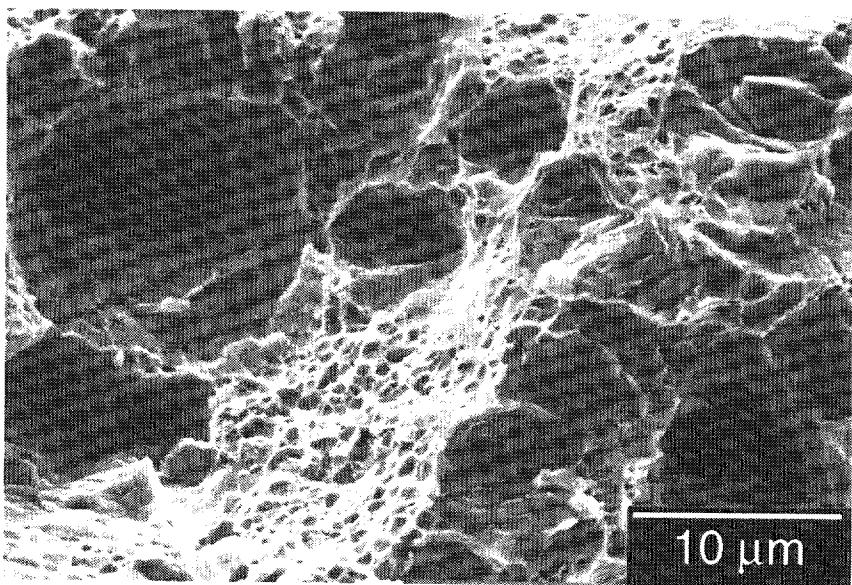
An example of the typical change in fracture mode can be seen in the next two figures. Figures 12a, b and c show the fracture surface of an as-received specimen tested to failure. At low magnification, Figure 12a shows that the fracture surface was quite flat with few distinguishing features. At higher magnification, Figure 12b reveals that the fracture could be described as having occurred via a process of transgranular ductile rupture. Fractured tungsten carbide particles decorate the fracture surface, indicating that these precipitates were well bonded to the matrix. Finally, Figure 12c reveals a generally bi-modal size distribution of dimples, where large, 5-10 μ m dimples (nucleated around the fractured carbides) are surrounded by much smaller dimples not associated with

Figure 12. Fracture surface morphology of as-received Haynes 230. a) Fracture surface was quite flat with few distinguishing features. b) Higher magnification image reveals that fracture occurred via a process of transgranular ductile rupture. Fractured tungsten carbide particles decorate the fracture surface, indicating that these precipitates were well bonded to the matrix.

Figure 12. c) Large, 5-10 μm dimples (nucleated around the fractured carbides) are surrounded by much smaller dimples yielding a bi-modal distribution of dimples.

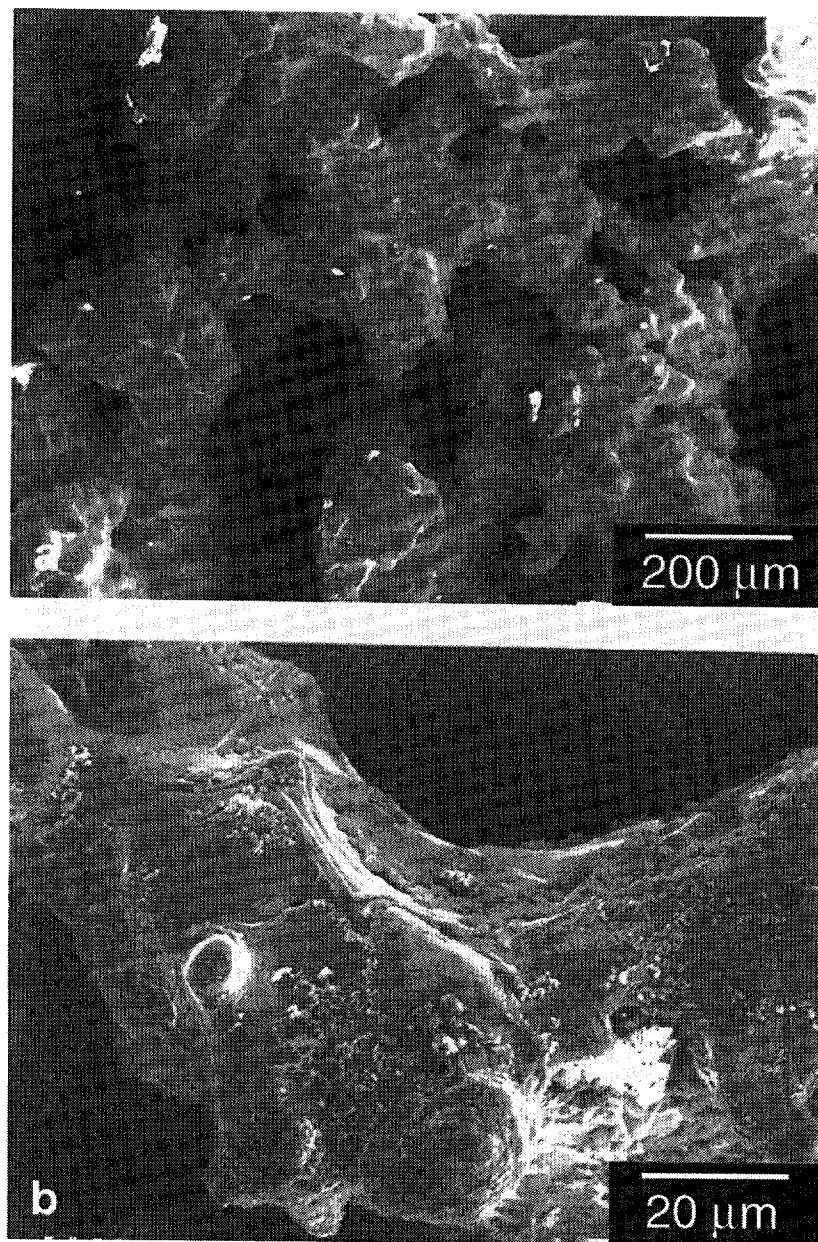
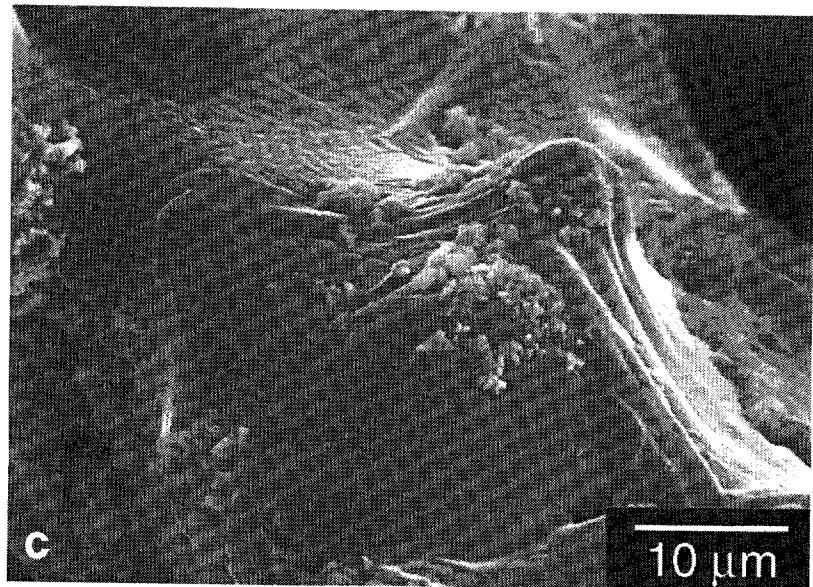
Archived sections of the brazed powder structure were used to assess the effects of long-term NaK exposure. Figures 14a, b and c are successively higher magnification SEM micrographs of the as-brazed stainless steel. Figure 14a reveals that the patch was composed of irregularly shaped particles with a free volume previously estimated to be $\approx 60\%.$ [8] The irregular shape of the metal powder particles suggests that they were produced by a water atomization process. After brazing, the particle surfaces are covered with contamination composed of $0.5\text{--}2\ \mu\text{m}$ silicon-rich particulates, see Figure 14b. These are likely to be silicon oxide particles. Such contamination is not typical of water atomized metal powders and we suspect that it arises from the post-atomization handling of the powders and/or the brazing process. At very high magnification, Figure 14c reveals the presence of a "terraced" structure on the surface of the metal powder. Such structures can arise from thermal etching.

The brazed patch was examined in detail. There was no evidence of spalling, cracking or any other structural degradation resulting from repeated thermal cycling. This was somewhat surprising in light of the relatively rigorous thermal cycling profile imposed on the patch over the operating history of the pool-boiler. Figures 15a and b are micrographs taken from the brazed patch in the pool-boiler. Figure 15a shows that the patch maintained the same general high surface area, open morphology of the as-brazed patch. The surface contamination shown in Figure 14b and c is no longer apparent. Silica will not be reduced by NaK as the alkali metal oxides are less thermodynamically stable than $\text{SiO}_2.$ [16] The absence of the silica contamination is therefore likely the result of some minimal dissolution of the underlying stainless steel allowing the contamination to break free or of thermal cycling which could promote the detachment of weakly bound particles. In addition, the zirconium getter can reduce silica which would facilitate its removal by either loss of adhesion or, possibly, dissolution. Figure 15b shows that the terraced structure on the original stainless steel powder surfaces was no longer visible, suggesting that the stainless steel suffered a very small amount of dissolution due to NaK exposure. This observation supports the argument that the loss of the silica contamination was the result of dissolution of the stainless steel.

Figure 14. Successively higher magnification micrographs of an as-brazed enhanced boiling surface stainless steel powder patch. a) Irregular stainless steel particles suggest a water atomization process. b) Silica contamination is present on the SS powder particle surfaces.

Figure 14 c) Terraced structure on the surface of the metal powder can arise as the result of thermal etching.

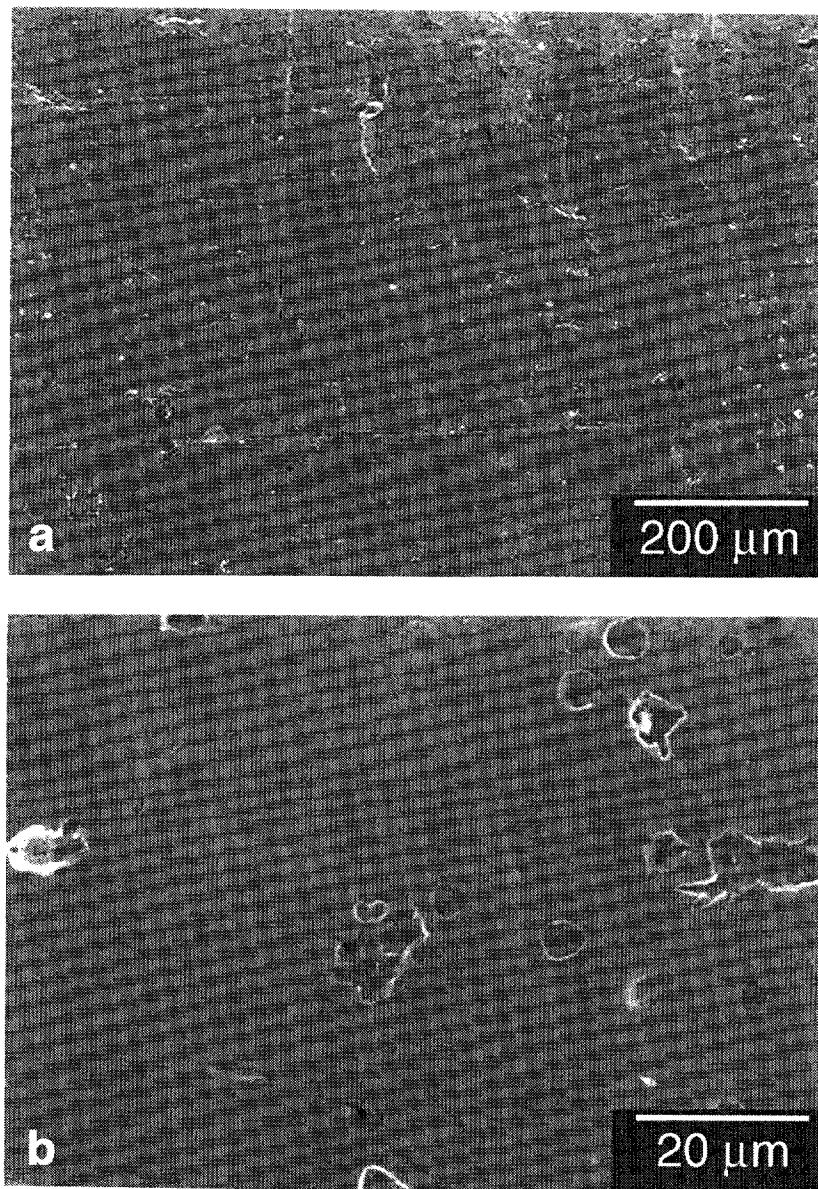
Scanning electron microscopy of the as-received thermowell tubing is shown in Figures 16a and b. Figure 16a shows, at low magnification, a horizontal surface striation and disturbed metal, both indicative of the tube drawing process. Dark regions resulting from surface contamination are also apparent. At higher magnification, Figure 16b reveals the presence of imbedded particles and pullouts, also indicative of a drawn surface. Aside from these, the surface of the tubing was essentially featureless, exhibiting neither any grain boundary structure nor any unusual surface morphology. In contrast, the IN 600 thermowells removed from the pool-boiler exhibited dramatic changes in structure. Figures 17a and b show the surface of a thermowell that was located below the liquid level of the NaK. At low magnification, the surface striations apparent in Figure 16a are no longer visible nor are the areas of darker contrast associated with surface contamination. However, the grain boundary structure can be clearly seen, obvious evidence of intergranular attack. At high magnification, Figure 17b the nature of the grain boundary dissolution is apparent. The alloy immediately adjacent to each grain boundary has a faceted appearance indicated that there was preferential dissolution along certain crystallographic orientations. Figure 17b also reveals that the grain surfaces themselves exhibit similar faceting, indicating that the alloy as a whole was subject to crystallographically preferred dissolution. The response of the IN 600 was the same in the condenser and as such no additional microscopy is presented. Metallographic cross-sections of the NaK-exposed tubing were prepared and it was determined that the grain boundary dissolution extended approximately 1-2 grain diameters into the tubing sidewall. The behavior of IN 600 observed here was similar to that reported for another nickel-based alloy, IN718, exposed to NaK at temperatures between 677°C and 777°C.[17] In that study the alloy exhibited evidence of grain boundary attack after 1090 hours of exposure.

Figure 16. a) Scanning electron micrographs of the as-formed IN600 thermowell tubing.
b) Imbedded particulates and pullouts are evident on the surface of the as-formed tubing.

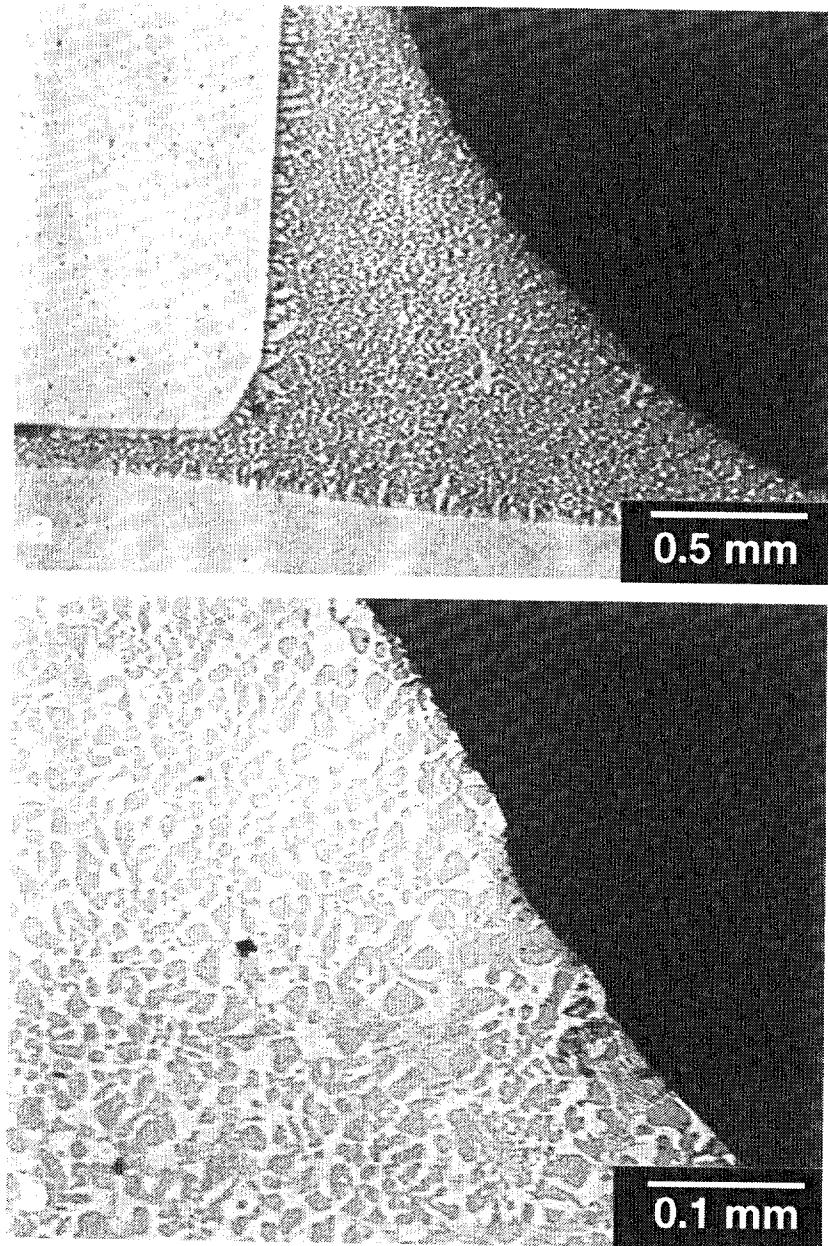
Figure 21a is an optical micrograph that shows the microstructure of a typical as-brazed joint between the Haynes 230 pool-boiler vessel to the Haynes 230 endcap. Within the interior of the braze some spherical porosity was occasionally noted (although not shown in this figure). This porosity is presumed to have formed during the brazing cycle due to entrapped gas. Figure 21b, also a higher magnification micrograph and reveals that the

Figure 21. a) Optical micrograph of a typical as-brazed joint between pool boiler vessel and endcap. b) The bulk of the braze consists of a two-phase structure. The lighter phase is nickel - boron. The darker regions are nickel - silicon. These two phases exist in nearly equal proportions.

bulk of the braze consisted of a two-phase structure. EDS analysis was used to determine the composition of these two regions. The results reveal that the lighter phase shown in Figure 21b was a composed of \approx 94 wt.% nickel and \approx 5.5 wt.% boron while the darker regions were composed of \approx 88 wt.% Ni and \approx 11 wt.% silicon. Both phases contained between 0.5 and 1.0 wt.% chromium. These two phases existed in nearly equal proportions and therefore the elemental analyses are consistent with the overall composition of the braze alloy presented in Table I. Backscatter electron imaging revealed that the silicon-rich phase (either as-brazed or NaK-exposed) was, in fact, composed of a finer structure containing regions of greater and lesser silicon (see Figure 22). At high magnification the interface between the braze and the Haynes 230 showed evidence of other phases resulting from the interdiffusion of the BNi-3 and Haynes 230 constituents. The formation of such structures in brazed joints is common and is minimized by holding temperature and time to the minimum necessary to achieve a sound joint.[20]
