INTERGRANULAR CRACKING OF INOR-8 IN THE MSRE

H. E. McCoy

B. McNabb

NOVEMBER 1972

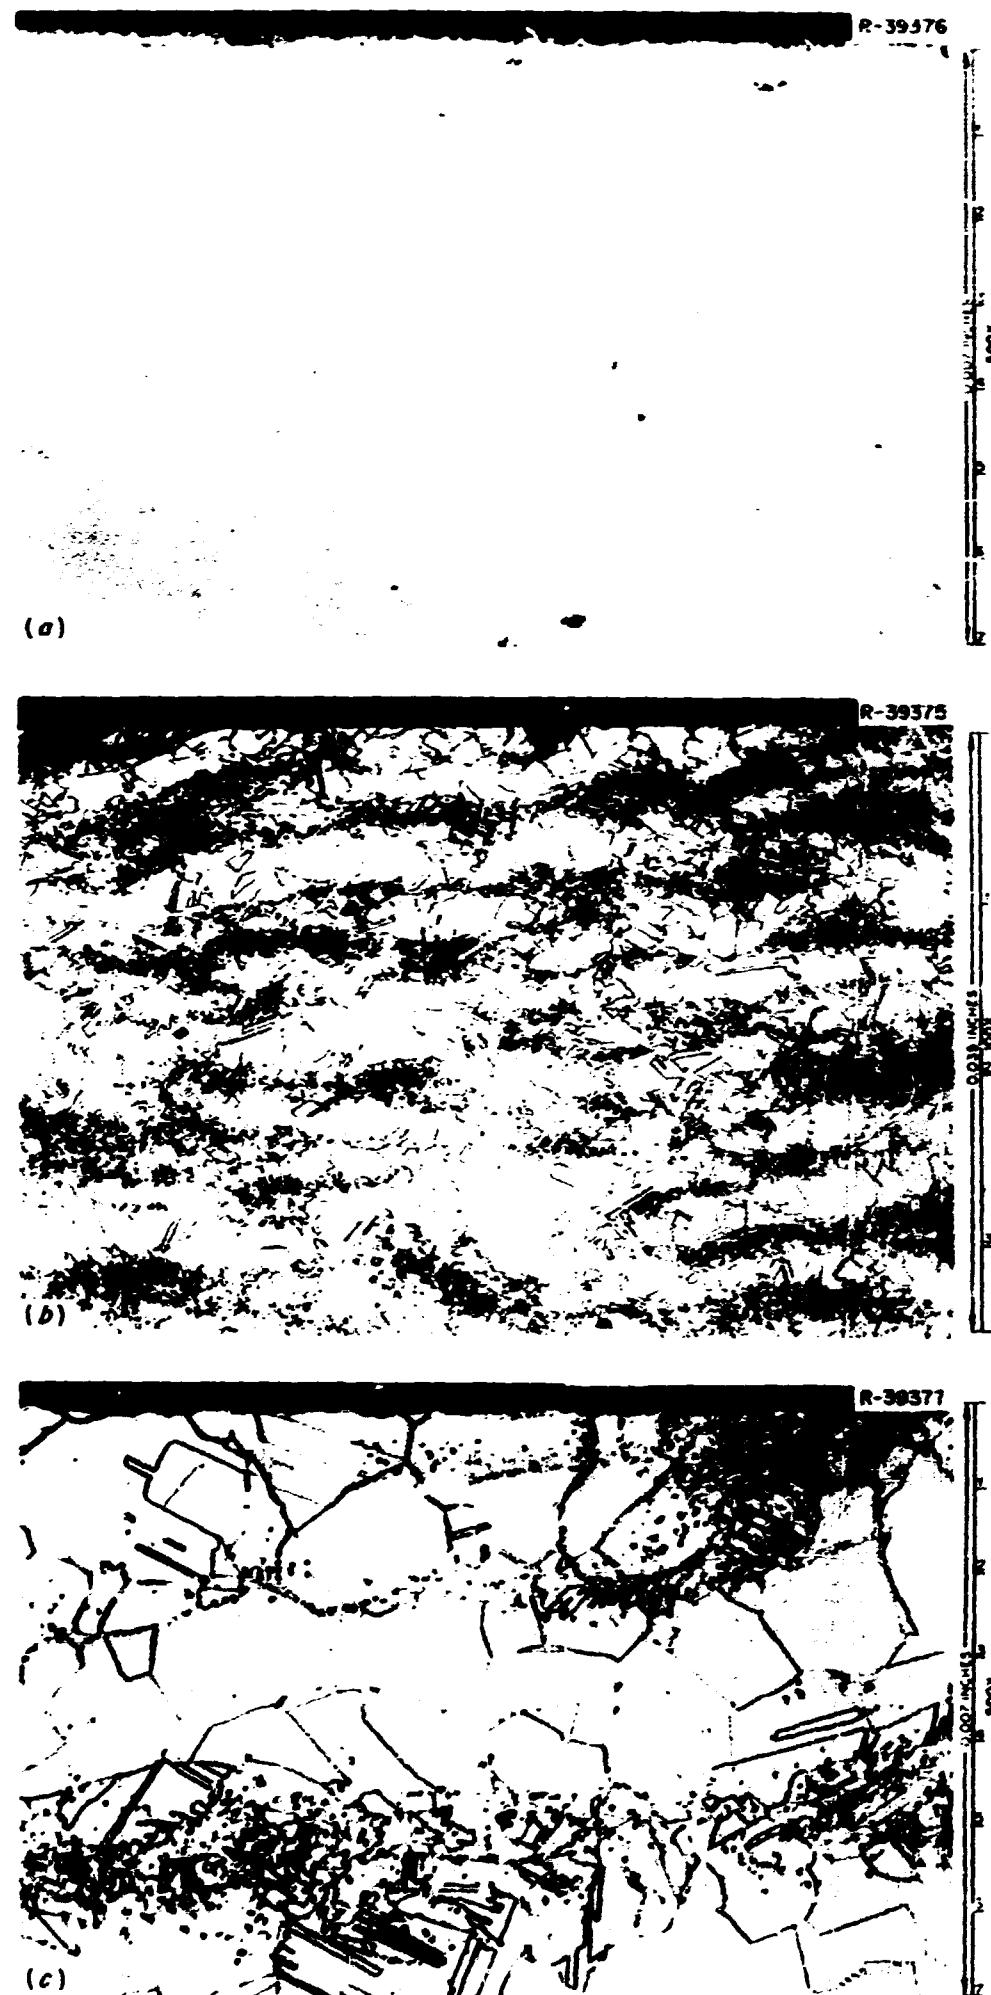
Fig. 14. Photomicrographs of Titanium-Modified INOR-8 (Heat 21545) Removed from the MSRE After 5554 hr above 500°C. Edge exposed to flowing salt. (a) As polished. 500x. (b) Etchant: aqua regia. 100x. (c) Etchant: aqua regia. 500x. Reduced 33%.

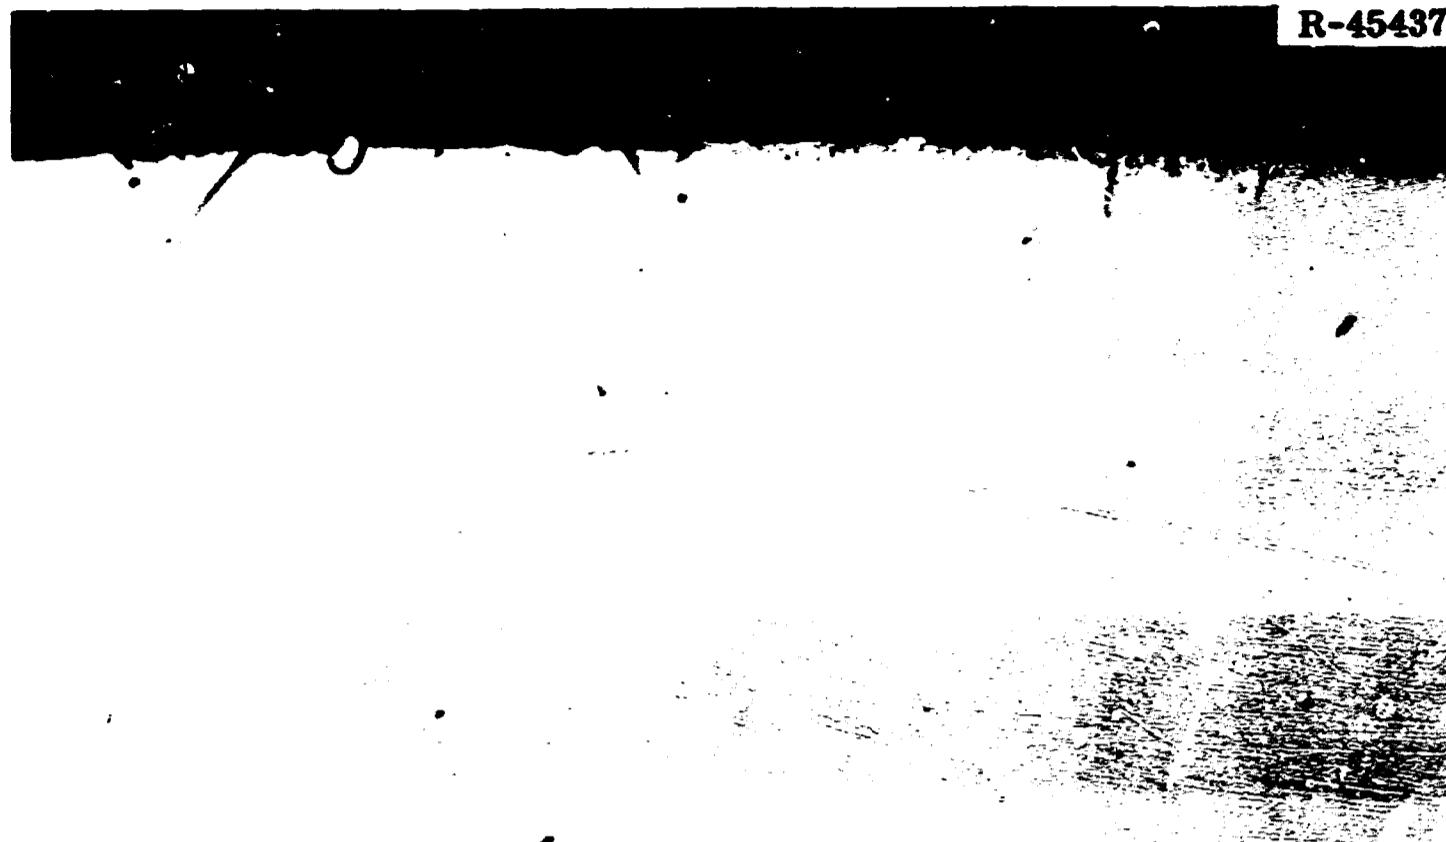
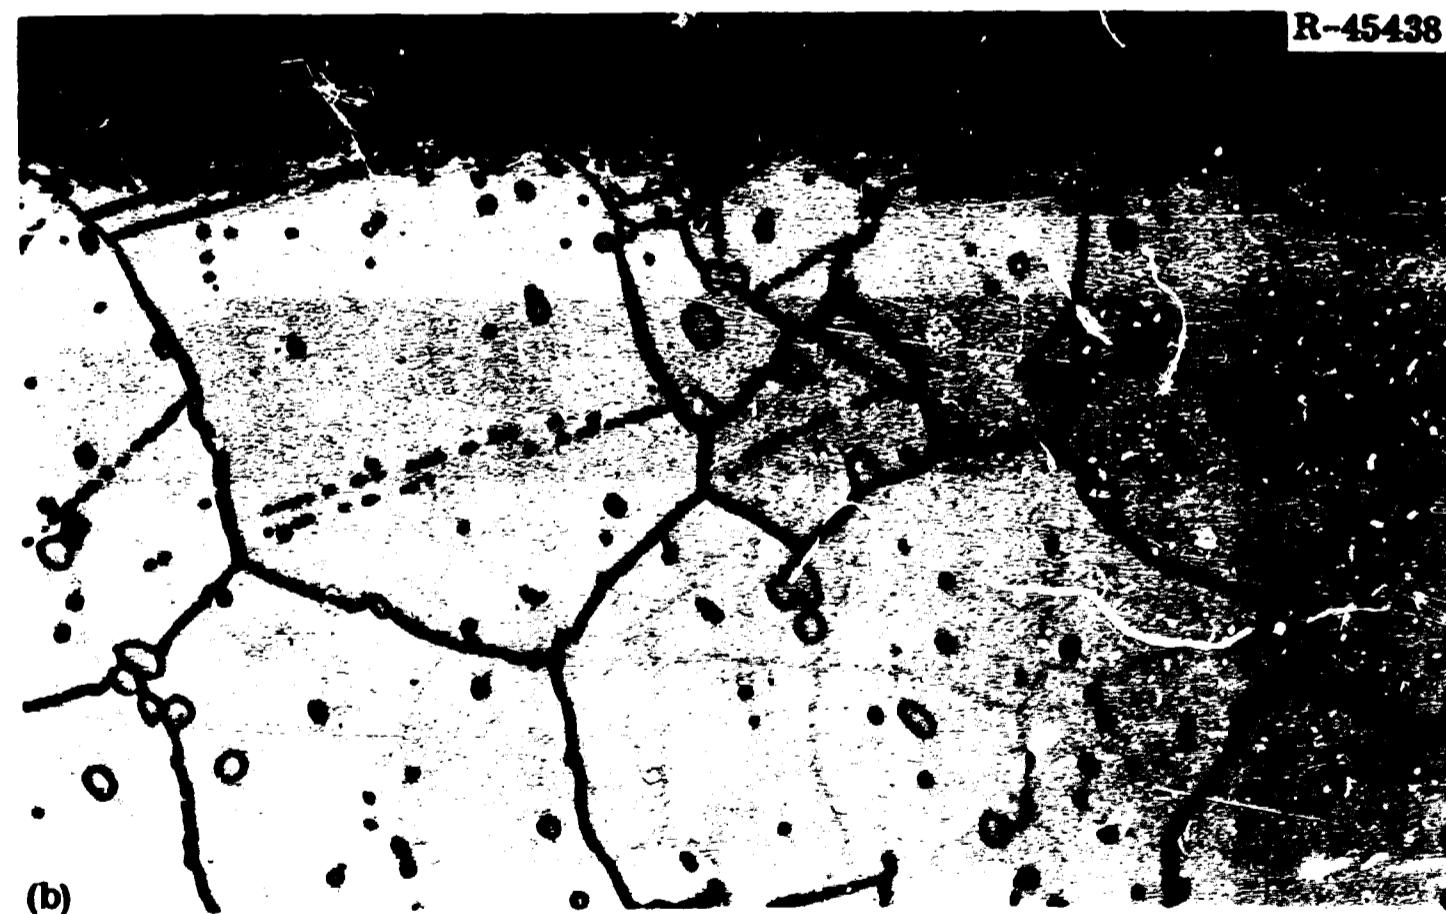
Stringers RR2, with the standard heats, had been exposed 2 to 4 times as long as the standard alloy specimens in the first group. (The factor depends upon which exposure index is used; see Table 3.) Effects of the longer exposure were evident in metallographic examinations of unstrained specimens. Figures 19 and 20 are of specimens of heats 5065 and 5085 exposed on stringer RR2 in the core. Some of the grain boundaries near the surface are visible in the as-polished condition, and a few appear to be opened as small cracks with a maximum visible depth of about 1 mil. The etched views show the large amounts of carbide precipitate that formed along the grain boundaries and the modified structure near the surface, which is thought to be due to working from machining. In samples of these heats exposed in the control facility, grain boundaries were not visible in as-polished samples. This is shown for heat 5065 in Fig. 21. As in the core specimens, however, etching brought out the carbide precipitate and the modified structure near the surface. The microstructure of control specimens of heat 5065 was quite similar.

Fig. 20. Photomicrographs of INOR-8 (Heat 5083) Surveillance Specimens Exposed to Fuel Salt for 11,933 hr above 500°C. 500x. Shallow reaction layer is seen near surface. (a) Unetched (b) Etched (glyceria regis).

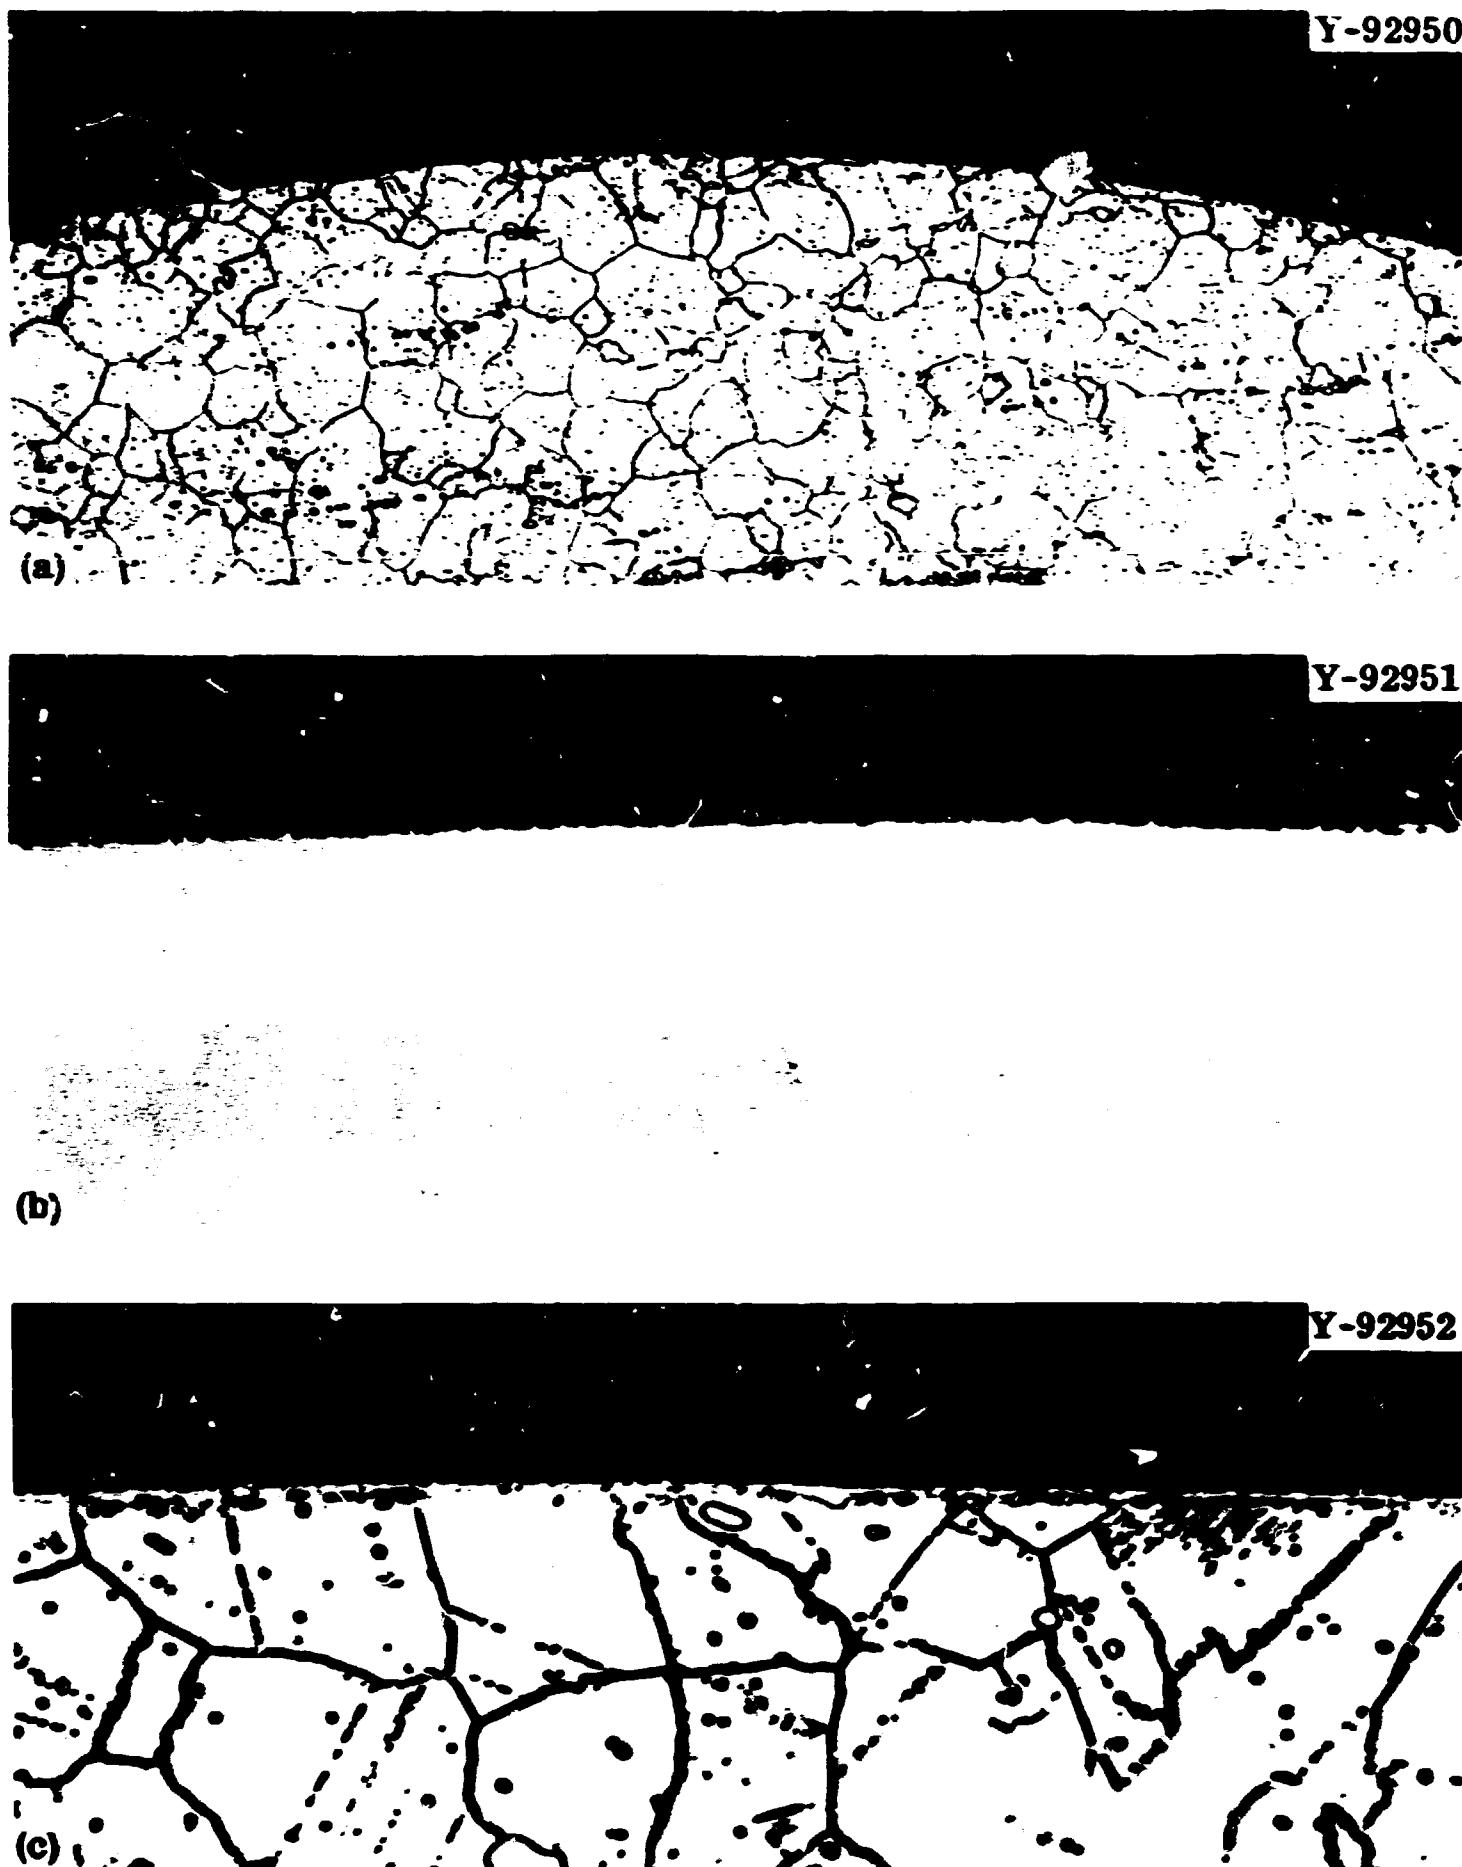
Fig. 21. Photomicrographs of INOR-8 (Heat 5065) Surveillance Control Specimens Exposed to Static Barren Fuel Salt for 11,933 hr above 900°C. Note the shallow reaction layer near the surface. (a) Etched. 100x. (b) As polished. 500x. (c) Etched. 500x. Etchant: glyceria regia.

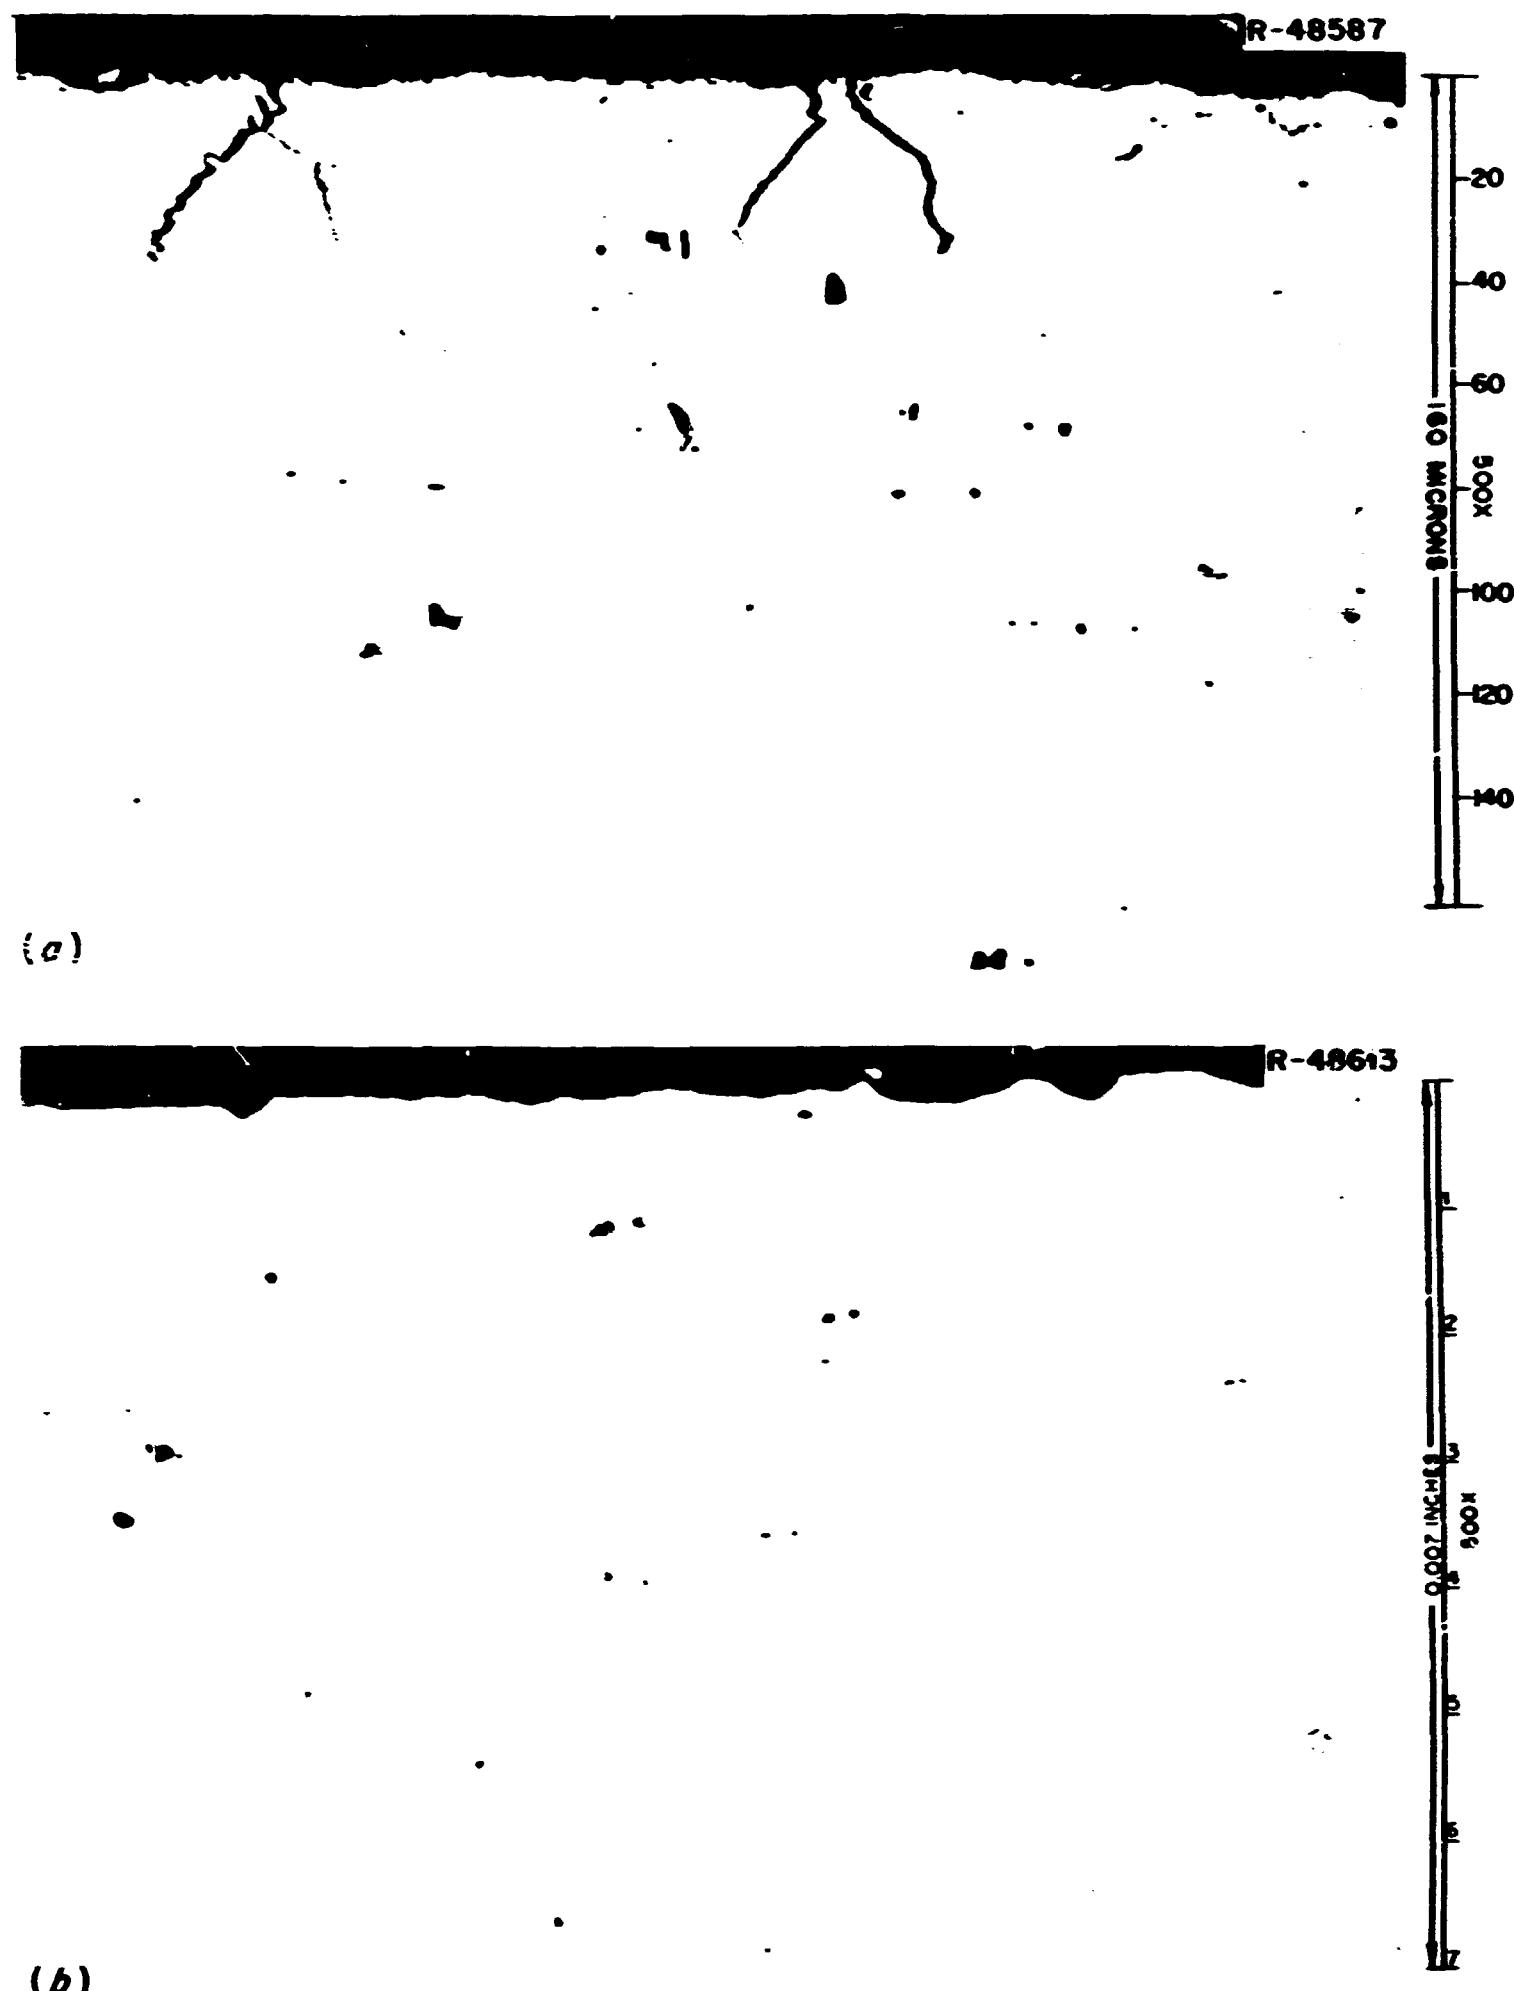
Cracking at the surface of unstrained material was even more evident in the examination of the straps that bound stringer RR2. These straps and those around the control stringer CR2 were of standard INOR-8 heat 5055. As shown in Fig. 22, the strap exposed in the core had cracks to a depth of about 1.5 mils. Cracks were distributed uniformly, both on surfaces exposed to flowing salt and those facing the graphite specimens. In contrast, the straps exposed in the control facility did not show any cracks. The straps after being formed, had been annealed for 1 hr at 1180°C and should not have been stressed thereafter since they expanded more at high temperature than did the graphite they enclosed.

Fig. 22. Photomicrographs of INOR-8 (Heat 5055) after Exposure to (a) the MSRE Core and (b) the MSRE Control Facility for 11,933 hr above 500°C. This material was used for straps for the surveillance assembly. As polished. 500x.

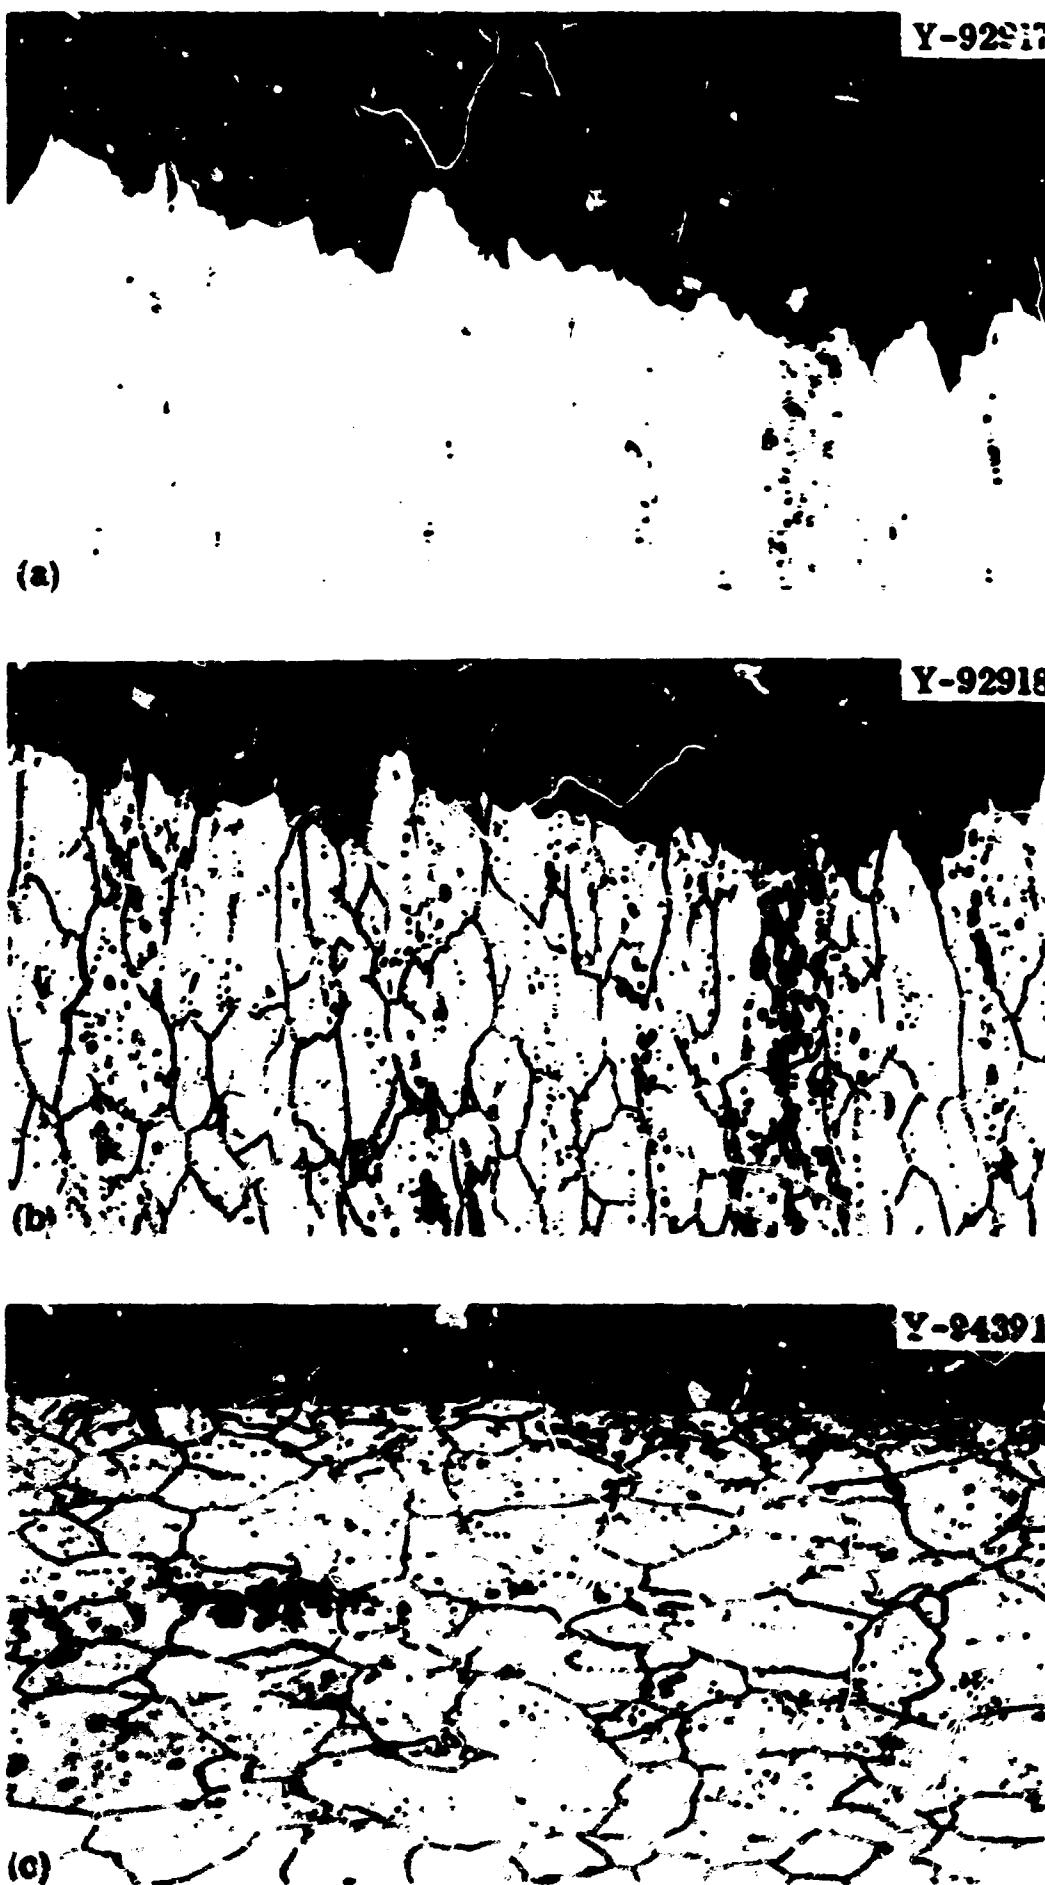
Microstructures of stressed samples of heat 5065 from the control facility and from the core are shown in Figs. 23 and 24, respectively. Numerous intergranular edge cracks are found in the sample from the core (Fig. 24) and very few in the sample from the control facility (Fig. 23). The fractures of both of these samples are largely intergranular at all locations and not just near the edge, which is further evidence that the reduction in fracture strain (Table 5) is due to carbide precipitation along the grain boundaries and not related to the intergranular cracking near the surface. Tested samples of heat 5085 from the control facility and the core are shown in Figs. 25 and 26, respectively. The as-polished views in the latter figure show some of the large carbide particles that fractured during testing.

Fig. 23. Photomicrographs of a LNOR-8 (Hast 5065) Sample Exposed to Static Barren Fuel Salt for 11,933 hr. above 500°C and Then Tested at 25°C and a Strain Rate of 0.05/min. 100x. (a) Fracture, as polished. (b) Fracture, etched. (c) Edge of stressed portion, etched. Etchant: glyceria regia.

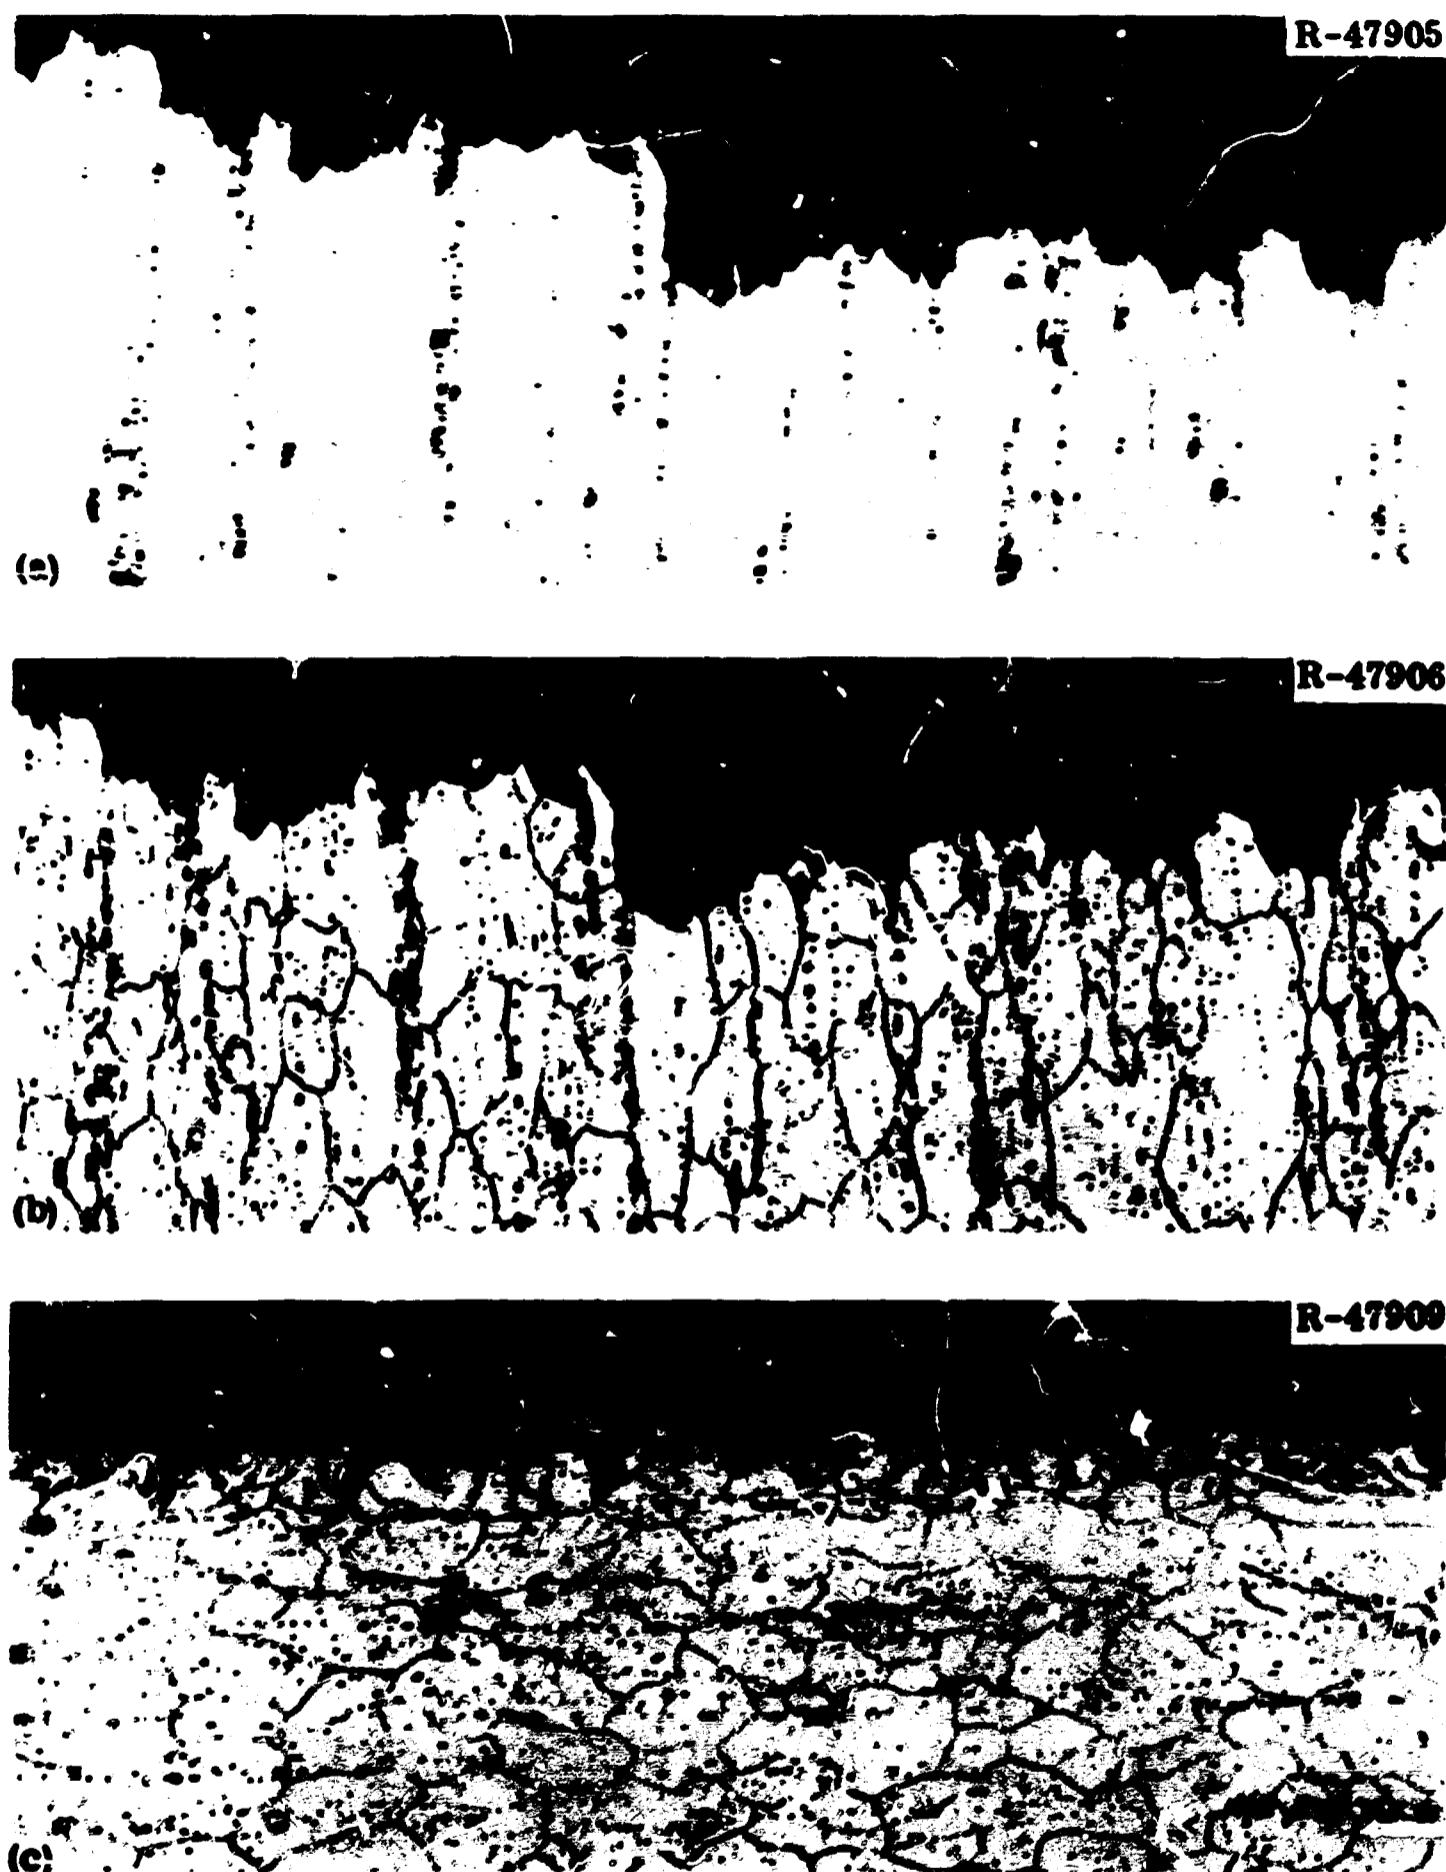
Fig. 24. Photomicrographs of INOR-8 (Heat 5065) Sample Exposed to Fluoride Salt in the NSRE for 11,933 hr above 500°C and Then Tested at 25°C and a Strain Rate of 0.05/in./sec. Thermal fluence was 9.4×10^{20} neutrons/cm². 100x. (a) Fracture, as polished. (b) Fracture, etched. (c) Edge of stressed portion. Etchant: aqua regia.

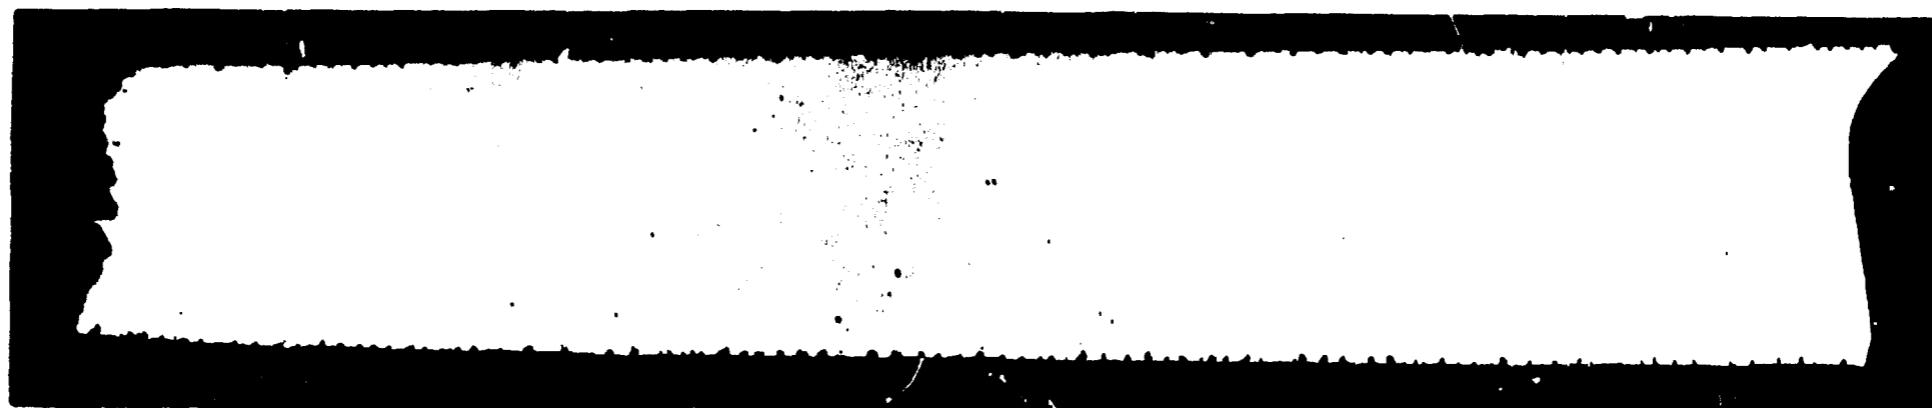
The samples that were fractured at 25°C were repolished at a later date, one-half of each fractured sample was photographed. The composite microstructures for heat 5065 are shown in Fig. 27. There are obviously more intergranular cracks in the sample exposed to the core than in the sample exposed in the control facility. There were 3 cracks per inch with an average depth of 1.0 mil in the control sample and 230 cracks per inch with an average depth of 1.8 mils in the sample from the core. A composite photograph of the tested portions of the heat 5085 sample is shown in Fig. 28. There were 134 cracks per inch along the edge of the sample from the core with an average depth of 1.9 mils. None were visible along the edge of the control specimen.

Fig. 27. Sections of Heat 5065 Tested at 25°C After Exposure to Fuel Salt for 11,933 hr above 500°C. Diameters of specimens are about 0.1 in. The fractures are on the left end.

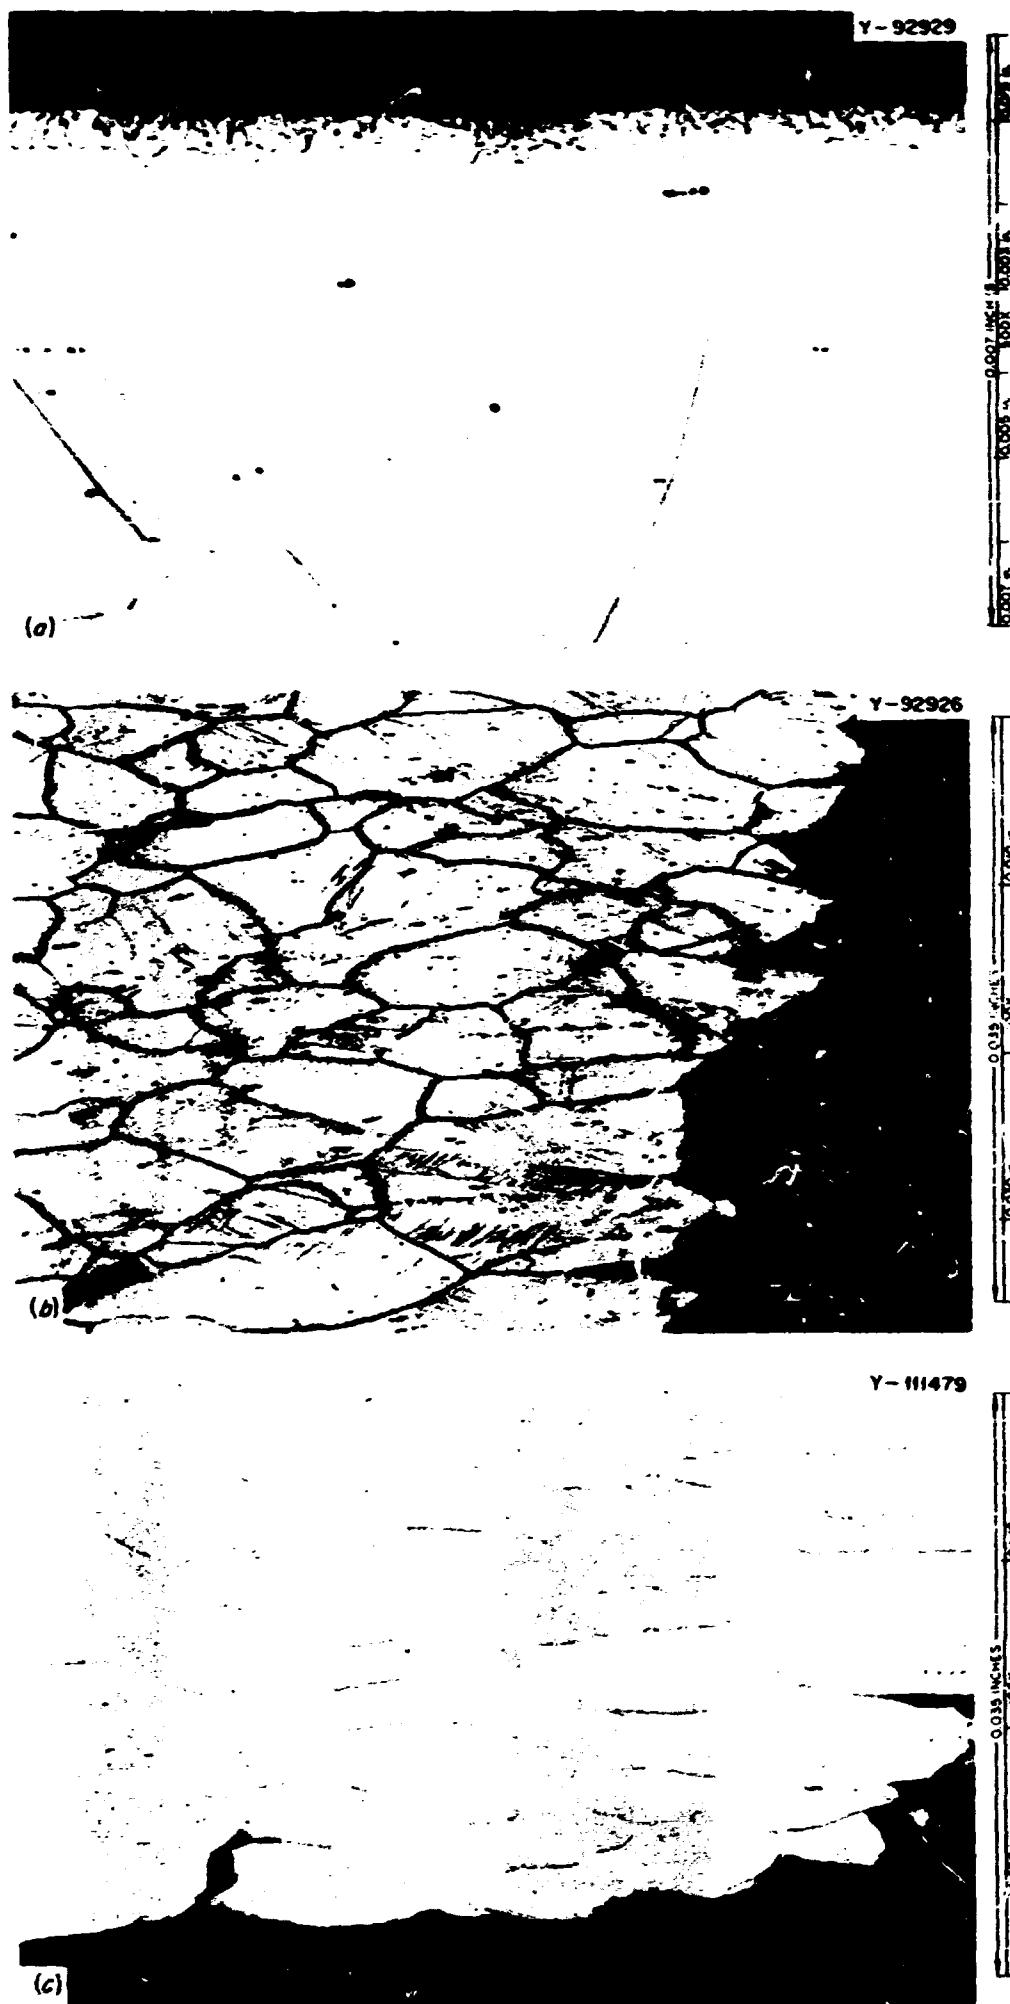
Figures 29 and 30 are photomicrographs of strained specimens of heat 67-502 (modified with 0.49% Ti and 2.15% W and containing 0.04% Fe). The specimen exposed in the control facility (Fig. 29) has its edges

Fig. 29. Photomicrographs of Alloy 67-502 (see Table 1) Exposed to Depleted Fuel Salt for 6379 hr Above 500°C and Tested at 25°C. (a) Edge of unstressed portion, (b) Fracture, (c) Edge of stressed portion. Figs (a) and (c) etched lightly. Fig. (b) etched more heavily with glycerol regia.

coated with small crystals of almost pure iron. (The control facility was constructed of material containing 4 to 5% Fe, so the transfer of Fe to an alloy that contained only 0.04% Fe is quite reasonable.) The sample strained 55% before fracture, and the fracture was mixed transgranular and intergranular. The edge was uneven from the large deformation, but there were very few intergranular separations. The sample from the core (Fig. 30) deformed almost as much (52%) before fracturing. In contrast to the control specimen, edge cracking occurred at almost every grain boundary. The cracks generally extended to a depth of about 5 mils, with the maximum depth being about 7 mils. However, as shown in the view of the fracture, this material tended to crack intergranularly and these internal cracks may have in some cases linked together with the surface cracks to make them extend deeper.

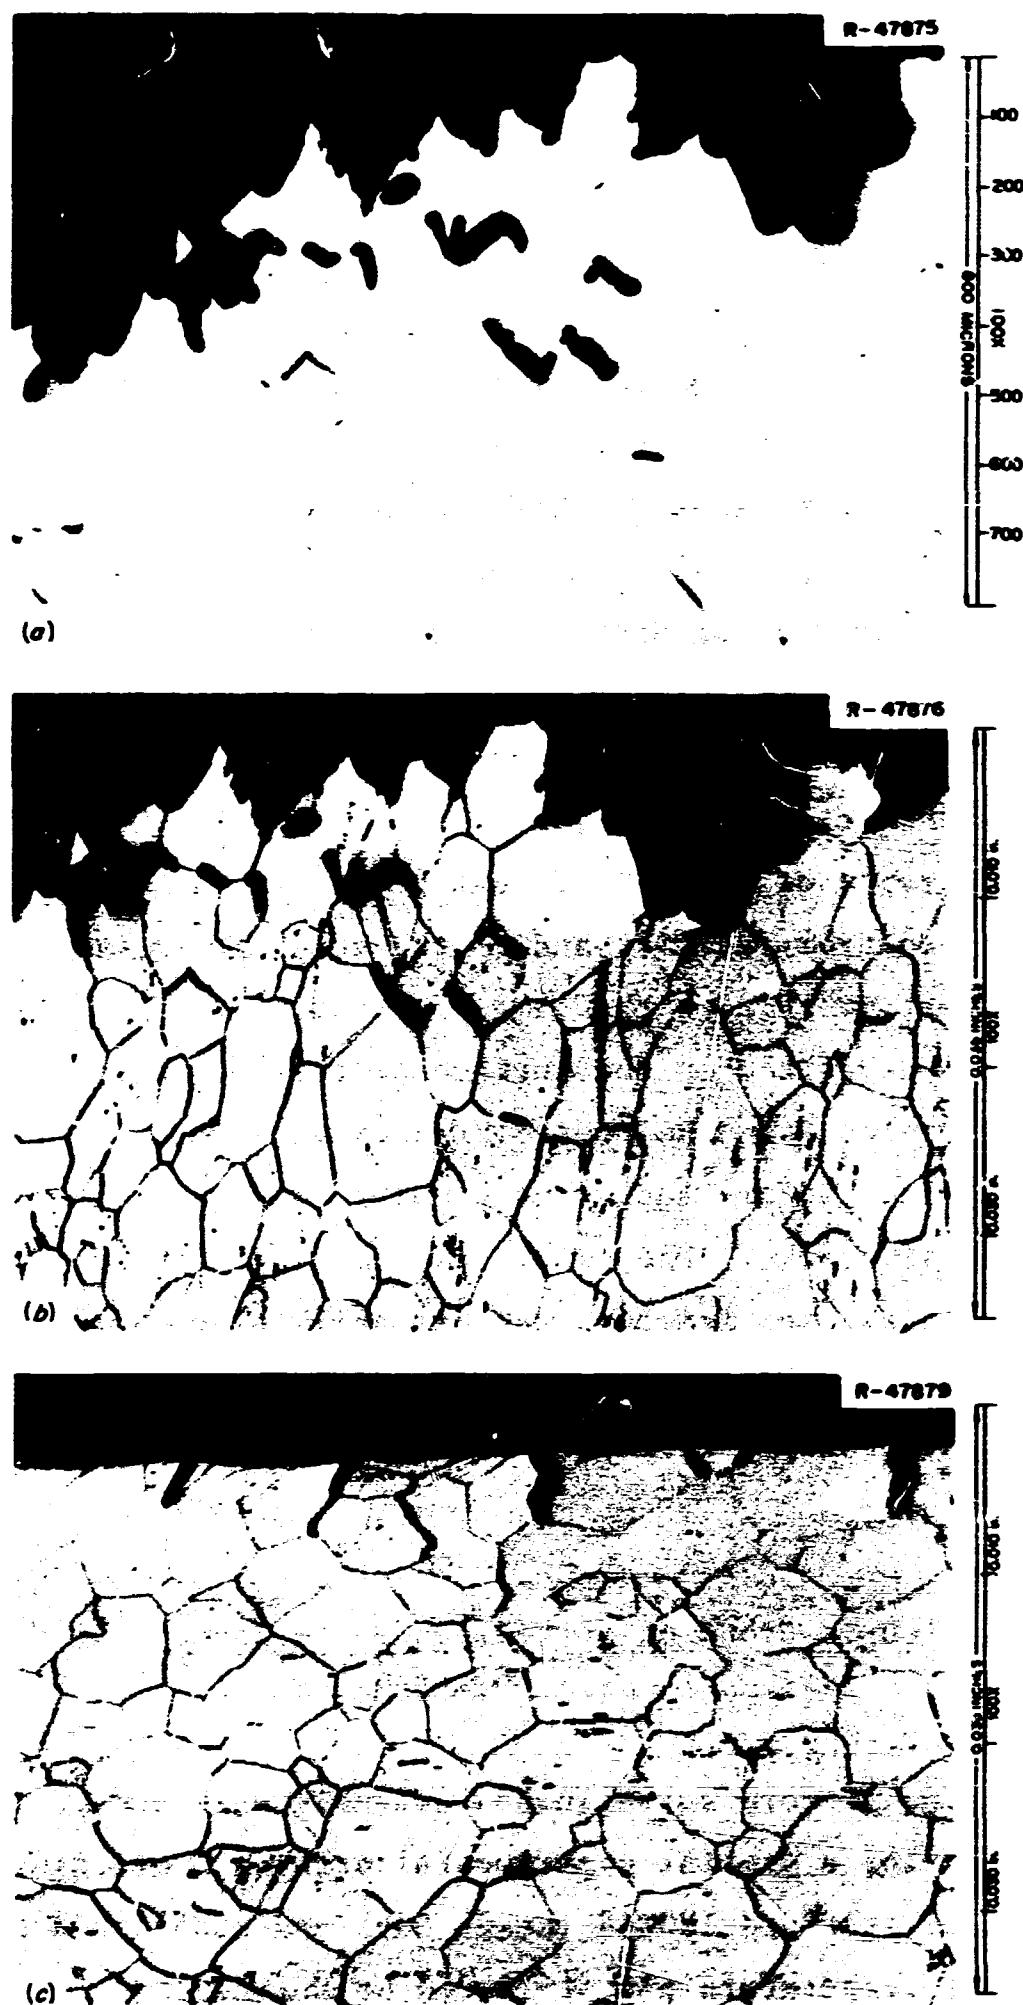
Fig. 30. Photomicrographs of Alloy 67-502 Sample Exposed to Fluoride Salt in the MSRE for 6379 hr Above 500°C and then Tested at 25°C. 100x.
(a) Fracture, as polished. (b) Fracture, etched. (c) Edge of stressed portion, etched. Etchant: aqua regia. Reduced 33%.
