INTERGRANULAR CRACKING OF INOR-8 IN THE MSRE

H. E. McCoy

B. McNabb

NOVEMBER 1972

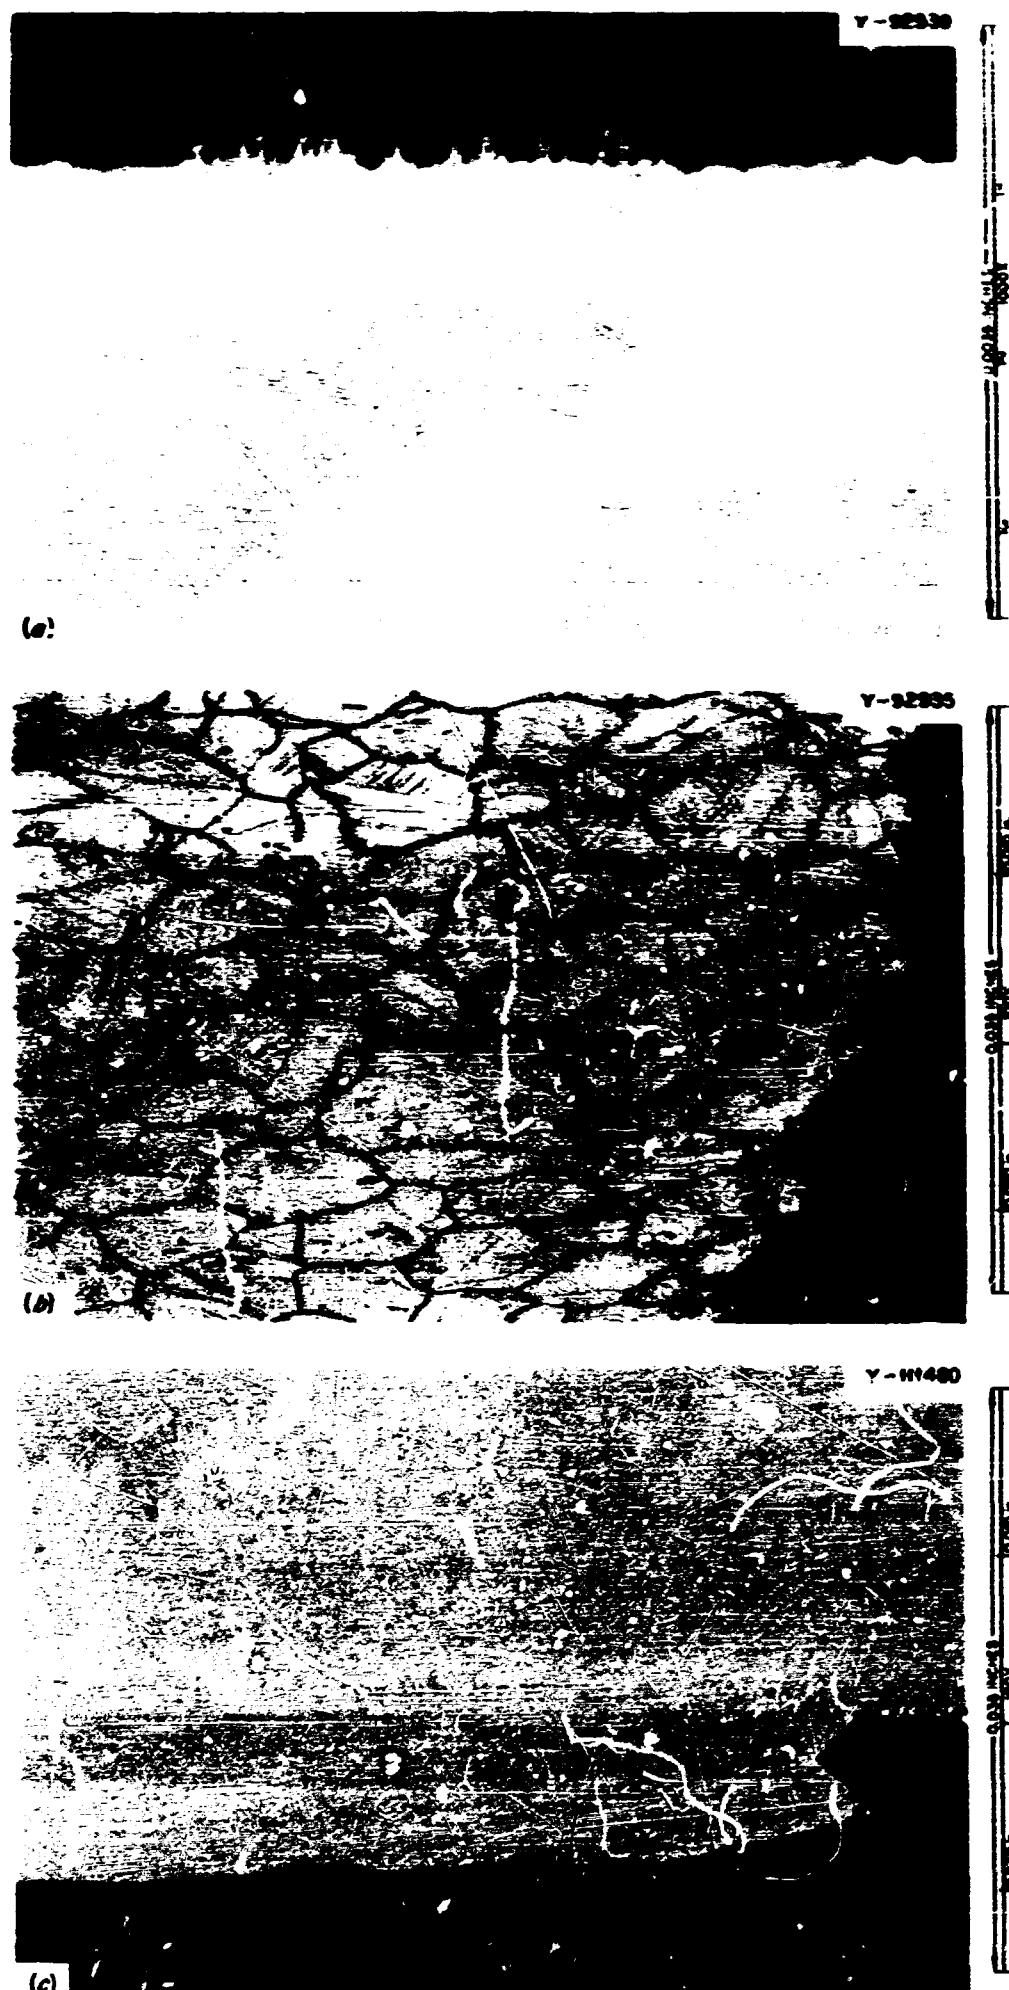
Photomicrographs of samples of heat 67-504 tested at 25°C after exposure in the control facility and in the core are shown in Figs. 31 and 32. This heat modified with 0.50% Hf, contained 0.97% Fe. As shown in Fig. 31, iron deposited on the surface of this heat as it did on 67-502. This sample, from the control facility, deformed 55% before failing with a mixed inter- and transgranular fracture. There were no intergranular edge cracks. The sample exposed in the core deformed 52% before fracture. The fracture was primarily transgranular but there were frequent edge cracks (Fig. 32). Most boundaries were cracked, but the cracks extended only to a depth of about 2 mils in the fields that were photographed.

Fig. 31. Photomicrographs of Alloy 67-504 (see Table 1) Exposed to Depleted Fuel Salt for 6279 hr Above 500°C and Tested at 25°C. (a) Edge of unstressed portion, (b) Fracture, (c) Edge of stressed portion. Figs (a) and (c) as-polished and Fig. (b) etched with glyceria regia. Reduced 33.5%.

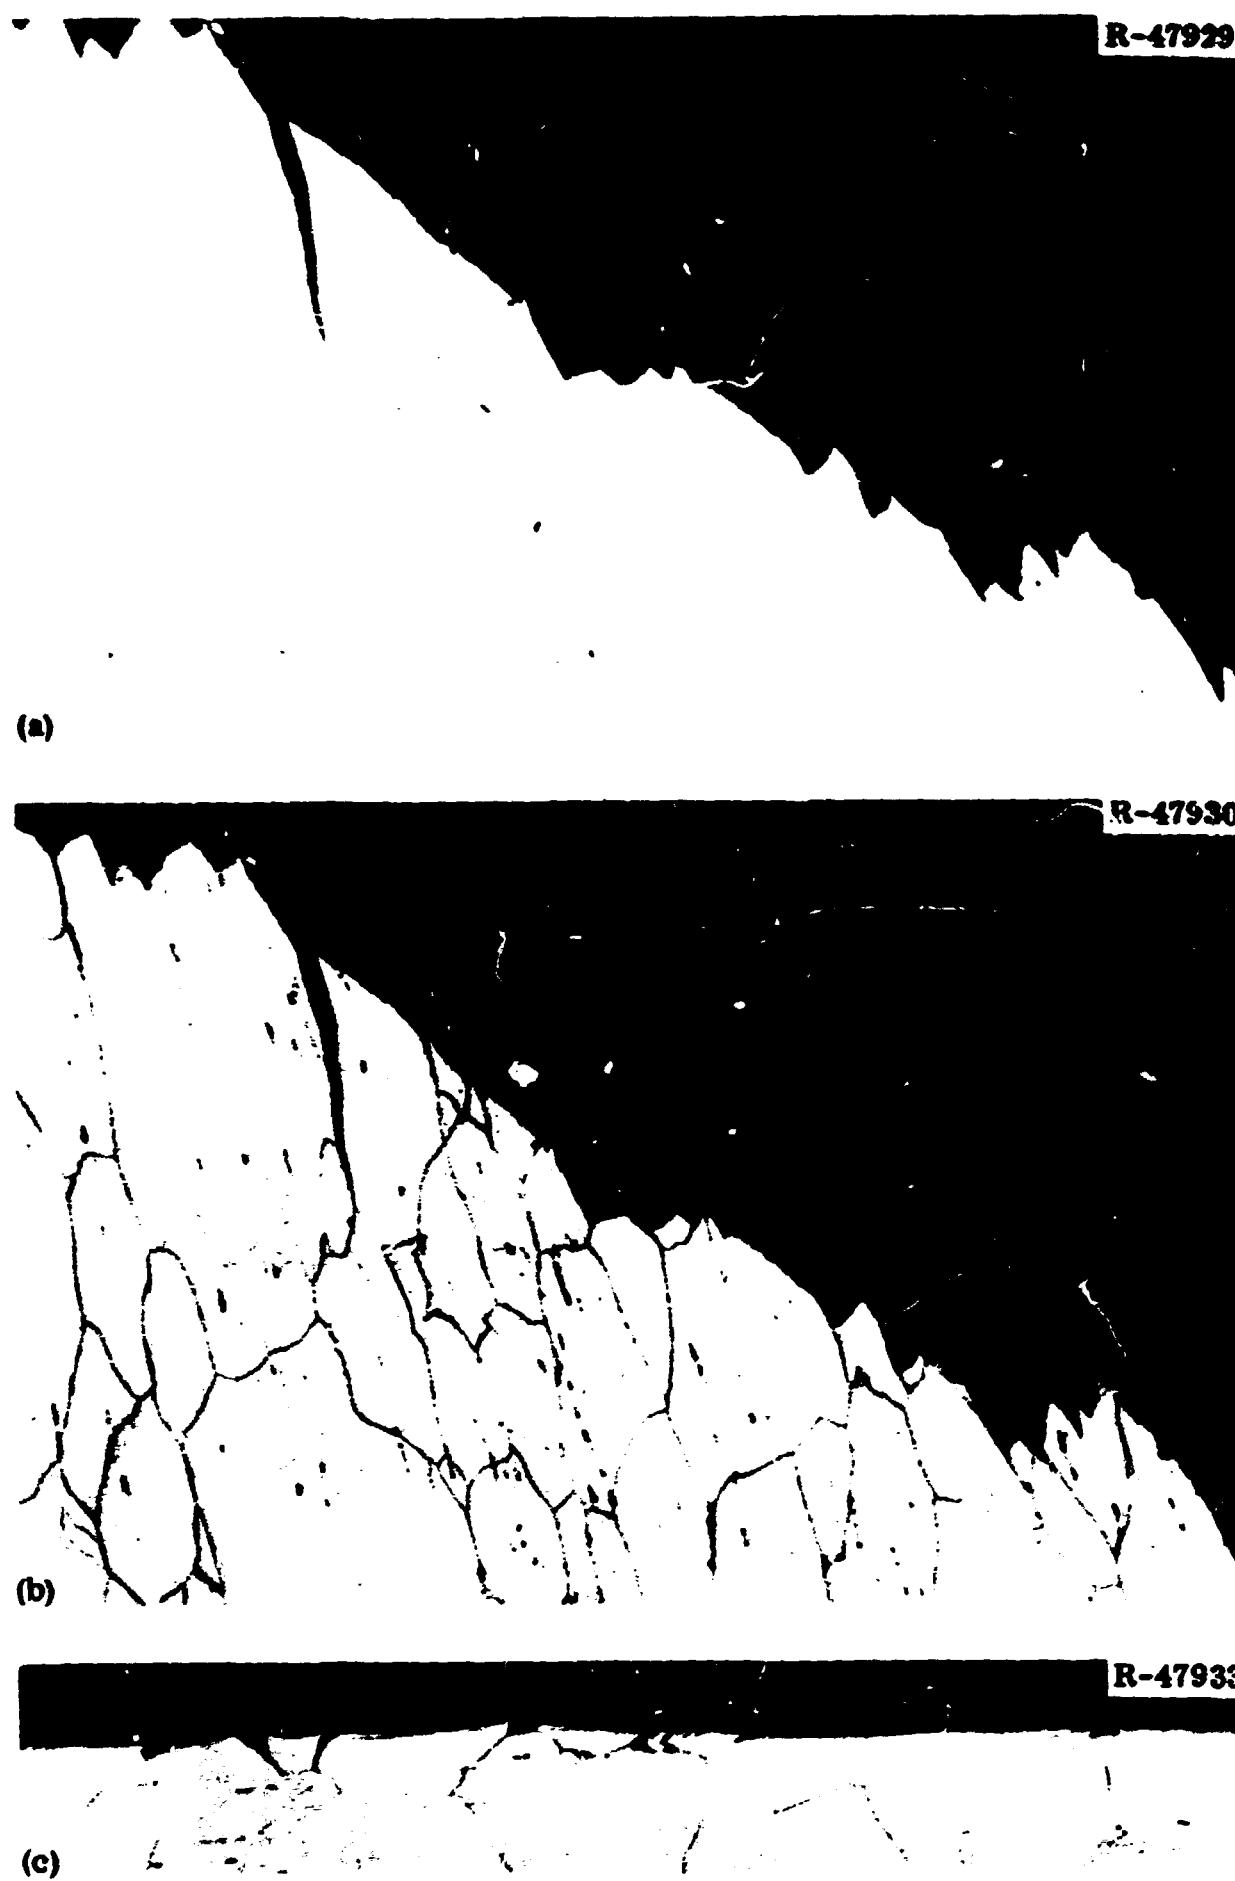
Fig. 32. Photomicrographs of INOR-8 (Heat 67-504) Sample Exposed to Fluoride Salt in the MSRE for 6379 hr Above 500°C and Tested at 25°C. 100x. (a) Fracture, as polished. (b) Fracture, etched. (c) Edge of Stressed portion, etched. Etchant: aqua regia. Reduced 14%.

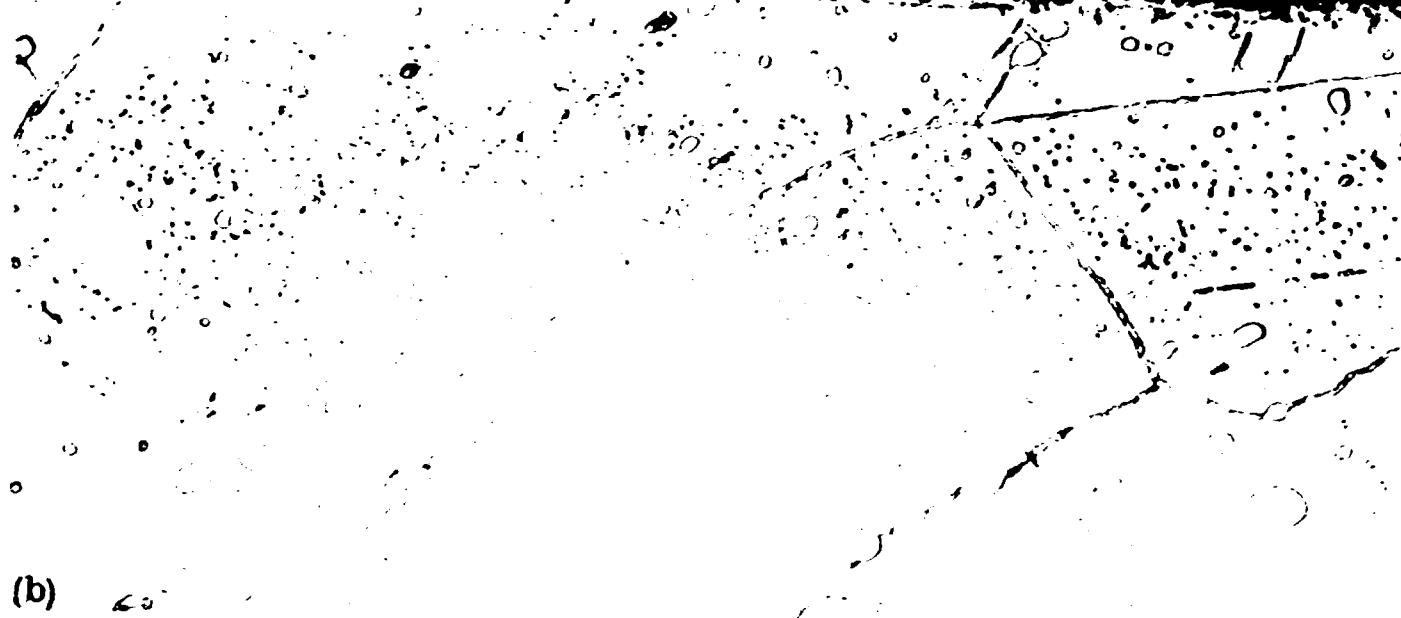
Photomicrographs of unstrained specimens of heats 5065 and 5085 from RL2 revealed many grain boundaries near the surfaces that were visible in the as-polished condition. The view of a specimen of heat 5065 in the as-polished condition, (Fig. 33) shows a thin surface layer (believed to be the cause of the visible discoloration) and some grain boundaries visible to a depth of about 2 mils. Etching this particular sample revealed the typical carbide structure plus a narrow band near the surface that seems to have a high density of carbide. Photomicrographs of heat 5085 after removal from the core are shown in Fig. 34. Many of the grain boundaries are visible in the as-polished condition to a depth of about 2 mils. Etching reveals the typical microstructure with very extensive carbide precipitation. In the as-polished view of the heat 5065 control specimen (Fig. 35), grain boundaries are also visible, but in this case the appearance is uniform across the sample and is due to polishing long enough that the different grains are at different elevations. Etching reveals the shallow surface modification and the typical carbide structure. The heat 5085 specimen from the control facility, shown in Fig. 36, was also slightly overpolished so that the grains are visible in the as-polished condition. Etching revealed the typical microstructure and the shallow surface modification.

Fig. 33. Typical Photomicrographs of INOR-8 (Heat 5065) Exposed to the MSRE Core for 19,136 hr Above 500°C. (a) As polished. (b) Etchant: aqua regia. 500x.

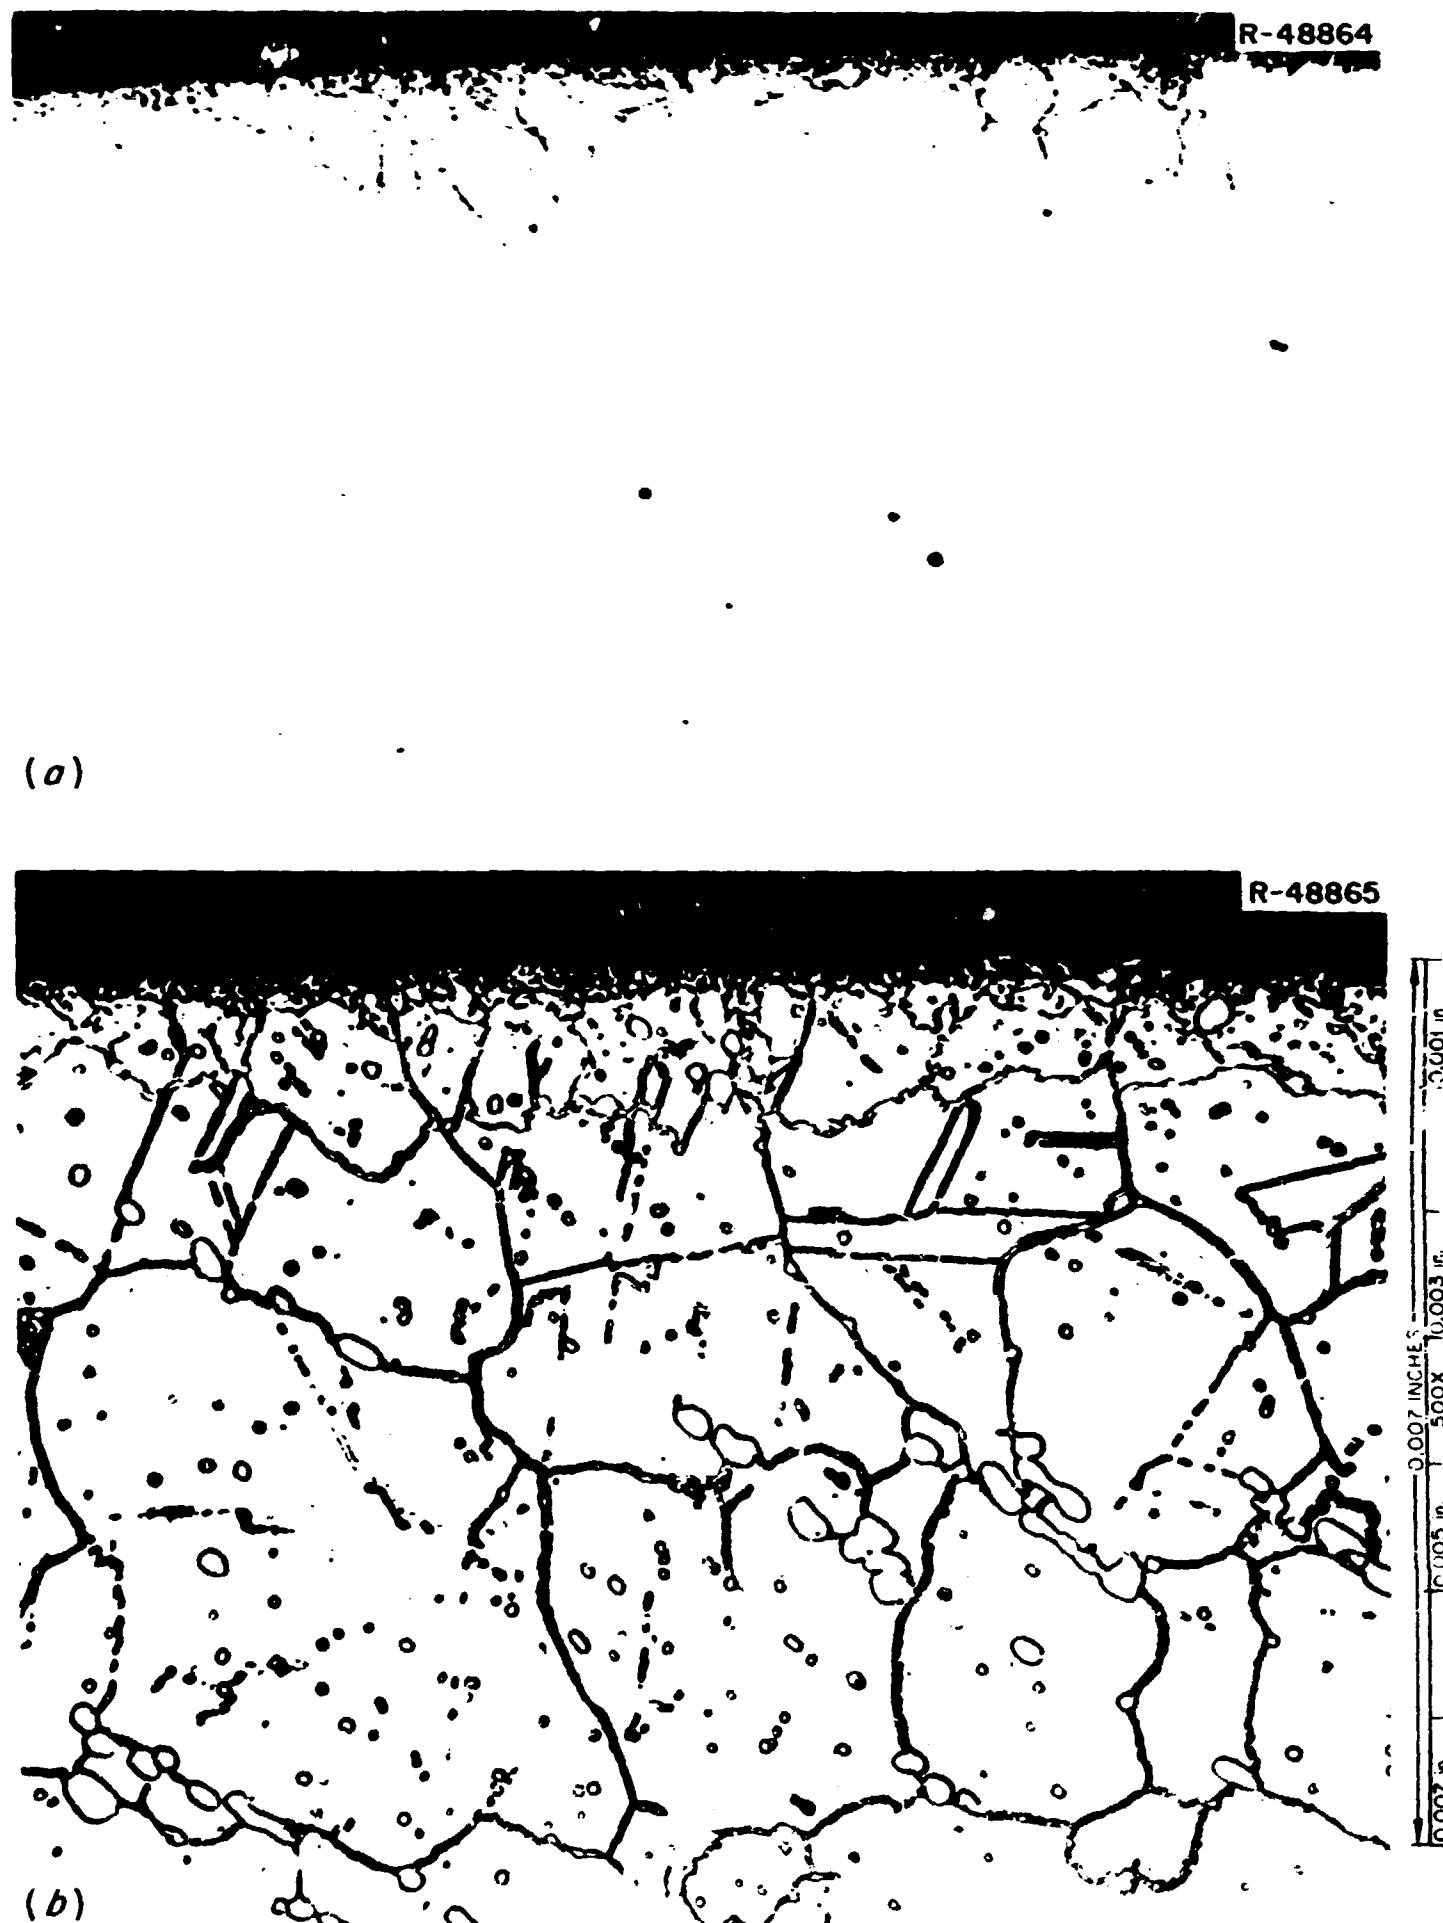
Fig. 34. Typical Photomicrographs of INOR-8 (Heat 5085) Exposed to the MSRE Core for 19,136 hr Above 500°C. (a) As polished. (b) Etchant: glyceria regia. 500x.

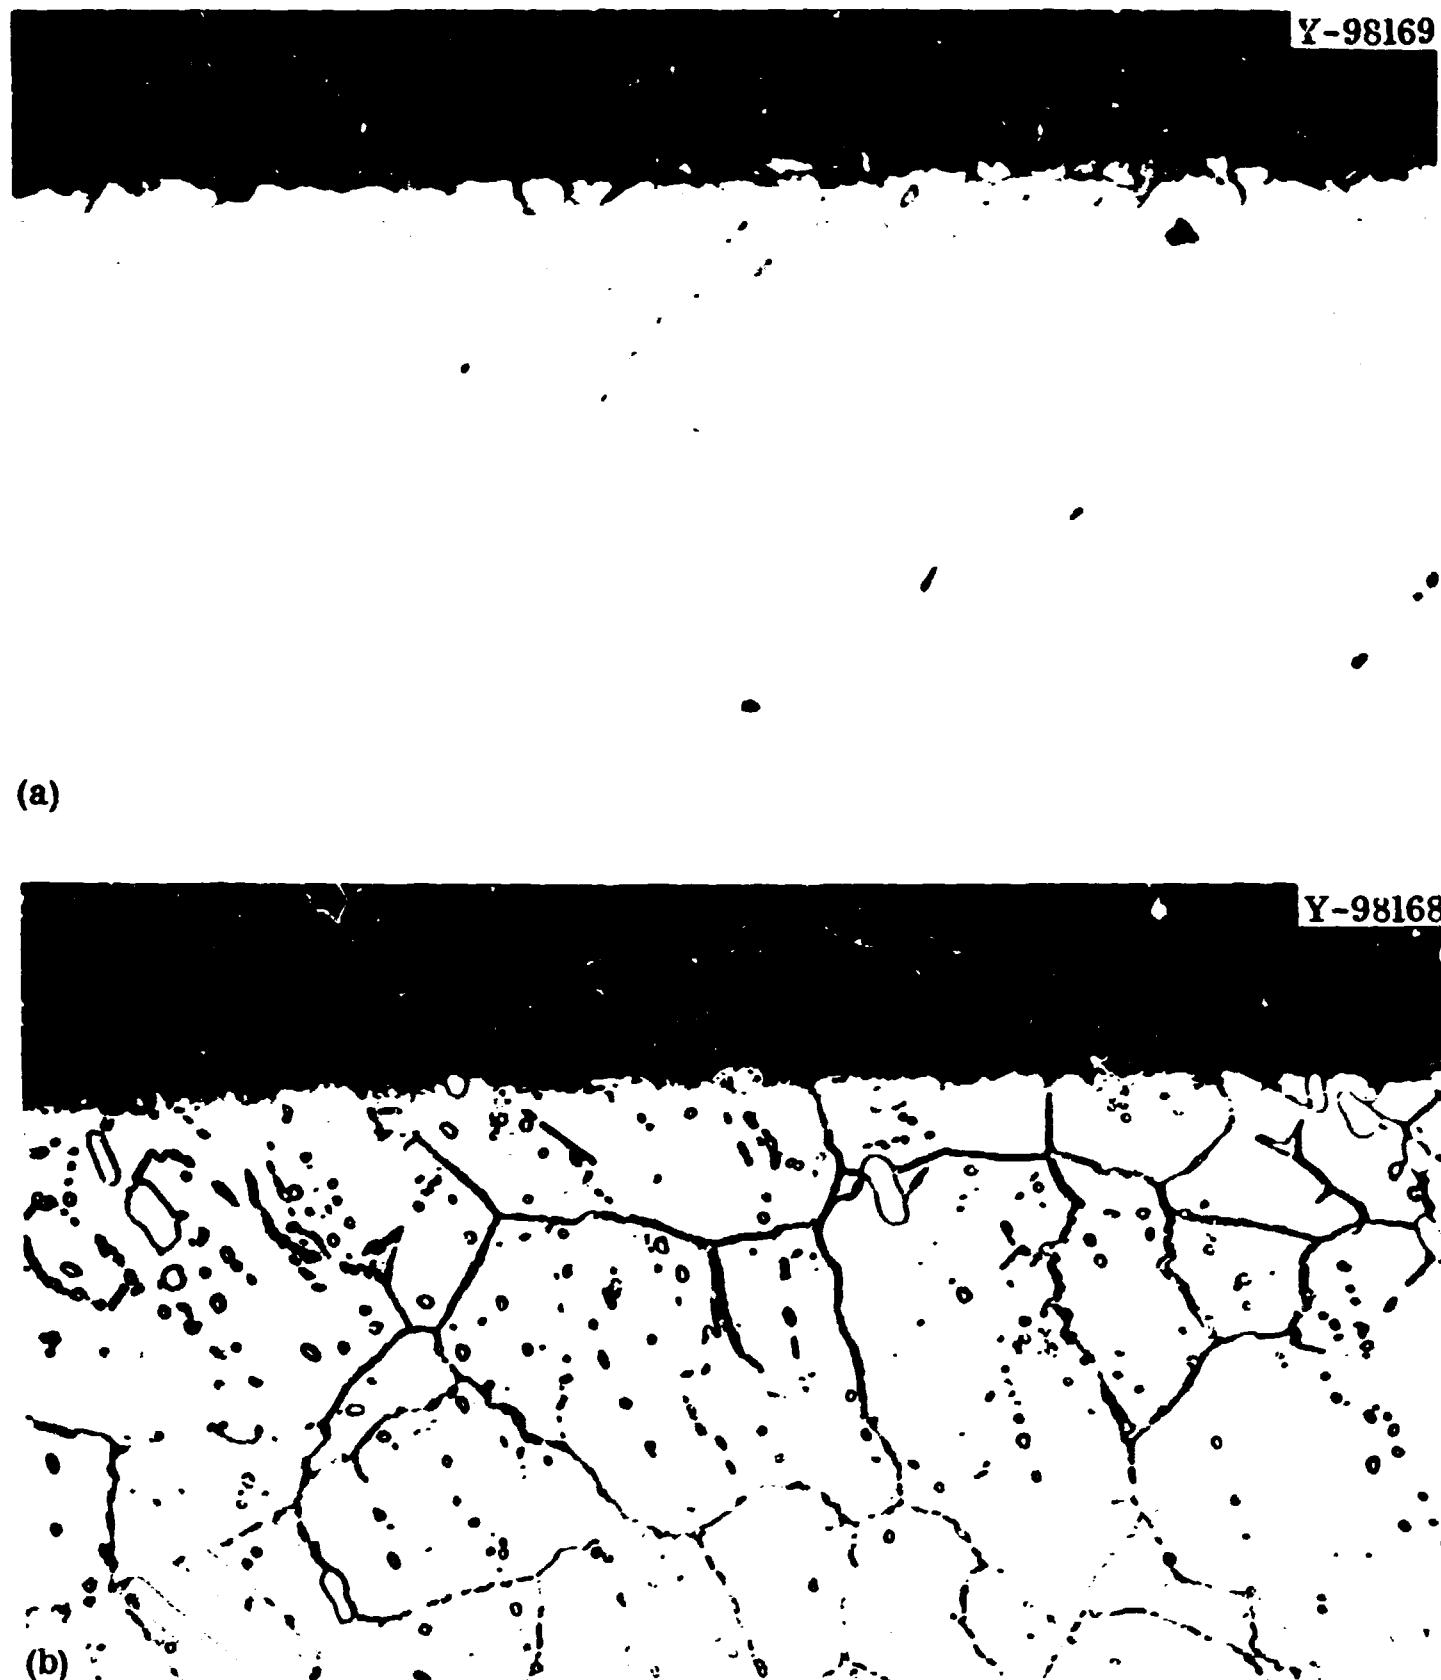
Fig. 35. Typical Photomicrographs of Heat 5065 After Exposure to Static Unenriched Fuel Salt for 19,136 hr Above 500°C. 500x. (a) As polished. (b) Etchant: glyceria regia.

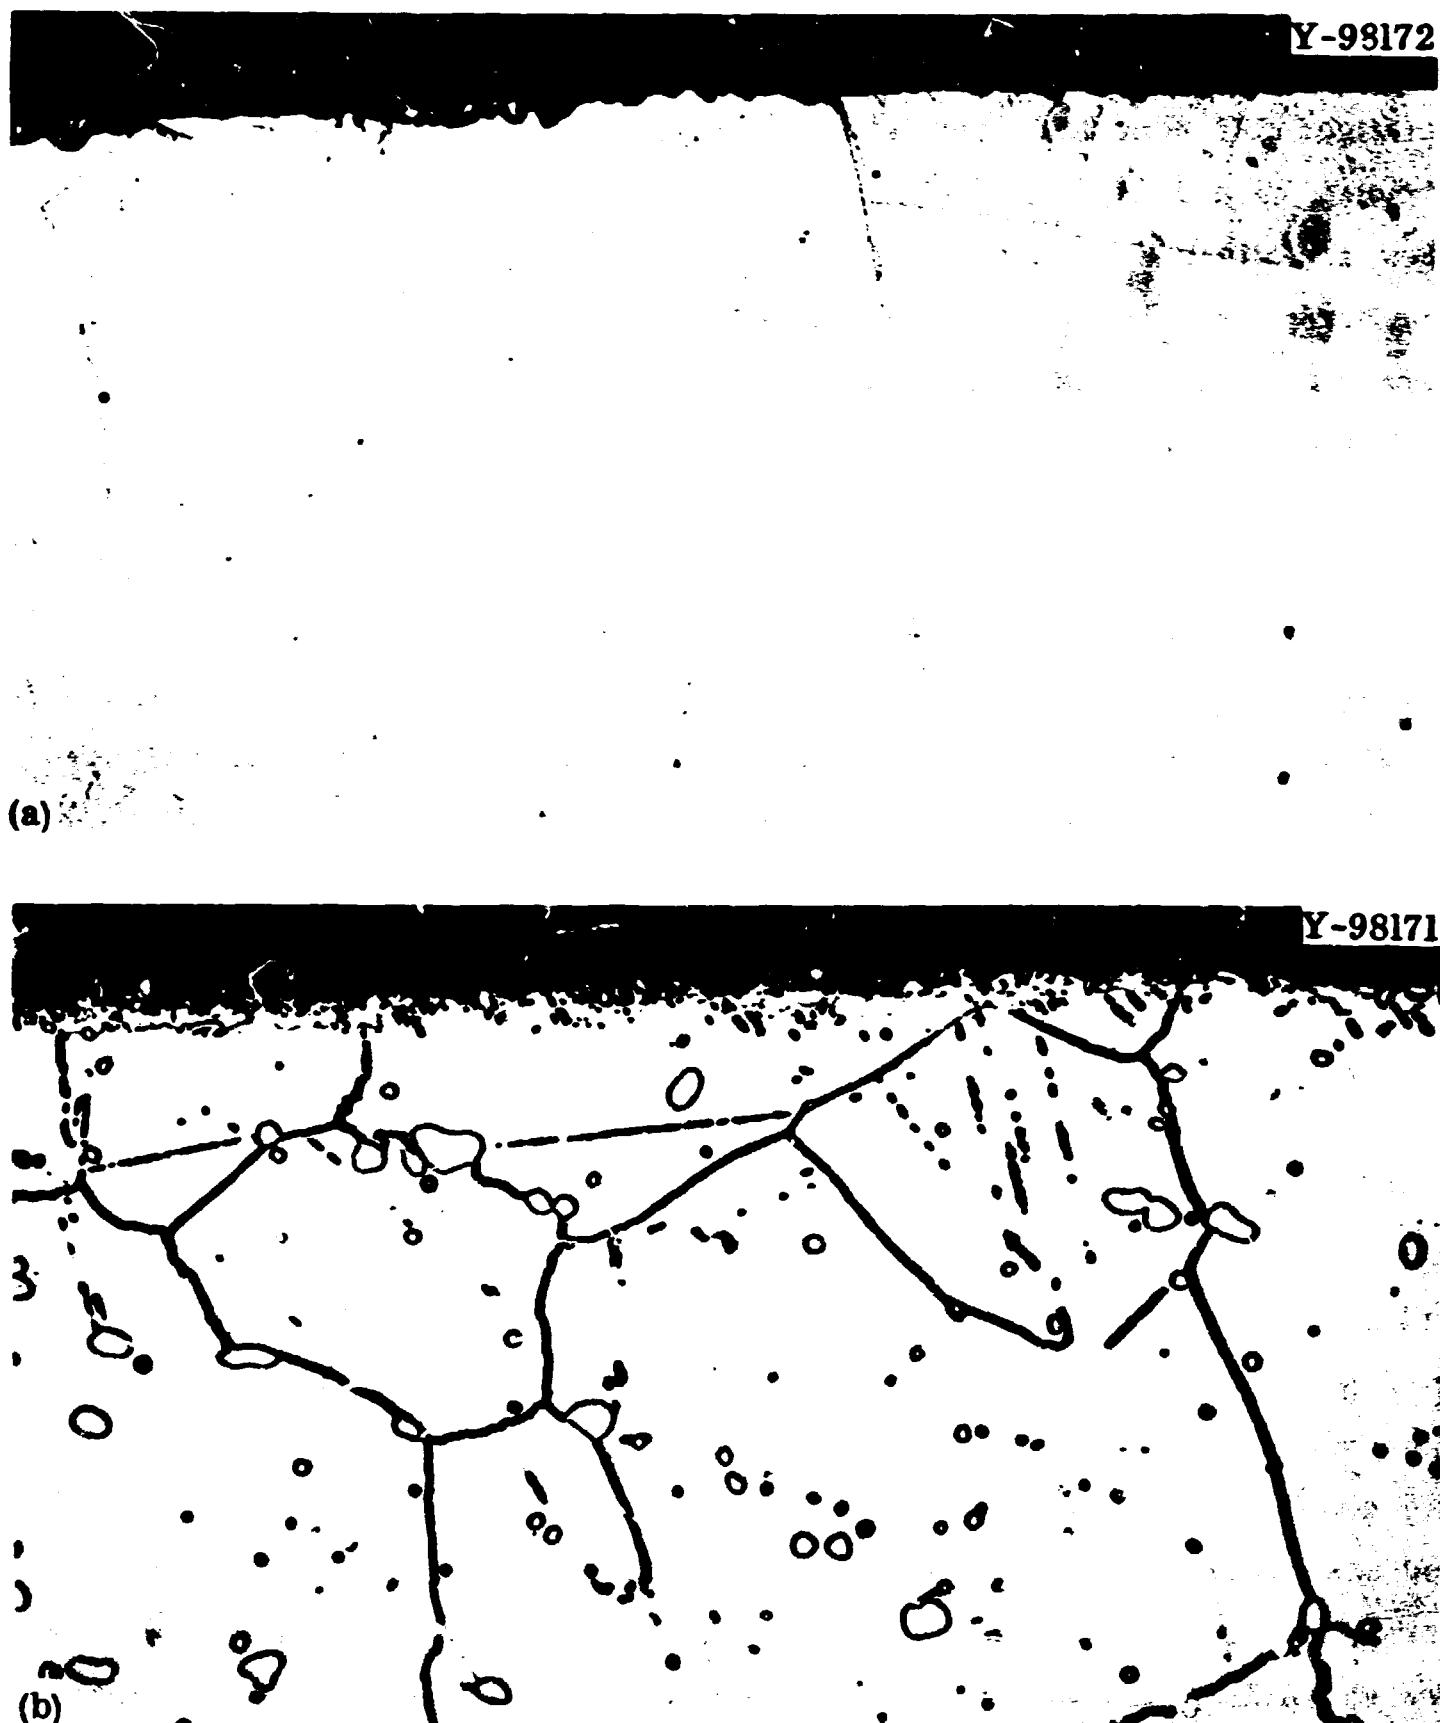
Fig. 36. Typical Photomicrographs of Heat 5085 After Exposure to Static Unenriched Fuel Salt for 19,136 hr above 500°C. 500 \times . (a) As polished. (b) Etchant: glyceria regia.

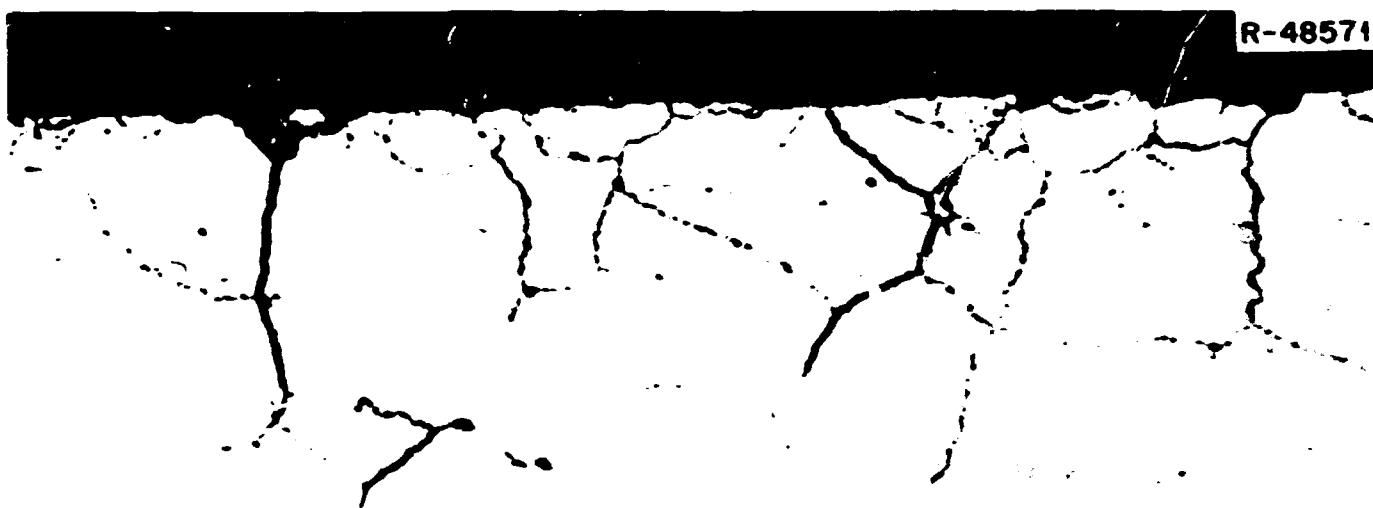
As in the previous set of core specimens, the straps of heat 5055 showed more cracks in the nominally unstrained condition than did the tensile specimens on the same stringer. A section of a strap from stringer RL2 that had been exposed, along with the specimens shown in Figures 33 and 34, is shown in Fig. 37. The cracks in this as-polished view are visible to a depth of about 3 mils, about twice as deep as in the strap exposed 12,000 hr during ^{235}U operation (Fig. 22). Heat 5055 straps were also used on the stringers exposed only during the ^{233}U operation (7200 hr). A specimen of one of these straps is shown in Fig. 38. In the as-polished condition, cracks were visible to a depth of about 1 mil; etching made them visible to a depth of about 3 mils. The cracking was quite uniform along all surfaces of the straps, indicating that the deformation of the 20-mil straps during removal was not a factor in the appearance of the cracks. Examination of unirradiated control straps failed to reveal a similar type of cracking.

Fig. 37. Typical Microstructure of INOR-8 (Heat 5055) After Exposure to the MSRE Core for 19,136 hr Above 500°C. This material was used for straps for the surveillance assembly. As polished. 500x.

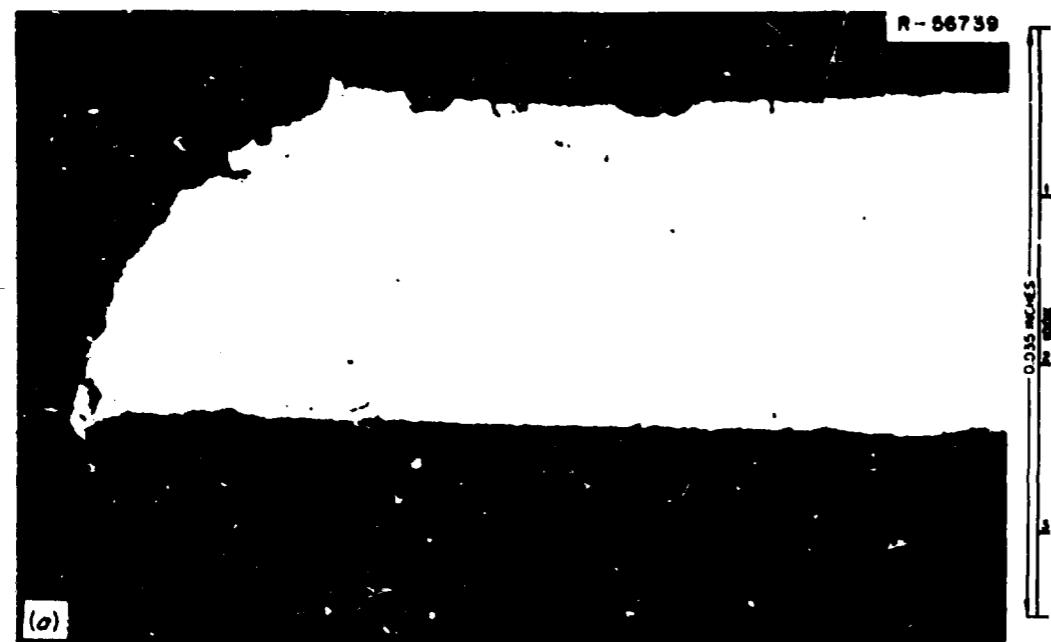
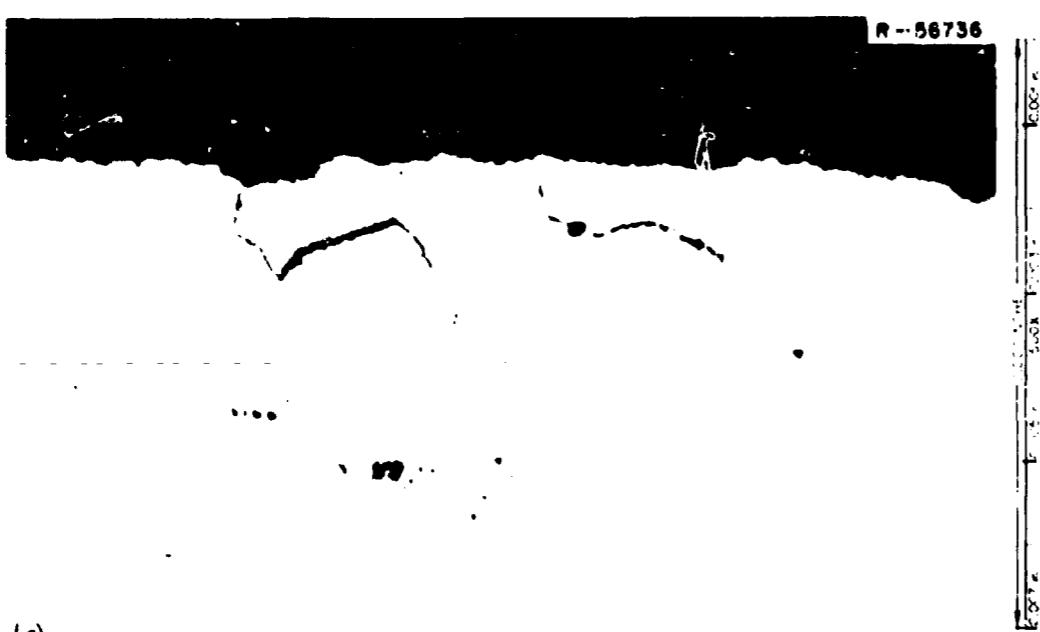
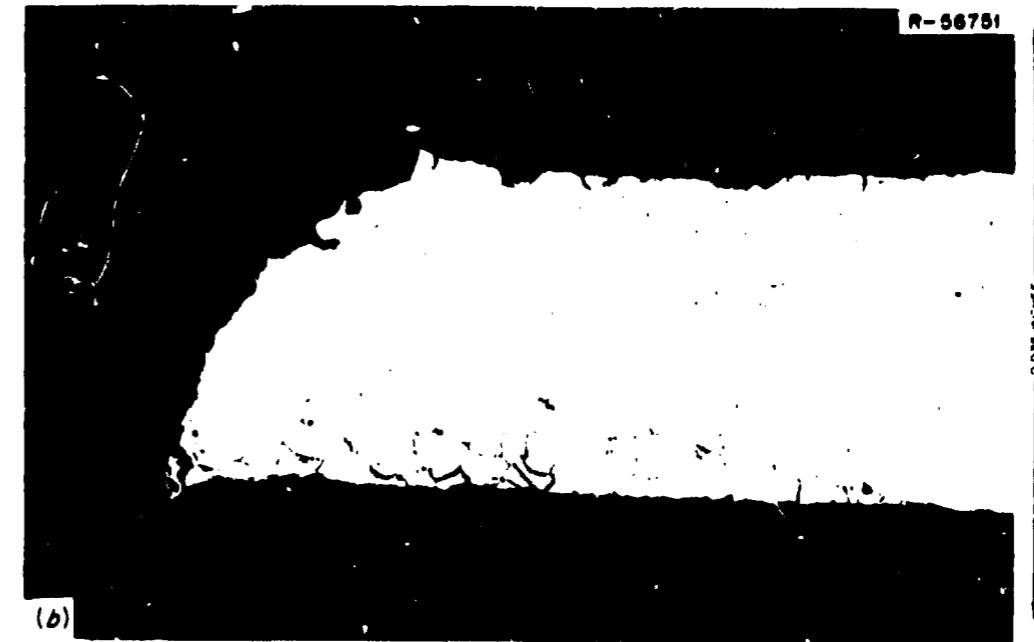
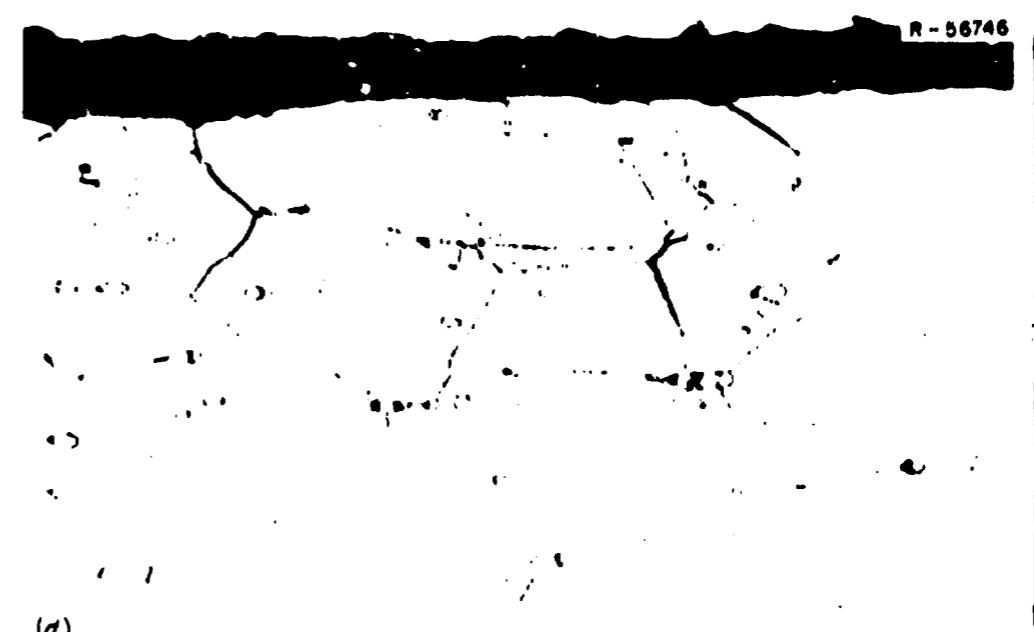
One other interesting specimen that showed extensive cracking was a piece of thin INOR-8 sheet (heat 5075) that had been attached to the strap shown in Fig. 38. The sheet had been rolled to 4 mils and annealed 0.5 hr at 1180°C . The edges of the foil were wrapped around the strap to hold the material in place. Thus the outside surface of the foil would have been exposed to flowing salt and the underside and the folded ends to salt that flowed less rapidly. The foil was extremely brittle and broke while it was being removed from the strap. The photomicrographs in Fig. 39 show that the foil had extensive grain boundary cracks, with many appearing to extend throughout the 4 mil thickness. In some areas the cracks were more numerous on the outside where the material was curved and was in contact with rapidly flowing salt. Photomicrographs of a strap and foil that were exposed to static salt in the control facility are shown in Figs. 40 and 41. The samples showed no evidence of intergranular cracking.

Fig. 38. Photomicrographs of INOR-8 (Heat 5055) Strap Exposed to the MSRE Core 7203 hr above 500°C. (a) As-polished view near cut (b) Etched view near cut (c) As polished view of outside edge (d) Etched view of outside edge. Etchant: Lactic acid, HNO₃, HCl. Reduced 32%.

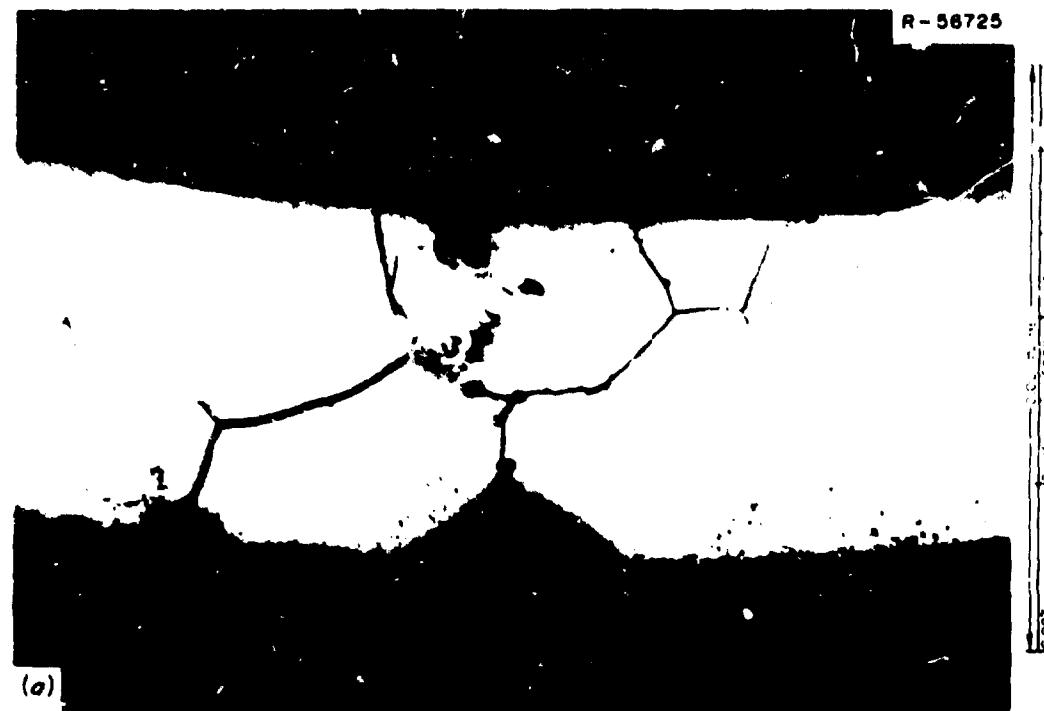
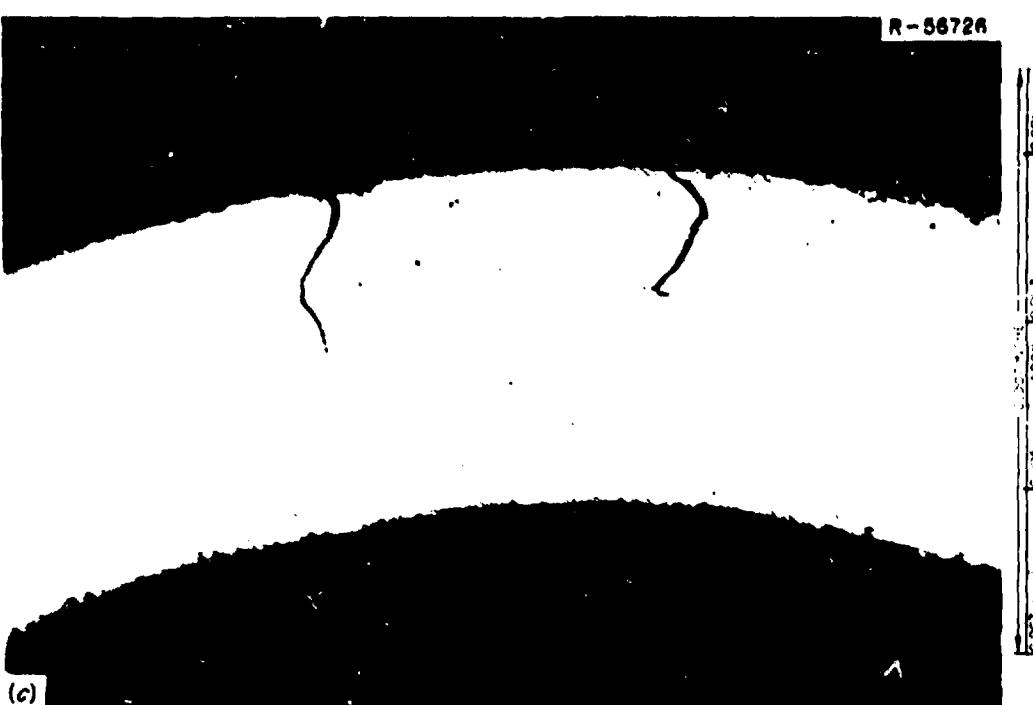
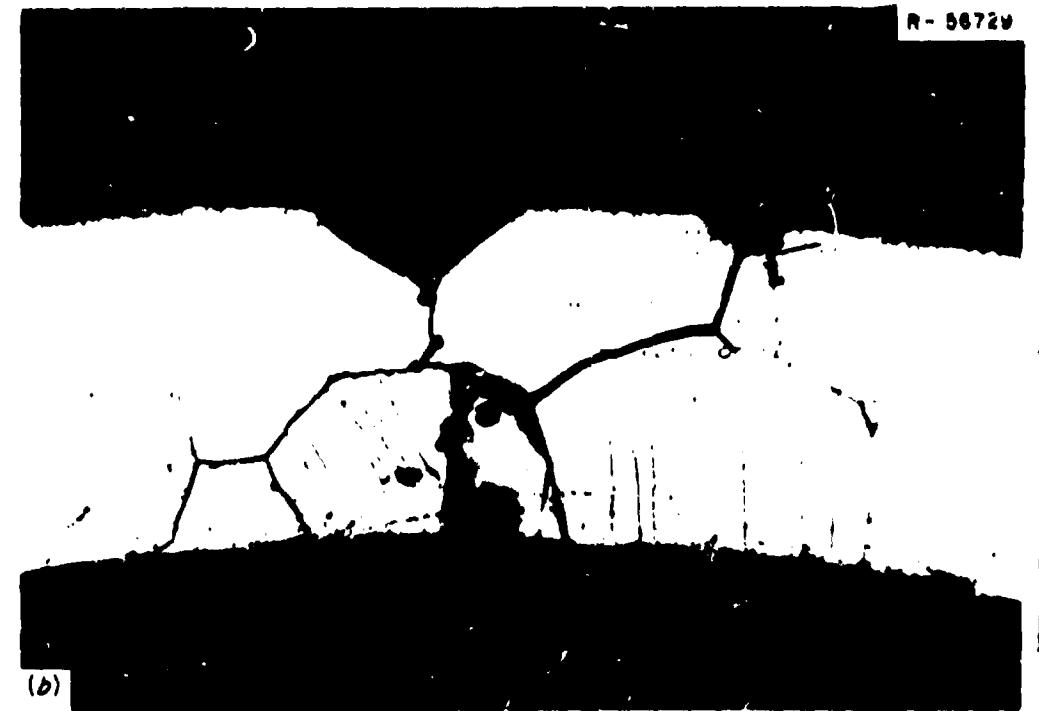
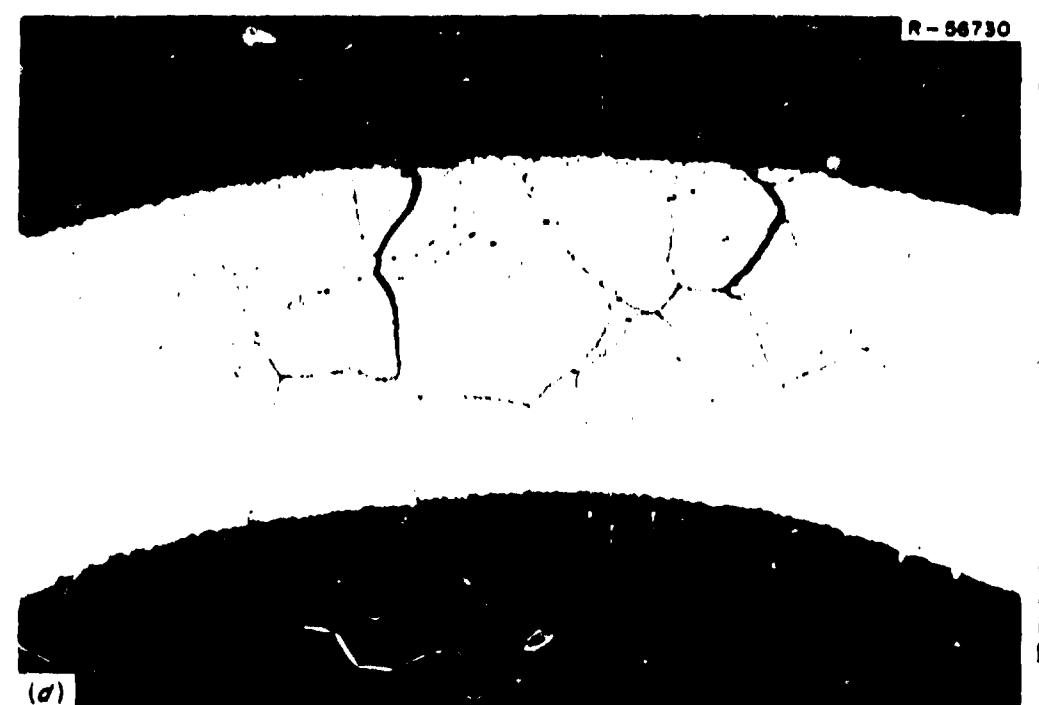
Fig. 39. Photomicrographs of Two Specimens From a Thin INOR-8 (Heat 5075) Foil that was Attached to the Strap Shown in the Previous Figure. The curvature was caused by forming before being inserted into the MSRE. (a) As polished (b) Etched (c) As polished (d) Etched. Etchant: Lactic acid, HNO_3 , HCl . Reduced 32%.
