INTERGRANULAR CRACKING OF INOR-8 IN THE MSRE

H. E. McCoy

B. McNabb

NOVEMBER 1972

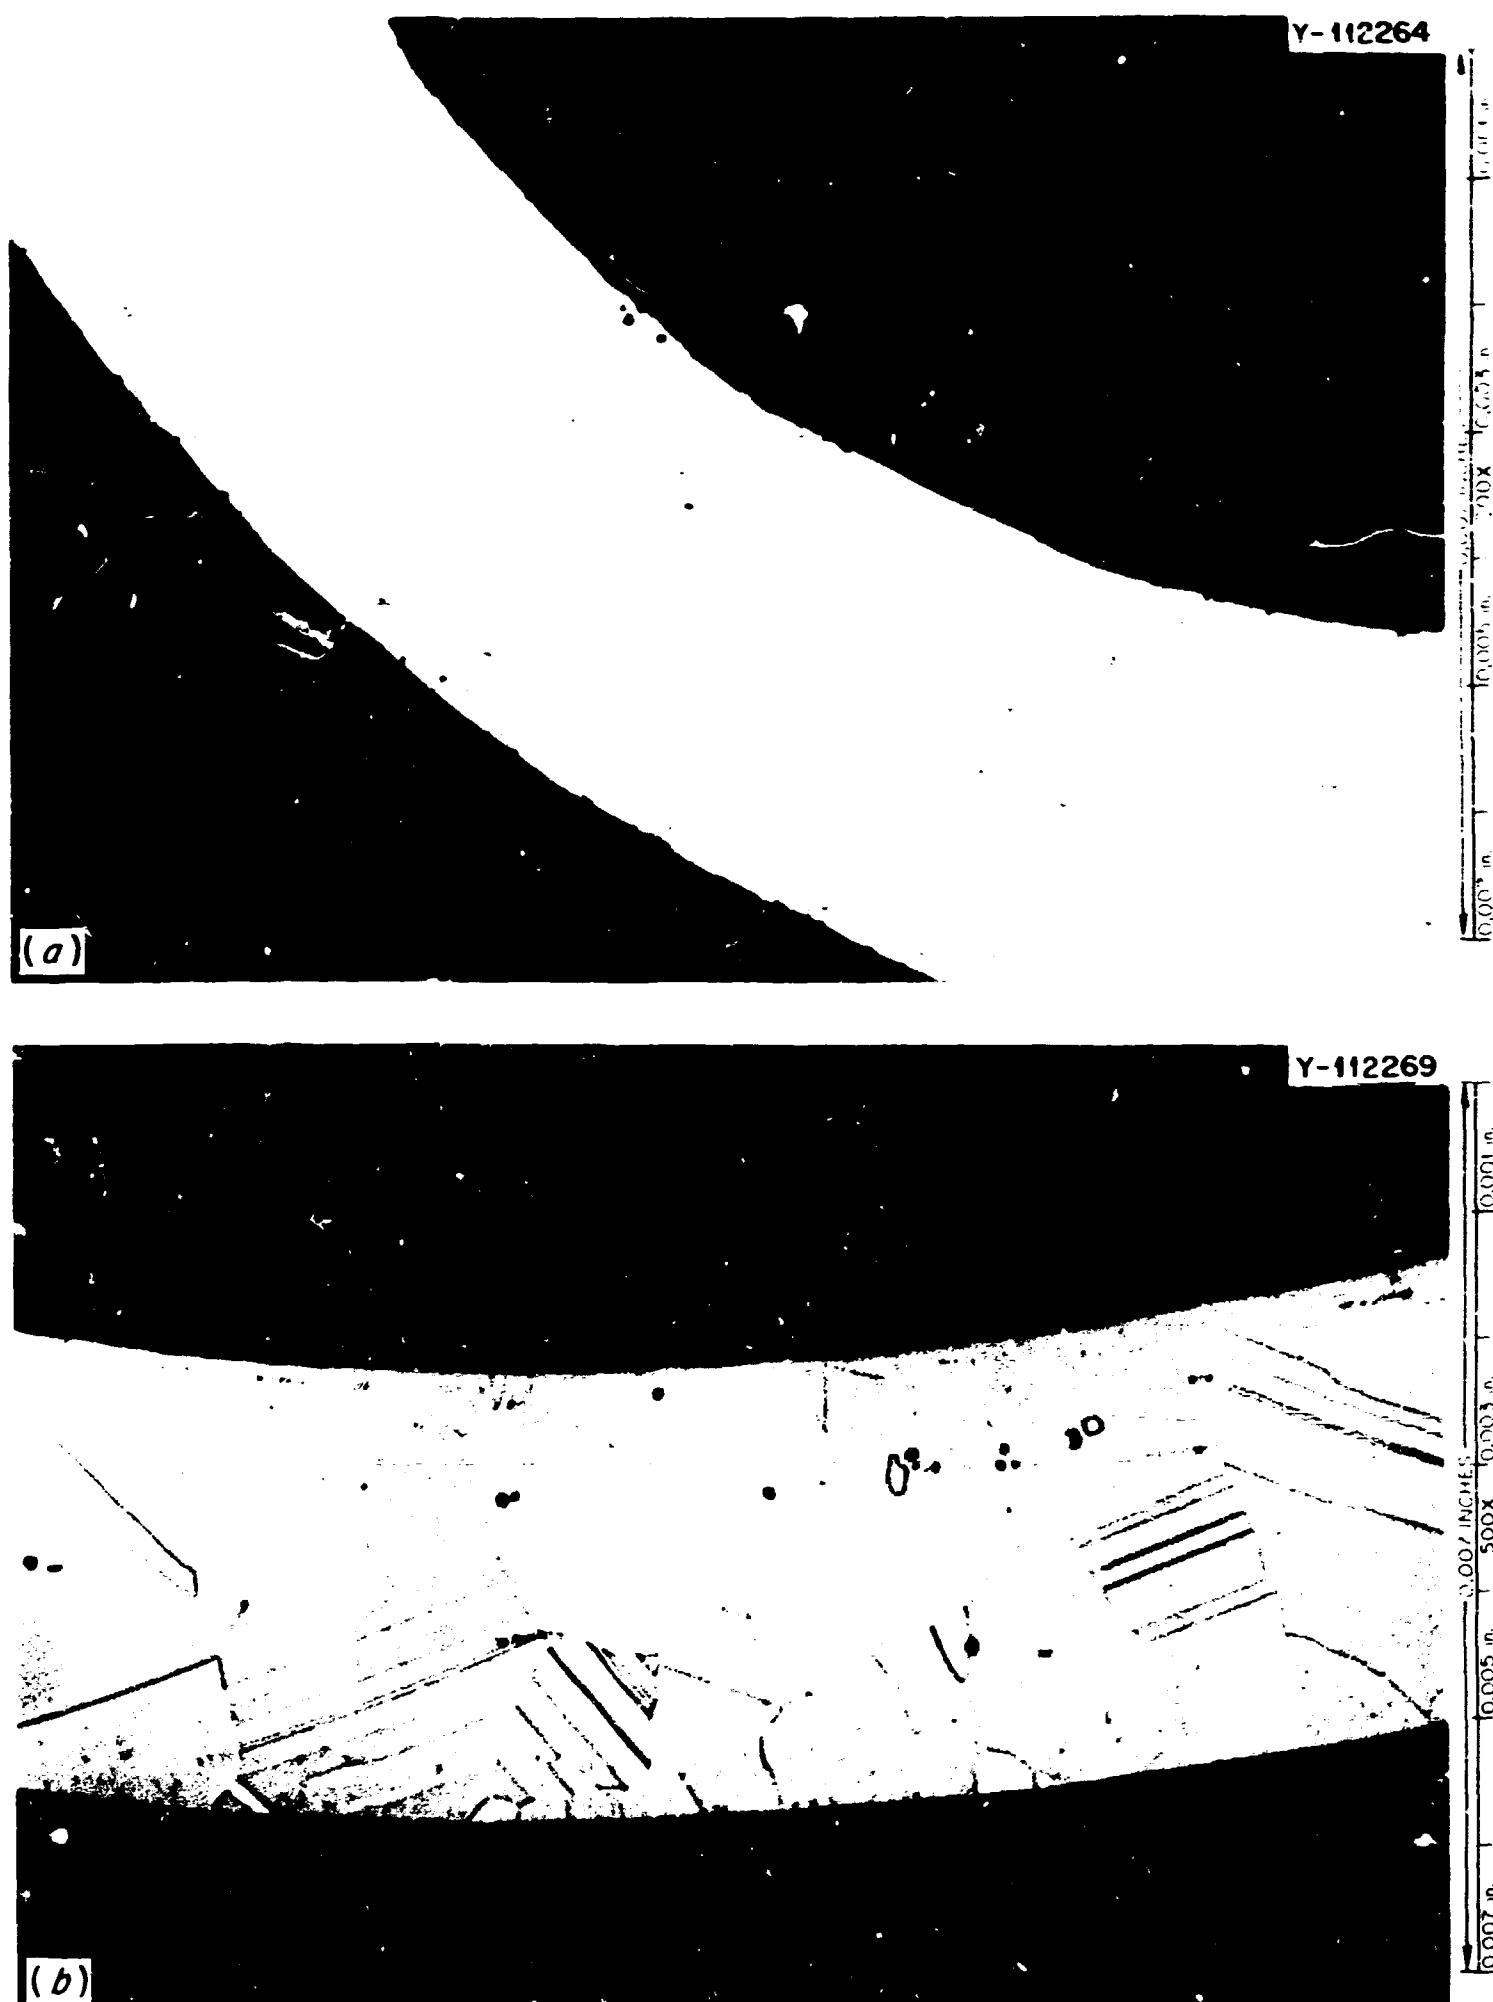
One other interesting specimen that showed extensive cracking was a piece of thin INOR-8 sheet (heat 5075) that had been attached to the strap shown in Fig. 38. The sheet had been rolled to 4 mils and annealed 0.5 hr at 1180°C . The edges of the foil were wrapped around the strap to hold the material in place. Thus the outside surface of the foil would have been exposed to flowing salt and the underside and the folded ends to salt that flowed less rapidly. The foil was extremely brittle and broke while it was being removed from the strap. The photomicrographs in Fig. 39 show that the foil had extensive grain boundary cracks, with many appearing to extend throughout the 4 mil thickness. In some areas the cracks were more numerous on the outside where the material was curved and was in contact with rapidly flowing salt. Photomicrographs of a strap and foil that were exposed to static salt in the control facility are shown in Figs. 40 and 41. The samples showed no evidence of intergranular cracking.

Fig. 41. Photomicrographs of a Thin INOR-8 (Heat 5075) Foil that was attached to the strap shown in the Previous Figure. (a) As Polished, (b) Etched with glyceria regia. 500x.

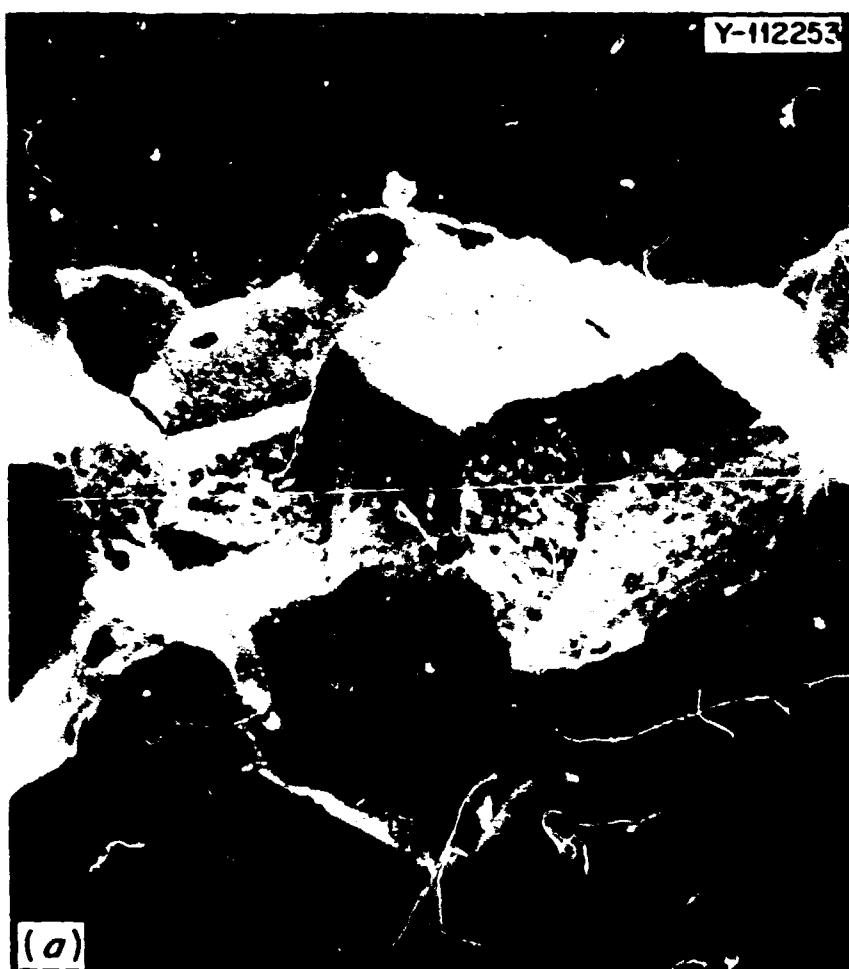
A fracture surface of the foil from the MSRF was examined by the scanning electron microscope (SEM) and Auger spectroscopy. The fracture is shown in Fig. 42 and is intergranular. The SEM with a dispersive x-ray analytical system indicated the presence only of the elements normally

Fig. 42. Scanning Electron Micrograph of INOR-8 (Heat 5075) Foil Exposed to the MSRE Core for 7203 hr Above 500°C. (a) Topographical view of fracture showing the surfaces of the fractured grain boundaries. 500x. (b) 1000x.

found in INCR-3. Auger electron spectroscopy indicated that Te, S, and Mo were concentrated in the boundaries. Definite confirmation of the presence of these elements was difficult because many of the spectra overlapped.

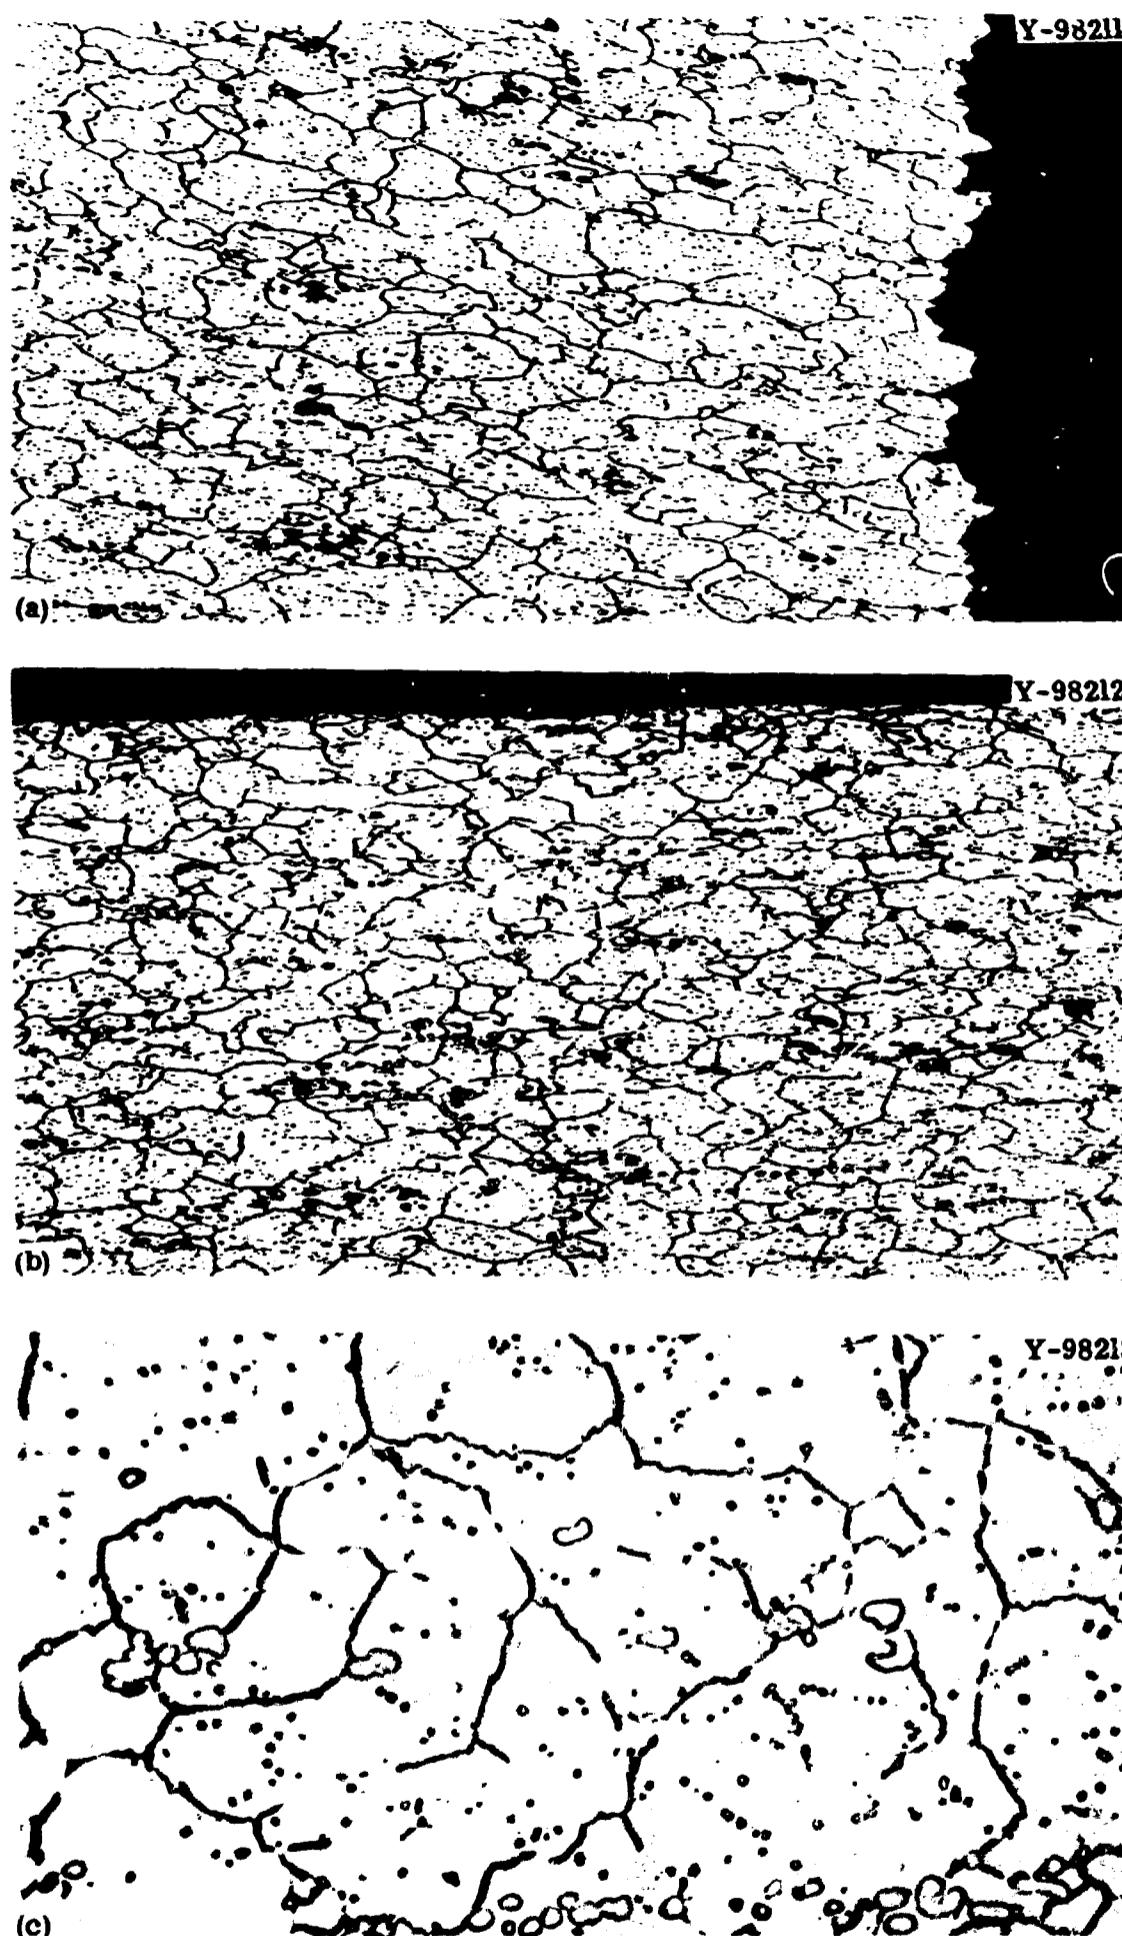
Fig. 43. Typical Photomicrographs of INOR-8 (Heat 5055) Sample Tested at 25°C After Being Exposed to Static Unenriched Fuel Salt for 19,136 hr above 500°C. Etchant: glyceria regia. (a) Fracture. 100x. (b) Edge near fracture. 100x. (c) Representative unstressed structure. 500x. Reduced 22%.

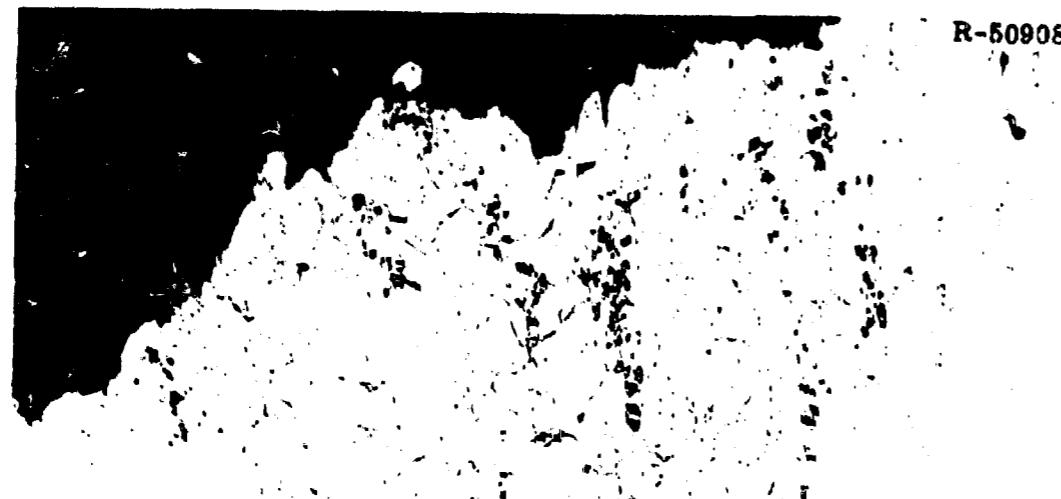
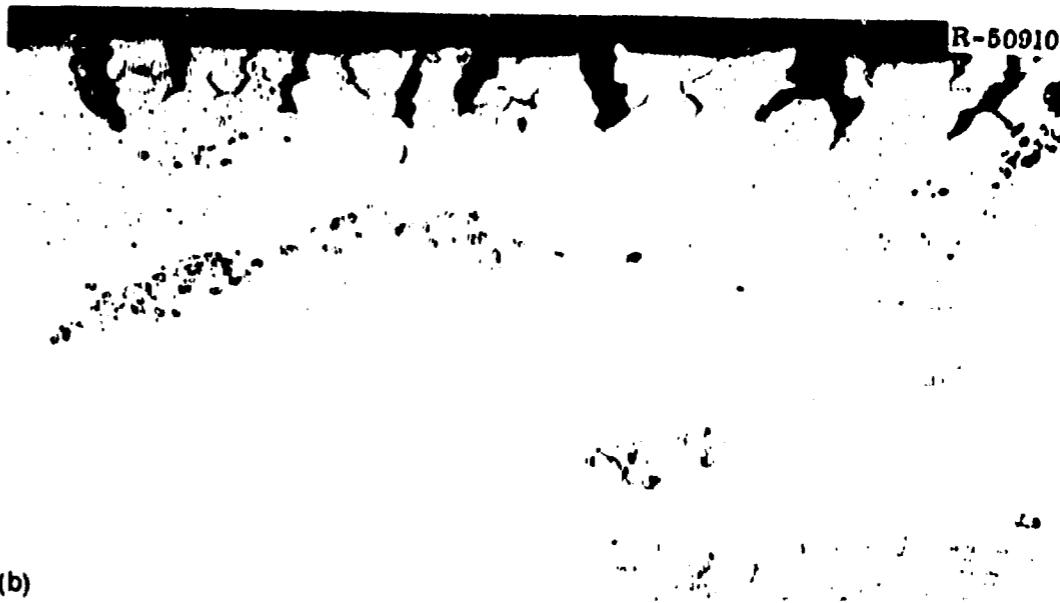
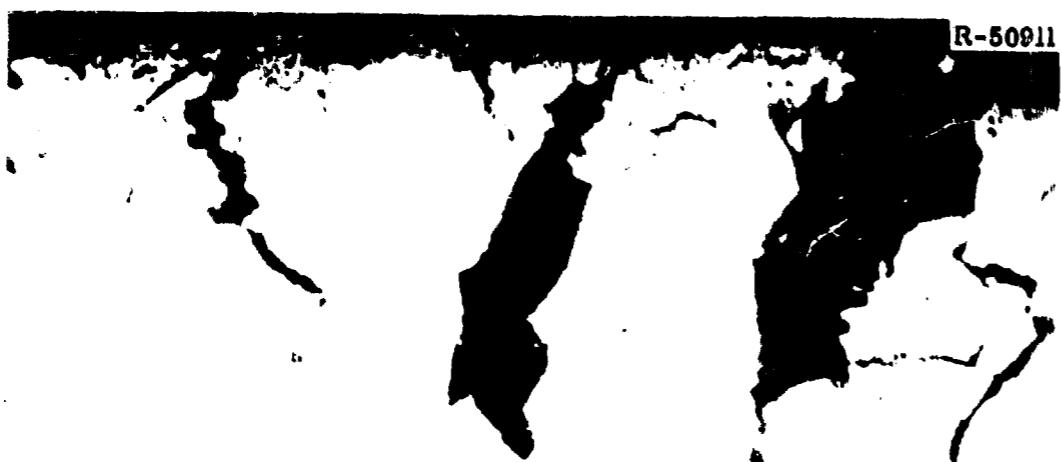
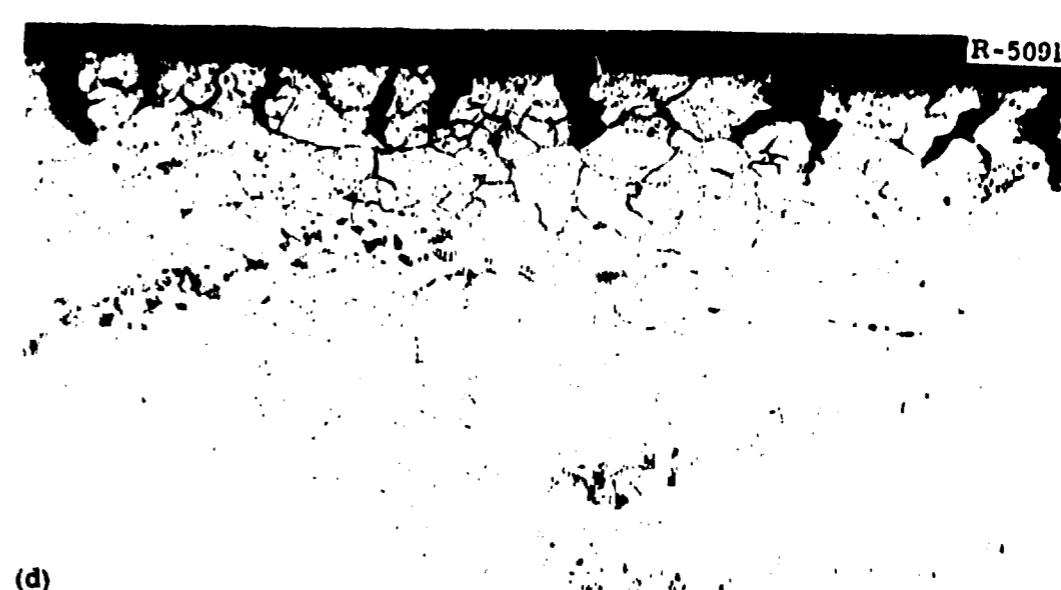
Fig. 44. Photomicrographs of INOR-8 (Heat 5065) Sample Tested at 25°C After Being Exposed to the MSRE Core for 19,136 hr Above 500°C and Irradiated to a Thermal Fluence of 1.5×10^{21} neutrons/cm². (a) Fracture, etched. 100x. (b) Edge, as polished. 100x. (c) Edge, as polished. 500x. (d) Edge, etched. 100x. Etchant: glyceria regia. Reduced 26%.

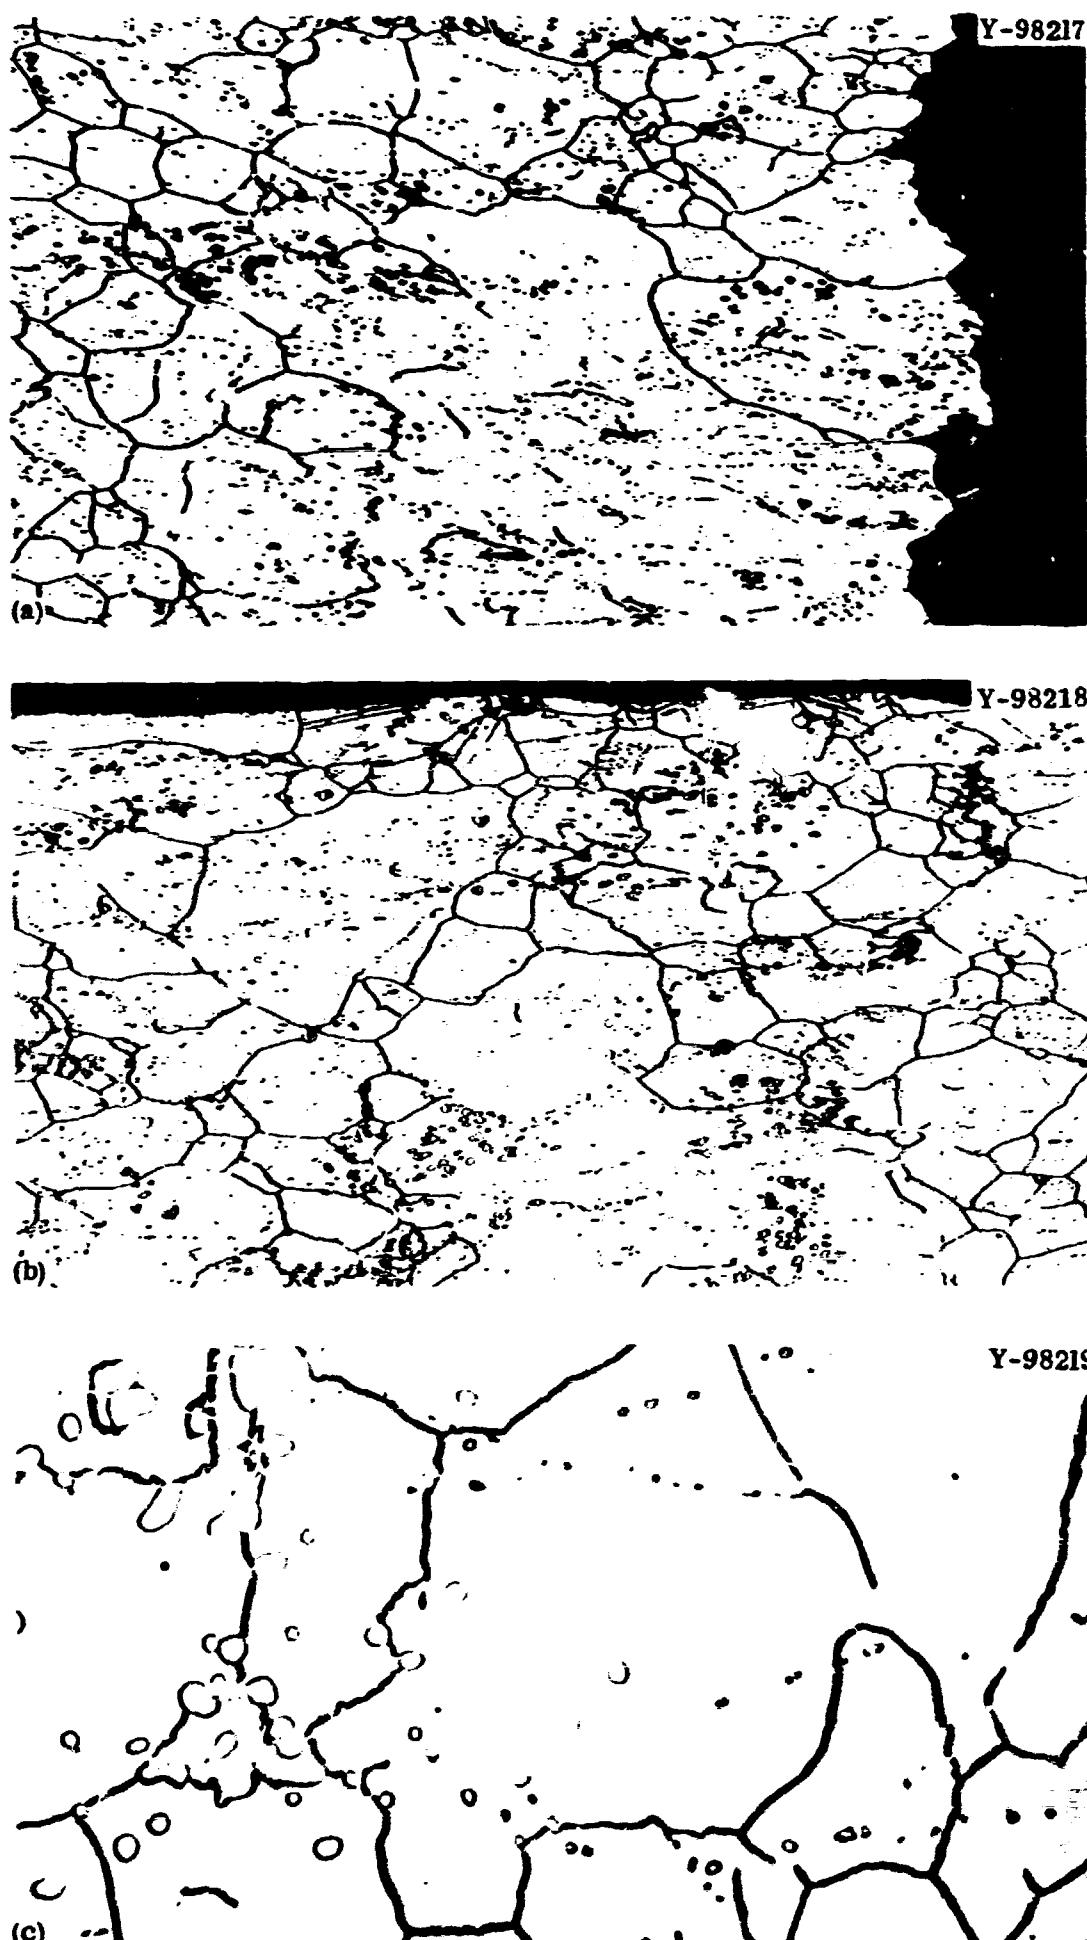
Fig. 45. Typical Photomicrographs of INOR 5 (Heat 5085) Sample Tested at 25°C After Being Exposed to Static Unenriched Fuel Salt for 19,136 hr Above 500°C. (a) Fracture, etched. 100x. (b) Edge near fracture, etched. 100x. (c) Representative unstressed structure, etched. 500x. Etchant: glyceria regia. Reduced 24.5%.

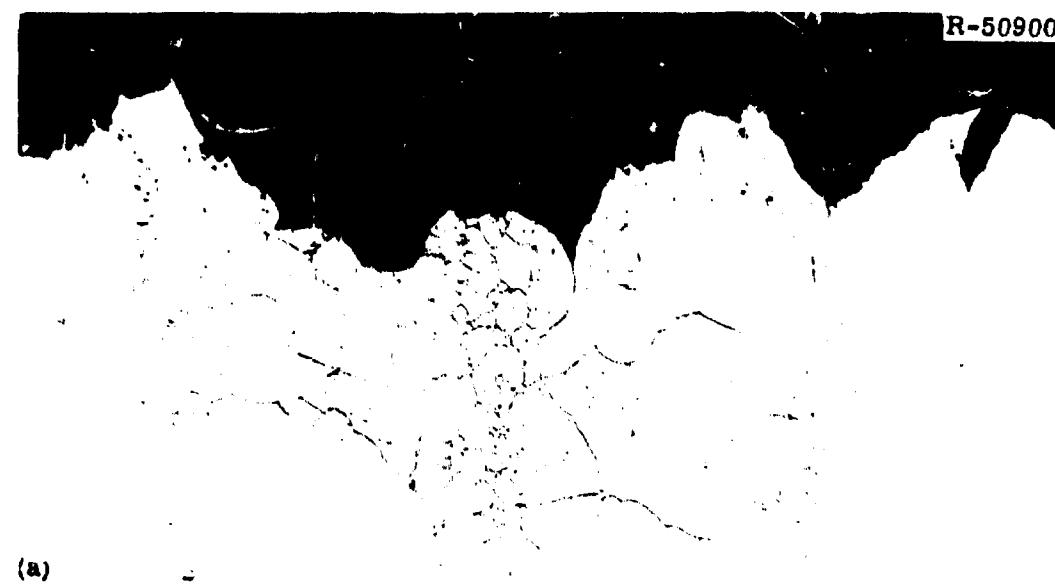
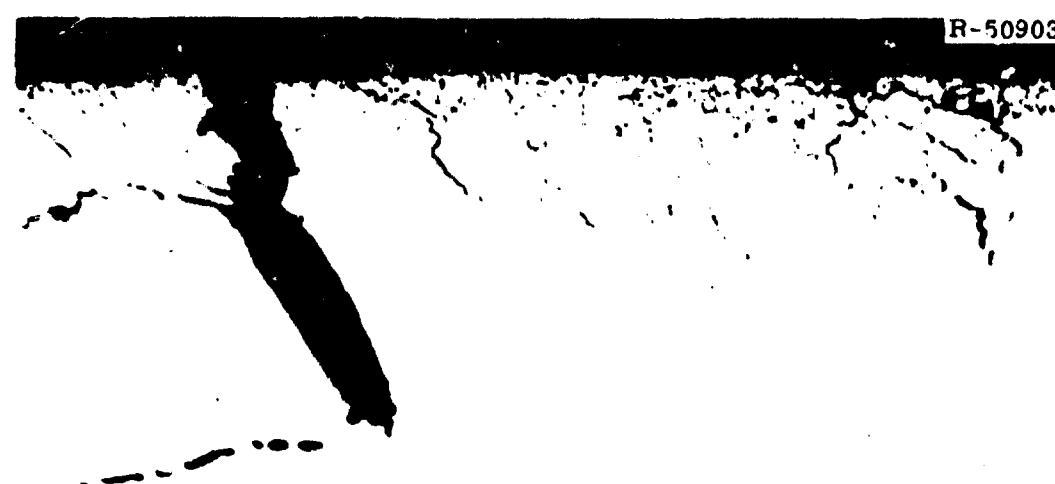
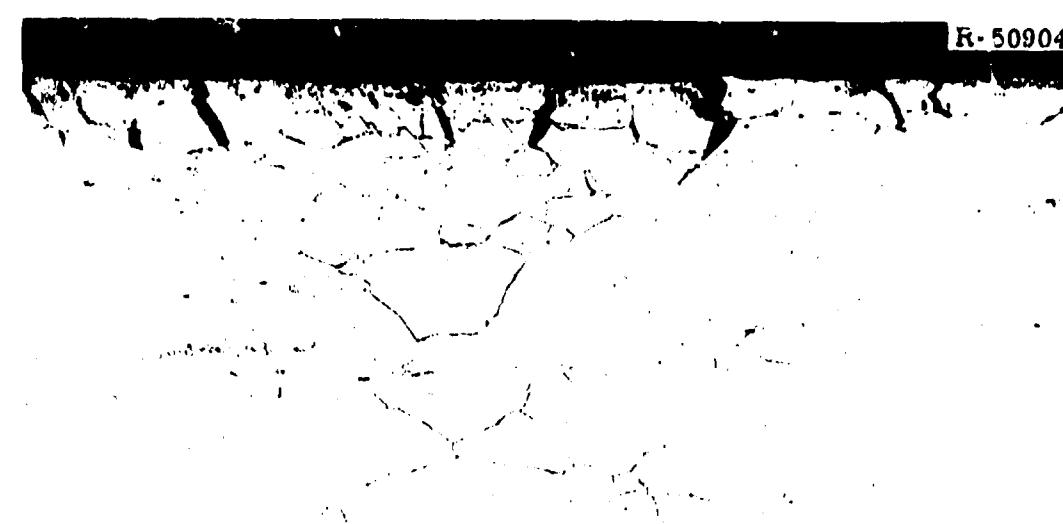
Fig. 46. Photomicrographs of INOR-8 (Heat 5085) Sample Tested at 25°C After Being Exposed to the MSRE Core for 19,136 hr Above 500°C and Irradiated to a Thermal Fluence of 1.5×10^{21} neutrons/cm². (a) Fracture, etched. 100x. (b) Edge, as polished. 100x. (c) Edge, as polished. 500x. (d) Edge, etched. 100x. Etchant: glyceria regia. Reduced 27%.

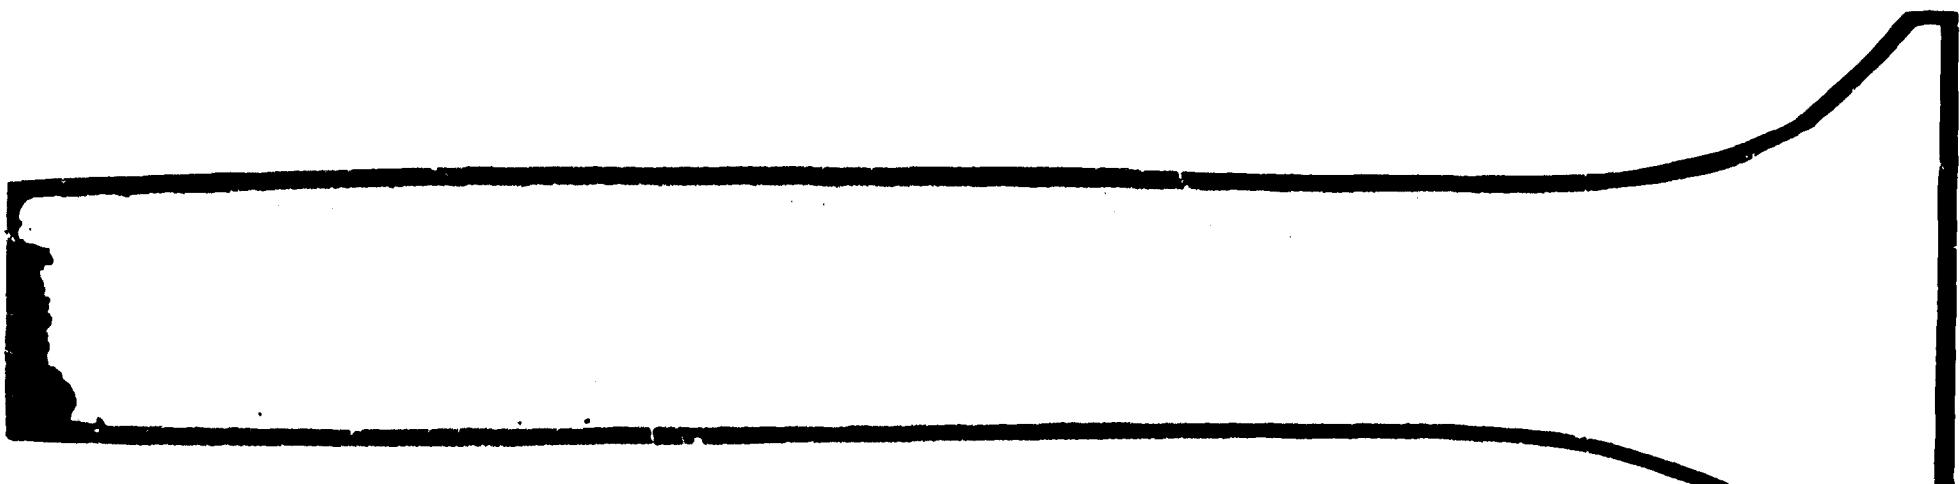
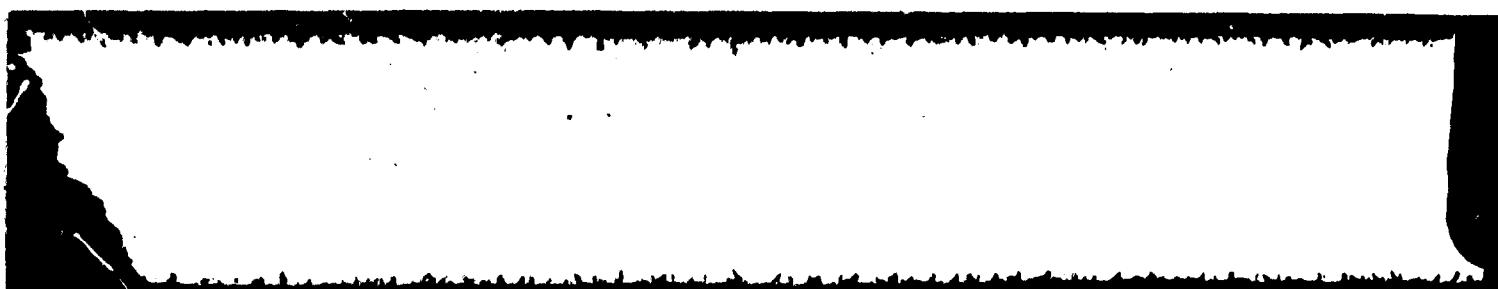
Fig. 47. Photomicrographs of INOR-8 (Heat 5065) Strained to Fracture at 25°C. Top specimen was exposed to static unenriched fuel salt for 19,136 hr above 500°C and the lower specimen was exposed to the MSRE core for the same time. The diameters are about 0.1 in.

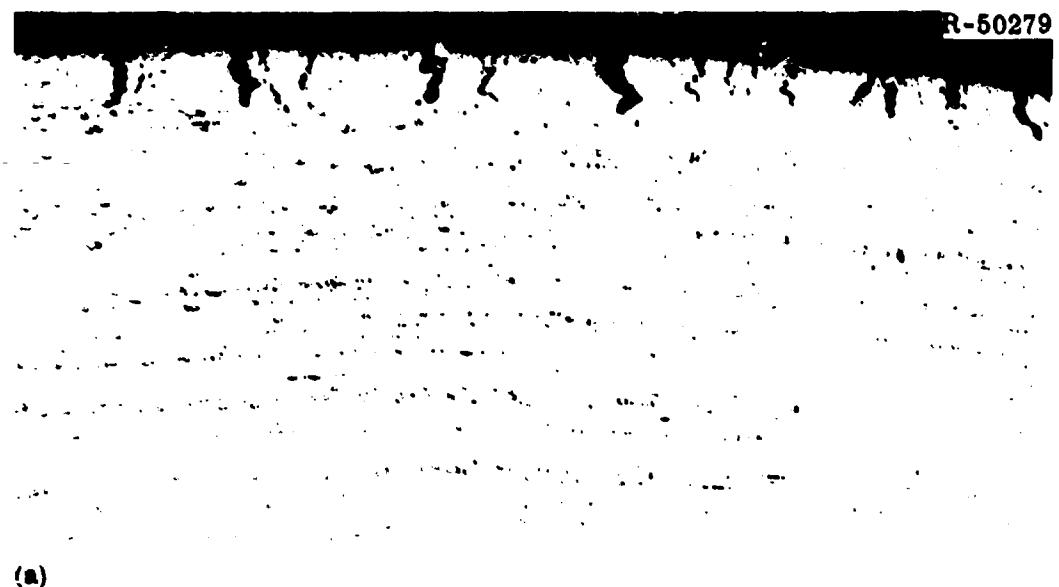
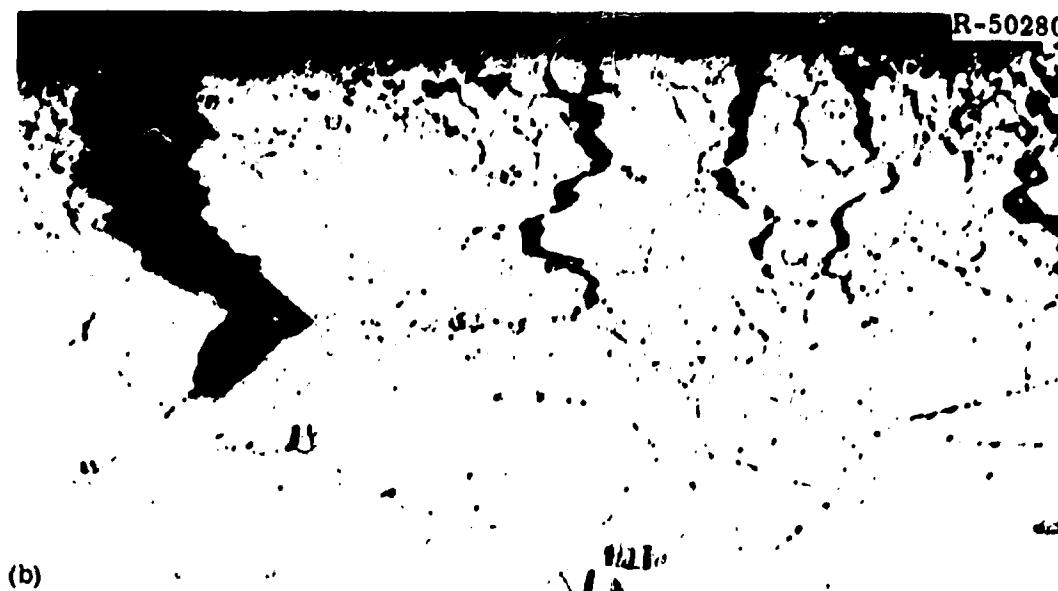
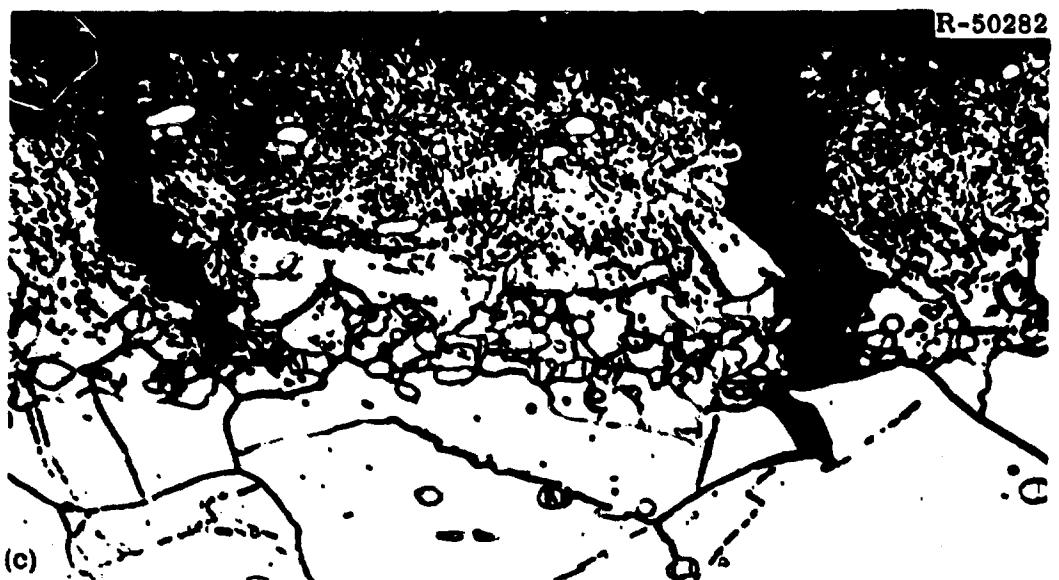
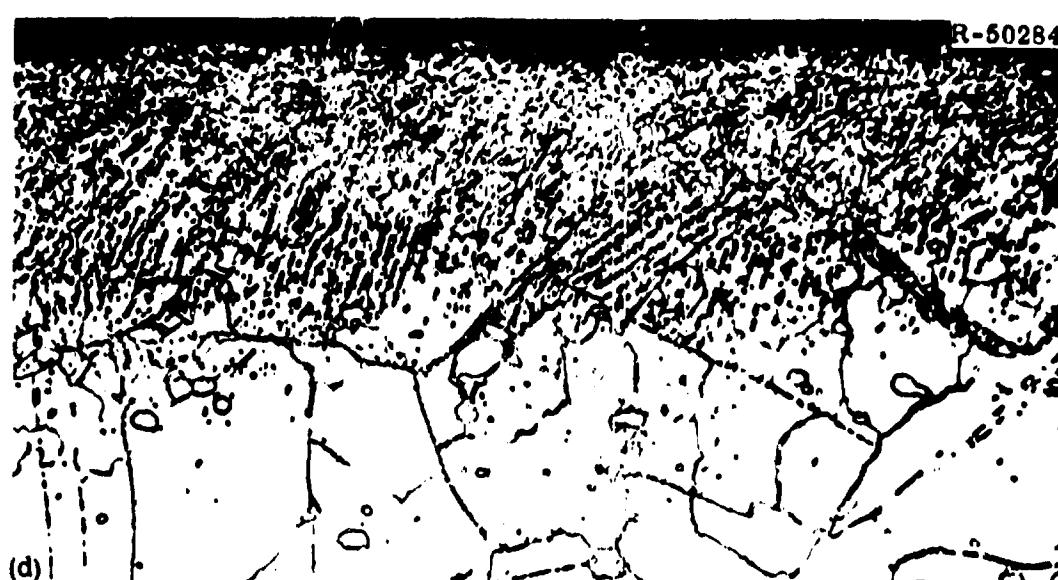
An additional experiment was made with a core sample of heat 5085 that had been cut too short for mechanical property testing. The remaining segment was bent about 30° in a vise, then was sectioned and examined metallographically. The resulting photomicrographs are shown in Fig. 49. The tension side had intergranular cracks to a depth of about 4 mils, but no cracks were evident on the compression side. Both the tension and compression sides etched abnormally near the surface because of the modification thought to be due to cold working.

Fig. 49. Typical Photomicrographs of INOR-8 (Heat 5085) Sample Exposed to the MSRE Core for 19,136 hr Above 500°C. The sample was bent in a vise. (a) As polished, tension side. 100x. (b) As polished, tension side. 500x. (c) Etched, tension side. 500x. (d) Etched, compression side. 500x. Etchant: aqua regia. Reduced 27%.

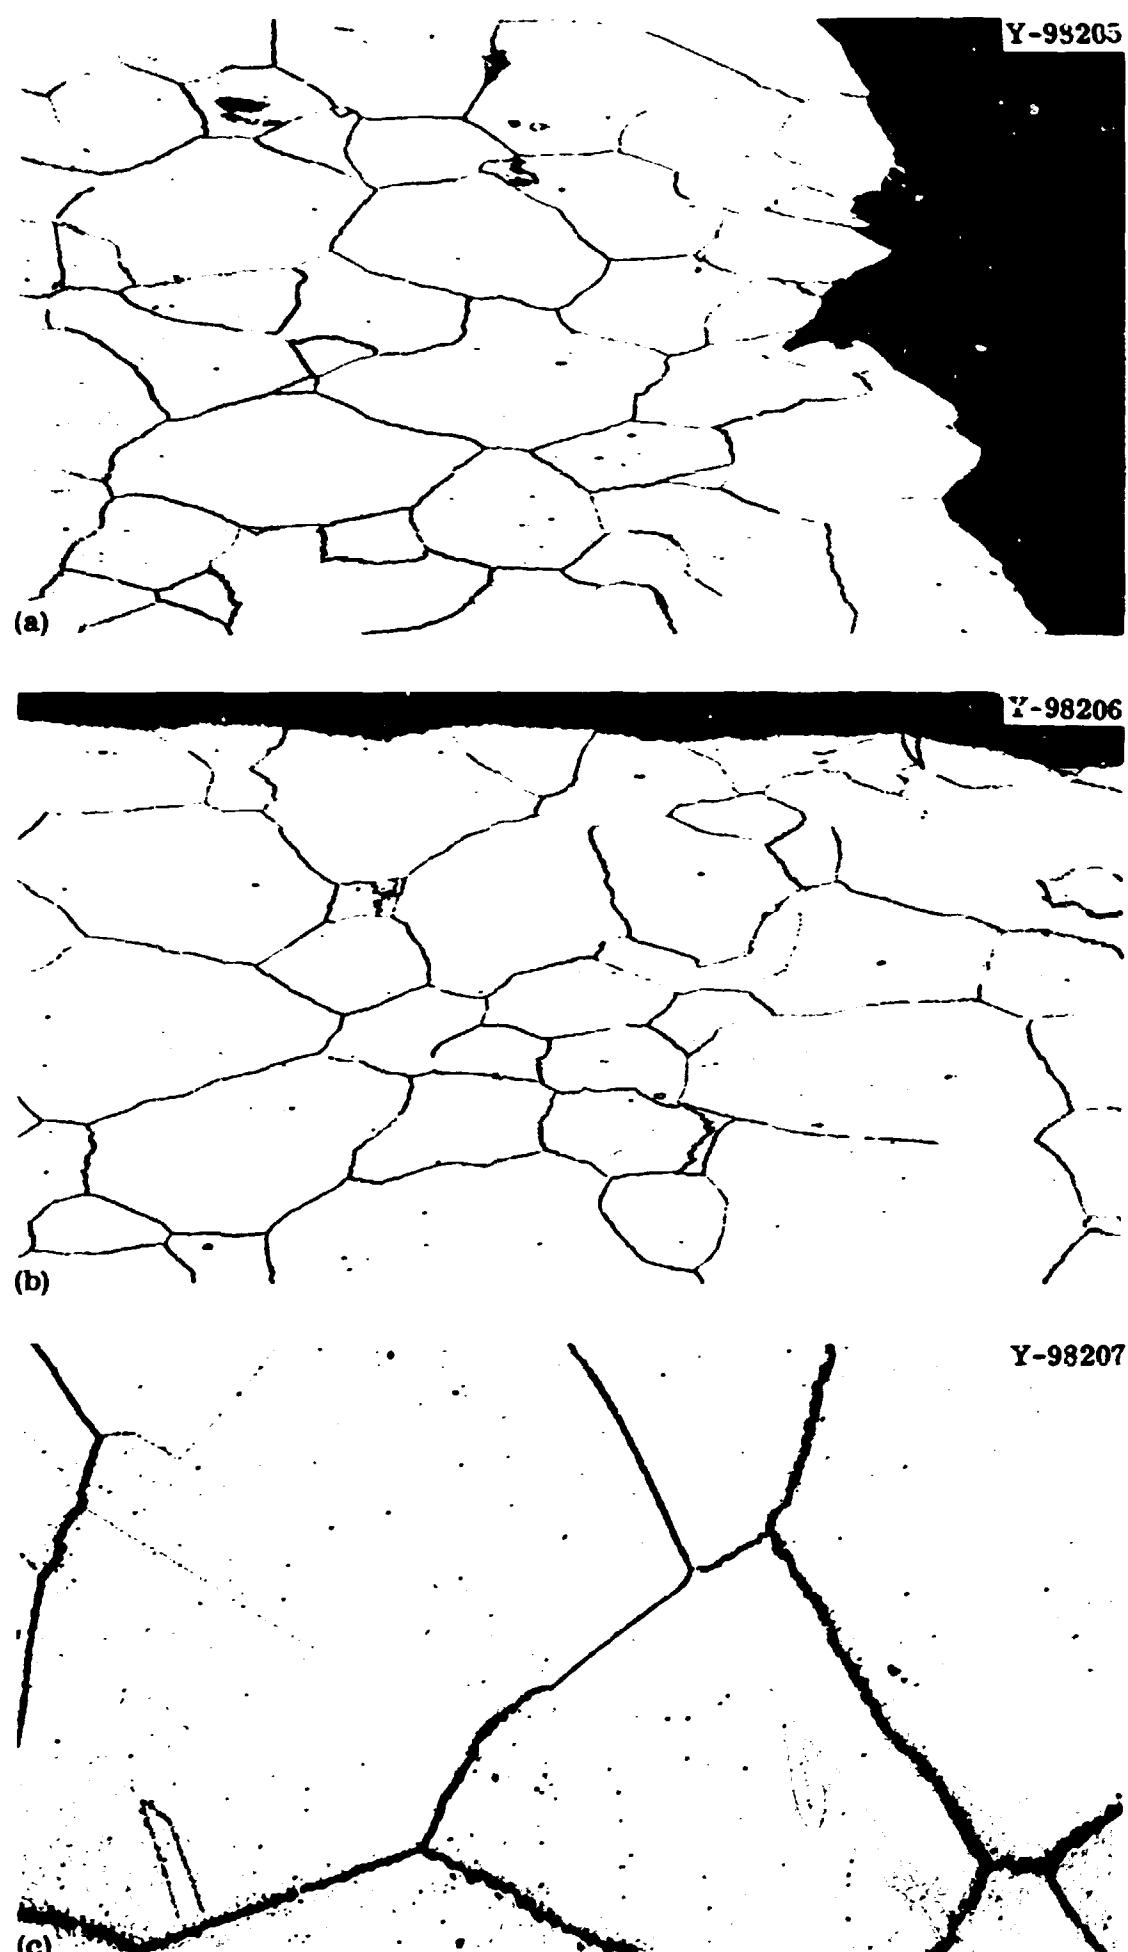
The specimens on stringers RR3 and RS4 were of two different heats of titanium-modified alloy: heat 7320, containing 0.65% Ti, and heat 67-551, containing 1.1% Ti. The 7200-hr exposure of these specimens had been entirely during the ^{233}U operation, in which the initial oxidation state was relatively high. The specimens were discolored and had much the same appearance as the standard heats. The samples were subjected to various mechanical property tests and some were examined metallographically. The microstructure of heat 7320 after exposure in the control facility and testing at 25°C is shown in Fig. 50. The sample deformed 50% before fracturing in a mixed mode. No edge cracks were visible. A similar sample that was exposed to the fuel salt is shown in Fig. 51. It failed after deforming 45%. Edge cracks were present along almost every grain boundary to a depth of 3 to 5 mils. Note that many of these cracks proceed to where the cracking grain boundary intersects another boundary. Note also that the crack tips are quite blunt indicating that they formed early during deformation and were simply spread by further deformation and did not propagate. Similar metallographic observations were made on heat 67-551. Control and core specimens deformed almost equal amounts before fracturing (52% and 51%). No edge cracks were observed in the sample from the control facility (Fig. 52), but numerous intergranular cracks were evident in the sample from the core (Fig. 53).

Fig. 50. Photomicrographs of a Modified INOR-8 (Heat 7320) Sample Tested at 25°C After Being Exposed to Static Unenriched Fuel Salt for 7203 hr Above 500°C. (a) Fracture. 100x. (b) Edge. 100x. (c) Typical unstressed microstructure. 500x. Etchant: glyceria regia. Reduced 22.5%.

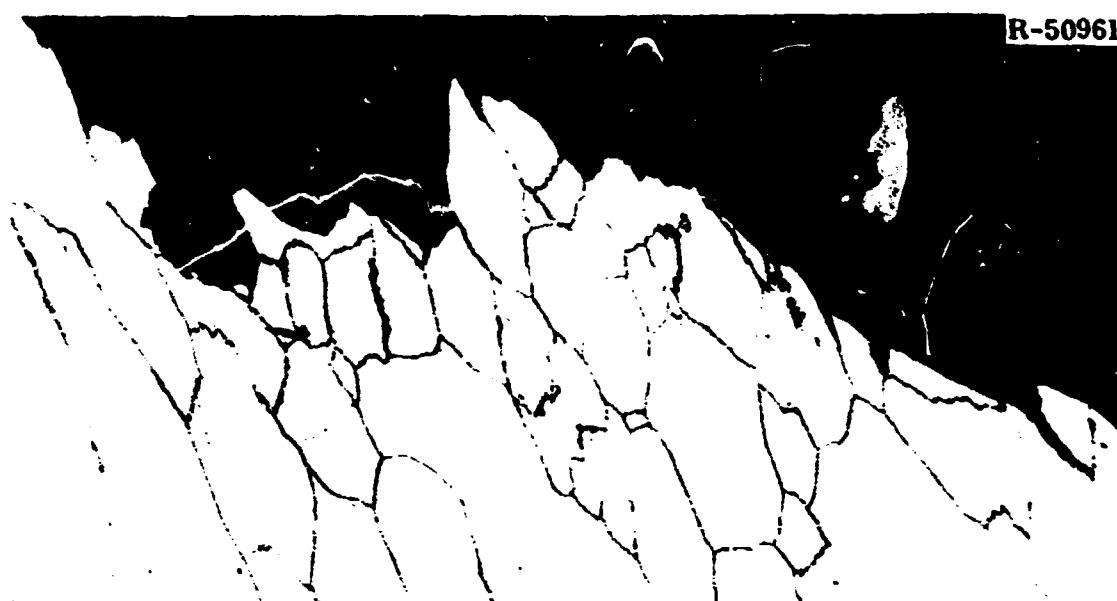
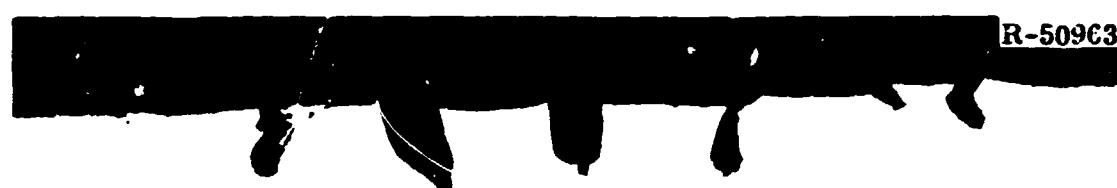
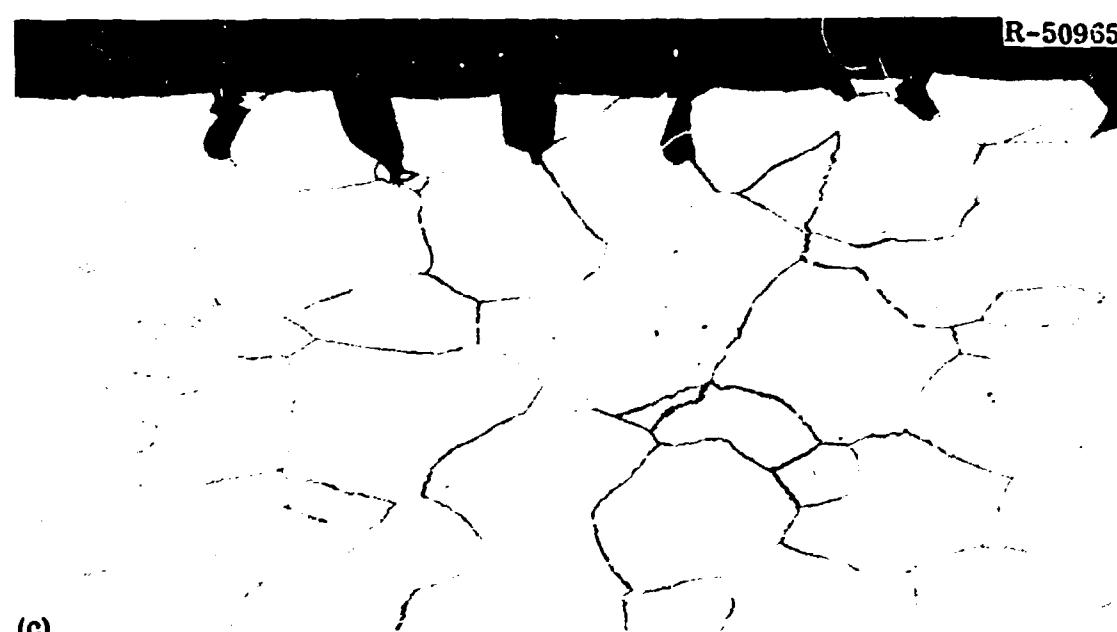
Fig. 51. Photomicrographs of a Modified INOR-8 (Heat 7320) Sample Tested at 25°C After Being Exposed to the MSRE Core for 7203 hr Above 500°C and Irradiated to a Fluence of 5.1×10^{20} neutrons/cm². (a) Fracture, etched, 100x. (b) Edge, as polished. 100x. (c) Edge, Etched. 100x. Etchant: glyceria regia. Reduced 22%.
