INTERGRANULAR CRACKING OF INOR-8 IN THE MSRE

H. E. McCoy

B. McNabb

NOVEMBER 1972

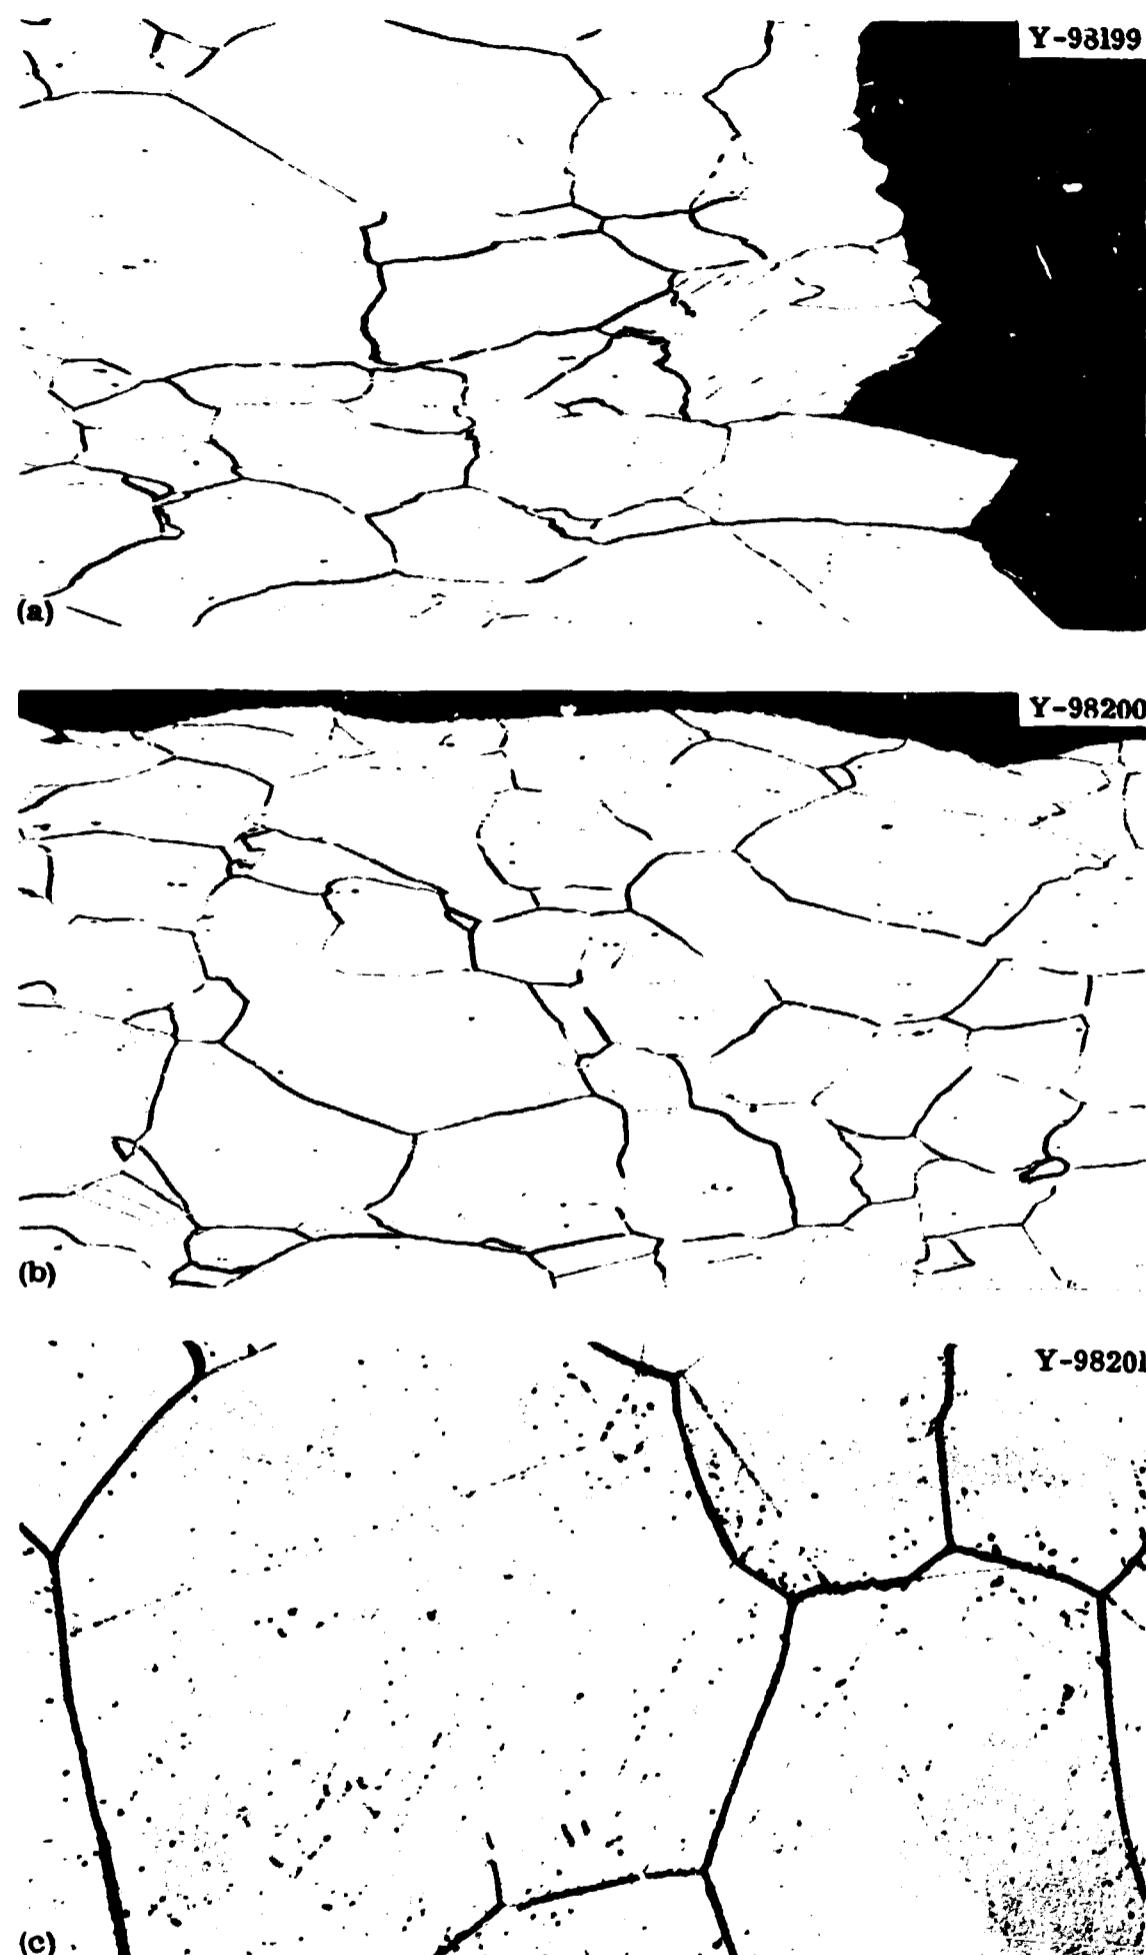
The specimens on stringers RR3 and RS4 were of two different heats of titanium-modified alloy: heat 7320, containing 0.65% Ti, and heat 67-551, containing 1.1% Ti. The 7200-hr exposure of these specimens had been entirely during the ^{233}U operation, in which the initial oxidation state was relatively high. The specimens were discolored and had much the same appearance as the standard heats. The samples were subjected to various mechanical property tests and some were examined metallographically. The microstructure of heat 7320 after exposure in the control facility and testing at 25°C is shown in Fig. 50. The sample deformed 50% before fracturing in a mixed mode. No edge cracks were visible. A similar sample that was exposed to the fuel salt is shown in Fig. 51. It failed after deforming 45%. Edge cracks were present along almost every grain boundary to a depth of 3 to 5 mils. Note that many of these cracks proceed to where the cracking grain boundary intersects another boundary. Note also that the crack tips are quite blunt indicating that they formed early during deformation and were simply spread by further deformation and did not propagate. Similar metallographic observations were made on heat 67-551. Control and core specimens deformed almost equal amounts before fracturing (52% and 51%). No edge cracks were observed in the sample from the control facility (Fig. 52), but numerous intergranular cracks were evident in the sample from the core (Fig. 53).

Fig. 52. Photomicrographs of a Modified INOR-8 (Heat 67-551) Sample Tested at 25°C After Being Exposed to Static Unenriched Fuel Salt for 7203 hr Above 500°C. (a) Fracture. 100x. (b) Edge. 100x. (c) Typical unstressed microstructure. 500x. Etchant: glyceria regia. Reduced 20.5%.

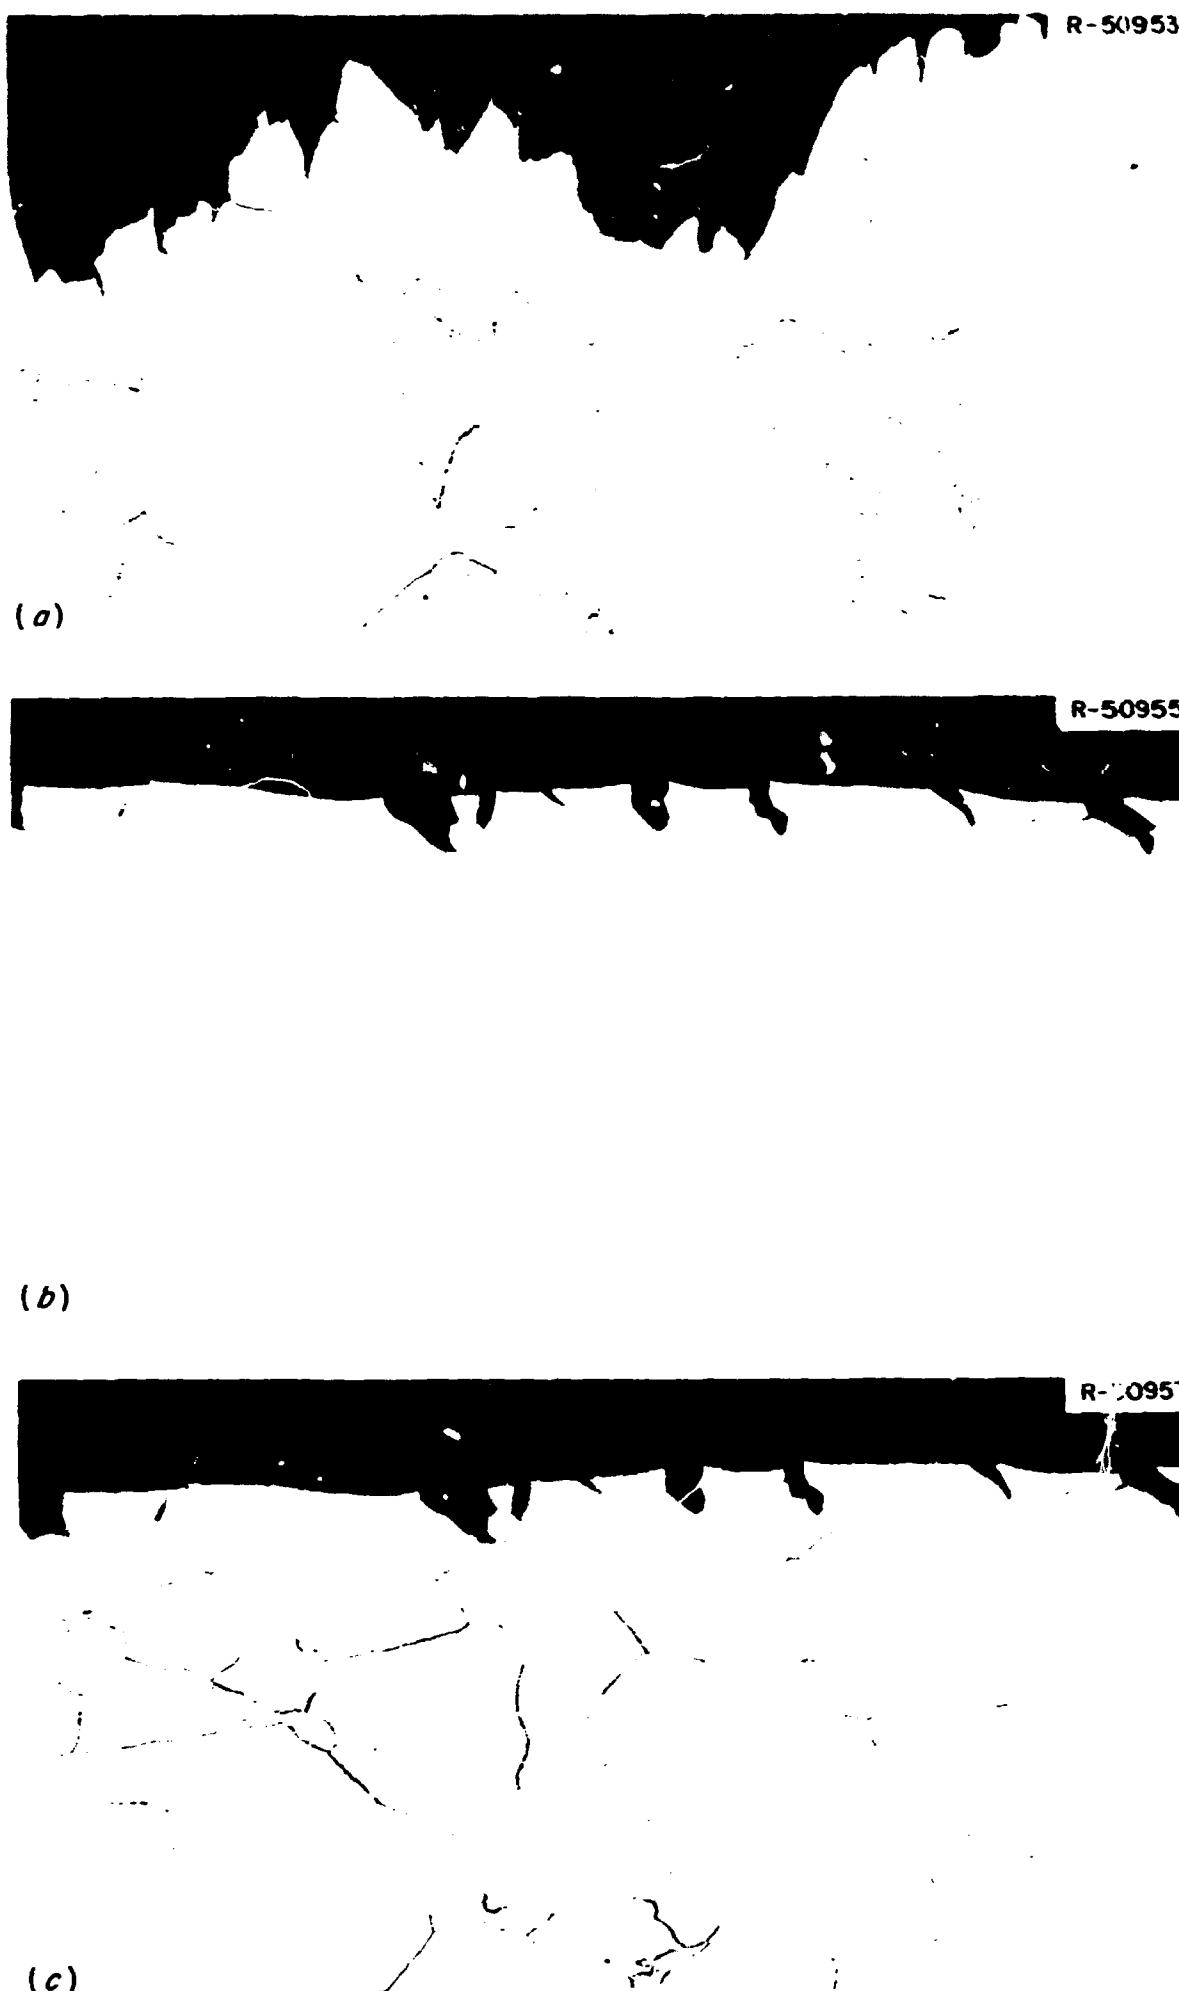
Fig. 53. Photomicrographs of a Modified INOR-8 (Heat 67-551) Sample Tested at 25°C After Being Exposed to the MSRE Core for 7203 hr Above 500°C and Irradiated to a Fluence of 5.1×10^{20} neutrons/cm². (a) Fracture, etched. 100x. (b) Edge, as polished. 100x. (c) Edge, etched. 100x. Etchant: Glyceria regia. Reduced 17%.

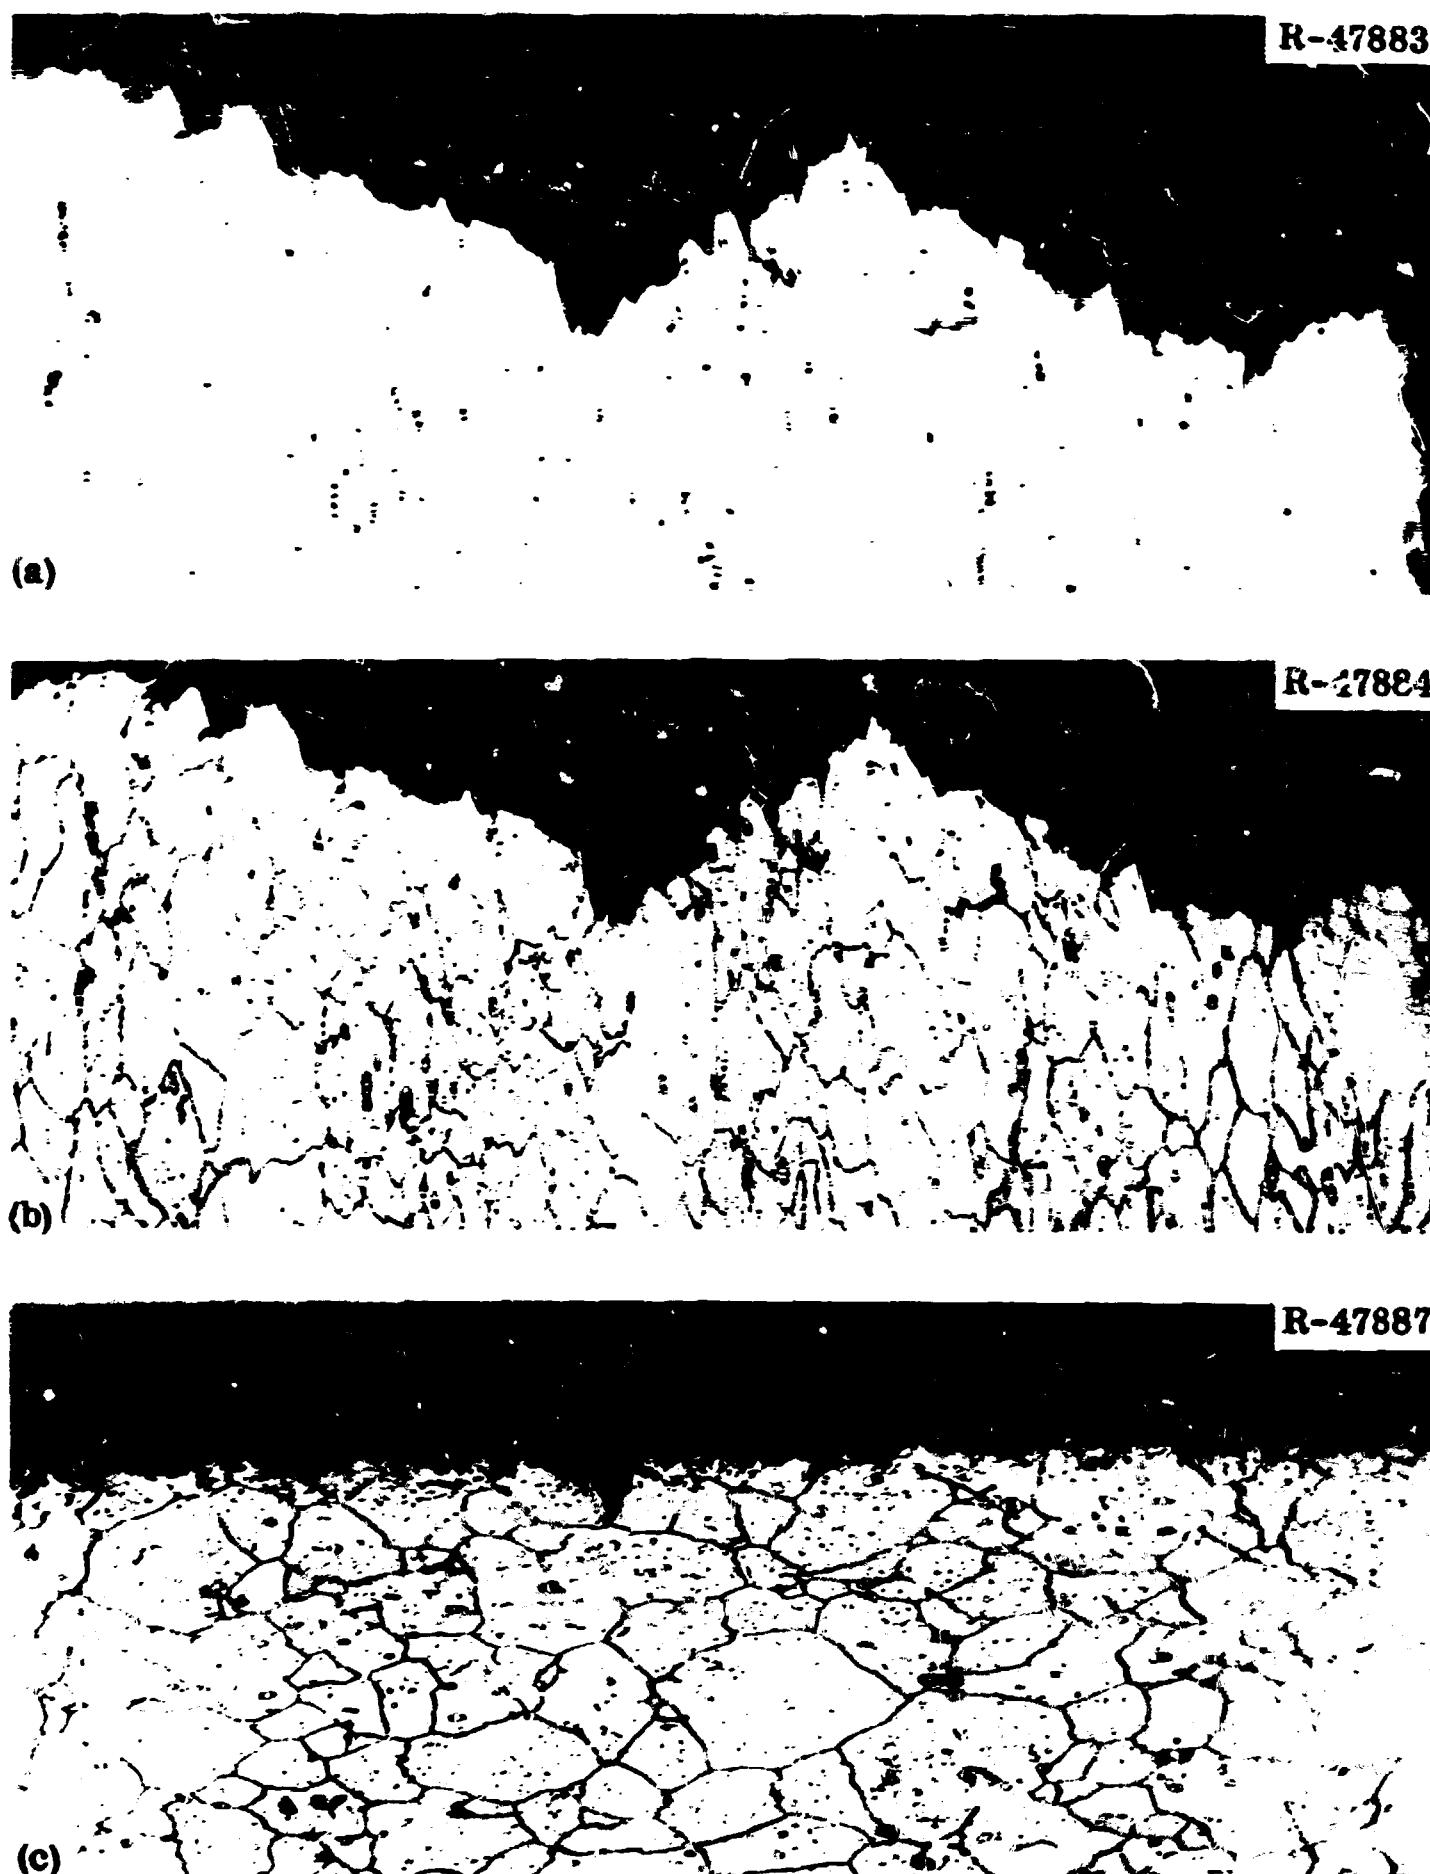
Figure 55 shows a sample of heat 5065 exposed to the cell environment and fractured at 25°C. The elongated grains attest to the large fracture strain (59%), and the fracture is mixed transgranular and intergranular. A heat 5085 specimen exposed the same length of time failed with only 33% fracture strain, in a primarily intergranular mode as shown in Fig. 56. Both specimens showed a few shallow surface cracks, but the oxide layer did not appear to affect the deformation of the specimens.

Fig. 55. Photomicrographs of INOR-8 (Heat 5065) Sample Tested at 25°C at a Strain Rate of 0.05/min. Sample had been irradiated to a thermal fluence of 2.6×10^{19} neutrons/cm² while being exposed to the cell environment above 500°C for 17,483 hr. 100x. (a) Fracture, as polished. (b) Fracture, etched. (c) Edge of stressed portion. Etchant: aqua regia.

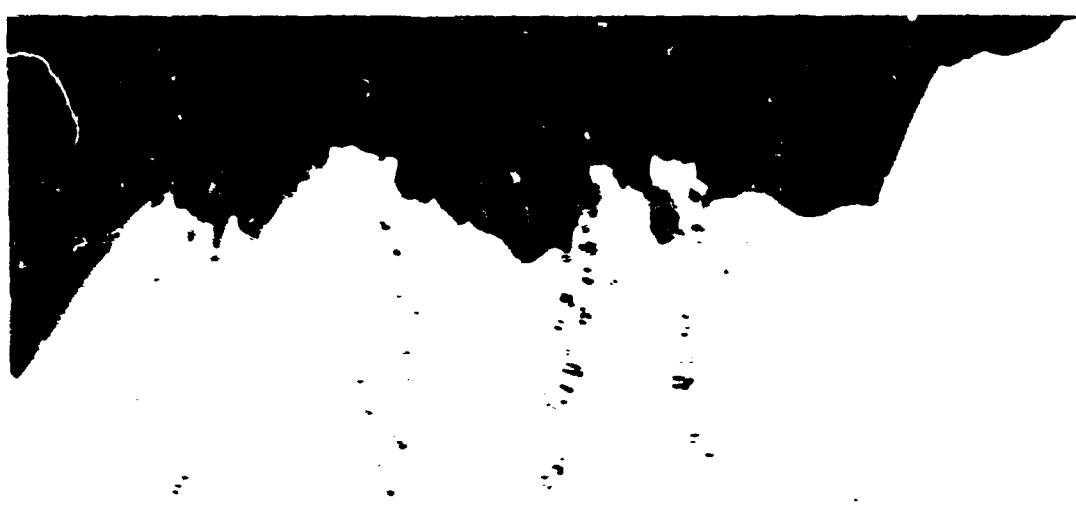
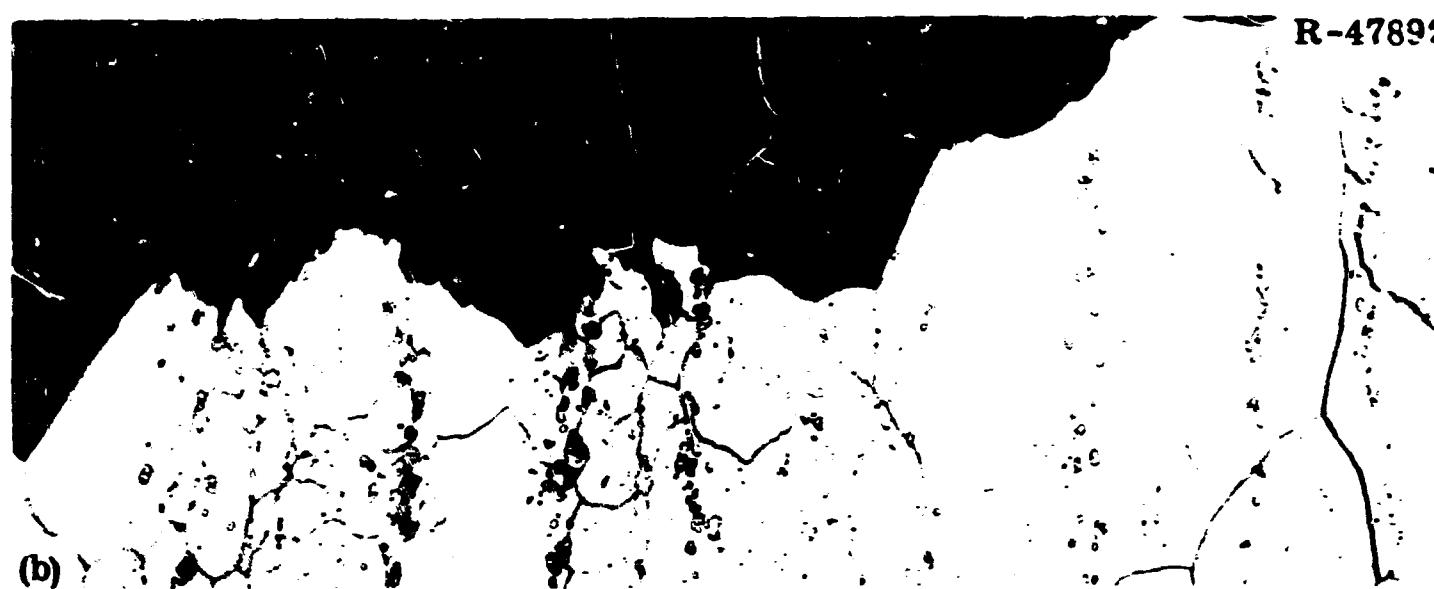
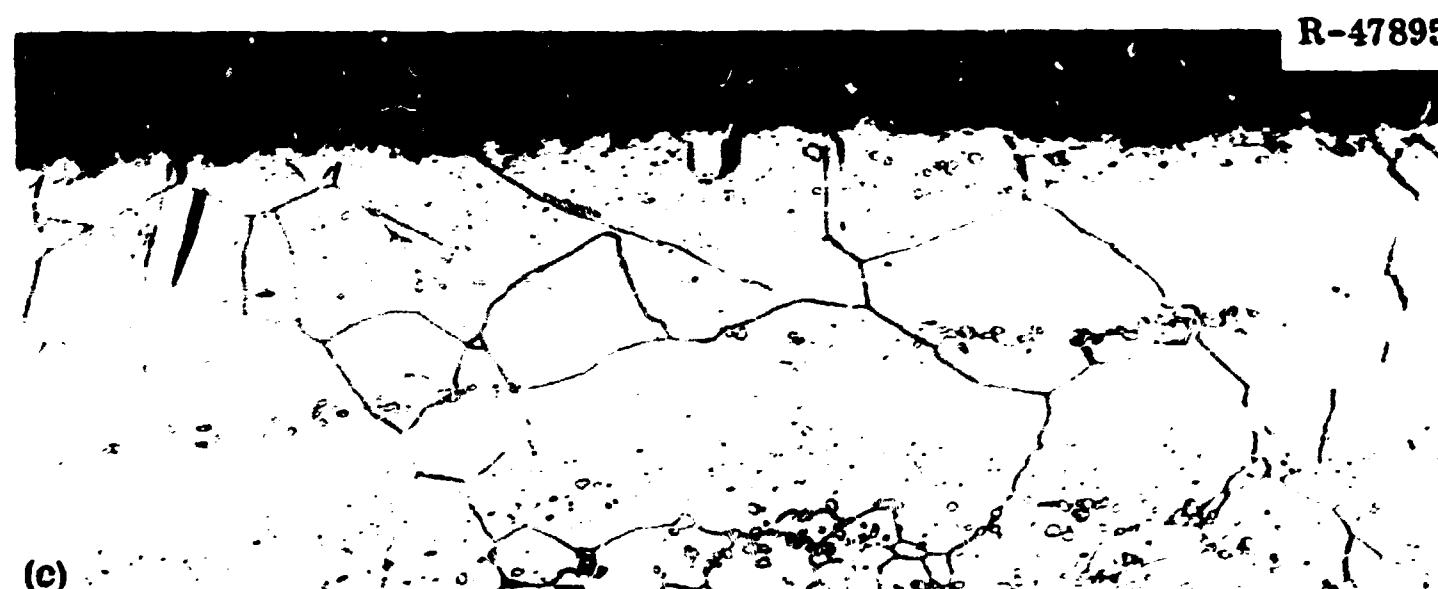
Fig. 56. Photomicrographs of INOR-8 (Heat 5085) Sample Tested at 25°C at Strain Rate of 0.05/min. Sample had been irradiated to a thermal fluence of 2.6×10^{19} neutrons/ cm^2 while being exposed to the cell environment above 500°C for 17,483 hr. 100x. (a) Fracture, as polished. (b) Fracture, etched (c) Edge of stressed portion. Etchant: aqua regia.

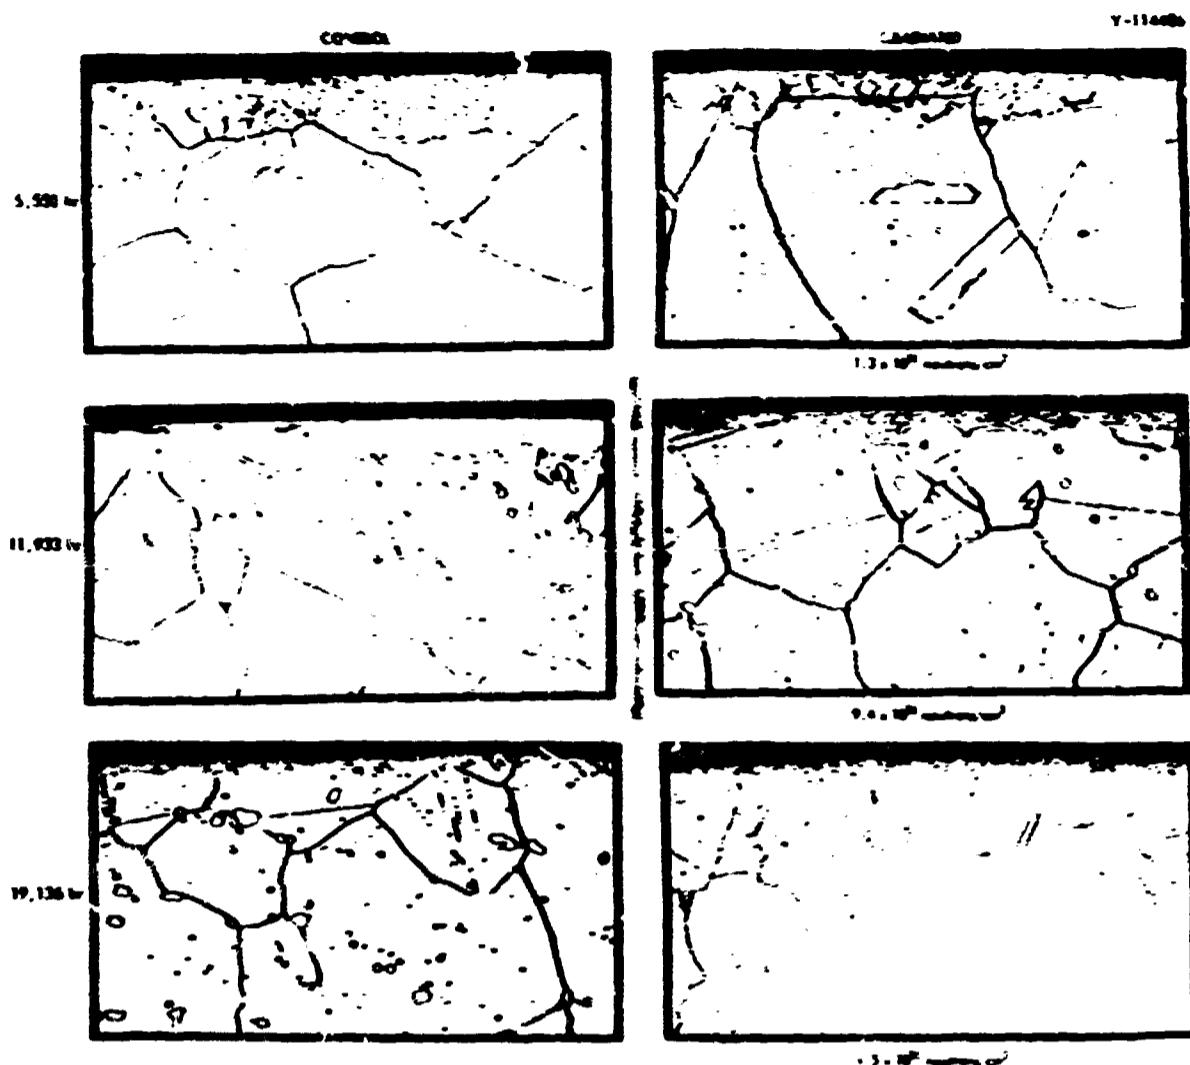
The photomicrographs in Fig. 57 show typical surface modifications noted on surveillance and control specimens after long annealing times at 650°C. The modification is generally less than 1 mil deep and is not detectably influenced by irradiation. Microprobe examination of the first control sample indicated that the modified region was slightly enriched in carbon and that none of the other alloying elements varied. Thus the modification appears to be a region of fine carbides that are dispersed along lines. We postulated that these lines were slip lines that resulted from the surface working during the final stages of fabrication. These slip lines would provide preferred sites for carbide precipitation when the alloy was held at 650°C.

Fig. 57. Photomicrographs of Unstressed INOR-8 (Heat 5085) Control and Irradiated Samples.

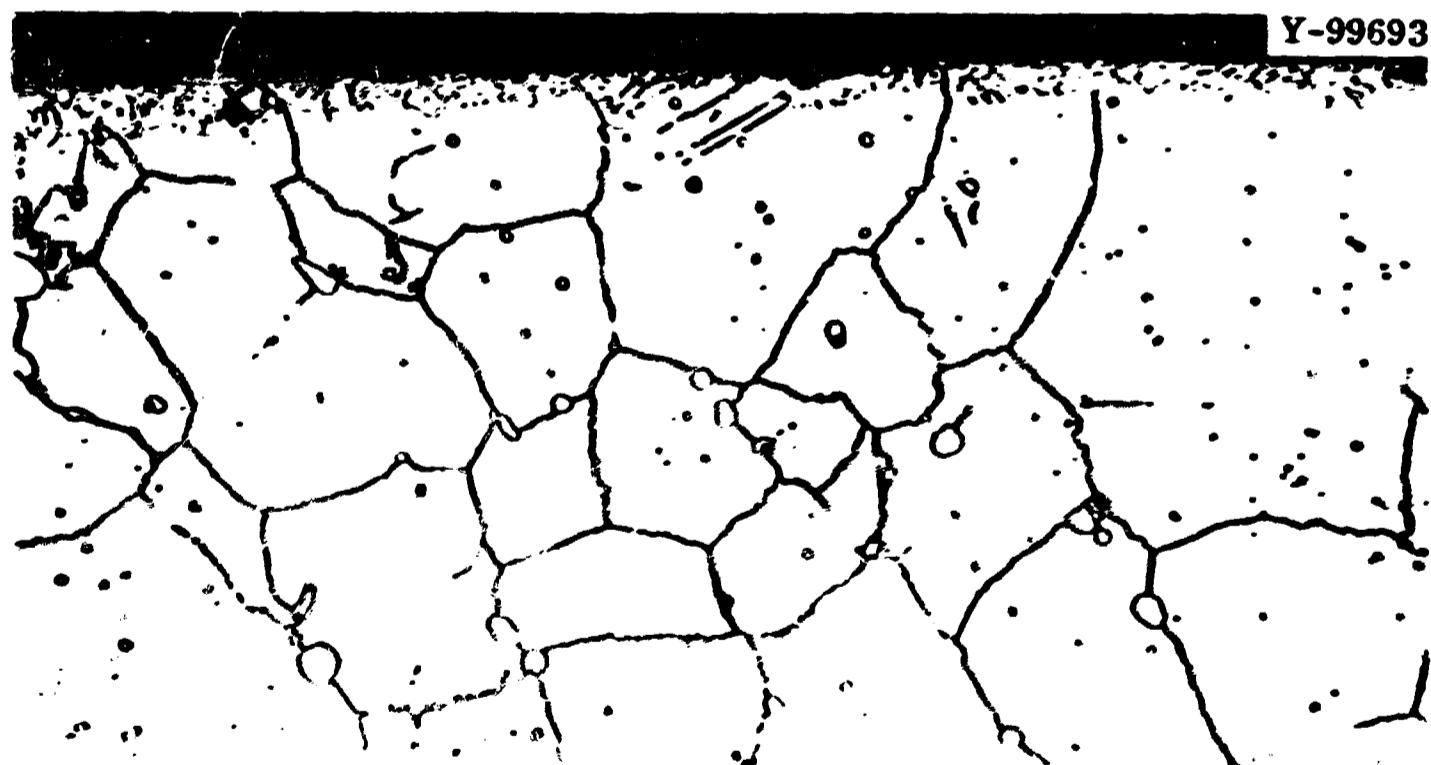
We were able to duplicate the surface modification by solution annealing a rod, centerless grinding, and annealing for a long period at 650°C. The resulting microstructure is shown in Fig. 58. It is quite similar to the microstructures in Fig. 57 and confirms that the modification is due to surface working. Thus, this modification is unrelated to the intergranular cracking phenomenon.

Fig. 58. Photomicrograph of INOR-8 (Heat 5085) Rod that was Annealed 1 hr at 1177°C, Centerless Ground 5.2 mils, and Annealed 4370 hr at 650°C in Argon. 500x. Etchant: glyceria regia.

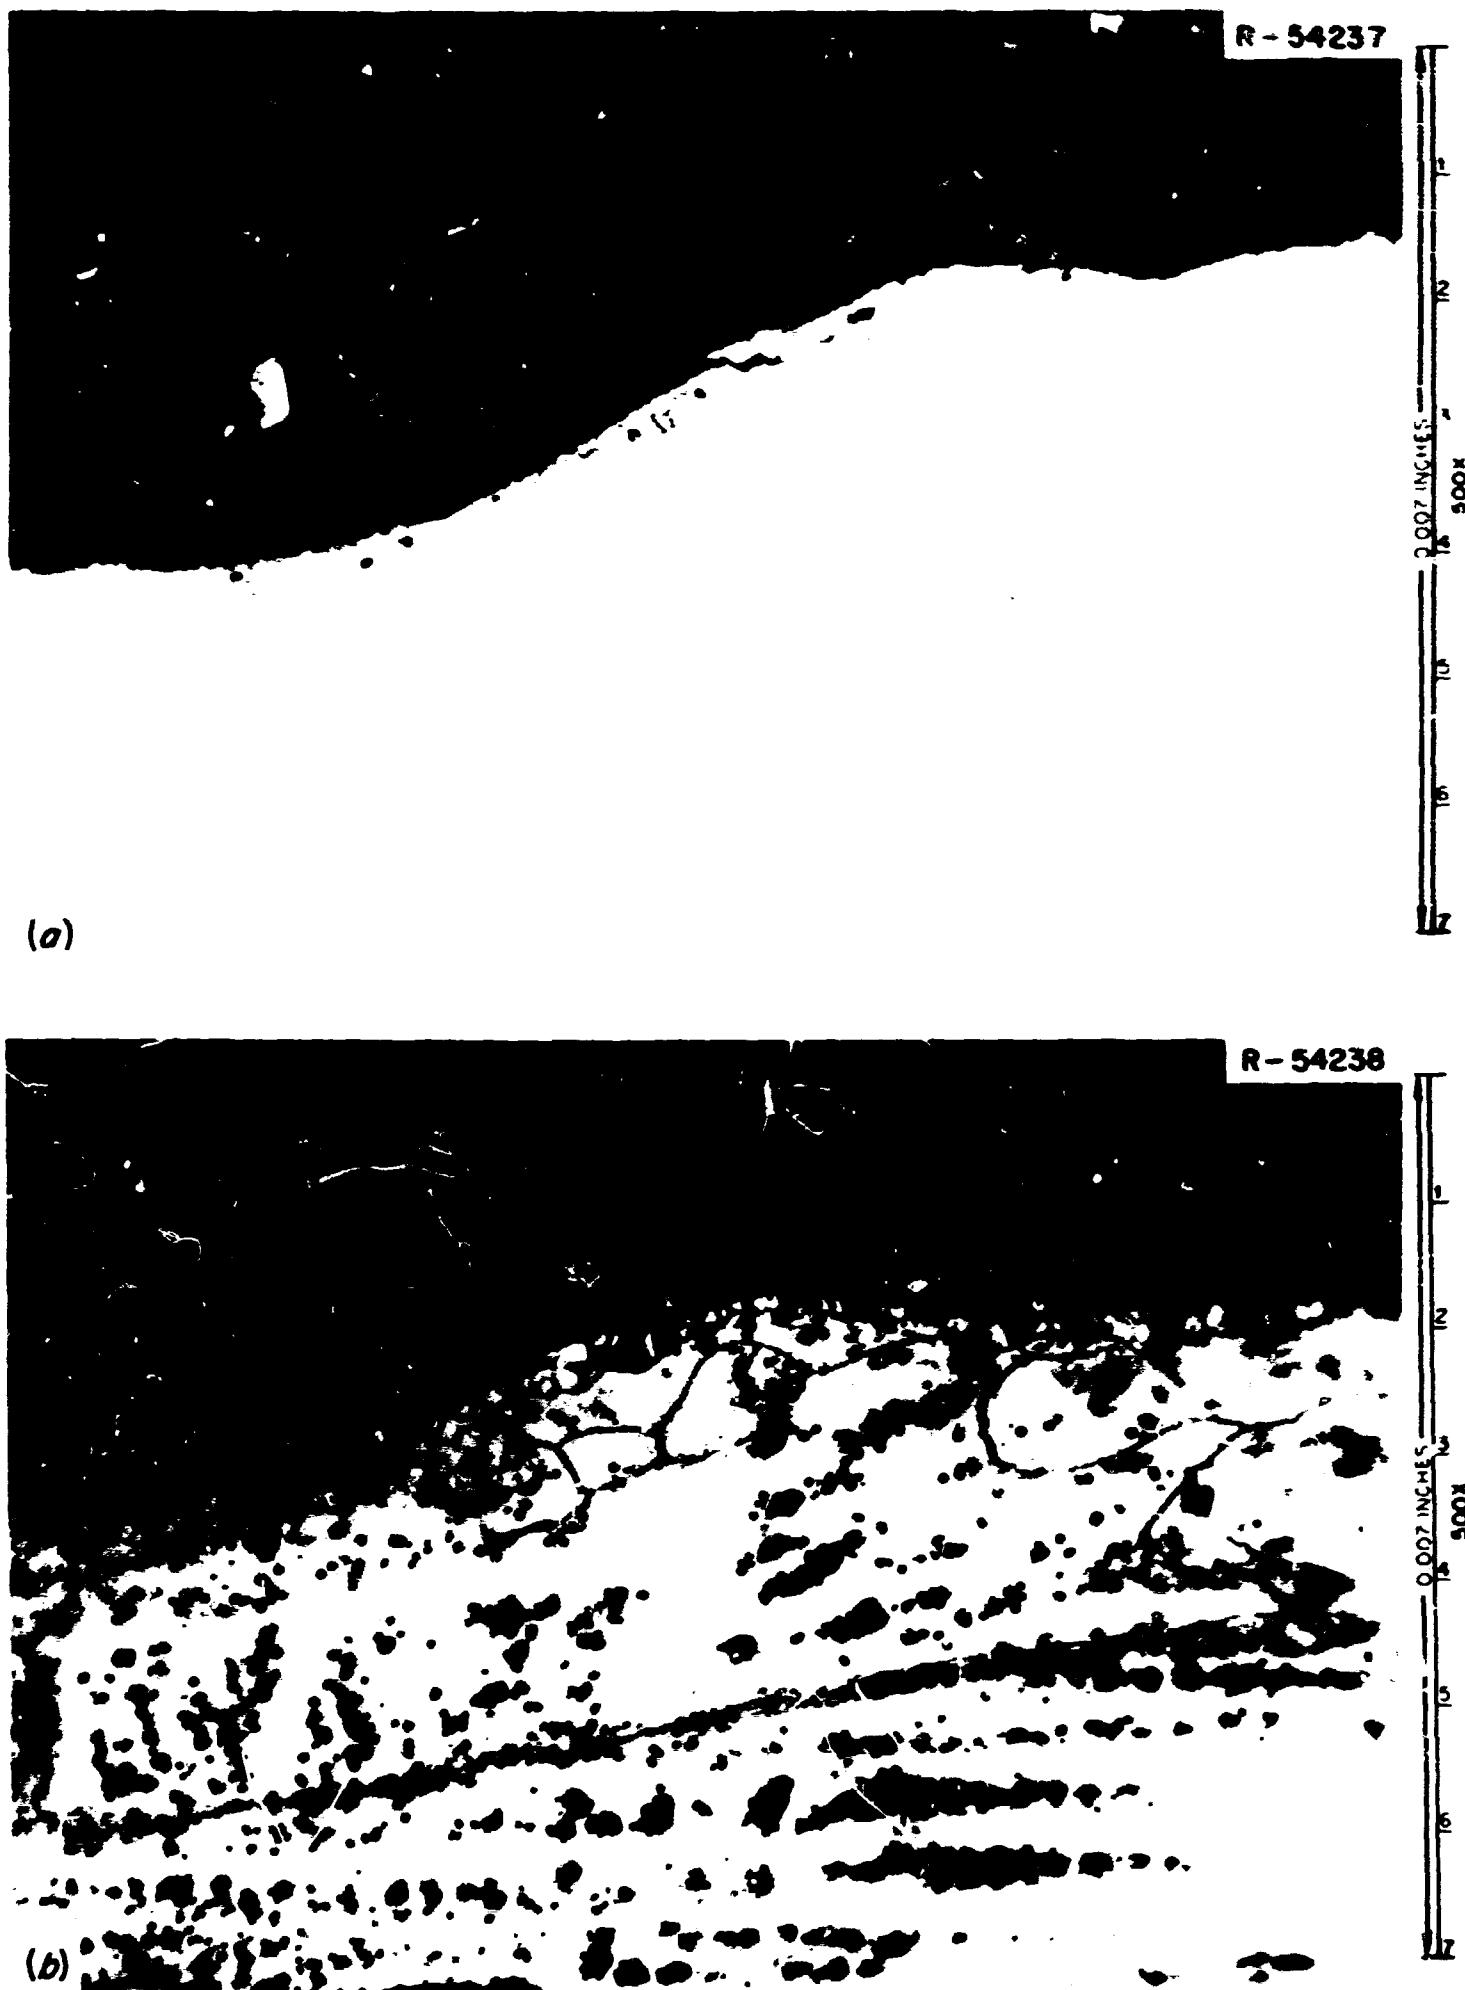
Photomicrographs of one of the weld beads are shown in Fig. 62. All of the surface shown was exposed to flowing fuel salt. Some dislodged grains are near the surface, and grain boundaries are visible in the as-polished condition to a depth of 1 to 1.5 mils.

Fig. 62. Photomicrographs of Outer Surface of Control Rod Thimble Showing the Weld Deposit Made to Hold the Spacer Sleeve. The weld surface was exposed to flowing salt. (a) As polished. (b) Etched: Aqua regia.

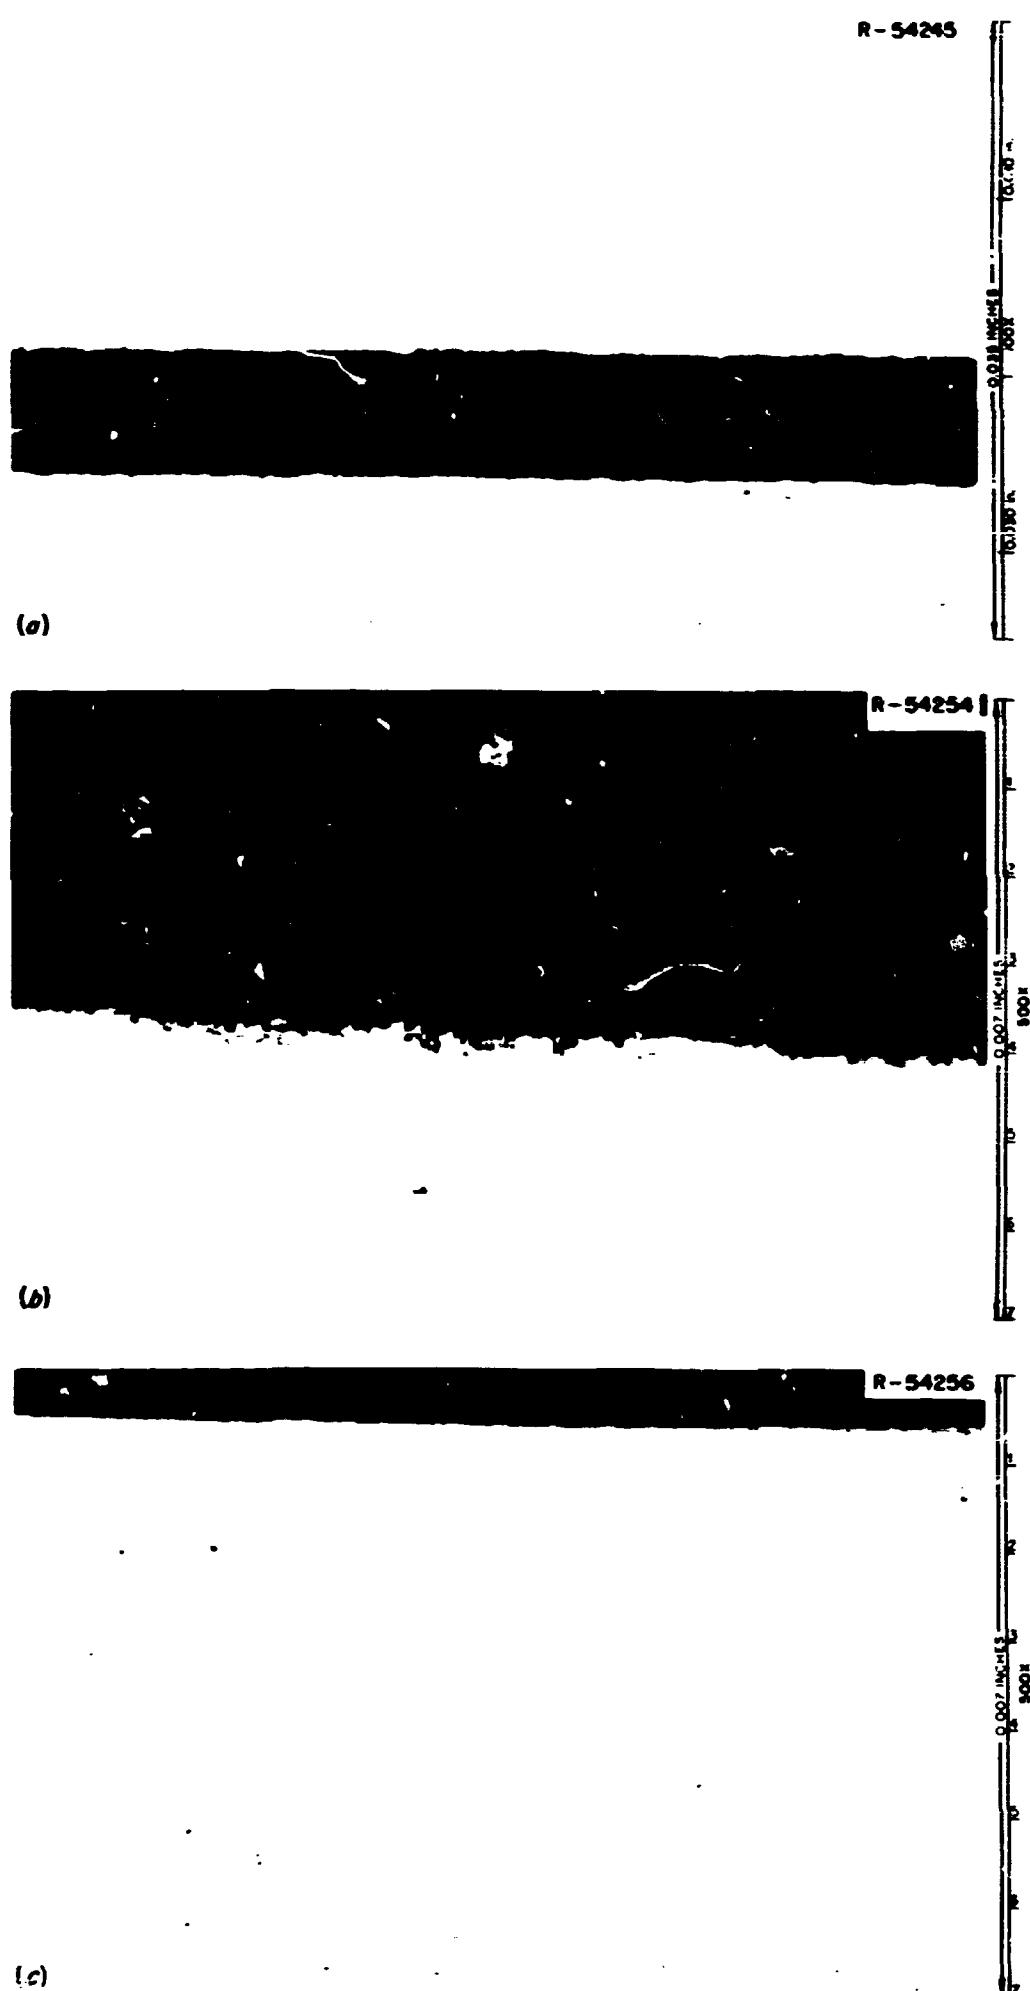
Photomicrographs involving the interface between the thimble and sleeve are shown in Fig. 63. Figure 63(a) shows the annular region with a separation of about 7 mils and some salt present. Few surface irregularities are visible at a magnification of 100 \times , indicating that they are considerably below 1 mil. Figure 63(b) is a 500 \times view of the thimble and shows some surface cracks to a depth of 0.3 mil. The outside of the sleeve is shown in Fig. 63(c); a few grain boundaries to a depth of about 1 mil are visible. Additional photomicrographs of the sleeve are shown in Fig. 64. The sleeve material does not appear to have received much working since the carbide is very inhomogeneously distributed. The grain size is larger than usual away from the stringers. The inner and outer surfaces both have modified structures. A higher magnification view of the inner surface [Fig. 64(b)] shows that much of the modification is a high density of primary carbide. The outer surface [Fig. 64(c)] has a shallow layer of small grains, likely due to a working operation.

Fig. 63. Photomicrographs of As-polished Surfaces of Control Rod Thimble and Sleeve. (a) Annulus between thimble and sleeve. Thimble surface is in upper part of picture. (b) Outside surface of control rod thimble, showing presence of some salt and shallow surface cracking. (c) Outside surface of sleeve. Surface exposed to flowing fuel salt.

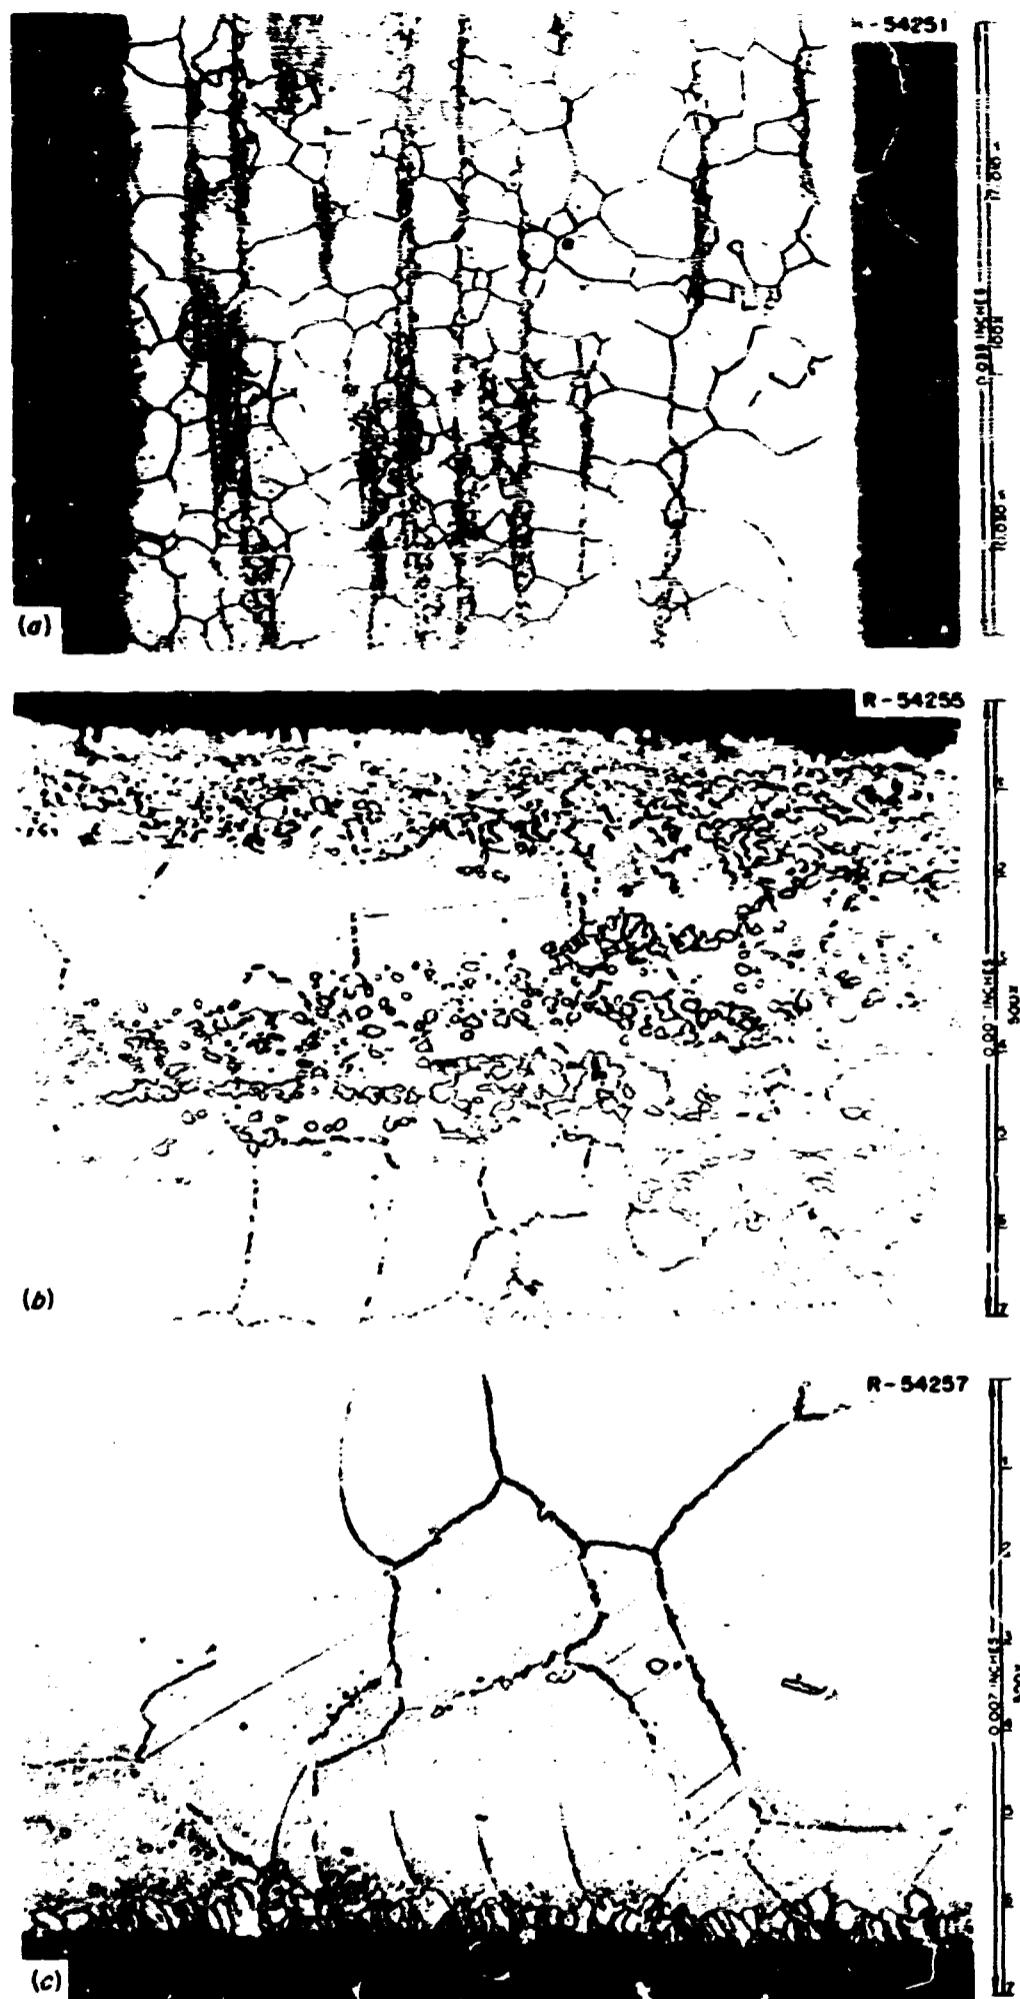
Fig. 64. Photomicrographs of Control Rod Sleeve. (a) Etched view showing general microstructure. Inner surface is on left and outer surface is on right. (b) Inner surface of sleeve. (c) Outer surface of sleeve. Etchant: Aqua regia. Reduced 30.5%
