INTERGRANULAR CRACKING OF INOR-8 IN THE MSRE

H. E. McCoy

B. McNabb

NOVEMBER 1972

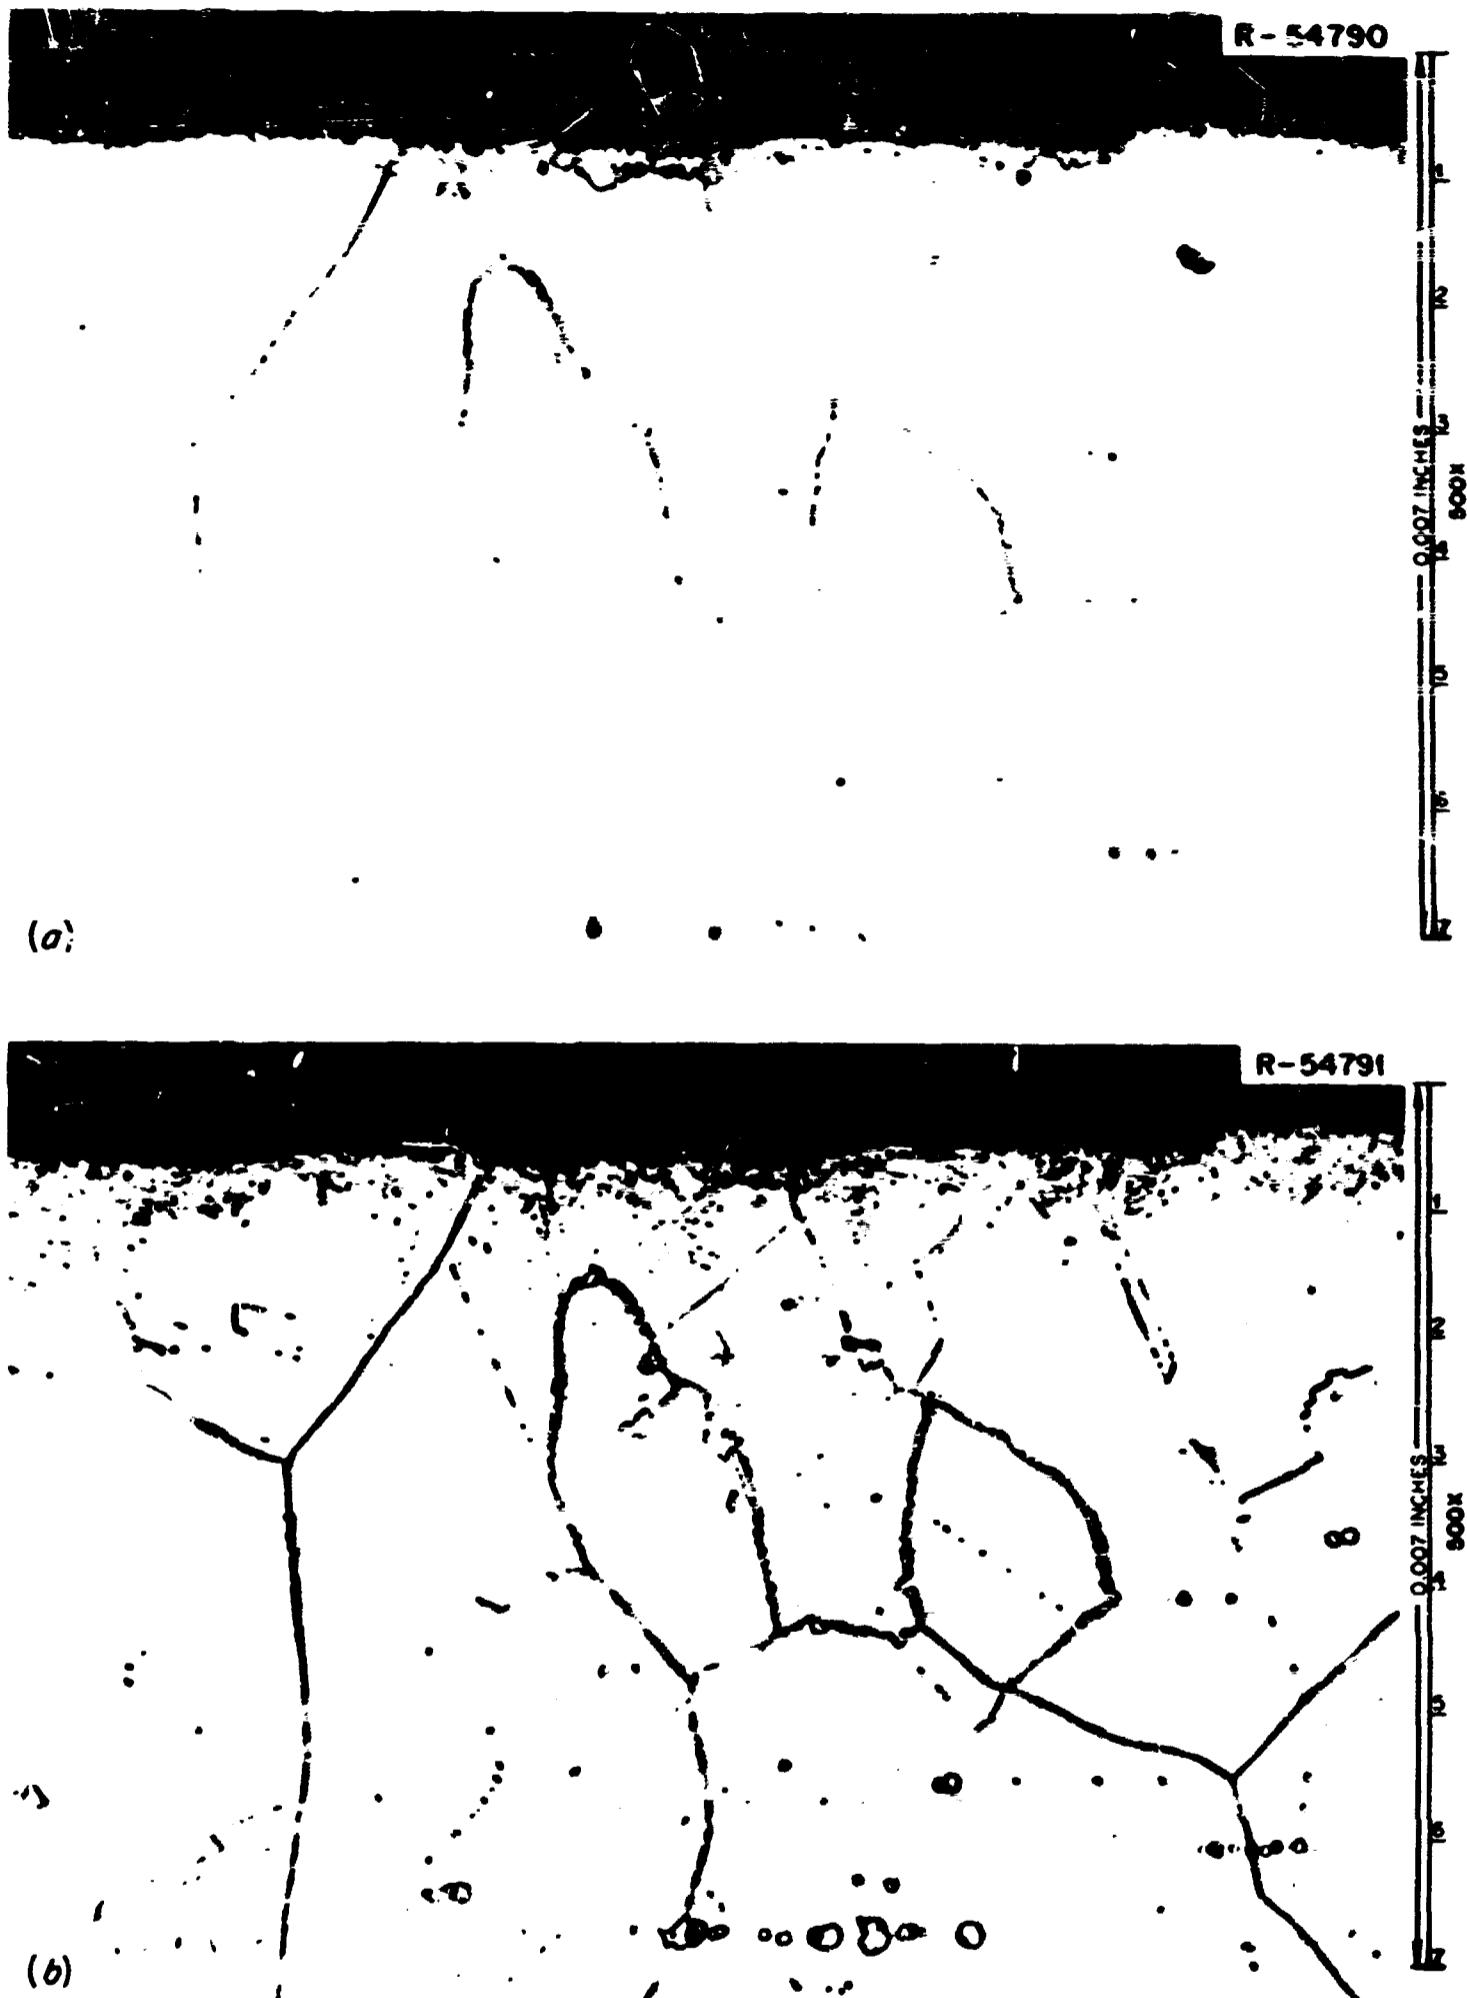
Fig. 65. Photomicrographs of Control Rod Thimble where it was Exposed Directly to Flowing Salt. (a) As polished. (b) Etched: Aqua regia.

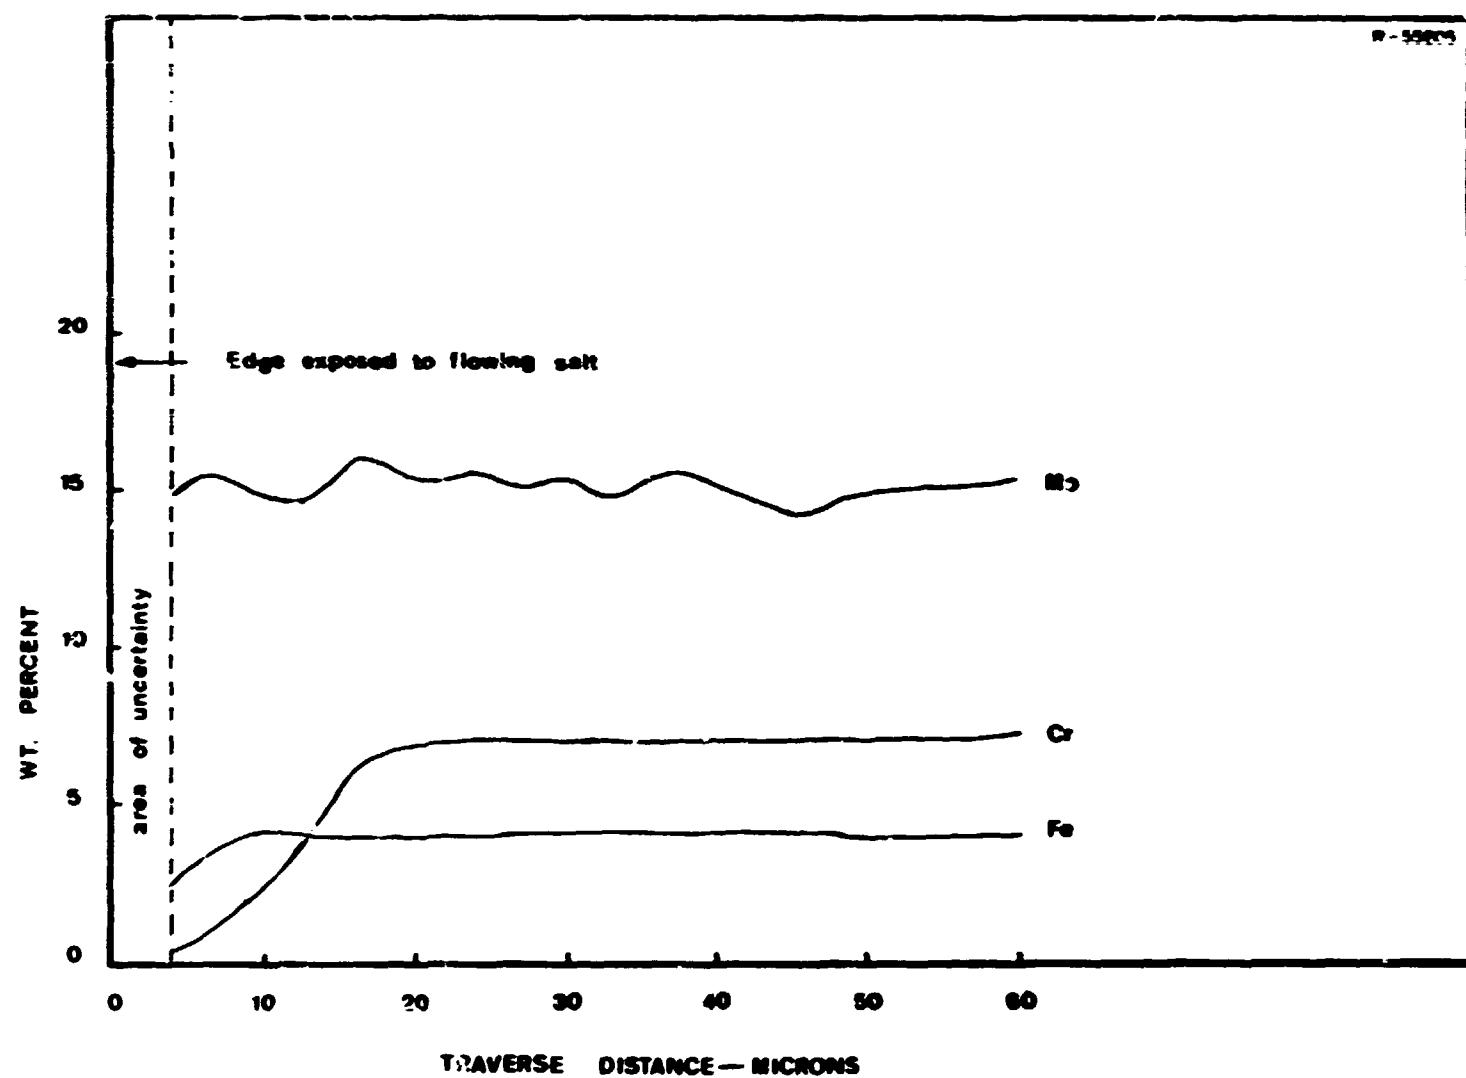
Microprobe scans were run on the thimble samples that were taken from under the sleeve and outside the sleeve. In the first case the thimble wall was exposed to almost static fuel salt, and no gradients in iron and chromium concentration could be detected within the 3- μm region of uncertainty near the surface. The sample outside the sleeve that was exposed to flowing fuel salt was depleted in chromium to a depth of almost 20 μm and in iron to a depth of 10 μm (Fig. 66). Thus the amount of corrosion that occurred varied considerably in the two regions. The measurements were not actually made, but a similar result likely occurred for the spacer sleeve. The inside surface was exposed to almost static salt and was likely not corroded detectably. The outside surface was exposed to flowing salt and likely showed iron and chromium depletion.

Fig. 66. Electron Microprobe Scan of Sample from Control Pd4 Thimble. The thimble had been exposed to the fuel salt for 21,040 hr and had been above 500°C for 30,807 hr.

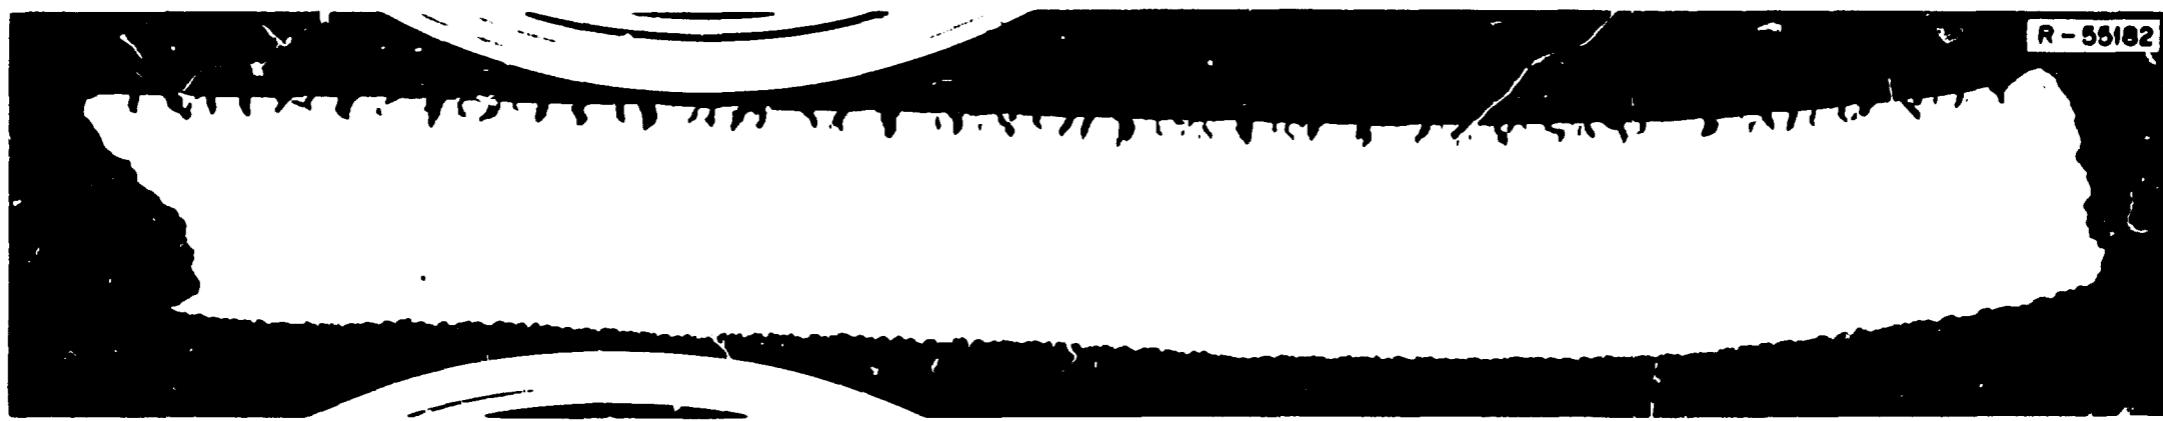
Fig. 69. Photomicrographs of a Deformed Section of the Control Rod Thimble. The fracture is on the left. The upper surface was in contact with flowing salt and the lower surface was exposed to the cell environment of N_2 plus 2 to 5% O_2 . The sample is about 0.06 in. thick.

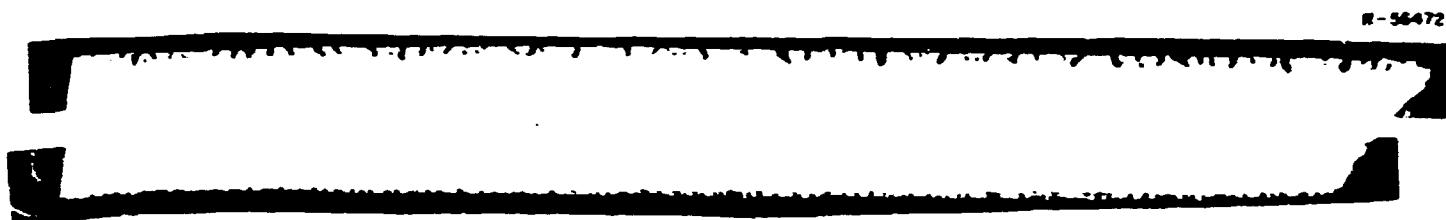
A similar sample was cut from the thimble under the sleeve, where the salt access was restricted. Photomicrographs of a specimen tested at 25°C are shown in Fig. 70. The cracks are quite similar to those in Fig. 68 for a sample that was exposed to flowing salt. The composite photograph in Fig. 71 is quite similar to Fig. 69 of the sample exposed to flowing salt. The sample in Fig. 71 had 257 cracks per inch, with average and maximum depths of 4.0 and 8.0 mils, respectively. The accuracy of our statistics and possible sampling inhomogeneities lead us to conclude that the severity of cracking is equivalent in the samples exposed to flowing and almost static salt. Thus flow rate over the range represented by these two sample locations does not appear to be an important variable.

Fig. 71. Composite Photograph Showing the Density of Cracking Along the Edge of a Portion of the Deformed Control Rod Thimble. 9.5x. The sample is 0.58 in. long. The fracture is on the left, the upper surface was exposed to fuel salt, and the lower surface was exposed to the cell environment of N_2 plus 2 to 5% O_2 .

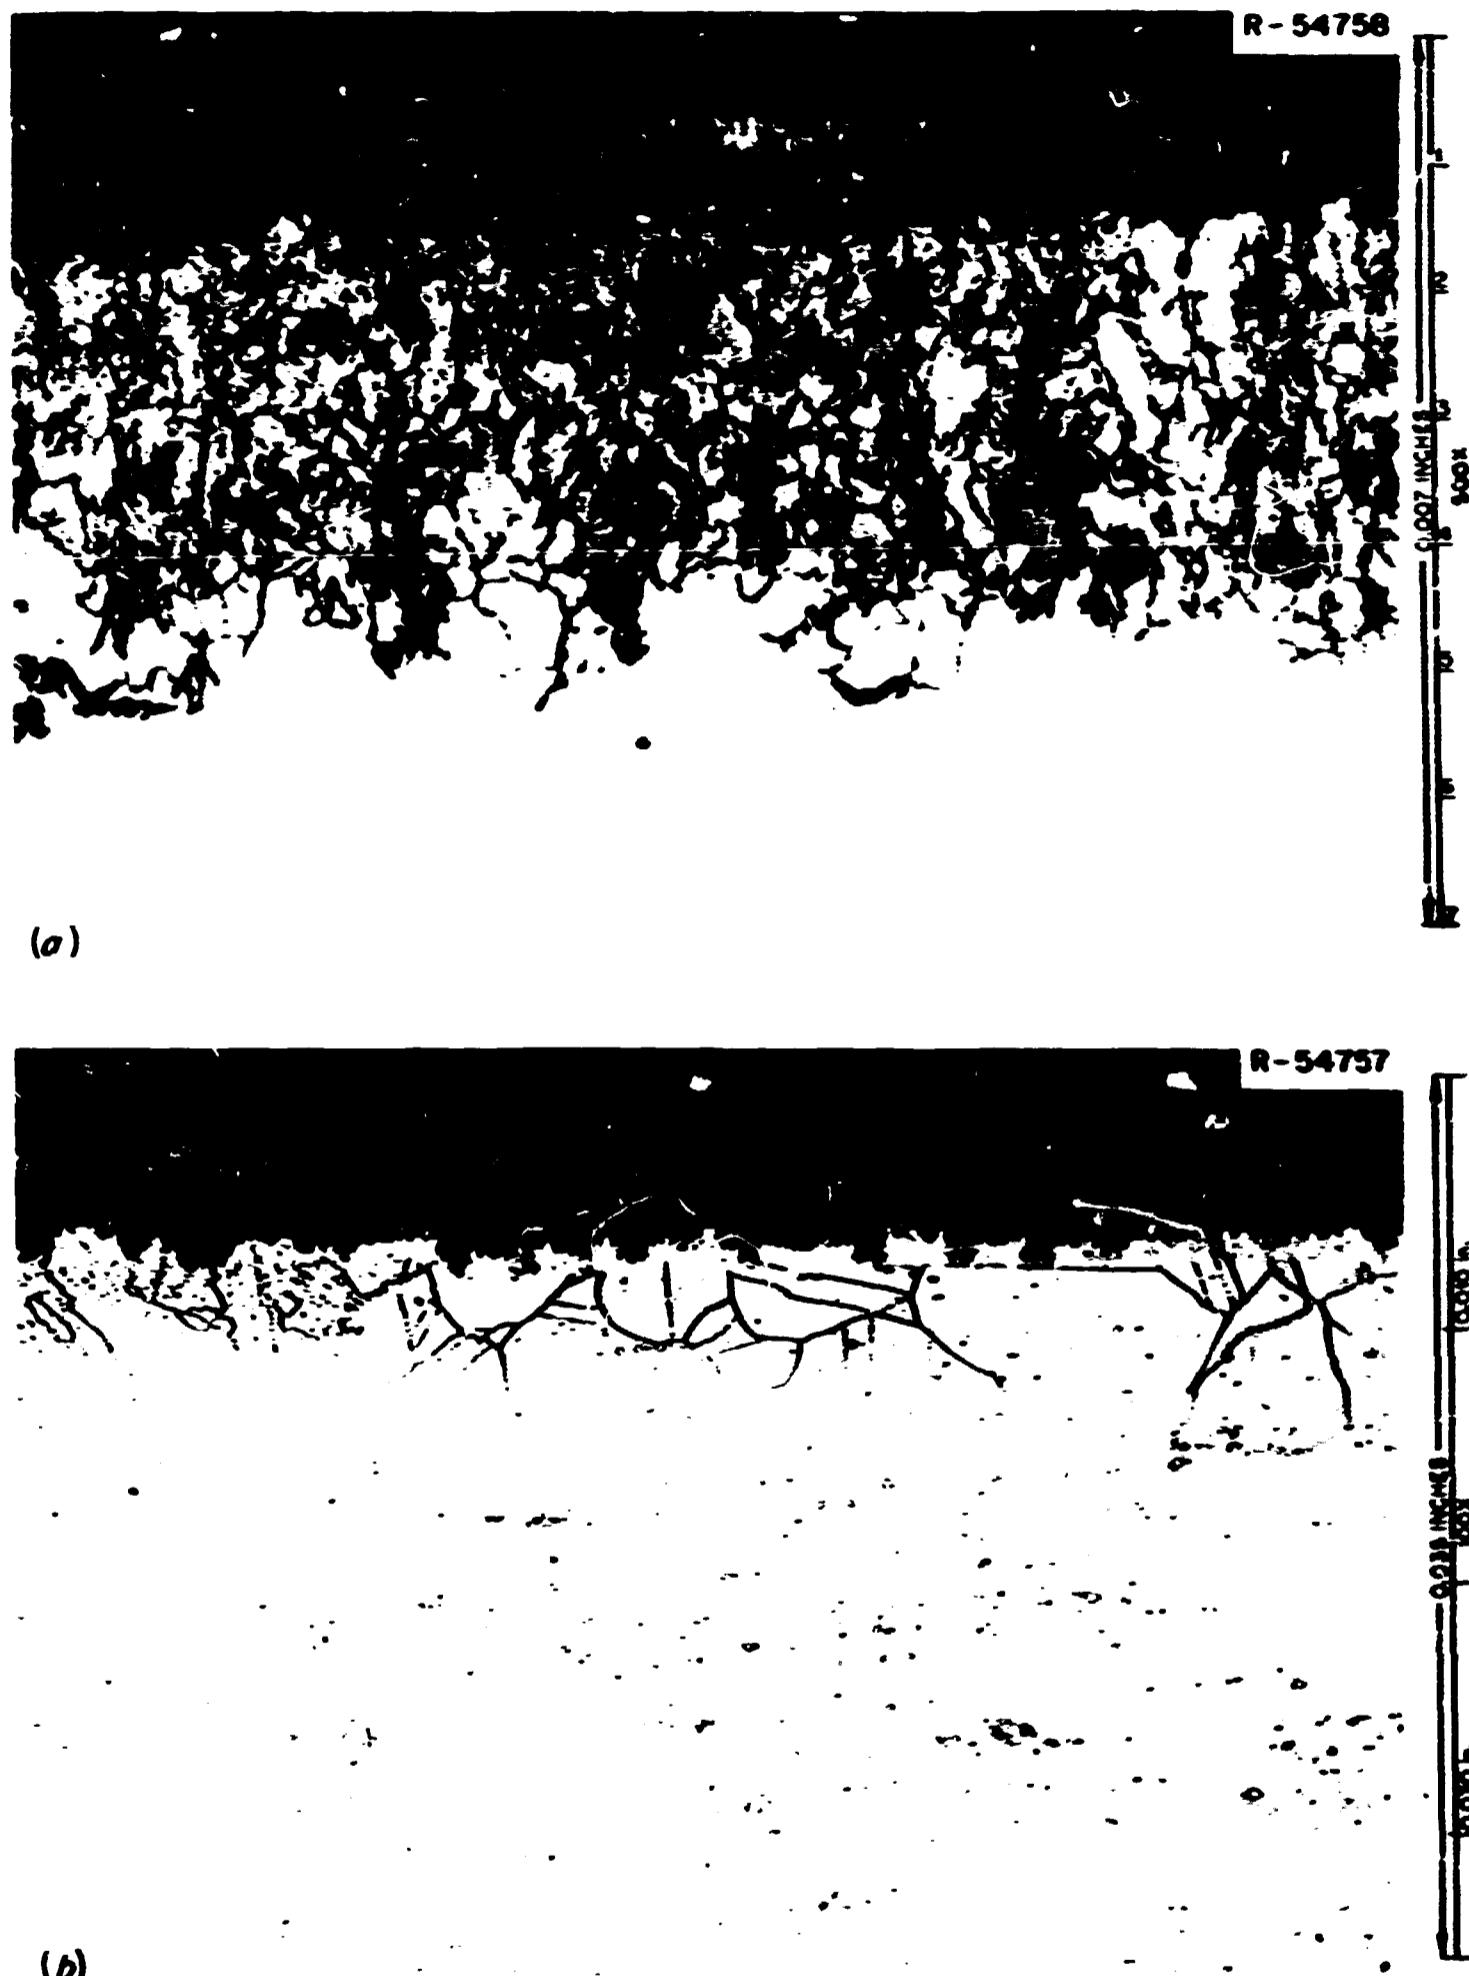
Photomicrographs of a cross section through the outer surface of the shell are shown in Fig. 76. The oxide on the outside surface is typical of that observed on INOR-8 at this temperature and extends to a depth of about 5 mils. Etching attacks the metal in the oxidized layer and etches the grain boundaries near the surface more rapidly than those in the interior. The inside surface of the shell (Fig. 77) shows some structural modifications to a depth of about 1 mil. No samples of the shell were deformed.

Fig. 76. Photomicrographs Showing the Outside Edge of the Primary Heat Exchanger Shell. This surface was exposed to 2 to 5% O₂ in N₂. (a) As polished, showing the selective oxidation that occurred. (b) Etched view showing that the metal in the oxidized layer was completely removed. Etched with aqua regia.

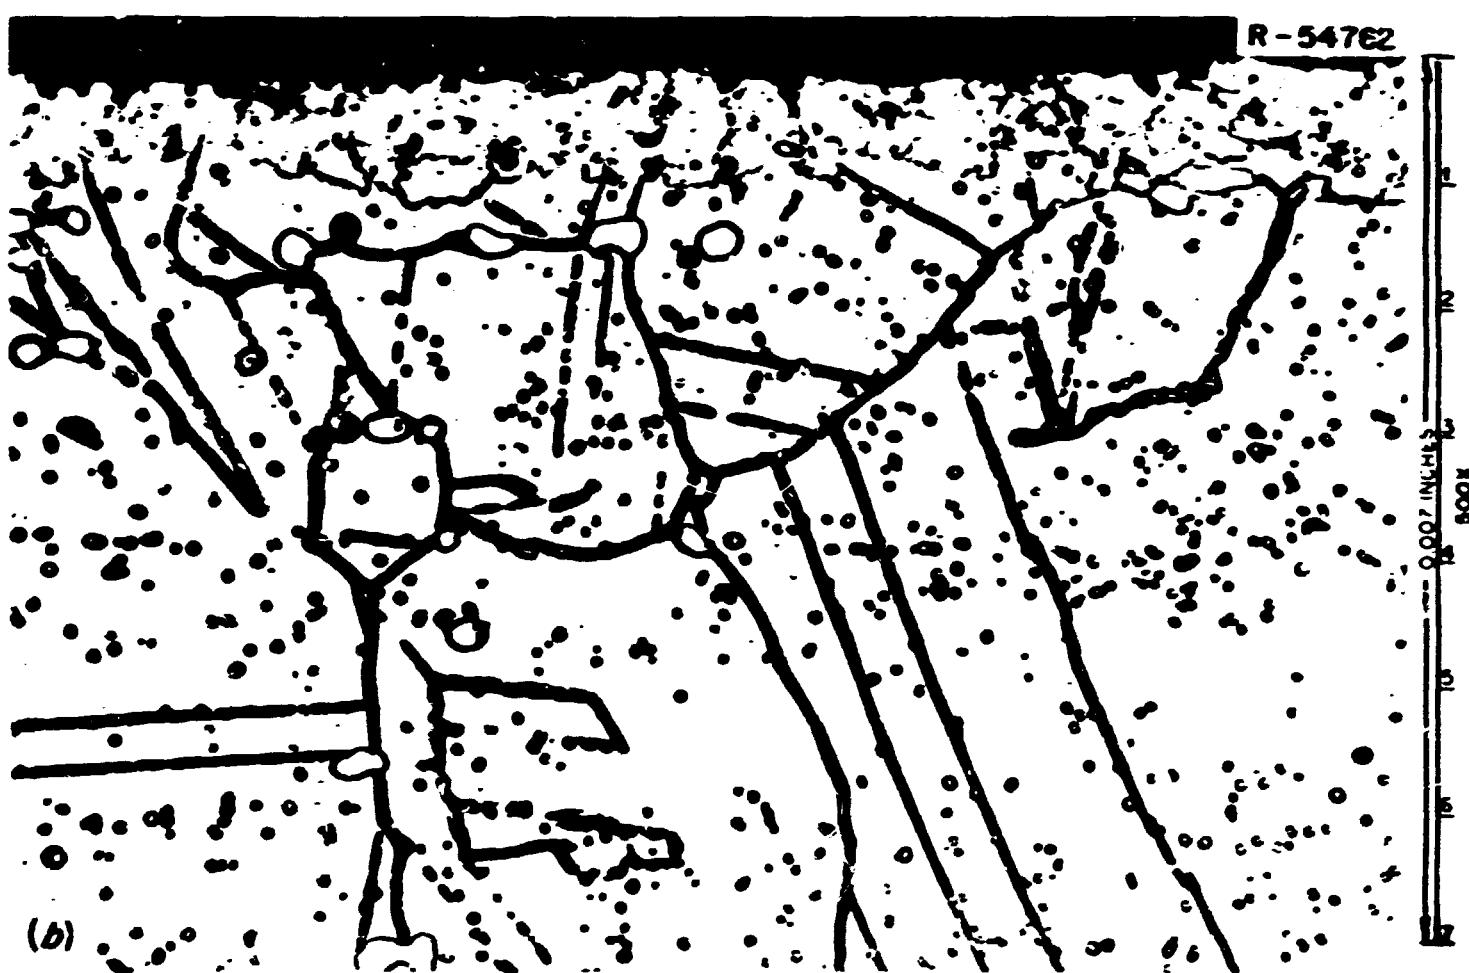
Fig. 77. Photomicrographs of the Inside Surface of the Primary Heat Exchanger Shell. The surface was exposed to fuel salt, and the modified structure to a depth of about 1 mil is apparent. (a) As polished. (b) Etched with aqua regia.

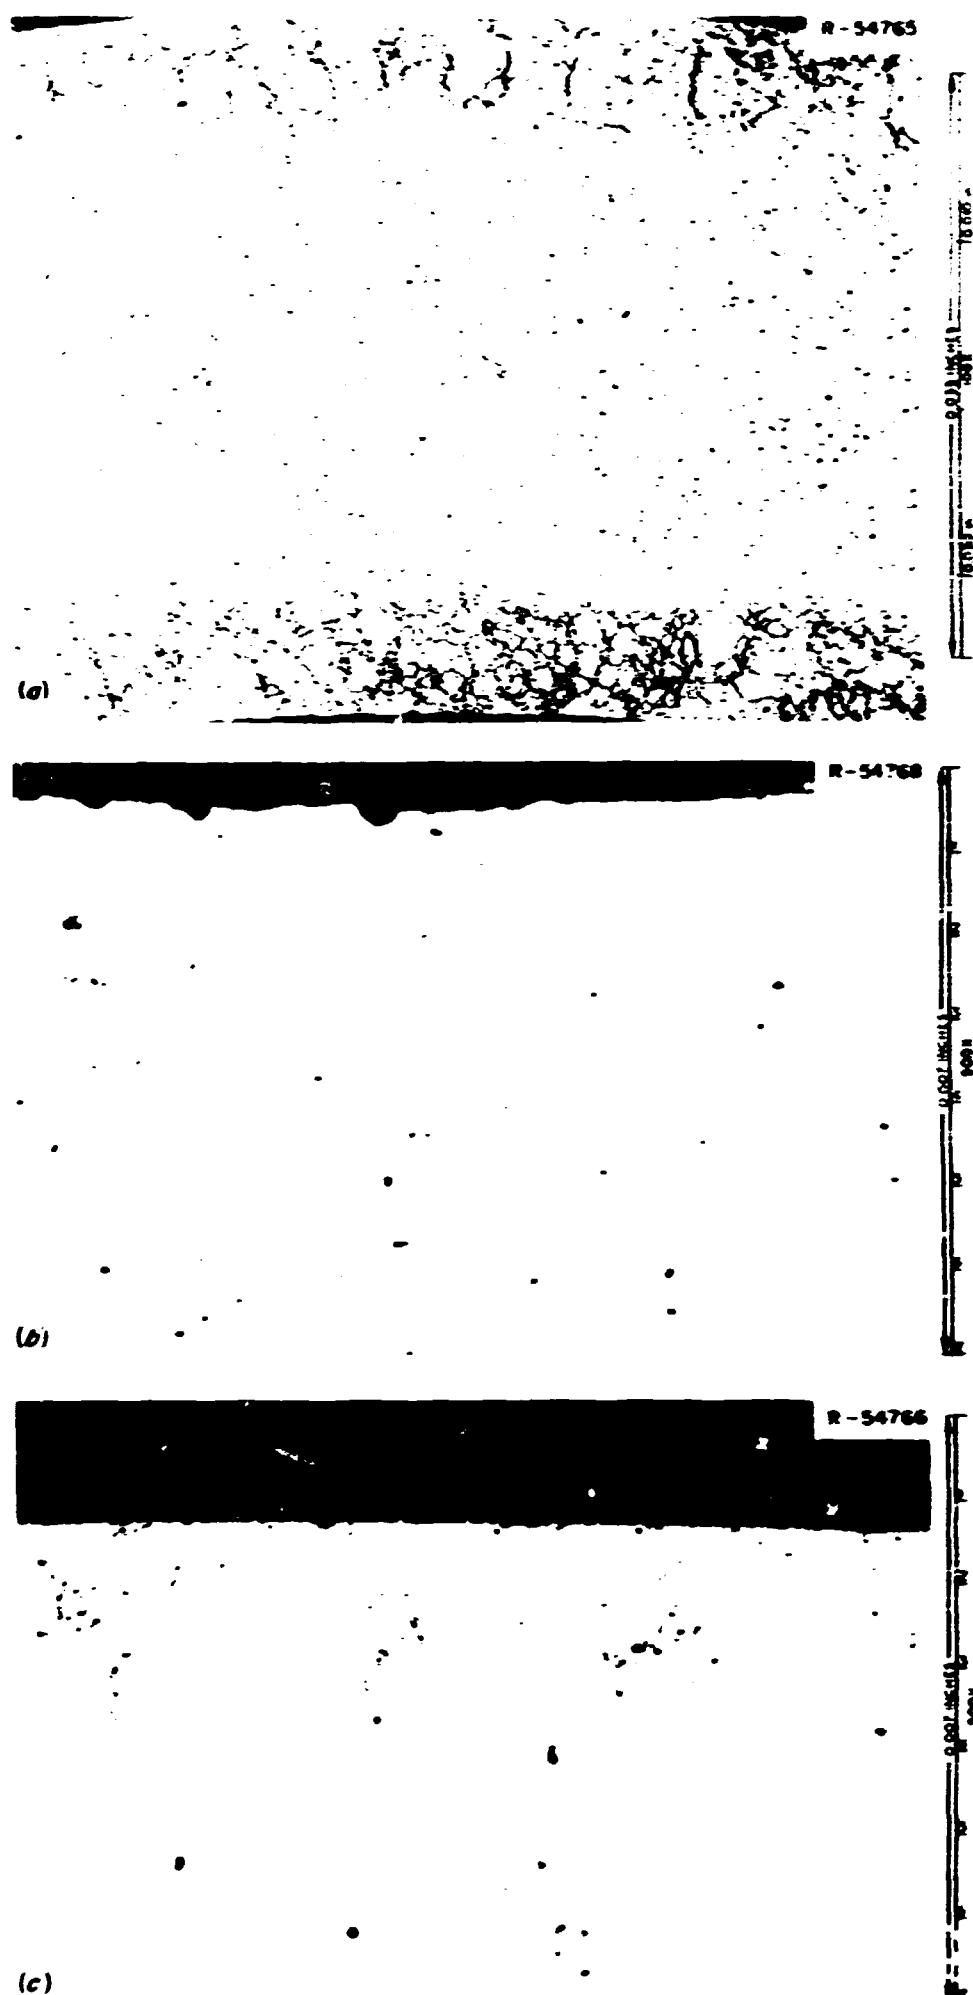
Fig. 78. Photomicrographs of a Cross Section of an INOR-8 Heat Exchanger Tube. (a) Etched with glyceria regia. (b) Inside surface in the as-polished condition after exposure to coolant salt. (c) Outside surface in the as-polished condition after exposure to fuel salt. Reduced 34%.

Similar photomicrographs of a longitudinal section of tubing are shown in Fig. 79. The features are quite similar to those discussed for Fig. 78. Both figures show some metallic deposits on the outside surface, which was exposed to fuel salt. These deposits are extremely small and could not be analyzed with much accuracy with the in-cell microprobe. However, they seemed to be predominately iron. Scanning across the tubing detected no concentration gradients of the major alloying elements in INOR-8.

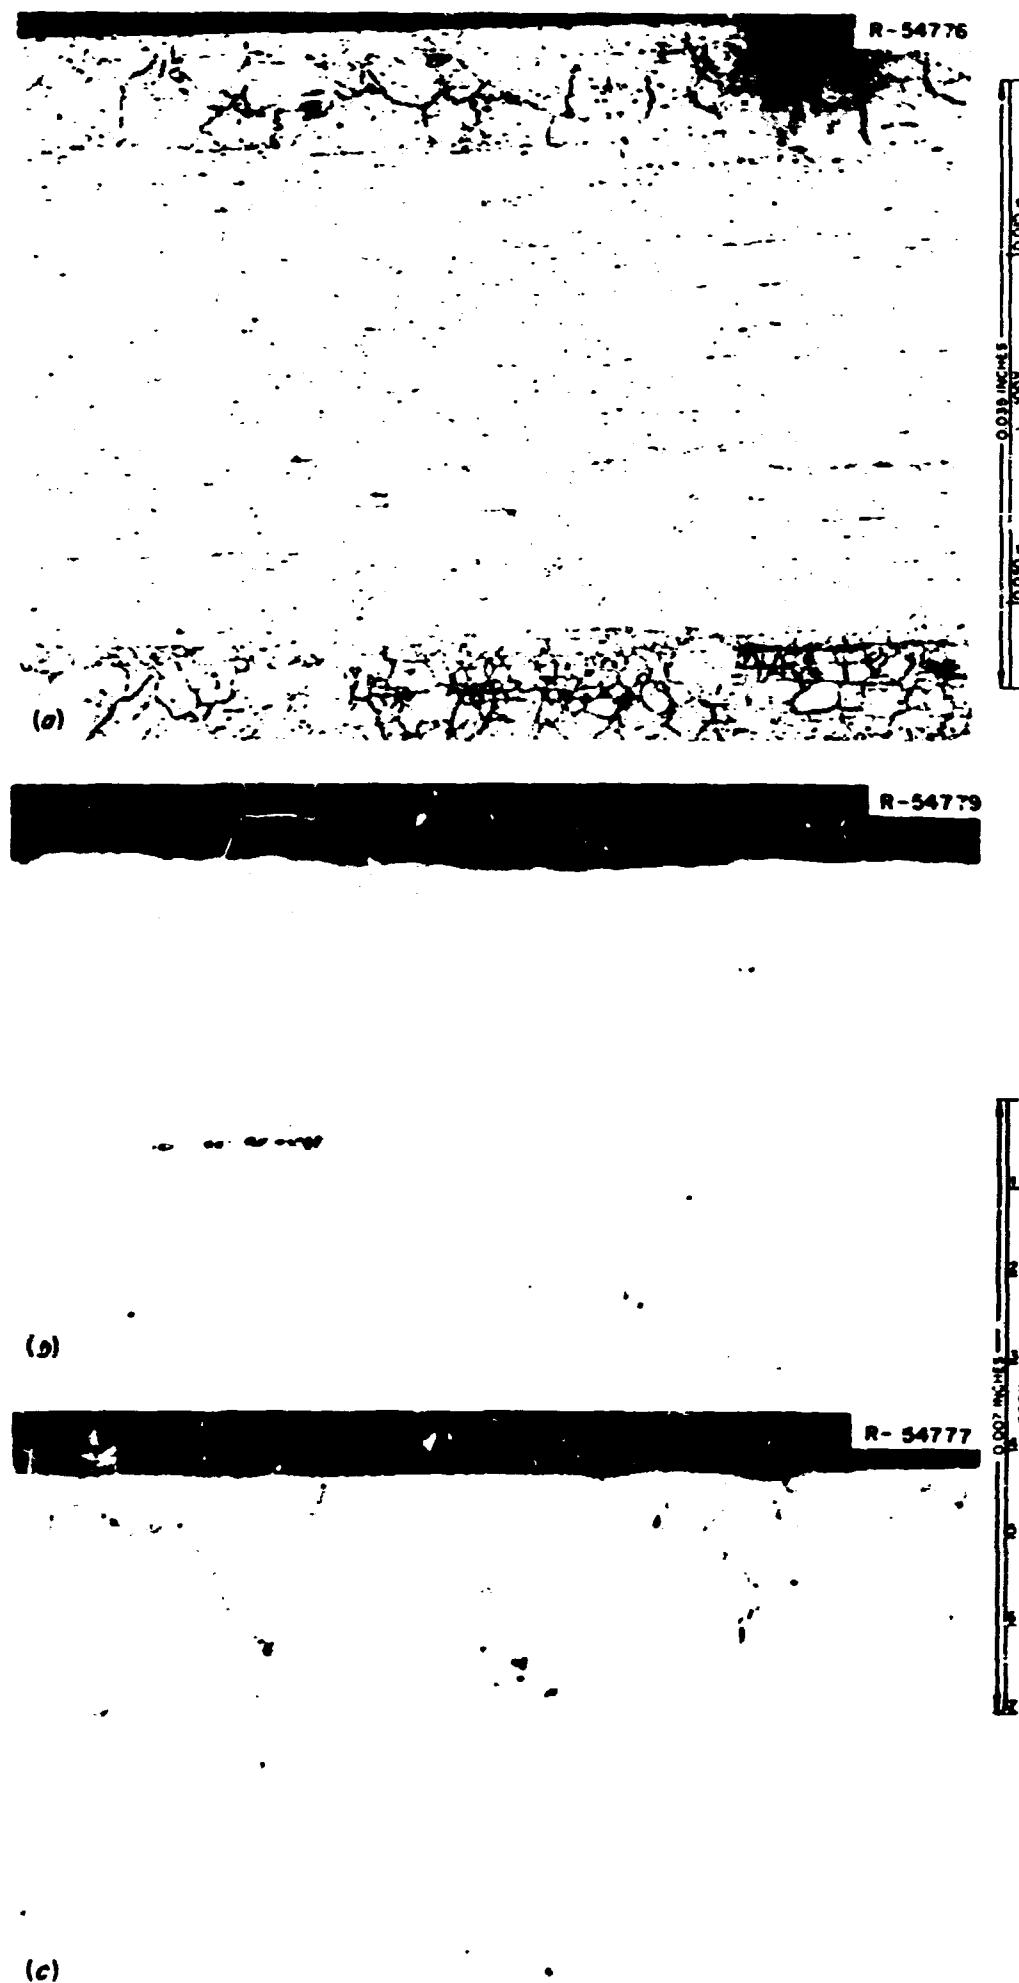
Fig. 79. Photomicrographs of a Longitudinal Section of an INOR-8 Heat Exchanger Tube. (a) Etched with glyceria regia. (b) Inside surface in the as-polished condition after exposure to coolant salt. (c) Outside surface in the as-polished condition after exposure to fuel salt. Reduced 31%.

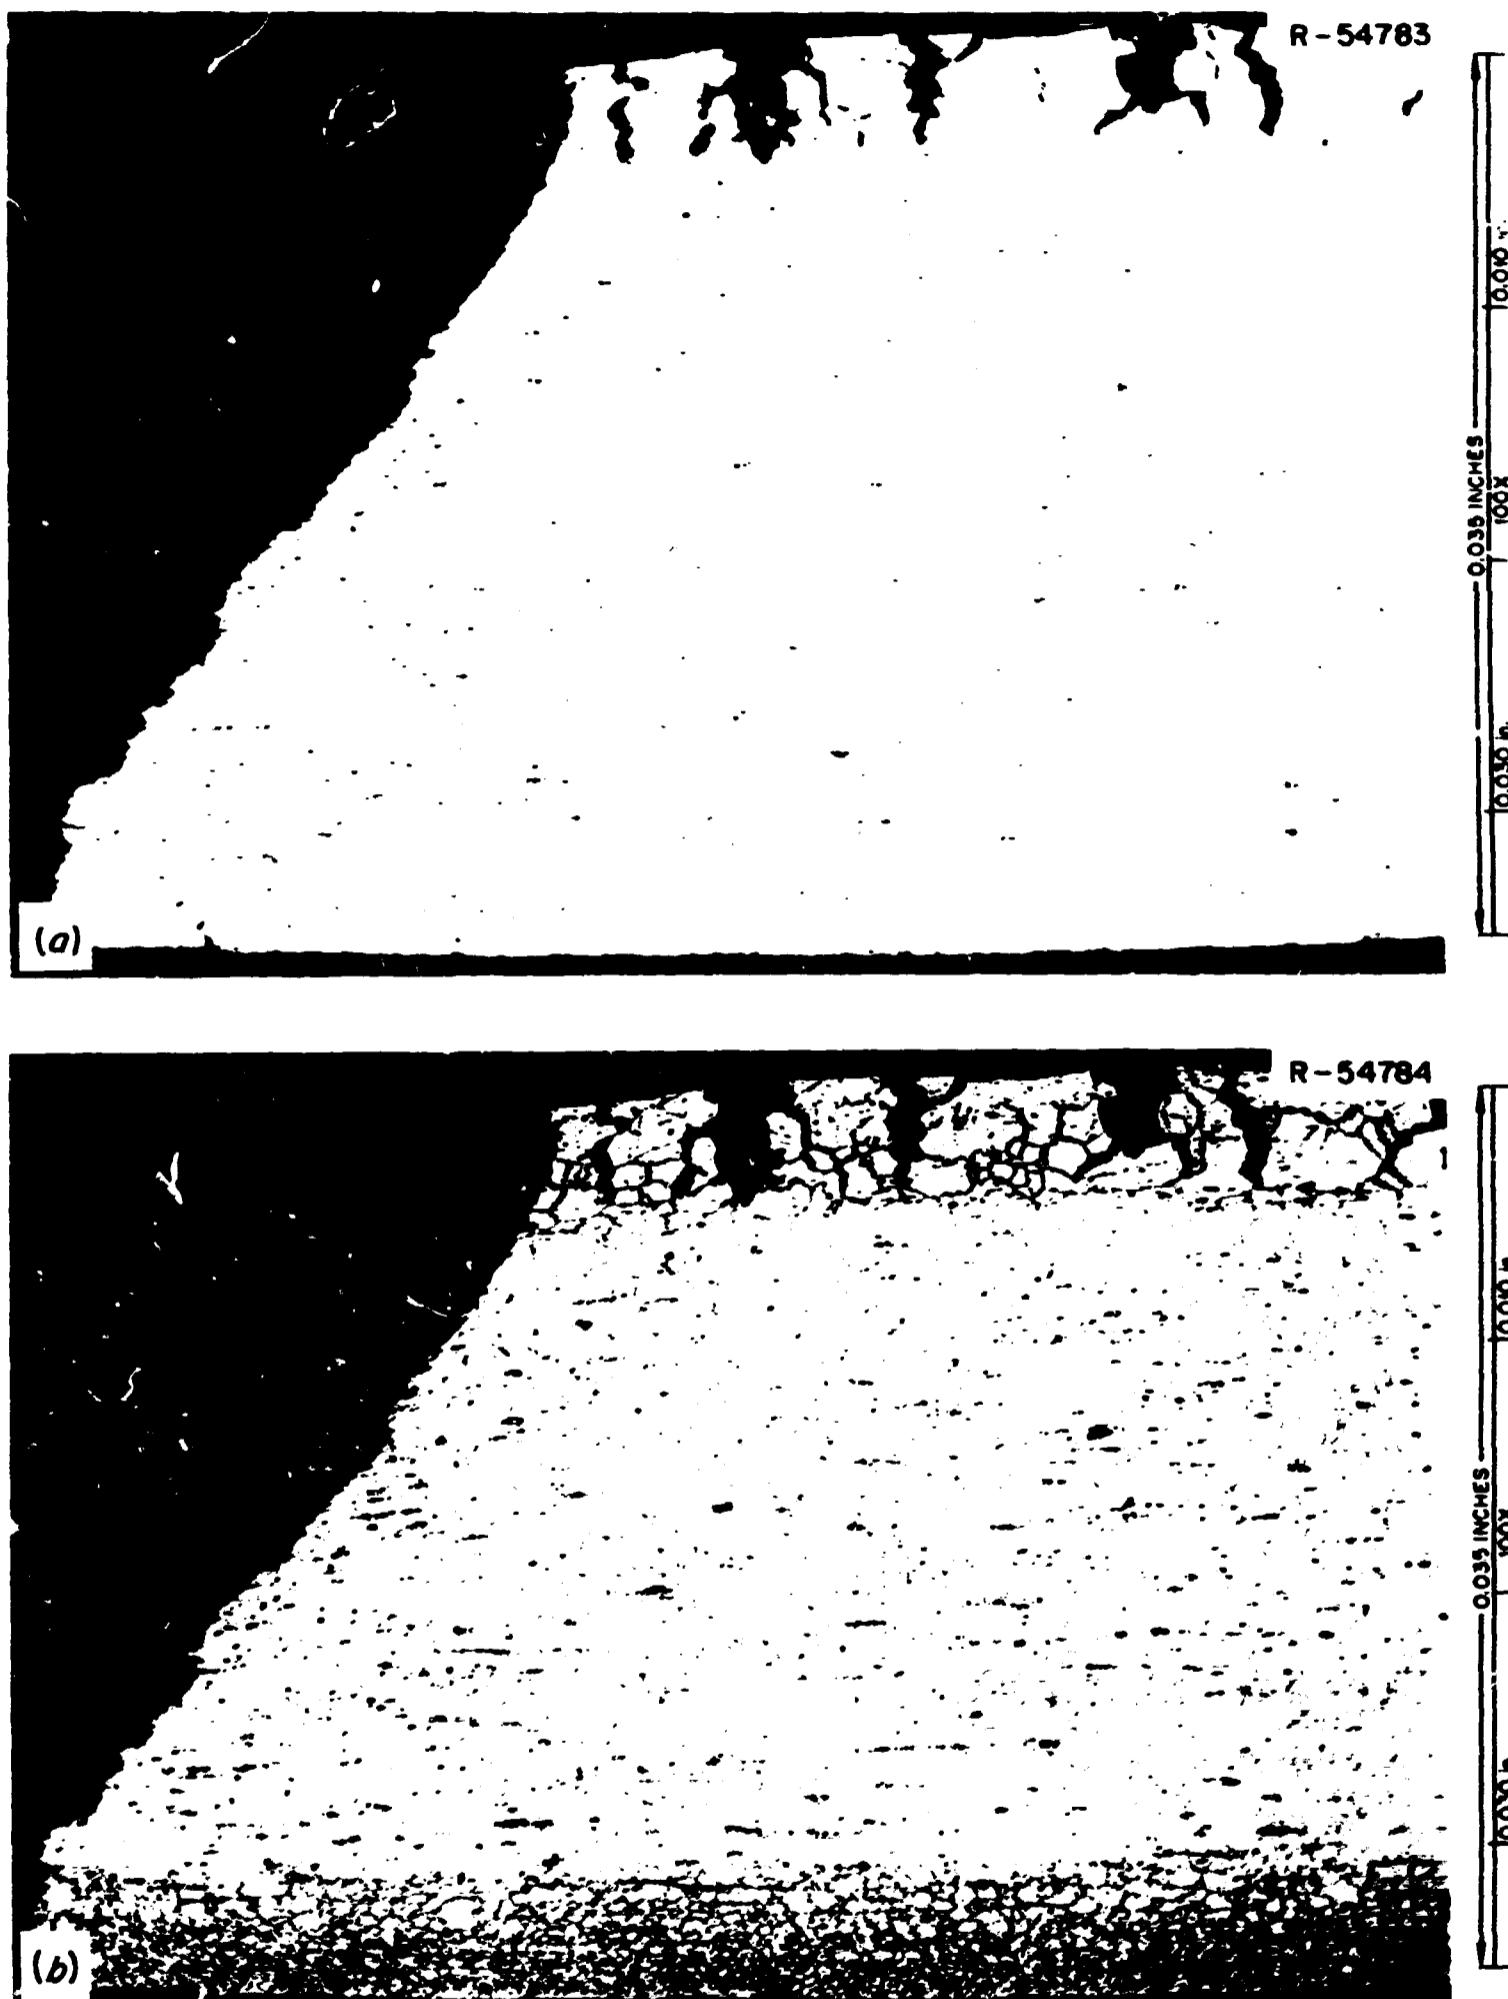
Photomicrographs of one of the tubes deformed at 25°C are shown in Fig. 30. Profuse intergranular cracks were formed to a depth of about 5 mils on the side exposed to fuel salt, but none were formed on the coolant salt side. Etching again revealed the abnormal etching characteristics near the surface, but whatever caused this etching characteristic did not result in grain boundary embrittlement.

Fig. 80. Photomicrographs of a Heat Exchanger Tube Deformed to Fracture at 25°C. (a) As polished. (b) Etched with aqua regia.

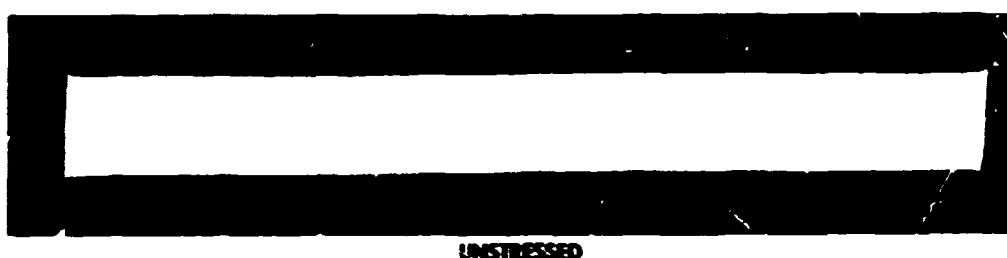
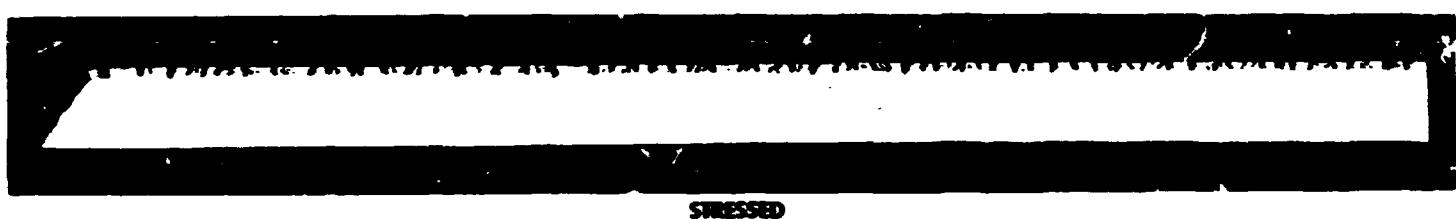
numbers and depths. A composite photograph of the two samples is shown in Fig. 81. The cracks are readily visible in the stressed sample but may not be apparent in the unstressed sample. A higher magnification print used in making the composite is shown in Fig. 82; the cracks can be more easily seen. The stressed sample had 262 cracks per inch with an average depth of 5.0 mils. Two counts were made on the unstressed sample. In the first count only those features that unequivocally were cracks were counted. This gave a crack count of 228 per inch with an average depth of 2.5 mils. In another count, we included some features that were possibly cracks and this gave a crack frequency of 308 per inch. Thus the number of cracks present before straining was about equivalent to that noted after straining. Straining did increase the visible depth. Some indirect evidence that the cracks were present initially and only spread open further during the tensile test was obtained from examination of the sample in Fig. 81. The sample length shown deformed 39% (Table 9), and the combined widths of the cracks account for 35% strain. Thus, the cracks widths very closely account for the total strain and indicate that the cracks formed with little or no deformation and spread open as the sample was deformed.

Fig. 81. Composite Photographs of Heat Exchanger Tubing Before and After Stressing. The width of the unstressed sample is 0.042 in.

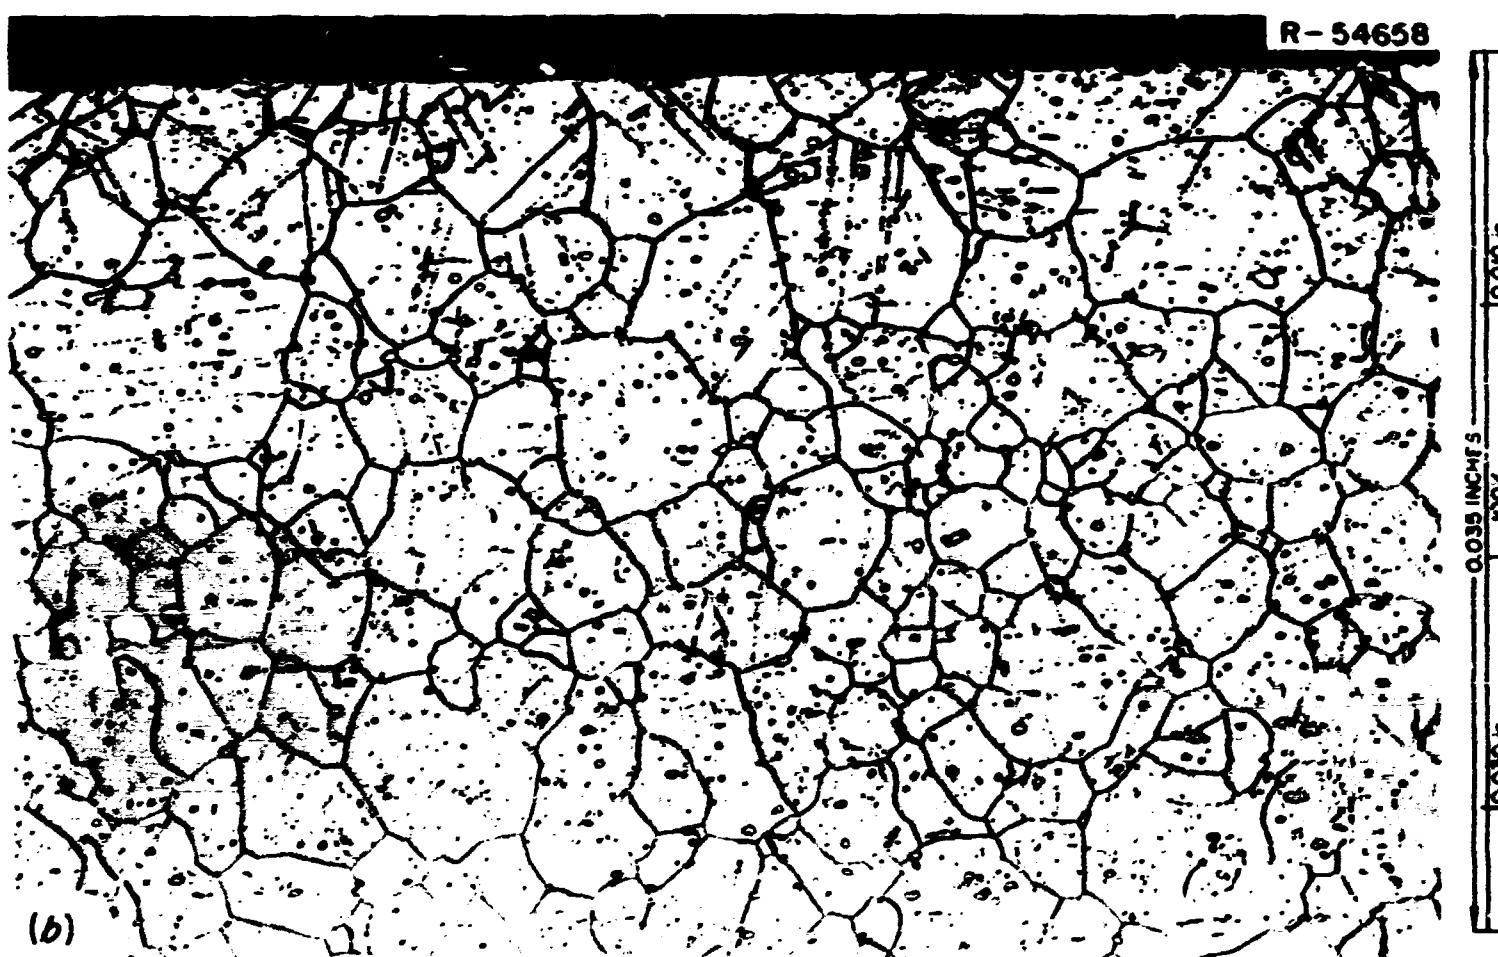
One of the sampler cage rods was examined metallographically. Photomicrographs of samples from the vapor and liquid regions are shown in Fig. 85 and 86, respectively. There is no intergranular penetration visible at this magnification. A heavy surface deposit is on the sample from the liquid region. This deposit was not examined by the electron microprobe analyzer, but a similar deposit on a copper capsule taken from

Fig. 85. Photomicrographs of an INOR-8 Rod from the Sampler Assembly Located Above the Normal Salt Level. (a) As-polished. (b) Etched with aqua regia.
