INTERGRANULAR CRACKING OF INOR-8 IN THE MSRE

H. E. McCoy

B. McNabb

NOVEMBER 1972

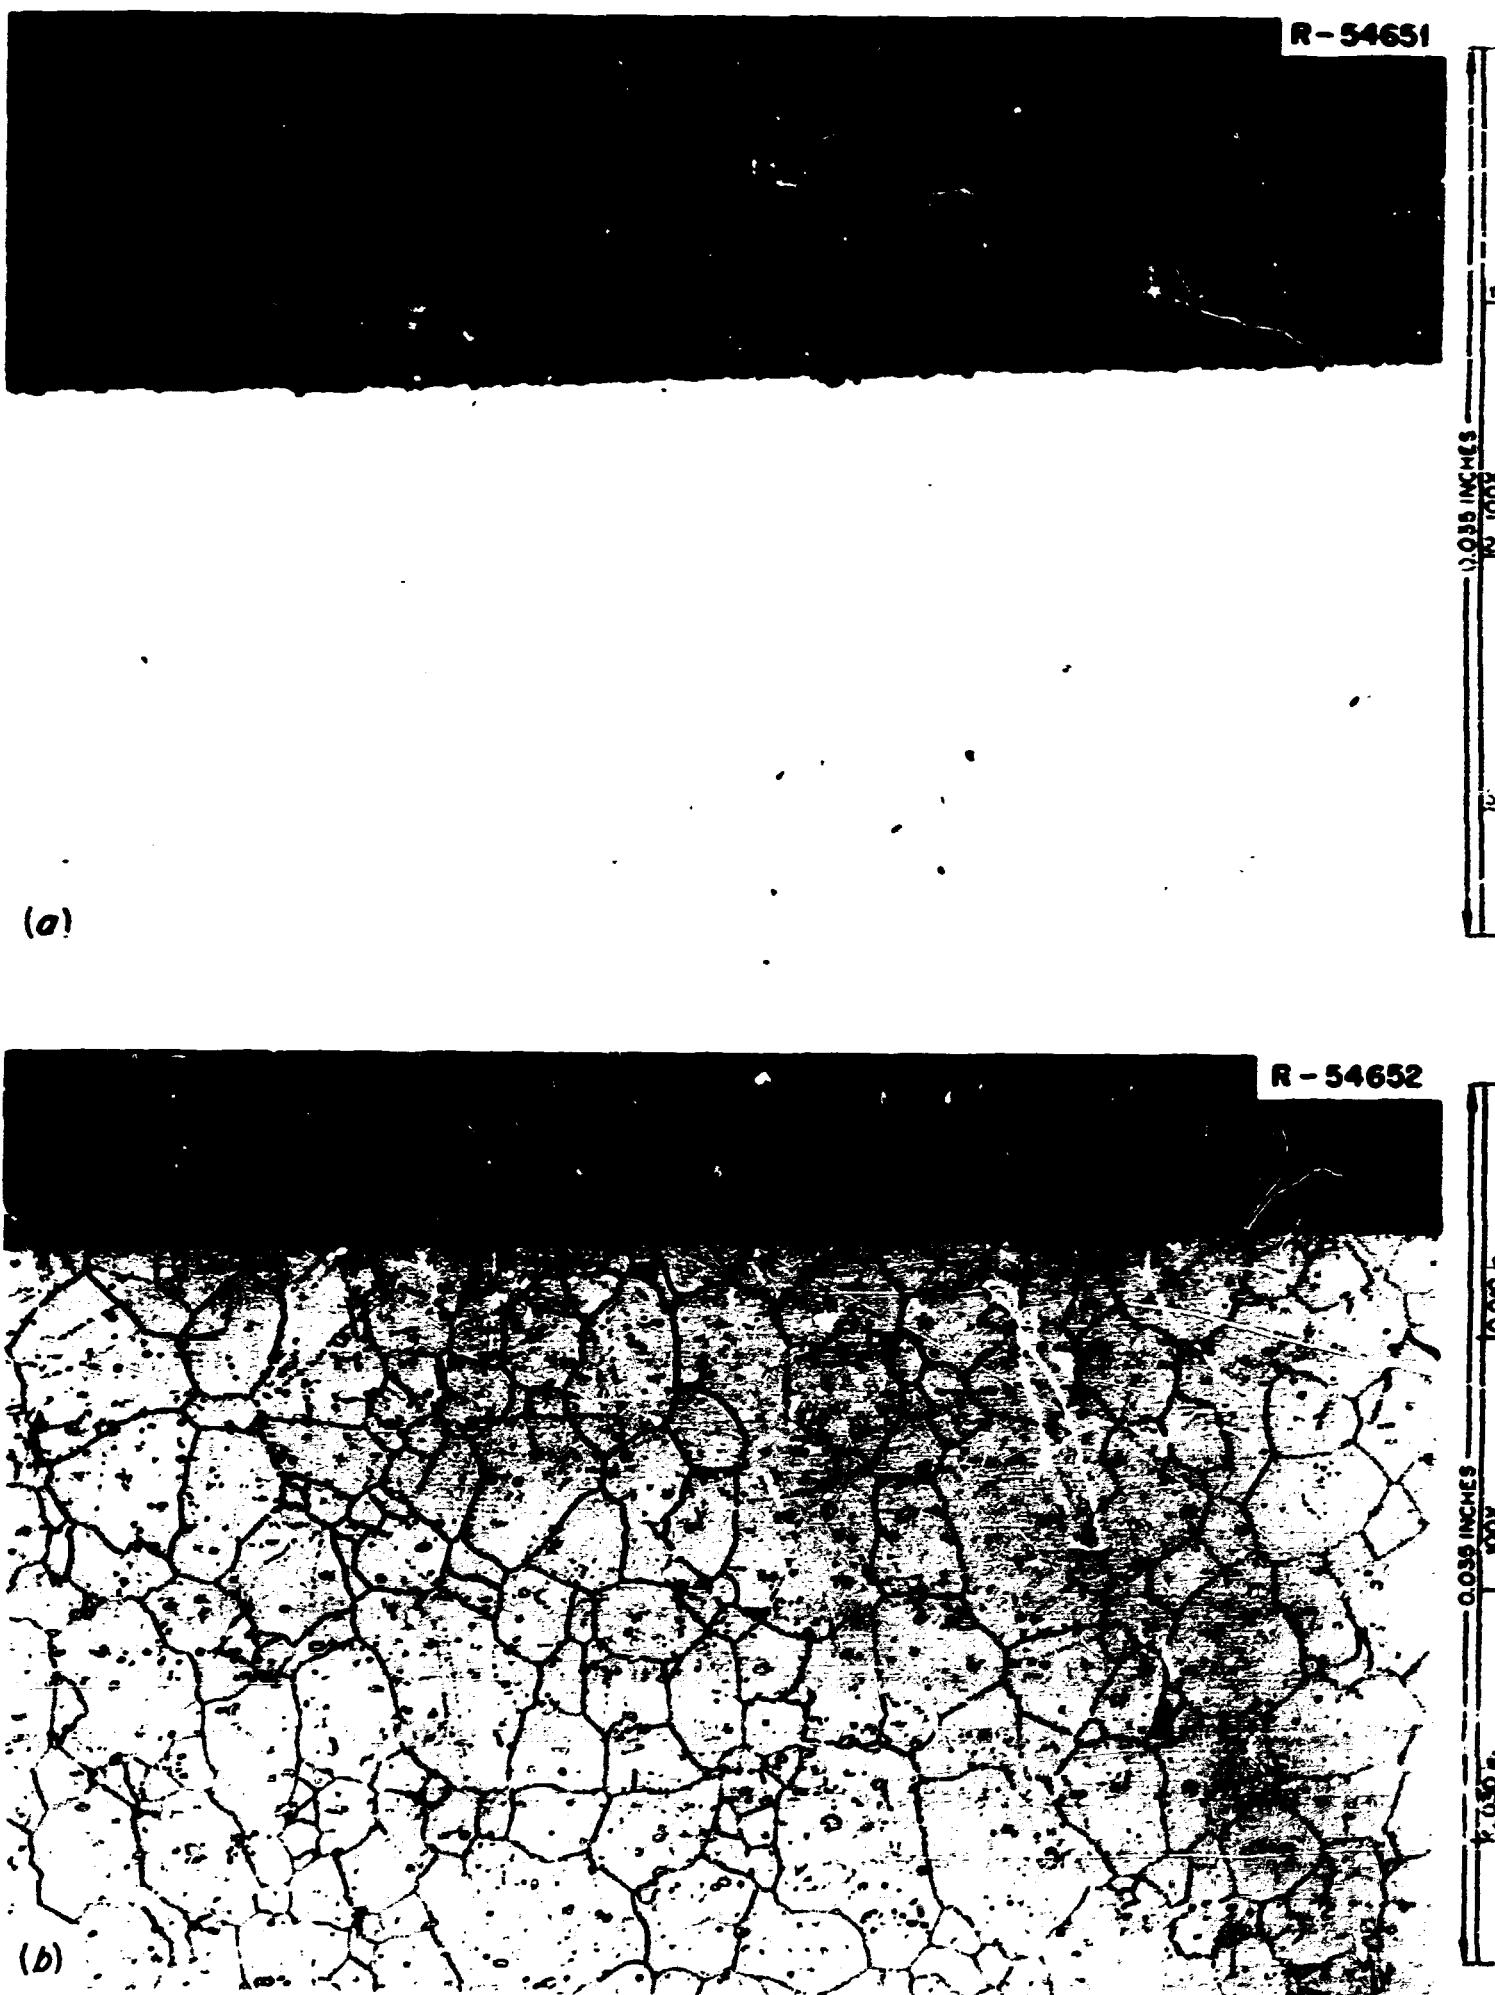
One of the sampler cage rods was examined metallographically. Photomicrographs of samples from the vapor and liquid regions are shown in Fig. 85 and 86, respectively. There is no intergranular penetration visible at this magnification. A heavy surface deposit is on the sample from the liquid region. This deposit was not examined by the electron microprobe analyzer, but a similar deposit on a copper capsule taken from

Fig. 86. Photomicrographs of an INOR-8 rod from the Sampler Assembly. Normally located below the salt level. (a) As polished. (b) Etched with aqua regia.

the sampler region was examined. The deposit contained some salt, but had regions that were high in the alloying elements in INOR-6: Ni, Cr, Fe, and Mo.

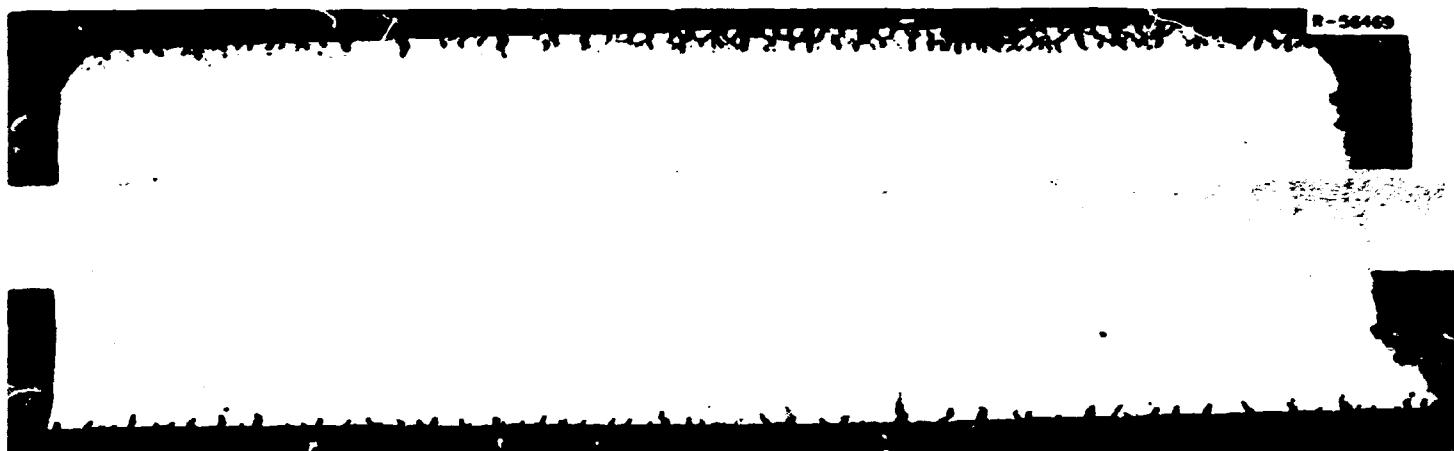
Fig. 88. Section of Sample Cage Rod that was Deformed at 25°C. 9.2x. The fracture (left) occurred at the salt-vapor interface. The rod is immersed further in the liquid from left to right. The length of the sample is 0.63 in.

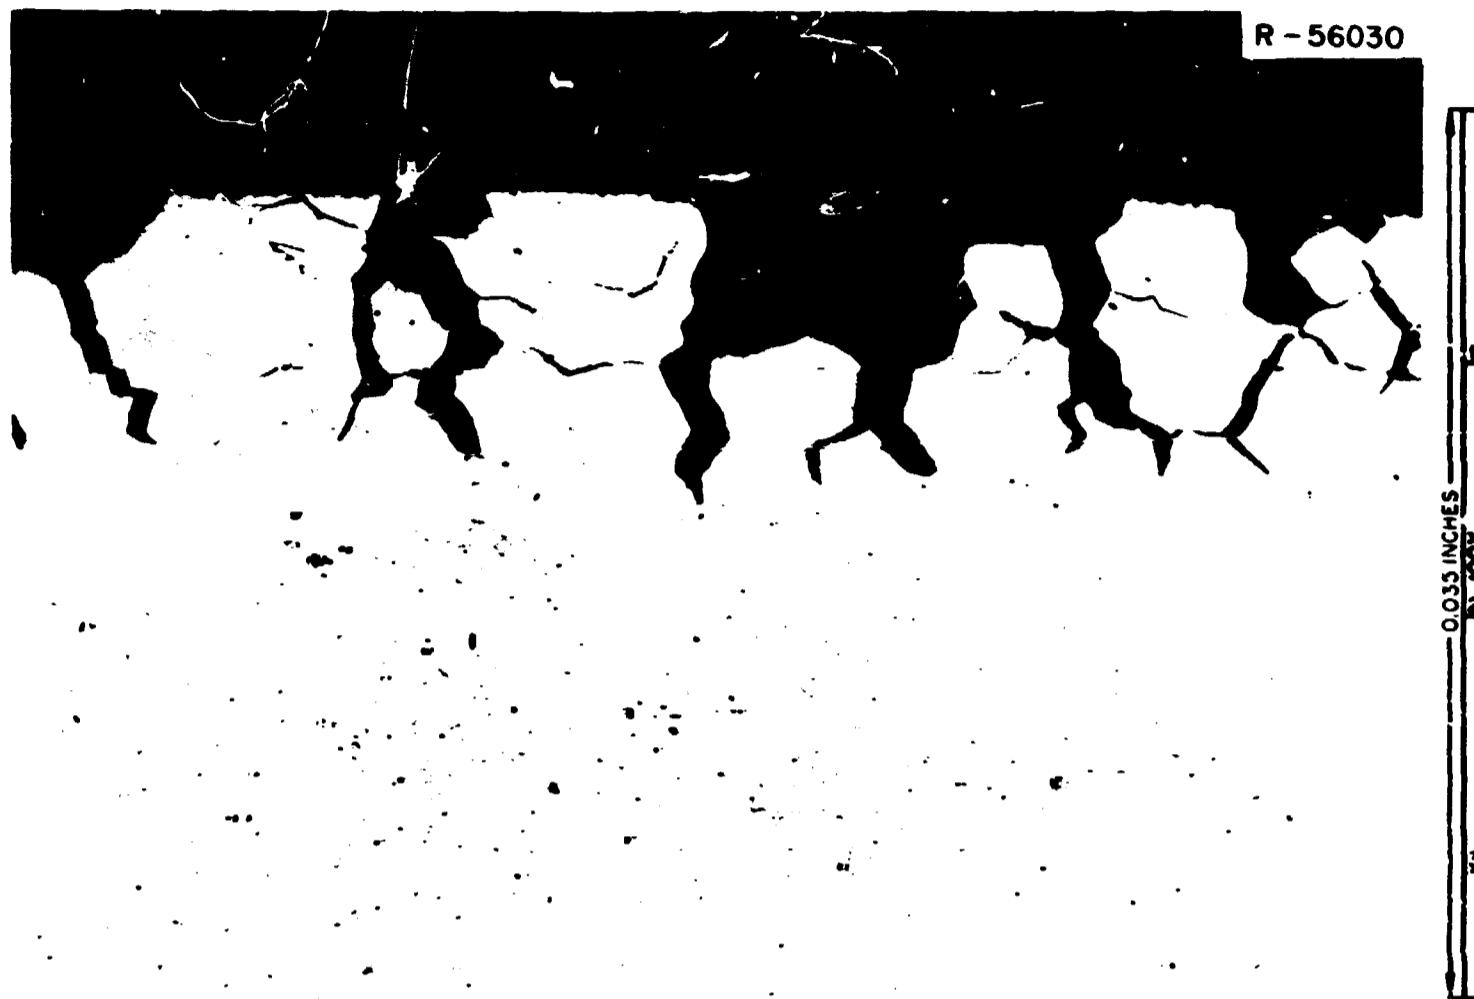
Fig. 89. Photomicrograph of Deformed Sampler Cage Rod Near the Fracture. As-polished.

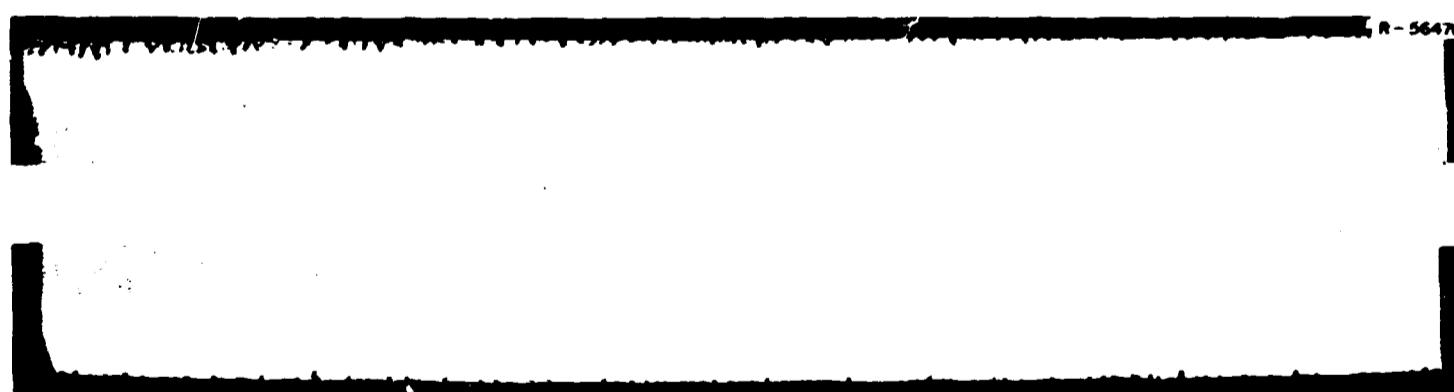
Fig. 90. Composite of Photomicrographs of Sampler Cage Rod that was Strained at 25°C. 6.2x. Left end of sample was 3/4 in. from fracture. The rod progressed further into the vapor region from left to right. The sample length is 0.72 in.

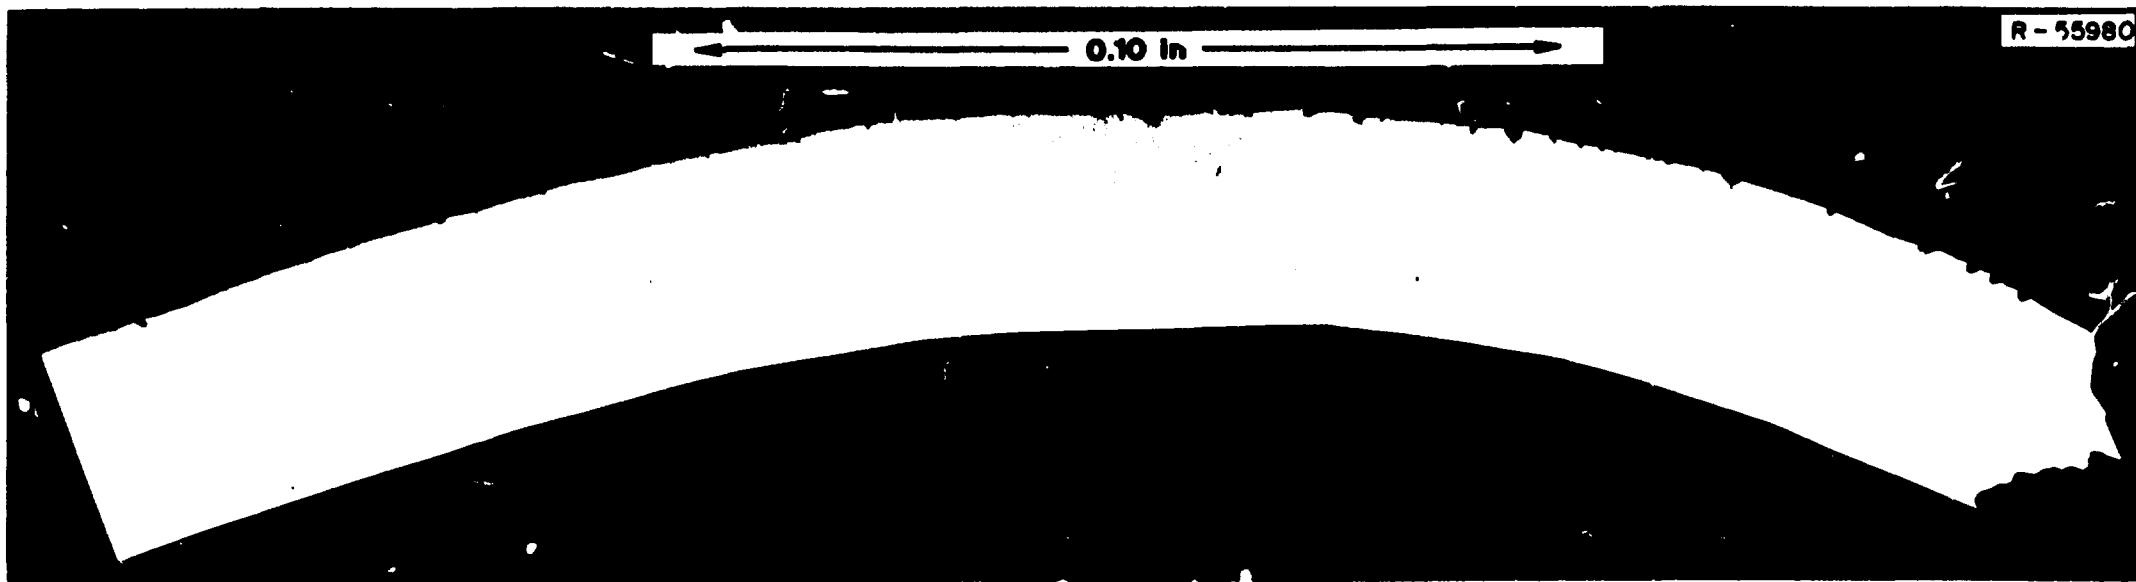
The bend samples of the mist shield were examined metallographically. Photomicrographs of the sample from the inside vapor region are shown in Fig. 92, and a composite of several photomicrographs is shown in Fig. 93. The edge cracks were intergranular and about 1 mil deep. The photomicrographs of the sample from the liquid region (Fig. 94) show that the cracks extended to a depth of about 8 mils in the liquid region. The composite photograph in Fig. 95 also shows the increased frequency and depth of cracking in the liquid region.

Fig. 93. Composite Photograph of the Tension Side of a Bend Sample from Inside Vapor Region of Mist Shield. Lower edge is not the compression side of the sample.

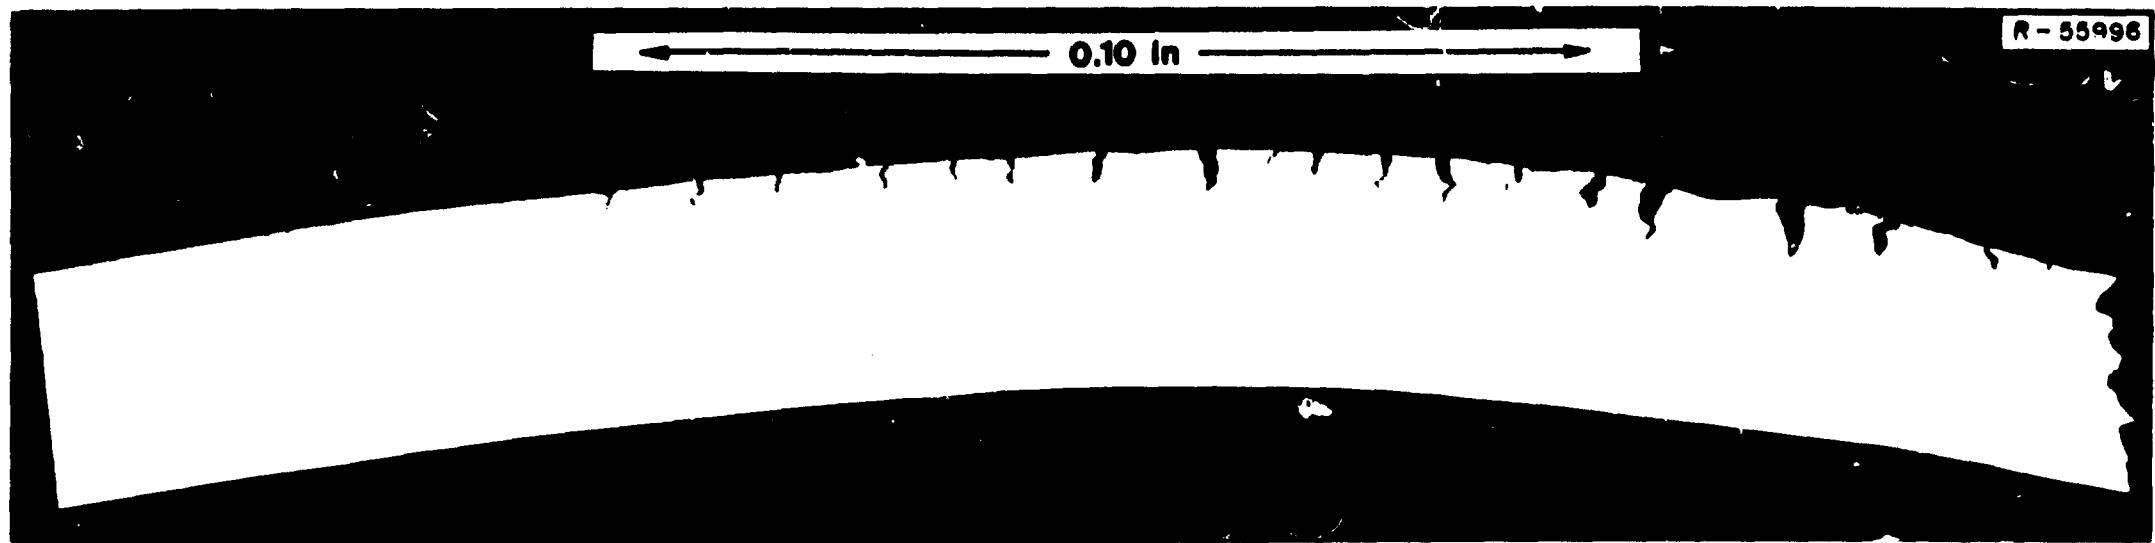
Fig. 95. Composite Photograph of the Tension Side of a Bend Sample from Inside Liquid Region of Mist Shield. Lower Edge is not the compression side of the sample.

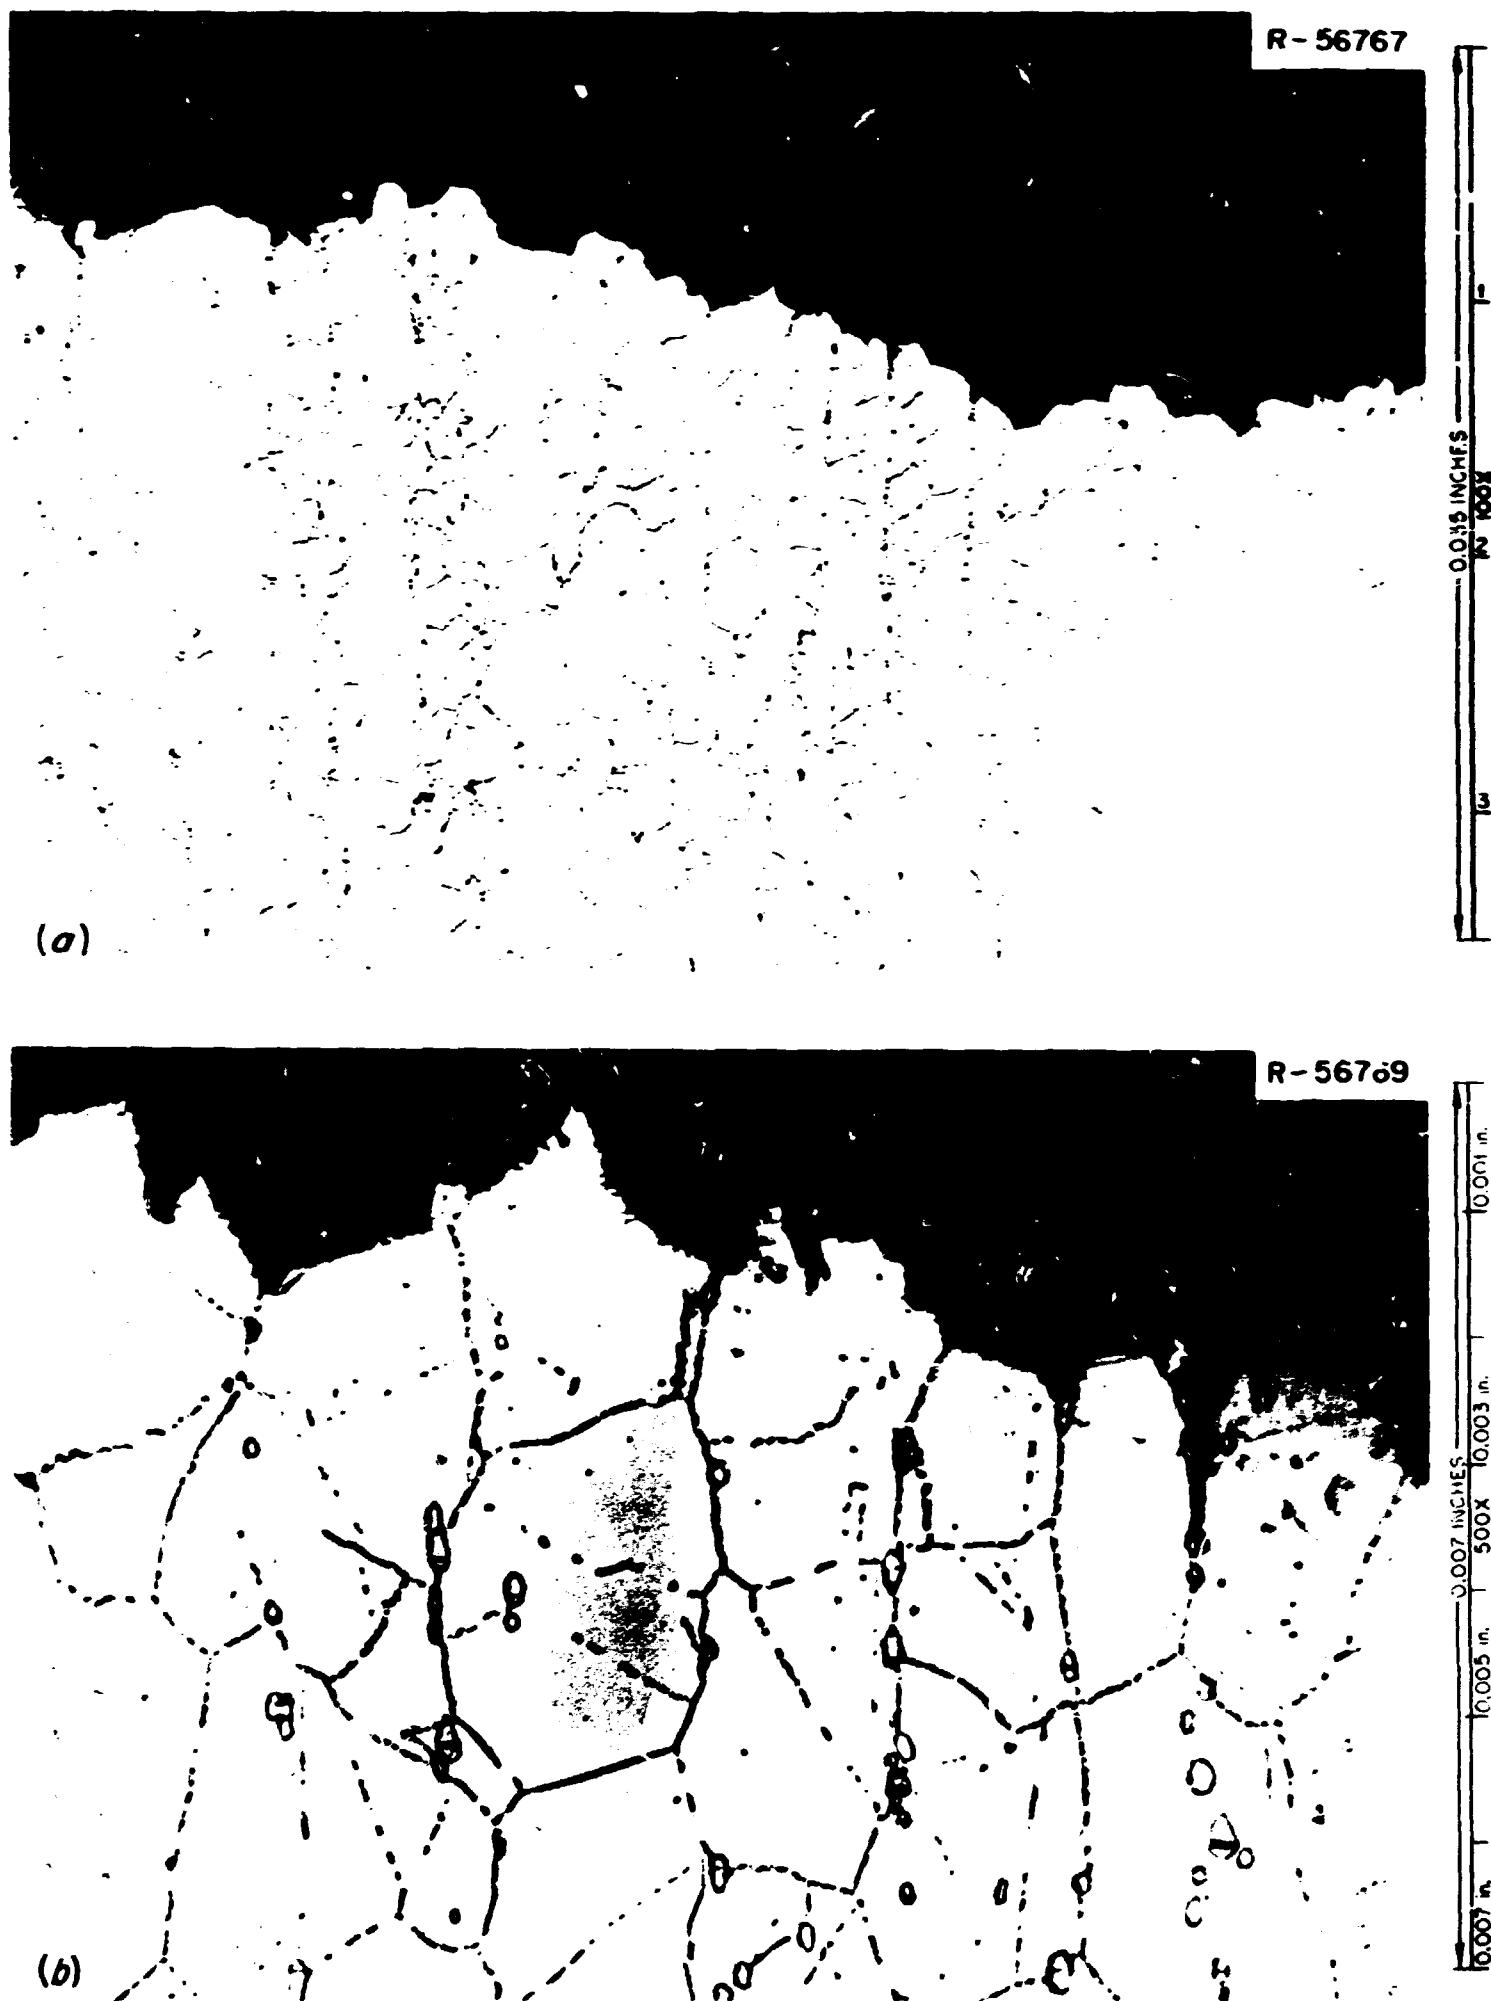
The sample from the outside liquid region was quite similar metallographically to that from the inside liquid region. Photomicrographs of the fracture and a typical region of the tension near the fracture are shown in Figs. 96 and 97, respectively. A composite of several photomicrographs is shown in Fig. 98. Photomicrographs of the outside vapor (salt spray) bend specimen at the fracture and on the tension side near the fracture are shown in Figs. 99 and 100, respectively. The composite of several photomicrographs in Fig. 101 shows that the cracks are not much deeper nor more frequent than in the liquid regions (compare Figs. 95, 98, and 101), but the tendency for grains to fall out is much greater. This is even more significant when one notes that the strain was the least in the sample from the outside vapor region (Table 10).

Fig. 96. Photomicrographs of the Fracture of a Bend Specimen from the Outside Liquid Region of the Mist Shield. (a) 100x. (b) 500x. Etchant: Lactic acid, HNO_3 , HCl .

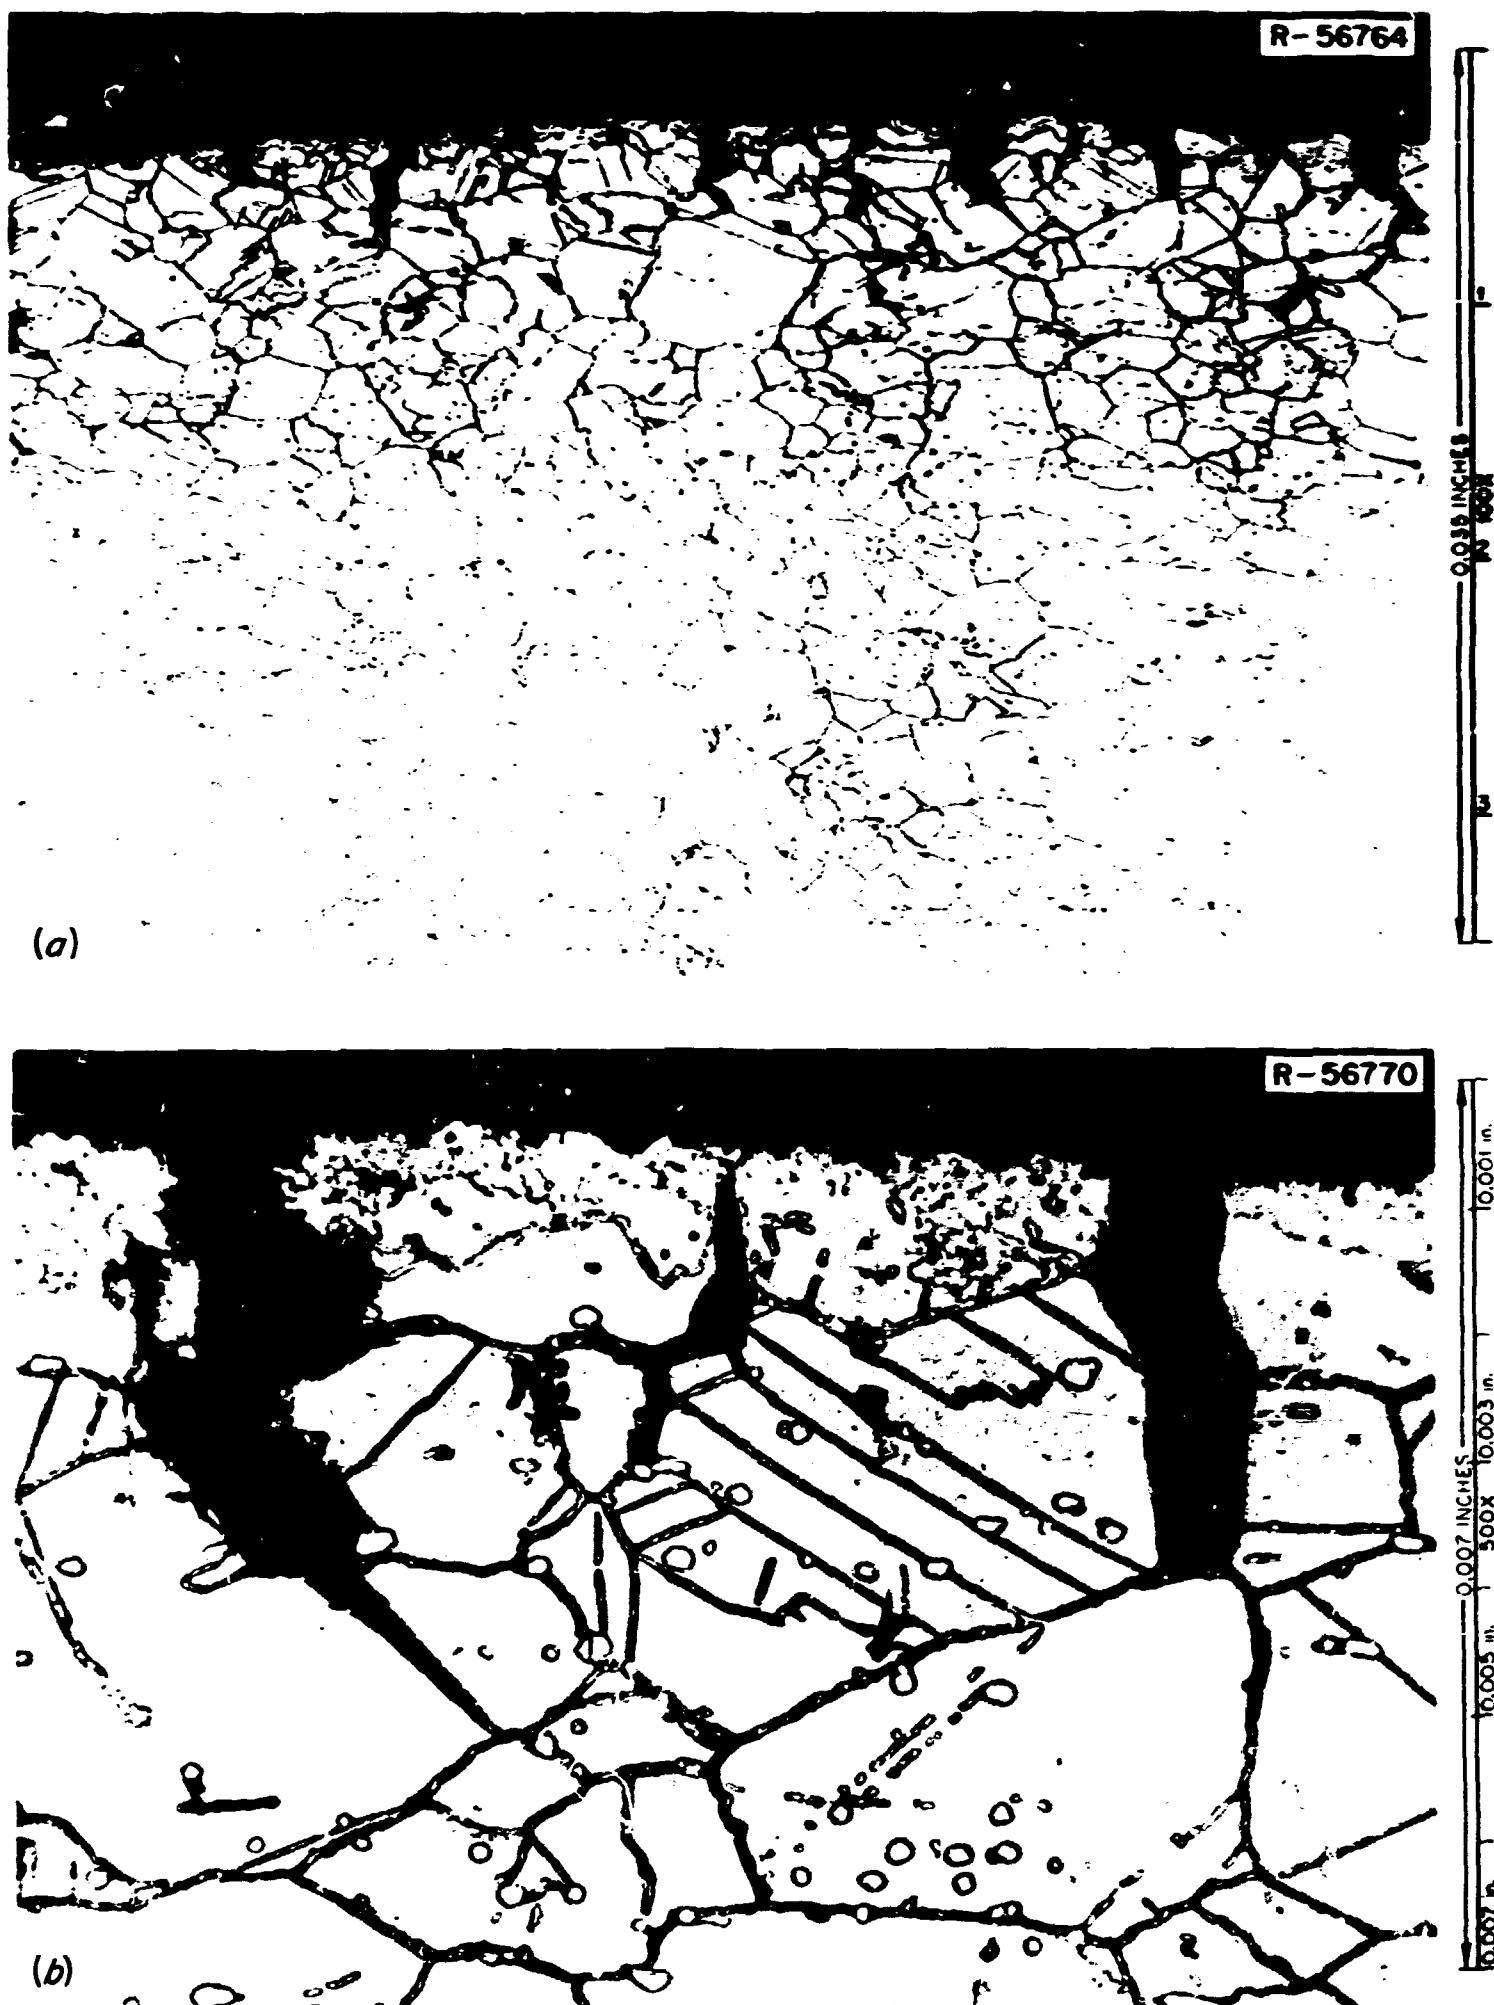
Fig. 97. Photomicrographs of the Tension Side Near the Fracture of a Bend Specimen from the Outside Liquid Region of the Mist Shield. (a) 100x. (b) 500x. Etchant: lactic acid, HNO_3 , HCl .

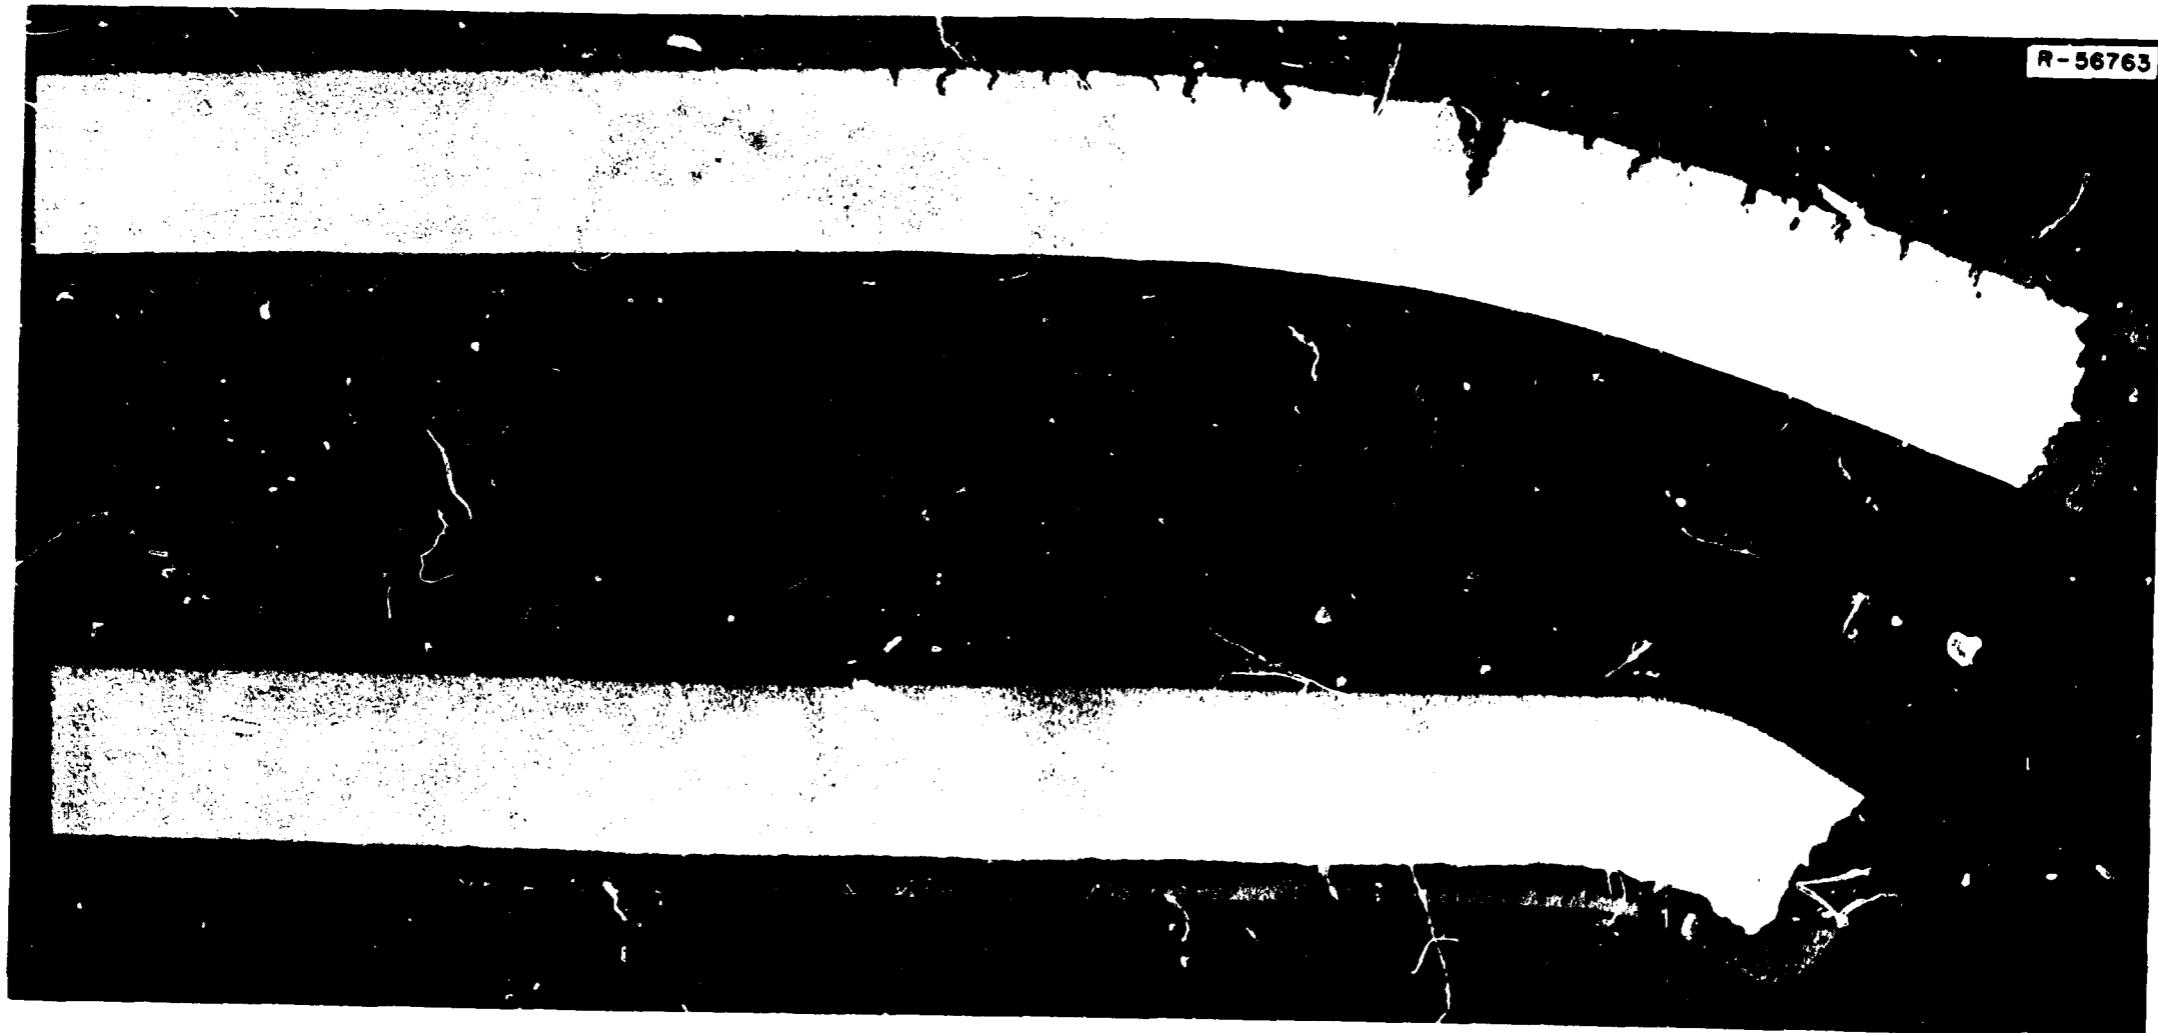
Fig. 98. Composite of Several Photomicrographs of a Bend Specimen from the Outside Liquid Region of the Mist Shield. Top portion shows the tension side and the lower portion shows the compression side. 24x.

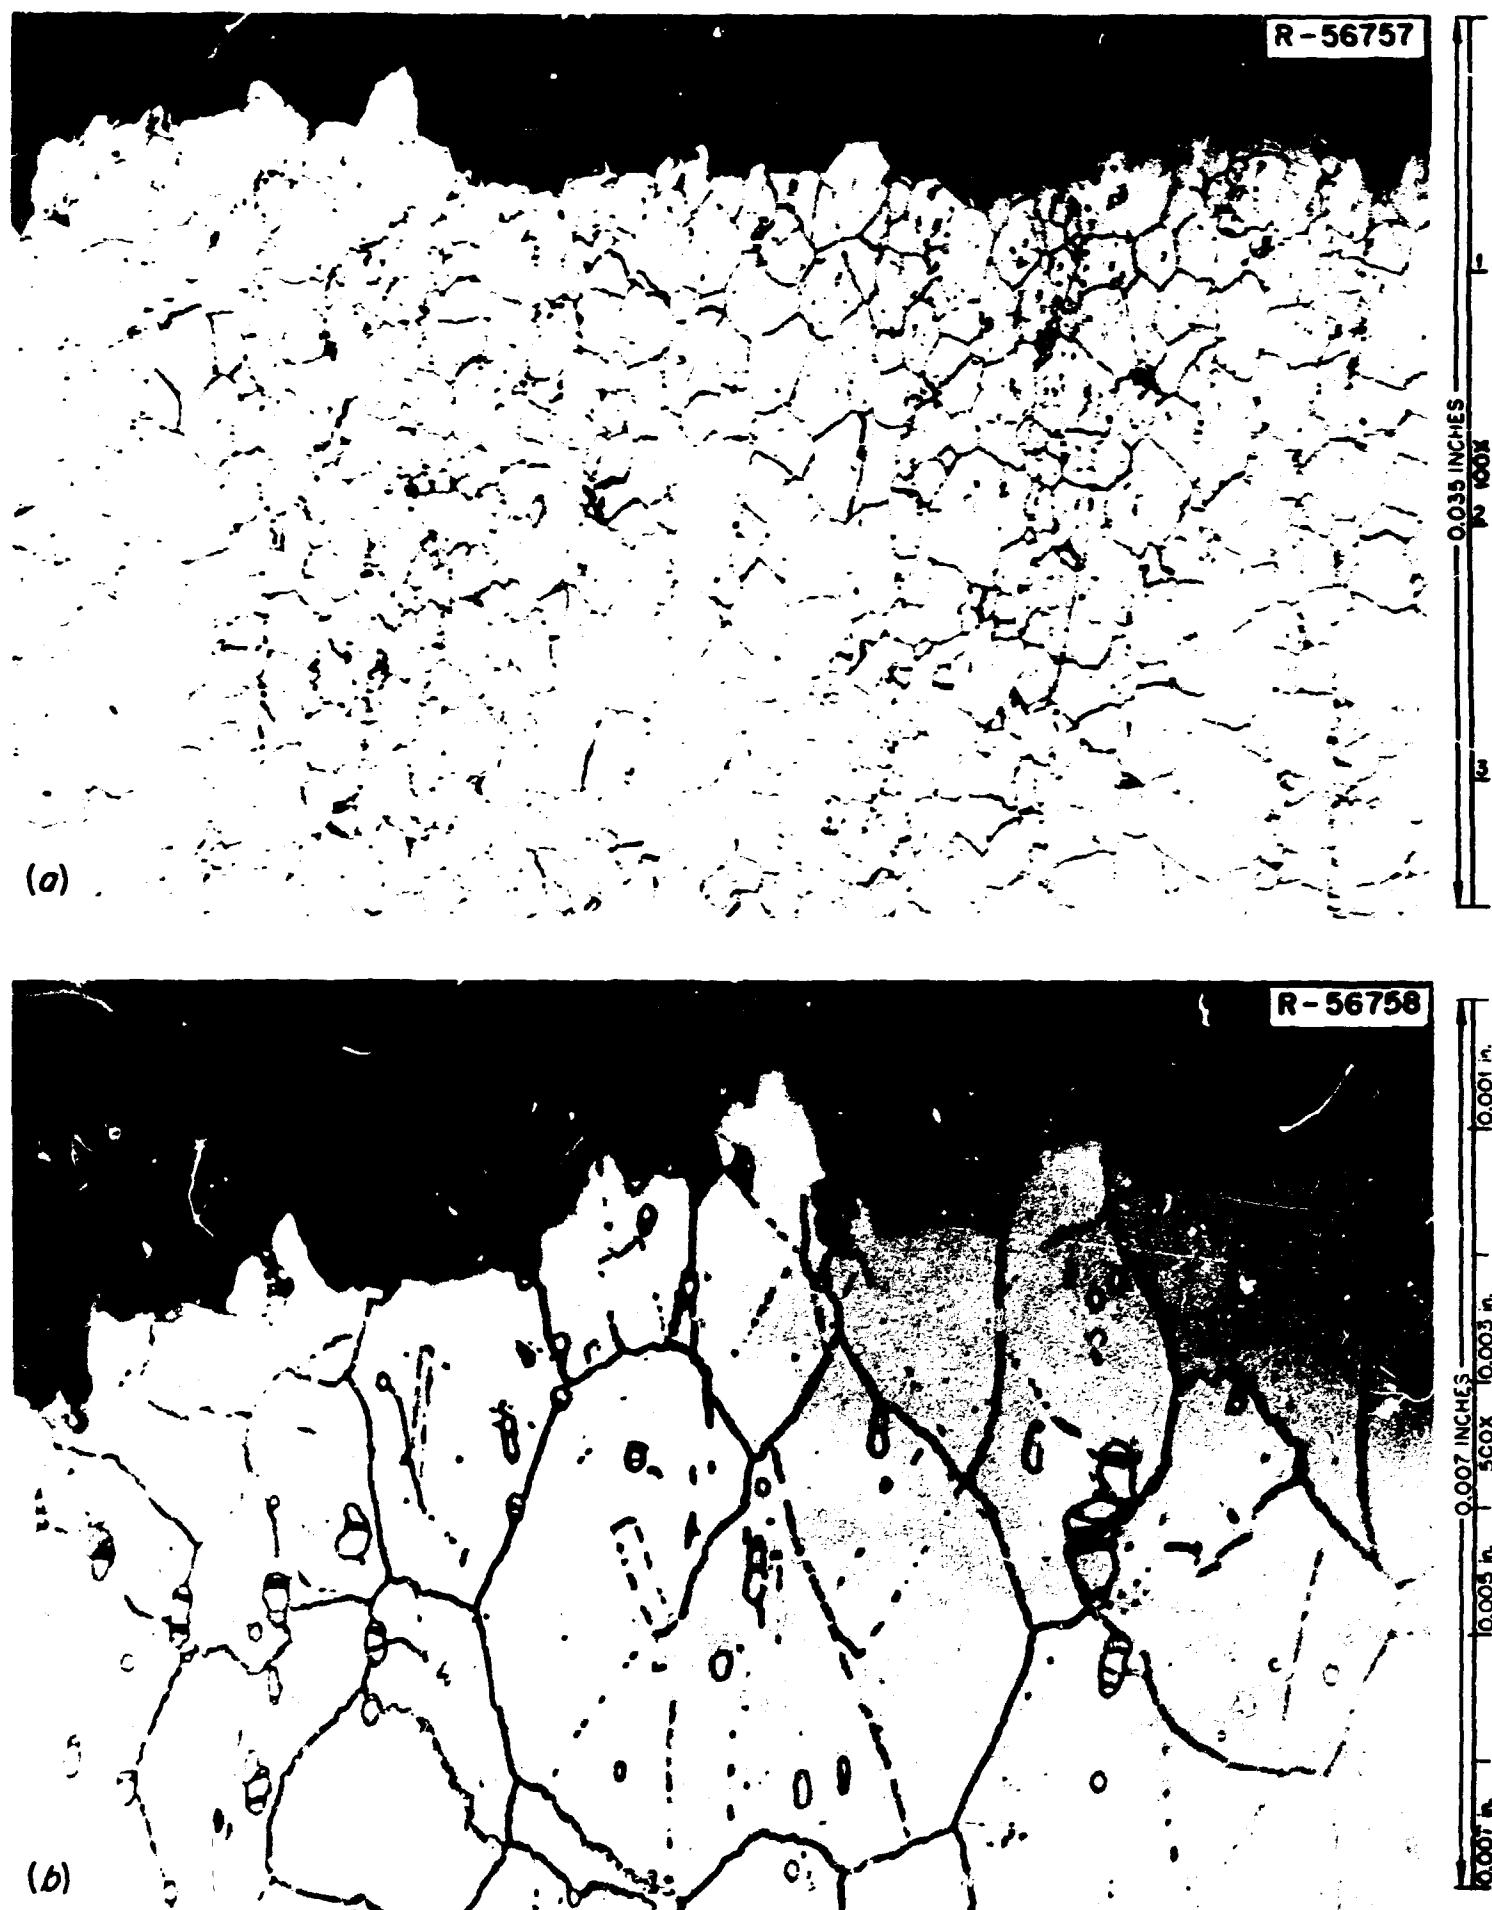
Fig. 99. Photomicrographs of the Fracture of a Bend Specimen from the Outside Vapor Portion of the Mist Shield. (a) 100x. (b) 500x.
Etchant: Lactic acid, HNO_3 , HCl .

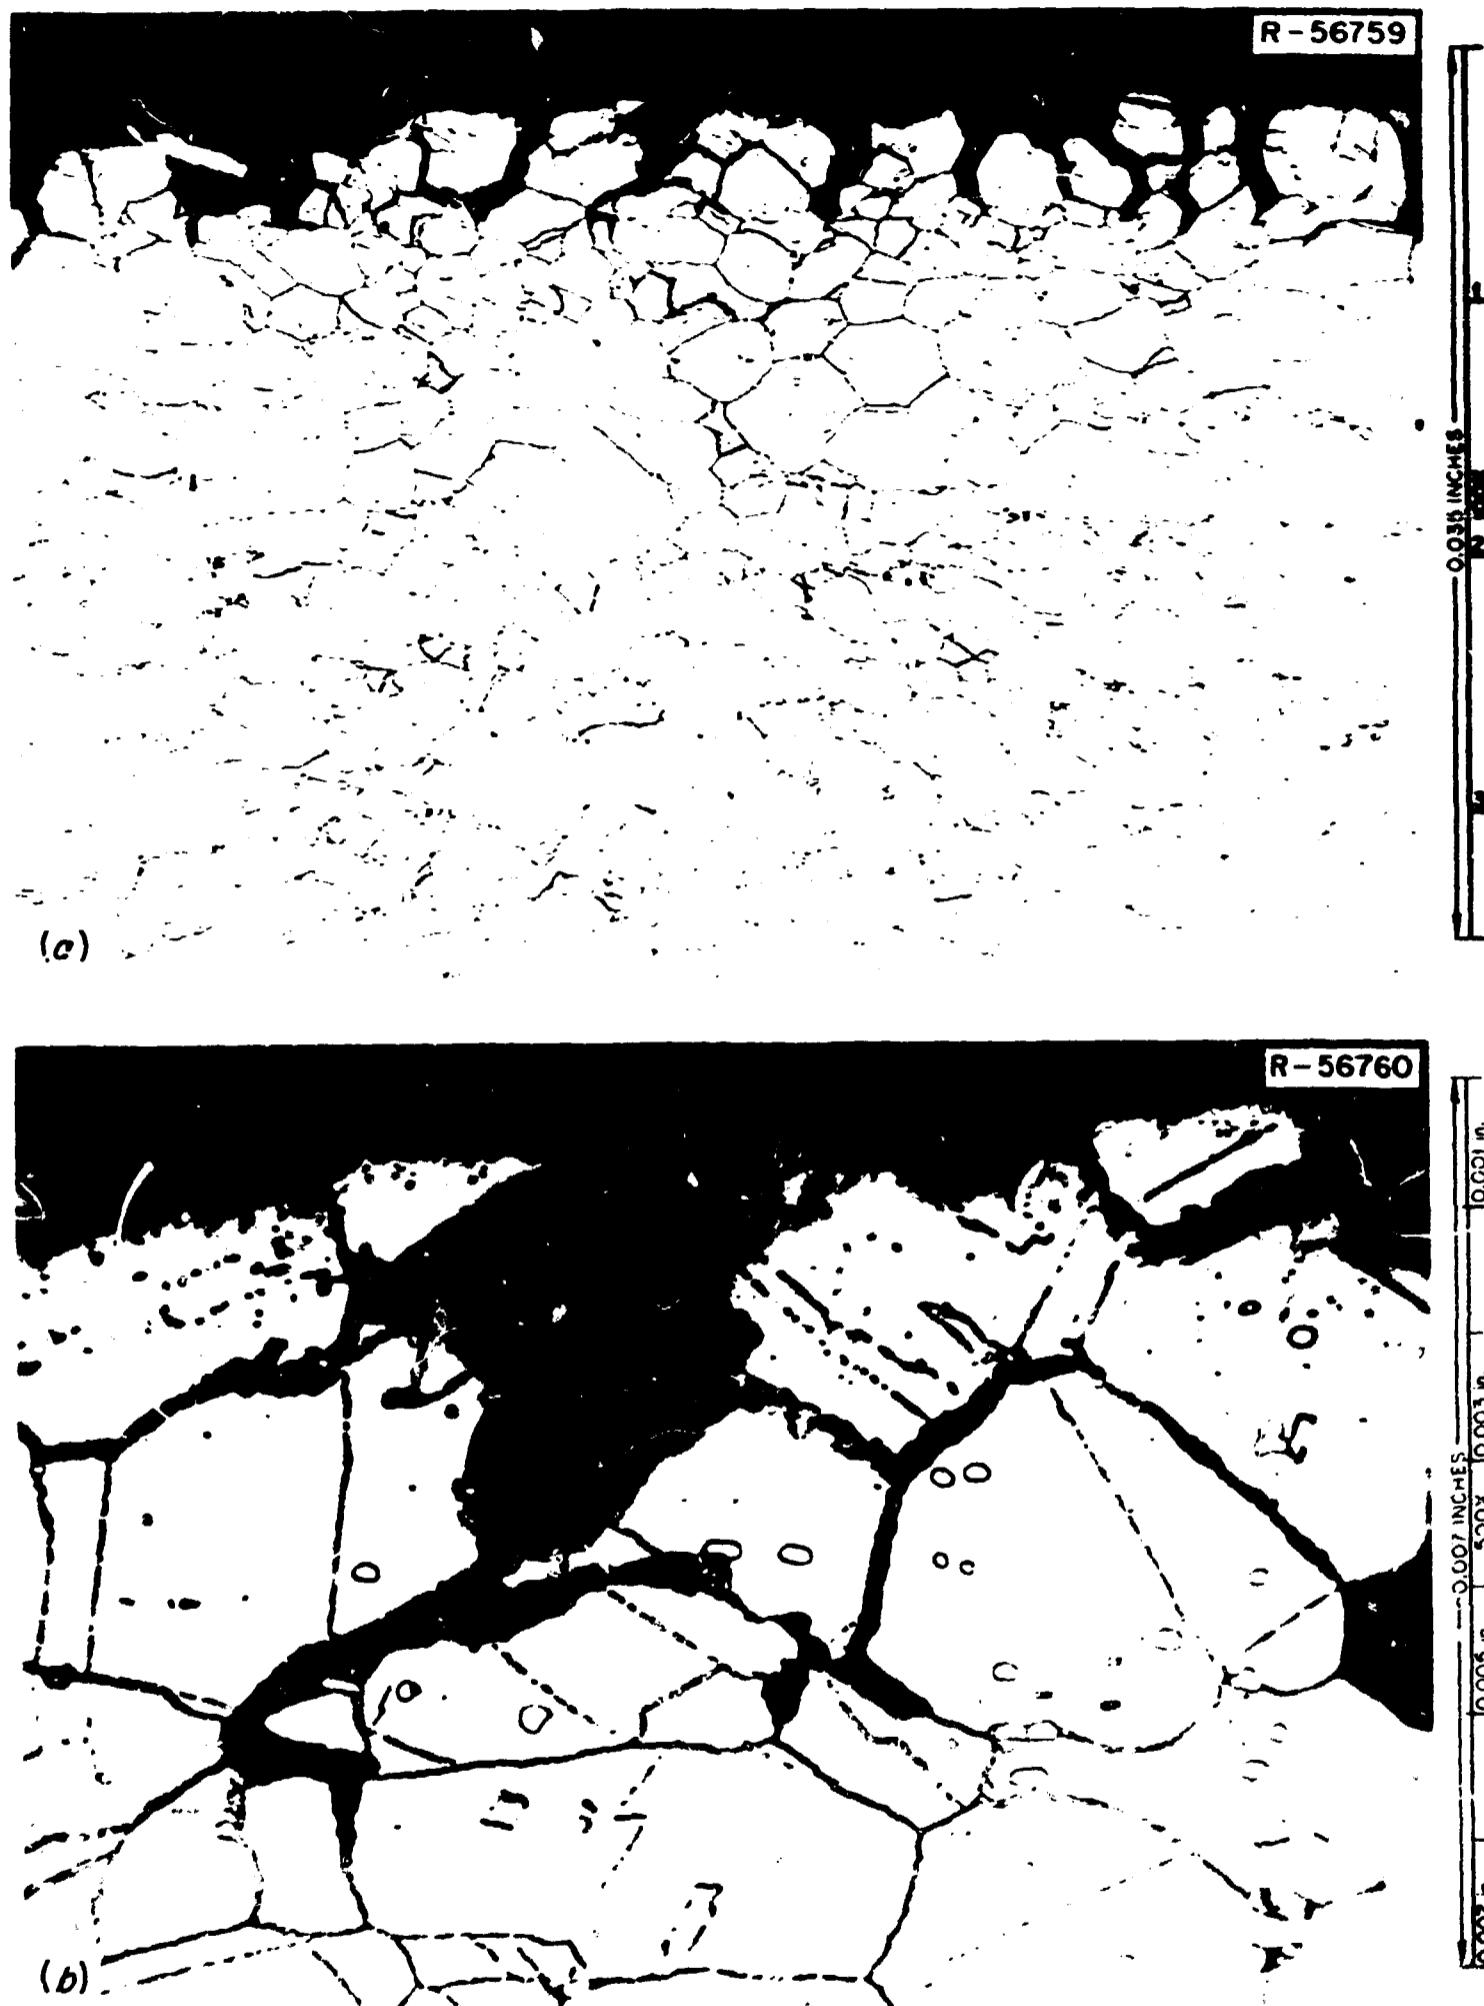
Fig. 100. Photomicrographs of the Edge Near the Fracture of a Bend Specimen from the Outside Vapor Portion of the Mist Shield. (a) 100x. (b) 500x. Etchant: Lactic acid, HNO_3 , HCl .
