INTERGRANULAR CRACKING OF INOR-8 IN THE MSRE

H. E. McCoy

B. McNabb

NOVEMBER 1972

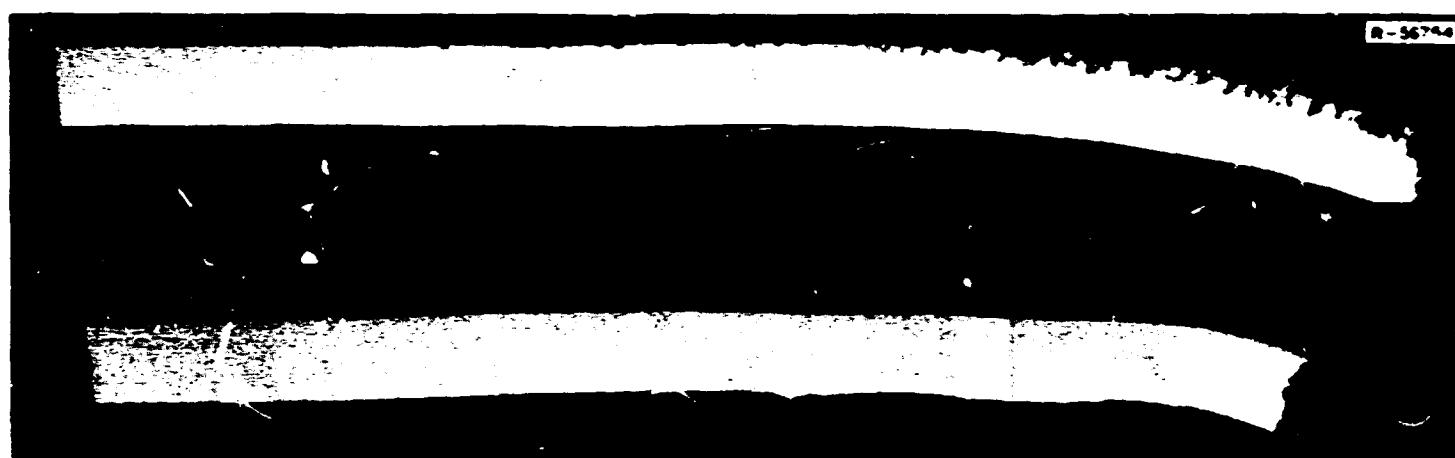
Fig. 101. Composite of Several Photomicrographs of a Bend Specimen From the Outside Vapor Region of the Mist Shield. Top portion is the tension side and the lower part is the compression side. 15x.

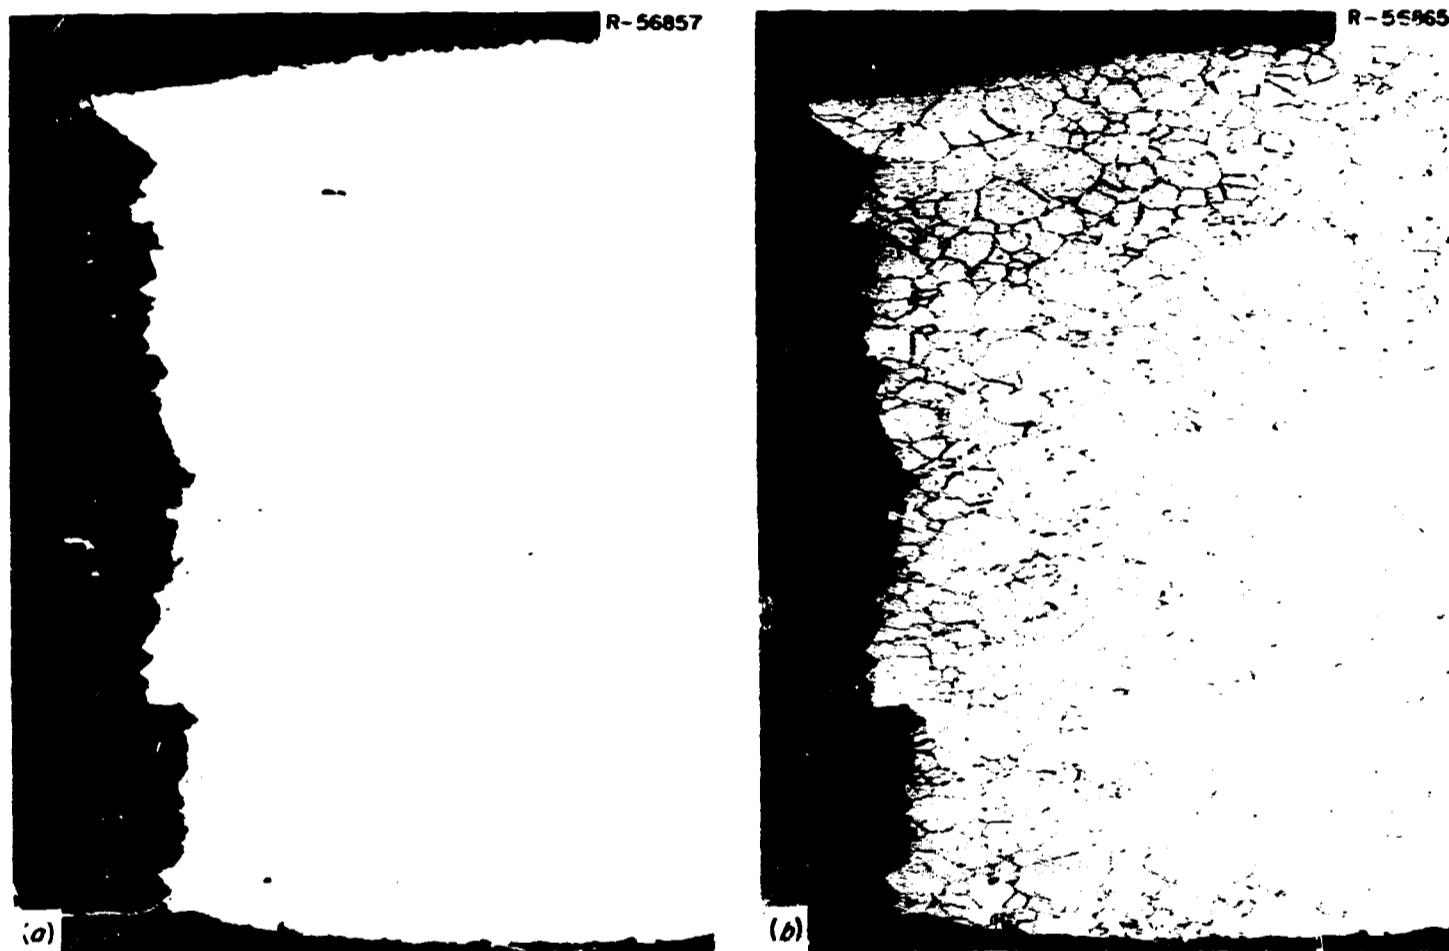
A metallographic section of one of the ring specimens is shown in Figs. 103 and 104. The fracture and both edges are visible in Fig. 103. The oxide is on the outside surface that was exposed to air (top) and shallow cracks formed on the salt side. Typical edges near the fracture are shown in Fig. 104. The cracks on the air side followed the oxide and did not penetrate further. The cracks on the salt side were intergranular and penetrated about 1 mil.

Fig. 103. Photomicrographs of the Fracture of a Ring Specimen from Freeze Valve 105 that was Deformed at 25°C. (a) As polished. (b) Etchant: Lactic acid, HNO_3 , HCl . 40x. Reduced 29.5%.

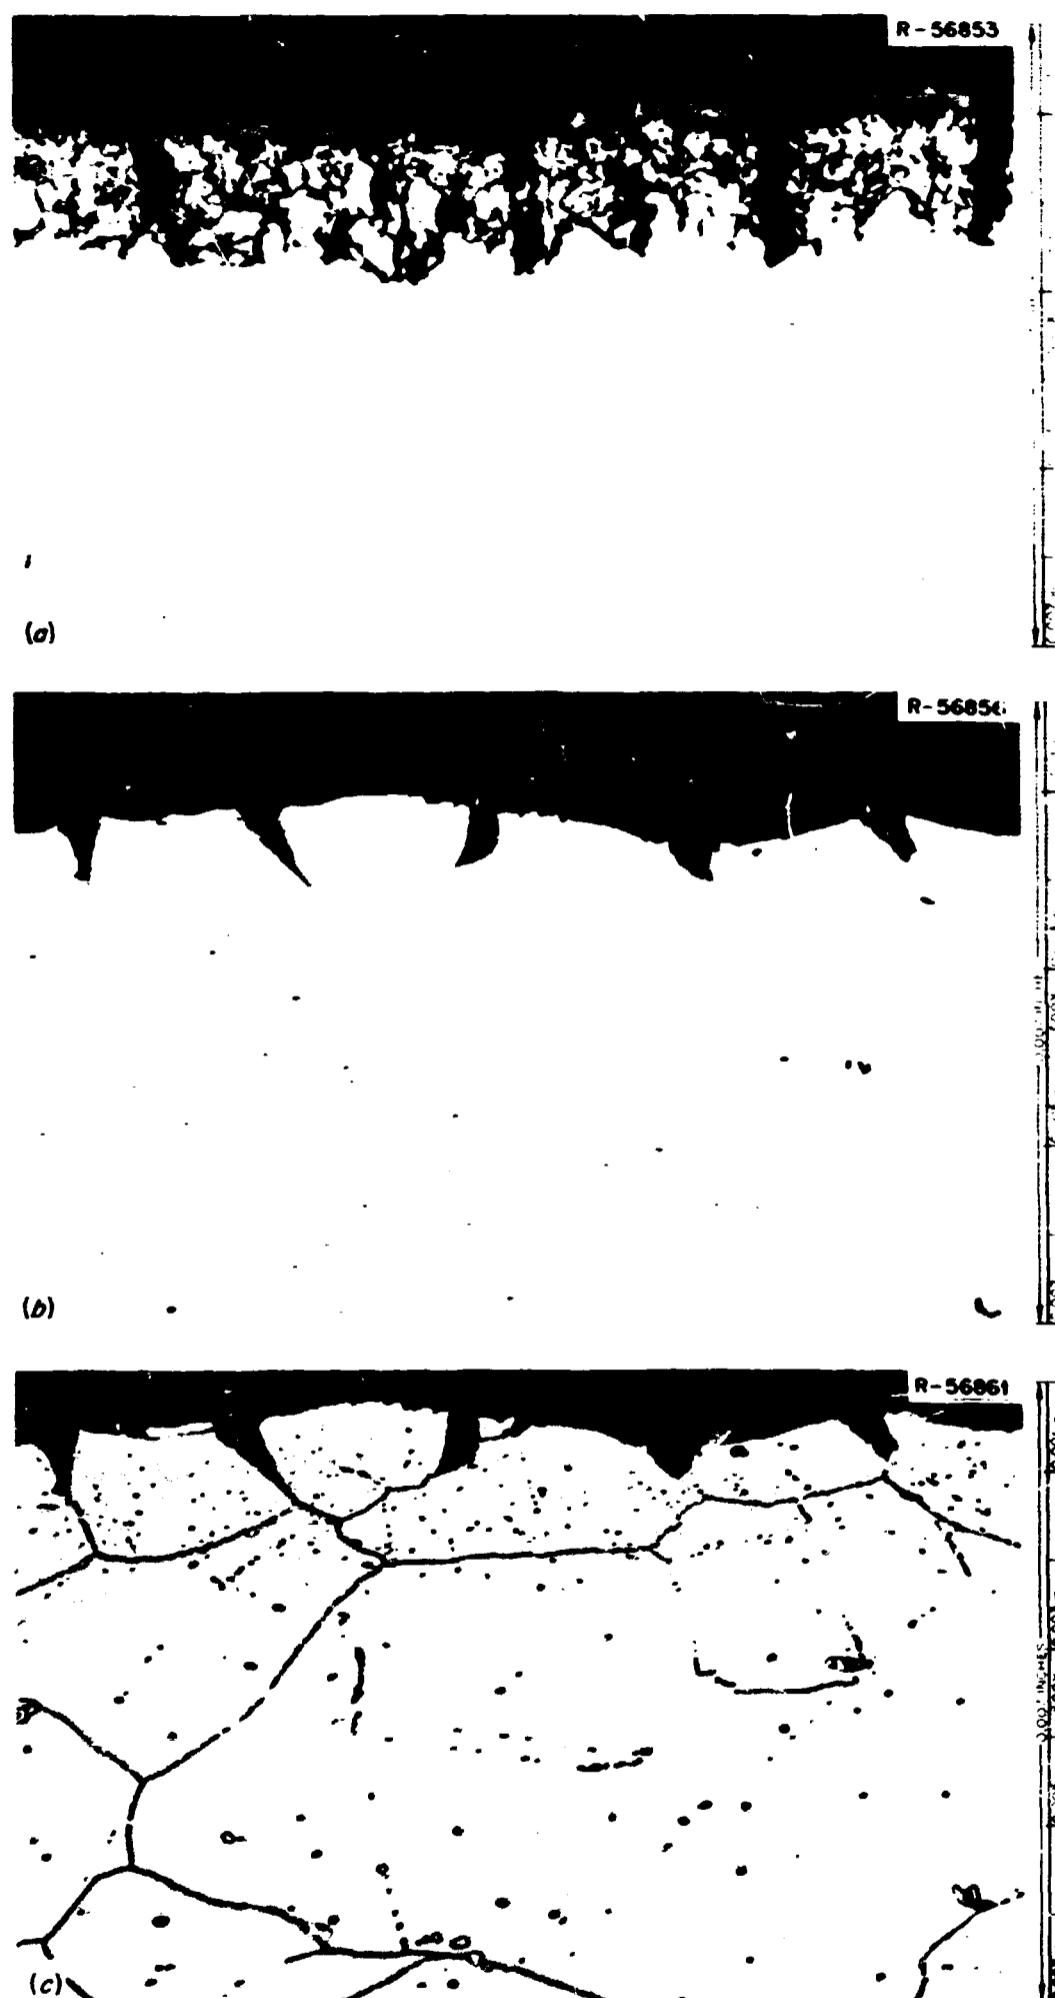
Fig. 104. Photomicrographs Near the Fracture of a Ring Sample from Freeze Valve 105 Deformed at 25°C. (a) Edge exposed to air, as polished. (b) Edge exposed to salt, as polished. (c) Edge exposed to salt, etched with lactic acid, HNO_3 , HCl . Reduced 30%.

product concentration was the one from FV 105. The fission product concentrations were generally less than on the other samples by an order of magnitude (Table 14) and the cracks were very shallow (Fig. 104).

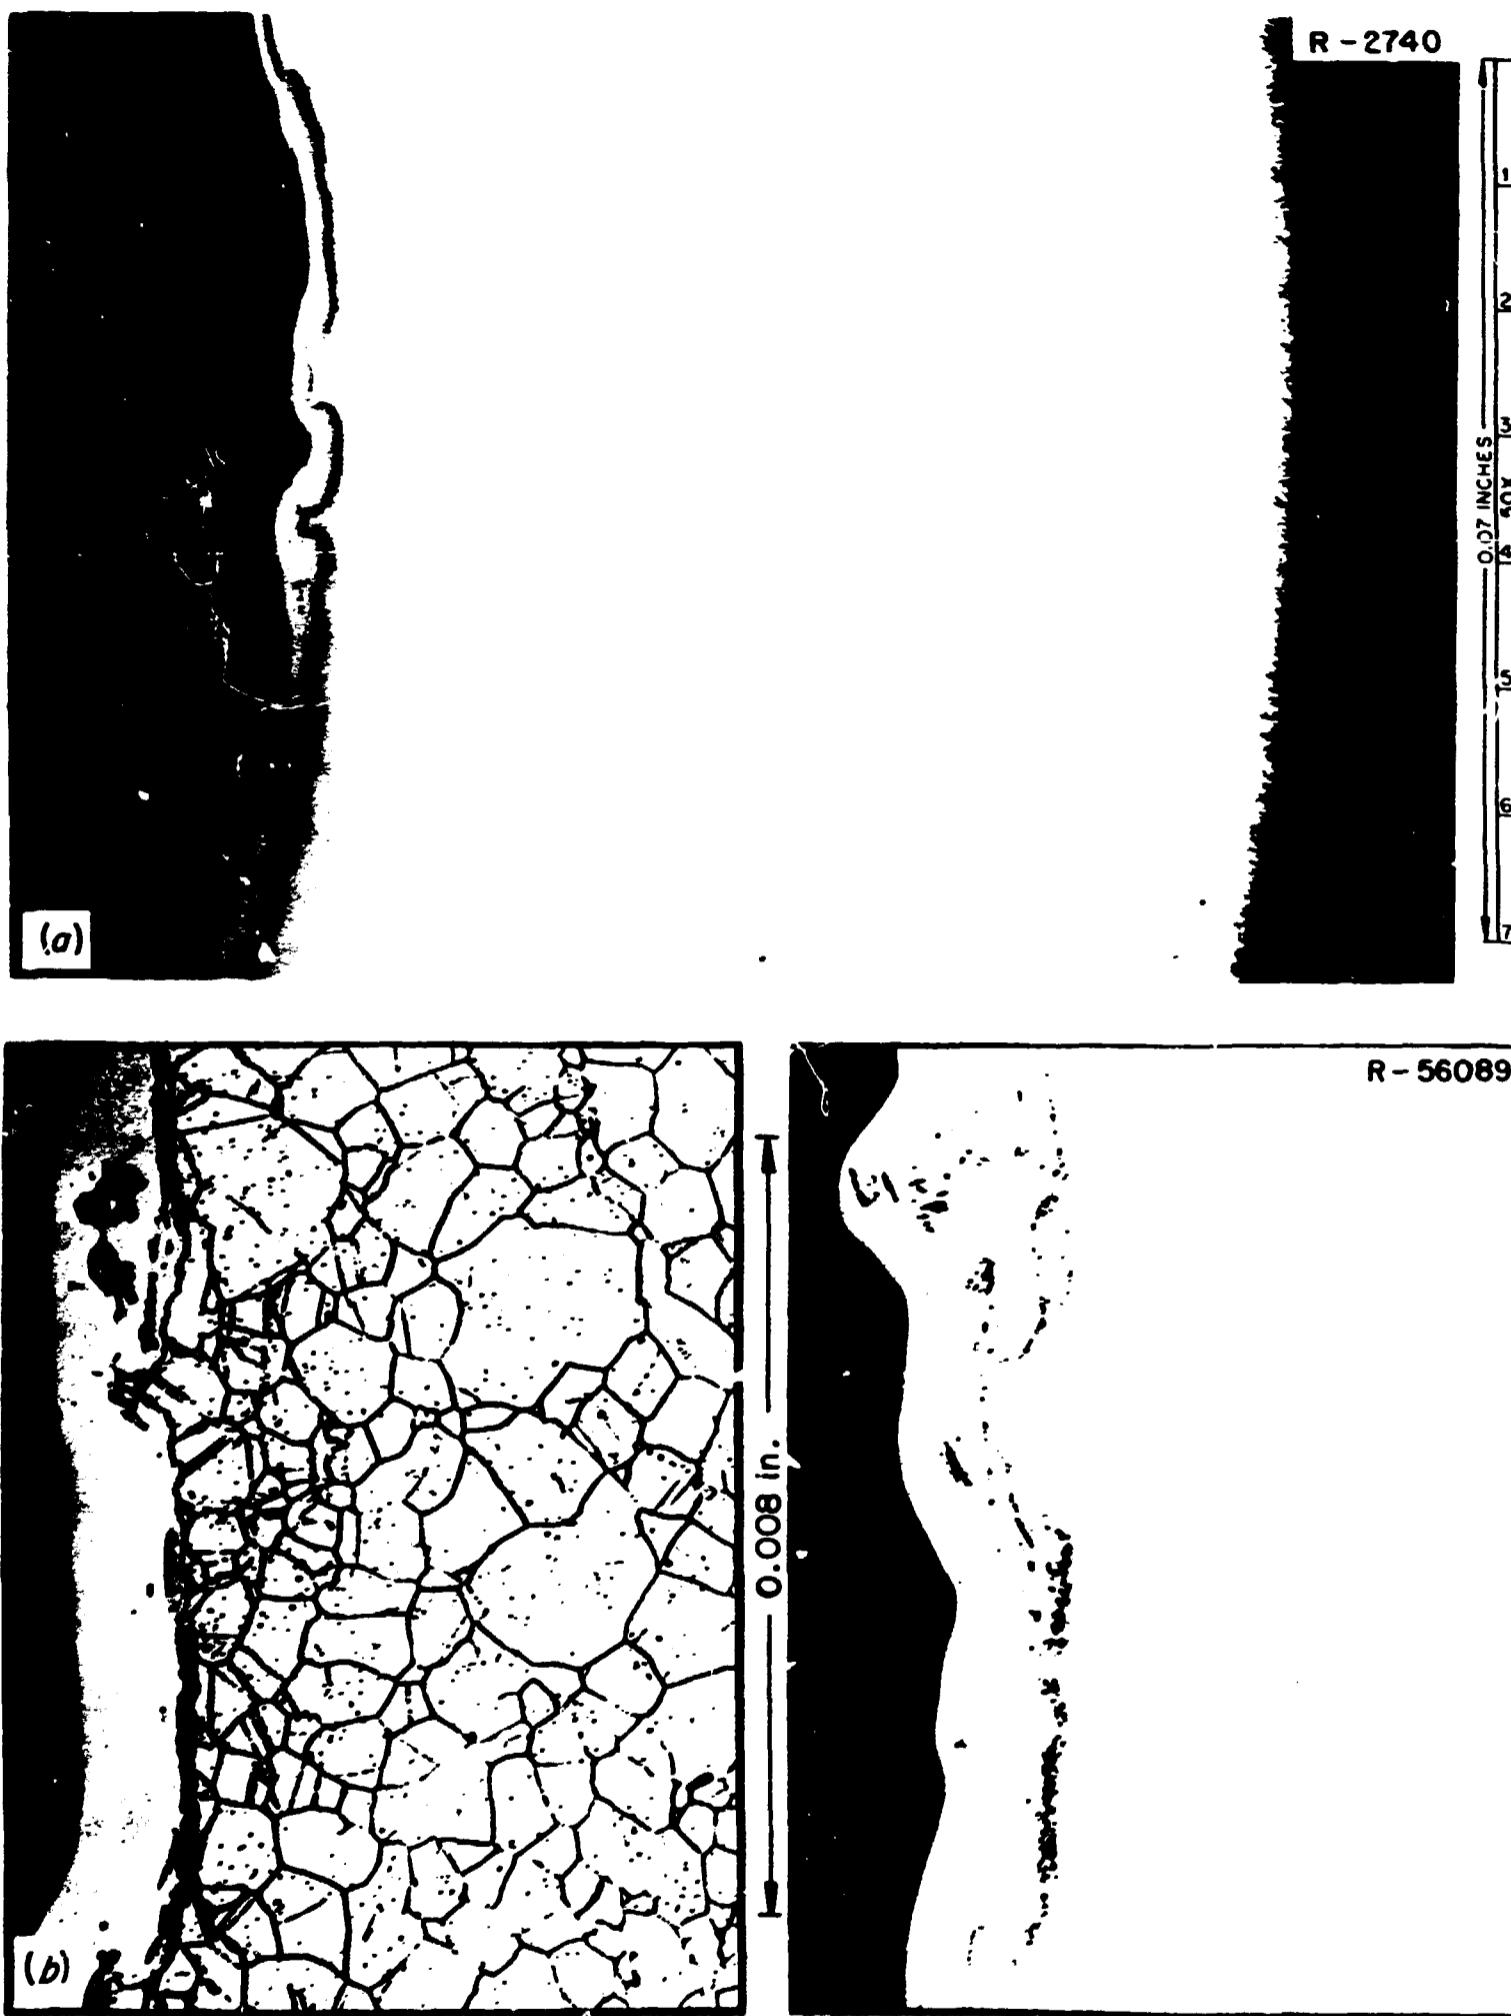
The uneven inner surface of the loop tubing may or may not have been due to the same phenomenon that caused the intergranular cracking in the MSRE. Note in Fig. 105 that the material was removed in increments of single grains. However, there is no evidence of partially cracked grains that had not been completely removed. The explanation of cavitation is also not very acceptable since the peak velocity was only about 1 ft/sec.

Fig. 105. Inside Tube Wall of INOR-8 from In-pile Loop MTR 44-1.
The coating is nickel plating used for edge preservation.

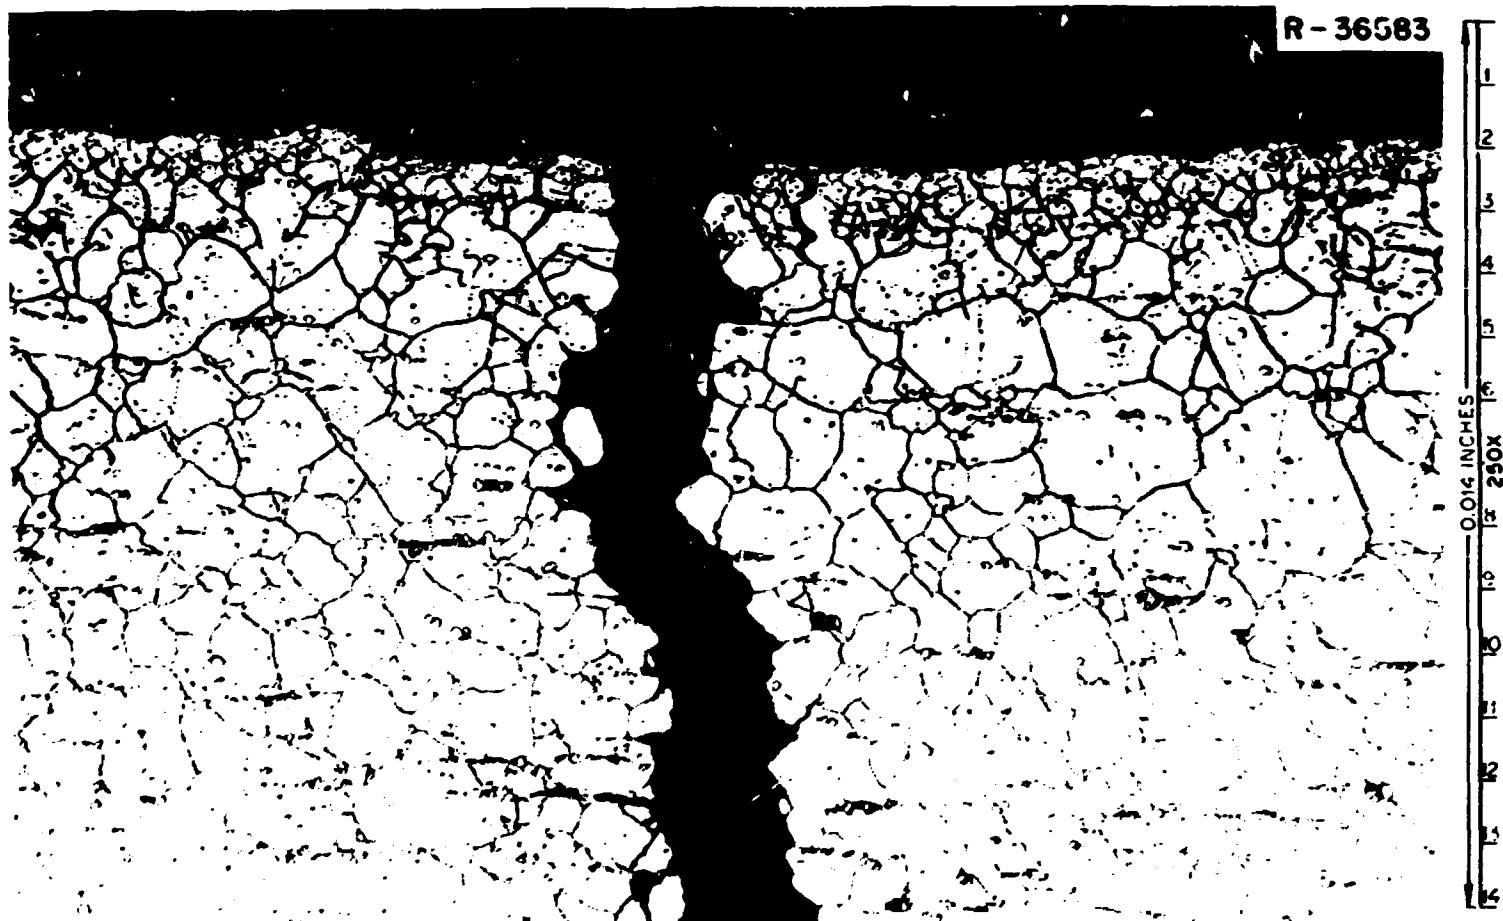
A more recent in-reactor thermal convection loop was run by Compere et al.²⁶ A schematic of the loop is shown in Fig. 106, and the pertinent operating statistics are given in Table 12. The loop was constructed of INOR-8, contained salt of composition ^7LiF - BeF_2 - ZrF_4 - UF_4 (65.3-28.2-4.8-1.7 mole %), and had a graphite region where power densities of 150 W/cm^3 of salt were attained. The loop had maximum and minimum operating temperatures of 720 and 545°C, respectively. The loop failed at the hottest portion after 1366 hr of nuclear operation. The failure (Fig. 107) is quite typical of high-temperature failures noted previously in this material after irradiation.⁴⁻⁷ Note that the inside surface is free of cracks except very near the point of failure.

Fig. 107. Photomicrograph of a Cross Section Showing the Inner Surface and Crack in Core Outlet Pipe of In-Reactor Loop 2. Located on top side of tubing. Etchant: Aqua regia.

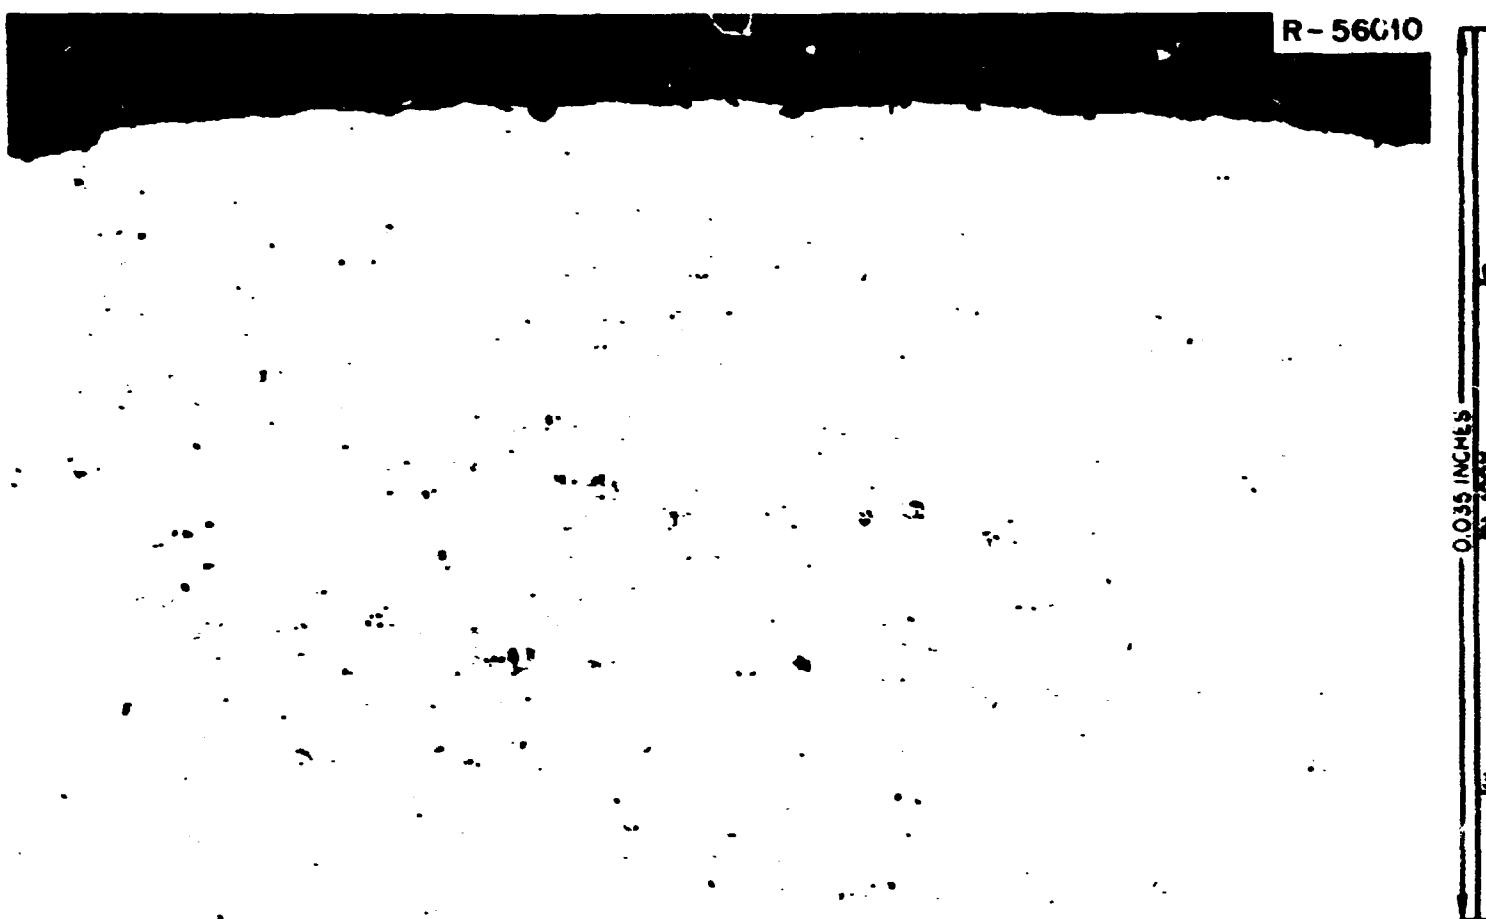
Two pieces of the loop were retrieved and tested. One sample was from the flat sheet used to fabricate the top of the "core section" where the graphite was located. A small sheet was cut, bent so that the surface exposed to the fuel salt was in tension, and examined metallographically. A typical photomicrograph is shown in Fig. 108. Surface cracks were very infrequent and extended to a maximum depth of 0.5 mil.

Fig. 108. Bend Specimen from Section of In-Reactor Loop Which Operated at 720°C. The tension side was exposed to the fuel salt.

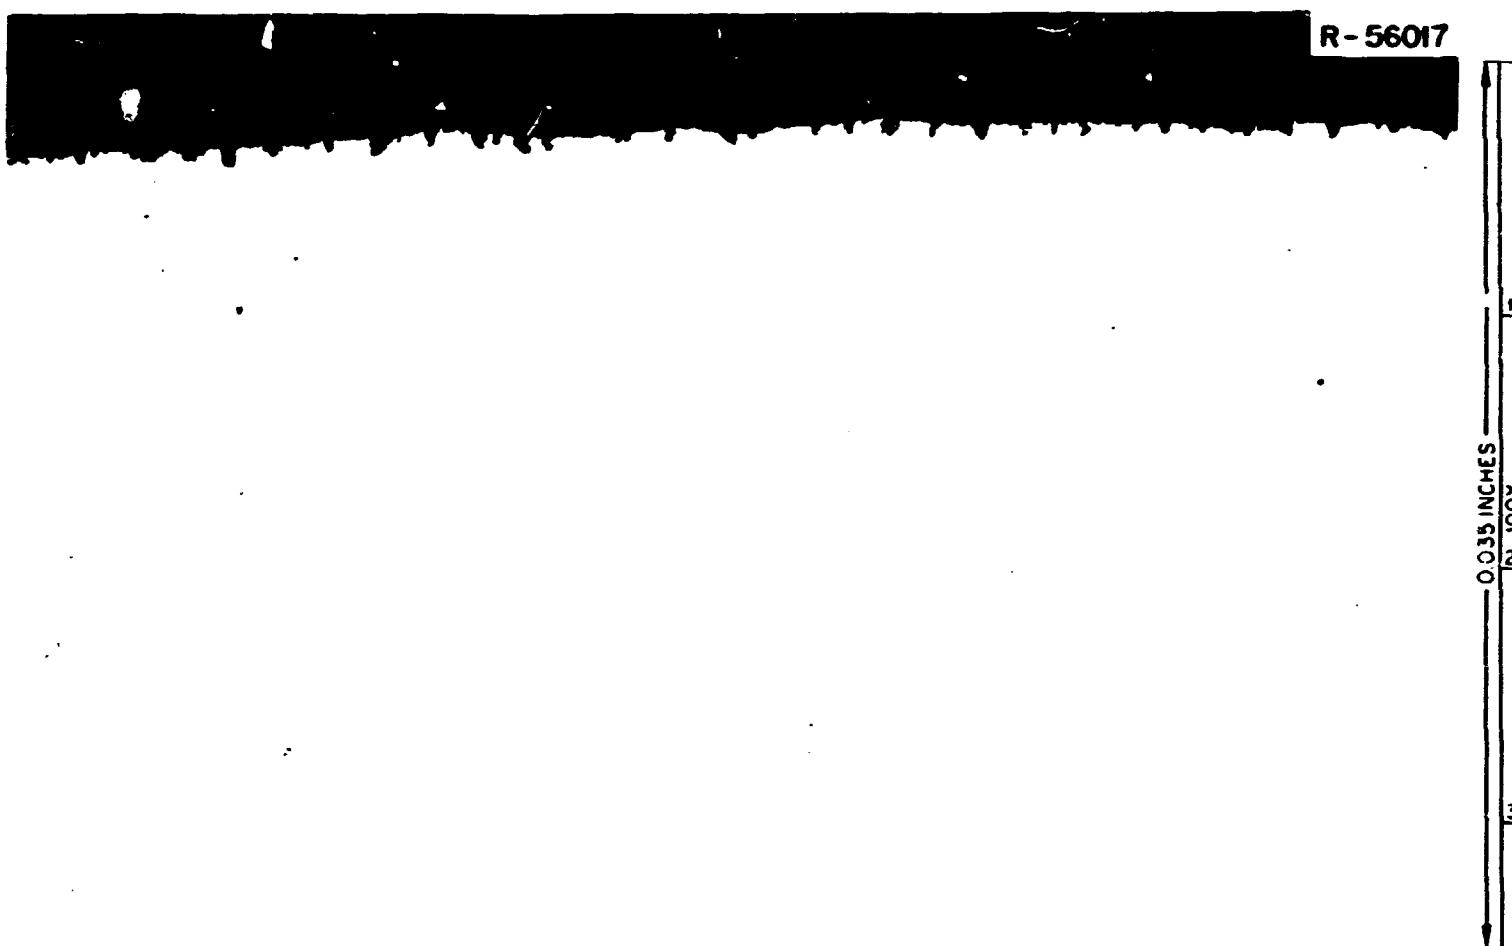
A piece of tubing was available from the coldest section, and it was deformed by crushing in a tensile machine. A typical view of the inside surface is shown in Fig. 109. Cracks occurred along almost every grain boundary, but they only extended to a maximum depth of 1 mil.

Fig. 109. Tension Side of Crushed Tubing from Coldest Part of In-Reactor Loop, Which Operated at 545°C.

The loops run by Trauger and Conlin had some regions from which grains were removed, but no intergranular cracks were visible. Strained samples of Compere's loop had shallow intergranular cracks similar to those noted in samples from the MSRE, particularly the sample exposed at 545°C (Fig. 109).

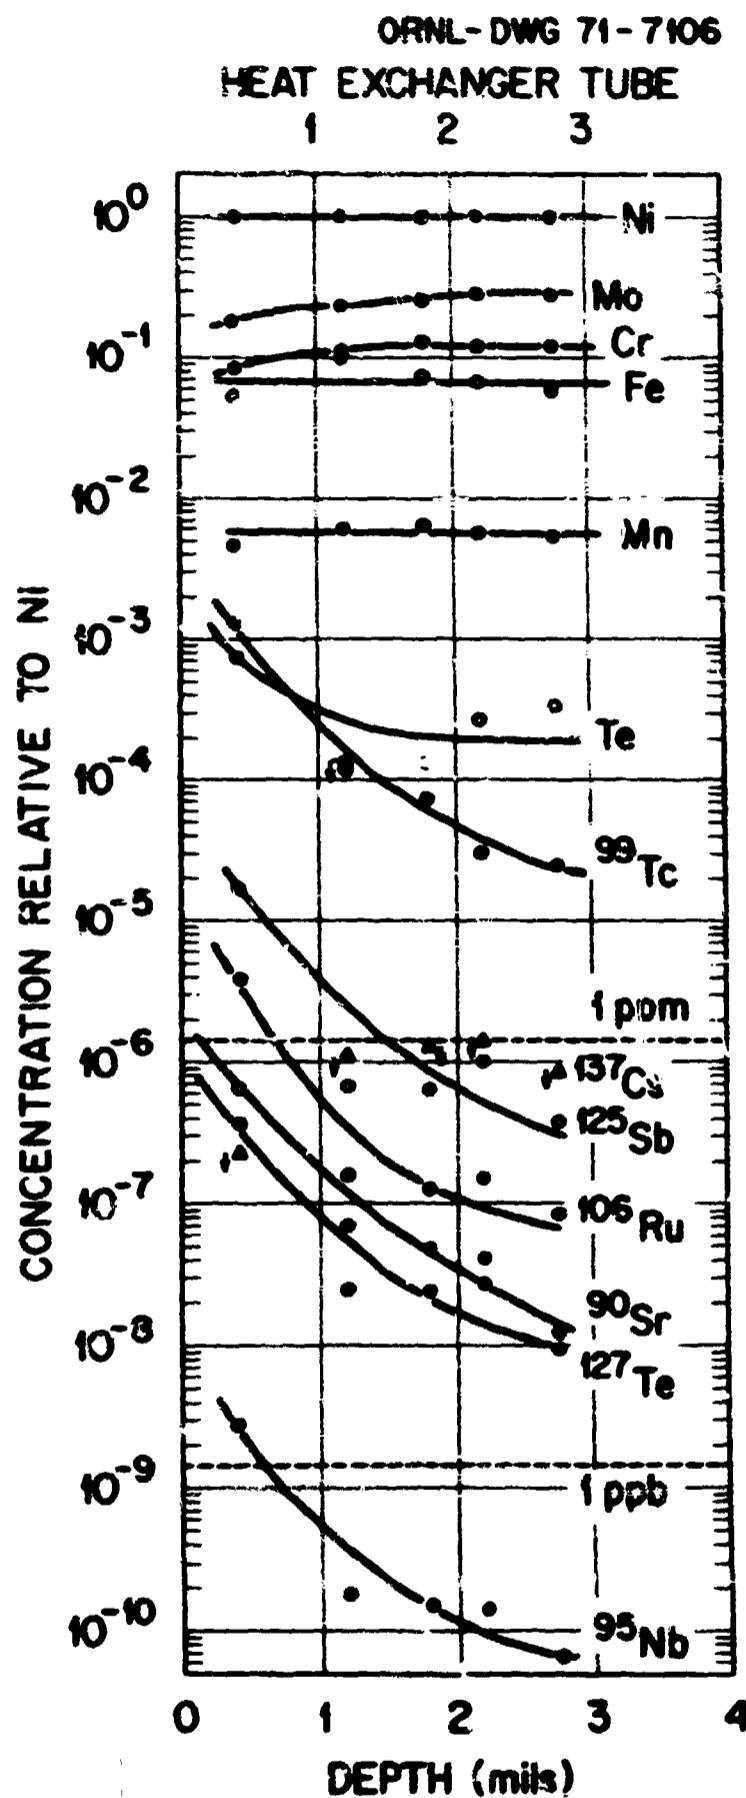
Two of the better profiles are shown in Fig. 110 and 111. The sample in Fig. 110 was a segment of heat exchanger tubing. Epoxy was cast inside to mask the surface that was exposed to coolant salt. The sample in Fig. 111 was a surveillance sample. We made diametral measurements with a micrometer, but these were not very accurate. We actually obtained the depth measurements by calculation from the measured nickel concentrations using the supplemental knowledge that the alloy was 70% Ni and that the volume of the solution was 140 cc.

Fig. 110. Concentration Profiles from the Fuel Side of a MSRE Heat Exchanger Tube. Arrows indicate that analytical values were reported as being less than the indicated point.

1. Several of the fission products penetrated the metal to depths of a few mils (Figs. 110 and 111).
2. The fission products Te, Ce, Sb, Sr, and Cs were concentrated in the cracked regions of a strained surveillance specimen. Sulfur and phosphorous were also concentrated in these same regions. It is possible that the segregation of sulfur and phosphorus to the grain boundaries in this alloy is a normal phenomenon.
3. Significant fractions of the total amounts of Te, Sb, Ru, and Tc were deposited on the metal surfaces.

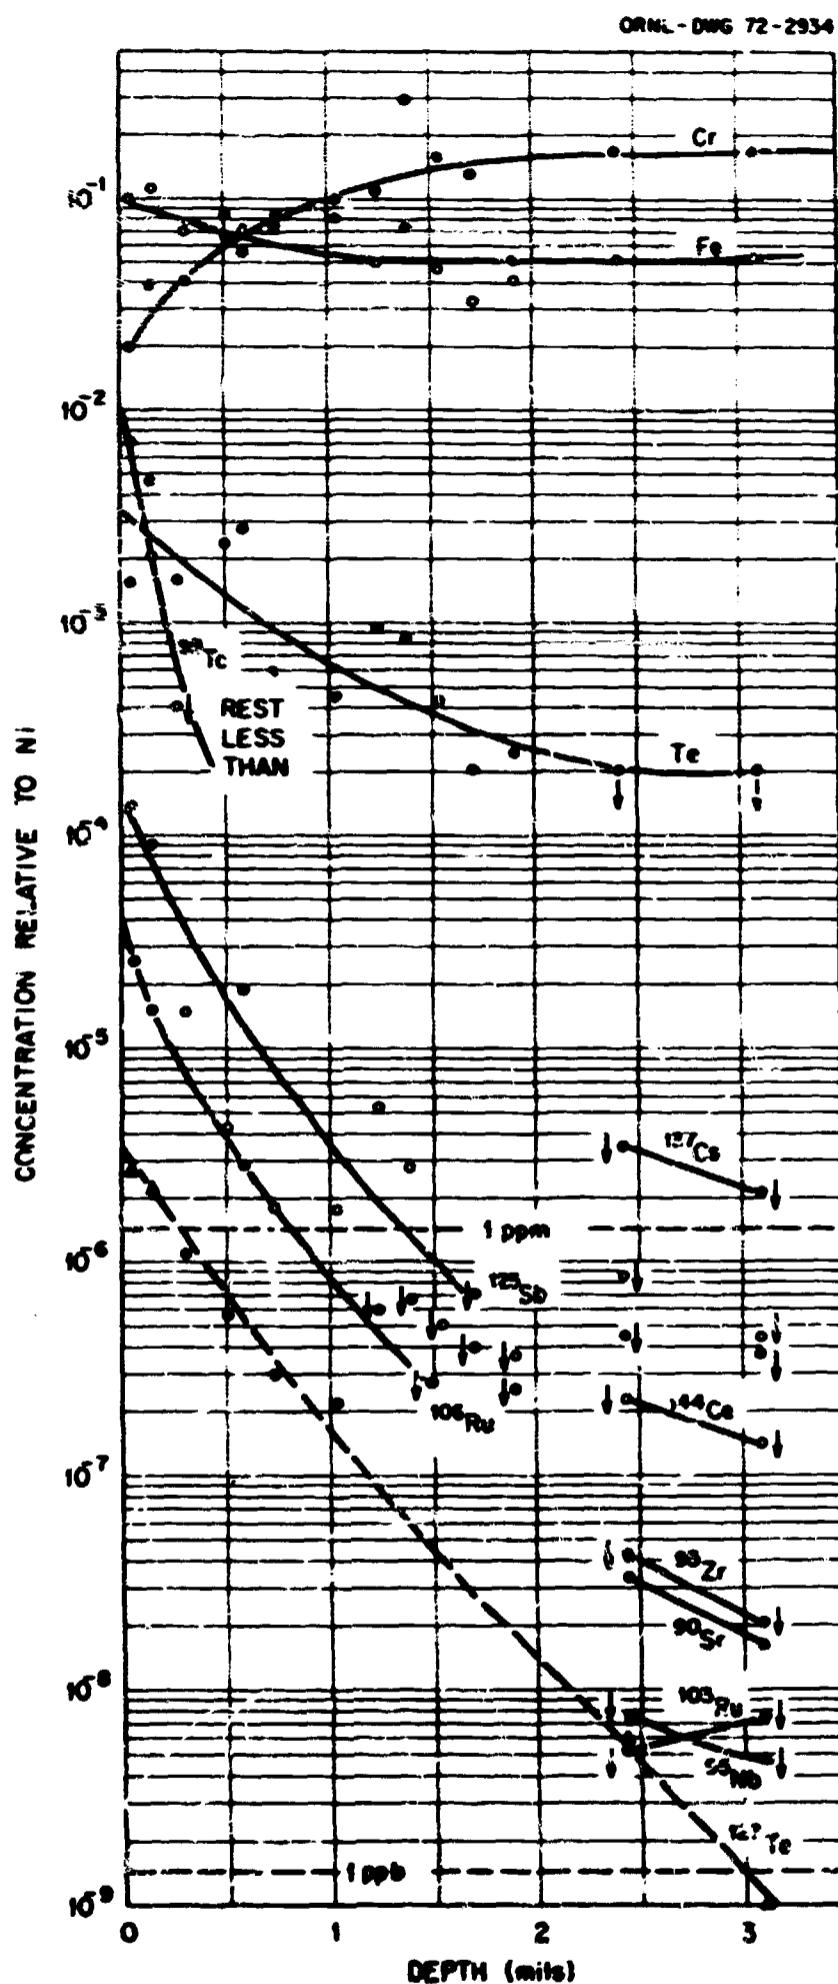
Fig. 111. Concentration Profiles from a Surveillance Sample Exposed in the MSRE for 19,136 hr. Arrows indicate that analytical values were reported as being less than the indicated point.
