Effect of Conductivity  
Between Fasteners and Aluminum Skin  
On Eddy Current Specimens

David G. Moore  
Sandia National Laboratories  
Federal Aviation Administration  
Airworthiness Assurance NDI Validation Center  
Albuquerque, New Mexico 87185  
(505) 844-7095

M. C. Hutchinson 9503821  
Boeing Commercial Airplane Group  
P.O. Box 3707  
M/S 9U-EA  
Seattle, Washington 98124-2207  
(206) 234-8392

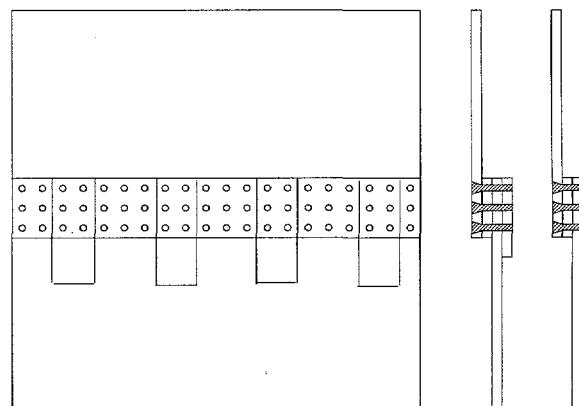
Figure 2. Panel design to simulate  
Boeing lap joint.

The specimens were designed to model pertinent aspects of an in-service 737 lap splice. Each test specimen consists of one mock doubler, four mock tear straps and two aluminum skins riveted together with a 76.2 mm (3") overlap (Figure 2). Programmed fatigue cracks were grown in aluminum sheets and placed as the lower skin. The spacing of the tear straps was varied to simulate manufacturing tolerances. Since the tear straps create a major source of noise for the eddy current inspection, the number of tear straps per unit length of lap splice was doubled. This gives an inspector a larger number of tear strap inspection sites with a minimum number of samples. The eddy current inspection is also effected by the skin thickness of the lap splice. Therefore, the top two layers of the specimens (upper skin and doubler) had two thickness values - 1.83 mm (0.072") and 2.03 mm (0.080"). The programmed fatigue cracks were created from starter notches at select locations. The lower skin panels were then cycled until the desired length of fatigue crack was reached. Starter notches were removed by drilling the final holes for fastener installation.
