Plutonium-239/Beryllium Neutron Source Surveillance and Testing

R. D. Madding, Jr. and R. E. Vallée

February 15, 1973

MOUND LABORATORY

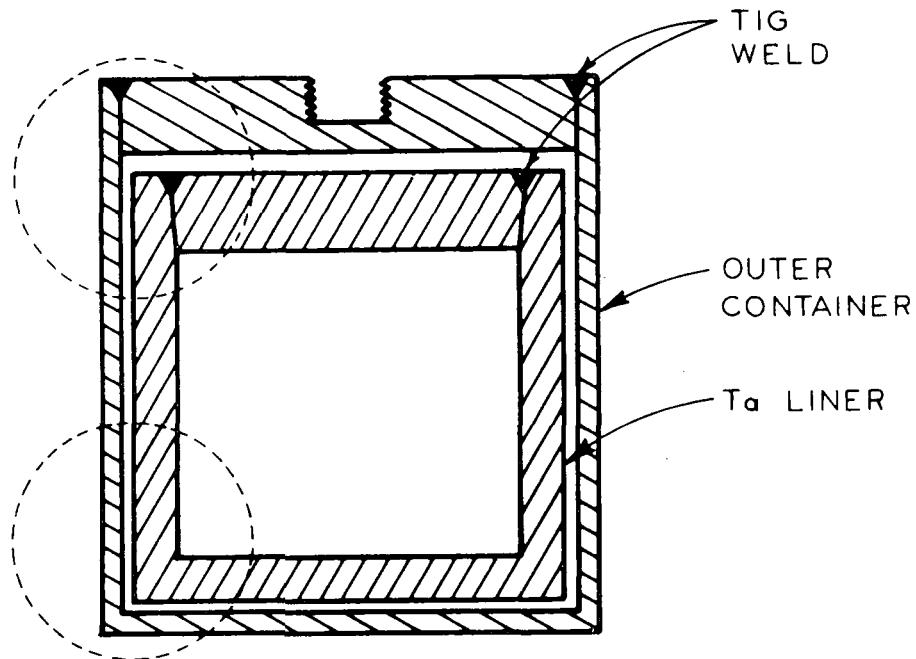
FIGURE 5 - Source areas subjected to metallographic examination (indicated by dotted circles).

Results During sectioning, various visual observations were made on each source and these are summarized in Table 6. With the exception of source M-1019 no visible cracks were noted in the outer container. Table 7 summarizes the results obtained during metallographic examination. From this table it can be seen that a few small cracks were found. The two sources, M-71 and M-1053-S, were the most severely cracked. Photomicrographs of these two sources are shown in Figures 6 and 7. Electron microprobe analysis was performed on the crack shown in Figure 6. No difference in composition was found in the region immediately adjacent to the crack and the second phase boundaries away from the crack. These areas were slightly enriched in oxygen, silicon, sulfur, and carbon with slight depletion in iron. This merely suggests a concentration of impurities which results when the lower melting constituent solidifies last. Microhardness values measured in the weld area varied between 150 and 200 Diamond Pyramid Hardness (DPH) which is typical of stainless steel. It is not expected that under normal conditions that these cracks would continue to propagate. It is also possible that the cracked areas are rather localized and are not necessarily continuous around the weld.
