NUREG/CR-6456
INEL-96/0089
AEOD/E97-01

Review of Industry Efforts To Manage Pressurized Water Reactor Feedwater Nozzle, Piping, and Feedring Cracking and Wall Thinning

Prepared by
V. N. Shah, A. G. Ware, A. M. Porter

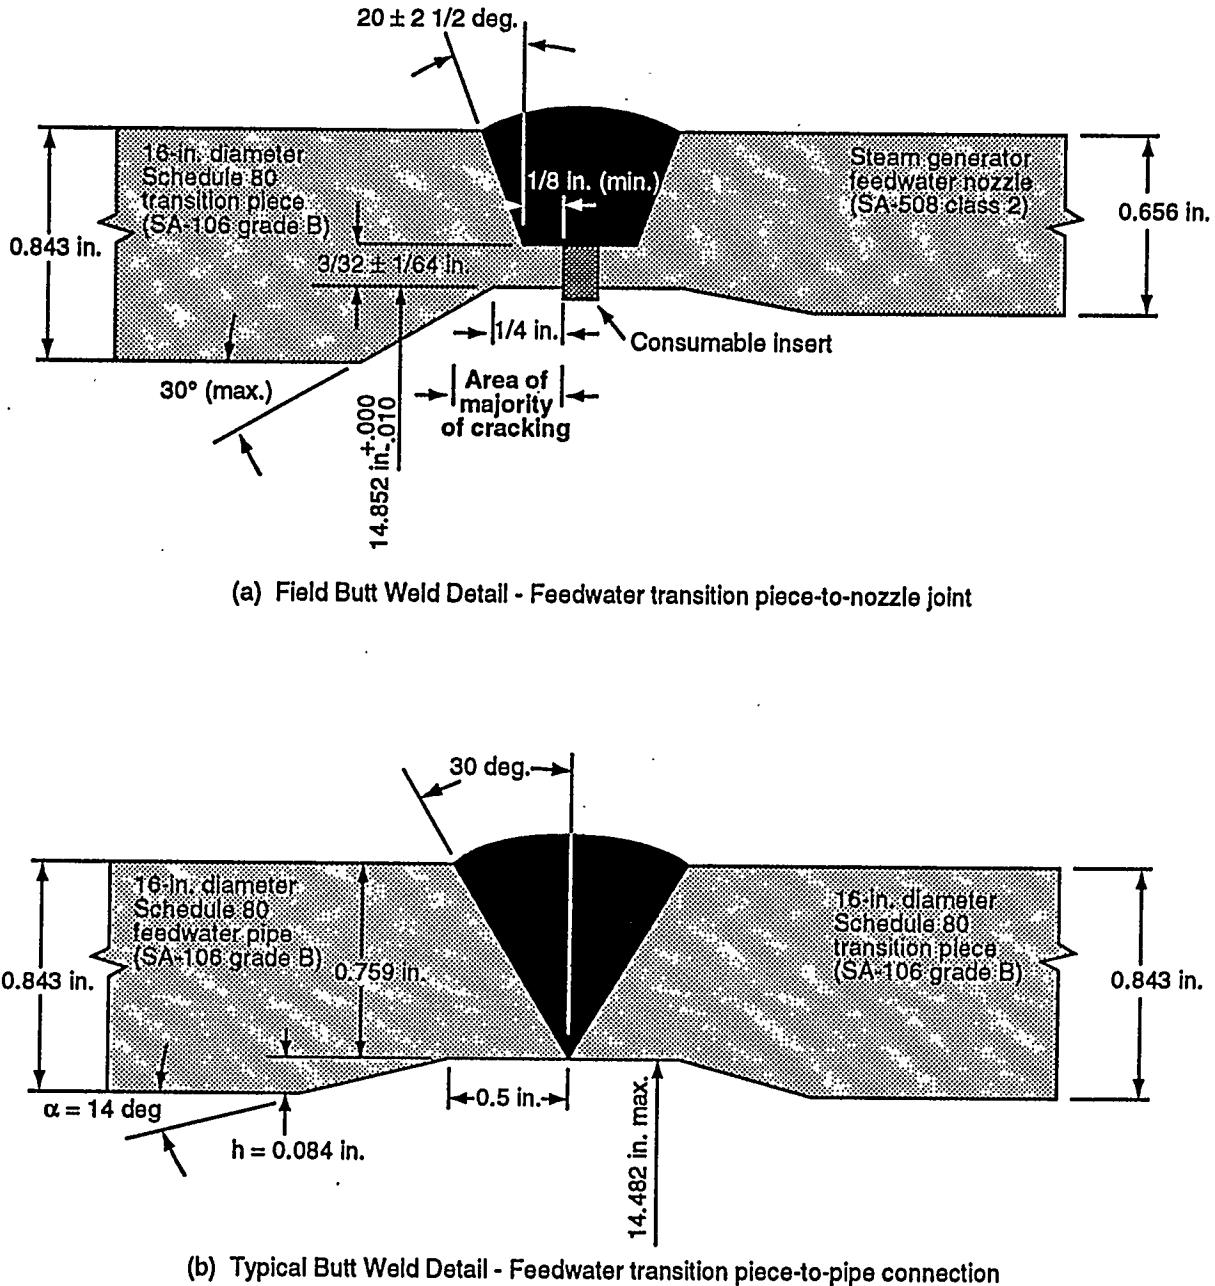
Figure 17 shows configurations for the Diablo Canyon nozzle-to-pipe and pipe-to-pipe welds (Cofie et al., 1994). The 230-mm (16-in.), Schedule 80 piping [nominal thickness 21.4 mm

(0.843 in.)] meets the Schedule 60 nozzle [nominal thickness 16.7 mm (0.656 in.)]. The weld preparation counterbore reduces the thickness, as measured in one nozzle, to as low as 13.7 mm (0.54 in.).

Figure 17. Construction drawings for feedwater nozzle and piping welds at Diablo Canyon Units 1 and 2 (Cofie et al. 1994). Copyright American Society of Mechanical Engineers; reprinted with permission.

The thickness transition is significantly more severe than for a typical piping system butt weld and introduces a high stress concentration. The field weld sometimes makes the discontinuity more severe, resulting in a higher stress concentration. For example, as shown in Figure 18, the notch caused by the weld penetration makes an angle β

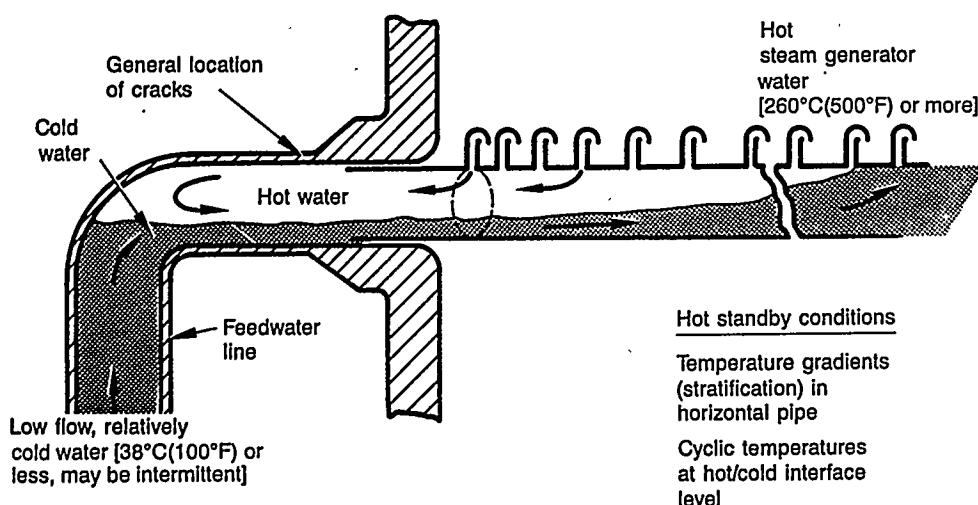
Figure 19 shows such a low-flow condition during hot standby. The upper portion of the pipe fills with hot steam or water from the steam generator while the bottom portion is filled with relatively cold auxiliary feedwater. The figure also shows the general location of fatigue cracks produced by thermal stratification. The height of the interface layer between cold and hot coolants in the pipe depends on the auxiliary feedwater flow rate, the temperature difference between the coolants, and the piping layout. The height increases as the auxiliary feedwater flow rate increases, and it fluctuates as the flow rate is increased and decreased to maintain the steam generator water level. While the steam dumps are cycling open and closed, there is a corresponding on and off cycling of the auxiliary feedwater. When the auxiliary feedwater flow rate is increased above a threshold flow rate, the cross section of the horizontal piping connected to the nozzle becomes completely filled with cold feedwater, and thermal stratification is no longer present. The threshold flow rate depends on the same parameters on which the height of the interface layer depends. Therefore, the threshold flow rates are different at different plants. For example, the threshold flow rate at the Diablo Canyon plants is about 757 l/min (200 gpm). The threshold flow rate is higher,

Figure 19. Flow stratification in PWR feedwater nozzle during low flow conditions (USNRC 1980).

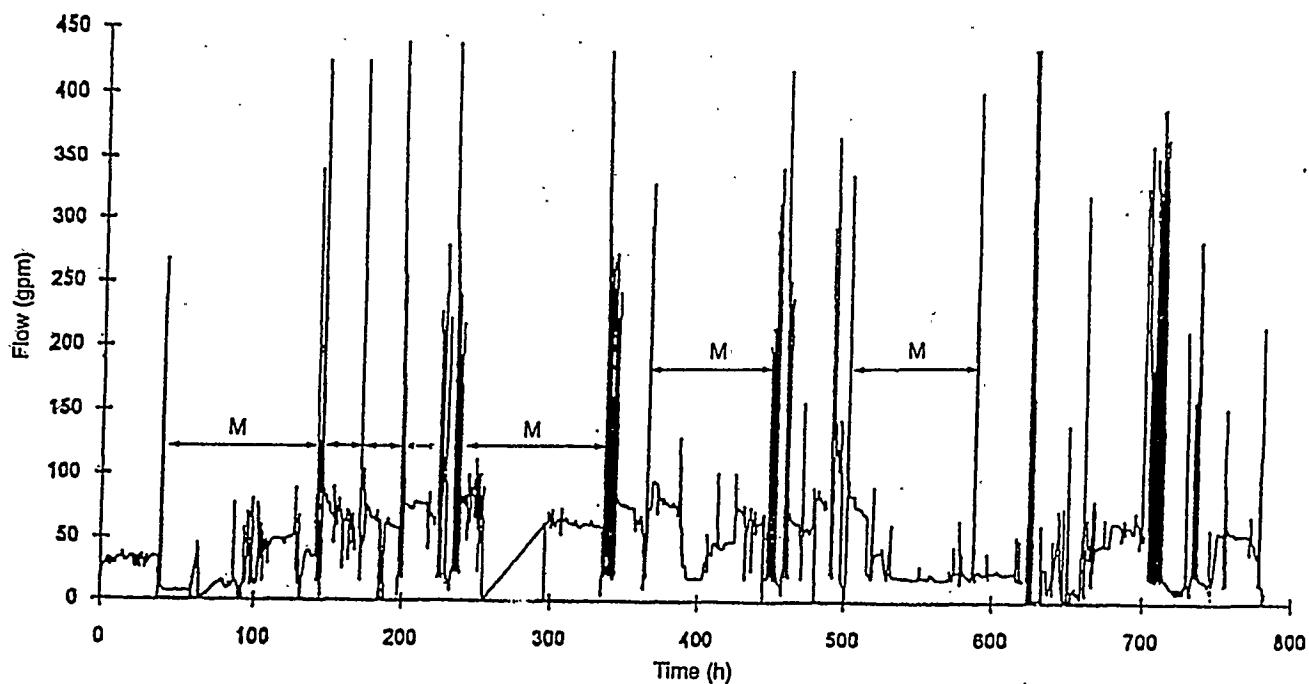
Figure 20 shows a typical history of auxiliary feedwater flow rates measured at Sequoyah Unit 1 during Modes 2 and 3 operation (Cofie et al

Figure 20. Auxiliary feedwater flow for Sequoyah Unit 1 showing automatic and manual controls (Cofie et al. 1994). Copyright American Society for Mechanical Engineers; reprinted with permission.

80 gpm). However, automatic auxiliary feedwater control resulted in large flow cycles from 0 to 757-1514 l/min (200-400 gpm) at frequencies of about 2 cycles/h. Though the automatic control accounted for only 13% of the total time, severe fluctuations in the flow rates occurred during automatic control that caused significant fatigue damage. Figure 21 shows typical periods of automatic and manual feedwater flows at Sequoyah Unit 2 (Shvarts et al. 1994). Obviously, the time of automatic auxiliary feedwater use is important for fatigue crack growth.

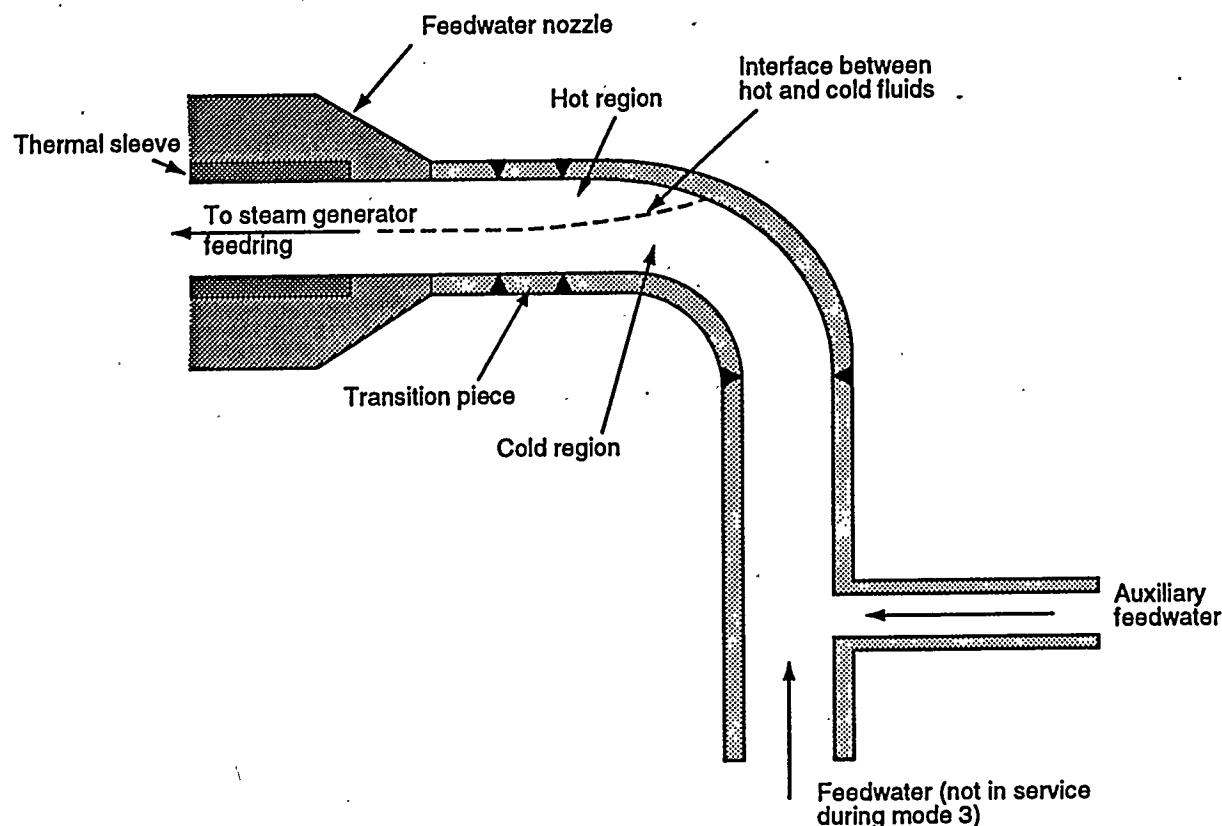
Figure 25. Stratified flows during operation of auxiliary feedwater system (TVA 1992a).

During periods of auxiliary feedwater operation, the flow partially fills the horizontal portion of the nozzle region, leading to the stratified fluid condition shown in Figure 25. The cold auxiliary feedwater [about 20 to 38°C (70 to 100°F)] fills the lower portion of the horizontal portion of the feedwater line and nozzle, and hot fluid [about 286°C (547°F)] from the steam generator fills the upper portion. When the auxiliary feedwater flow is terminated, the nozzle region temperature returns to the hot condition, and then when flow is reinitiated, the stratified condition is reestablished. This on-off auxiliary feedwater operation leads to cyclic thermal stratification. Figure 29 shows typical auxiliary feedwater flow rates with the auxiliary feedwater cycling on and off during automatic operation.

mode of operation, the auxiliary feedwater flows at about 760 l/min and fills the lower half of the feedwater piping cross section as shown in Figure 25. The pipe wall inside surface, near the interface, is probably subject to high-cycle fatigue damage caused by thermal striping.

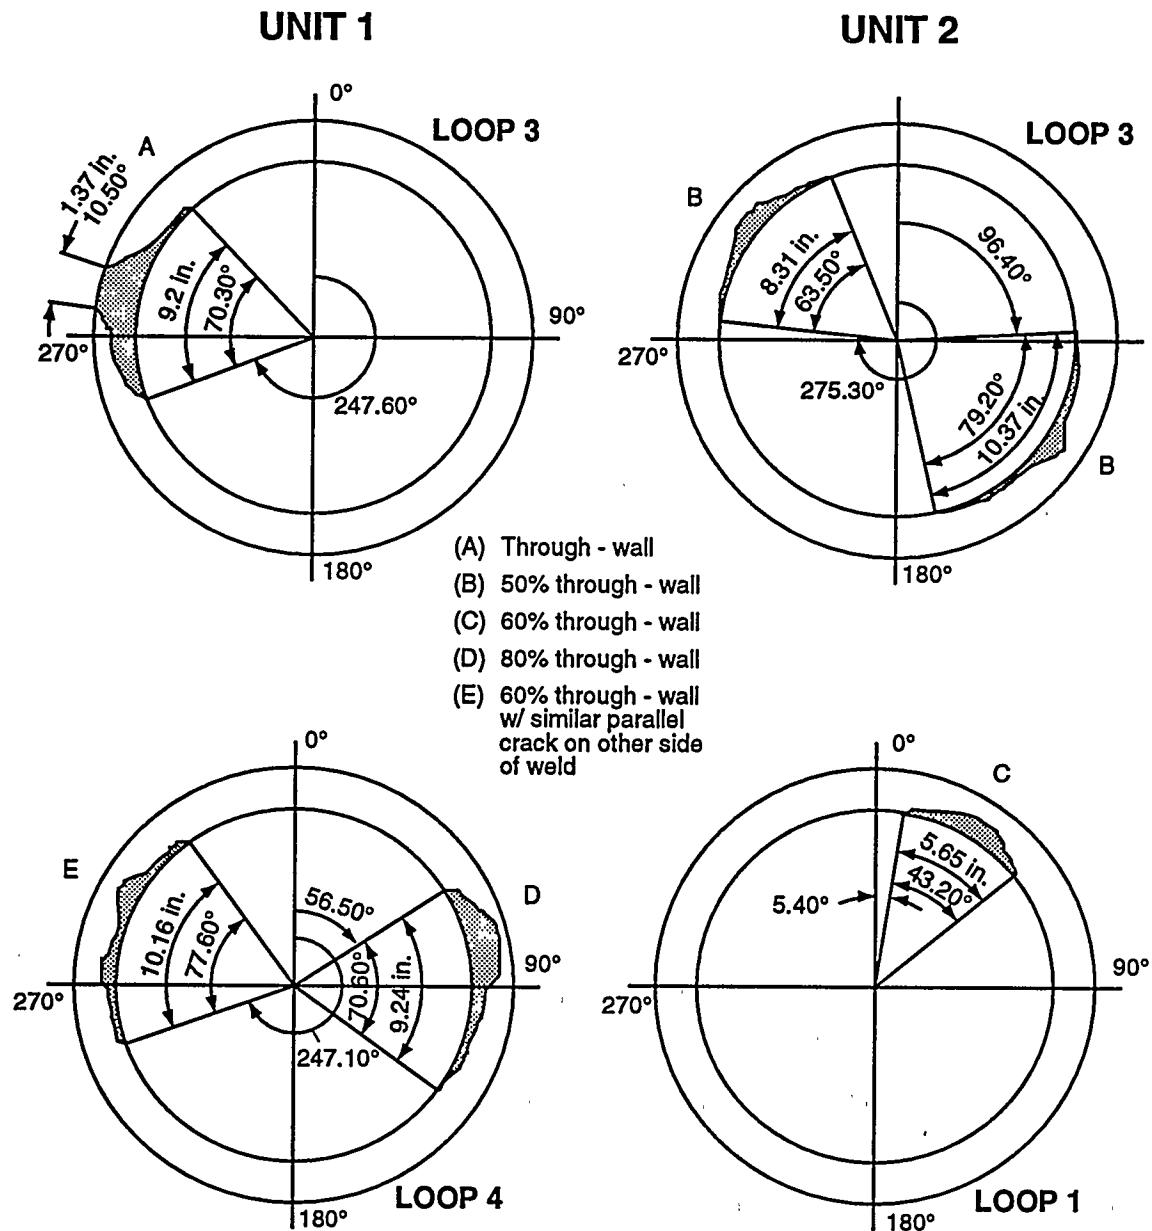
Figure 27 shows the extent and orientation of some of the primary cracks (TVA 1992a). Although only one of the cracks had penetrated the wall, the other five cracks shown were 50 to 80% through-wall. Figure 18 shows the primary and secondary cracking at the 270-degree location of Steam Generator 3 at Unit 1. The cracks on the Unit 1 steam generators were at the 90- and 270-degree locations, which indicates that the elevation of the hot and cold fluid interface might have been at the horizontal centerline of the pipe during periods of auxiliary feedwater operation. Thermal striping at the interface may have caused crack initiation, and the cracks were then propagated by cyclic thermal stratification. The crack locations on Unit 2 are more difficult to explain. The cracks on Steam Generator 3 at Unit 2 were rotated approximately 30 degrees clockwise from the 90-to-270-degree line, and the crack on Steam Generator 1 at Unit 2 was located near the top of the pipe. Two possible

explanations for these asymmetric crack profiles are (a) the elbow may be in a plane inclined to the vertical plane instead of in the vertical plane, or (b) the counterbore may have an asymmetric geometry.

Figure 27. Extent and orientation of primary cracks in feedwater nozzle-to-transition field weld at Sequoyah Units 1 and 2 found in 1992 (TVA 1992a).

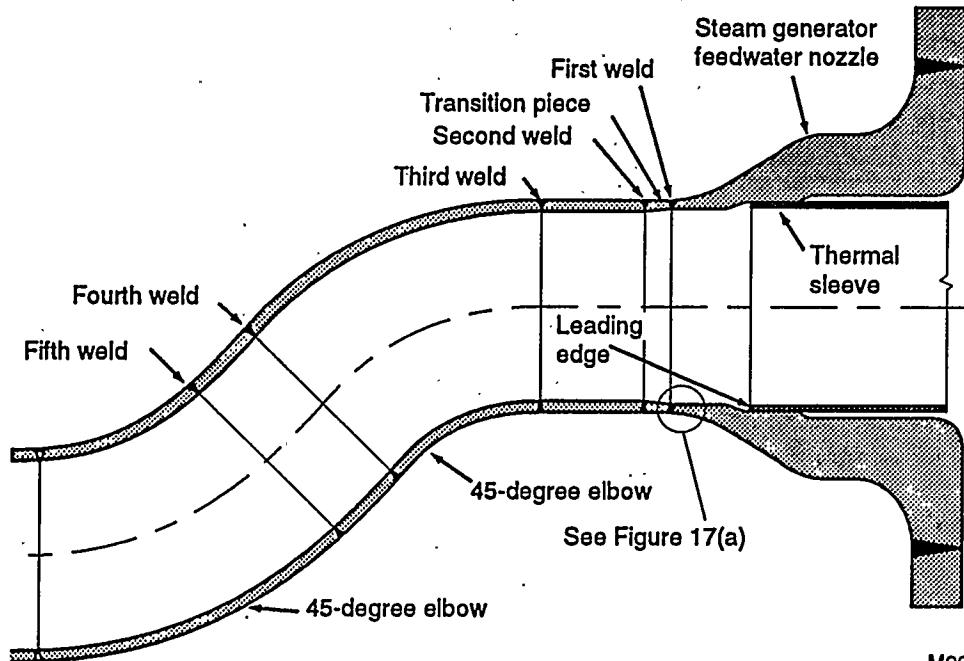
Diablo Canyon Units 1 and 2 are 4-loop Westinghouse PWRs. Figure 32 is a drawing of the SA-508 Class 2 steam generator nozzle and the adjacent SA-106 Grade B feedwater piping, typical for both units. A 51-mm (2-in.) long transition piece was field welded to the nozzle at the downstream end. At its upstream end, it is welded to a 203-mm (8-in.) long horizontal section of pipe, which in turn is welded to a 45-degree elbow. Figure 17 shows a construction drawing of the field welds (Cofie et al. 1994). The inside surfaces were counterbored in this region, resulting in a reentrant corner on each side of the weld at the transition to the thinnest section. Figure 17(a) shows that the thickness change is more pronounced, and the counterbore reentrant angle is

more notched on the upstream side of the transition piece-to-nozzle weld than for either the downstream side of this weld or for a typical transition piece-to-pipe weld counterbore. The transition piece-to-pipe counterbore, shown in Figure 17(b), has a reentrant angle of 166 degrees, versus 150 degrees for the transition piece-to-nozzle weld. Fatigue cracking typically occurs circumferentially around the pipe at the upstream end of the transition piece-to-nozzle weld, where the stress concentration is significantly more severe.

Figure 32. Feedwater nozzle area layout at Diablo Canyon Units 1 and 2 (Shvarts et al. 1994). Copyright American Society of Mechanical Engineers; reprinted with permission.

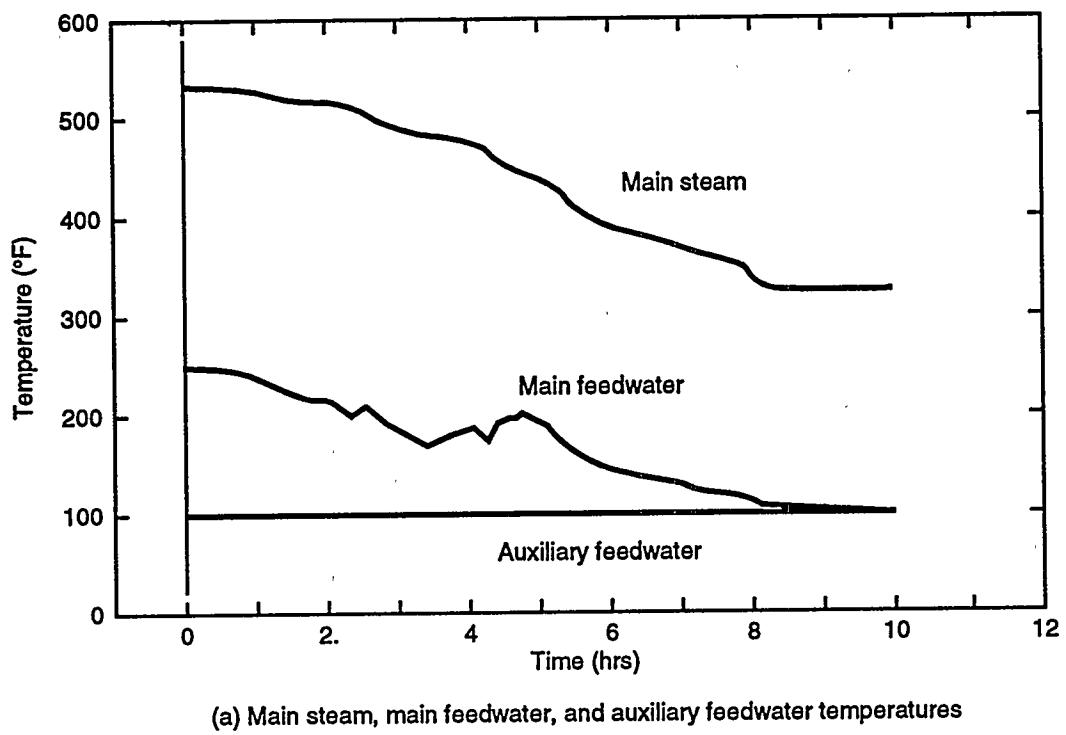
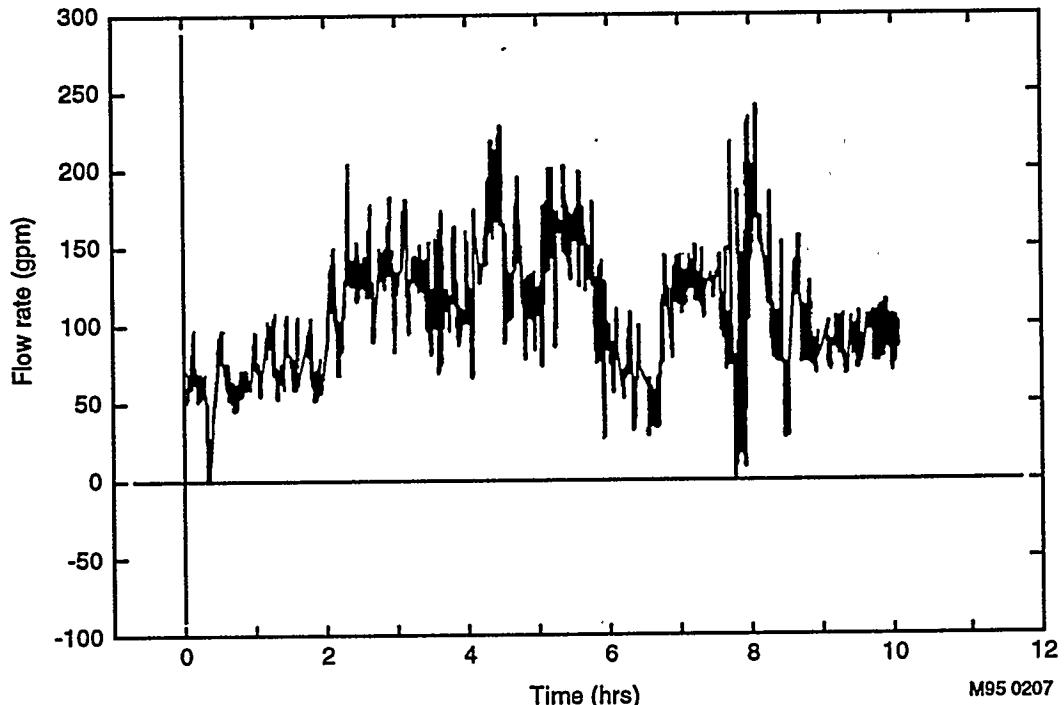
The Diablo Canyon auxiliary feedwater system was designed for minimum flow rates on the order of 830 l/min (220 gpm) per steam generator during accident conditions (PG&E 1992), but as the required flow is typically less than 830 l/min (220 gpm), fluctuations occur during automatic control operation. Figure 33(a) shows the temperatures during a cooldown on Unit 1 in 1992. The main steam temperature has been reduced from about 288 to 177°C (550 to 350°F), and the feedwater temperature has decreased from about 120 to 40°C (250 to 100°F) over about 9 hours, whereas the auxiliary feedwater temperature has remained constant at 38°C (100°F). Figure 33(b) shows the fluctuations in auxiliary feedwater flow rate during this period; the flow rate averages about 380 l/min (100 gpm). Plant data indicate that the auxiliary feedwater does not fill the nozzle until the flow rate reaches about 760 l/min (200 gpm) or more (Shvarts et al. 1994). Cycling involving changes in flow rates of about 380 l/min (100 gpm) occur at a rate of about 2 to 3 times per hour.

Figure 33. Temperatures and flow rate during cooldown on 9/13/92 at Diablo Canyon Unit 1, Steam Generator 1 (Peterson 1992).

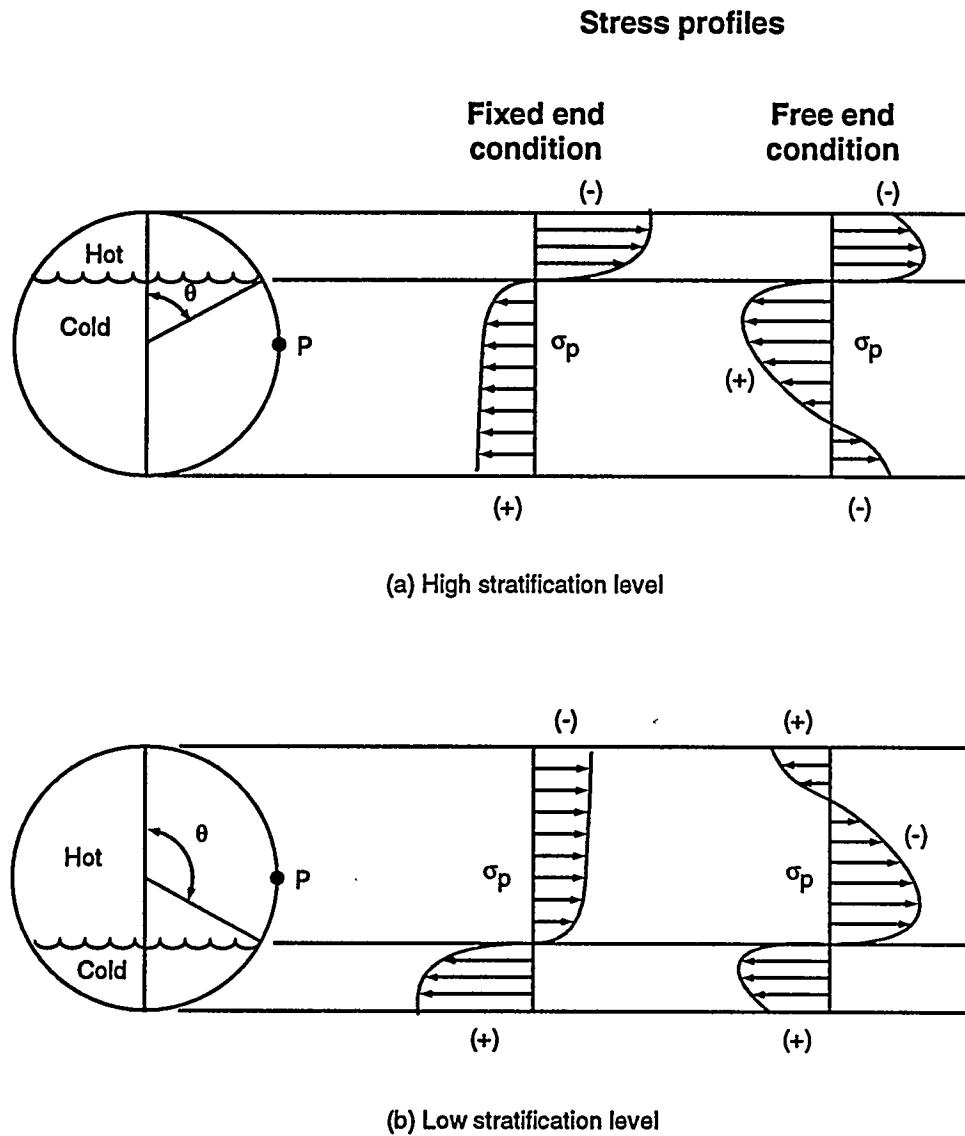
Figure 34 illustrates the flow in a straight feedwater pipe, showing that when the level oscillates from the bottom to the top of the pipe, the stress at location P alternates between tension and compression. In both diagrams of Figure 34, the cold auxiliary feedwater is flowing under a layer of hot fluid, and as auxiliary feedwater flow rate fluctuates, the cold water level increases and decreases, producing cyclic stresses. The true end condition is neither fixed nor free, but is restrained somewhere between the two conditions. However, at point P, the stress reversal is the same. Similarly, damage can occur in the upper region of the pipe when the flow is higher, almost filling the pipe. Thermal striping also may be taking place at the interface between the hot and cold layers.

Figure 34. Distribution of axial stresses in a long horizontal feedwater pipe for two different elevations of hot-and-cold coolant interface and for two different boundary conditions for the pipe ends (Shvarts et al. 1994). Copyright American Society of Mechanical Engineers; reprinted with permission.

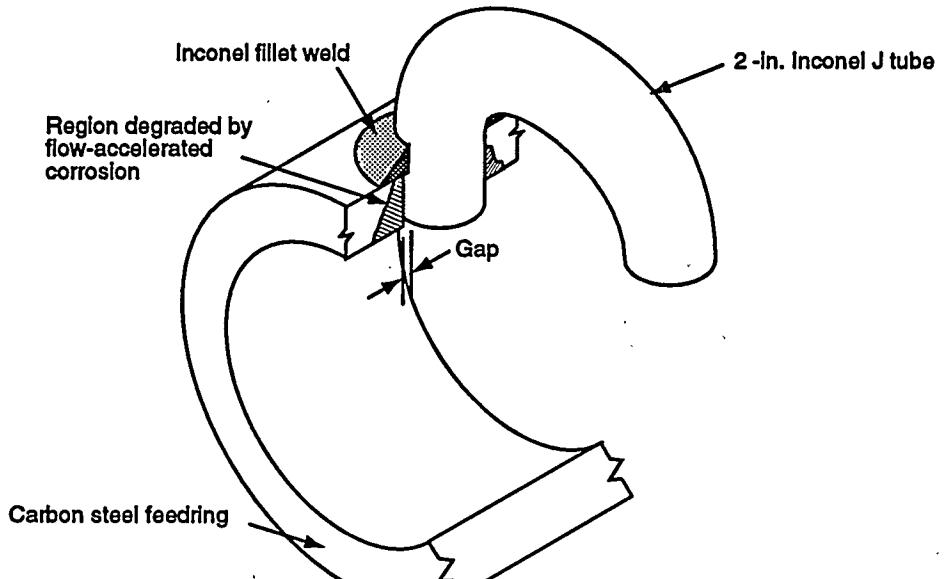
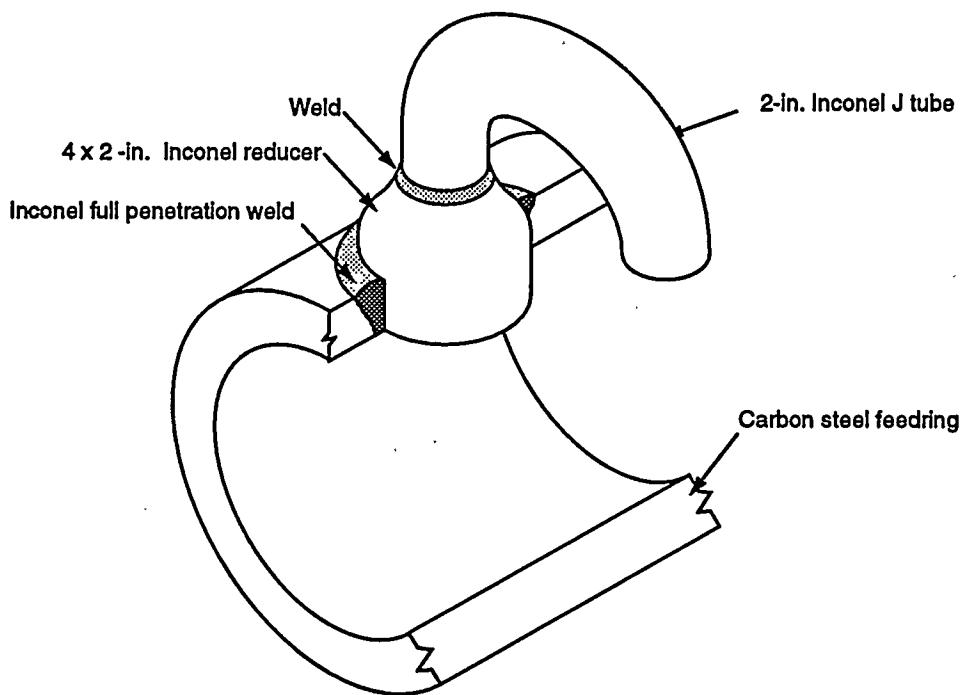
Figure 37. Changes in the Diablo Canyon J-tube design to mitigate flow-accelerated corrosion damage (Thailer, Dalal, and Goyette 1995). Copyright American Society of Mechanical Engineers; reprinted with permission.

Ten J-tubes in Unit 1 and eight in Unit 2 have recently been replaced with a modified design, shown in Figure 37(b). In the modified design, 102 x 51-mm (4 x 2-in.) Schedule 160 reducers (to reduce flow velocity) are welded to the feedring and ground flush with the feedring inside diameter (to reduce turbulence). Then the J-tubes are welded to the reducers. The J-tube length was shortened to maintain the original height above the feedring and the discharge orientation relative to the feedring. Similar damage to the carbon steel feedring at the entrance to the J-tubes was reported at Sequoyah Unit 1 in the early 1980s and a similar repair was performed (Chexal et al. 1996).

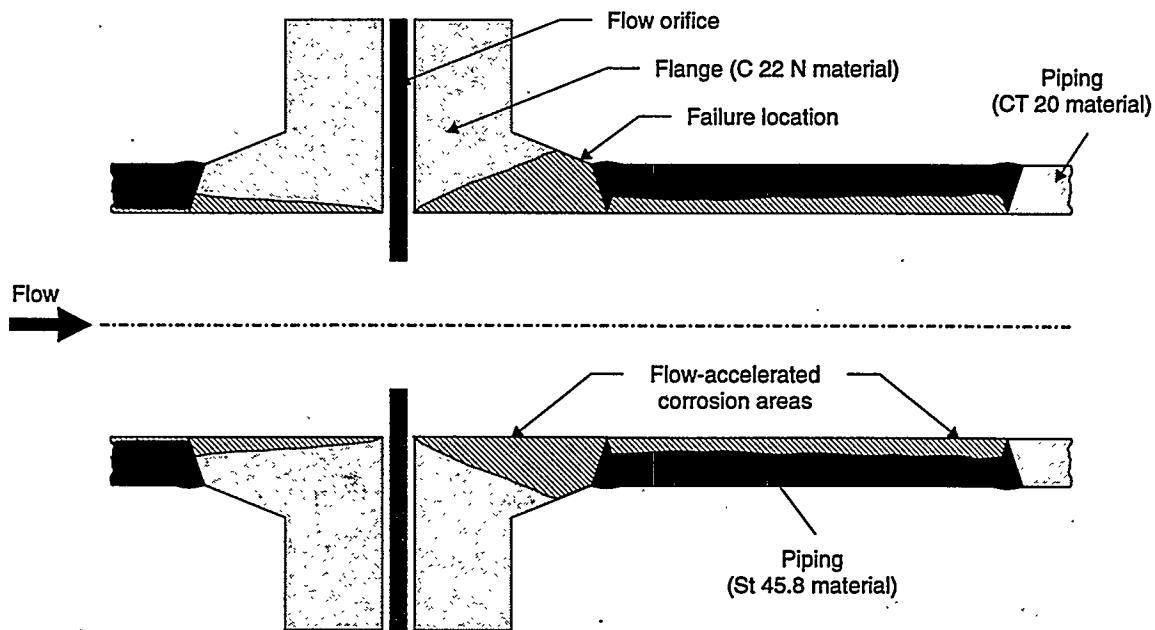
In May 1990, a feedwater pipe at Loviisa Unit 1 ruptured when the plant was operating at full power. The failure location was on the pressure side of a feedwater pump, immediately downstream of the flowmeter flange, as shown in Figure 39. The rupture was caused by a pressure

Figure 39. Loviisa Unit 1 feedwater pipe rupture caused by flow-accelerated corrosion (USNRC 1991a).

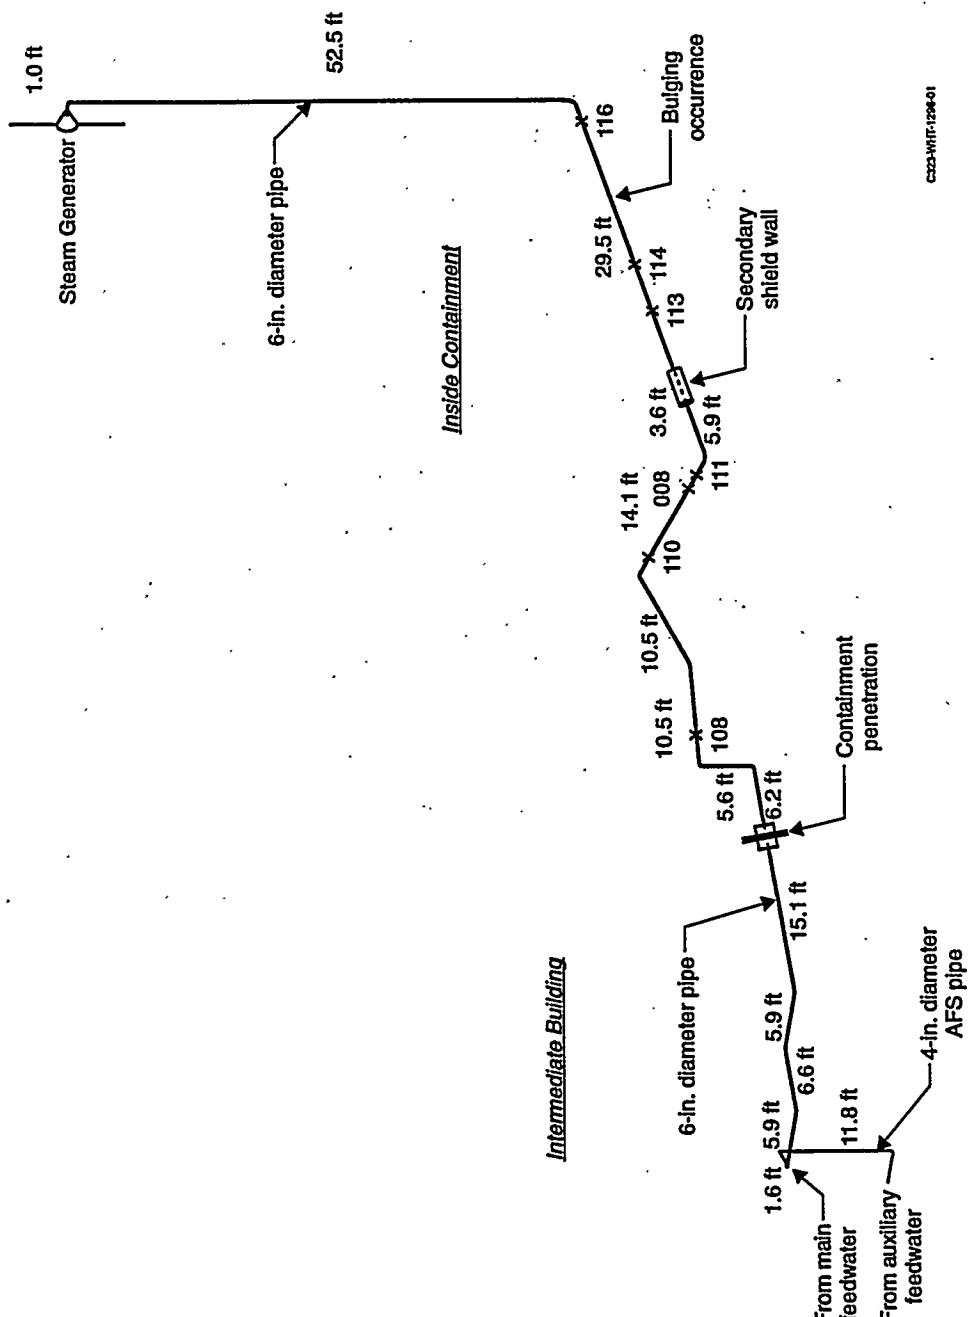
Figure 43. KRSKO Loop 2 auxiliary feedwater systems for KRSKO (Sexton, Kasahara, and Uffer 1982). (1 in = 25.4mm)

The water hammer at KRSKO was caused by a steam bubble collapse in an auxiliary feedwater line during a hot functional test in July, 1981. The horizontal portion of the line where the water hammer occurred was about 16 m (52.5 ft) below the auxiliary feedwater nozzle, as shown in Figure 43. The auxiliary feedwater pumps were being run intermittently during the test. Damage was mainly limited to inside the containment: the piping was shifted and bulged about 6 mm (0.25 in.) near the secondary wall (the probable location of water slug impact), and the pipe hangers were damaged. The piping movement was negligible in the intermediate building but paint on the auxiliary feedwater piping was blistered back to the motor-driven auxiliary feedwater pumps (Sexton, Kasahara, and Uffer 1982).

here. The steam generator water level was below the elevation of the auxiliary feedwater nozzle internal extension discharge. Then the significant back leakage of steam from the steam generator through the auxiliary feedwater line took place and caused the observed paint damage back to the motor-driven auxiliary feedwater pumps. The check valves in the discharge and suction lines of the auxiliary feedwater pumps had to have leaked to allow the back leakage of steam. The significant back leakage also resulted in the presence of steam in the horizontal portion of the auxiliary feedwater line. Then, when the cold feedwater was introduced into this portion of the line, the water hammer caused by steam bubble collapse occurred (Sexton, Kasahara, and Uffer 1982).

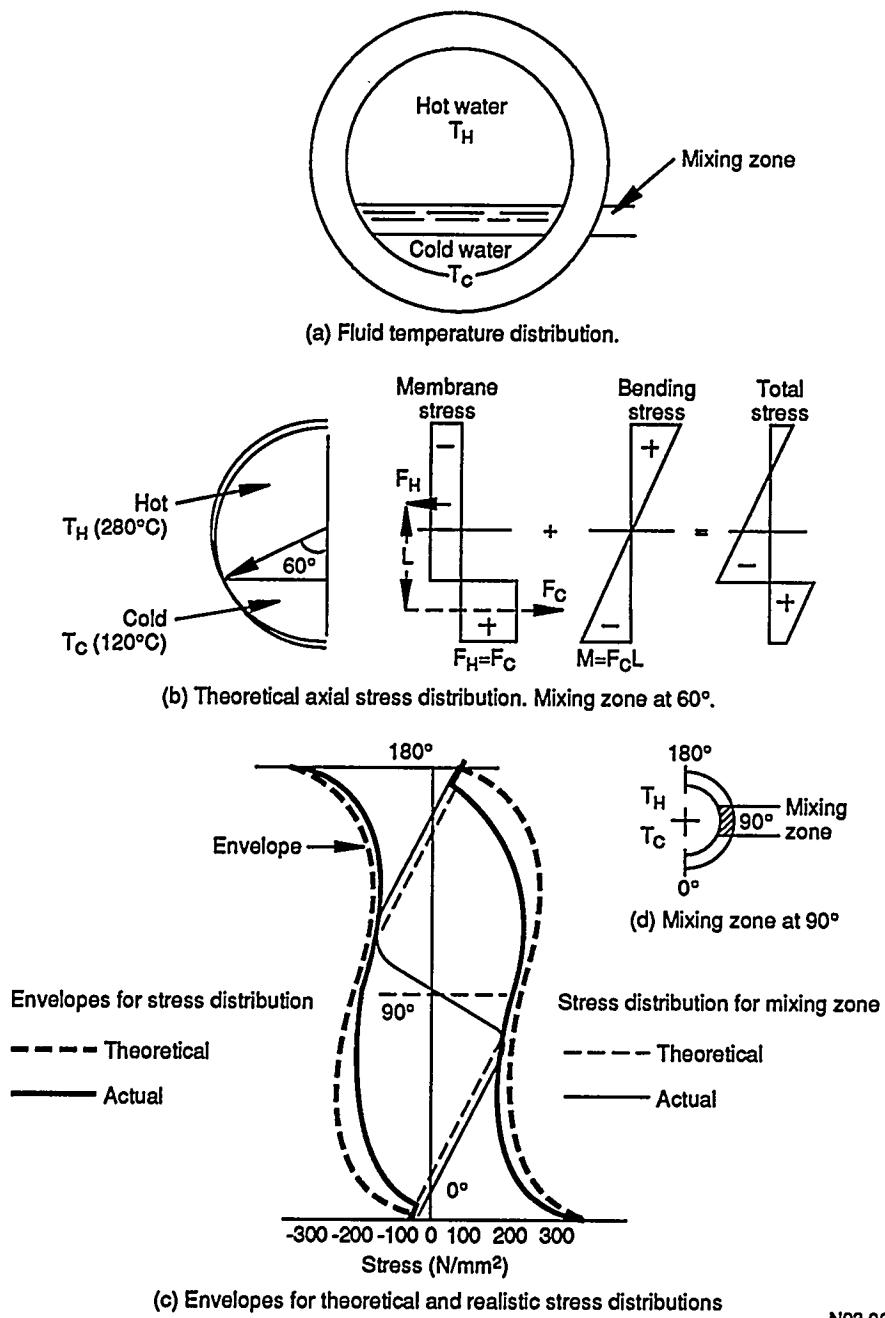
Figure 44. Thermal stresses in a pipe with stratified flow (Mikscha et al. 1985). Copyright Elsevier Science Publishers; reprinted with permission.

An interface layer (mixing zone) is developed between the hot and cold fluid layers, as shown in Figure 44(a) (Mikscha et al. 1985). The elevation of the interface layer (height of the cold fluid layer) and its thickness depend primarily on the mass

Stratified flow introduces through-wall axial and circumferential bending stresses whose magnitudes are determined by the top-to-bottom temperature difference ($T_H - T_C$), and the elevation and thickness of the interface layer. Figure 44(b) shows the theoretical distribution of the axial bending stresses caused by stratified flow when the interface layer is at 60 degrees from vertical. This distribution assumes that the ends of the horizontal section of the piping are constrained from rotation and the thickness of the mixing layer is zero. This stress distribution is comparable to the stress distribution in a bimetallic strip subjected to a uniform temperature change. The resultant axial stresses are presented as the sum of the membrane and bending stresses. The portion of pipe below the mixing layer experiences tensile axial stresses, whereas the portion above the mixing layer experiences predominantly compressive axial stresses. The theoretical maximum axial stresses are near the mixing layer. The axial stresses need to be multiplied by a stress concentration factor introduced by any geometric discontinuity such as the counterbore typically present in the feedwater piping. Distribution of the axial stresses is symmetric with respect to the vertical diameter of the pipe cross section, provided the end constraints and the geometric discontinuity, if any, are also symmetric.

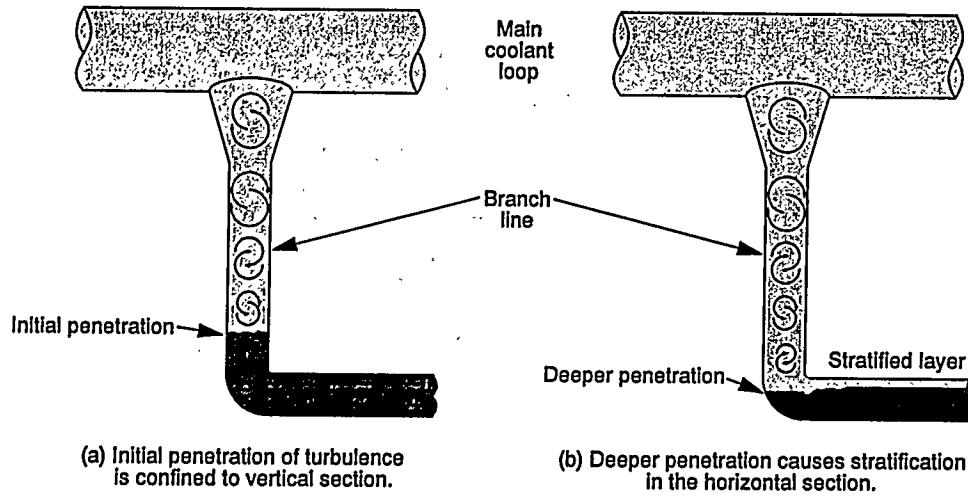
Figure 47. A change in the penetration depth of turbulence from power variations can cause thermal stratification and cycling in a branch line (Martin 1993).

Figure 47(a). Then, an operational transient such as a power change caused the turbulence to penetrate the full length of the vertical section and produce stratification in the elbow at the end and in the adjacent horizontal section of the branch line, as shown in Figure 47(b). With further changes

in power, the length of the turbulent penetration receded and the stratified layer was no longer present. Thus, the base metal and welds of the elbow and the horizontal portion of the branch line experienced cyclic thermal stresses and fatigue damage.

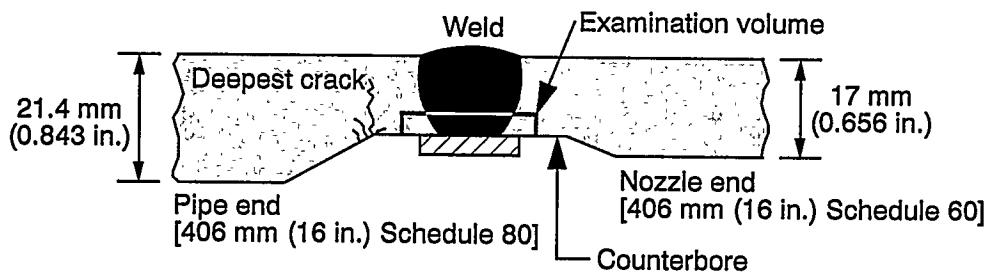
As a result of these inspections, cracking was detected in 18 operating PWRs. The cracks were generally oriented circumferentially and located either at the weld root location or at the reentrant corner of the counterbore on the upstream (pipe) side of the nozzle weld, as shown in Figure 57. The cracking was determined to be caused by thermal fatigue, possibly assisted by the corrosive environment of the secondary system. As shown in the figure, cracking occurred at some plants at the counterbore corner outside the Code examination volume and, therefore, could have been overlooked during previous periodic inservice inspections. Several plants also noted pitting, which was revealed by destructive analysis. Code ultrasonic examination methods employ angle beam techniques (i.e., 45-degree shear waves) designed to detect cracks but not pits. Pit detection requires use of specialized, small-diameter, focused 0-degree probes.

Figure 57. Typical PWR feedwater nozzle-to-pipe weld with geometric discontinuity (counterbore) and cracking outside the Code examination volume.

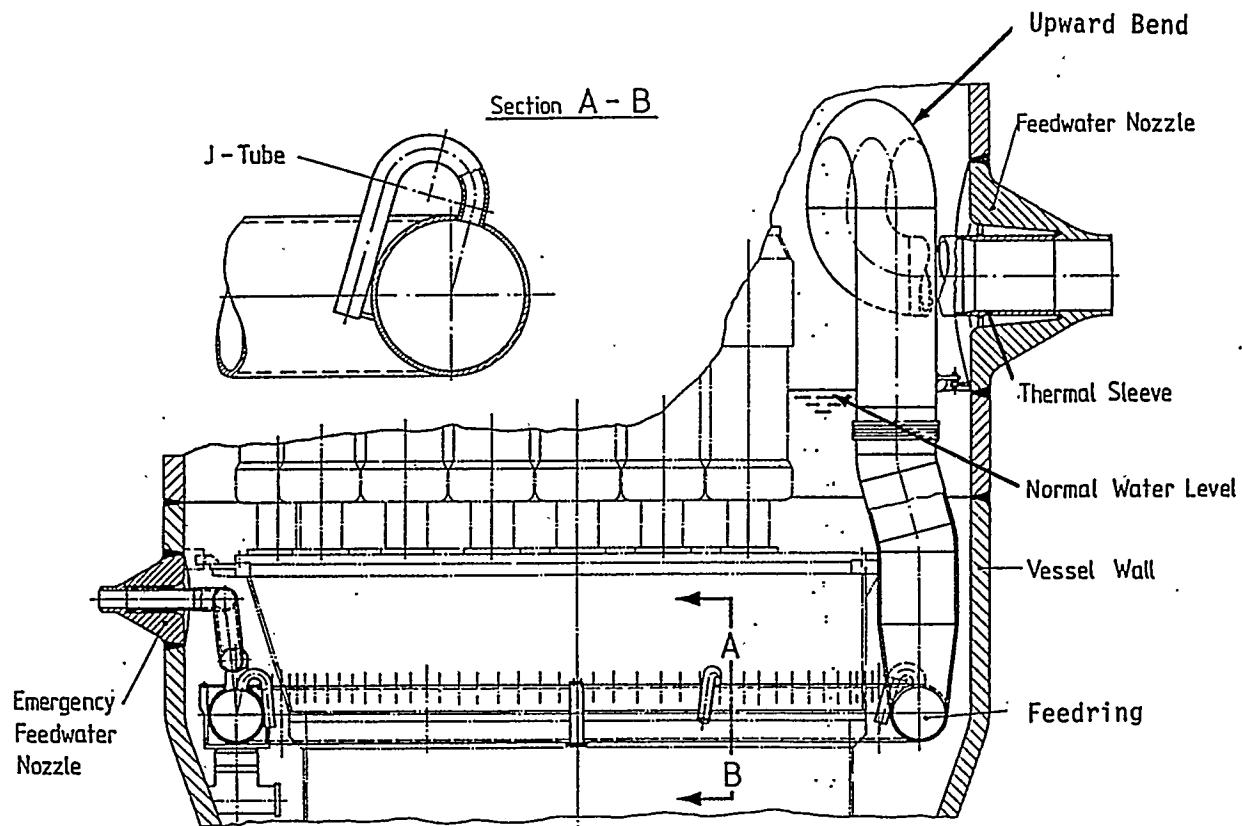
Several design changes have been made in the steam generators designed by Siemens/KWU to reduce or eliminate the possibility of flow stratification taking place. Flow stratification occurred in the horizontal portion of the main feedwater piping attached to the original Siemens steam generators when the flow rate of the main feedwater was low, as shown in Figure 65. This caused cracking in the heat-affected zone and in the base metal near the weld between the feedwater nozzle and the piping (Braschel, Miksch, and Schucktanz 1984). To prevent flow stratification from taking place, an upward bend has been incorporated in the piping connecting the thermal sleeve to the feeding inside the steam generator as shown in Figure 66.

Figure 66. Modified layout of the feedwater distribution piping inside Siemens/KWU steam generators. The upward bend in the piping prevents flow stratification. Courtesy of P.-J. Meyer, Siemens/KWU.

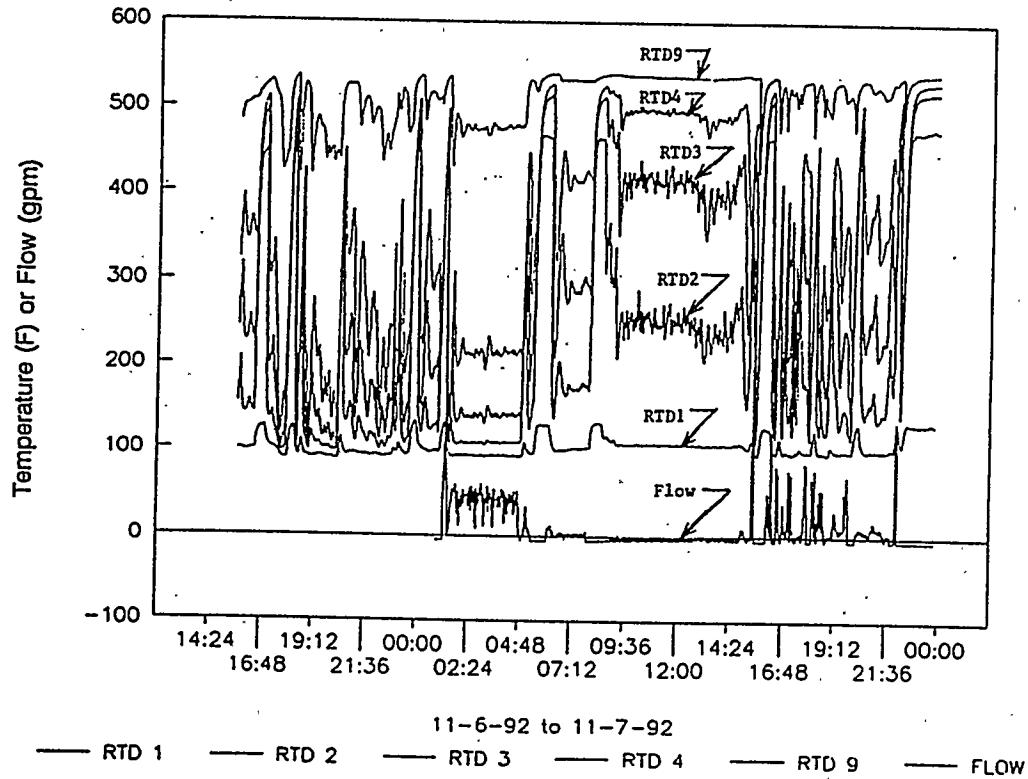
temperature, and flow rate; auxiliary feedwater flow rate; and reactor coolant loop 2 temperature) were collected for the same time period at the same time intervals. The nozzle region was subjected to thermal stratification with a maximum top-to-bottom temperature difference of approximately 232°C (450°F) for about 3½ days. The steam generator was fed exclusively with auxiliary feedwater during this time period. Then the main feedwater flow was established and the auxiliary feedwater flow was terminated during Mode 2 operations and there was no stratification.

Figure 69 shows typical data from five of the nine RTDs and also the auxiliary feedwater flow rate over a 33-hour period. A finite element analysis was used to determine the height of the interface layer of the stratified coolant that would match the measured temperature distribution at the outside surface. Four parameters were varied for this analysis: the inside surface convective heat transfer

Figure 69. Local on-line fatigue monitoring results for feedwater nozzle-to-pipe weld at Diablo Canyon Unit 1 (Shvarts et al. 1994). Copyright American Society of Mechanical Engineers; reprinted with permission.
