NUREG/CR-6220  
SAND94-0769

# An Assessment of Fire Vulnerability for Aged Electrical Relays

Prepared by  
R. A. Vigil, S. P. Nowlen

Prepared for  
**U.S. Nuclear Regulatory Commission**

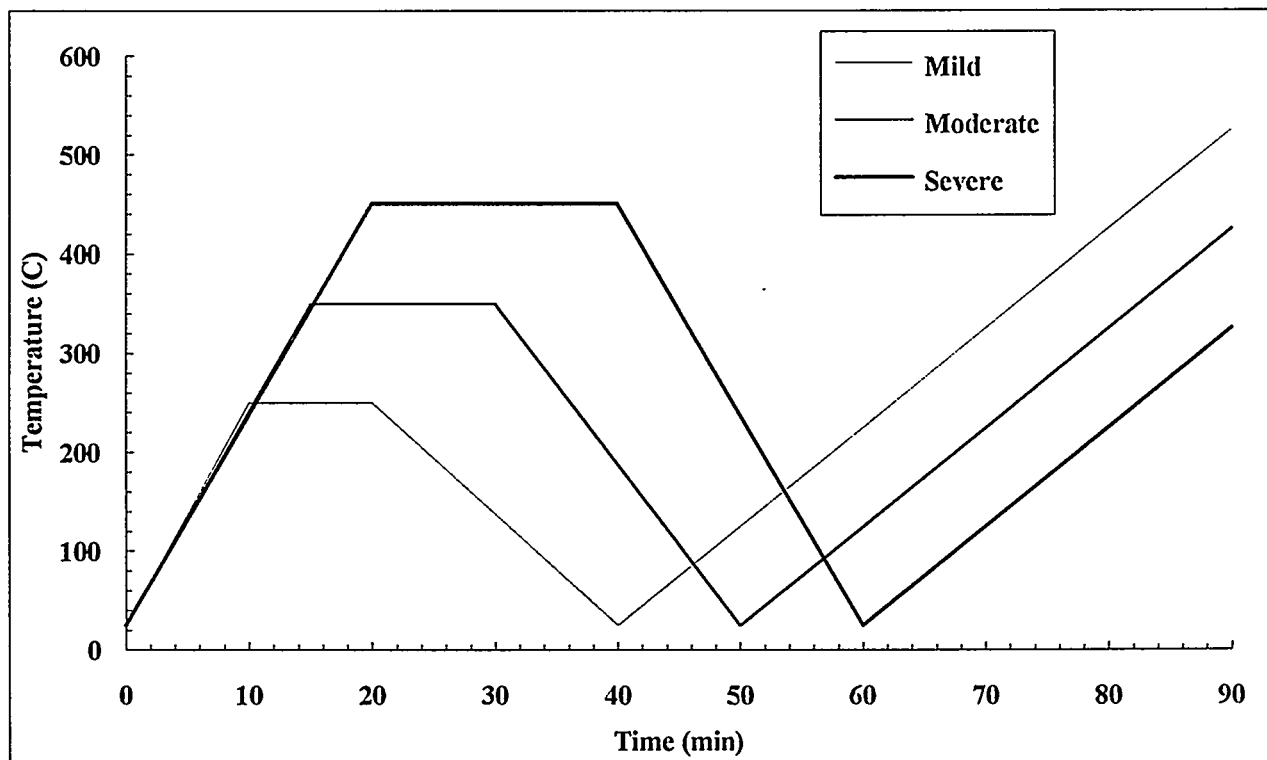
Figure 3 SCETCh temperature exposure profiles

- the exposure temperature was increased from ambient at a rate of approximately 20 °C/min (initial ramp);
- upon attaining a predetermined temperature the exposure was held constant for a specified time (plateau);
- exposure temperature was then decreased toward ambient conditions over a period of approximately 20 minutes (cool-down).

For the mild exposure profile, the initial ramp lasted for approximately 10 minutes, reaching a plateau temperature of 250 °C, which was held for an additional 10 minutes. For the moderate

exposure profile, the initial ramp lasted for approximately 15 minutes, reaching a plateau temperature of 350 °C, which was held for an additional 15 minutes. For the severe exposure profile, the initial ramp lasted for approximately 20 minutes, reaching a plateau temperature of 450 °C, which was held for an additional 20 minutes.

The second phase of each exposure profile consisted of an upward ramp in temperature at a rate of 10 °C/min until relay failure was detected. The relay under test would undergo the second phase if and only if it had survived the first phase of the exposure profile. This second phase of the exposure profile was intended to assess the relative margin by which a relay had survived the initial phase of the exposure profile. For example, if the relay failed at a substantially higher temperature than the first phase plateau temperature, then it could be concluded that the

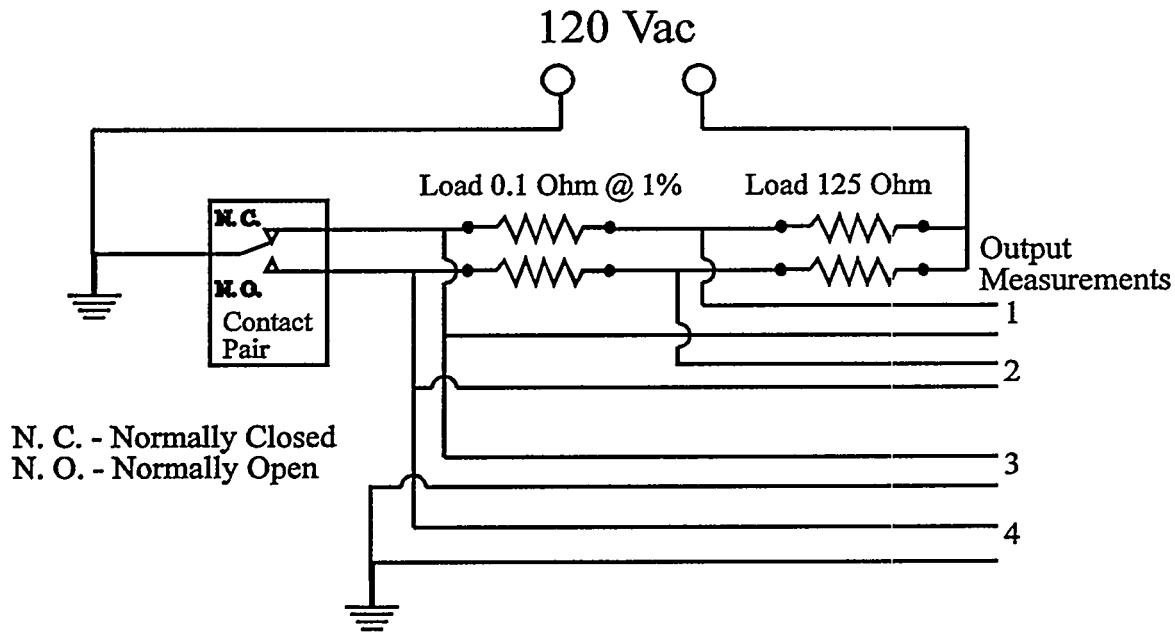
Figure 4 Measurement schematic for each contact set and measurement matrix

Additional measurements made during each measurement cycle included the relay's coil resistance, contact set resistance, and leakage currents. An electrical schematic of the simulated load and performance monitoring circuit used for each contact set is shown in Figure 4. The

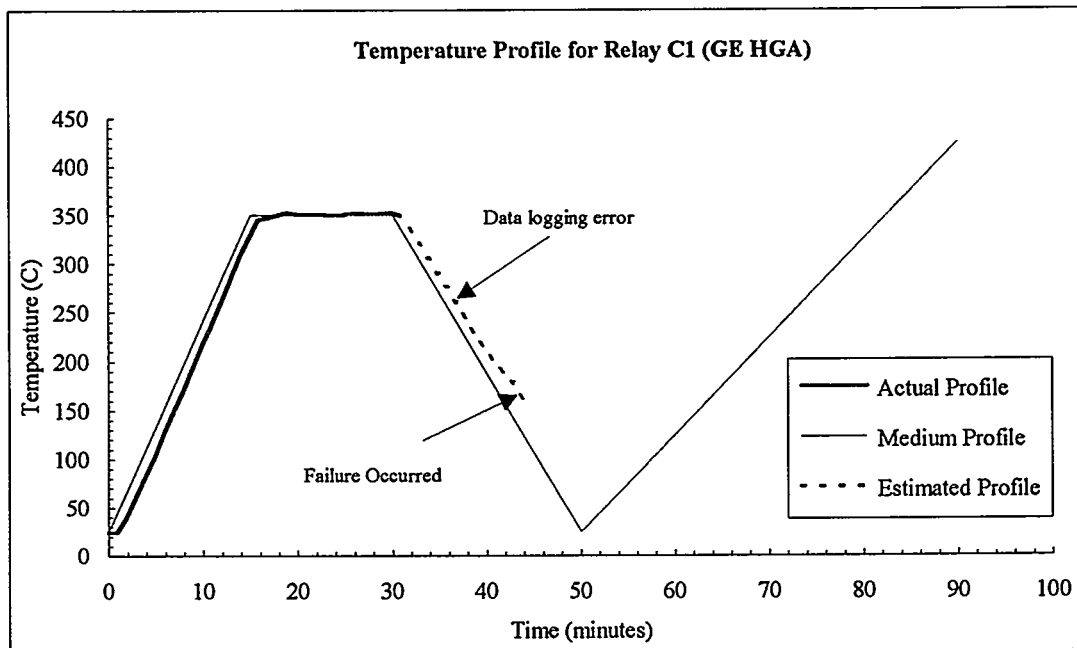
Figure A-11 SCETCh temperature exposure for relay C1

Results for the GE HGA relays indicated that aging did not impact the thermal vulnerability of the relays. However, one of the aged samples displayed a unique failure in that it failed during the cool-down portion of the first phase of the moderate exposure profile. The remaining three relays survived to temperatures in excess of 450 °C. Three of the relay failures were attributed to the accumulation of an unknown substance that formed on the top of the coil's spool just below the armature. The final failure was attributed to deformation of the coil top plate.
