POSTIRRADIATION EVALUATION
OF ZIRCALOY-2 PRTR PRESSURE TUBES

L. J. DEFFERDING

NOVEMBER, 1962

POSTIRRADIATION EVALUATION
OF ZIRCALOY-2 PRTR PRESSURE TUBES
PART I

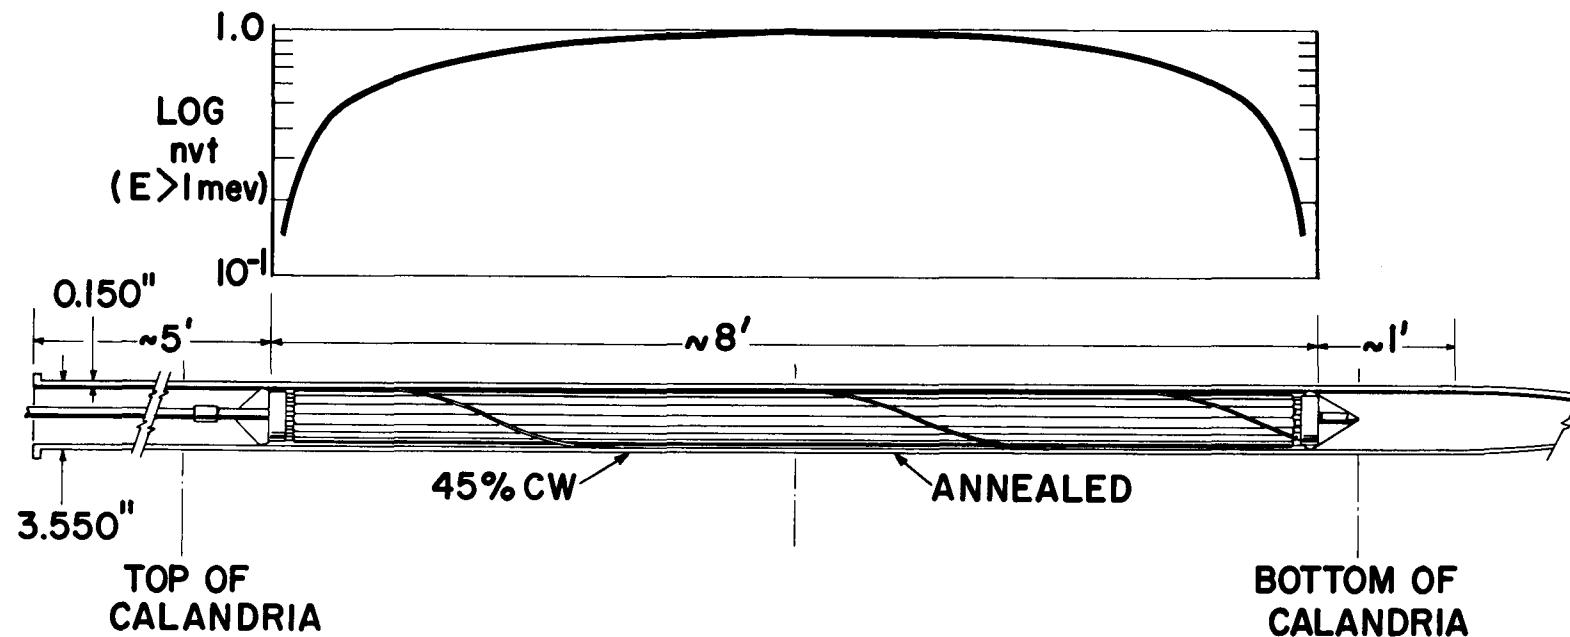
FIGURE 2

support marks and since this is at the end of the active portion of the fuel element there is a very steep gradient of fast neutron exposure (Figure 2). The exposure listed in Table II is that of the middle of the sample. The indicated scatter of burst strength of samples from Location A may be partly due to the difficulty in calculating the neutron exposure at this point. Samples from Location B were selected to determine the effect of total reactor environment on the burst properties. These samples were located in an area where the neutron flux was more uniform and the average exposure was higher. Two samples were taken from these areas. One of these was the only tube where a defect caused the failure at a lower stress than was expected.

PRTR Pressure Tube Assembly Showing Position of Fuel Element in the Tube Relative to Fast Neutron Exposure over the Active Portion of the Element, and the Approximate Location of the Annealed and Cold-Worked Portions of the Pressure Tube
