ENRICO FERMI ATOMIC POWER PLANT

CURRENT EXPERIENCE SERIES

COMPILED OF CURRENT TECHNICAL EXPERIENCE AT ENRICO FERMI ATOMIC POWER PLANT NOVEMBER 1968

PREPARED BY
Atomic Power Development Associates, Inc.
with the Cooperation of
Power Reactor Development Company
and
The Detroit Edison Company

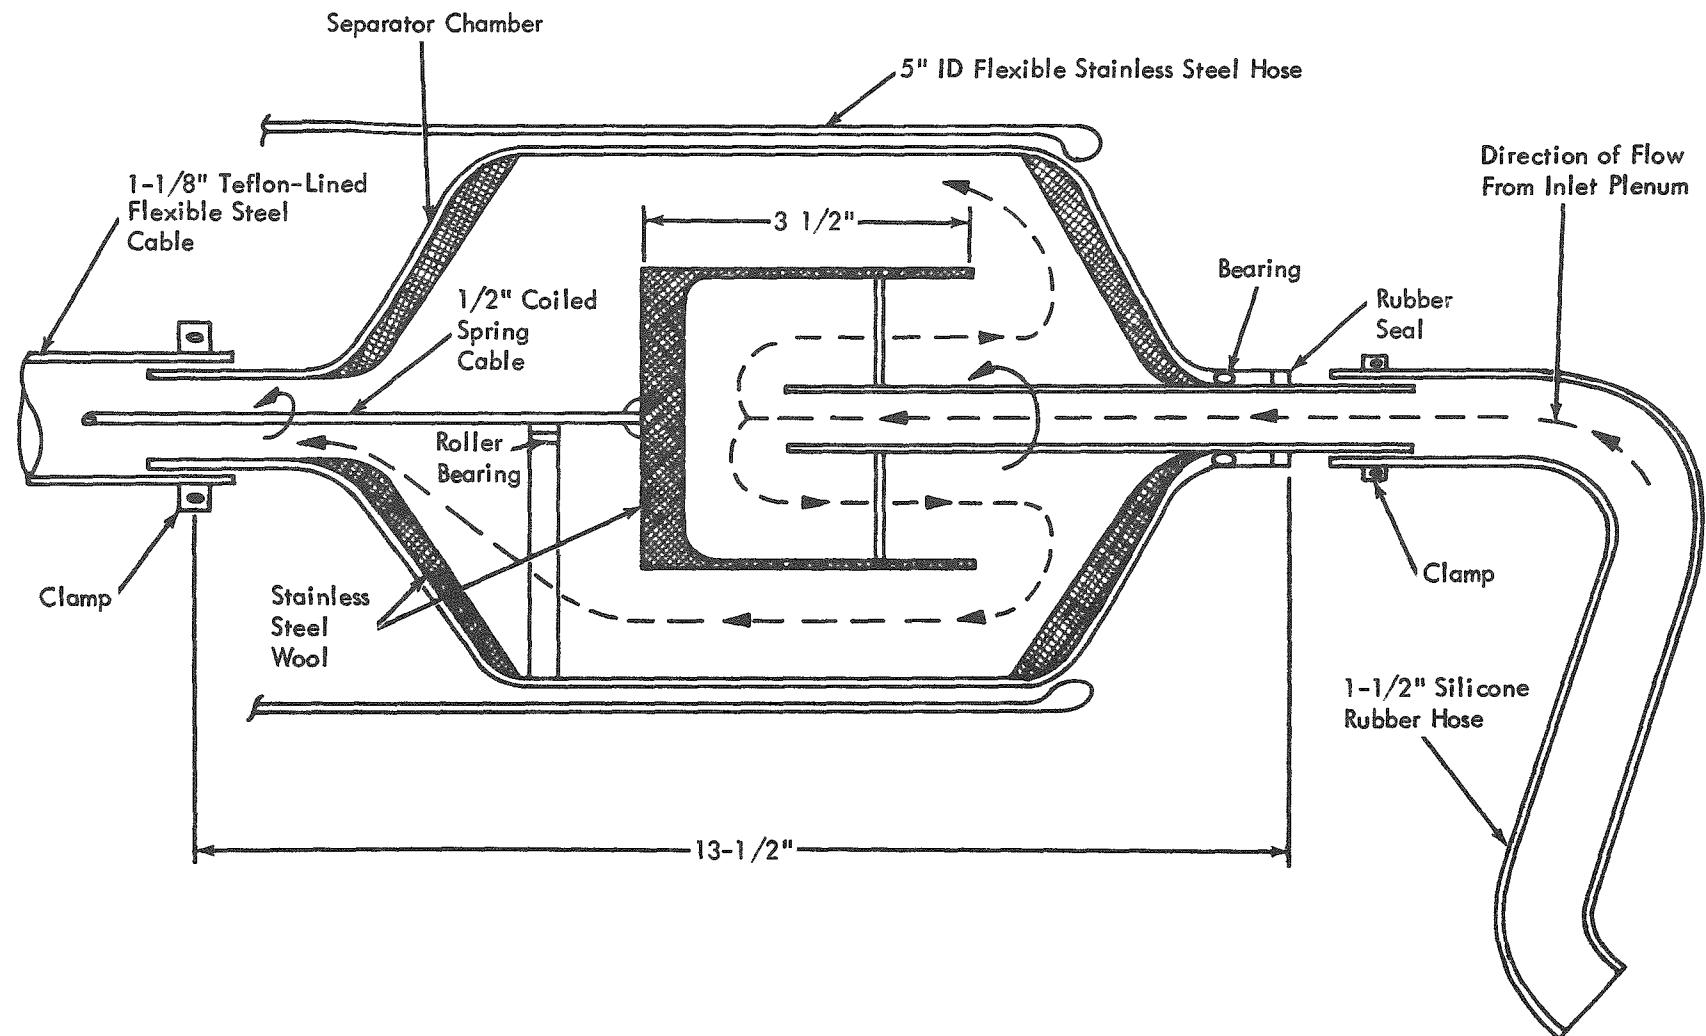
FIG. 6 VACUUM LINE WITH SEPARATOR CHAMBER

Figure 6 shows the concept of a vacuum cleaner-separator for insertion through the 14-inch inlet pipe to remove debris from the core inlet plenum. The design of this vacuum cleaner has been completed and the components are presently being procured and fabricated. Preliminary tests (see Sec. II, G-2) have given assurance that the plant waste gas system can be used as a vacuum source.

The separator chamber shown in Figure 6 is designed to remove and retain solid material and particulate matter by a double change in gas flow direction and impingement on stainless steel wool. Positioning the silicone rubber vacuum hose in the inlet plenum is accomplished by advancing or retracting the separator chamber inside a flexible aluminum carrier hose and by rotating the separator internal element to which the silicone rubber hose is clamped. Previous mock-up tests showed that the spine-type manipulator, when extended toward the outer area of the inlet plenum, was incapable of accurately positioning the silicone rubber hose.

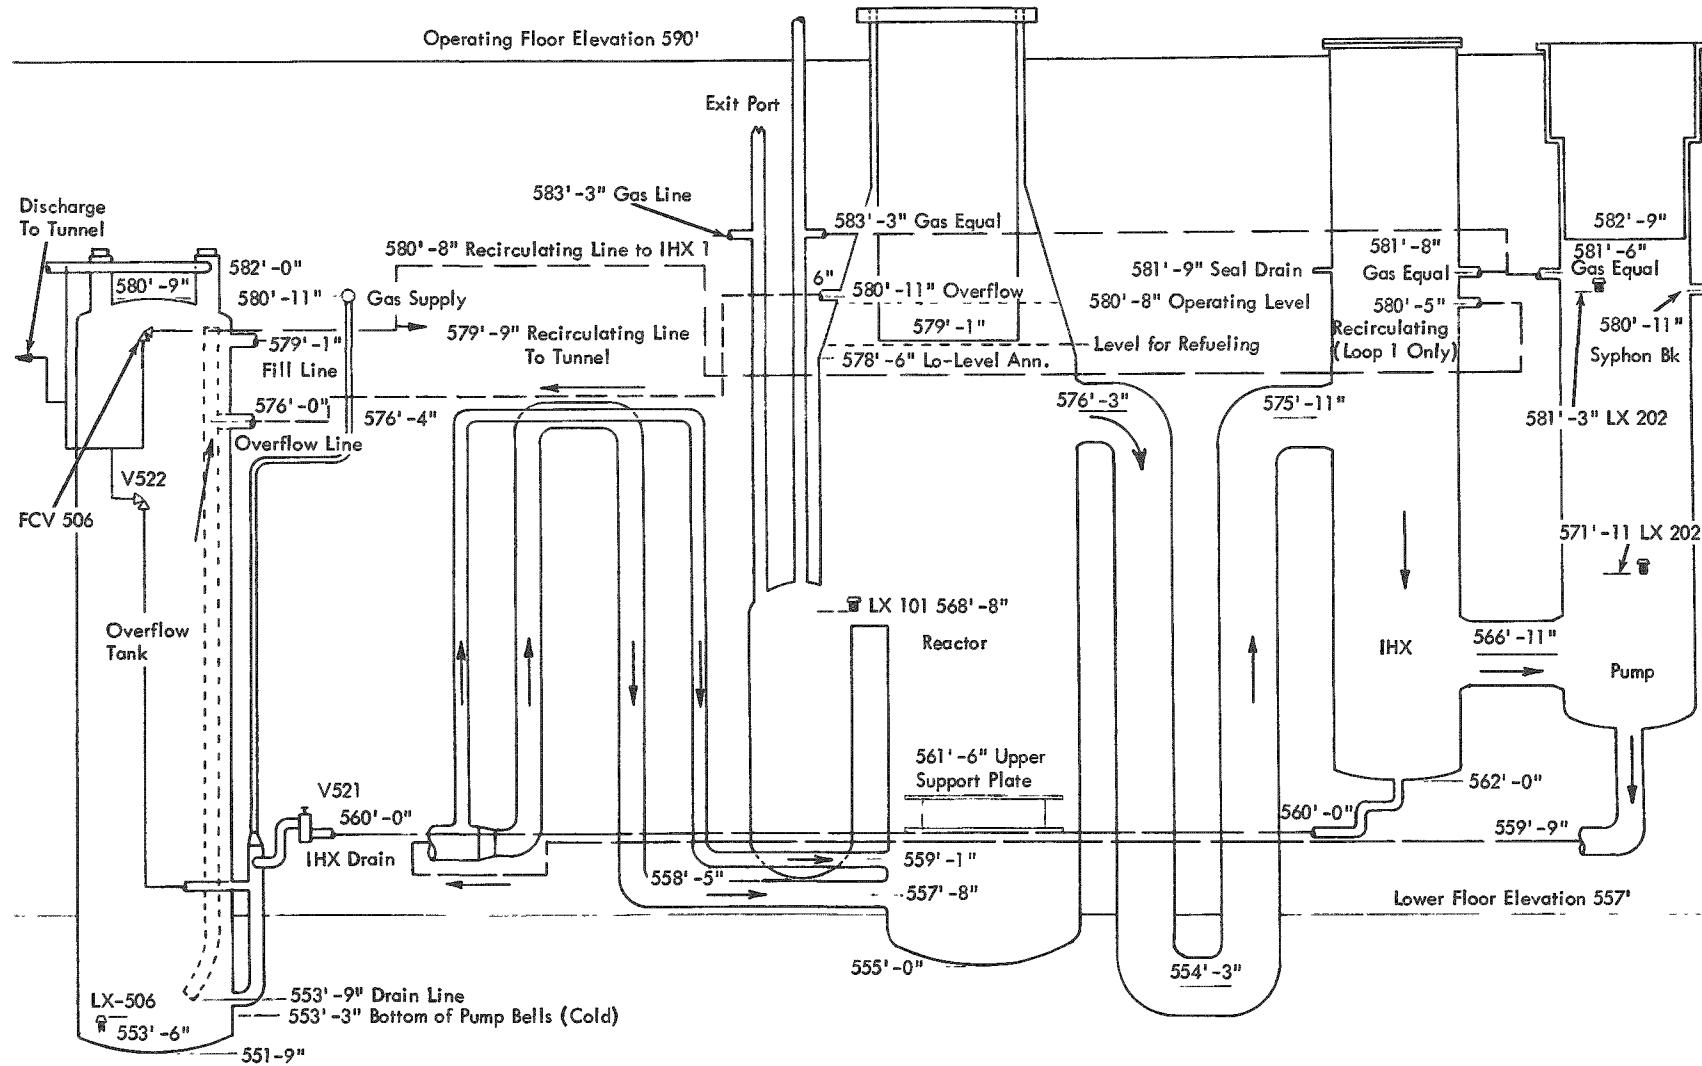
FIG. 7 PRIMARY SODIUM SYSTEM ELEVATION LAYOUT

In the manner of the August 1967 drain operation, the sodium level in the reactor vessel and the No. 1 primary loop was lowered from the operating level at an elevation of 580 feet 11 inches to an elevation of 575 feet (see Figure 7), at which point no further spill-over from the reactor vessel through the 30-inch discharge pipe was possible. The drop in

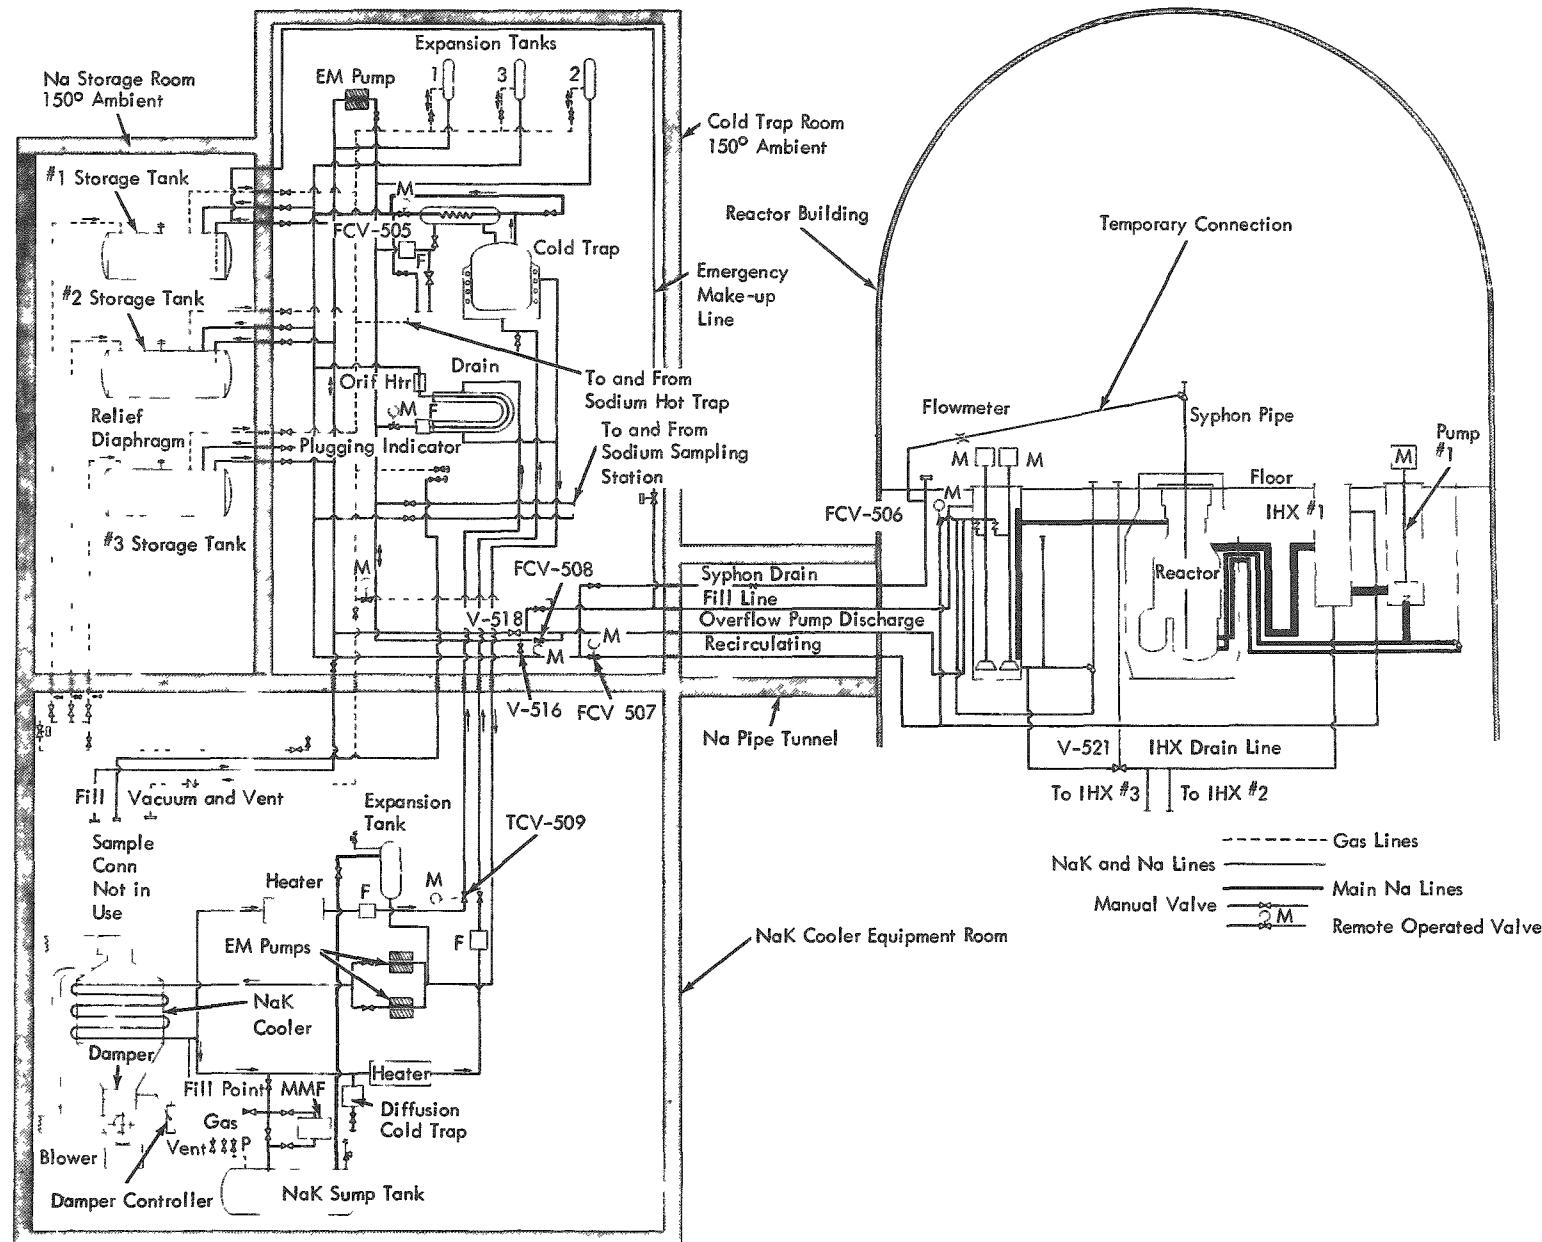
FIG. 8 PRIMARY SODIUM SERVICE SYSTEM FLOW DIAGRAM

sodium level was accomplished by alternate draining through the No. 1 IHX drain line to the overflow tank and the transfer by an overflow pump to the No. 2 and 3 storage tanks. The sodium level in the No. 1 primary loop was further decreased to an elevation of 572 feet by the same alternate drain-and-pump process. The balance of the sodium in the reactor vessel was transferred to the No. 2 and No. 3 storage tanks by siphoning action through a temporarily installed siphon pipe and temporary drain line which discharged through the plant siphon drain system (see Figure 8).

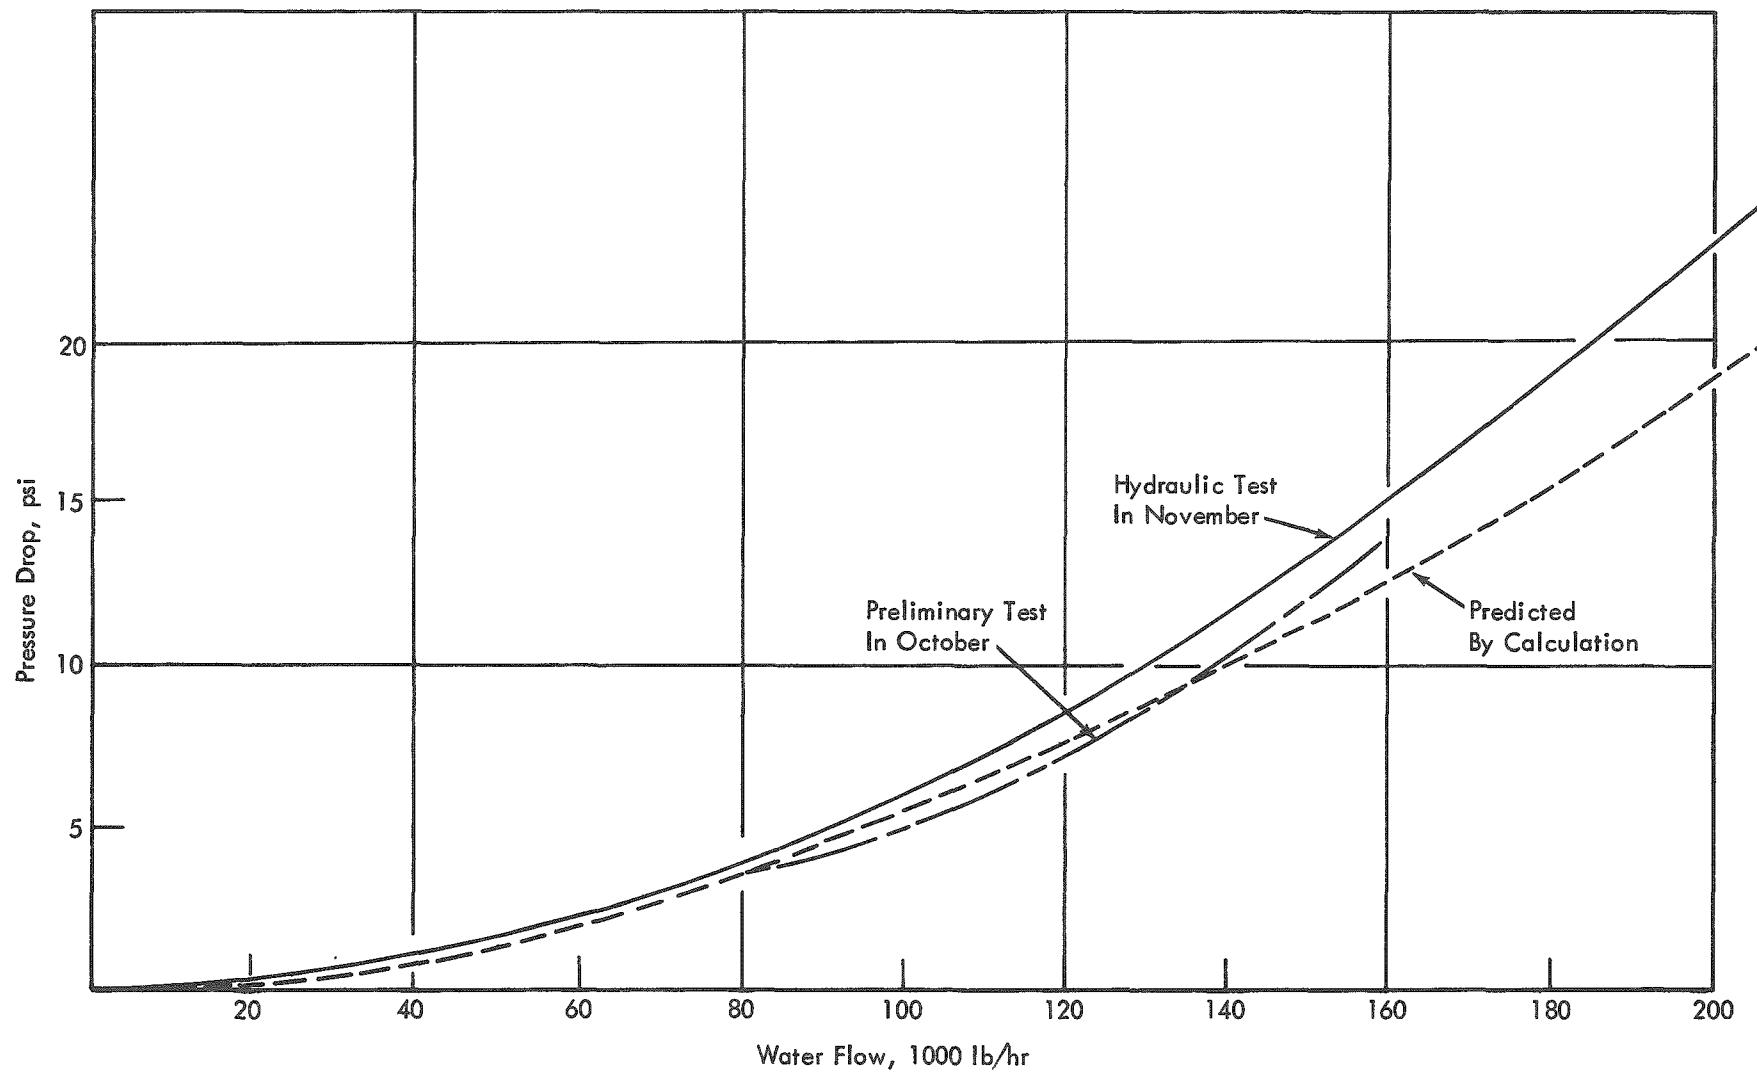
FIG. 9 FLOW- ΔP CHARACTERISTICS OF THE NO. 3 STEAM GENERATOR WITH TUBE ORIFICES INSTALLED

The first test, which was a preliminary one because precision instrumentation for measuring pressure drop across the steam generator was not then available, indicated that the actual pressure drops across the unit at various flows are less than those predicted by calculations made at that time. A review and subsequent refinement of the calculations resulted in a revised prediction of the flow- ΔP characteristics to be expected. Results of the preliminary test in October are in agreement with the revised prediction as shown in Figure 9.

In the second test, precision instrumentation for measuring pressure differential was used. Inlet feedwater conditions were 350 F temperature and pressures in the range of 930 to 960 psig. Flows ranged between 27,000 lb/hr and 210,000 lb/hr, the latter being the flow characteristic of 200 Mwt conditions. The test results are given in Figure 9 and are shown to be in agreement with the results of the first test and with the revised prediction of flow- ΔP characteristics.

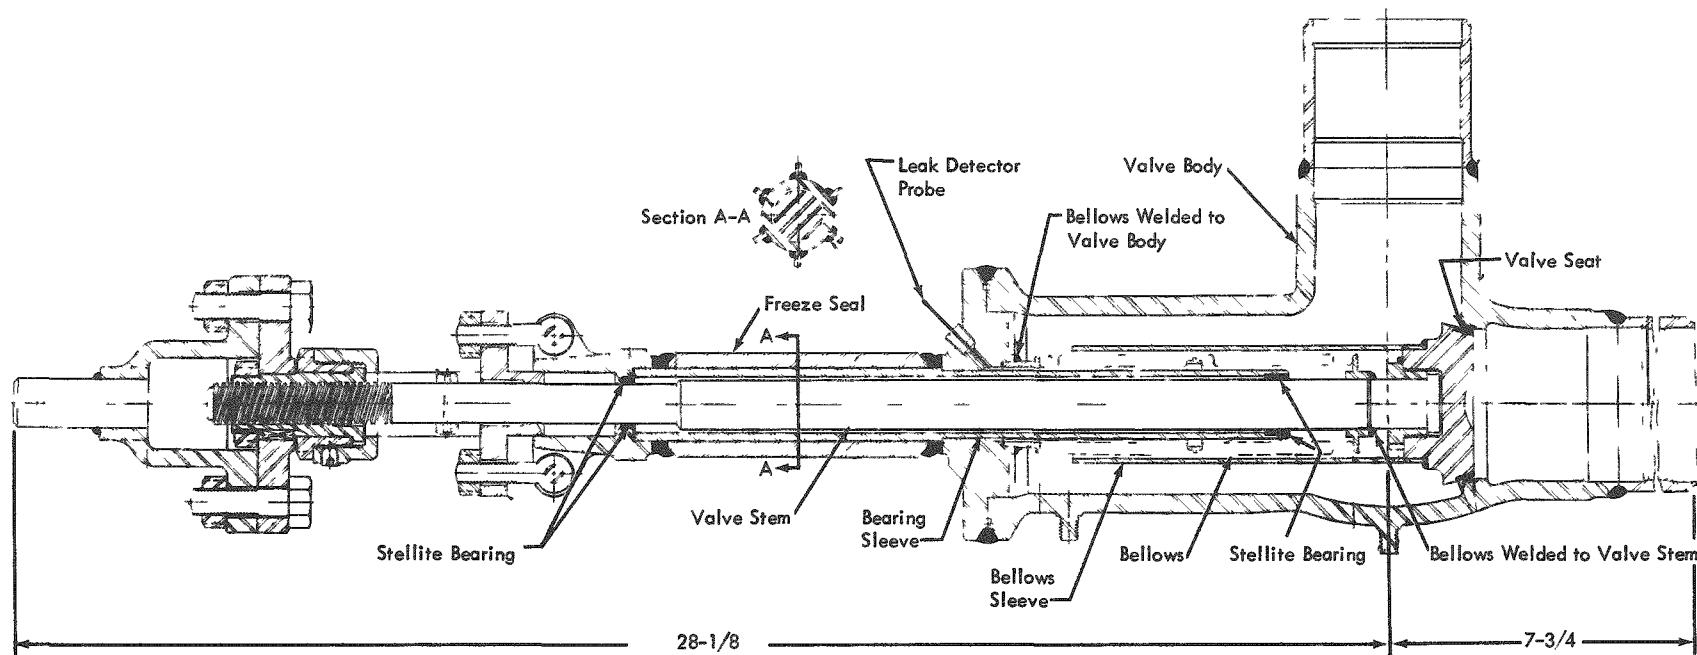
FIG. 11 DETAIL SKETCH OF TYPICAL PRIMARY SODIUM SYSTEM BELLows SEAL VALVE

During the life of the plant to date, there have been nine failures of bellows-type sodium valves. The bellows form a seal between the valve body and the moveable valve stem to maintain positive integrity of the sodium system in which the valve is installed. The bellows valve also has a freeze-seal feature which is the elongated valve stem housing maintained near ambient temperature. Any sodium leakage from the interior of the bellows would freeze in the stem housing and prevent the release of sodium to the atmosphere. Figure 11 shows the bellows and freeze seal features.

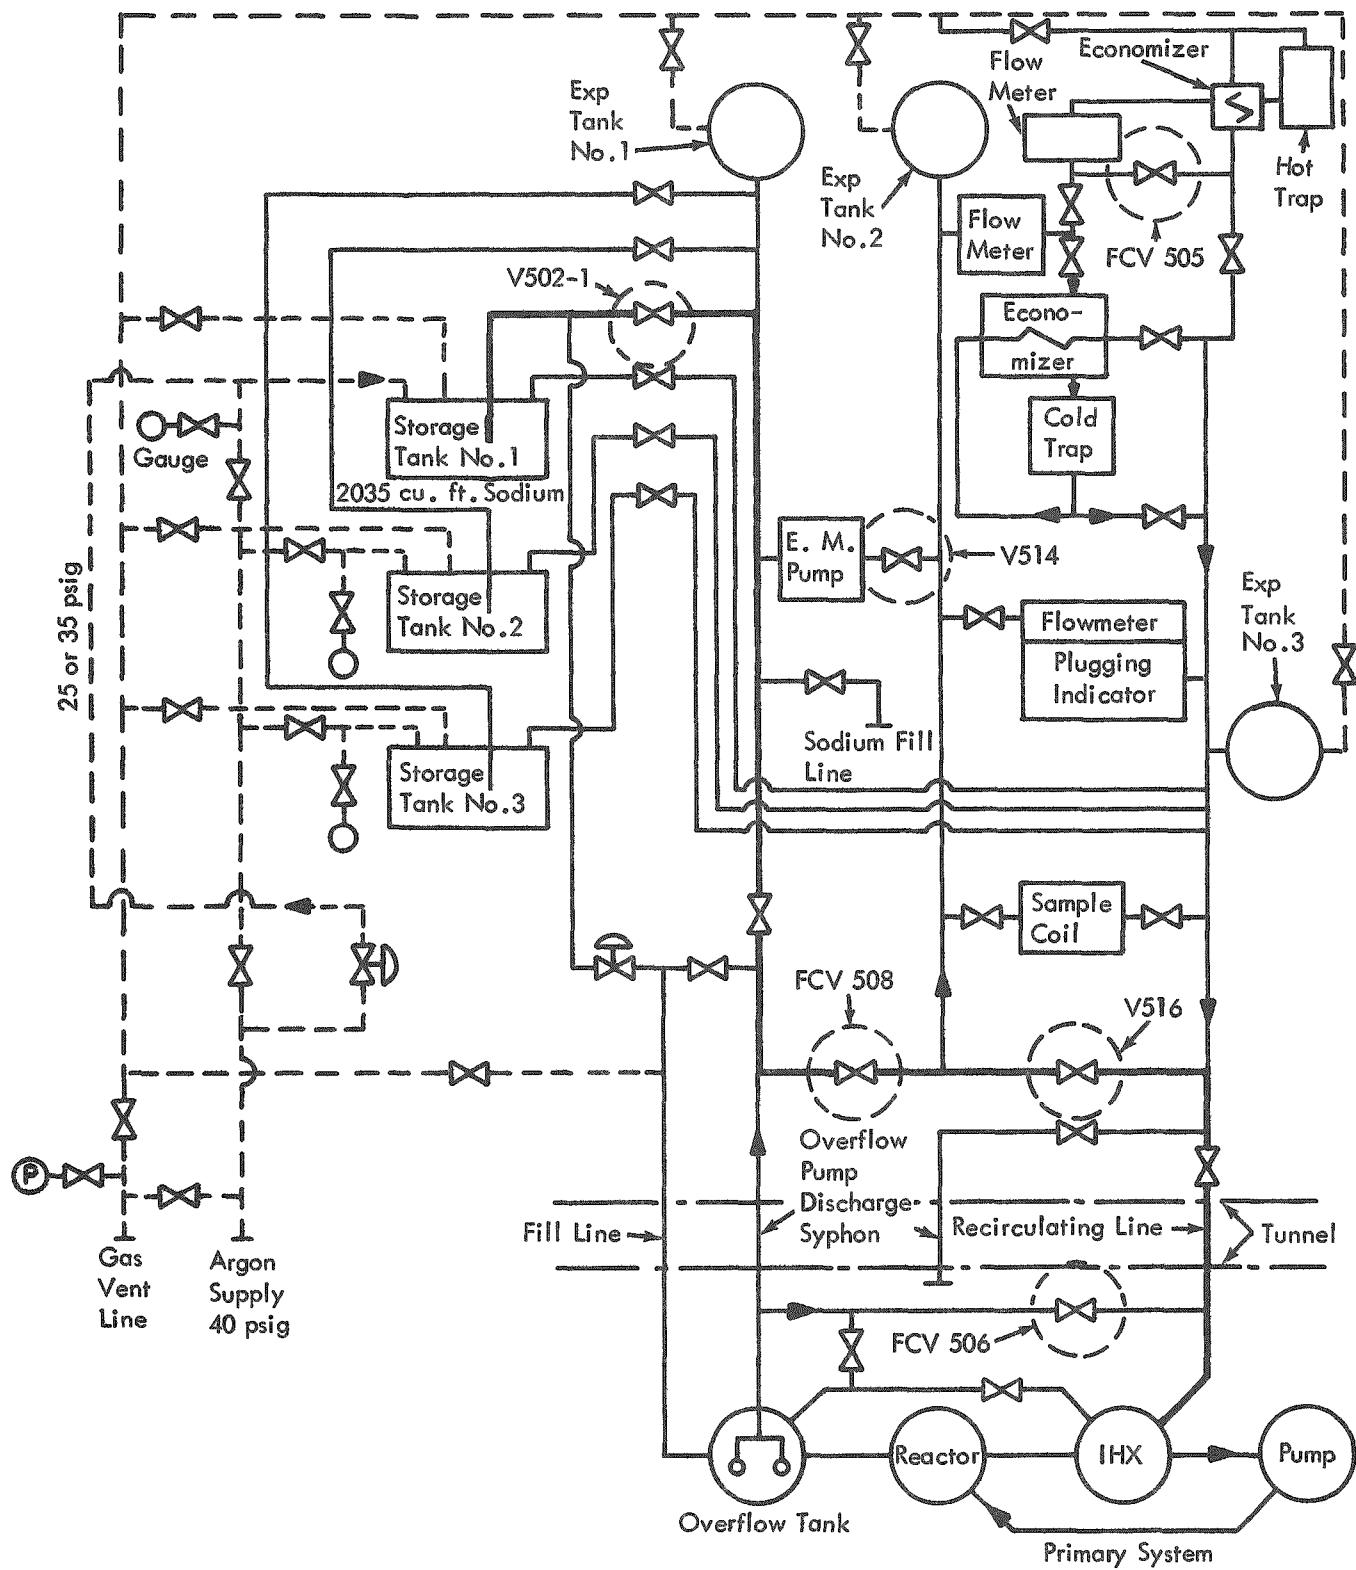
FIG. 12 SCHEMATIC DIAGRAM OF PRIMARY SODIUM SERVICE SYSTEM

Table I lists the bellows failures by valve number, the year in which failure occurred, and comments on the nature of failure. The comments are based on metallographic examination of the failed bellows. All of the 500 series valves are in the primary sodium service system and their locations are shown in Figure 12. There are about 30 primary sodium bellows valves. Valve V840 is in the secondary sodium system and FCV 509 is in the NaK cooling system for the primary sodium cold trap. The most recent bellows failures, in valves V502-1 and V516, were reported in APDA-CFE-21, page 39.

<u>Valve No.</u>	<u>Year Failed</u>	<u>Comments on Failure</u>
V 840	1961	Fatigue failure, possibly by vibration; no evidence of carburization in area of failure; in service 2 weeks
FCV 506	1961	Intergranular fatigue cracks not typical of Type 321 stainless steel bellows material but could be expected with the high carburization found. Carburization was evident on both inside and outside surfaces. In service 8 months
FCV 508	1961	Comments the same as for FCV 506 except that cracks appear to have been initiated from inside surface. In service about 1 year.
FCV 505	1962	Fatigue failure; cracks not intergranular; only slightly carburized; in service 33 months
V 514	1962	Mechanical abrasion; in service 39 months
FCV 506	1965	Crack initiated at inside wall; working of crack edges indicated cracks extended through bellows wall before service; in service 4 years and 4 months since last failure, above
TCV 509	1967	Valve returned to vendor for repair; in service 8 years

V 502-1	1968	Crack initiated from inside bellows; it is likely that crack was produced when bellows was formed and that stress relief eliminated evidence of cause; in service 8-1/2 years
V 516	1968	Same comment as for V502-1; in service 8-1/2 years
